Sea Link

Document 9.80: Integrated Geophysical and Geotechnical Survey Report - Extract

**VOLUME 4 - INTEGRATED GEOPHYSICAL & GEOTECHNICAL
SURVEY REPORT**

**SEA LINK
MARINE CABLE ROUTE SURVEY**

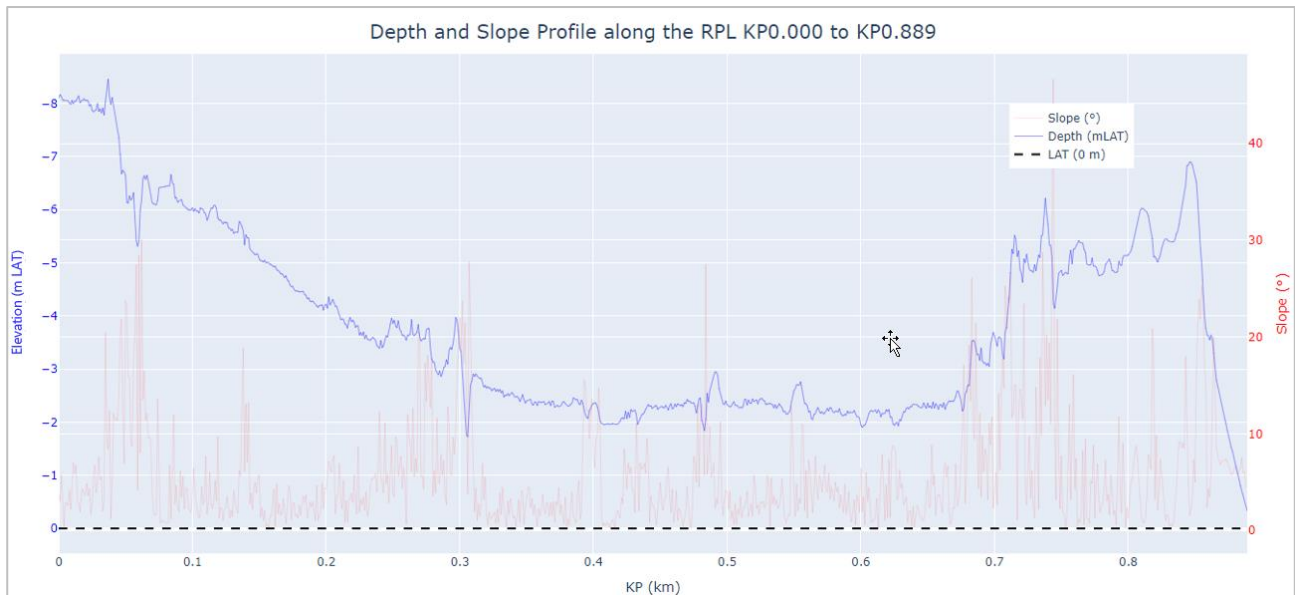
Figure 10-2: Aldeburgh Landfall Elevation and Slope Profile

The average slope along the route is less than 5° (4.54° - gentle according to gradient classification scheme). A maximum slope of 31.70° was observed at KP 0.743 on the shingle bank, representing a localized topographic feature (Figure 10-2).

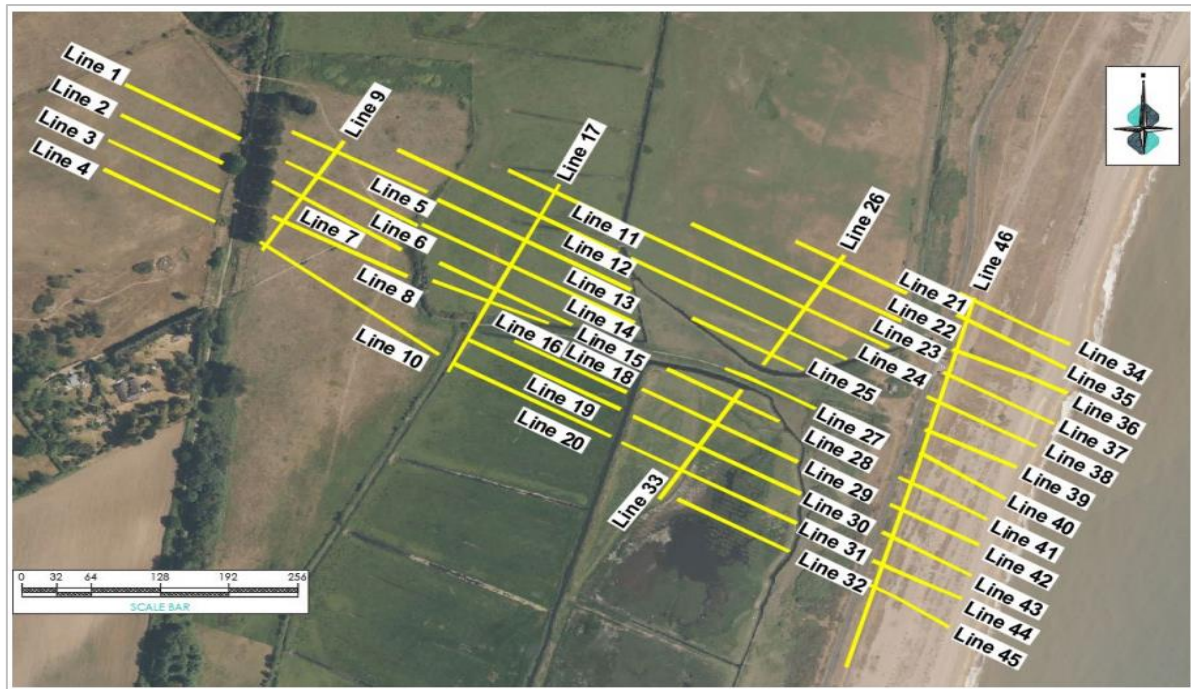
Figure 10-4: Seismic Refraction Survey Lines at Aldeburgh – Plan View

Interpretation	P-wave velocity (km/s)	Possible Lithology
Layer 1	0.35	Shallow, unsaturated, uncompacted sandy soils/sandy beach deposits
Layer 2a	1.2	(Beach) Unsaturated SANDs and GRAVELs or Red Crag deposits
Layer 2b	1.9	(RSPB & Farmland) Red Crag Formation (possible saturated/weathered interface on beach)

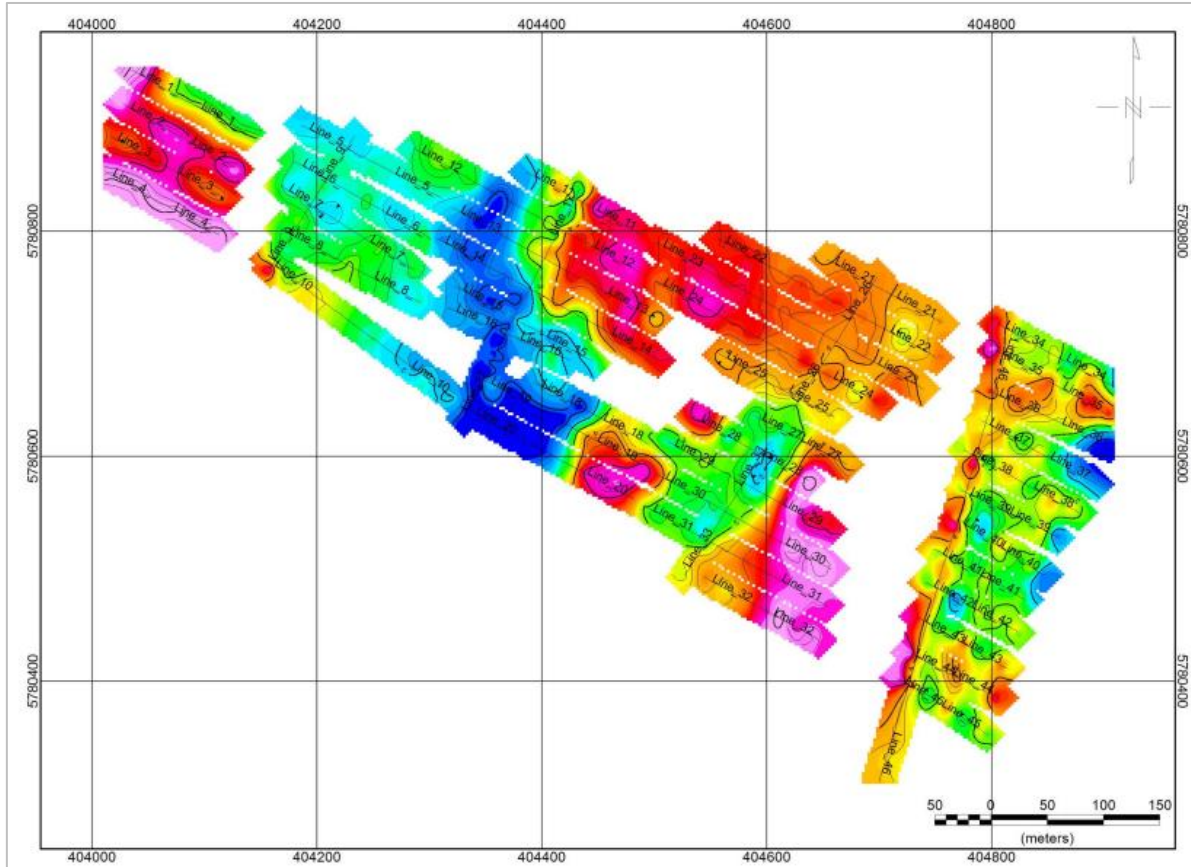
Figure 10-5: Isopach Diagram for Layer 1 (whole site)

Similarly, in the RSPB and adjacent farmland areas, a comparable two-layer configuration is observed. The upper layer (Layer 1), also with a velocity of 0.35 km/s, represents uncompacted, unsaturated sandy soils (Figure 10-5). The underlying layer (Layer 2b), with a higher velocity of 1.9 km/s, is interpreted as the Red Crag Formation. Across these areas, the top of Layer 2b lies between 3.4 m above LAT and 4.2 m below LAT.

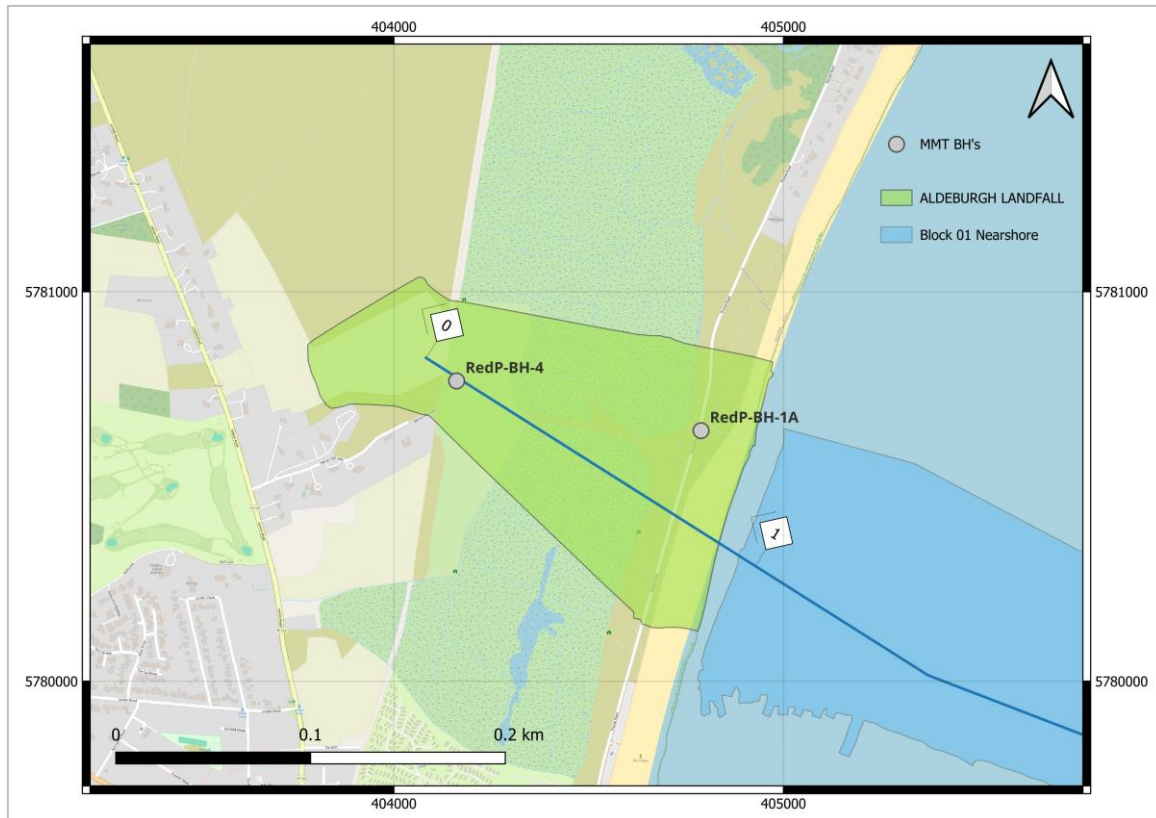
Figure 10-6 Location Plan for Aldeburgh Landfall Nearshore KP 0.000 to KP 0.900

Two cable percussive boreholes were undertaken by SSL along the new RPL alignment within the Aldeburgh landfall, these were RedP-BH-1A and RedP-BH-4. The locations are shown schematically below in Figure 10-6. Both boreholes reached the target depth of 30.00 m, with RedP-BH-4 reaching 30.45 m due to the final SPT test being undertaken at the base of the hole.

RedP-BH-1A (KP 0.696) is recorded as containing 1.50 m of Made Ground, overlying a 2.00 m thick bed of medium dense slightly silty sandy GRAVEL. A layer of very soft to soft CLAY is encountered from 3.50 m to 5.20 m, with a slight hydrocarbon odour recorded within these strata. A bed of spongy fibrous PEAT with strong hydrocarbon odour underlies the CLAY to a depth of 6.50 m. Medium to very dense SAND is encountered from 6.75 m to 24.70 m, underlain by firm to very stiff CLAY to the base of the hole at 30.00 m. A groundwater strike at 5.50 m is recorded during drilling, with the level rising to 2.50 m after a 20-minute period.

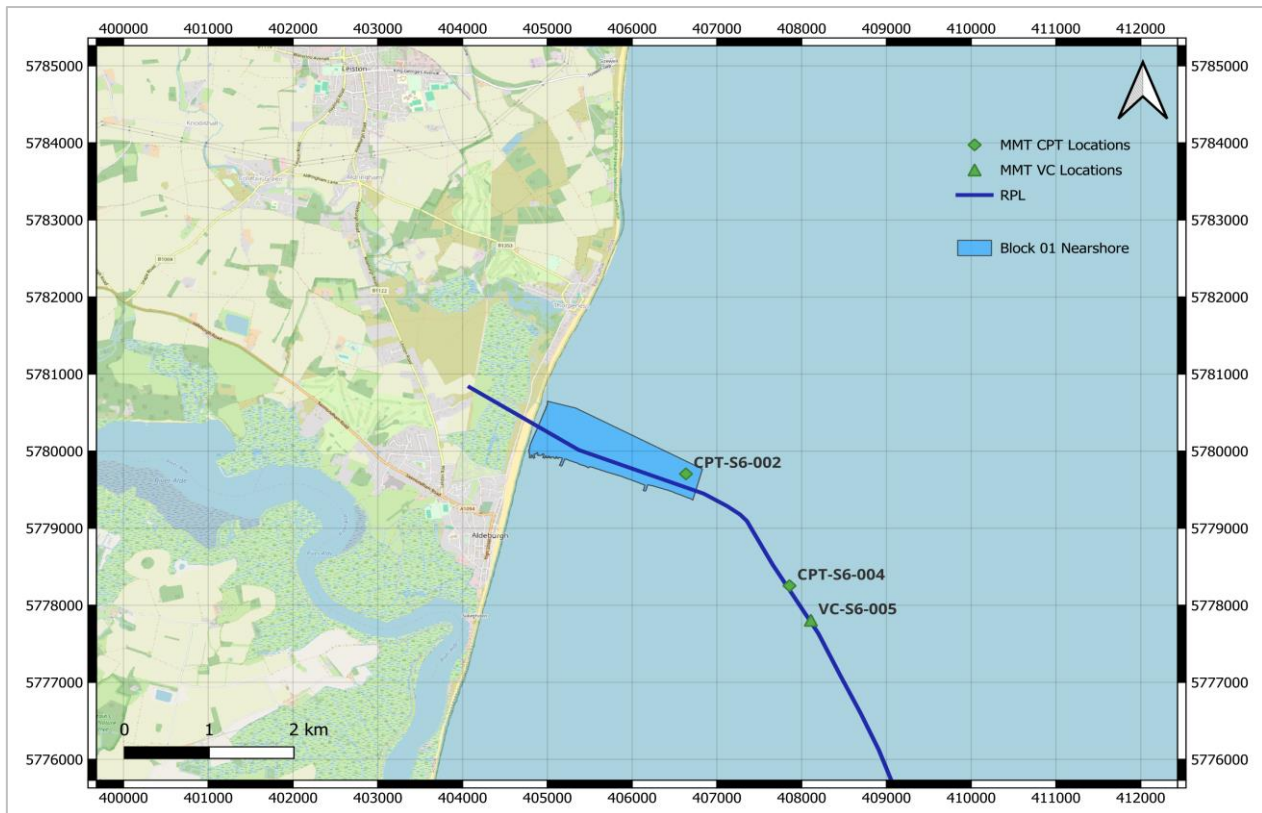
Figure 10-11: Location plan for Block 01 Nearshore KP 0.000 to KP 3.000

A single geotechnical location was undertaken within the nearshore section of Block 01, this was MMT location CPT-S6-002 at KP 2.815. The location is shown schematically below in Figure 10-11.

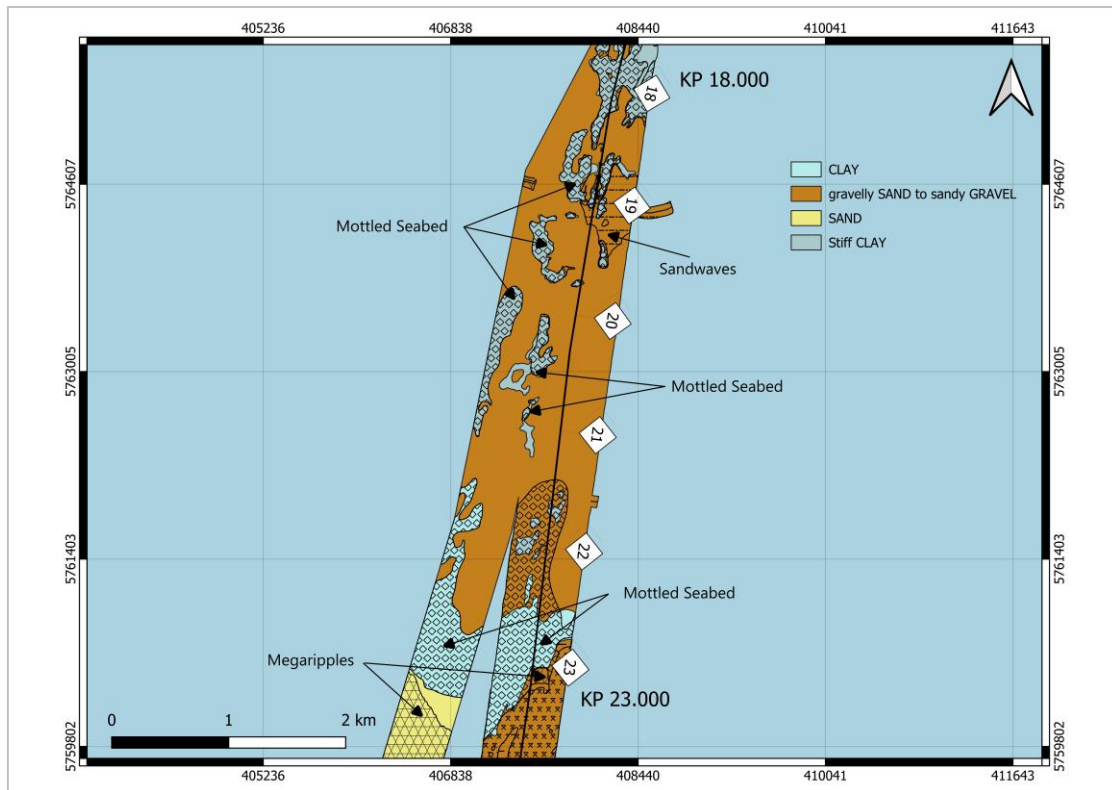
The surficial geology in Block 02 is composed of gravelly SAND to sandy GRAVEL, SAND, CLAY, and stiff CLAY. From KP 8.900 to KP 11.542, and again from KP 12.345 to KP 33.000, the surficial geology predominantly consists of gravelly SAND to sandy GRAVEL. Where encountered in geotechnical locations, this sediment is described as loose to medium-dense silty gravelly SAND and very sandy GRAVEL.

Exposed CLAY appears along the route from KP 12.155 to KP 12.345, KP 12.770 to KP 12.911, and from KP 22.605 to KP 23.026. It is described in CPT_002 as low-strength sandy gravelly CLAY. Additionally, patches of stiff CLAY are observed along the RPL from KP 10.014 – KP 10.019, KP 10.523 – KP 10.553, KP 10.604 – KP 10.648, KP 16.855 – KP 16.897, KP 17.780 – KP 18.248, KP 18.855 – KP 18.874, KP 19.023 – KP 19.029, KP 19.054 – KP 19.061, and from KP 21.658 to KP 21.727, as described in VC/CPT-016.

Notable seabed features along the RPL include areas of mottled seabed, observed from KP 11.318 to KP 11.542, KP 12.155 to KP 12.345, KP 12.774 to KP 12.911, KP 17.780 to KP 19.740, KP 21.419 to KP 23.206, and KP 32.490 to KP 32.878.

The route exhibits erosional feature between KP 23.270 – KP 24.038, KP 24.055 – KP 24.082, KP 24.106 – KP 24.250, KP 24.426 – KP 24.482, KP 24.554 – KP 24.627, KP 24.757 – KP 24.774, KP 24.873 – KP 26.418, KP 26.541 – KP 26.647, KP 26.728 – KP 28.791, KP 28.830 – KP 28.905, and from KP 28.948 to KP 29.012, which lies within the SAND sediments. Figure 10-21 to Figure 10-25 illustrate the seabed sediments and features present in Block 02.

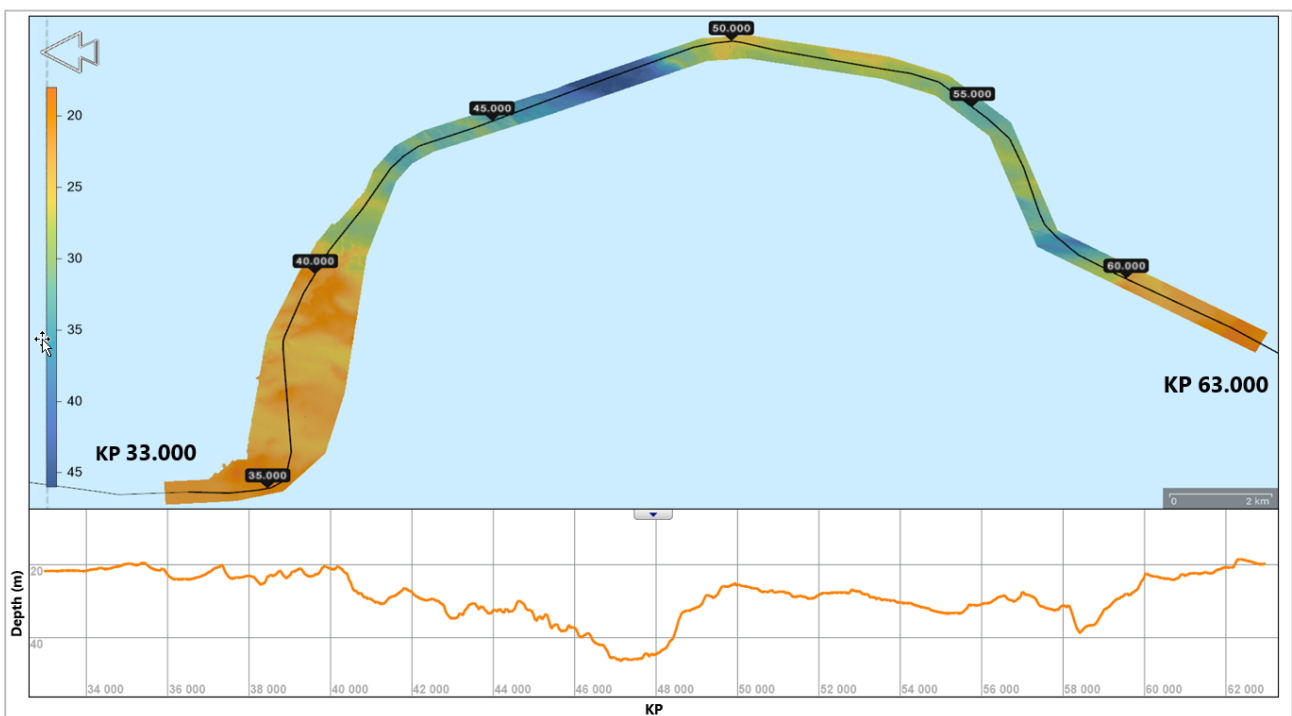
Figure 10-31: Overview of the Bathymetry in Block 03 between KP 33.000 and KP 63.000

The average seabed gradients along the RPL are less than 2° (1.05° - gentle according to gradient classification scheme). The maximum slope of 20.05° occurs at KP 49.964, an area characterized by ripples and megaripples (see Figure 10-32). A band of ripples extends across the route at KP 54.772, and from KP 57.900 onwards, the seabed rises in a series of undulations ranging from 37 meters to 20 meters in depth. These wave-like formations have an average wavelength of 1 km and amplitudes ranging from 1 to 6 meters.

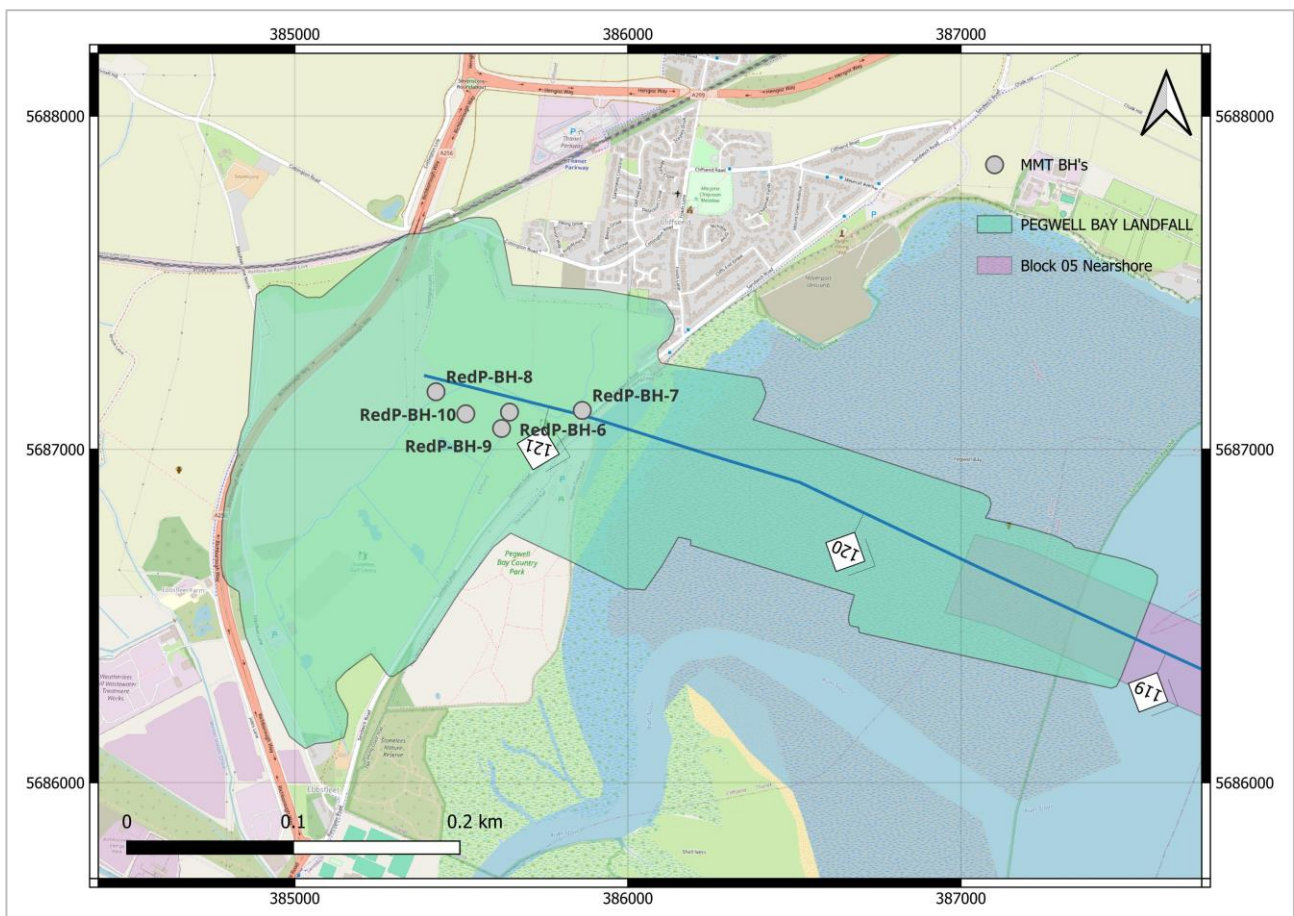
Figure 10-82 Location Plan for Pegwell Bay landfall between KP 119.323 to KP 121.382

Five cable percussive boreholes with rotary follow-on were undertaken by SSL along the new RPL alignment within the Pegwell Bay landfall, these were RedP-BH-6 to RedP-BH-10. The locations are shown schematically below in Figure 10-82.

RedP-BH-7 (KP 120.900) encountered 1.10 m of made ground at the surface, comprising CLAY with a mix of anthropogenic inclusions. Very soft to soft slightly sandy clayey SILT is recorded underlying the made ground to a depth of 1.75 m, transitioning into soft slightly sandy silty CLAY to 5.90 m. A bed of coarse flint GRAVEL is then present from 5.90 m to 6.10 m, at which point the cable percussive hole was stopped, with the borehole continued using rotary techniques. Sample recovery was poor between 6.10 m and 11.11 m, with the only material recovered being flint GRAVEL between 8.05 m and 8.18 m identified as the Bullhead Beds, and structureless CHALK composed of slightly sandy silty angular to subangular GRAVEL between 8.18 m and 8.50 m. Structureless CHALK composed of slightly sandy silty angular to subangular GRAVEL and COBBLES is encountered from 11.11 m to 12.48 m, transitioning to very weak to weak medium to high density CHALK to the base of the location at 31.00 m.
