# Sea Link

**Volume 6: Environmental Statement**

**Marine Archaeological Technical Report - Figures**

## Application Document 6.4.4.6.A Marine Archaeological Technical Report - Figures

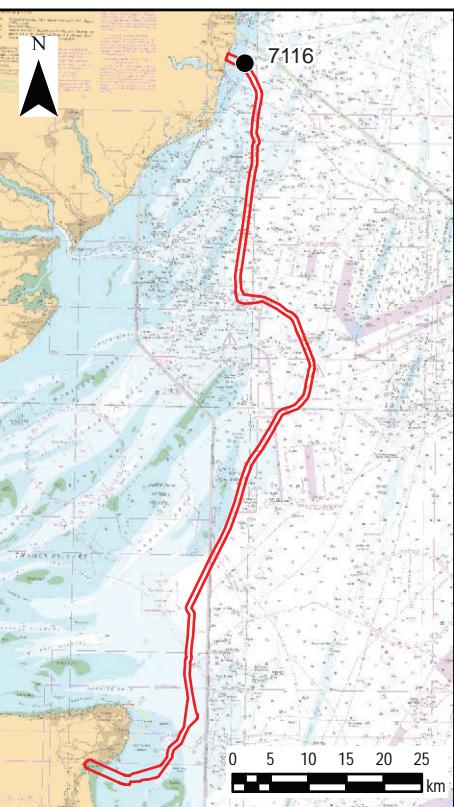
Sidescan sonar waterfall image of wreck 7116, 60 m range per channel

Build	Type	Unknown		
	Construction	Unknown		
	Dimensions (m)	Unknown		
	Shipyard	Unknown		
Loss	Cause	Unknown		
Extent of Survival	The wreck appears to be mostly intact with one end buried or highly degraded. The wreck is situated within an area of mobile sediments that may periodically conceal the wreck and any associated debris.

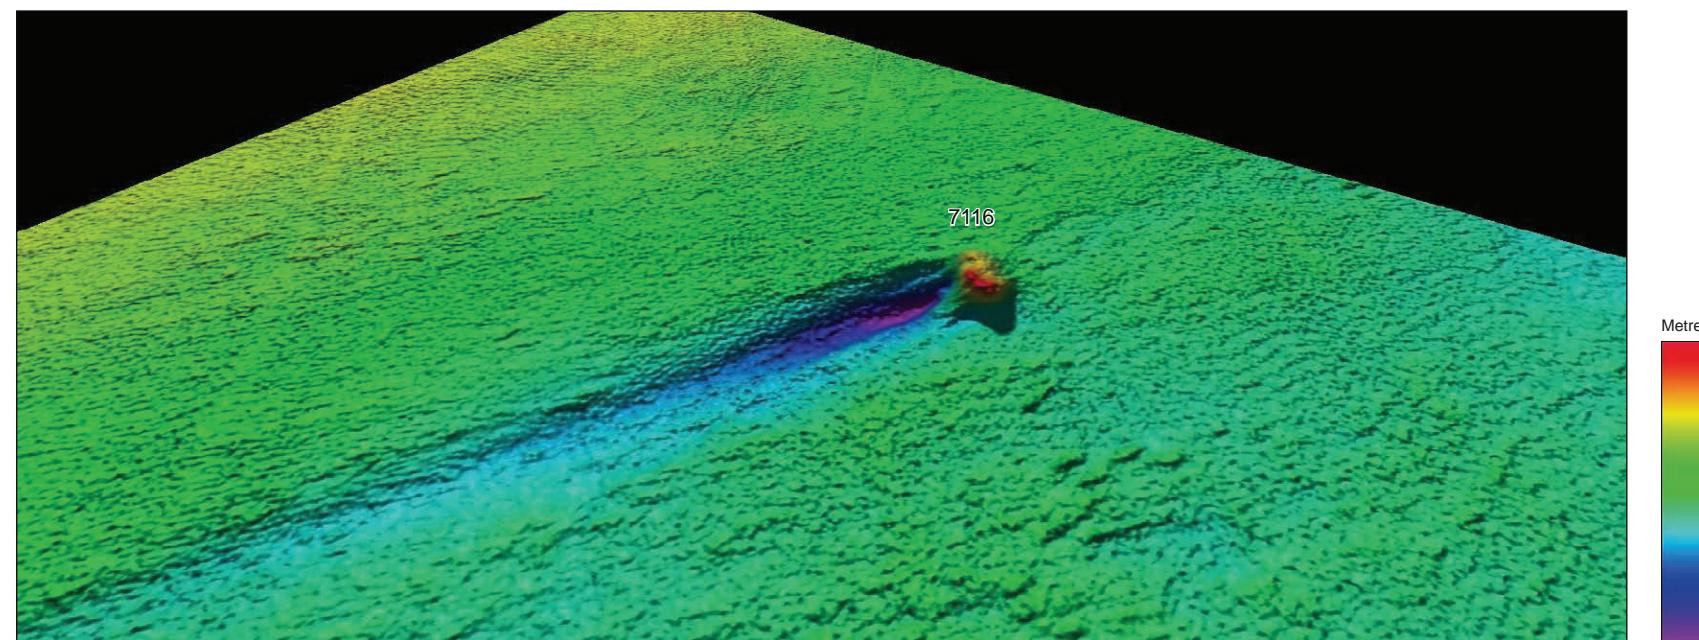
## ID 7116 – UKHO 87090 – Unknown

Location	407157 E 5779594 N	Area	Sea Link Offshore Block 1
Archaeological Importance	High		
Geophysical survey dimensions and notes		<p>Wreck 7116 is an unknown wreck that corresponds with a UKHO record (87090).</p> <p>The wreck is visible in the SSS data as an indistinct spread of dark reflectors with slight shadows; multiple angular objects are visible within an area of disturbed seabed. The wreck measures 15.5 x 8.4 x 0.7 m and its full extent may be buried.</p> <p>In the MBES data the wreck is visible as a large oval mound with an uneven peak, with distinct scouring to the south measuring 25.0 m long and approximately 0.5 m deep. The mound's edges are indistinct which may suggest it is partially buried.</p> <p>No anomalous features were identified in the Mag. data at this location.</p>	
Build	Type	Unknown	
	Construction	Unknown	
	Dimensions (m)	Unknown	
	Shipyard	Unknown	
Loss	Cause	Unknown

Extent of Survival		<p>In the UKHO record the wreck was first identified in 2017 and had recorded MBES dimensions of 10.2 x 5.0 x 1.0 m.</p> <p>In the 2021 geophysical data the wreck has no distinguishable characteristics, the larger 2021 geophysical dimensions may indicate the wreck has become more exposed since 2017. Associated scouring and sediment accumulation may indicate the wreck is periodically buried.</p>

MBES grid image, x 1 vertical exaggeration, looking north-west

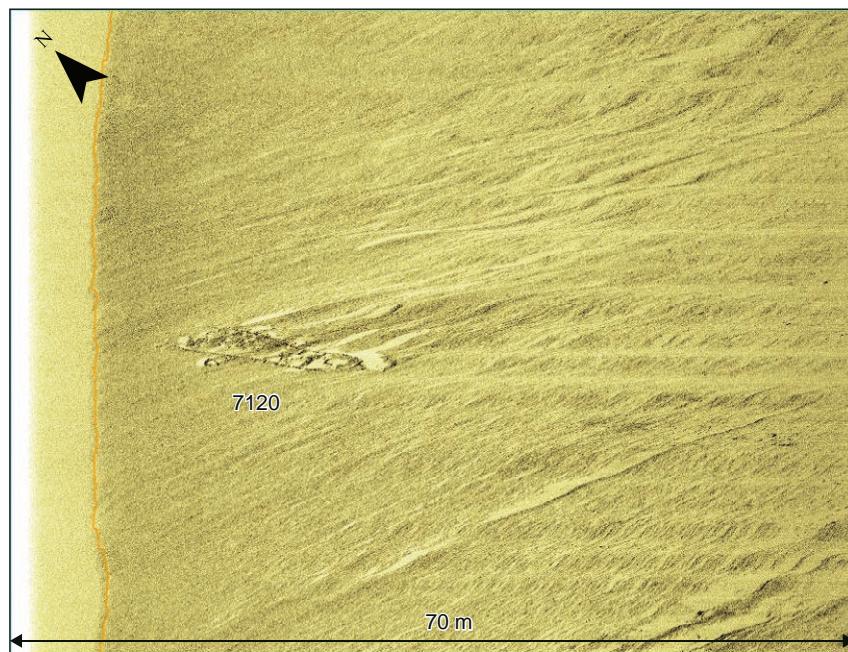
## ID 7120 – Unknown

Sidescan sonar waterfall image of wreck 7120, 70 m range per channel

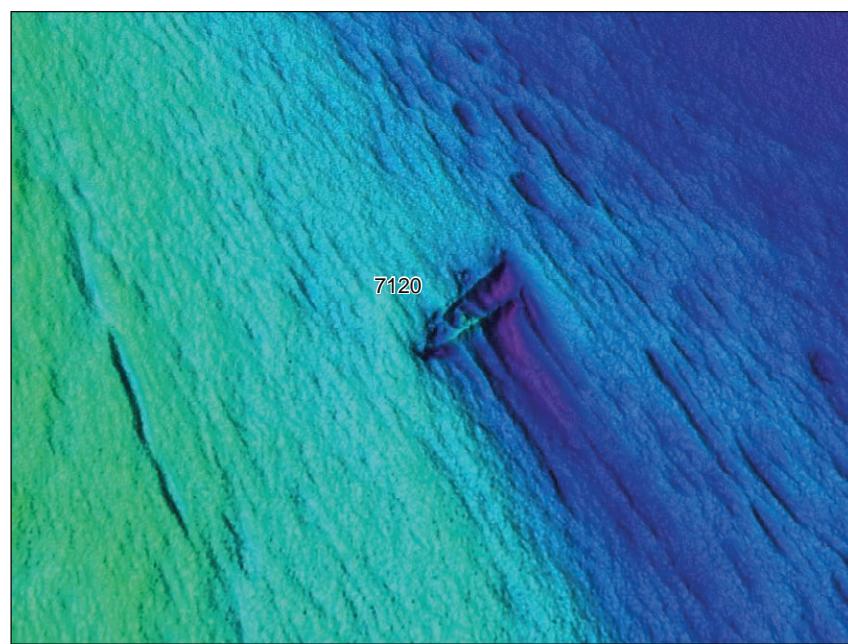
Mag profile image

MBES grid image, x 1 vertical exaggeration, looking north-east

Build	Type	Trawler	
	Construction	Unknown, likely steel	
	Dimensions (m)	48.8 x 7.9 x 4.3 m, 457 tonnes (gross)	
	Shipyard	Unknown	
Loss	Cause	Mine	
Extent of Survival		<p>Recorded by the UKHO as the wreck of HMS <i>Tervani</i>, a trawler built in 1914 and mined in 1916. The vessel had one boiler and a triple expansion engine. The wreck was last surveyed in 2017 and reported as being intact and partially buried, with MBES dimensions of 48.1 x 8.1 x 2.4 m.</p> <p>The wreck was only partially covered by the 2021 SSS data and the recorded dimensions suggest the wreck extends beyond the data extents. No discernible superstructure was visible; however, some linear features were identified which may be part of the deck.</p> <p>Objects identified in the vicinity of the wreck and interpreted as associated debris indicate it is broken up.</p>

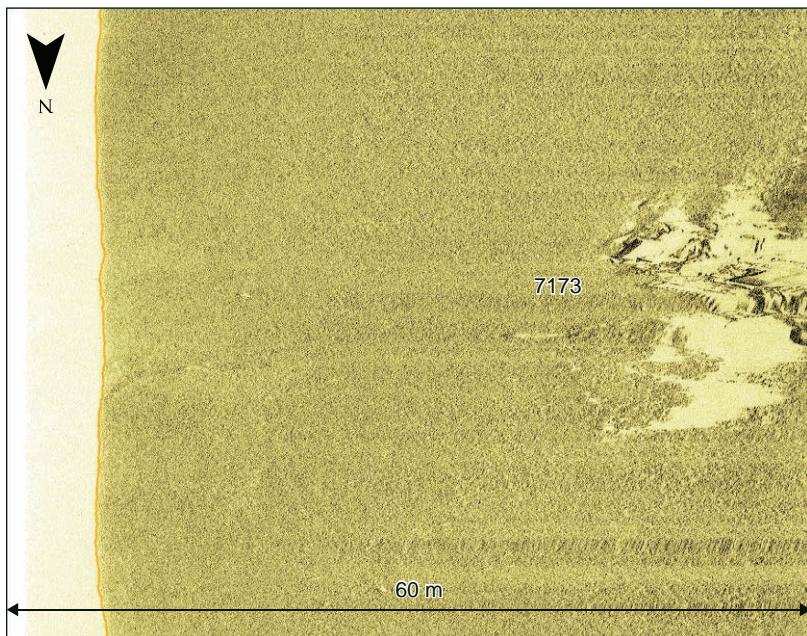
Sidescan sonar waterfall image of wreck **7173**, 60 m range per channel

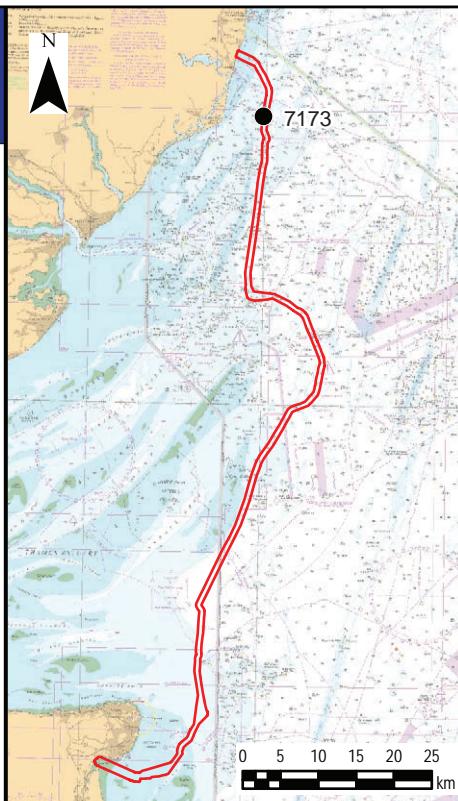
Mag profile image

Build	Type	Unknown	
	Construction	Unknown	
	Dimensions (m)	Unknown	
	Shipyard	Unknown	
Loss	Cause	Unknown	
Extent of Survival		<p>Associated with a UKHO record for an unknown wreck, last surveyed in 2017. It is described as a being largely intact and partially buried, with dimensions of <math>41.7 \times 6.5 \times 2.9</math> m.</p> <p>The wreck was partially covered by the 2021 SSS data and no discernible superstructure was visible. Objects identified in the vicinity of the wreck and interpreted as debris suggest it is broken up and highly degraded.</p>

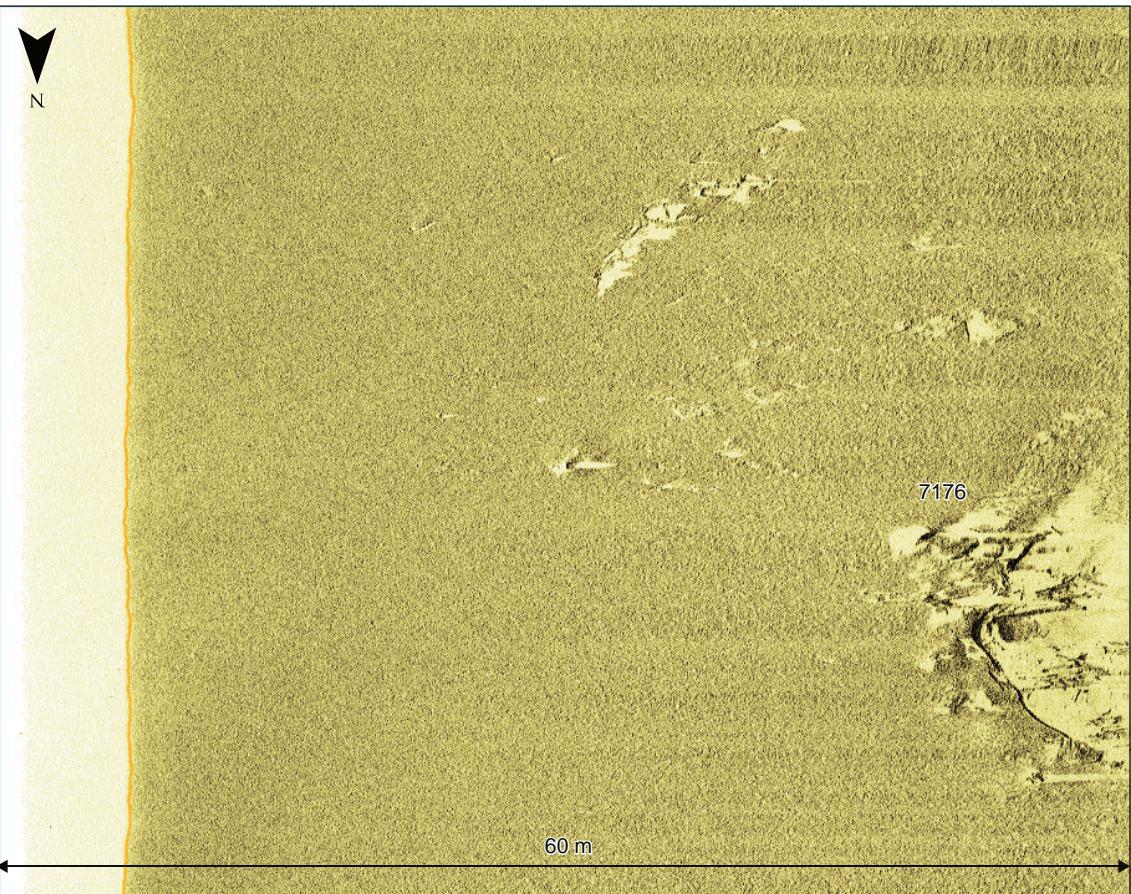
Sidescan sonar waterfall image of wreck **7176**, 60 m range per channel

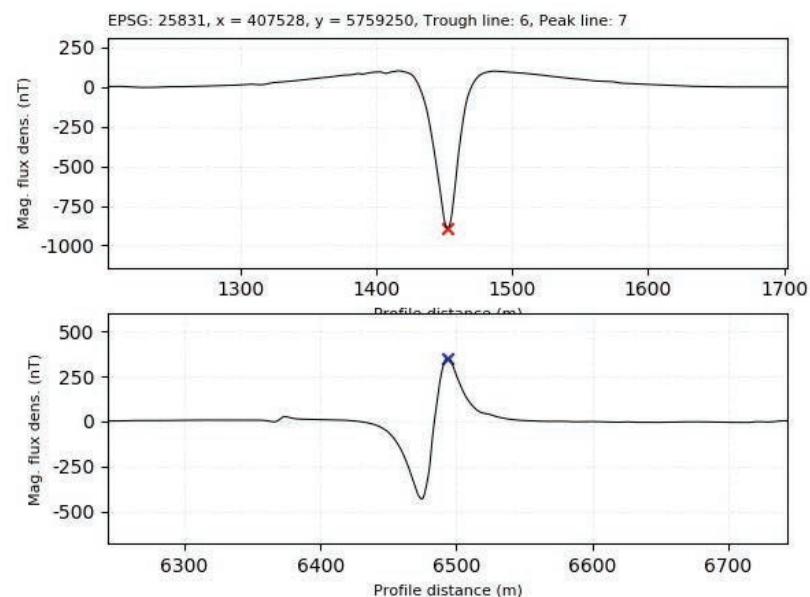
Build		<p>Type</p> <p>Construction</p> <p>Dimensions (m)</p> <p>Shipyard</p>	
Loss		<p>Cause</p> <p>Unknown</p> <p>Recorded in the UKHO as a 'dangerous wreck'. The wreck was last surveyed in September 2019, described as a partially buried wreck and broken apart. The dimensions were noted as 23 x 22.4 x 6.5 m. This differs from a previous survey on 31<sup>st</sup> December 1976, where it was noted, there is 'no sign of breakup' and no scour, suggesting the wreck is slowly disintegrating. In a previous survey on 13<sup>th</sup> December 1995, it was noted that the wreck 'appears to be netted'. This is hard to confirm from the data.</p> <p>In the data the wreck appears to be quite coherent, although the southwest of the wreck does look like it has some minor disintegration. In various surveys since 1976, the measurements of the anomaly have changed markedly, and it is visible in the data that the wreck is surrounded by sand waves, suggesting that the nearby seabed is active and regularly buries other pieces of debris.</p>

Mag profile image

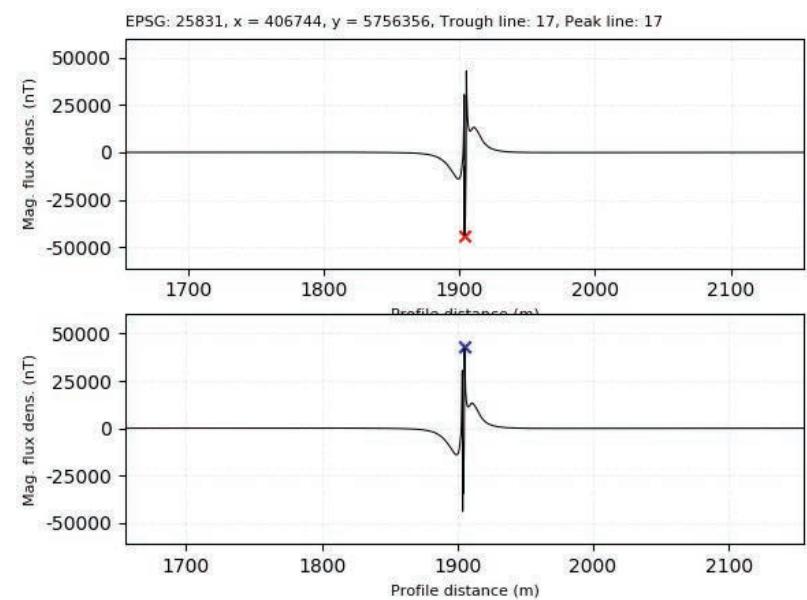
Build	Type	Steamship	
Build	Construction	Likely steel hulled, due to magnetic anomaly	
Build	Dimensions (m)	82 x 12.8 x 5.5 m	
Build	Shipyard	FREDRIKSTAD MEK VAERKS, FREDRIKSTAD	
Loss	Cause	Struck a mine and later sank whilst on tow, 28/02/1942	
Extent of Survival		<p>Recorded in the UKHO as a 'dangerous wreck' of the steam ship <i>Thyra</i> built in 1925 in Fredrikstad Mek Vaerks, Fredrikstad. It struck a mine on 28<sup>th</sup> February 1942 on passage from Hartlepool for London with a cargo of timber. It sank after being taken in tow.</p> <p>The wreck was last surveyed in September 2015, described as lying on its port side. The dimensions were noted as 84 x 20 x 9.6 m, like those recorded in the modern survey data. In a survey on 20<sup>th</sup> December 1995, it was noted that the wreck is netted. This is hard to confirm from the data.</p> <p>The structure of the wreck in the survey data appears to be coherent. The presence of a large void in the MBES data, down the length of the hull, shows that some degradation is taking place, with part of the hull potentially splitting away from the rest of the wreck. There are several seabed disturbances and debris fields of angular dark reflectors surrounding the wreck, further evidence of its ongoing disintegration. Surviving internal structure is visible in the MBES data, and in the SSS data as elongate dark reflectors.</p> <p>A dive on the wreck in September 1987 had to be cancelled due to a "Strong upswelling" in the area, with "Sand, shingle and shell being disturbed". This, combined with the data showing considerable scour suggests the seabed around the wreck is highly active. The reflectivity of the wreck is varied on the eastern end, suggesting it is partially covered with sediment.</p>

Mag profile image

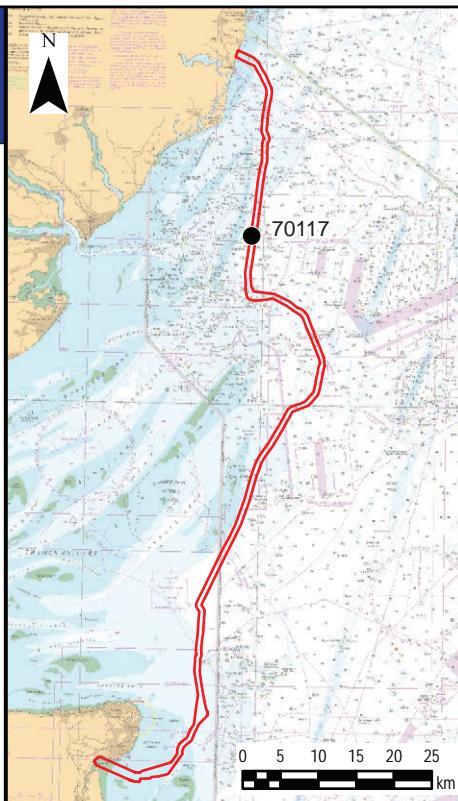
MBES grid image, x 1 vertical exaggeration, looking north

Build	Type	Submarine	
	Construction	Steel	
	Dimensions (m)	34.1 x 3.0 m	
	Shipyard	Vulkanwerke, Hamburg	
Loss	Cause	Mine	
Extent of Survival		<p>Recorded as UC11 (Possibly) in the UKHO and NMHR records, a German minelaying submarine that sank in 1918 after running into one of its own mines. The wreck is reported as being upturned, with a strong magnetic anomaly associated. The wreck was last surveyed in 2016 and described as being broken up with dimensions of 27.0 x 11.0 x 4.3 m. The UKHO record suggests that the wreck may have been salvaged in the past.</p> <p>In the 2021 geophysical data the wreck appears to be degraded and broken up. One piece of superstructure is visible, possibly the conning tower, although the UKHO record suggests the wreck is upturned, so may be a rudder, the hull is also highly degraded. The wreck is situated in an area of mobile sediments and it may periodically be buried. Associated debris has been identified in the vicinity of the wreck and there is potential for further debris to be buried.</p>

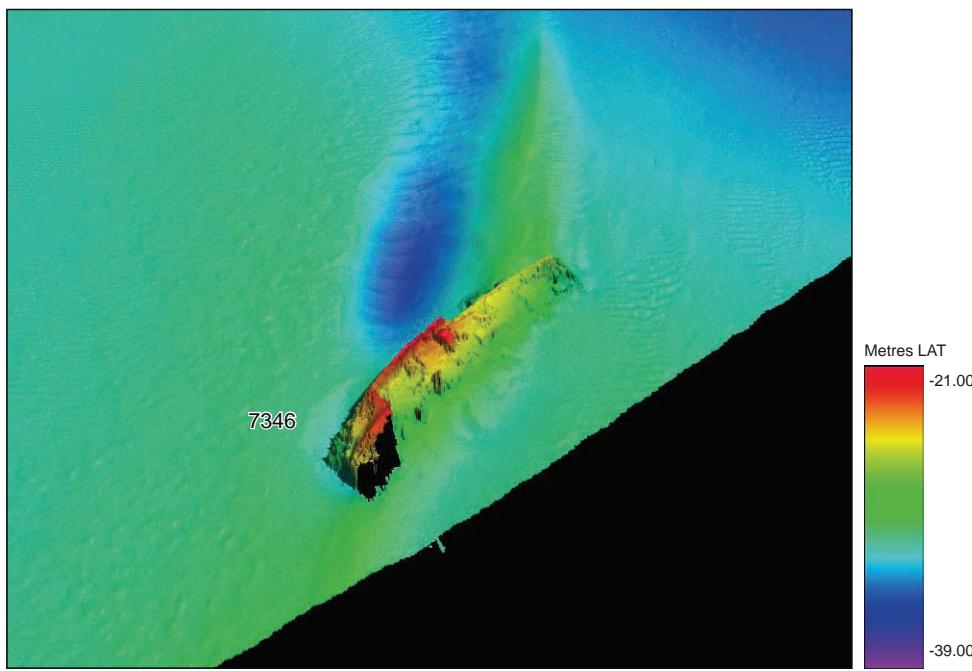
Sidescan sonar waterfall image of wreck 7346, measuring 70 m range per channel

MBES grid image, x 1 vertical exaggeration, looking south

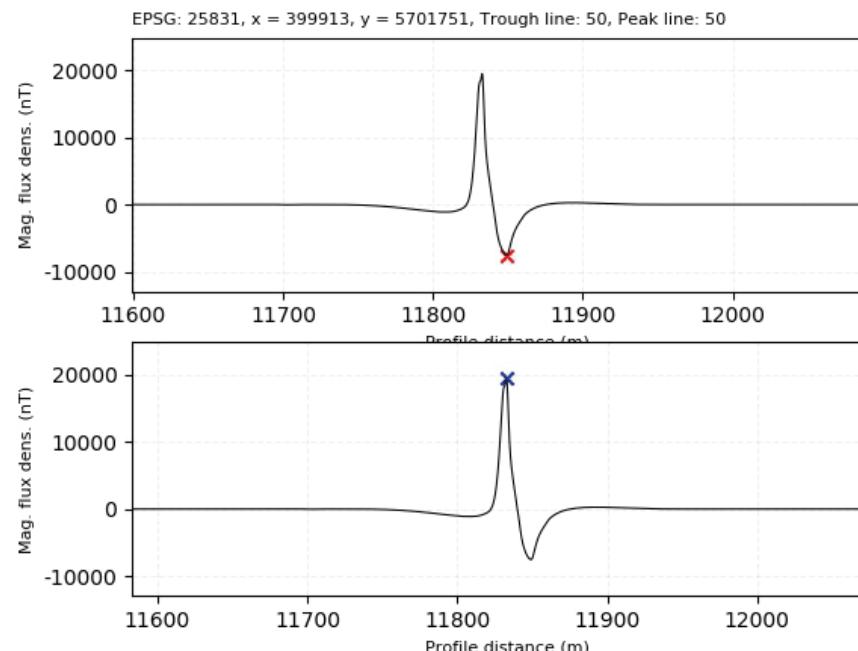
Build	Type	Steam ship	
	Construction	Unknown, likely steel	
	Dimensions (m)	106.7 x 12.2 x 7.0 m	
	Shipyard	Unknown	
Loss	Cause	Sunk by German submarine	
Extent of Survival		<p>Recorded by the UKHO and NMHR as <i>Saidieh</i>, a 3303 gross ton steam ship built in 1878. The vessel was sunk in 1915 by UB6, a German submarine. The wreck was last surveyed in 2017 and described as being partially broken up and buried with dimensions of 112.5 x 21.1 x 5.8 m.</p> <p>The larger geophysical dimensions in the most recent survey may indicate the wreck has collapsed, degraded further, or become more exposed since 2017. The wreck is situated on a relatively featureless area of seabed, but it has substantial sediment accumulation around it and it may periodically be buried. Associated debris has been identified in the vicinity of the wreck and further debris may be buried.</p>	
<p>EPSG: 25831, x = 399913, y = 5701751, Trough line: 50, Peak line: 50</p>

<p>Mag profile image</p>

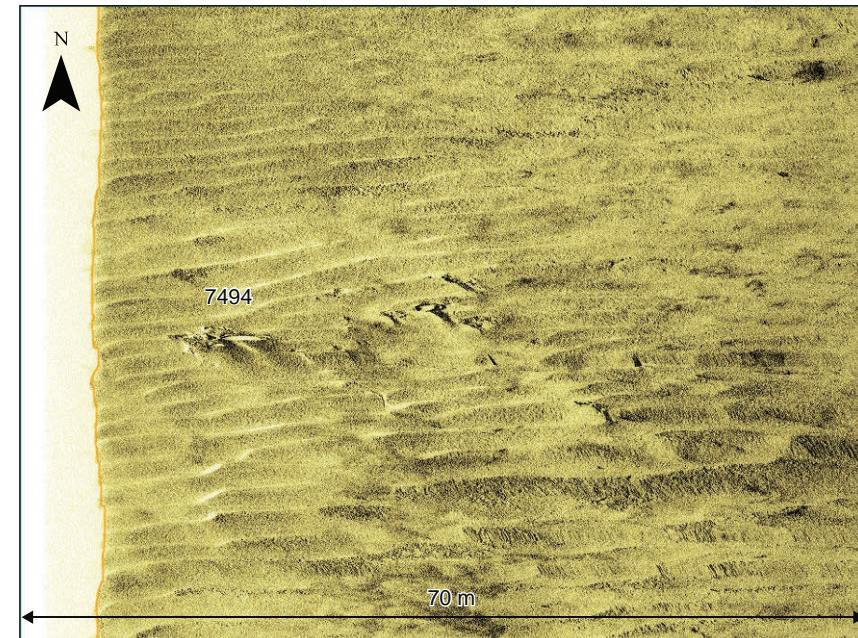
Type	Steam Ship				
Construction	Unknown, likely steel				
Dimensions (m)	45.7 x 7.6 x 5.2 m				
Shipyard	Unknown				
Loss	Cause	Mine			
Extent of Survival		<p>Recorded by the UKHO as <i>Klar</i>, a 518 gross ton steam ship that struck a mine and sank on passage from Tyne to Rouen in 1915. The wreck was last identified in 1997 with measurements of 50.0 x 45.0 x 1.0 m with scour extending for 65.0 m. The wreck was not identified in a MBES survey in 2018 and the record was amended to dead.</p> <p>In the 2021 geophysical data the wreck appears very broken up and degraded with no identifiable structure visible. The wreck is situated within sand waves and may be periodically buried, which may explain why it was not identified in 2018.</p>

Sidescan sonar waterfall image of wreck 7494, 70 m range per channel

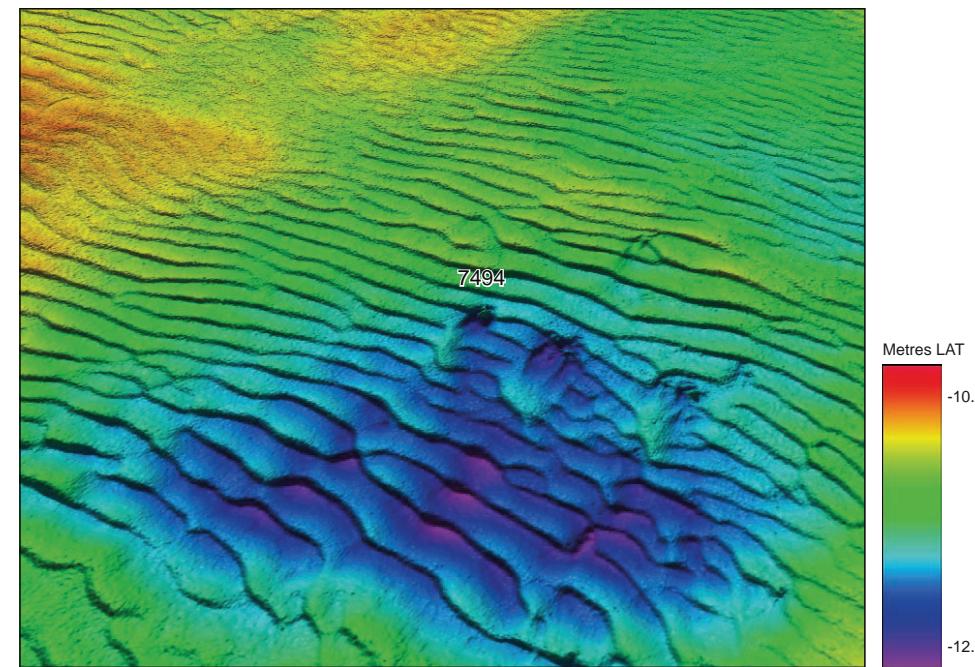
MBES grid image, x 1 vertical exaggeration, looking north-west

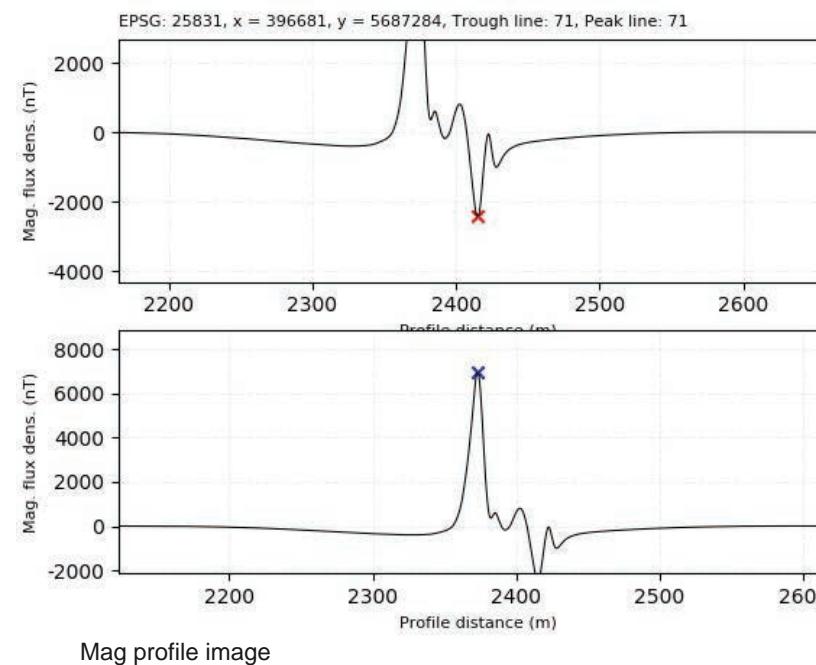
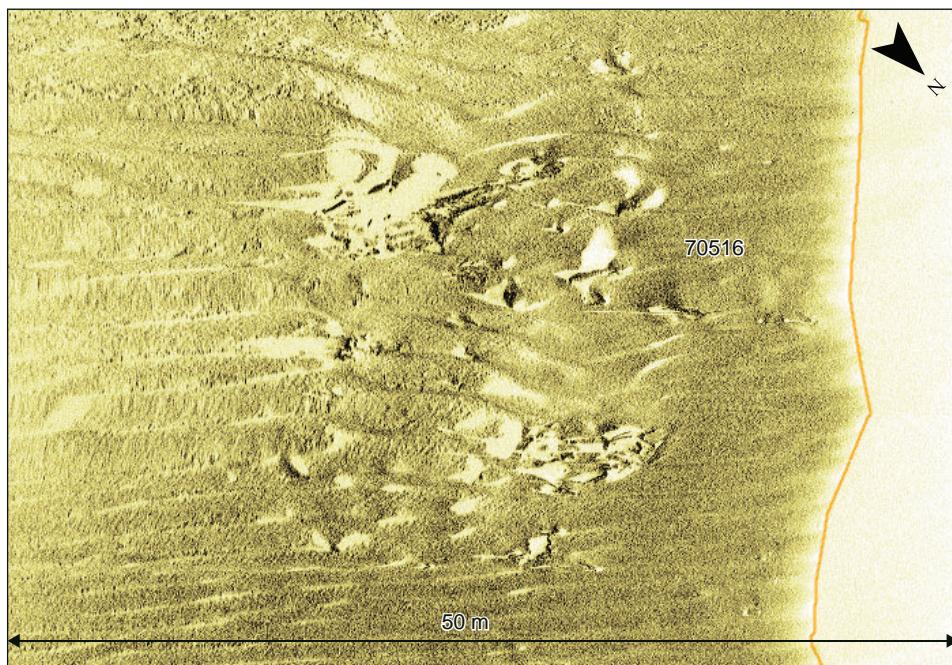
Loss	<p><b>Cause</b> Sunk by German aircraft, 03/02/1941</p> <p>The wreck is noted as being 'partially visible' as a 'small area of wreckage' in the UKHO record. It was last surveyed in September 2015 when it was found to have dimensions of 3.1 x 2.7 x 2 m, markedly different to the recorded dimensions in the data, although this may be a measurement of the largest piece of debris in the area, rather than the dimensions of the entire debris field. The UKHO records it as a 'strong' magnetic anomaly.</p> <p>In the data, the wreck is highly degraded. It is visible as a widely spaced debris field. While the structure of the ship has completely disintegrated, it is possible that large, angular mounds visible in the MBES and SSS data represent individual surviving components of the ship mentioned in the UKHO record, such as the engines or boiler. Scour is visible around the debris, and sand waves in the area suggest the seabed is active. As such, other nearby pieces of debris may be buried.</p> <p>It is noted that the wreck was "dispersed clear to seabed" in 1947, which likely accounts for its highly degraded state, and as such any coherent structure is unlikely to survive.</p>

Sidescan sonar waterfall image of wreck **70516**,  
50 m range per channel

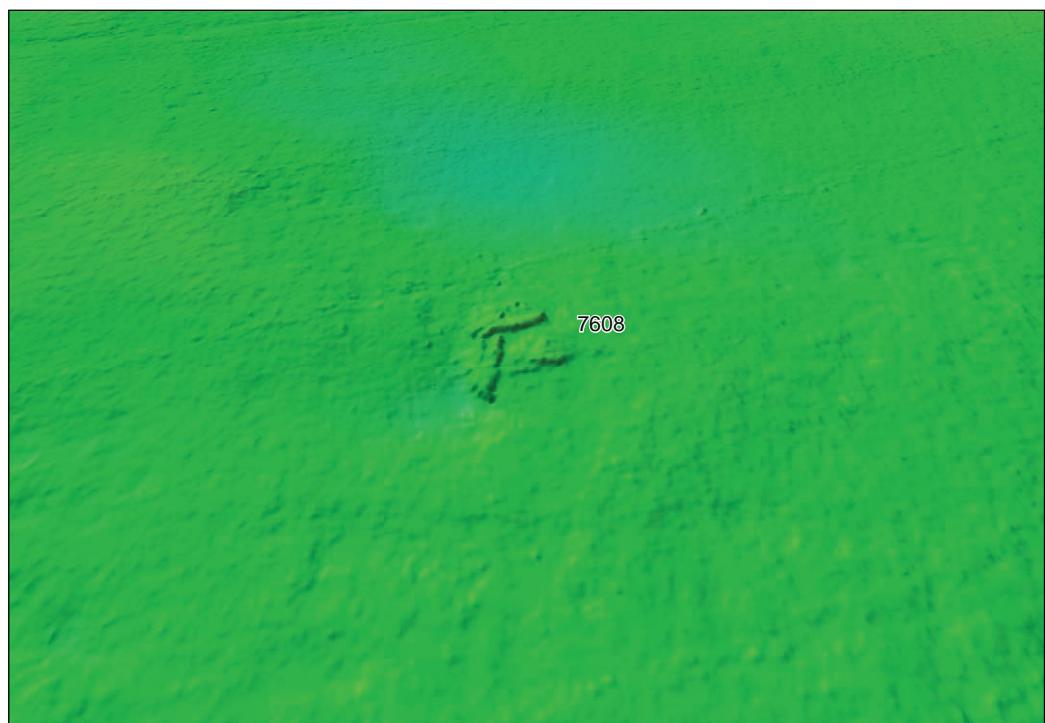
Anomaly 7608 (UKHO\_91237), MBES grid image, x1 vertical exaggeration, looking north

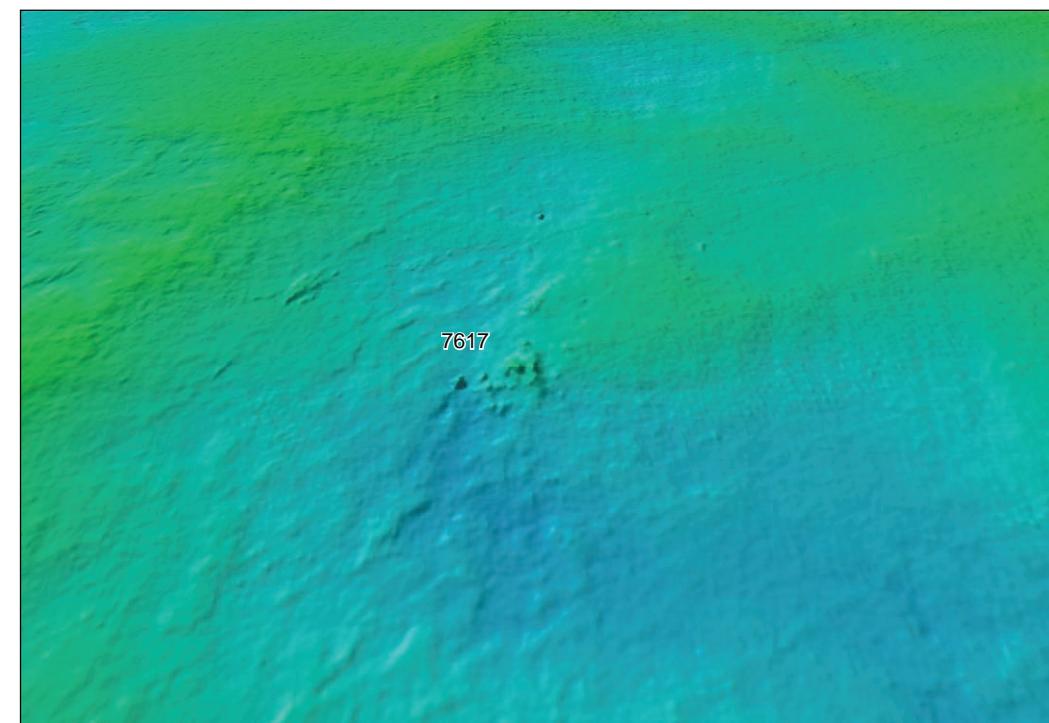
Anomaly 7617 (UKHO\_91236), MBES grid image, x1 vertical exaggeration, looking north

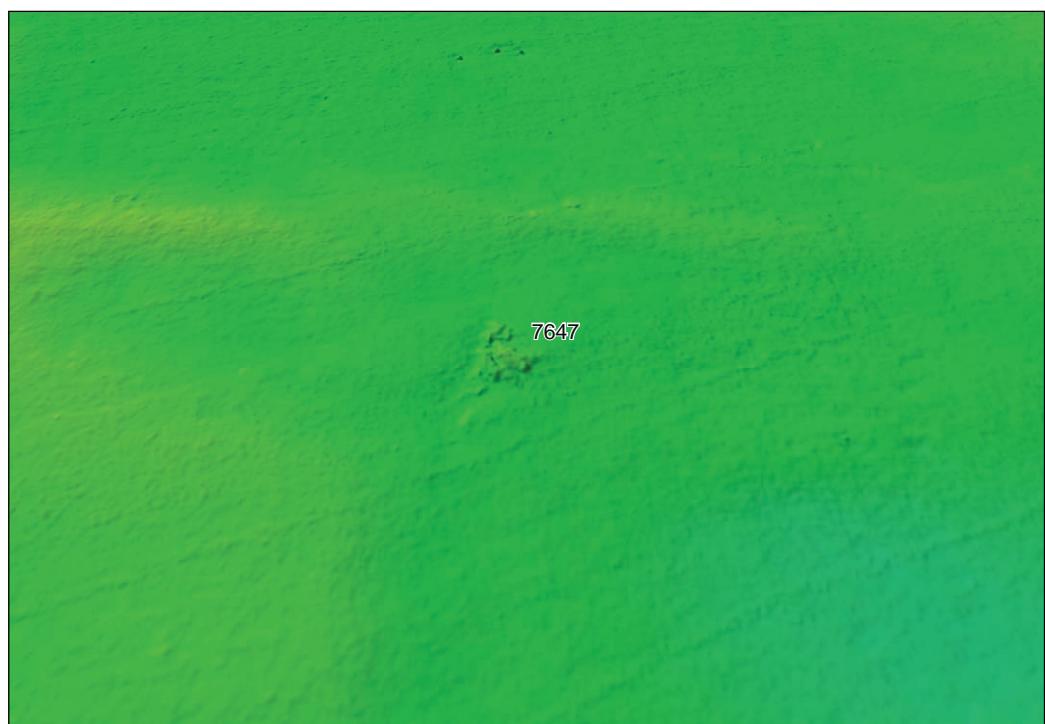
Anomaly 7647 (UKHO\_91206), MBES grid image, x1 vertical exaggeration, looking north

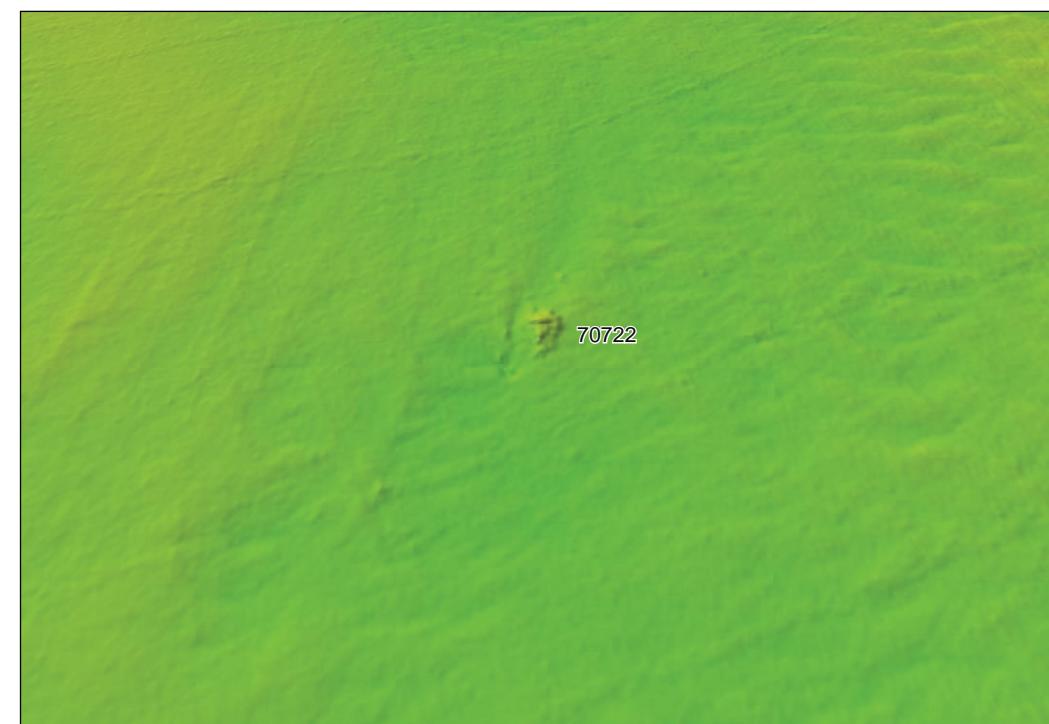
Anomaly 70722, MBES grid image, x1 vertical exaggeration, looking north
