# **NEMO Link Landfall, Pegwell Bay: Year 5 Post-Construction Monitoring Report**

**KPAL Report No: 020123**

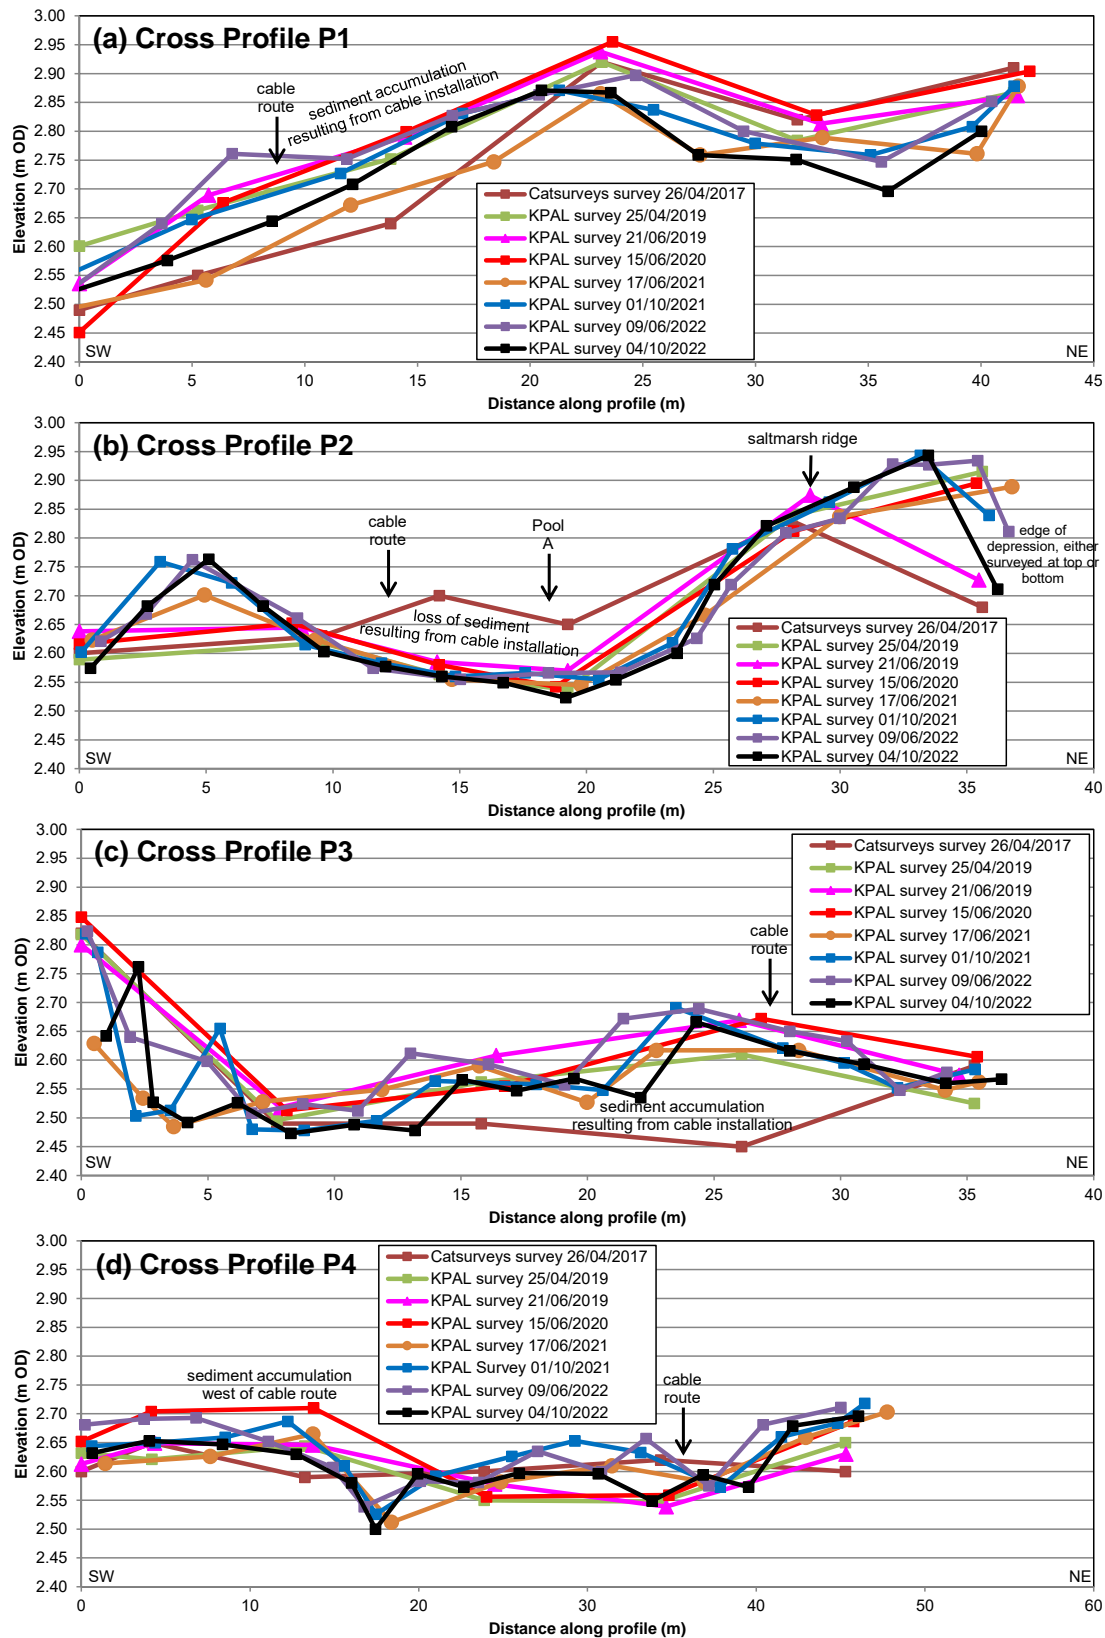
Figure 22. Comparison of Profiles P1 to P4 surveyed in on 26/04/2017, 25/04/2019, 21/06/2019, 15/06/2020, 17/06/2021, 01/10/2021, 09/06/2022 and 04/10/2022

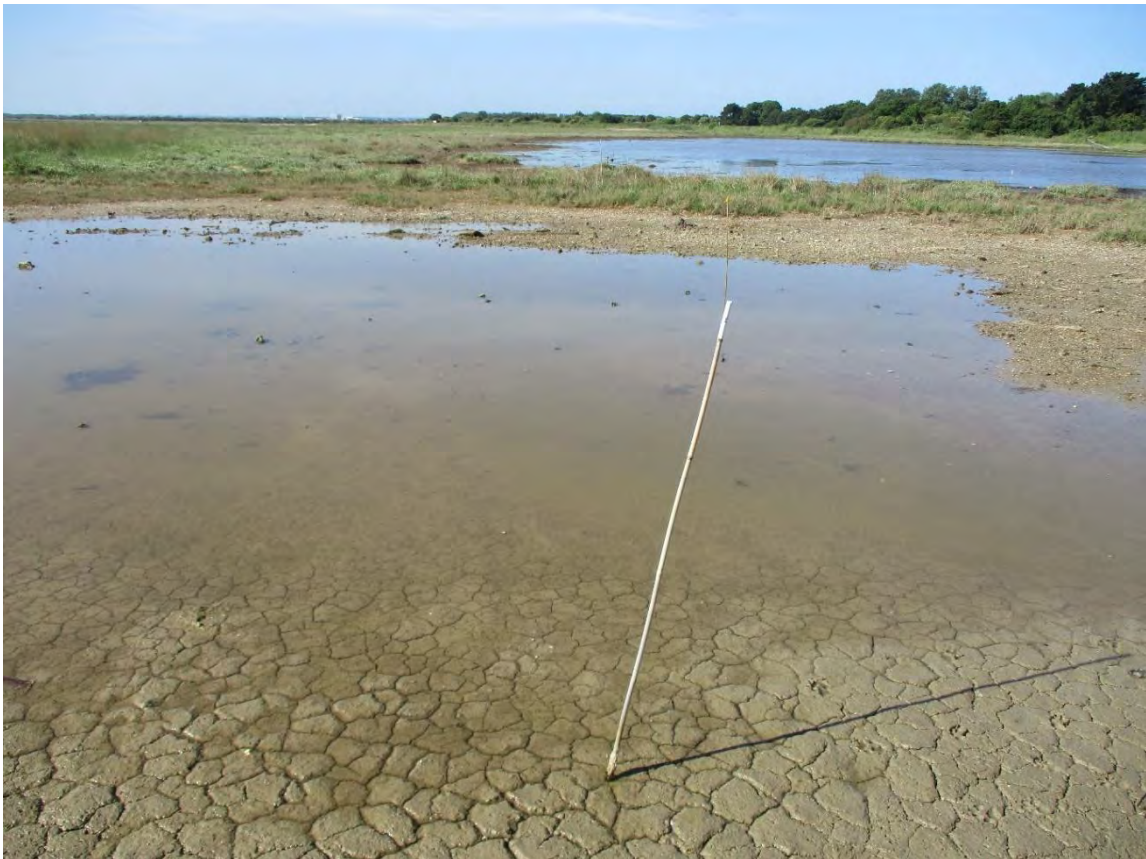
**Photograph A2.4** View from Pool A towards the Lagoon; note desiccation cracks

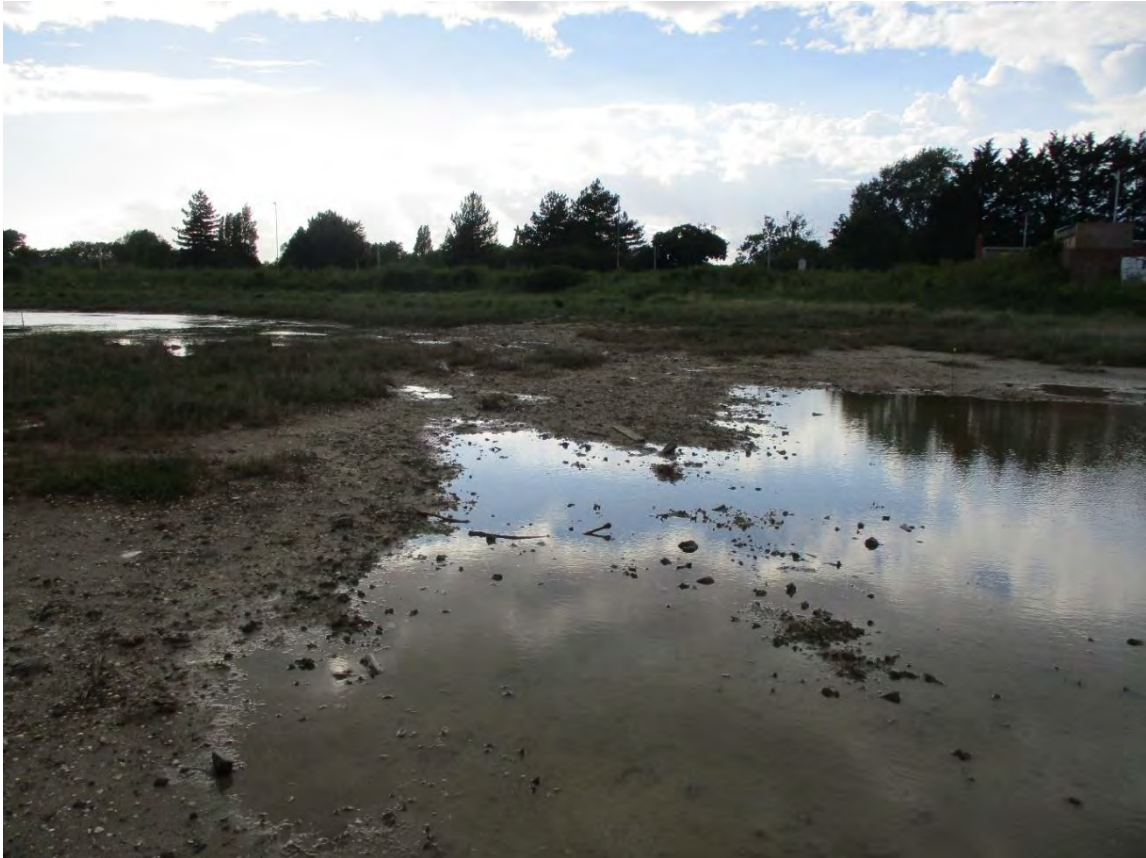
**Photograph A2.5** View across the connection between the cable corridor and Lagoon
