Sea Link

Document 9.143: Pegwell Bay Saltmarsh Limits Topographic Survey March 2026

**Pegwell Bay Saltmarsh Limits
Topographic Survey
March 2026**

KPAL Technical Note No: 160326

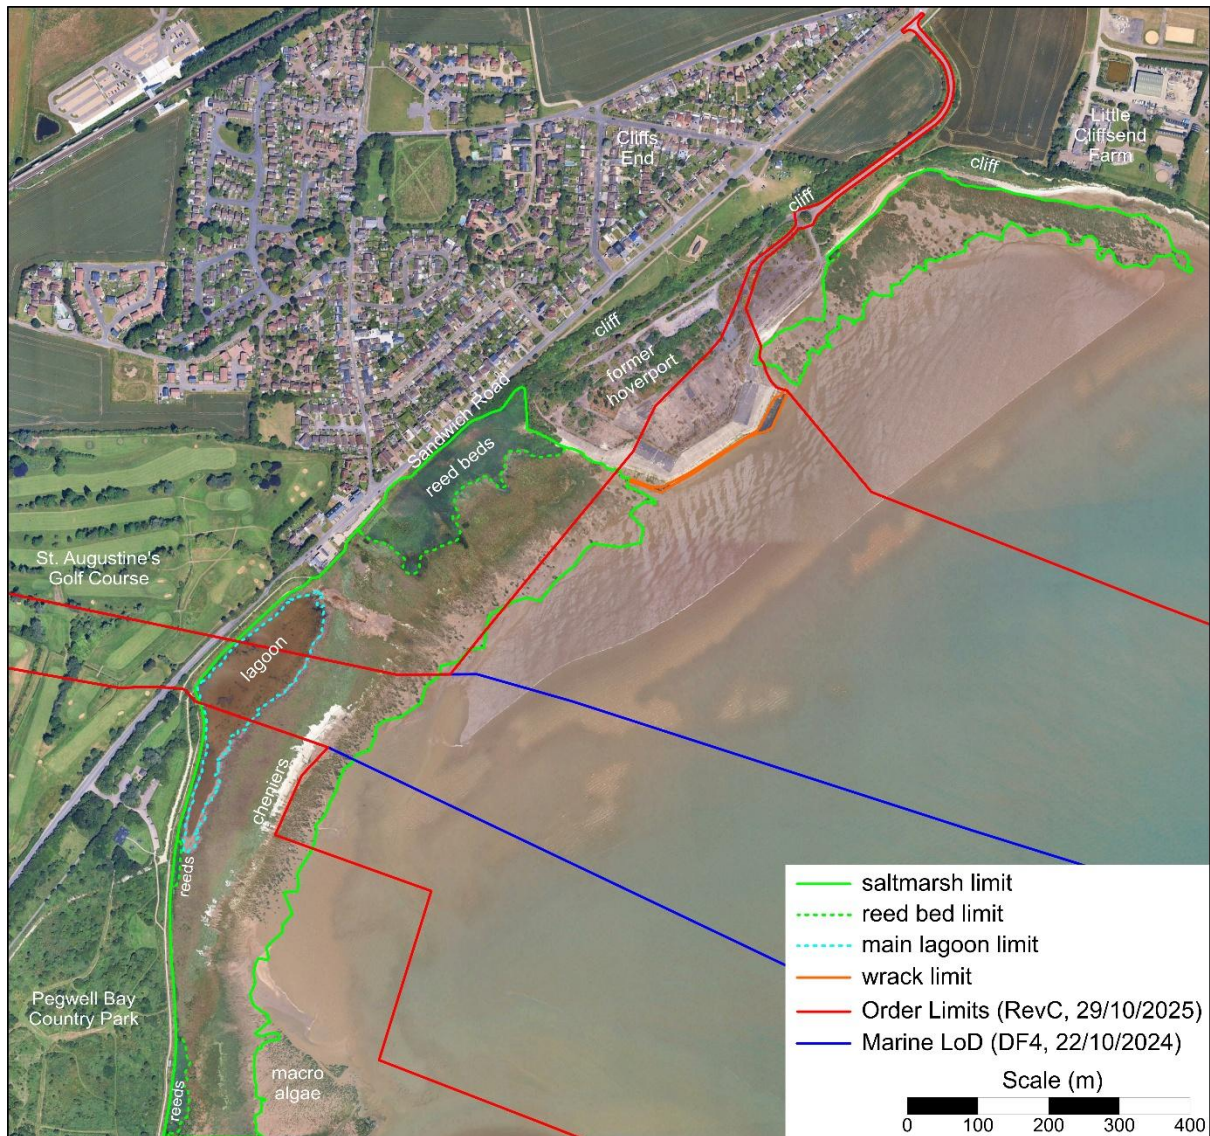
Figure 1. Extent of saltmarsh mapped on the ground by RTK GNSS on 24/03/2026, with the seaward limit of neighbouring ‘clumps’ shown as a solid green line. Reed beds and the main lagoon within the saltmarsh limits are shown with dashed green and blue lines respectively. The limits of macroalgae (‘wrack’) growing at the base of the hoverport ramps are shown by orange lines. The Sea Link Marine Order Limits and Marine LoD are also shown as solid red and blue lines, respectively. Base satellite image captured 14/04/2024 (source: Google Earth)

Figure 1 provides an overview of saltmarsh distribution with the entire survey area which extended from Little Cliffsend Farm in the north to Pegwell Bay Country Park in the south. The locations and extent of reed beds, the main brackish lagoon feature and shell cheniers within the broadly defined ‘saltmarsh’ area are also shown. More detailed enlargements of the northern, central and southern parts of the area, including other geomorphological features and man-made structures, are provided in Figures 2,3 and 4.

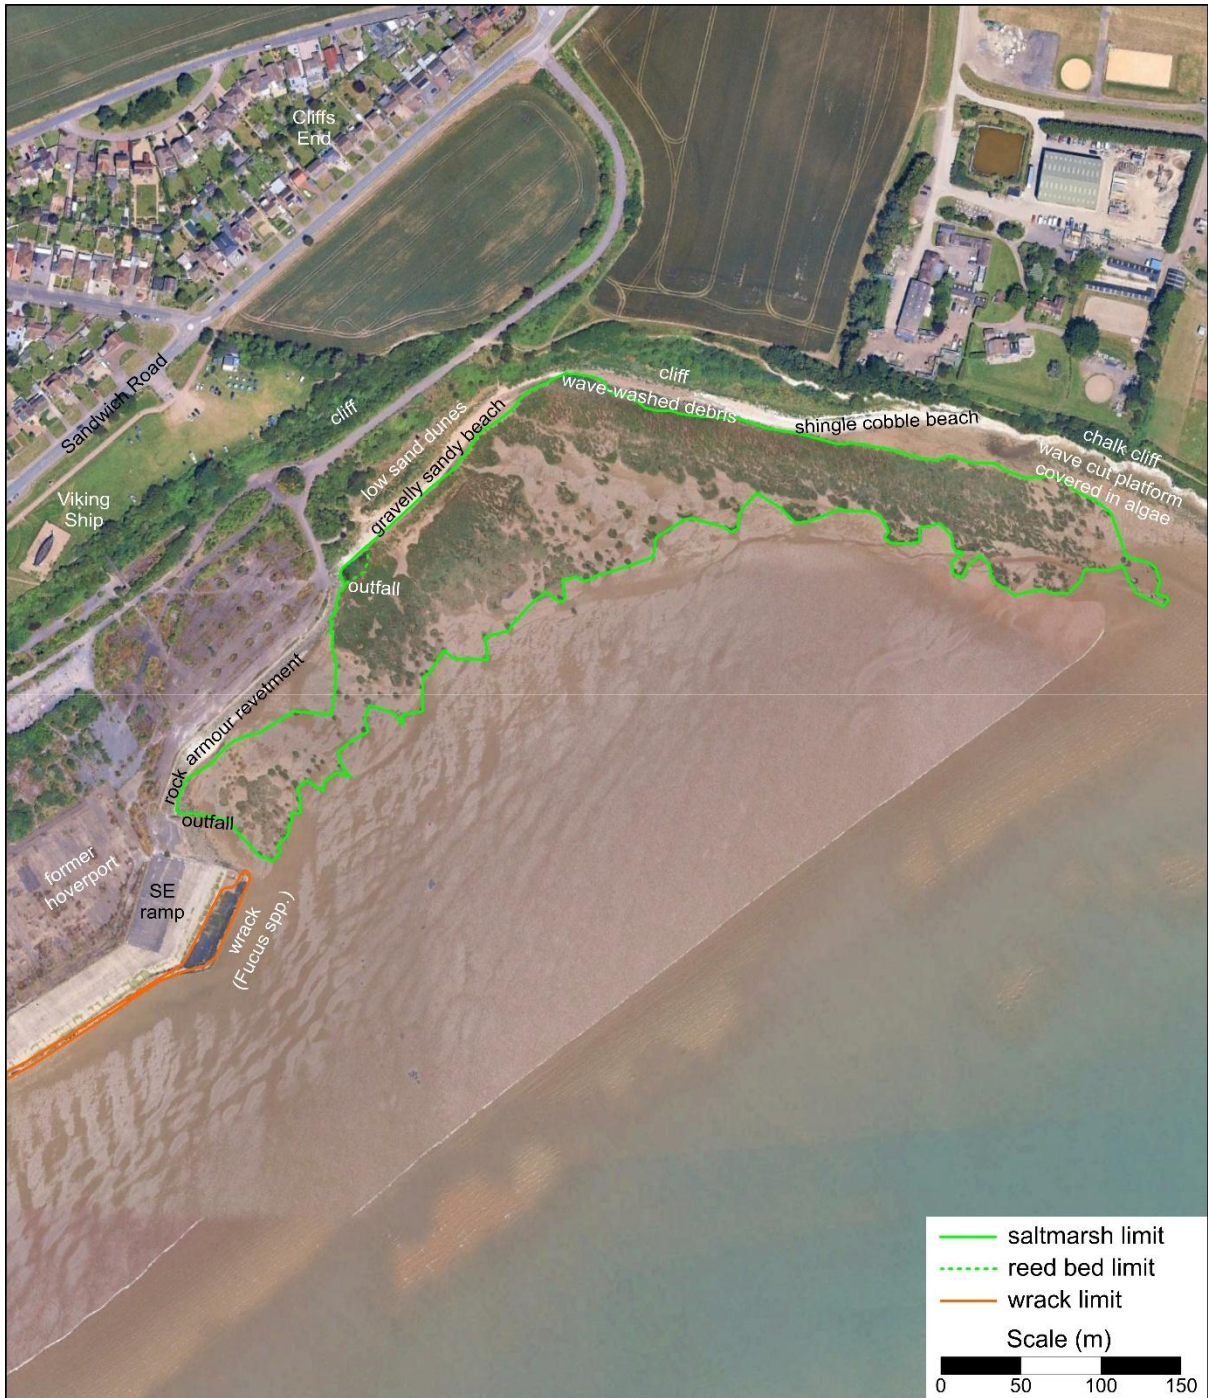
Figure 2. Enlargement of the northern part of Pegwell Bay: extent of saltmarsh mapped on the ground by RTK GNSS on 24/03/2026, with the seaward limit mapped as the convex hull of seaward marsh islands shown as a solid green line. Reed bed within the saltmarsh limits is shown with dashed green line. The limits of macro-algae ('wrack' growing at the base of the hoverport ramps) are shown with an orange line. Base satellite image captured 14/04/2024 (source: Google Earth)

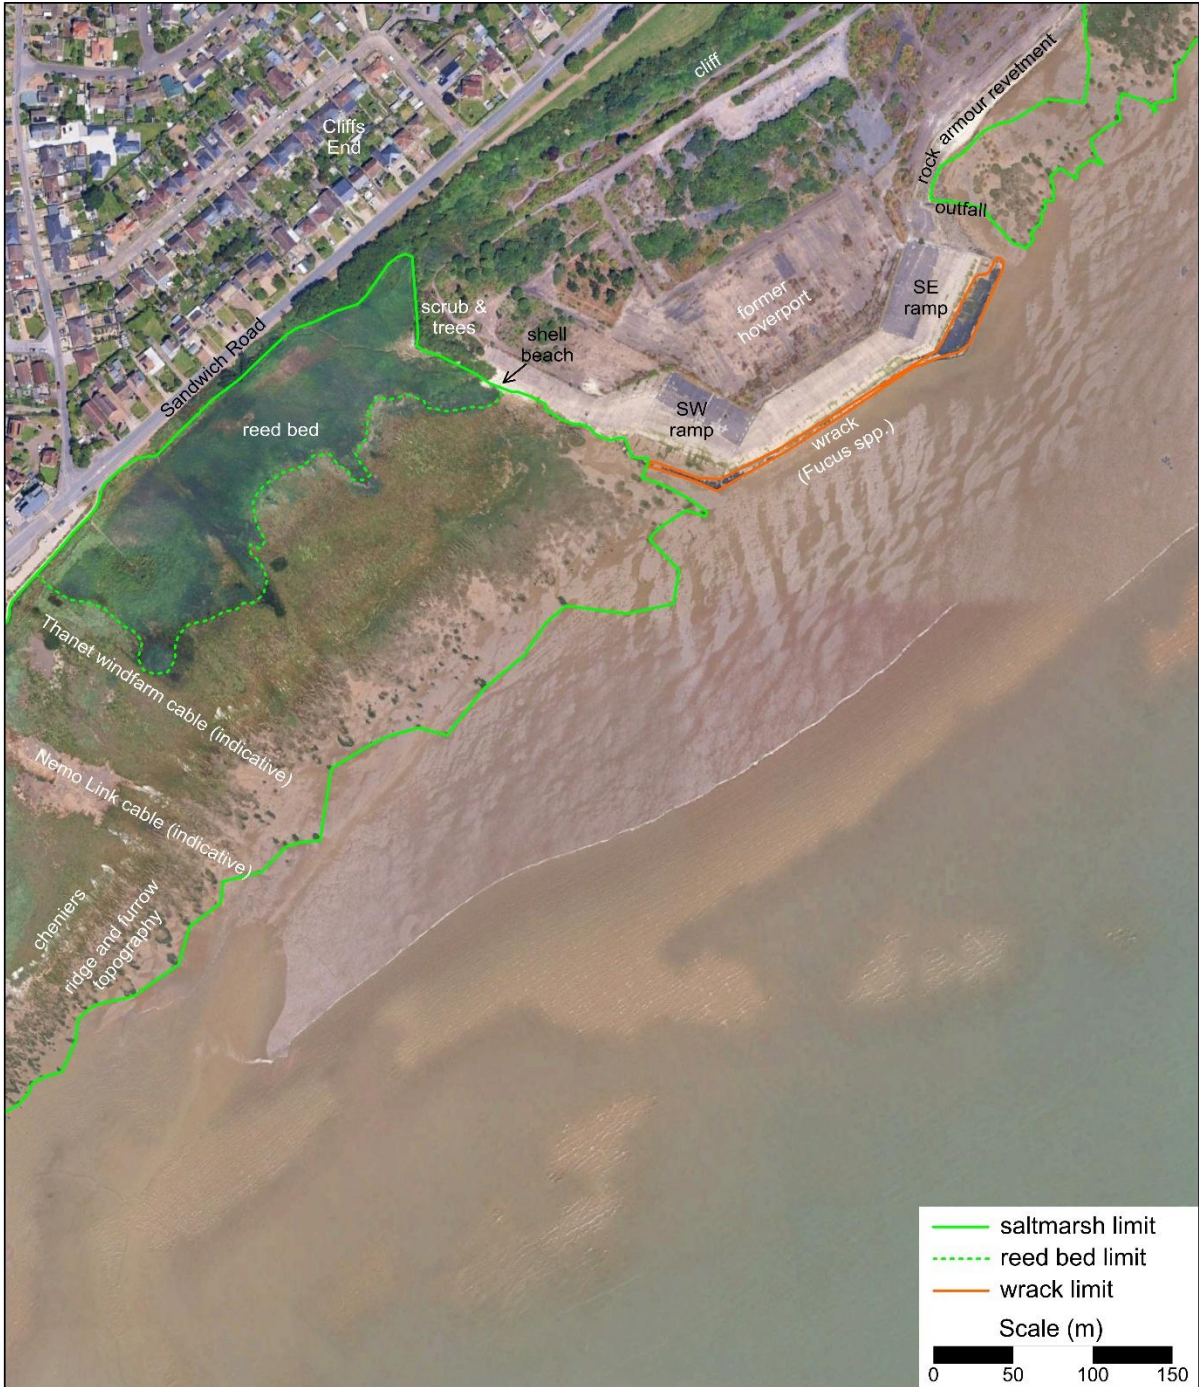
Figure 3. Enlargement of the central part of Pegwell Bay: extent of saltmarsh mapped on the ground by RTK GNSS on 24/03/2026, with the seaward limit mapped as the convex hull of seaward marsh islands shown as a solid green line. Reed beds within the saltmarsh limits are shown with a dashed green line. The limits of macro-algae ('wrack') growing at the base of the hoverport ramps is shown with an orange line. Base satellite image captured 14/04/2024 (source: Google Earth)

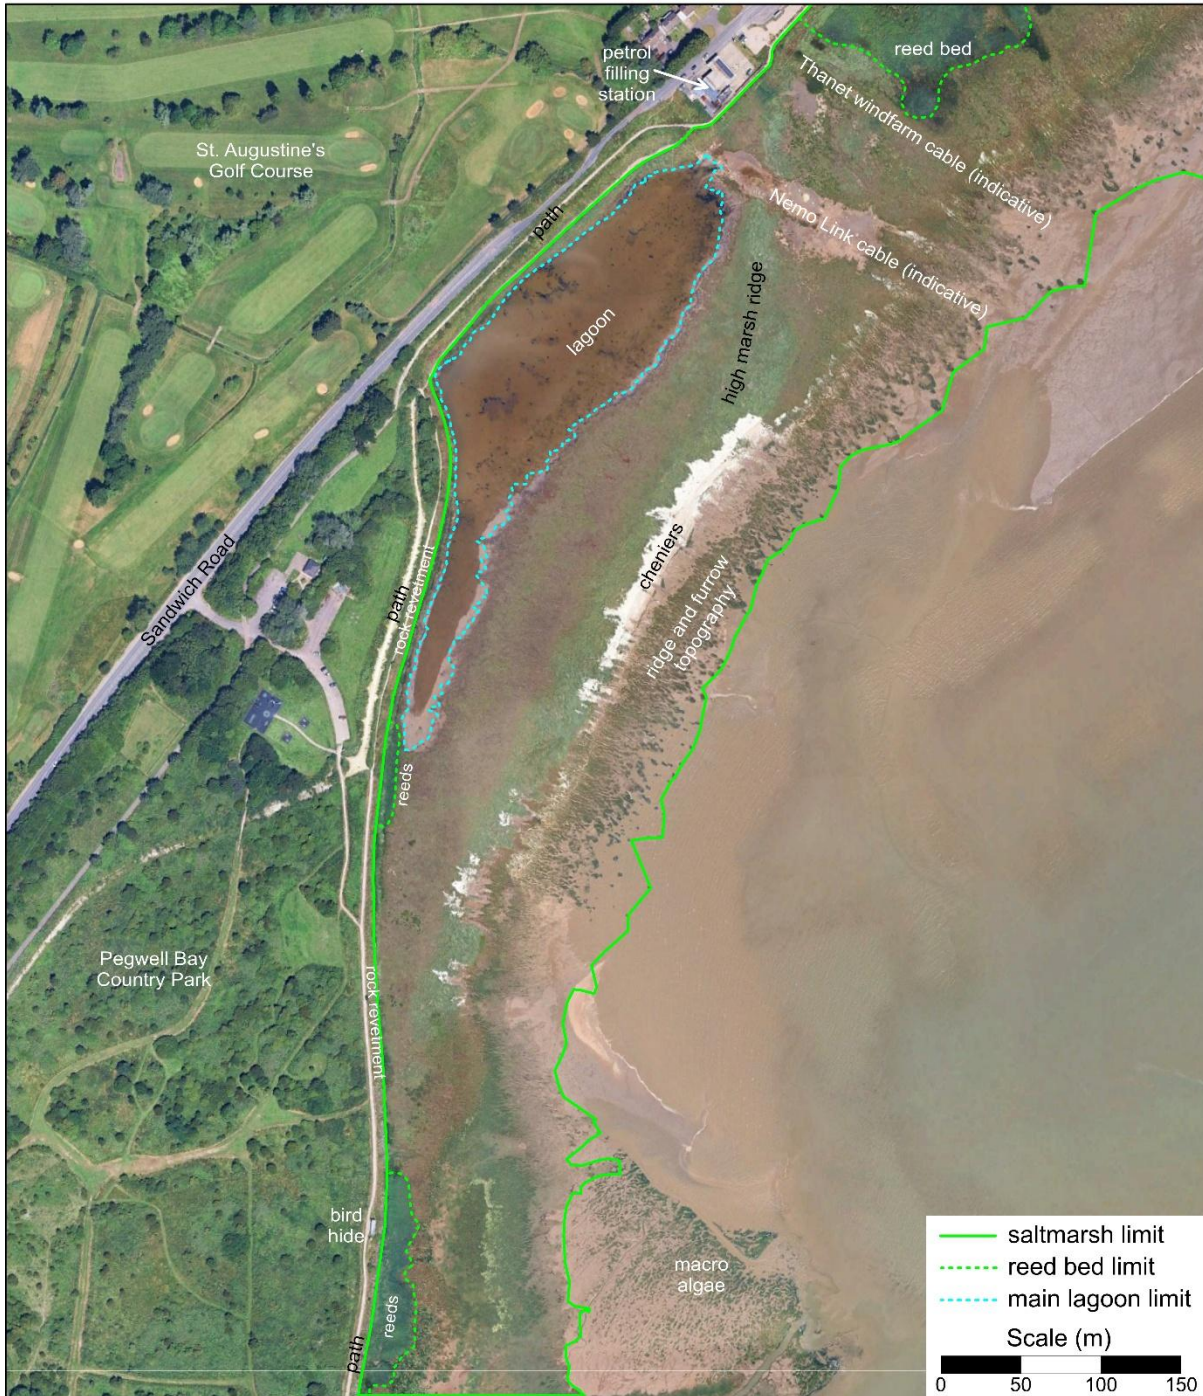
Figure 4. Enlargement of the southern part of Pegwell Bay: extent of saltmarsh mapped on the ground by RTK GNSS on 24/03/2026, with the seaward limit mapped as the convex hull of seaward marsh islands shown as a solid green line. Reed bed and the main lagoon within the saltmarsh limits are shown with dashed green and blue lines respectively. Base satellite image captured 14/04/2024 (source: Google Earth)

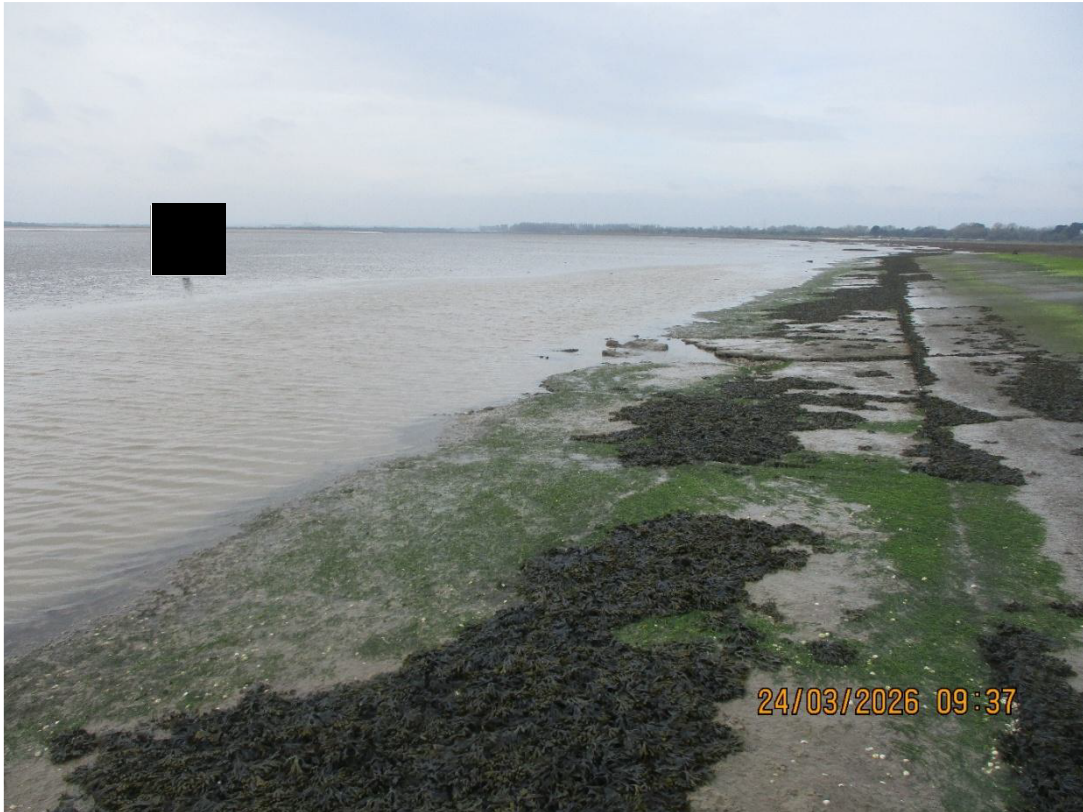
Photograph A1.1 The eastern side of the hoverport ramp, view south – no saltmarsh present

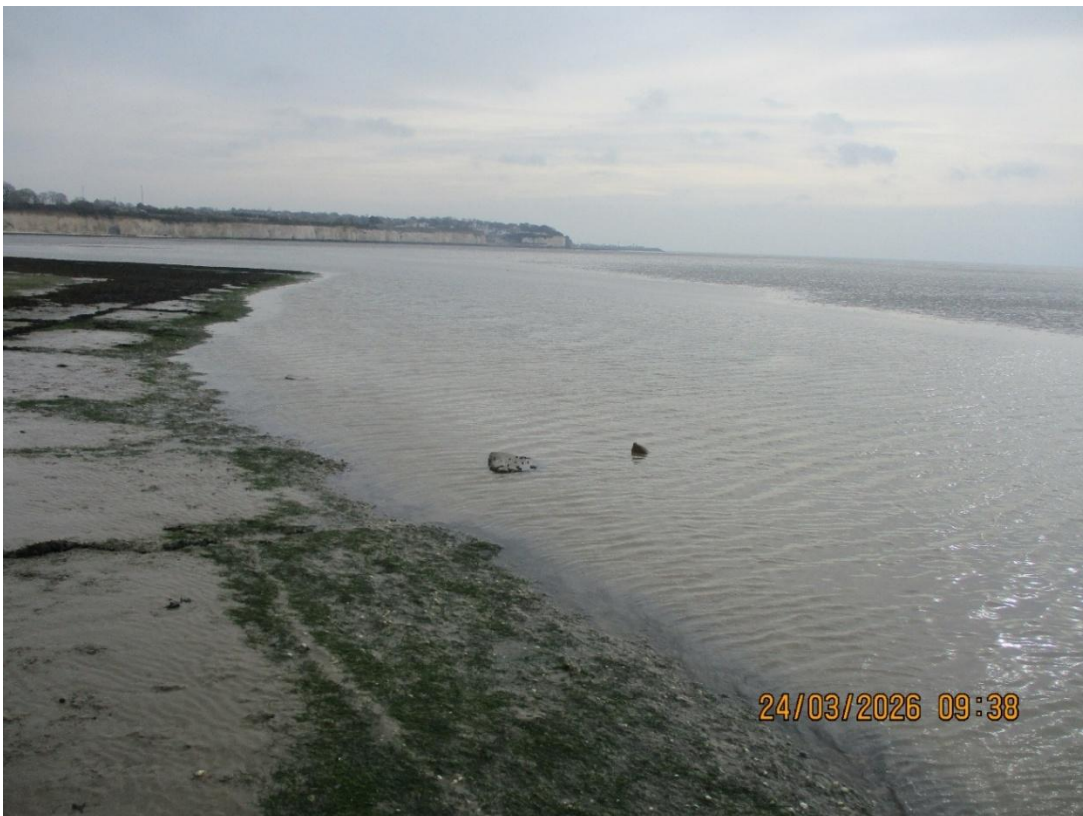
Photograph A1.2 The eastern side of the hoverport ramp, view north – no saltmarsh present

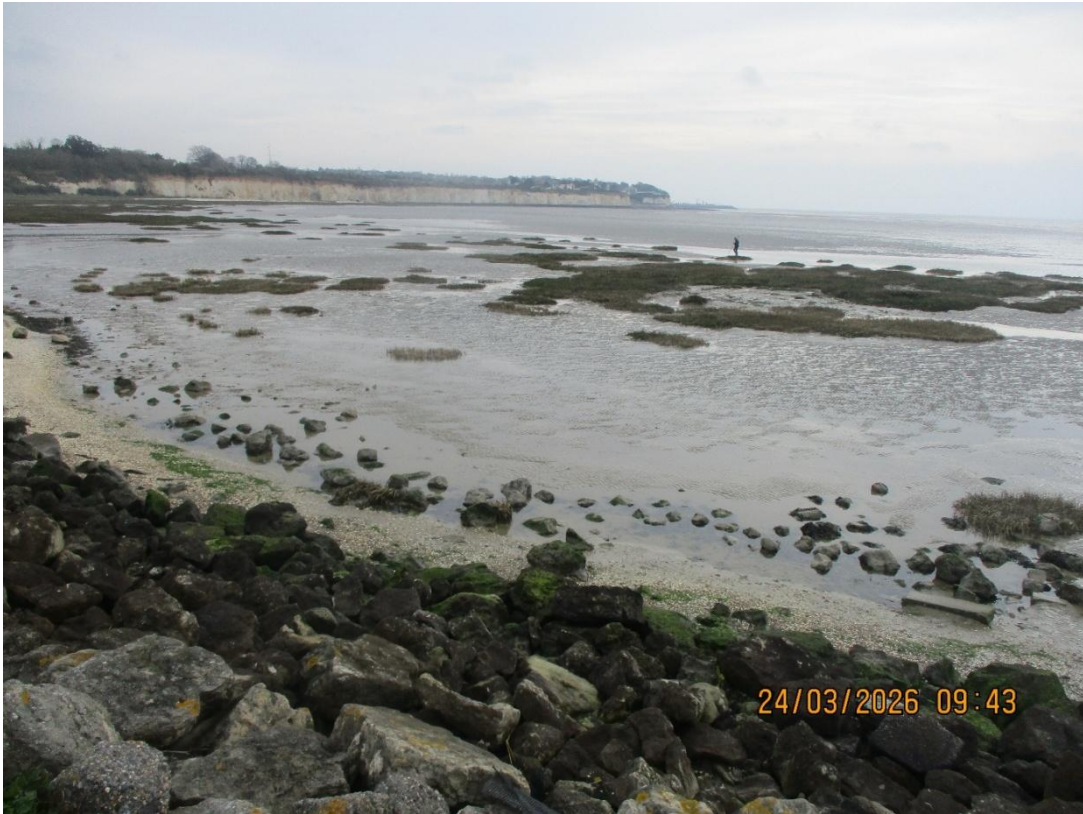
Photograph A1.3 Discontinuous patches of saltmarsh (mostly *Spartina* spp.) in the embayment to the north of hoverport, viewed from the top of the rock revetment

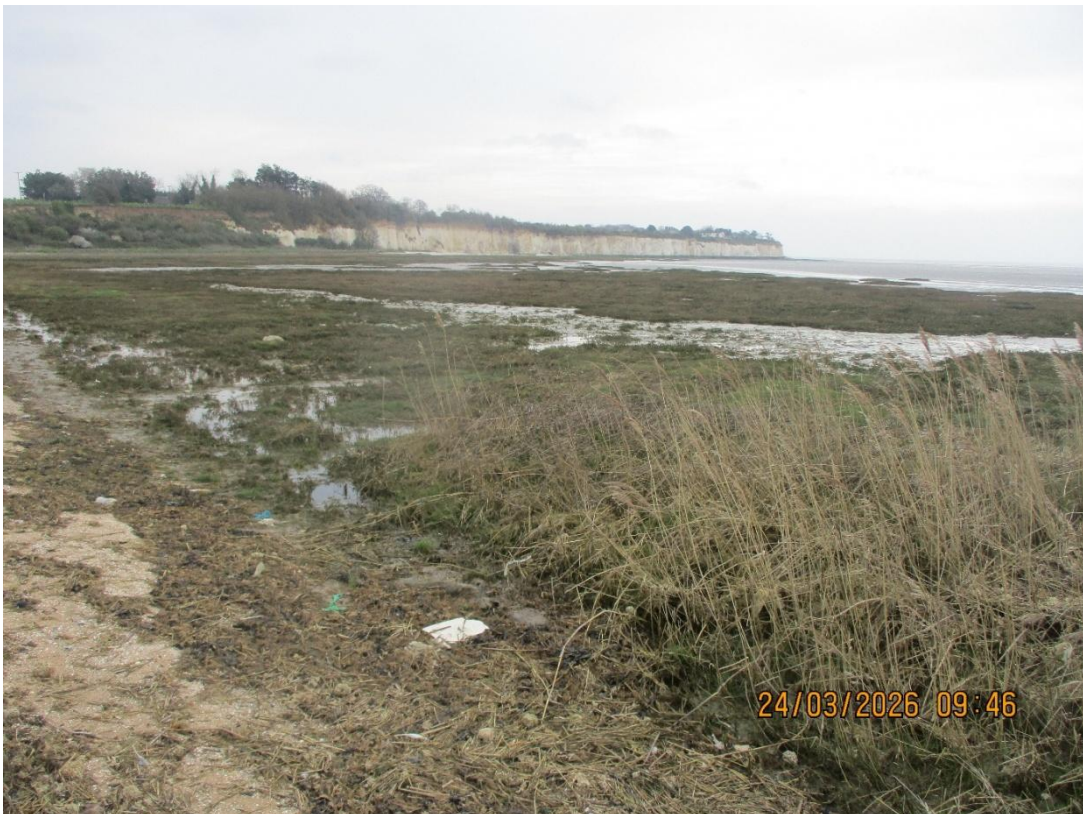
Photograph A1.4 Landward limit of saltmarsh defined by a high tide sandy beach and wave-rafter debris, north of the hoverport

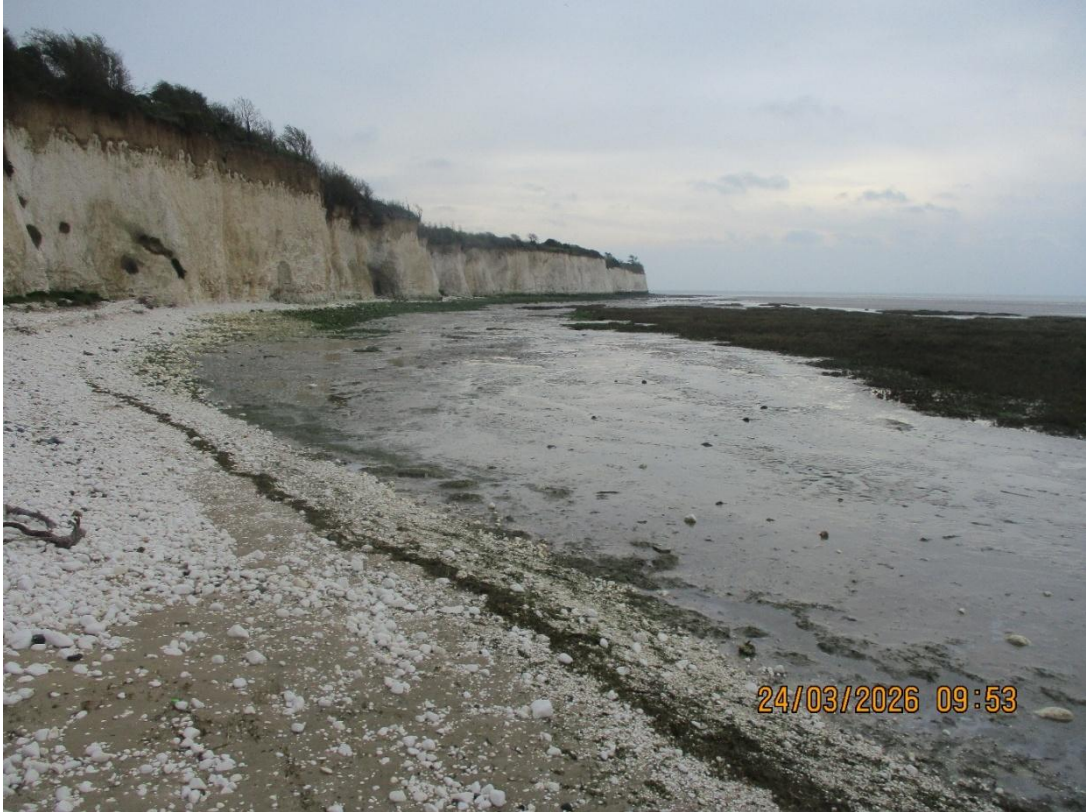
Photograph A1.5 Saltmarsh separated from a chalk cobble beach by muddy sand flats near the northeastern limit of the saltmarsh

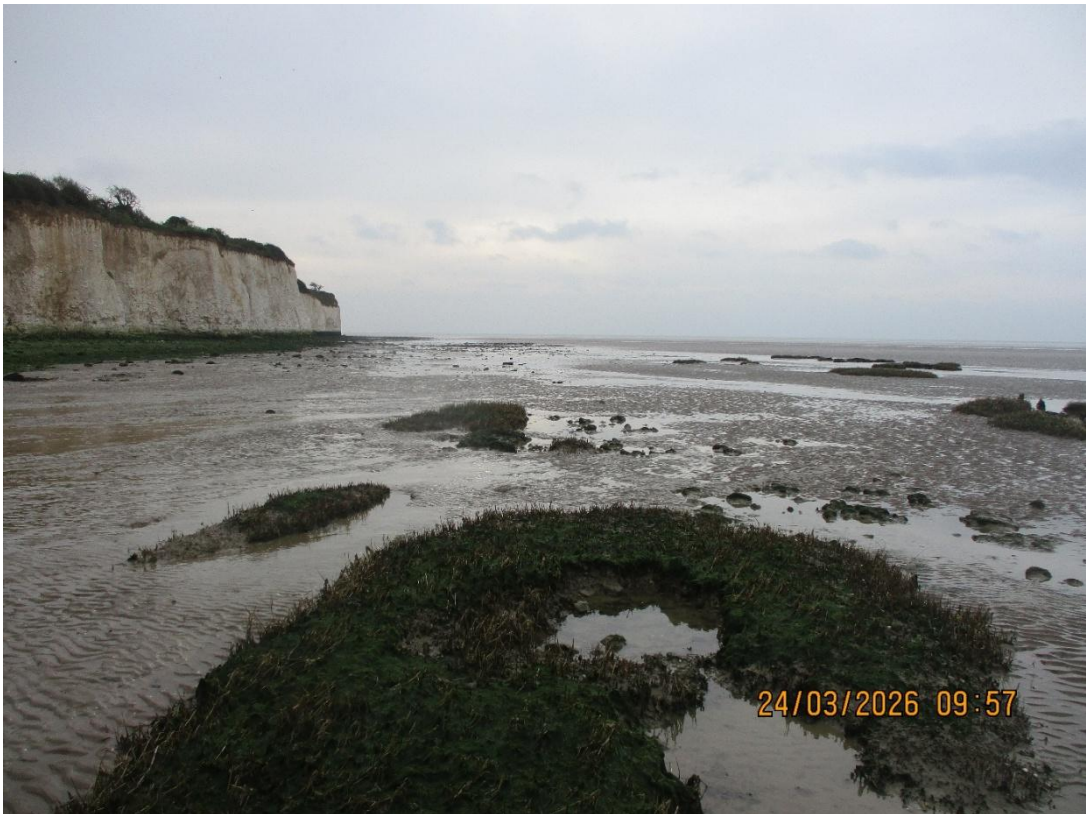
Photograph A1.6 The northeastern limit of saltmarsh

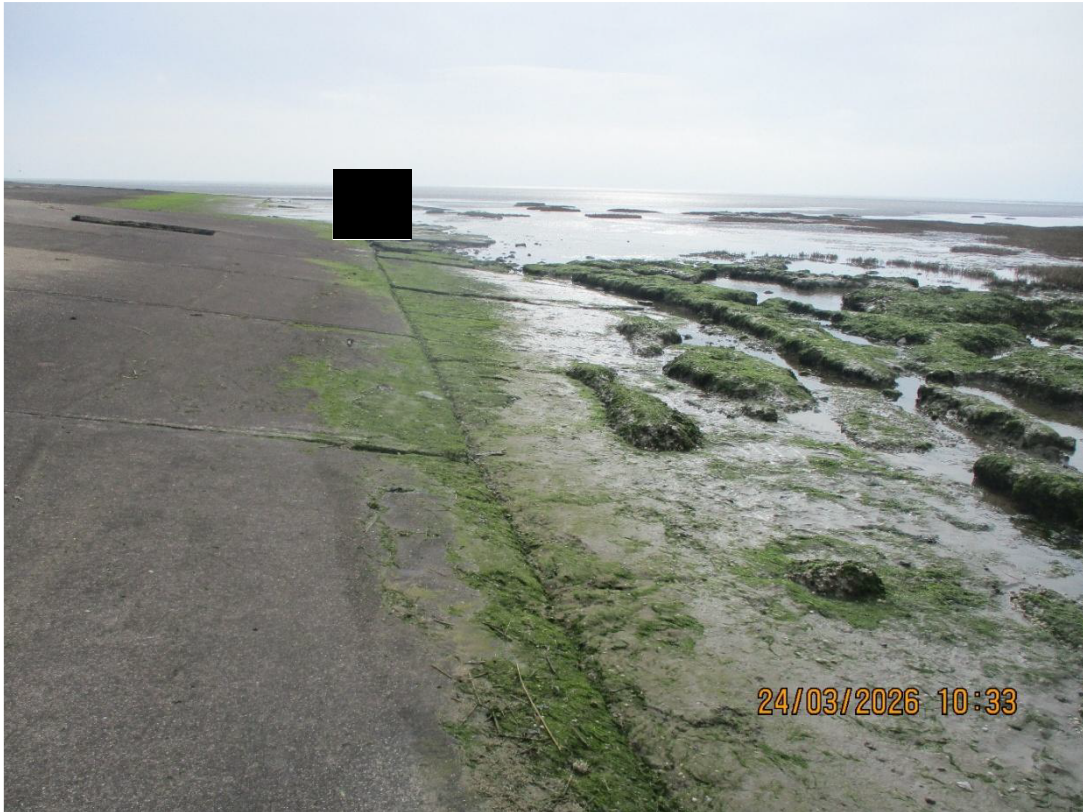
Photograph A1.7 Fragmented saltmarsh adjacent to the southwest ramp of the hoverport

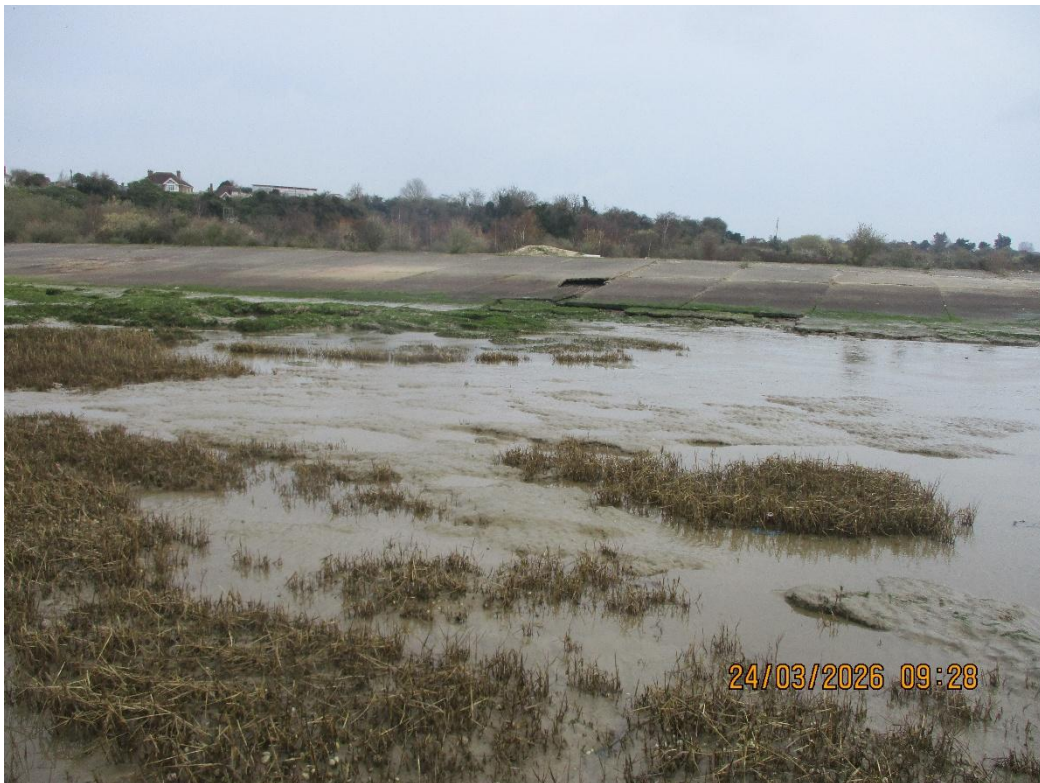
Photograph A1.8 Patches of saltmarsh close to the southwest ramp of the hoverport

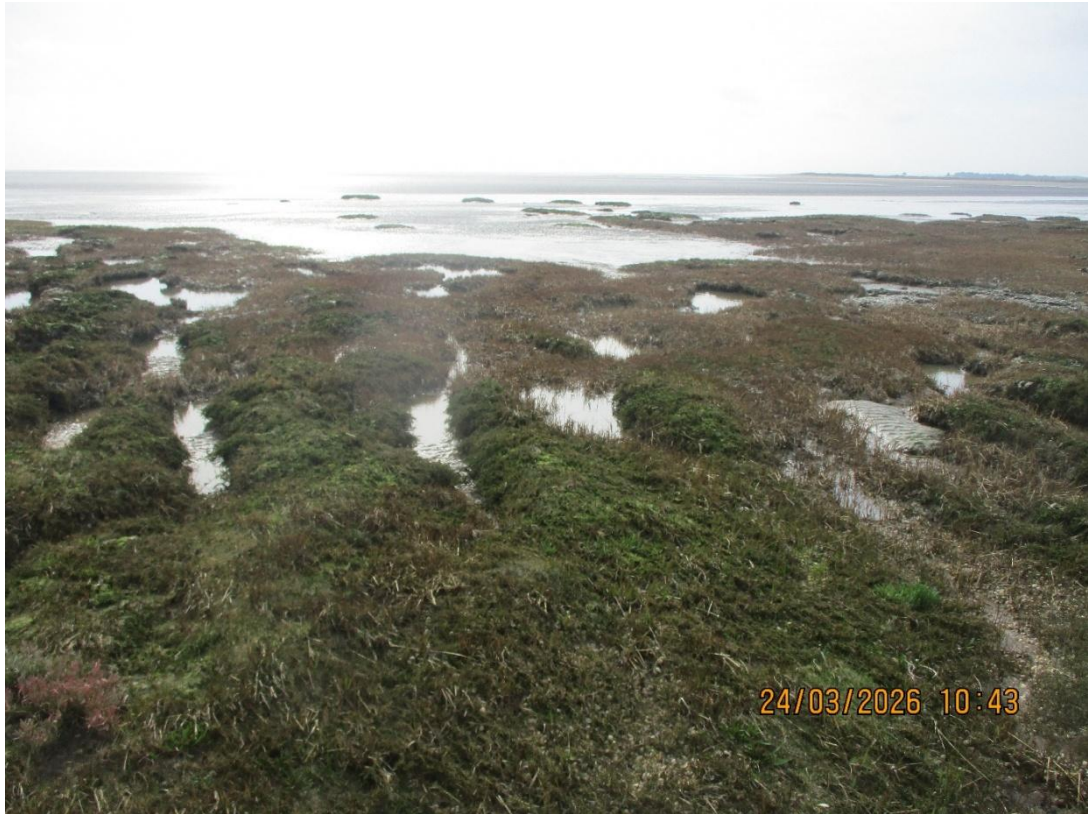
Photograph A1.9 View seaward across the saltmarsh edge just south of the hoverport

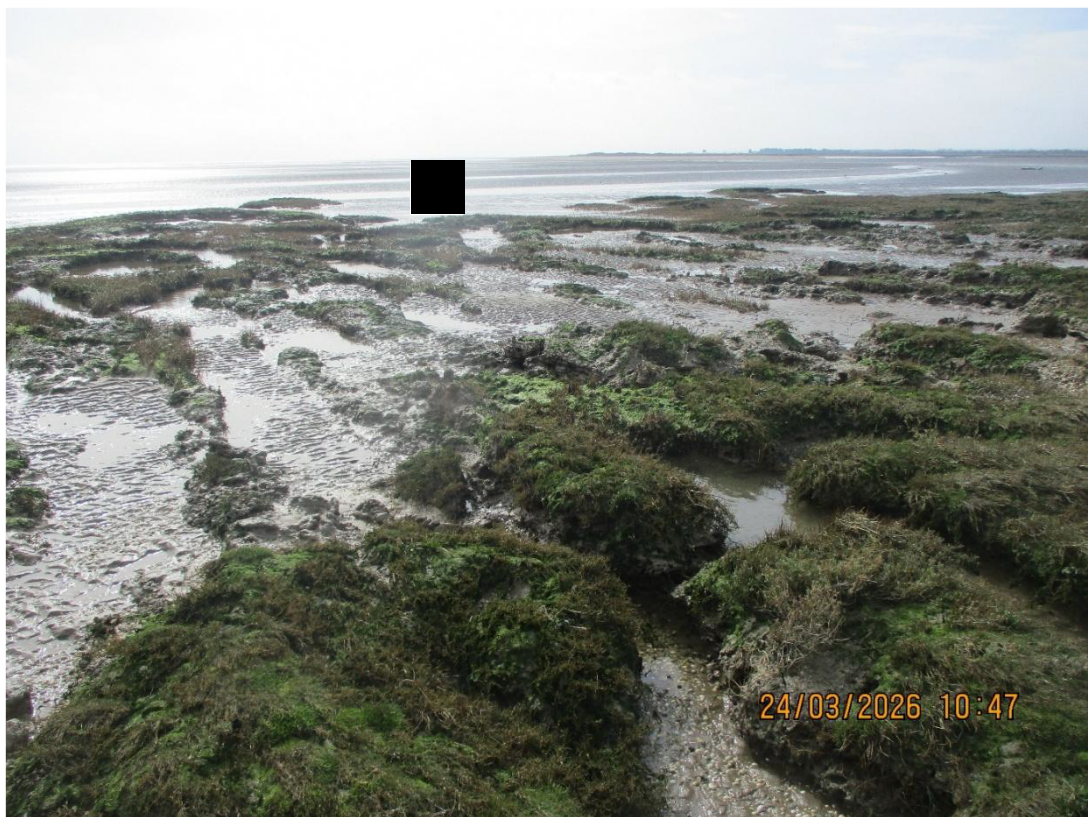
Photograph A1.10 Fragmented saltmarsh edge in the mid part of the embayment to the south of the hoverport

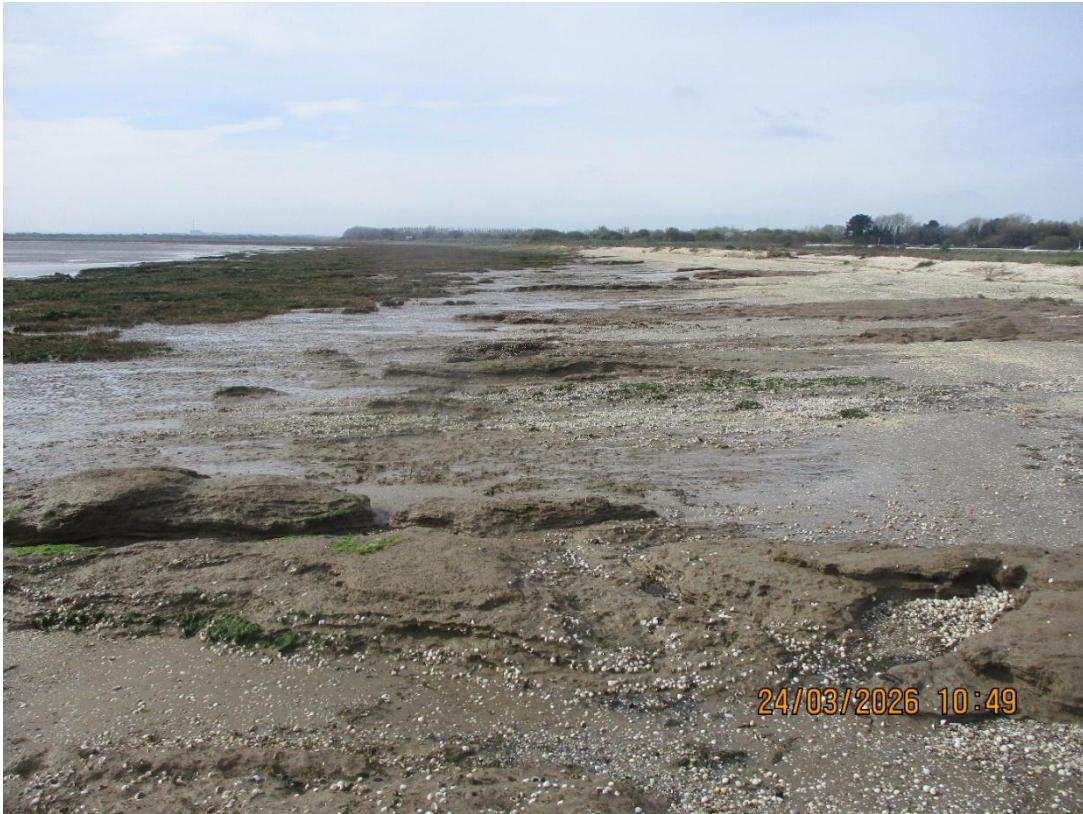
Photograph A1.11 Zone of eroded middle saltmarsh separating a zone of healthy lower marsh (mainly *Spartina*) from chenier (shell) ridges rolling back over the higher marsh ridge, south-central part of the embayment (south of the Nemo Link cable corridor)

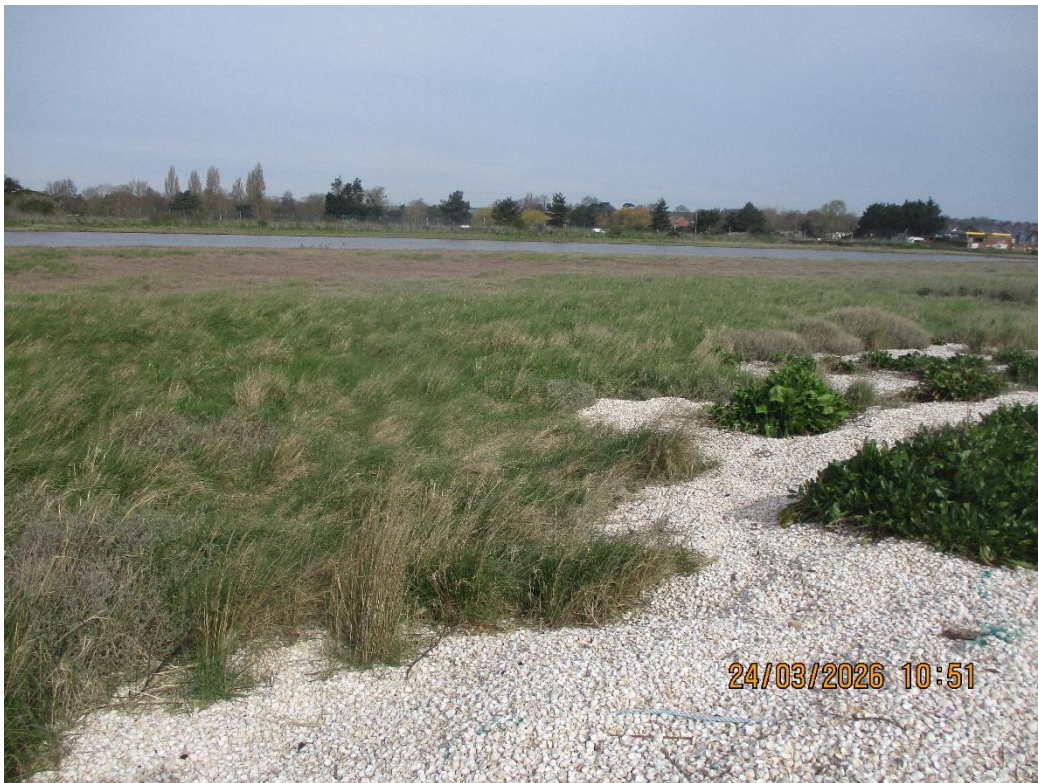
Photograph A1.12 View landwards towards the brackish lagoon from the chenier ridge rolling back over high saltmarsh in the south-central part of the bay

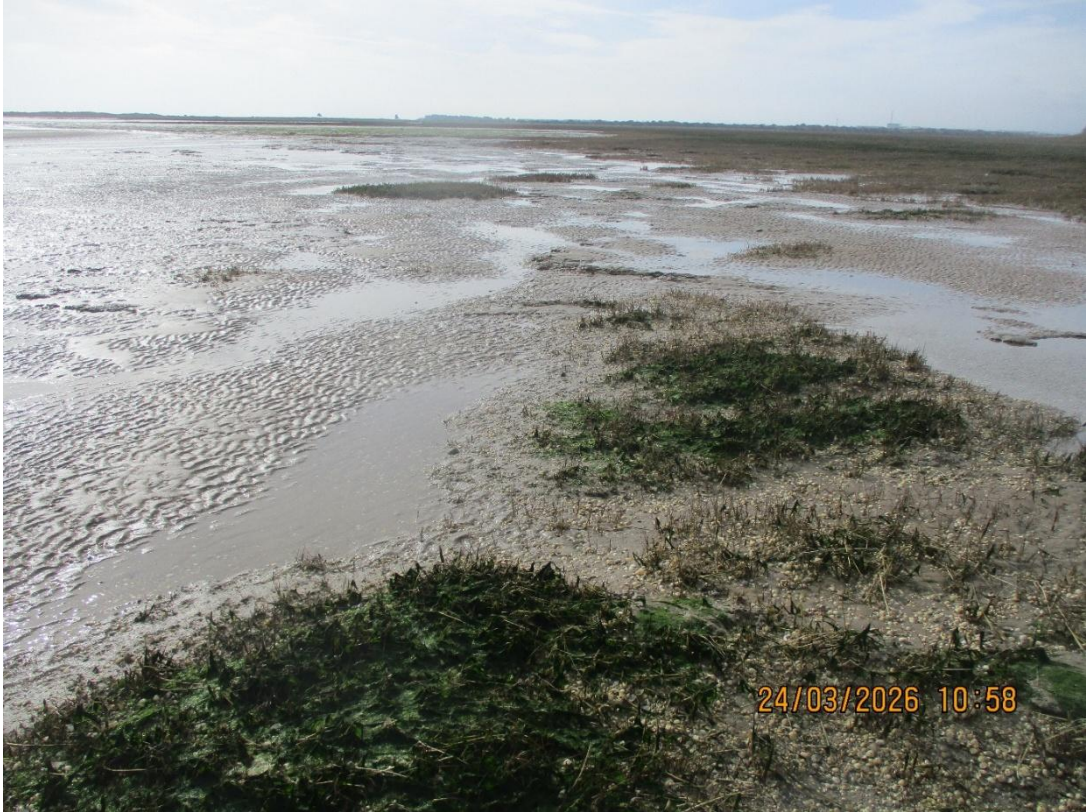
Photograph A1.13 Relatively stable marsh edge in the southern part of the bay opposite Pegwell Bay Country Park

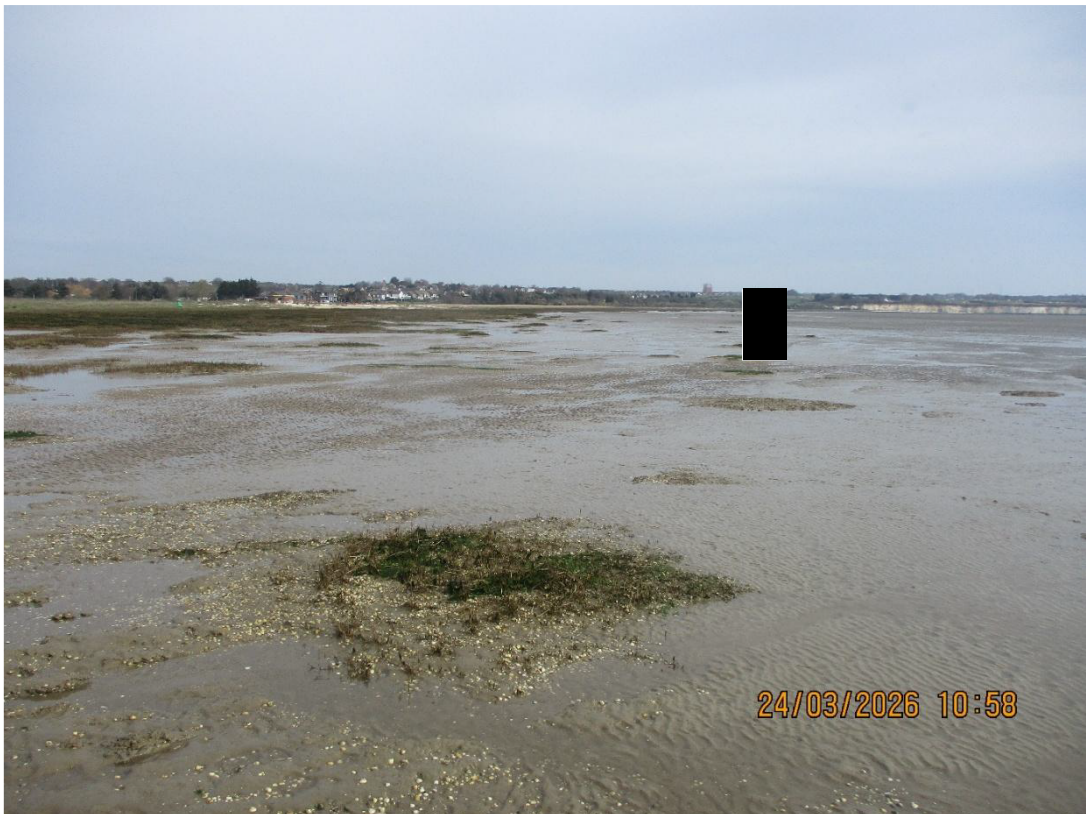
Photograph A1.14 The saltmarsh edge opposite the southern part of Pegwell Bay Country Park

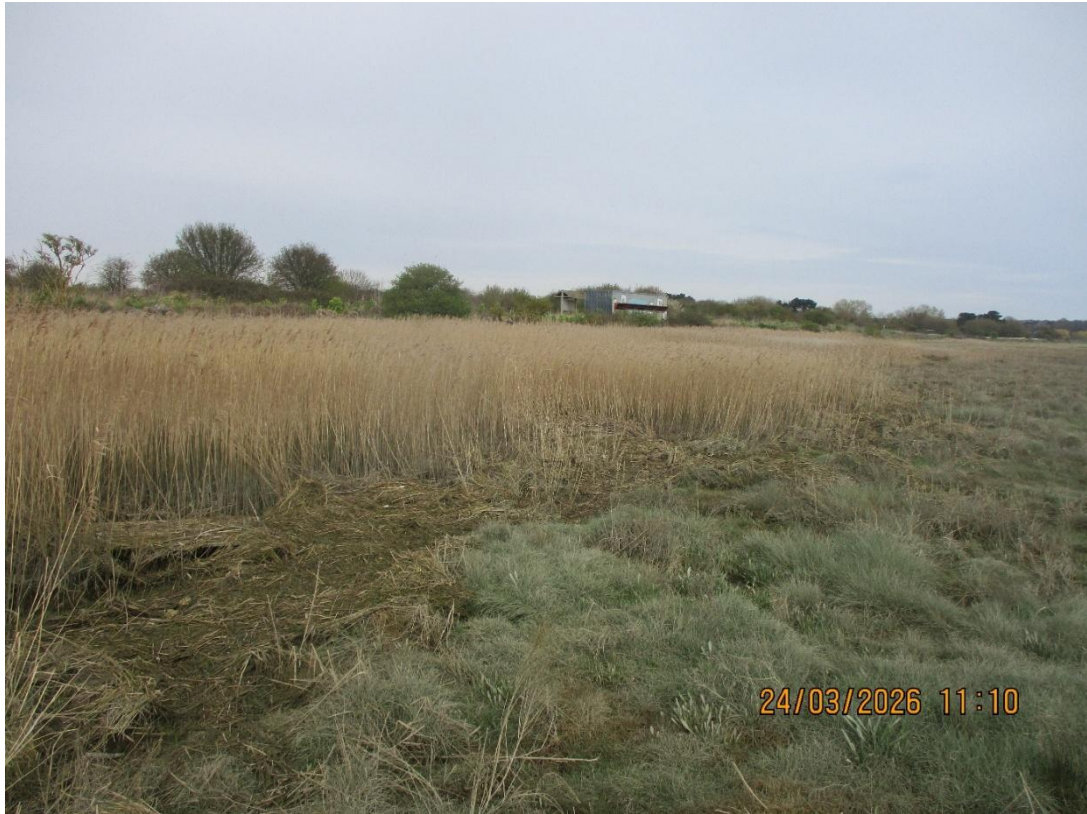
Photograph A1.15 *Phragmites* reed bed at the landward margin of the saltmarsh fronting the Pegwell Bay Country Park rock revetment, south of the bird hide
