# Norwich to Tilbury

## Volume 6: Environmental Statement

Document: 6.8.A13 Environmental Statement Appendix 8.13 - Otter  
and Water Vole Report (redacted) - Clean Version

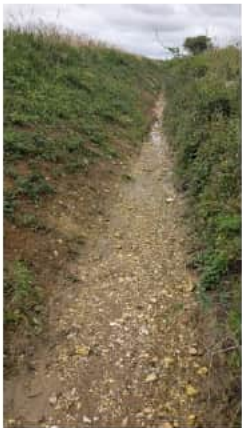
| Project Section | Watercourse ID | Survey Dates | Image | Otter Field Signs Observed | Otter Presence | Water Vole Habitat suitability | Water Vole Field Signs Observed | Water Vole Presence |
|---|---|---|---|---|---|---|---|---|
| A | 212 | 19/05/25,<br>04/08/25 | | None | No signs recorded | Poor habitat | None | Confirmed absence |

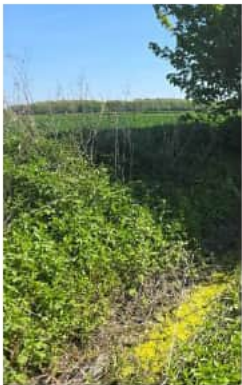
| Project Section | Watercourse ID | Survey Dates | Image | Otter Field Signs Observed | Otter Presence | Water Vole Habitat suitability | Water Vole Field Signs Observed | Water Vole Presence |
|---|---|---|---|---|---|---|---|---|
| B | 479 | 29/04/25 | | None | No signs recorded | Unsuitable habitat | Considered absent: no further survey required | Confirmed absence |

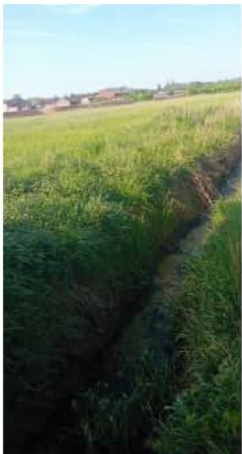
| Project Section | Watercourse ID | Survey Dates | Image | Otter Field Signs Observed | Otter Presence | Water Vole Habitat suitability | Water Vole Field Signs Observed | Water Vole Presence |
|---|---|---|---|---|---|---|---|---|
| C | 43 | 30/04/25,<br>08/07/25 | | None | No signs recorded | Sub-Optimal habitat | Feeding station, potential burrow | Potential presence |

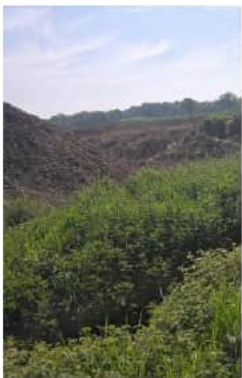
| Project Section | Watercourse ID | Survey Dates | Image | Otter Field Signs Observed | Otter Presence | Water Vole Habitat suitability | Water Vole Field Signs Observed | Water Vole Presence |
|---|---|---|---|---|---|---|---|---|
| C | 484 | 30/04/25 | | None | No signs recorded | Unsuitable habitat | None | Confirmed absence, habitat Unsuitable habitat |

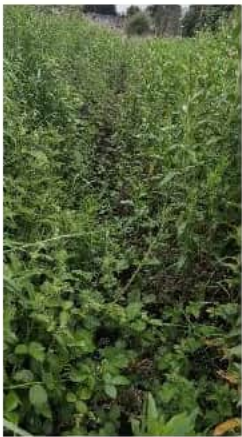
| Project Section | Watercourse ID | Survey Dates | Image | Otter Field Signs Observed | Otter Presence | Water Vole Habitat suitability | Water Vole Field Signs Observed | Water Vole Presence |
|---|---|---|---|---|---|---|---|---|
| D | 353 | 21/05/25,<br>06/08/25 | | None | No signs recorded | Poor habitat | None | Confirmed absence |
