MORGAN AND MORECAMBE OFFSHORE WIND FARMS: TRANSMISSION ASSETS

Annex to Applicants response to MMO and NE submission at Deadline 3: Assessment of Seabed Level Vertical Variability for Morgan Offshore Wind Farm- Appendix C

C Landfall Assessment: Coastlines, Beaches and Nearshore Processes

C.2 Difference in beach level between historical topographical surveys

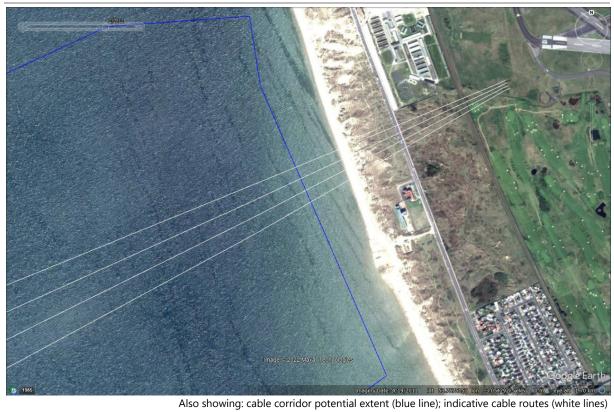
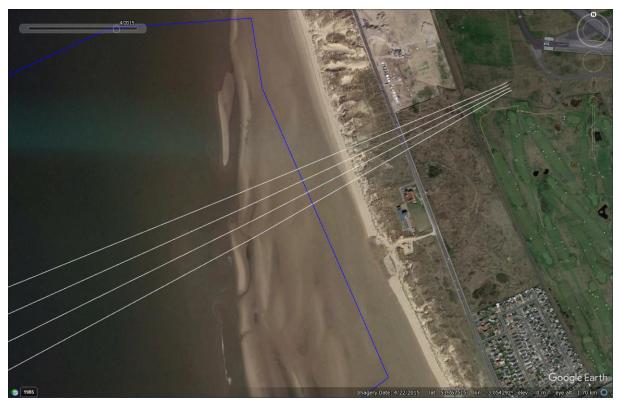
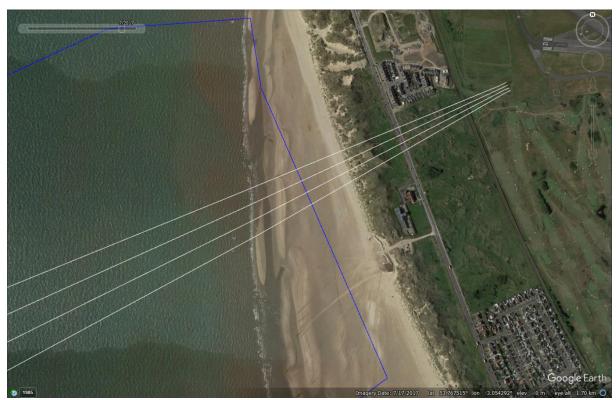
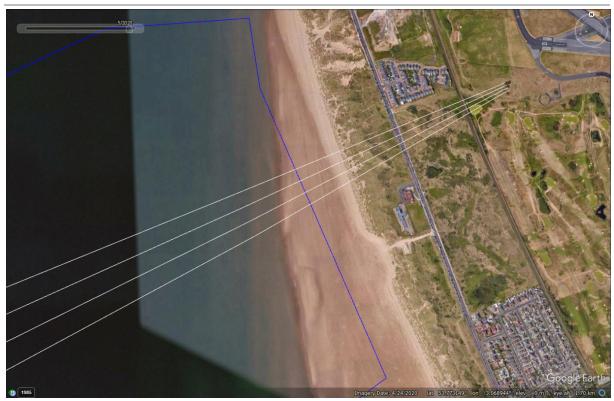
Figure 35. Satellite Imagery of Morgan Landfall (1 January 2000)

Figure 36. Satellite Imagery of Morgan Landfall (1 January 2005)

Figure 37. Satellite Imagery of Morgan Landfall (19 April 2011)

Figure 38. Satellite Imagery of Morgan Landfall (22 April 2015)

Figure 39. Satellite Imagery of Morgan Landfall (11 March 2016)

Figure 40. Satellite Imagery of Morgan Landfall (17 July 2017)

Figure 41. Satellite Imagery of Morgan Landfall (29 June 2018)

Figure 42. Satellite Imagery of Morgan Landfall (24 April 2020)

Figure 43. Satellite Imagery of Morgan Landfall (27 May 2020)

Figure 44. Satellite Imagery of Morgan Landfall (22 July 2021)

More recent historic imagery of the beach at the landfall (between 2000 and 2021) is shown in **Figure 35** to **Figure 44**. For each survey, nearshore wave conditions in the 90 days prior to data collection are illustrated in Figure 45 to Figure 48. The figures illustrate the dune system on the upper foreshore and large ridge and runnel features on the sandy lower foreshore, trending approximately parallel to the coastline. Comparing the available historical images, the dunes surrounding the proposed cable route is associated with several large and dynamic dunes that are susceptible to movement.
