Hinkley Point C Connection Project

Appendix 9J – Factual Report on Ground Investigation Hinkley to Seabank 400kV Connection

FACTUAL REPORT
on
GROUND INVESTIGATION
on
HINKLEY TO SEABANK 400KV
CONNECTION

OCTOBER 2013
REPORT NO: 727635

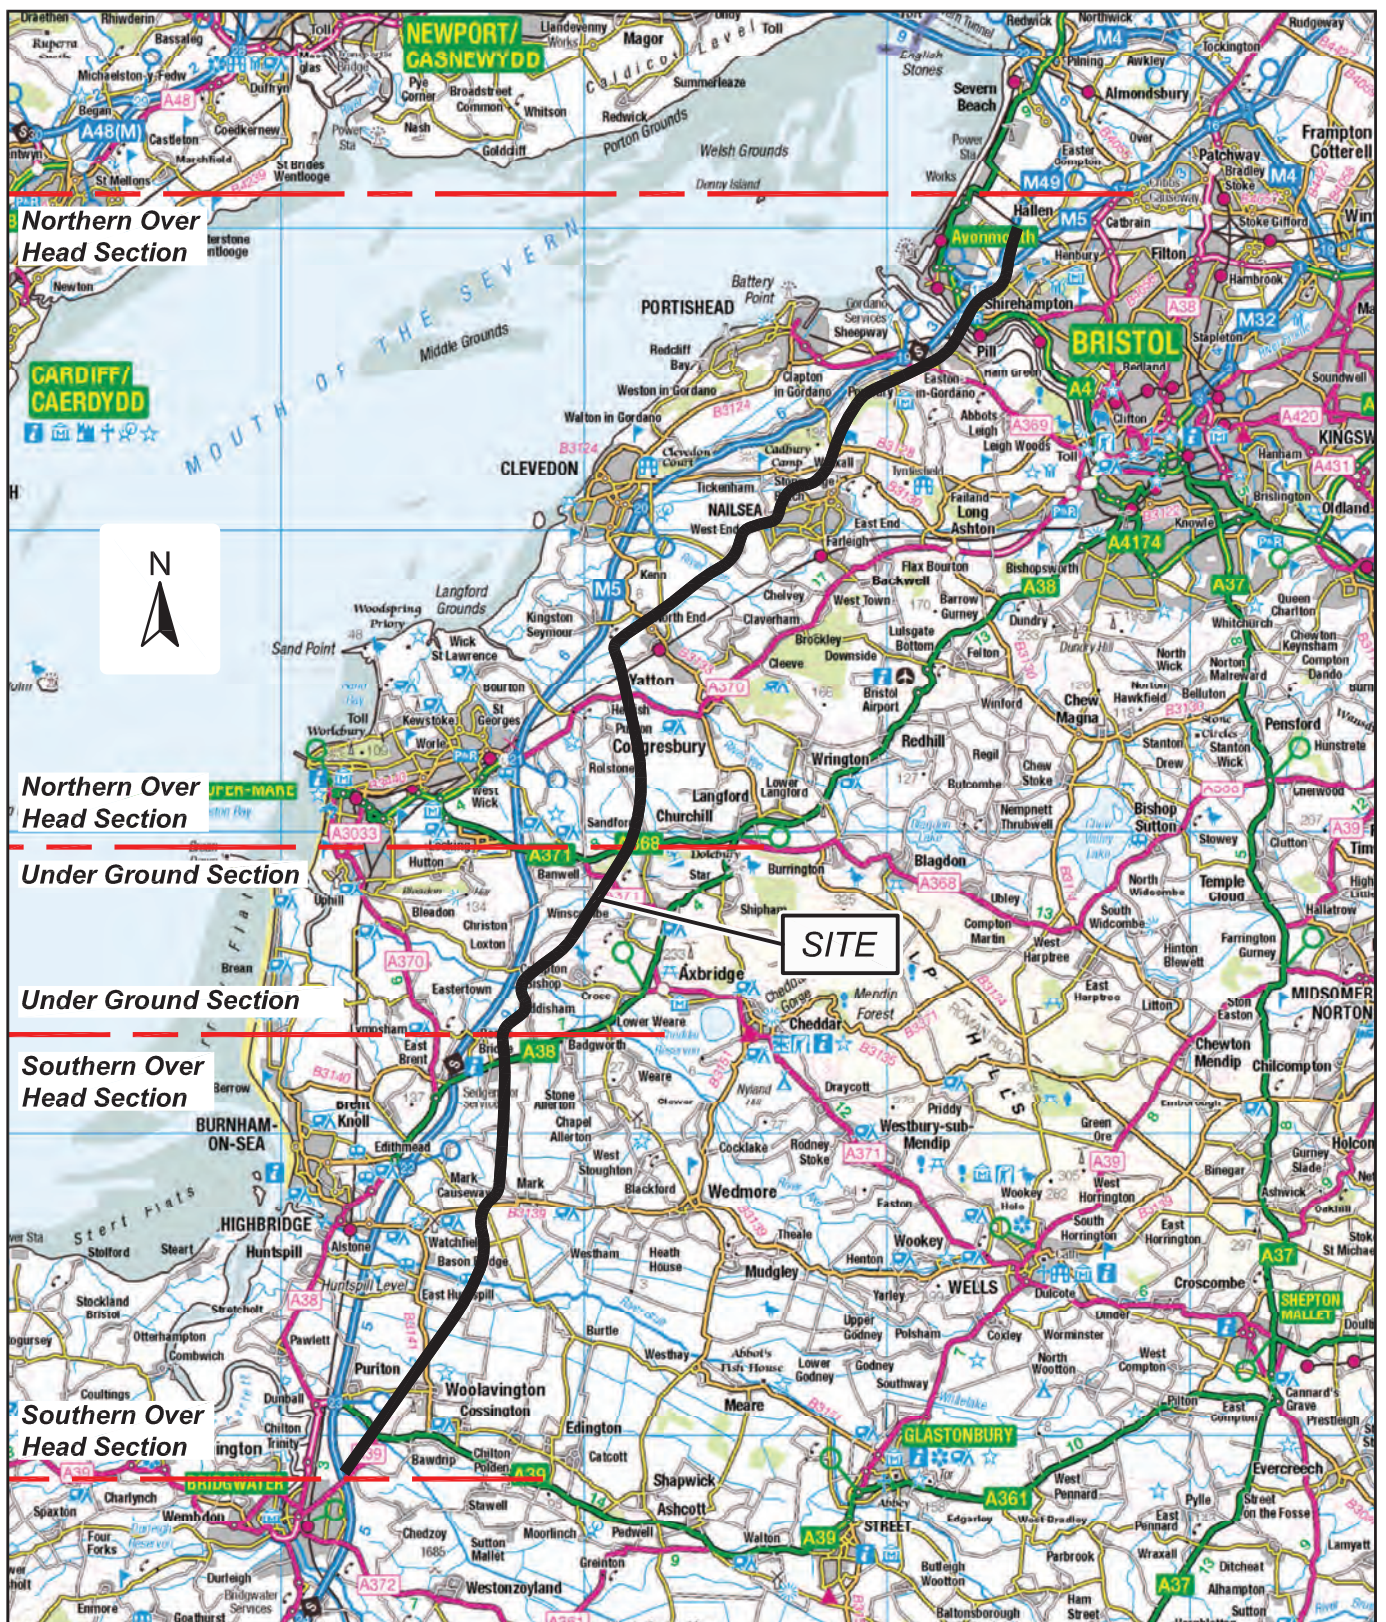
FIGURE No
1

- (i) Site Location Plan
- (ii) Exploratory Hole Location Plans
- (iii) Exploratory Hole Location Coordinate Summary Sheet

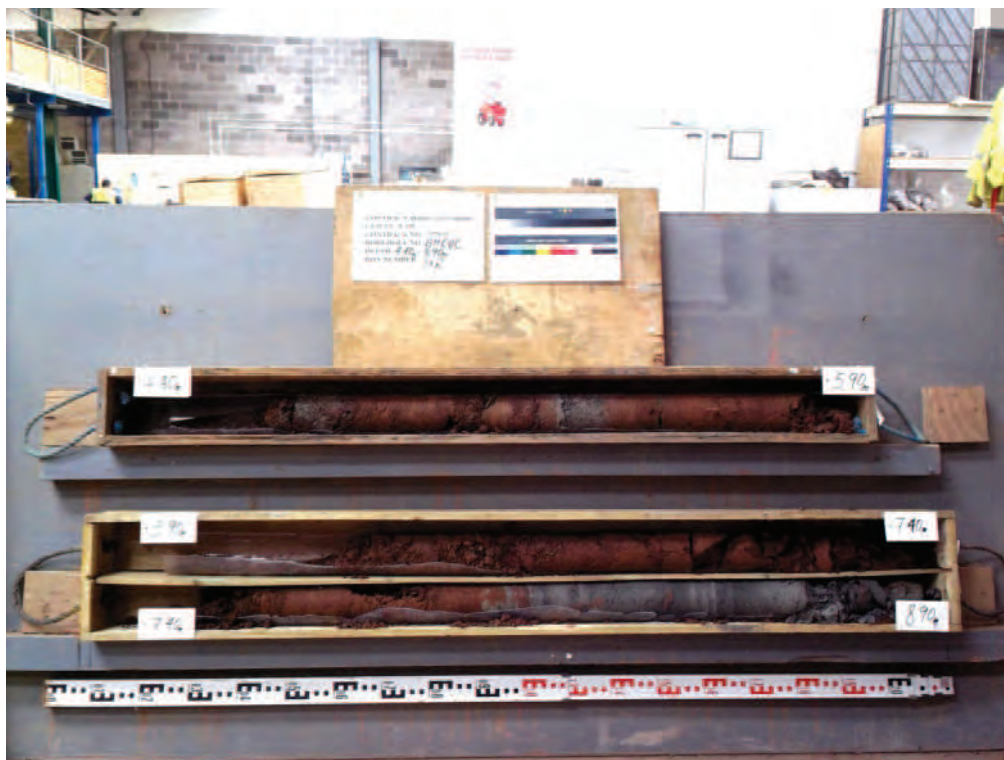
BHC8C 4.40m to 8.90m

4.40-5.90										Extremely weak to very weak thinly laminated reddish brown MUDSTONE breaks up/crumbles into fine to coarse angular blocks of extremely weak to very weak reddish brown mudstone along extremely closely spaced joints. Bedding fractures are 5° to 10° very closely to closely spaced undulating rough infilled with reddish fine to coarse gravel limestone. Joints are extremely closely spaced tight. (MERCIA MUDSTONE GROUP) . . . joints at 4.92m depth 50° undulating rough tight.

7.40-8.90 7.40-7.82	2	SPT	N=113*	97	13	10				... bedding fractures at 5.00m, 5.30m, 5.37m and 5.46m depth are 5° to 10° infilled with red clay. ... between 5.25m and 5.34m depth greenish grey extremely weak to very weak mudstone/siltstone. ... joint at 5.30m depth is 45° planar rough tight. ... between 5.54m and 5.63m depth vertical vein of white gypsum. Extremely weak to very weak thinly laminated reddish brown MUDSTONE breaks up/crumbles into fine to coarse angular blocks of extremely weak to very weak reddish brown mudstone along extremely closely spaced joints. Bedding fractures are 5° to 10° very closely to closely spaced undulating rough infilled with reddish fine to coarse gravel limestone. Joints are extremely closely spaced tight. (MERCIA MUDSTONE GROUP) (stratum text copied from layer at 4.40m depth from previous sheet) ... occasional white gypsum veins between 6.50m and 6.80m depth. Mudstone is very weak and crumbles into angular blocks of very weak mudstone when handled (MMGII). ... joint at 7.00m depth 60° undulating rough infilled with reddish brown gravelly clay up to 2.5mm. Extremely weak to very weak thinly laminated greenish grey SILTSTONE. Joints/fissures are randomly orientated and extremely closely spaced tight. (MERCIA MUDSTONE GROUP Zone II) ... between 8.40m and 8.60m depth green siltstone becomes very weak and MMGI. ... siltstone crumbles into angular block of extremely/very weak siltstone between 8.60m and 8.85m depth (MMGII). ... joint at 8.65m depth 45° undulating rough tight. ... below 8.85m depth siltstone is intact. ... between 8.90m and 10.20m depth mudstone breaks up into fine to coarse angular blocks of extremely weak red mudstone (MMGII). ... greenish grey siltstone between 9.70m and 9.85m depth. ... band of red MMGIII between 10.20m and 10.30m depth (possible differential weathering). Description on next sheet	4.98	8.10

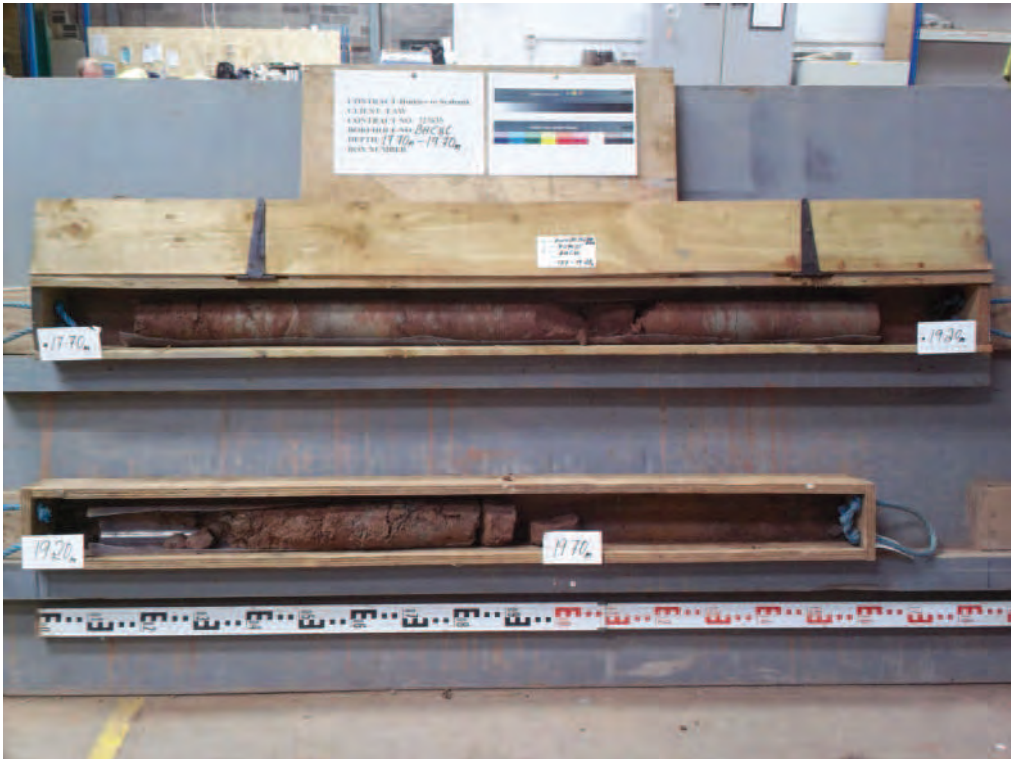
BHC8C 17.70m TO 19.70m

19.20-19.70 19.20-19.61	10	SPT(c)	N=115*	93	80	60	350 NI 150 350			(MERCIA MUDSTONE GROUP) ... joint at 15.45m and 15.62m depth is 70° planar rough clean. ... mudstone becomes extremely weak to very weak below 15.78m and 16.00m depth. ... joint at 15.94m depth is 40° undulating rough infilled with red clay up to 2mm. ... between 16.00m and 16.40m depth occasional green grey mottling/bands of siltstone. ... incipient joint at 16.30m depth is 70° planar rough with brown oxidation stains on fracture surface. ... between 16.65m and 16.80m depth mudstone becomes extremely weak. ... between 17.00m and 17.30m depth MMGI becomes MMGIII (stiff reddish clay with frequent lithorelicts). ... at 17.45m depth joint is 60° planar rough infilled with reddish clay up to 2mm. ... red mudstone between 17.90m and 18.40m depth contains frequent greenish grey mottling. Extremely weak reddish brown mottled greenish grey MUDSTONE. Joints are 50° to 70° closely to medium spaced undulating rough/planar rough tight/open filled with red clay/clean. (MERCIA MUDSTONE GROUP Zone II) (stratum text copied from layer at 17.80m depth from previous sheet) ... joint at 18.90m depth is 70° planar rough open infilled with red clay up to 2mm. ... at 19.20m depth possibly MMGIII with frequent lithorelicts of very weak mudstone. Borehole terminated at 19.70m depth.	-6.62	19.70

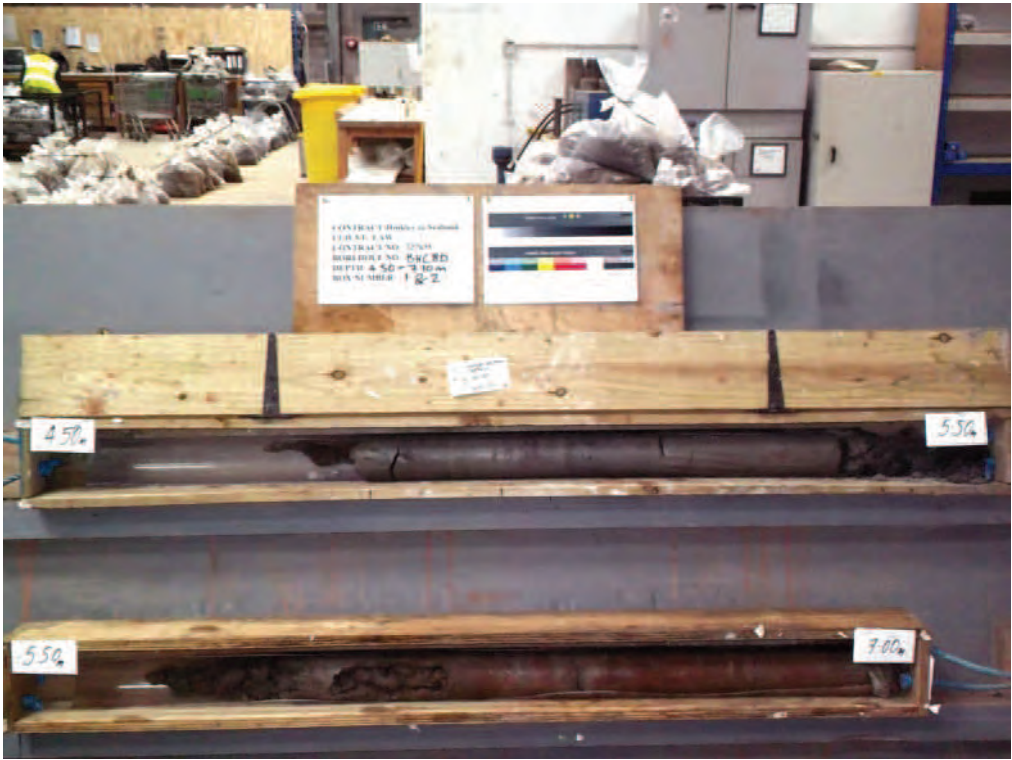
BHC8D 4.50m to 7.00m

5.50-7.00 5.50-5.95	2	SPT	N=101	100	0	0				Extremely weak thinly laminated extremely closely fissured/jointed grey silty distinctly weathered MUDSTONE breaking into angular blocks of extremely weak grey mudstone. Joints/fissures are extremely closely spaced. (MERCIA MUDSTONE GROUP) ... between 4.50m and 4.90m depth grey mudstone breaks up into angular blocks of extremely weak mudstone. (stratum text copied from layer at 4.50m depth from previous sheet) ... becomes reddish brown mudstone between 5.40m and 5.45m depth. ... between 5.50m and 6.00m depth damaged by SPT action.	6.22	6.00

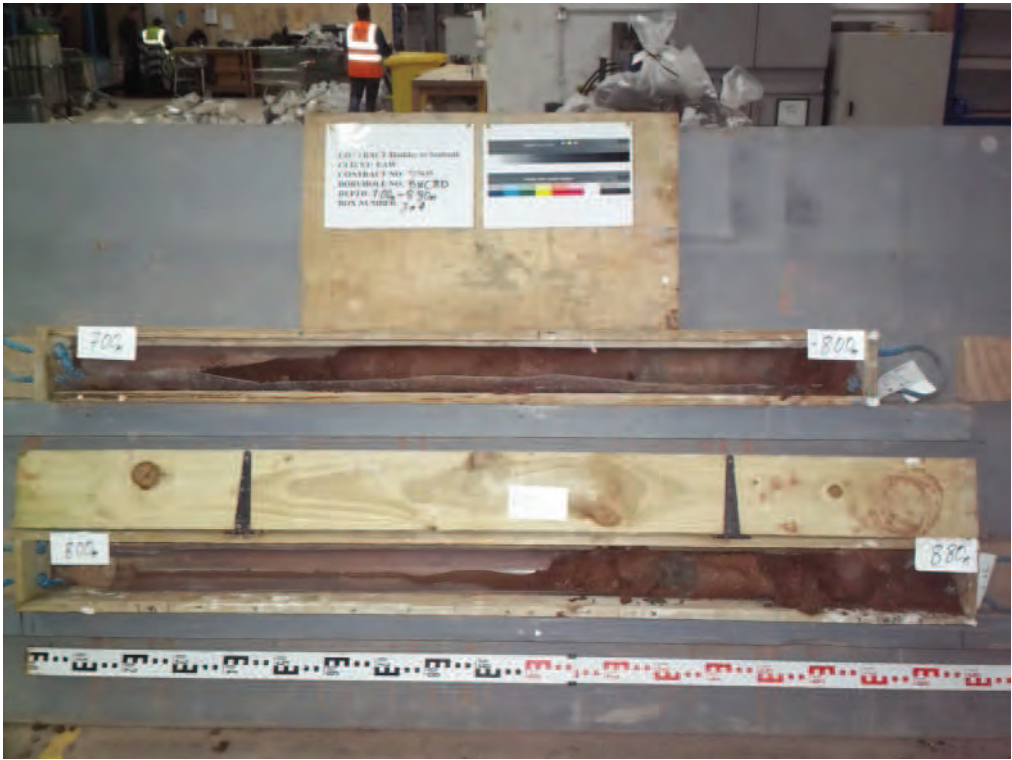
BHC8D 7.00m to 8.80m

7.00-8.00 7.00-7.41	3	SPT	N=118*							Extremely weak to very weak thinly laminated reddish brown mottled greenish grey MUDSTONE breaks up into fine to coarse angular blocks of extremely weak/very weak mudstone when handled. Joints/fissures are extremely closely spaced very tight. Bedding is 10°. Bedding fractures are not clear. (MERCIA MUDSTONE GROUP Zone II) ... reddish brown mudstone between 6.20m and 7.00m depth contains frequent greenish grey mottling/greenish grey siltstone. ... between 7.10m and 7.20m depth becomes MMG III with frequent fine to medium extremely weak angular lithorelicts of mudstone. ... becomes MMGII with extremely weak angular blocks of red mudstone between 7.20m and 8.00m depth. ... between 7.60m and 7.90m depth bed of extremely weak greenish grey siltstone(MMGIII). ... between 7.90m and 8.00m depth recovered as fine to coarse angular gravel of extremely weak reddish brown and greenish mudstone. ... extremely weak grey siltstone between 8.23m and 8.30m depth. ... between 8.50m and 8.80m depth recovered as fine to coarse angular blocks of extremely weak angular mudstone. ... at 9.20m depth occasional greenish grey mottled greenish grey siltstone. ... between 9.20m and 10.10m depth mudstone is extremely weak breaks up into angular blocks when handled.

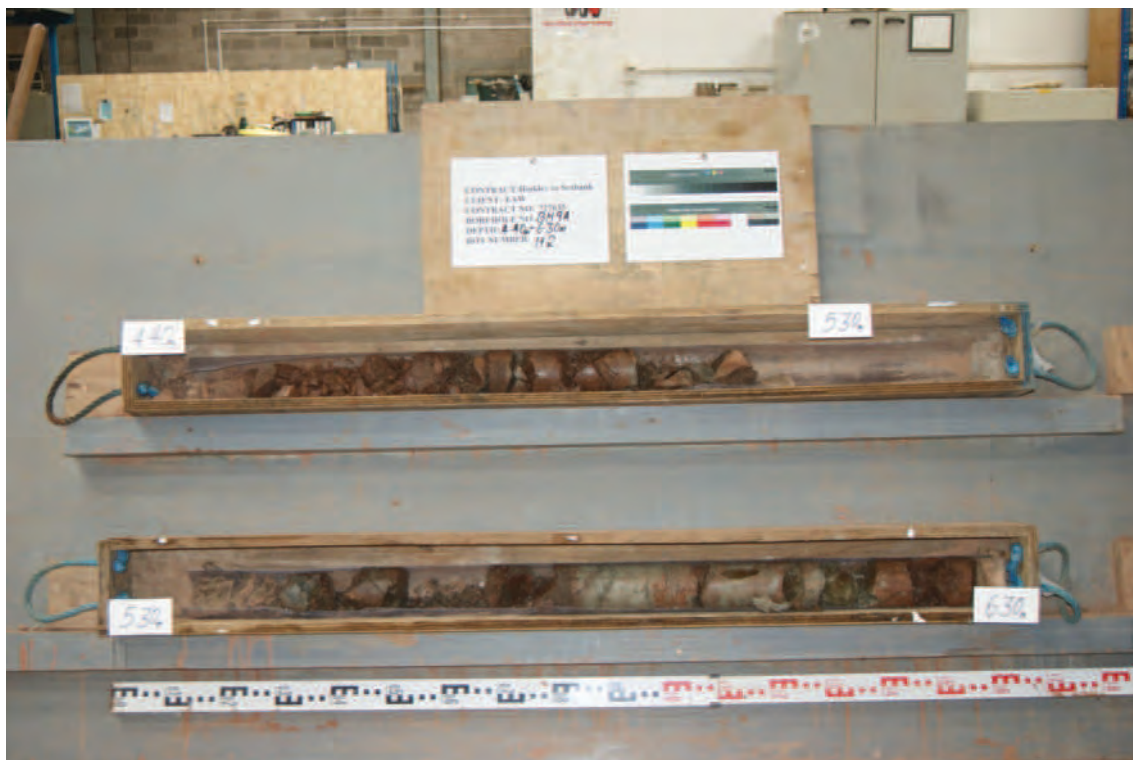
BHC9A 4.40m to 6.30m

4.40-5.30										Medium strong very thinly to thinly bedded reddish brown mottled greenish grey silty MUDSTONE. Bedding is 5°. (MERCIA MUDSTONE GROUP Zone I) ... between 4.40m and 5.30m depth most of the fractures are randomly orientated. Extremely to very closely spaced with fine to medium gravel infilled in the fractures. (possible intensely fractured zone). ... between 4.85m and 5.00m depth non intact (possible intensely fractured zone). ... between 5.04m and 5.17m depth joint is 80° planar rough with non intact upper wall rock. ... between 5.30m and 5.45m depth non intact breaking along randomly orientated fractures with some iron staining along the fractures in places. ... between 5.56m and 5.65m depth joint is 60° planar rough clean.

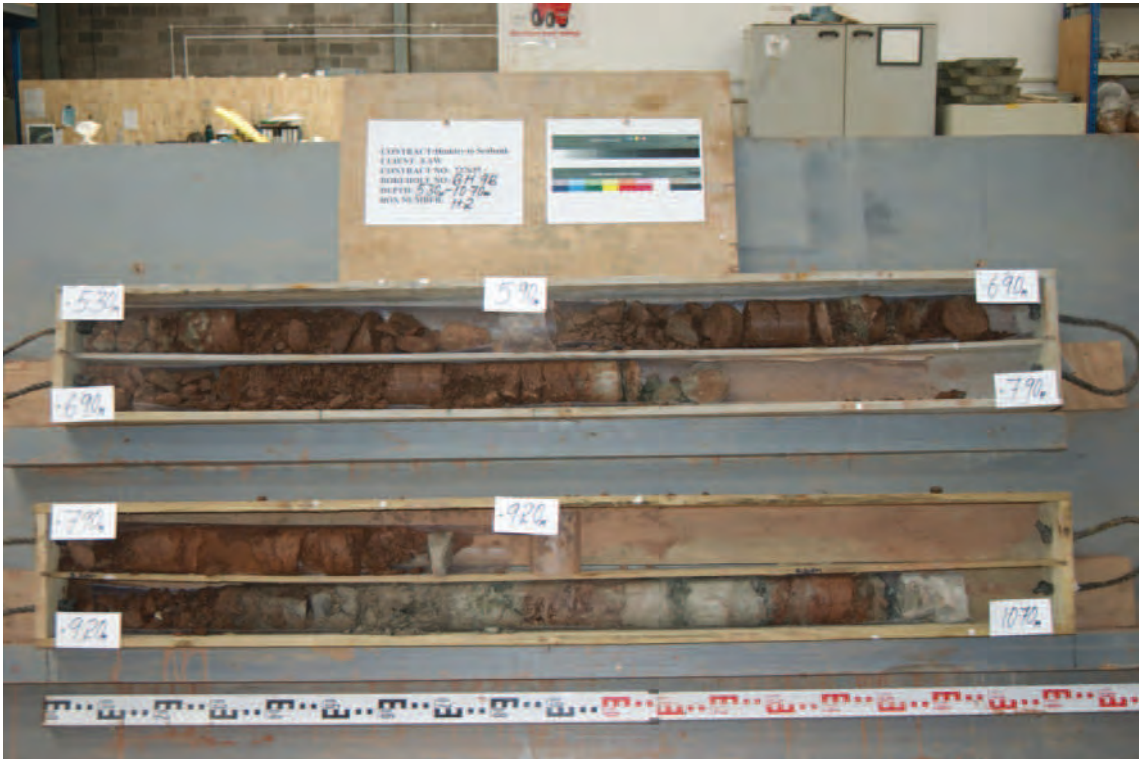
BHC9B 5.30m to 10.70m

5.30-5.90													
5.90-6.90	1	SPT	N=316*							Very weak to weak reddish brown silty MUDSTONE with occasional greenish grey mottling. Recovered as fine to coarse angular blocks of intact rock (possible intensely fractured zone). (MERCIA MUDSTONE GROUP Zone I) . . . between 5.42m and 5.55m depth core with full diameter where as 5.55m and 5.90m depth mudstone recovered as fine to coarse angular blocks of intact MMGI mudstone. . . . between 5.90m and 6.40m depth non intact recovered as weak fine to coarse angular blocks of weak mudstone broken along randomly orientated fractures. . . . between 6.40m and 6.60m depth fractures are 10° are very closely to closely spaced. . . . between 6.70m and 6.90m depth non intact recovered as extremely weak to very weak fine to coarse angular gravel of red mudstone (possibly weakened by prolonged percolation of water and subsequent weathering). . . . between 6.90m and 7.45m depth non intact recovered as fine to coarse weak angular fragments of silty mudstone. . . . between 7.42m and 7.52m depth mudstone non intact and very weak. . . . between 7.55m and 7.65m depth recovered as fine to coarse angular fragments of extremely weak to weak mudstone..		(2.60)

7.90-8.16	3	SPT	N=200*	38	0	0				... between 7.60m and 7.70m depth vertical vein of white fibrous gypsum. ... between 7.80m and 7.90m depth medium strong greenish grey siltstone. Firm reddish brown silty CLAY formed by the complete weathering of mudstone (possible intensely fractured zone undergone prolonged weathering). (MERCIA MUDSTONE GROUP Zone IVb) <i>(stratum text copied from layer at 7.90m depth from previous sheet)</i>	11.83	8.90

9.20-10.70	4	SPT	N=97	93	23	17	NI 80 140			Extremely weak extremely closely fissured/jointed reddish brown MUDSTONE crumbles/breaks up into fine to coarse angular blocks of extremely weak mudstone (possible intensely fractured zone undergone prolonged weathering). (MERCIA MUDSTONE GROUP Zone II) Very weak to extremely weak very thinly to thinly bedded greenish grey SILTSTONE with very closely to closely spaced reddish brown extremely/very weak reddish brown mudstone. (MERCIA MUDSTONE GROUP Zone I) ... between 9.20m and 9.35m depth red brown mudstone recovered non intact. ... between 9.20m and 10.05m depth non intact (possible intensely fractured zone) and weakened. ... between 9.90m and 10.05m depth red mudstone recovered non intact. ... siltstone between 9.95m and 10.30m depth bedding fractures are closely spaced. ... bedding fracture at 10.15m depth wall rock on either side of the fracture is weakened and disintegrated due to prolonged weathering along the fracture. ... between 10.30m and 10.50m depth red mudstone becomes very weak. Extremely weak very thinly to medium spaced reddish brown and greenish MUDSTONE crumbles into fine to coarse angular blocks of extremely weak mudstone. Bedding is 25°. (MERCIA MUDSTONE GROUP Zone II) ... between 10.82m and 10.97m depth possible bedding fracture. <i>Description on next sheet</i>	11.58	9.15

10.70-12.20	5	SPT	N=182*	100	33	17	NI 30 160			... between 10.30m and 10.50m depth red mudstone becomes very weak. Extremely weak very thinly to medium spaced reddish brown and greenish MUDSTONE crumbles into fine to coarse angular blocks of extremely weak mudstone. Bedding is 25°. (MERCIA MUDSTONE GROUP Zone II) ... between 10.82m and 10.97m depth possible bedding fracture. <i>Description on next sheet</i>	10.03	10.70

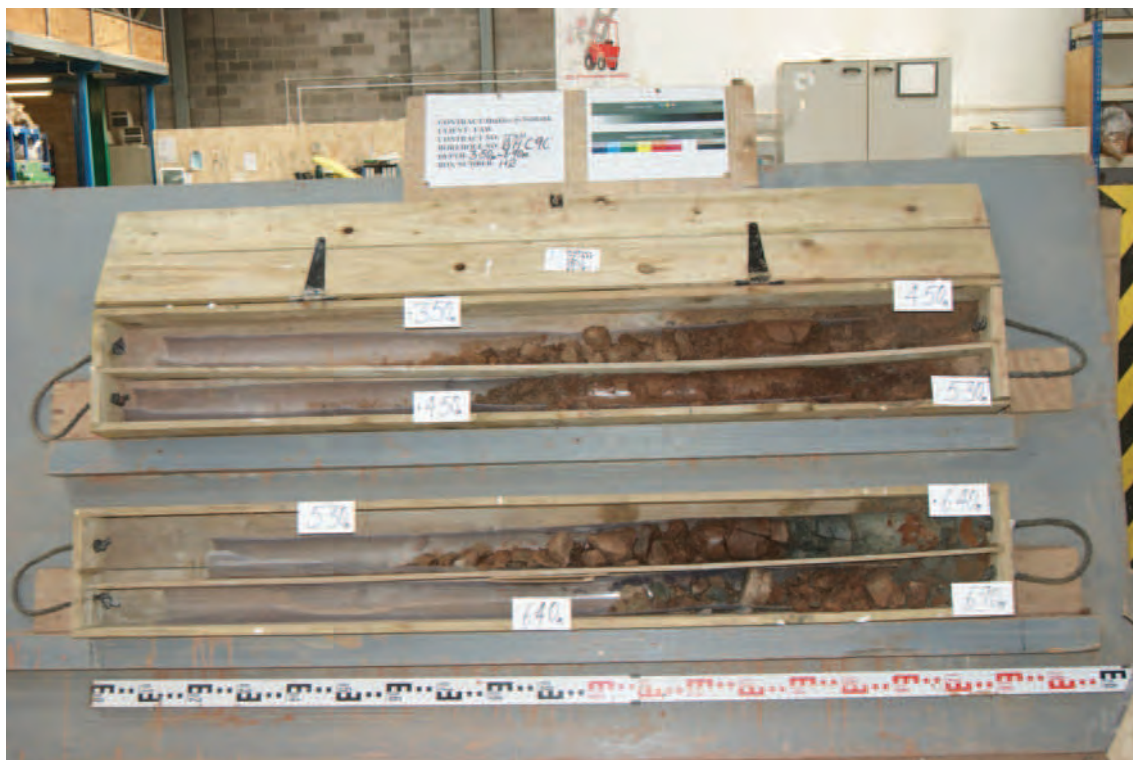
BHC9C 3.50m to 6.90m

3.50-4.50				↑	↑	↑				Weak reddish brown mottled green grey MUDSTONE recovered non intact (possible intensely fractured zone). Bedding dipping between 15° and 20°. (MERCIA MUDSTONE GROUP) ... between 3.50m and 4.05m depth recovered as angular fine to coarse weak mudstone.	16.88	4.20	
				70	0	0				... between 4.10m and 4.20m depth recovered as fine to coarse angular weak mudstone.

5.30-6.40				↓	↓	↓				Weak very thinly bedded reddish brown silty MUDSTONE with occasional green grey mottling. Fractures are 5° to 15° undulating rough clean. (MERCIA MUDSTONE GROUP)	15.08	6.00

6.40-6.90	10	SPT(c)	N=125*	82	27	0				discolouration on joint. Weak greenish grey SILTSTONE. (MERCIA MUDSTONE GROUP Zone I) ... siltstone between 6.00m and 6.10m depth fractured randomly due to possible intense fracturing.	14.78	(0.30)

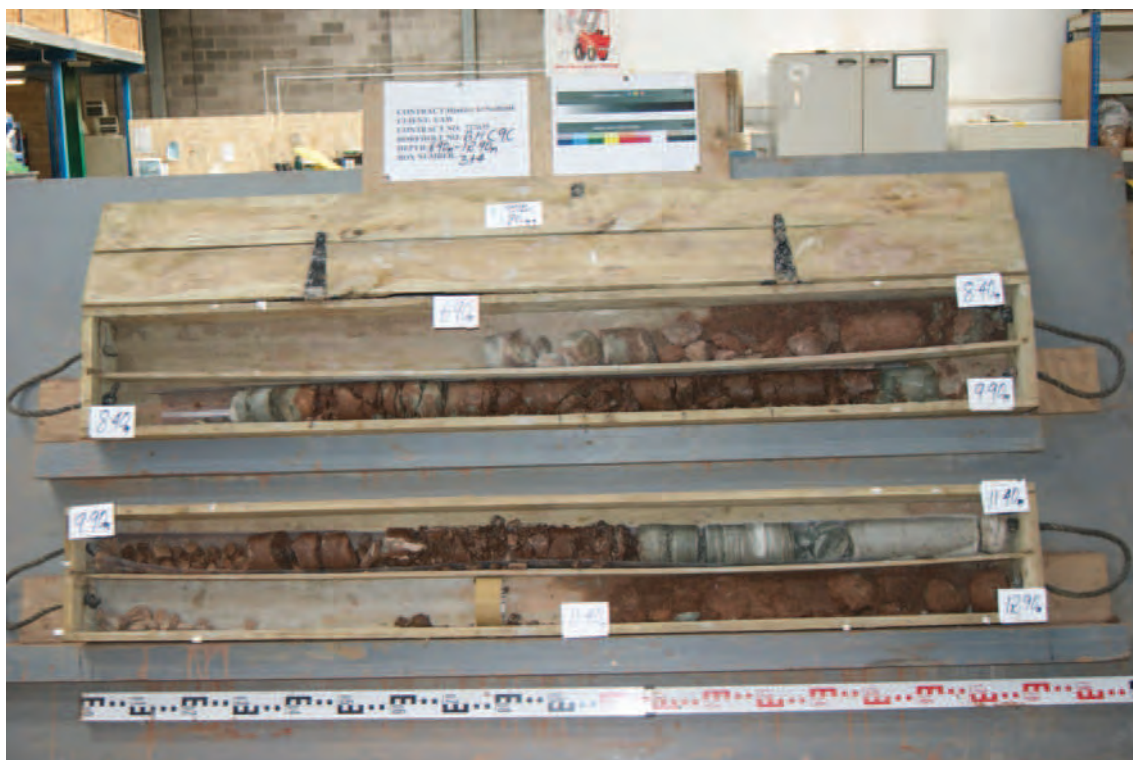
BHC9C 6.90m to 12.90m

6.90-8.40				60	13	0				Weak reddish brown mottled greenish grey silty MUDSTONE recovered as fine to coarse angular gravel of weak red mudstone with pocket of red clay (possible intensely fractured zone). (MERCIA MUDSTONE GROUP Zone I) ... between 6.30m and 6.40m depth very weak to extremely weak reddish brown mudstone crumbles into fine to coarse angular blocks (MMGII) of very weak to extremely weak mudstone (possible differential weathering). ... between 6.90m and 8.00m depth recovered as low (up to 41%) recovered as cobble and angular gravel of red mudstone with irregular fracture surfaces.		(2.10)

8.40-8.52							NI 30 60			Weak very thinly to thinly bedded reddish brown mottled green silty MUDSTONE with randomly orientated irregular fractures (possible intensely fractured zone). Bedding is 25°. Bedding fractures are 25° planar partly open/open fractures are randomly orientated extremely closely spaced clean with infilling of fine to medium gravel of siltstone. (MERCIA MUDSTONE GROUP Zone I) <i>Description on next sheet</i>

9.90-11.40 9.90-10.05	12	SPT(c)	N=429*	93	35	0	NI 30 60			... joint between 8.53m and 8.65m depth is 65° planar rough with black spots. ... 30mm cavity containing gypsum crystals (possibly formed by dissolution) at 8.65m depth. Weak very thinly to thinly bedded reddish brown mottled green silty MUDSTONE with randomly orientated irregular fractures (possible intensely fractured zone). Bedding is 25°. Bedding fractures are 25° planar partly open/open fractures are randomly orientated extremely closely spaced clean with infilling of fine to medium gravel of siltstone. (MERCIA MUDSTONE GROUP Zone I) <i>(stratum text copied from layer at 8.40m depth from previous sheet)</i> ... between 9.90m and 10.10m depth fractures.		(2.35)	
										... between 10.25m and 10.70m depth vein of (15mm) fibrous gypsum vein dipping almost vertically.	10.33	10.75	
				93	48	16	NI 50 140			Weak thinly jointed greenish grey MUDSTONE interlaminated with thin laminations of brown oolitic limestone. Bedding fracture is 5° very closely to closely spaced undulating rough clean/infilled with greenish clay. (MERCIA MUDSTONE GROUP)	9.98	11.10

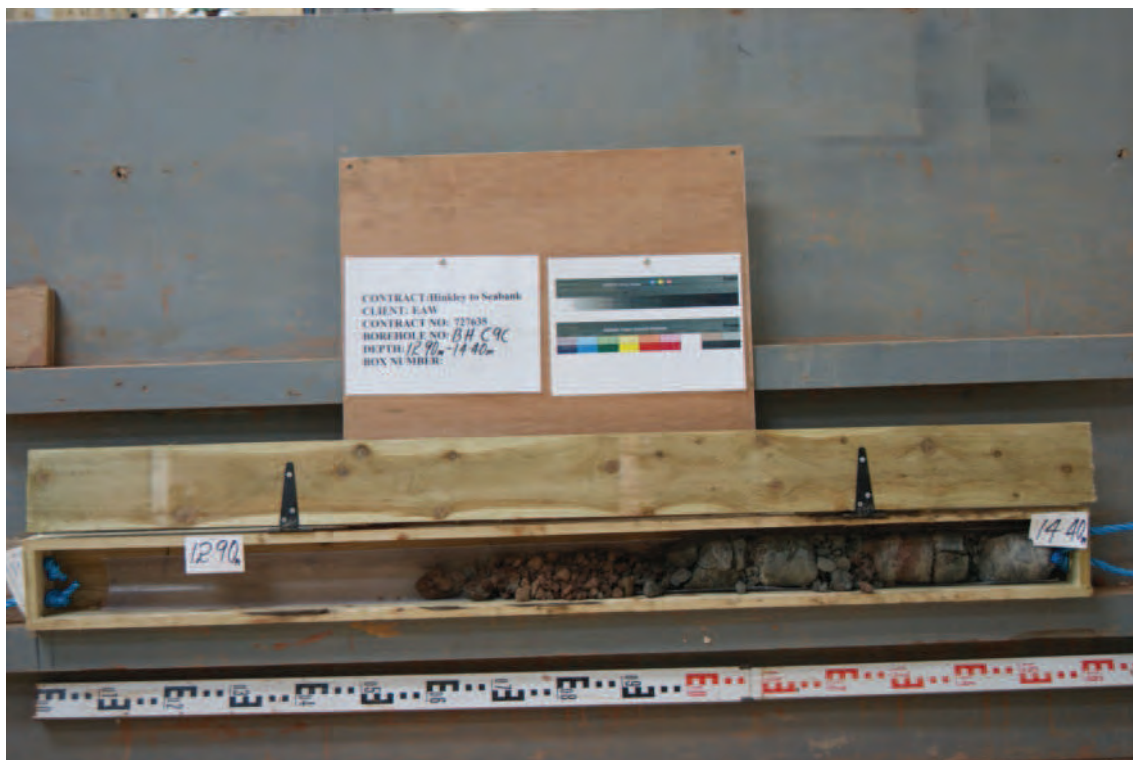
BHC9C 12.90m to 14.40m

12.90-14.40	14	SPT(c)	N=375*	33	4	0				Recovered as reddish brown very clayey fine to coarse angular GRAVEL of extremely weak mudstone with cobble of medium sub angular greenish grey and reddish brown siltstone (possible intensely fractured zone). (MERCIA MUDSTONE GROUP) <i>(stratum text copied from layer at 11.40m depth from previous sheet)</i>	8.18	12.90

12.90-13.06										Recovered as fine to coarse angular GRAVEL of reddish brown weak mudstone with pockets of very clayey angular gravel of red mudstone. (MERCIA MUDSTONE GROUP) ... between 12.90m and 13.80m depth recovery is only 25% (possible intensely fractured zone).			
				53	17	0	NI 50 90				7.23	13.85

14.40-14.58	15	SPT(c)	N=200*							Weak thinly laminated to very thinly bedded greenish grey slightly weathered SILTSTONE. Fractures are 5° to 85° very closely spaced undulating rough infilled with fine to medium gravel of siltstone non intact mudstone. (MERCIA MUDSTONE GROUP) ... joint between 13.87m and 13.96m depth is 85° planar rough clean. ... between 14.02m and 14.12m depth non intact (possible intensely fractured zone). ... bed of (20mm) of reddish brown very weak mudstone at 14.20m depth. ... at 14.40m depth bedding fracture is 5° undulating rough infilled with fine to coarse gravel of green siltstone. Borehole terminated at 14.40m depth.	6.68	14.40
