# Environmental Statement Ground Environment Appendix 9J Part 2

Hinkley Point C Connection Project

Appendix 9J – Factual Report on Ground Investigation  
Hinkley to Seabank 400kV Connection

Contract: <b>Hinkley to Seabank 400kV Connection</b>			Client: <b>Electricity Alliance West</b>			Borehole: <b>BHC9D</b>		
Contract Ref: <b>727635</b>		Start: <b>4.6.13</b> End: <b>11.6.13</b>	Ground Level (m AOD): <b>20.32</b>		National Grid Co-ordinate: <b>E:340853.0 N:158444.0</b>		Sheet: <b>1 of 10</b>

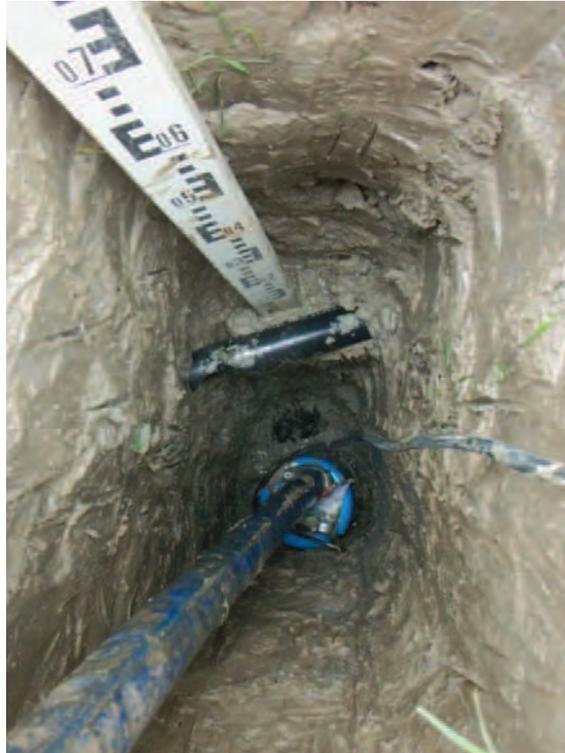
TH1 Water Main and Trace Cable

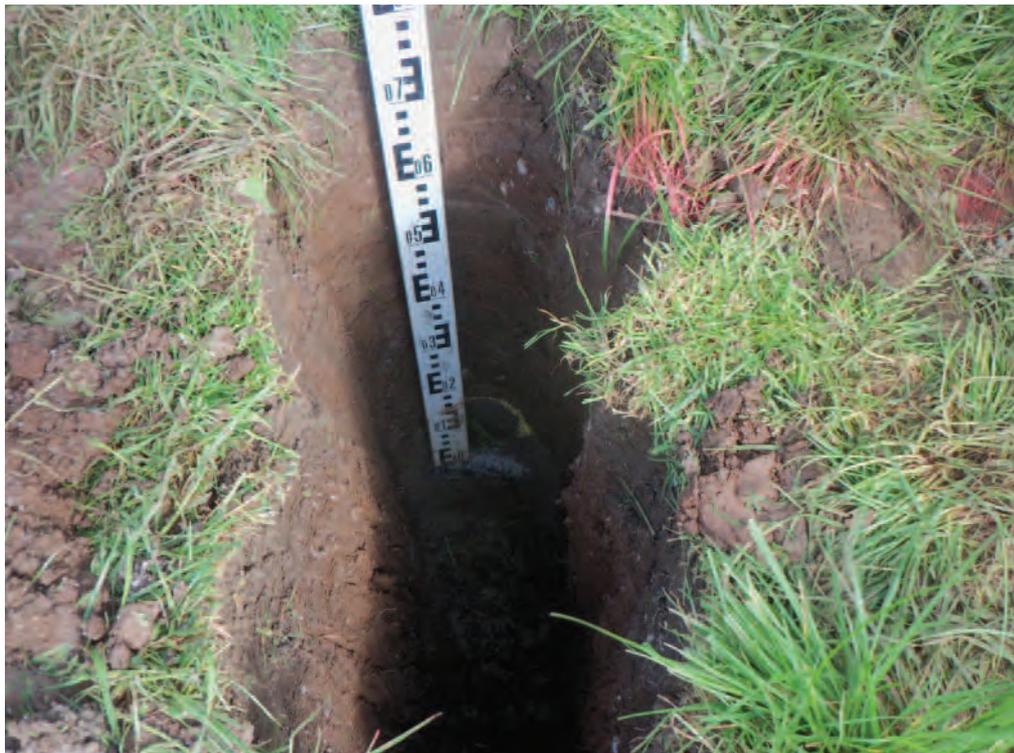
TH2 Electric Cable

- (A)** Electrical cable  
0.80m depth ~ 0.60° orientation
- (B)** Yellow Plastic Hazard Tape  
50mm above electric cable

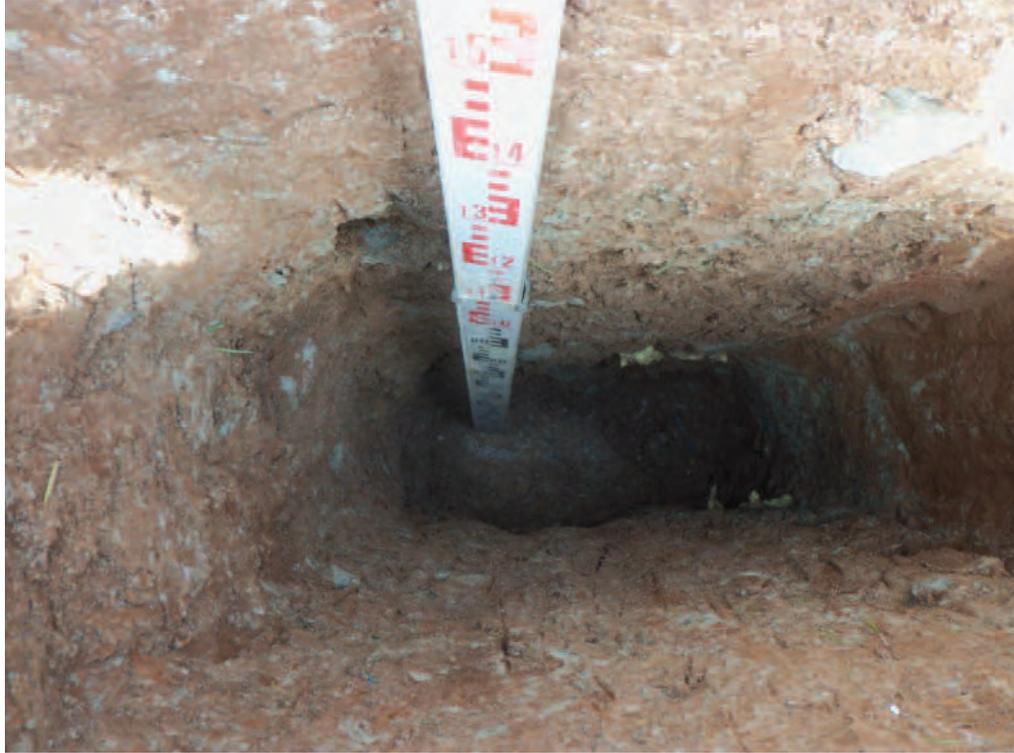
TH3 Water Main and Trace Cable

- (A) Water Main**  
1.80m depth ~ 185° orientation  
Asbestos, ~ 450mm Ø
- (B) Trace Cable**  
1.90m depth ~ 185° orientation,  
with black plastic sheath, ~ 25mm Ø.  
Yellow marker tape above.
- (C) Yellow Plastic Hazard Tape**  
1.50m depth, 150mm wide

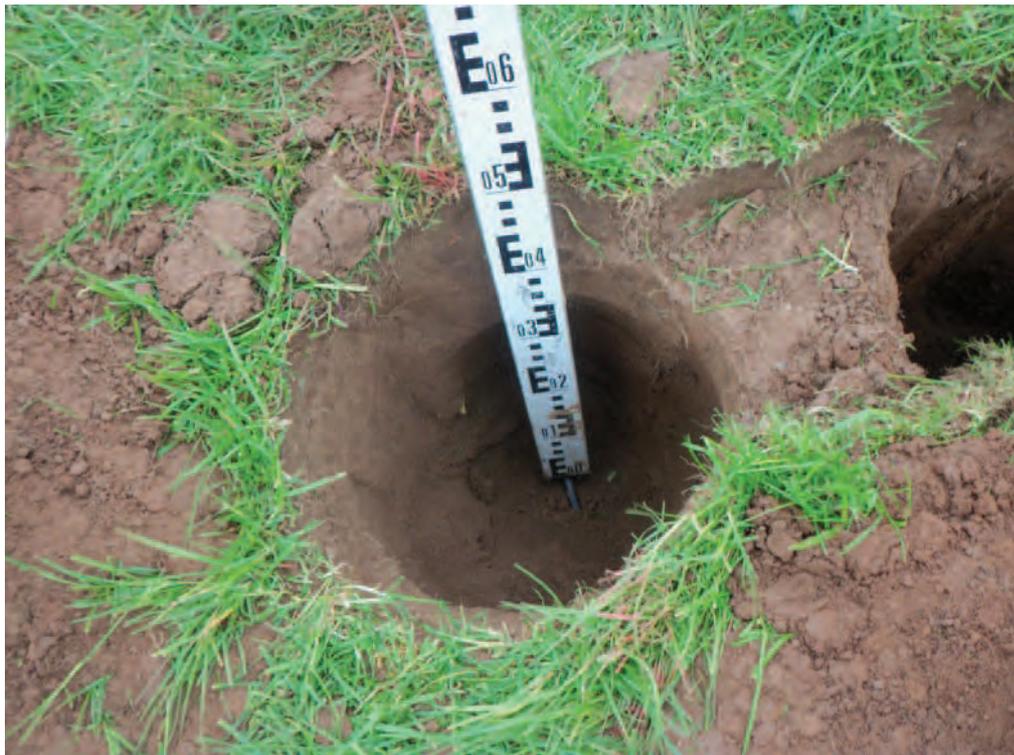
TH4C Electric Cable

<b>General Remarks</b>	
	1. Trial pit sidewalls stable. 2. Trial pit dry. 3. Electric cable 0.45m depth: 338077.3, 156079.3, 12mm diameter, black, 115° orientation. Yellow hazard tape above, no protective backfill material. 4. Location: Webbington.	
All dimensions in metres		Scale: <b>1:25</b>
Method Used: <b>Hand dug</b>	Plant Used: <b>Hand tools</b>	Logged By: <b>Wallwood</b>

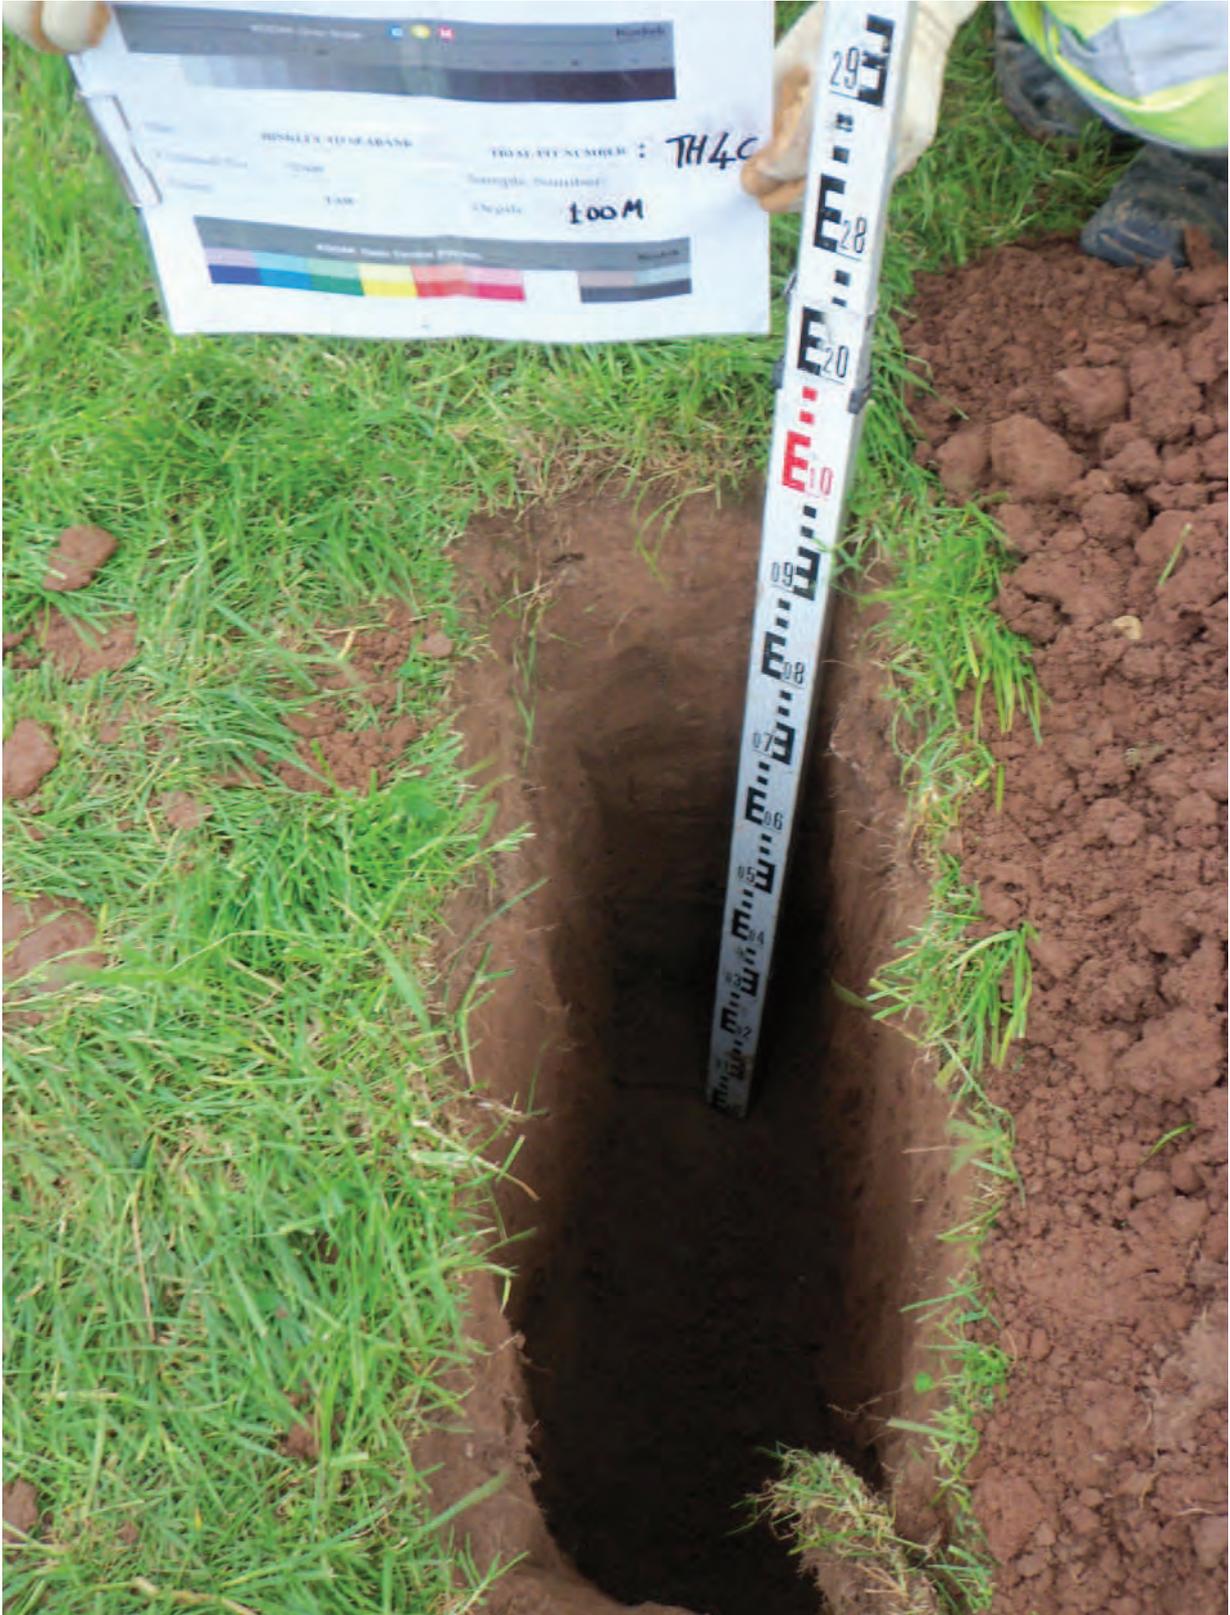
TH4C Sidewalls

Ⓐ Electric Cable  
 0.45mm depth, 12mmØ, black,  
 115° orientation. Yellow hazard type above

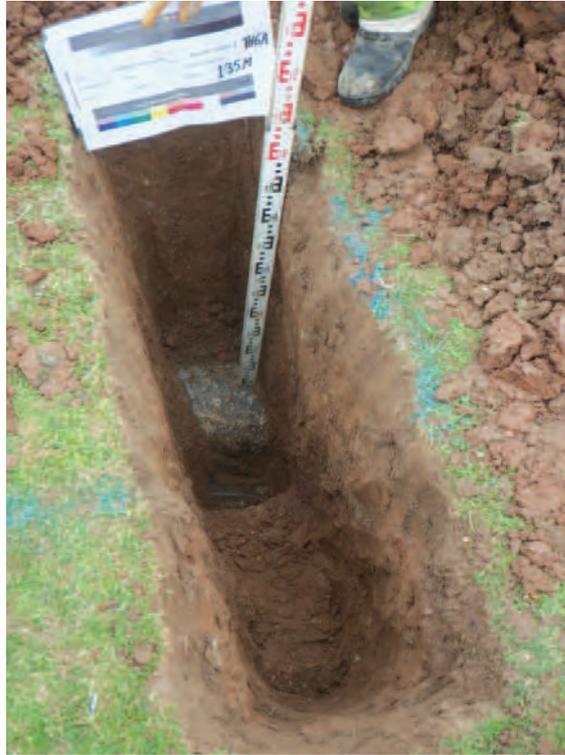
TH6A Water Main

- Ⓐ Water Main  
1.05m depth, probably asbestos  
300 - 400mm Ø ~ 150° orientation
- Ⓑ Trace Cable  
1.30m depth, black plastic  
sheath ~ 25mm Ø. 150° orientation.
- Ⓒ Yellow Plastic Hazard Tape  
1.05m depth, 140mm wide,  
reads 'Caution Electric'

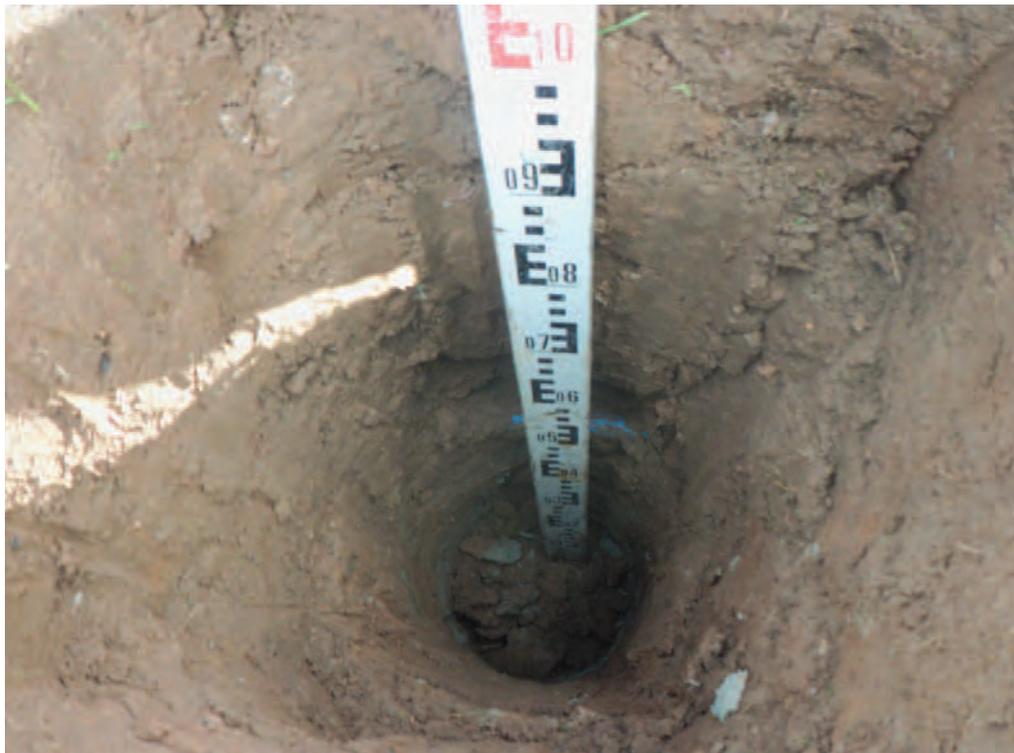
TH6B Domestic Type Water Pipe

Plan (Not to Scale) 	<b>General Remarks</b>	
	1. Sidewalls stable. 2. Trial pit dry. 3. Excavated to find water main. Main not found but small diameter domestic style water pipe found at 0.75m depth: 340389.6, 158237.2 4. Location: Lox Yeo Valley (Mendips).	
All dimensions in metres		Scale: <b>1:25</b>
Method Used: <b>Hand dug</b>	Plant Used: <b>Hand tools</b>	Logged By: <b>Wallwood</b>

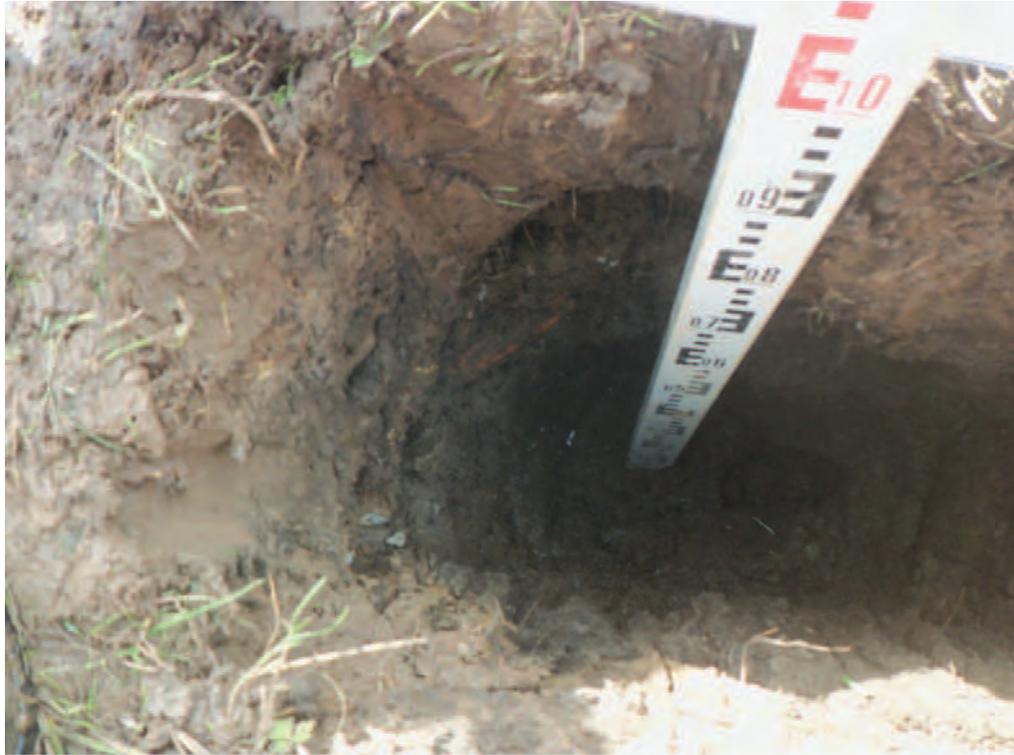
TH6E Land Drain

- Ⓐ **Electric Cables**  
0.85m depth cluster of 3 electric cables.  
Red sleaths. Each ~ 40-60mm Ø, Yellow hazard tape above, Trending ~ 170°
- Ⓐ **Land Drain**  
0.60m depth. ~ 048° orientation

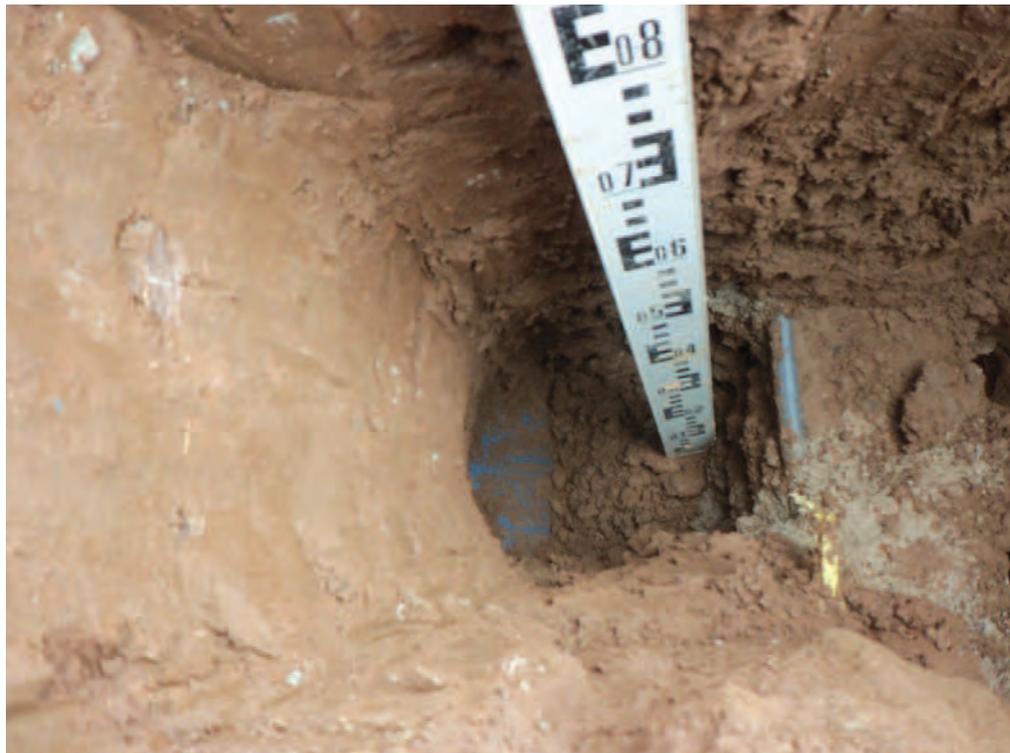
TH7 Water Main and Trace Cable

Ⓑ Trace Cable  
0.75m depth, black plastic sheath, ~25mm Ø,  
100 - 110° orientation. Yellow hazard tape

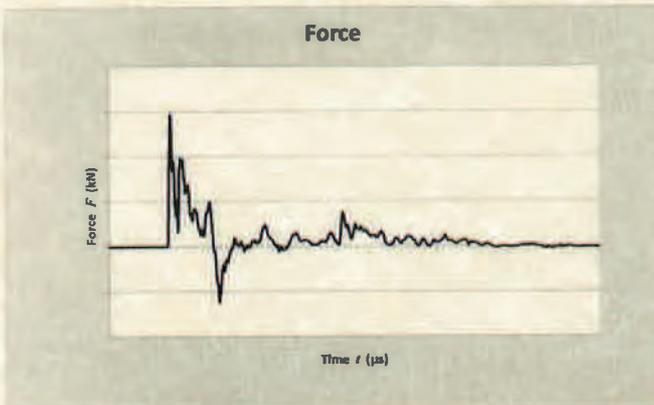
Fig. B.1 and B.2 BS EN ISO 22476-3 2005

Key  
 1 Anvil  
 2 Part of instrumented rod  
 3 Drive Rod  
 4 Strain Gauge  
 5 Accelerometer  
 6 Ground  
 $F$  Force  
 $d_r$  Diameter of rod

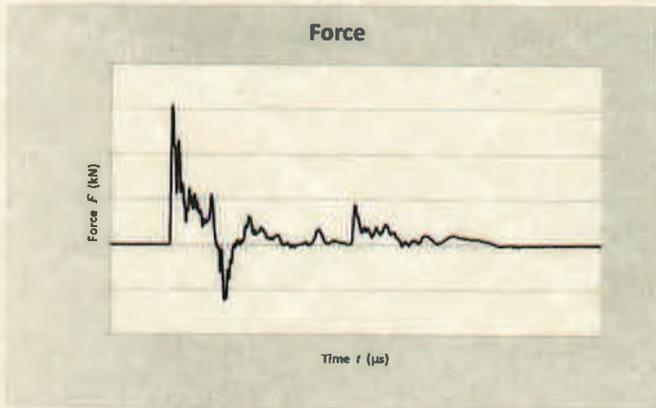
Fig. B.1 and B.2 BS EN ISO 22476-3 : 2005

**Key**  
 1 Anvil  
 2 Part of instrumented rod  
 3 Drive Rod  
 4 Strain Gauge  
 5 Accelerometer  
 6 Ground  
 $F$  Force  
 $d_r$  Diameter of rod

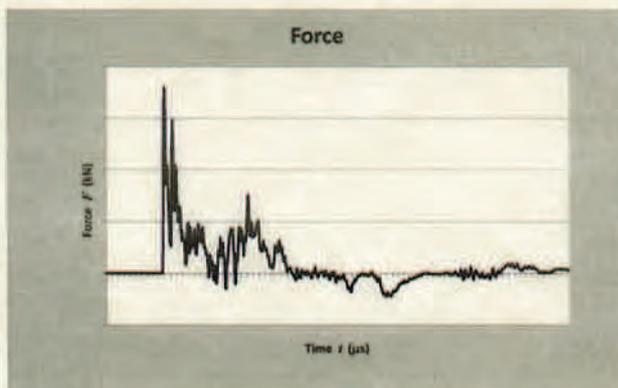
Fig. B.1 and B.2 BS EN ISO 22476-3 : 2005 + A1 : 2011

**Key**  
 1 Anvil  
 2 Part of instrumented rod  
 3 Drive Rod  
 4 Strain Gauge  
 5 Accelerometer  
 6 Ground  
 F Force  
 $d_r$  Diameter of rod

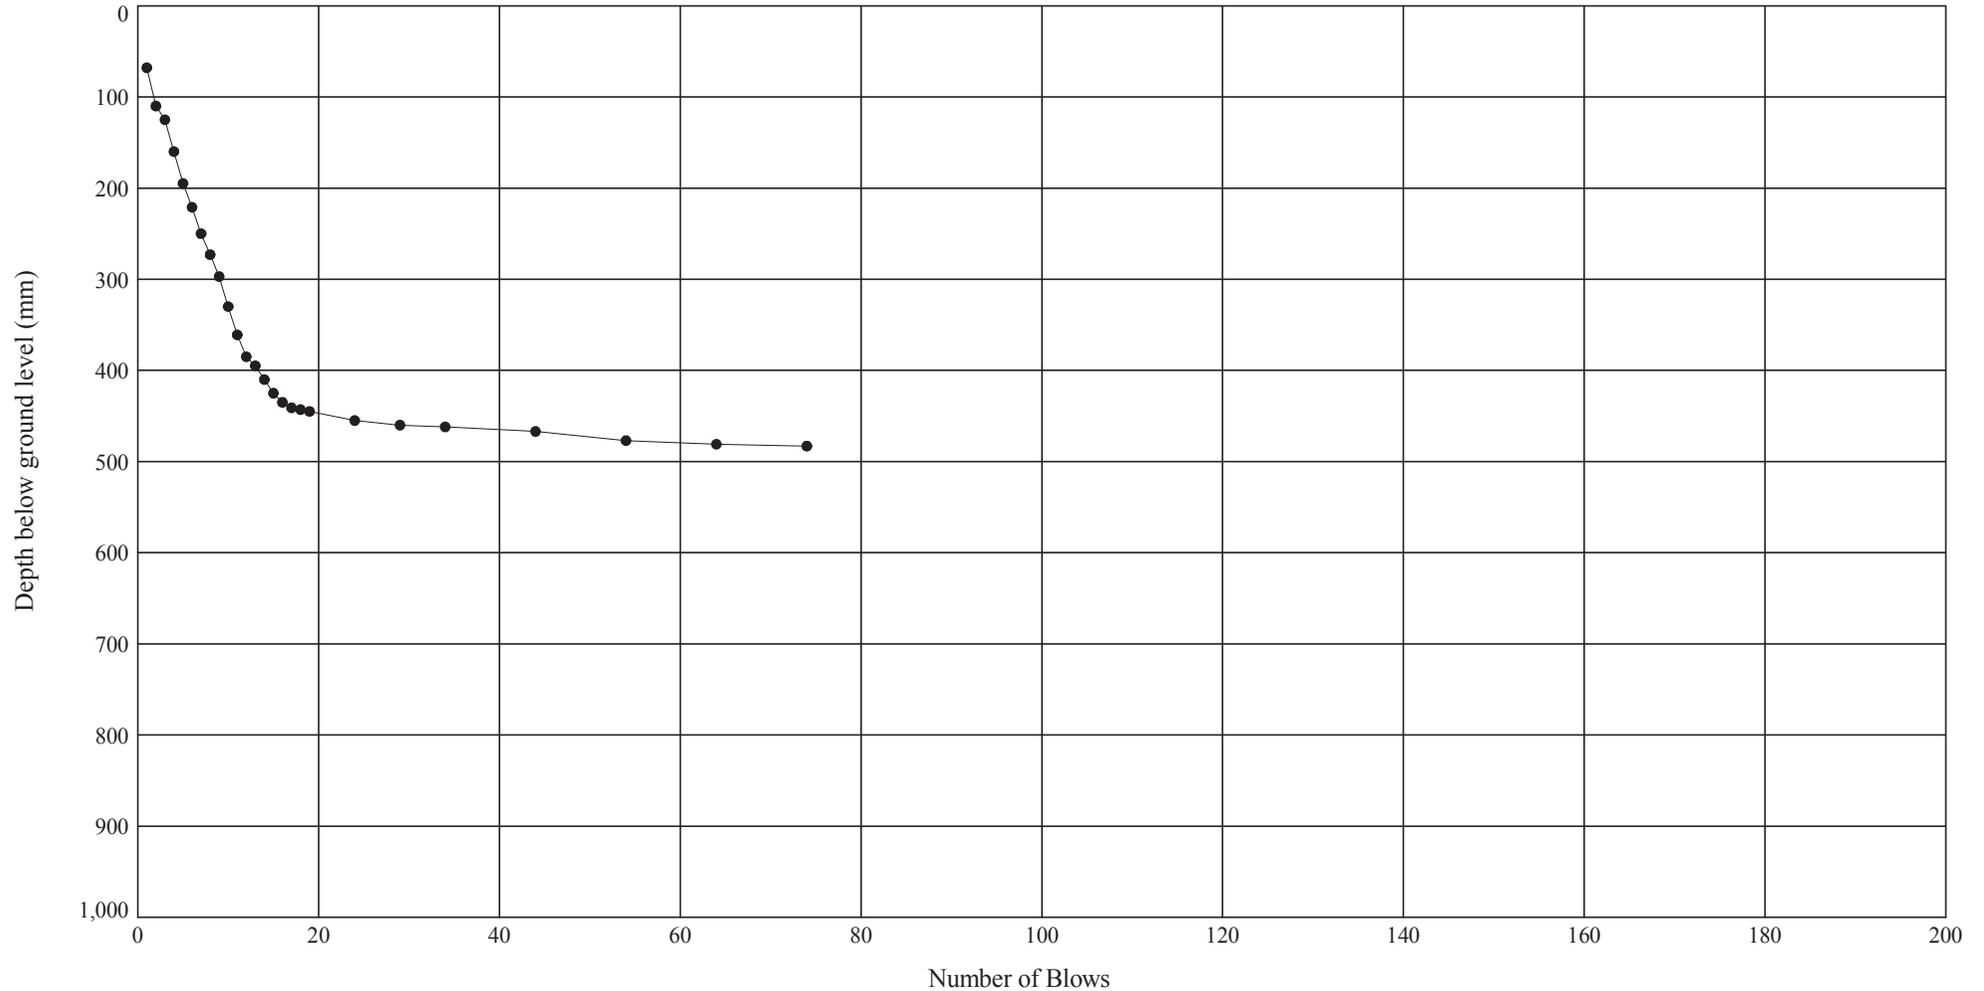
National Grid Co-ordinates: **E:333756.7 N:141390.5**

**Notes: Test conducted in pasture field. Test terminated at 548mm reading as minimal penetration may result in equipment damage. Location: Woolavington.**

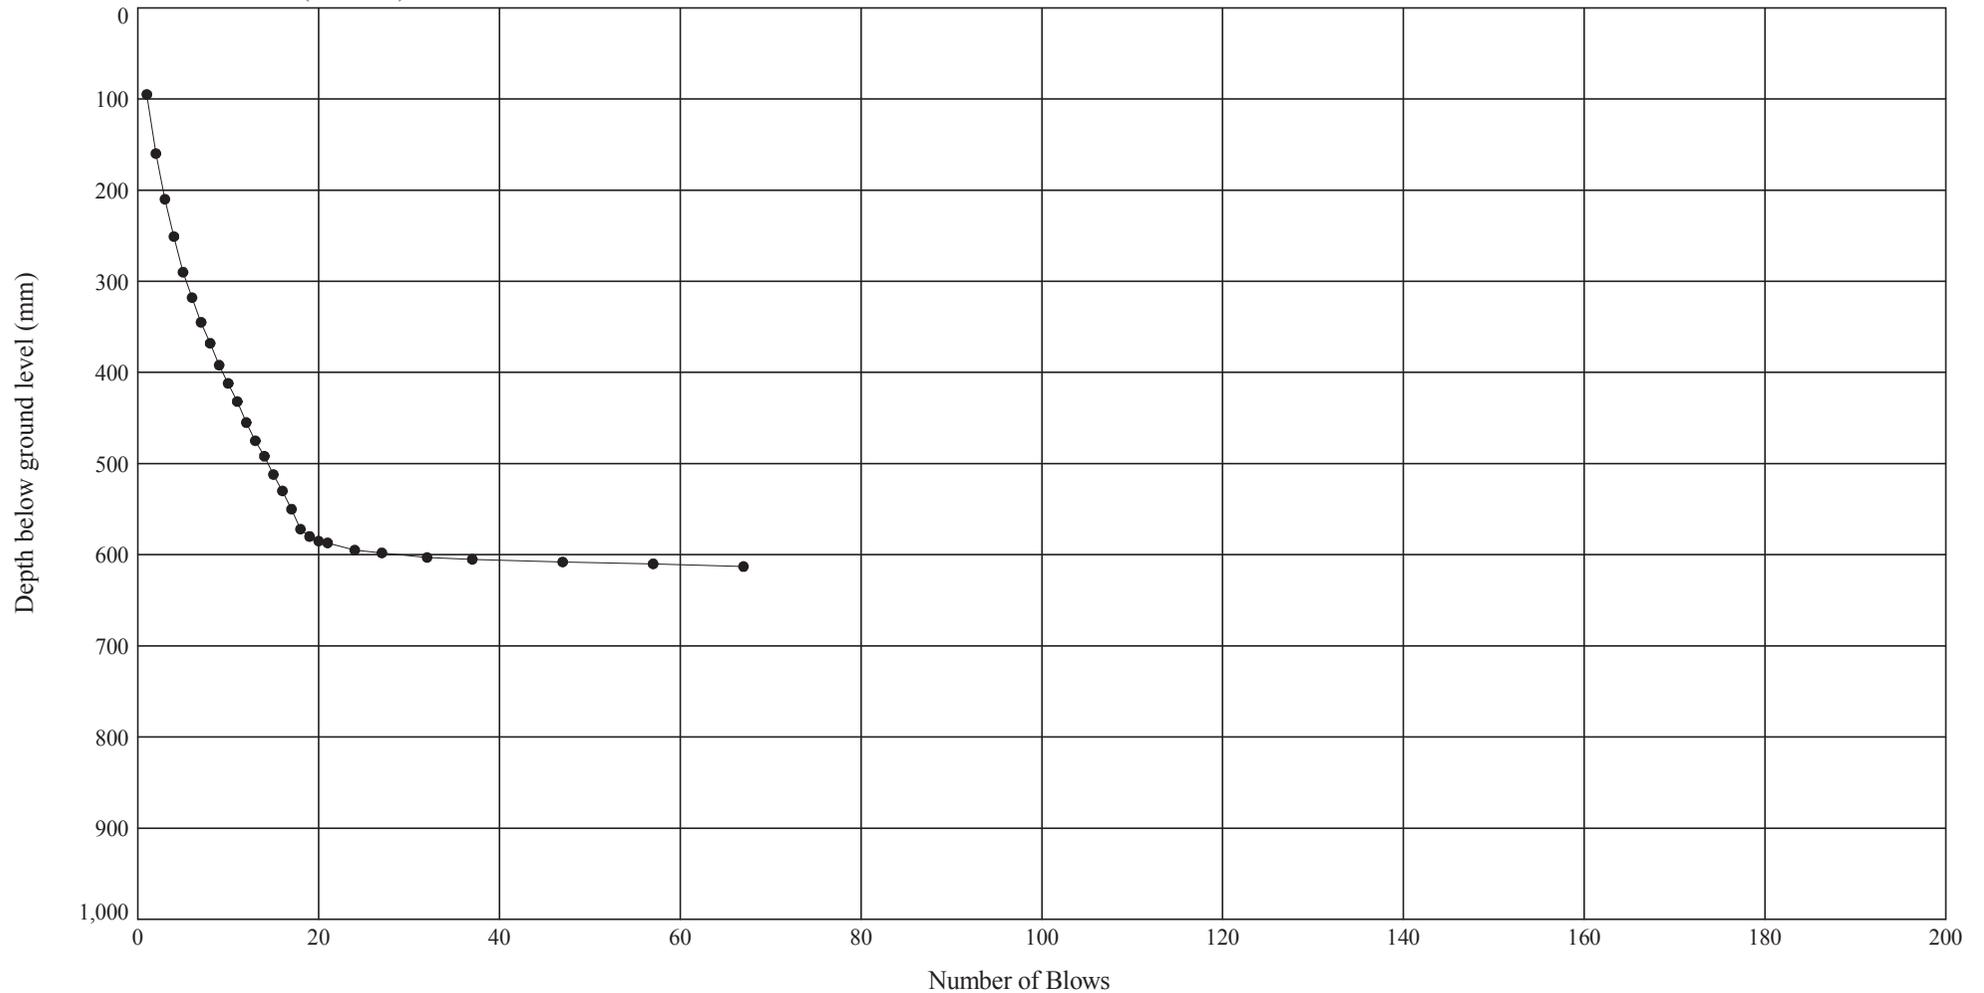
National Grid Co-ordinates: **E:334122.3 N:142169.2**

**Notes: Test conducted in pasture field. Test terminated at 83mm reading as minimal penetration may result in damage to equipment. Location: Woolavington.**

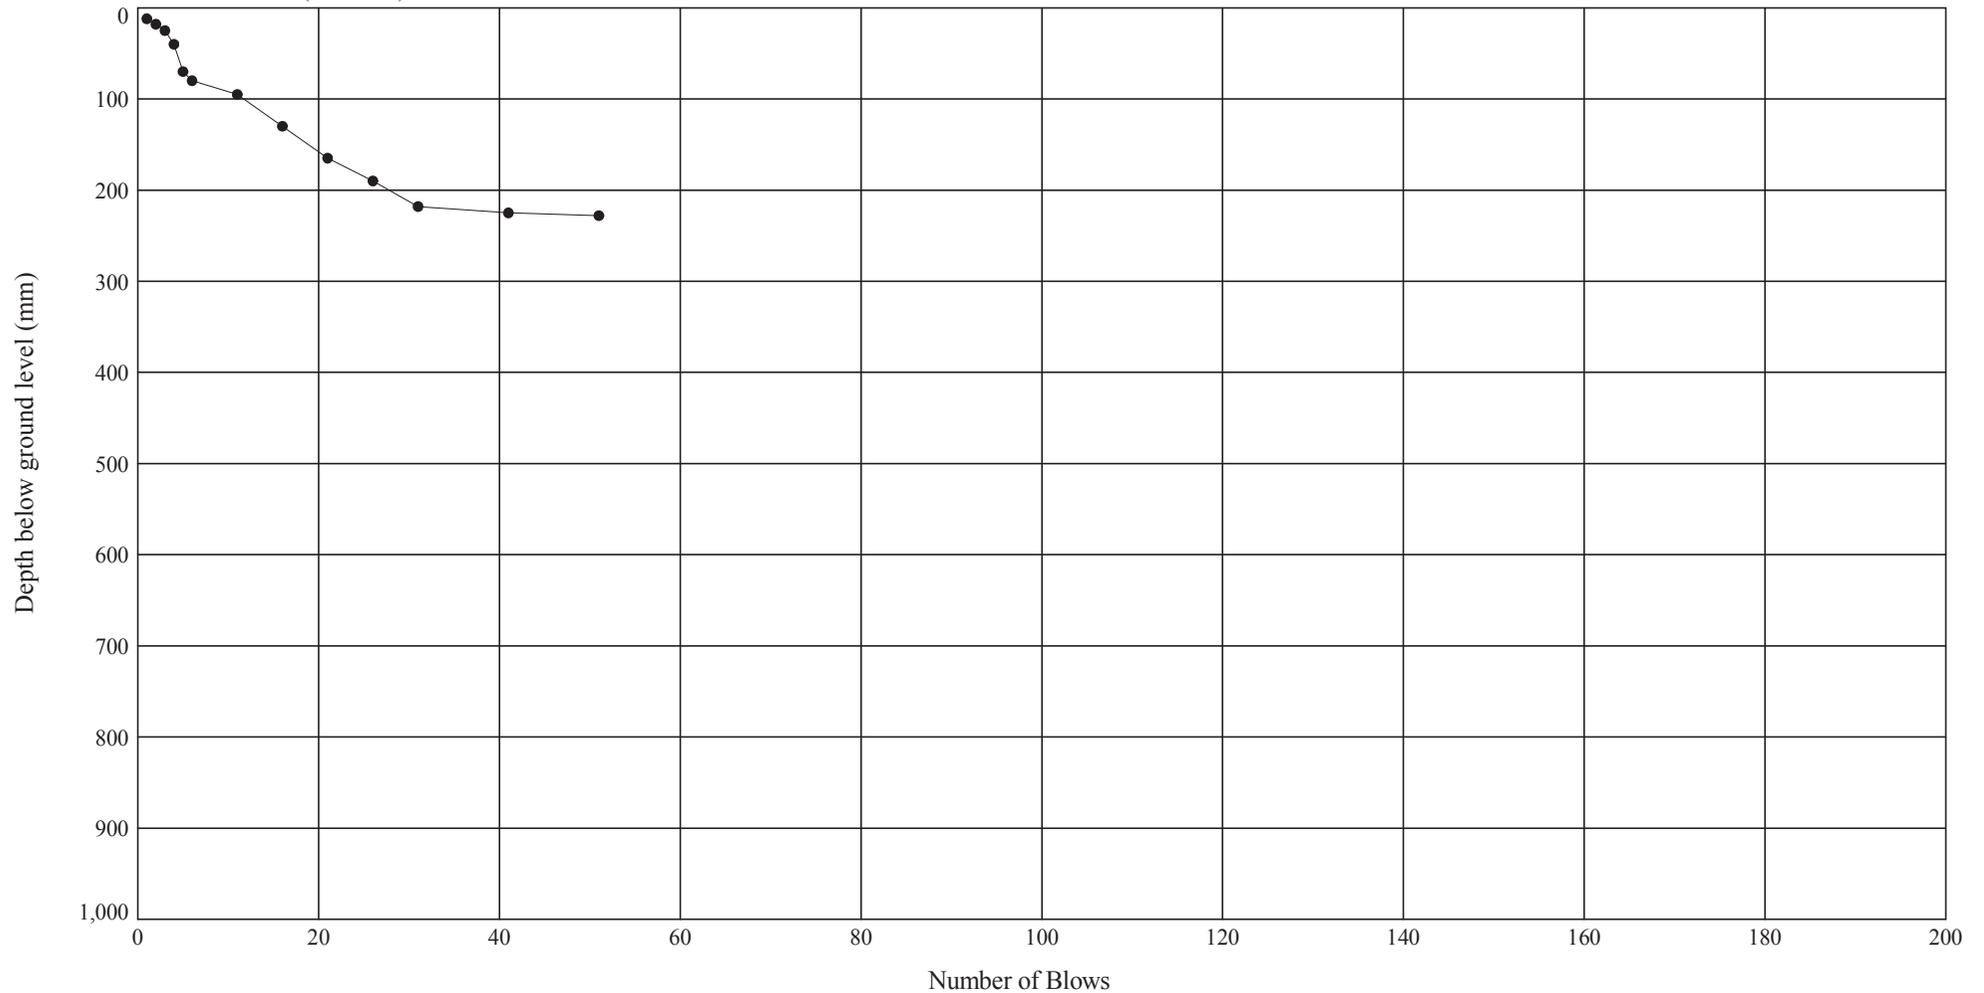
National Grid Co-ordinates: **E:351752.2 N:177374.5**

**Notes: Test beside tarmac road terminated at 368mm reading as slow penetration. Unable to relocate as CAT picking up services. Location: Avonmouth Dock.**

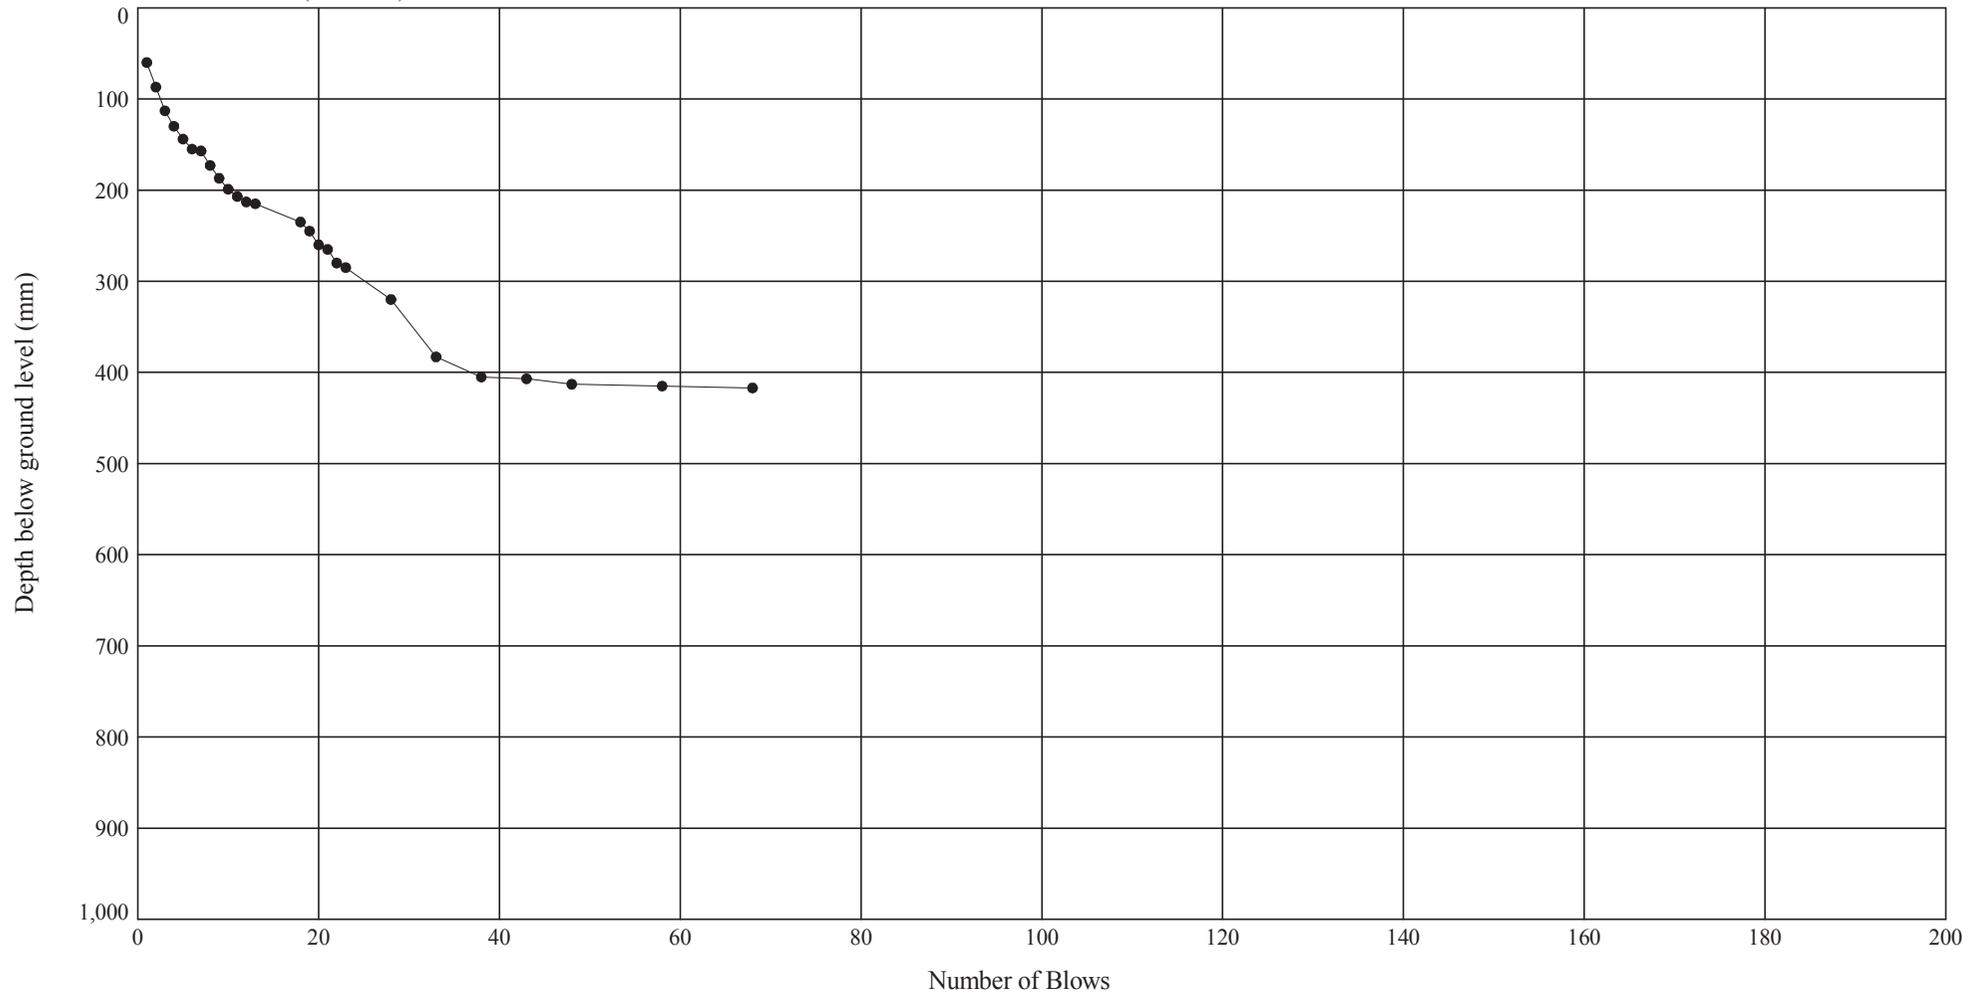
National Grid Co-ordinates: **E:351519.2 N:177934.4**

Notes: **Grass waste land low penetration rate may damage equipment test stopped at 542mm reading. Location: Avonmouth Dock.**

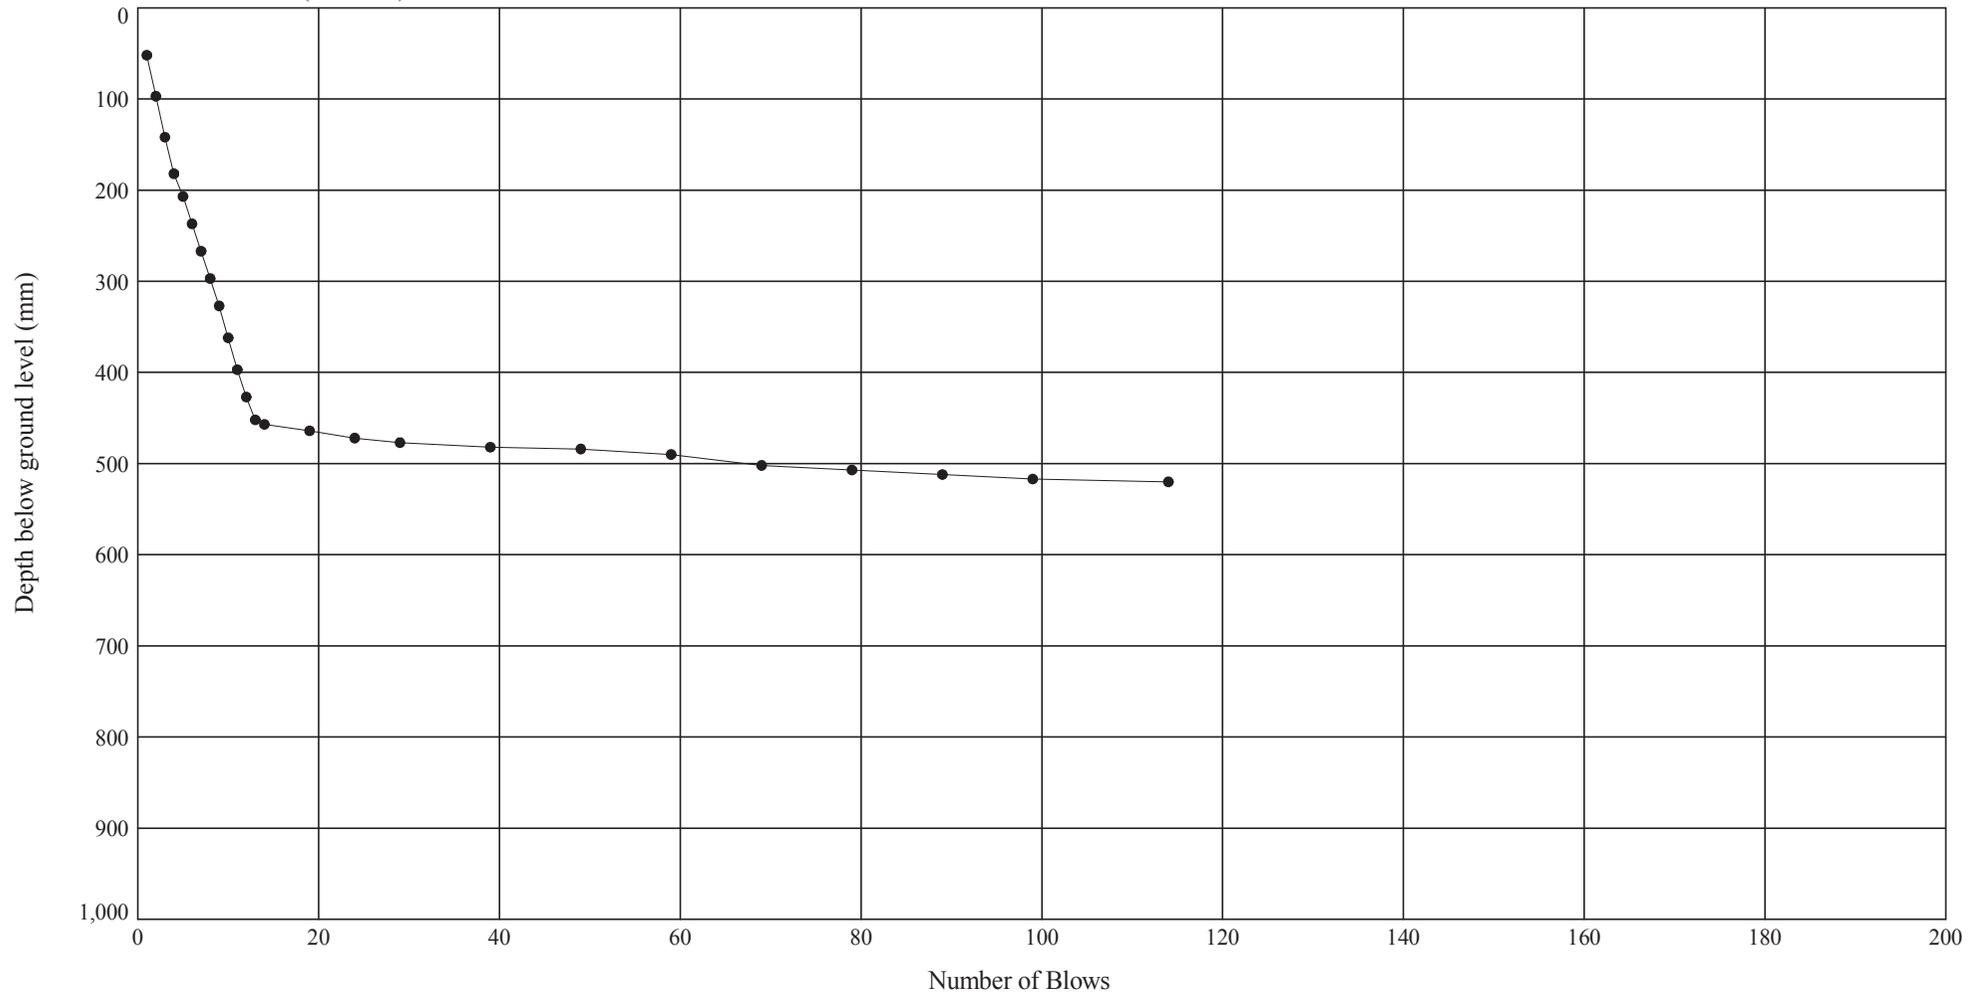
National Grid Co-ordinates: **E:338117.3 N:156245.2**

Notes: **Probe sunk under own weight to 298mm reading as in freshly tild field. Location: Webbington.**

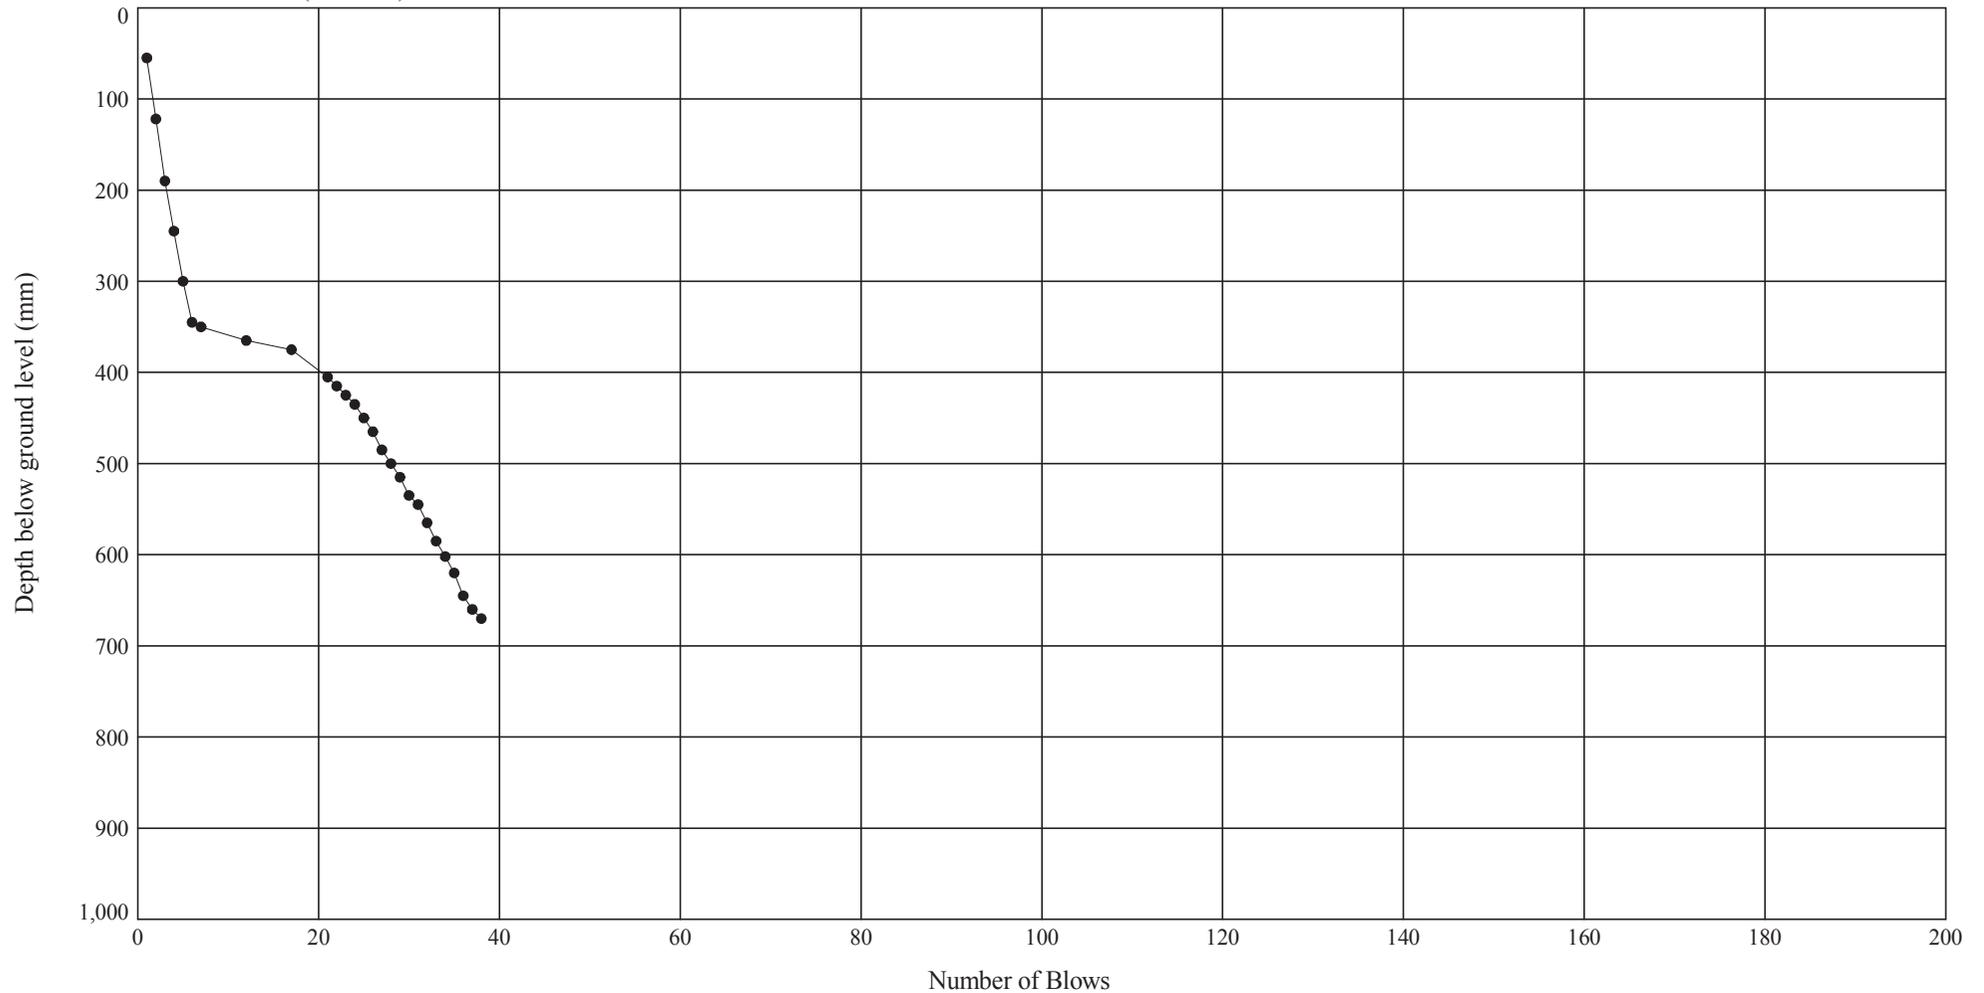
National Grid Co-ordinates: **E:338165.2 N:156366.3**

Notes: **Probe sunk under own weight to 285mm reading as in freshly tild field. Location: Lox Yeo Valley (Mendips).**
