Hinkley Point C Connection Project

Appendix 9K – Factual Report on Ground Investigation on New Electricity Substation at Sandford, Somerset

FACTUAL REPORT
on
GROUND INVESTIGATION
on
NEW ELECTRICITY SUBSTATION
AT SANDFORD, SOMERSET

OCTOBER 2013
REPORT NO: 727635J

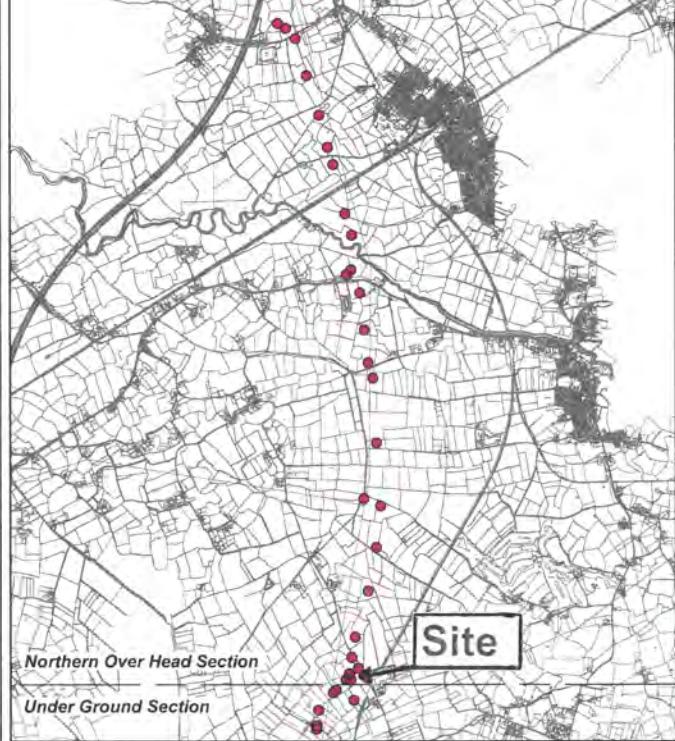
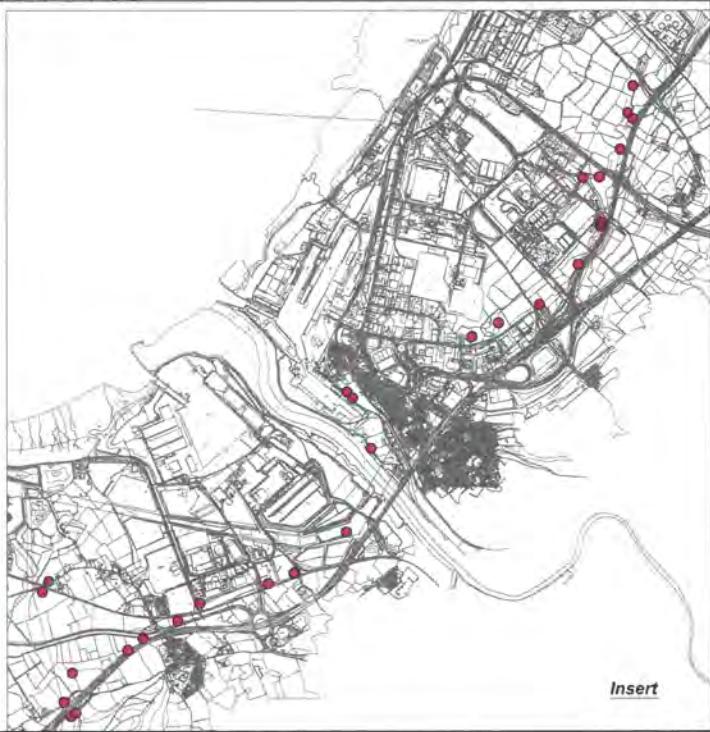
- (i) Exploratory Hole Location Plan
- (ii) Exploratory Hole Location Coordinates Summary Sheet

See Insert For Continuation of Northern Over Head Section

3 no. cable percussion boreholes, all of which were extended by rotary coring, (SWABH2, SWABH6A and SWABH7) were completed between 7 and 28 June 2013 at locations shown on the Exploratory Hole Location Plan in Appendix A. The scope of investigation and choice of investigation equipment was decided by the Electricity Alliance West (the Engineer) in consultation with Jacobs Engineering Group Inc (the Client's consulting engineer). Sampling and in-situ testing details were specified by the Engineer.

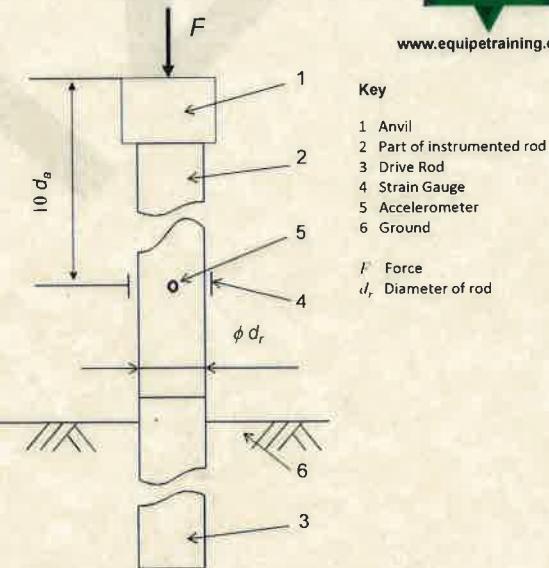
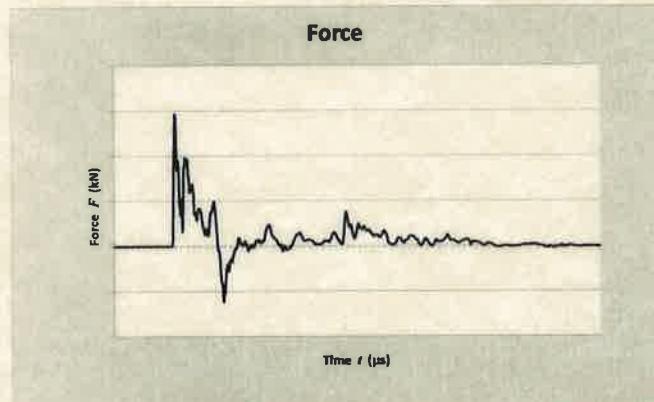
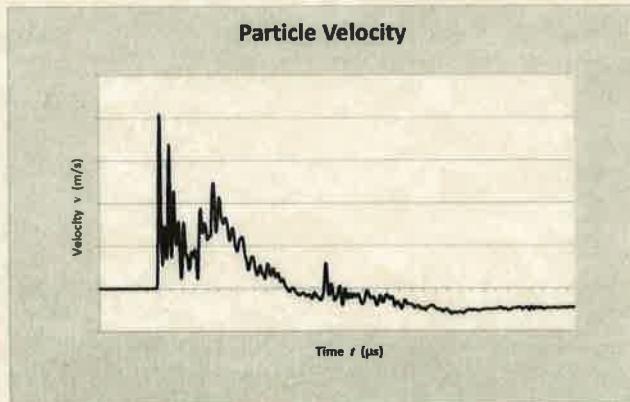
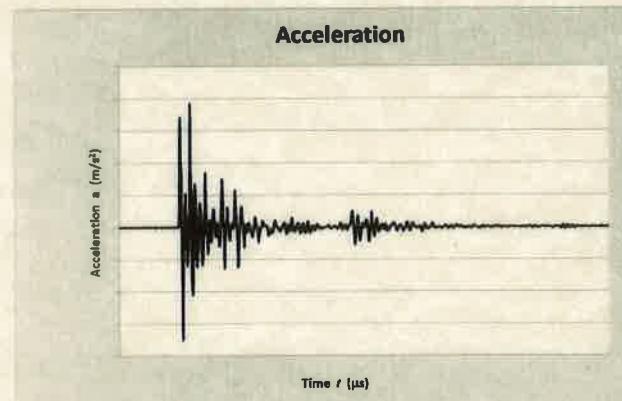
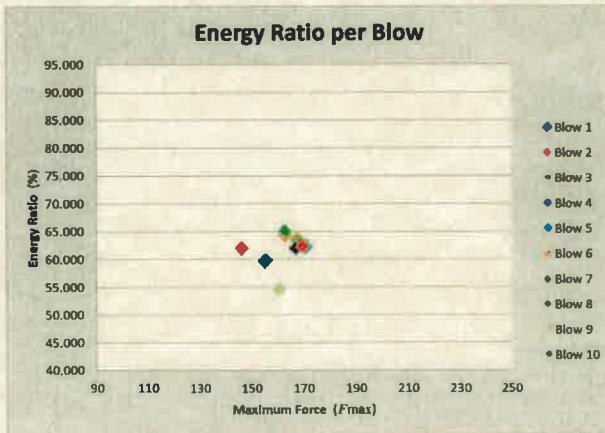
Fig. B.1 and B.2 BS EN ISO 22476-3 : 2005

Characteristics of the instrumented rod

Diameter $d_r =$ 0.052 m
 Length of the instrumented rod 0.558 m
 Area $A =$ 11.61 cm²
 Modulus $E_a =$ 206843 MPa

Standard Penetration Tests (SPT) were carried out in the exploratory holes, where noted in the preceding sections, in accordance with BS EN ISO 22476-3 using a hammer or hammers which had been calibrated for efficiency. The calibration certificates are included in Appendix C.

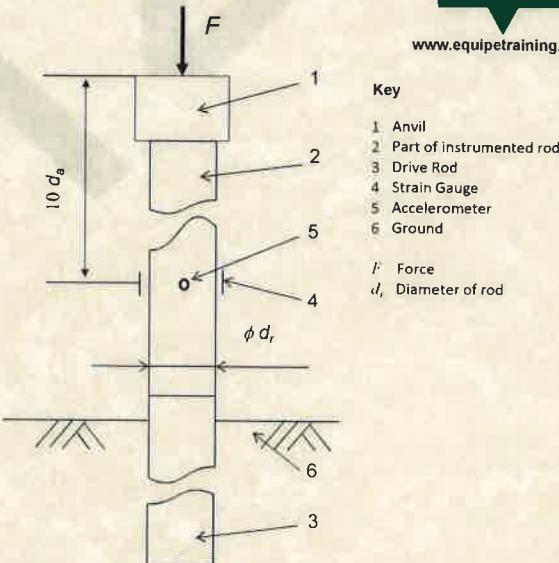
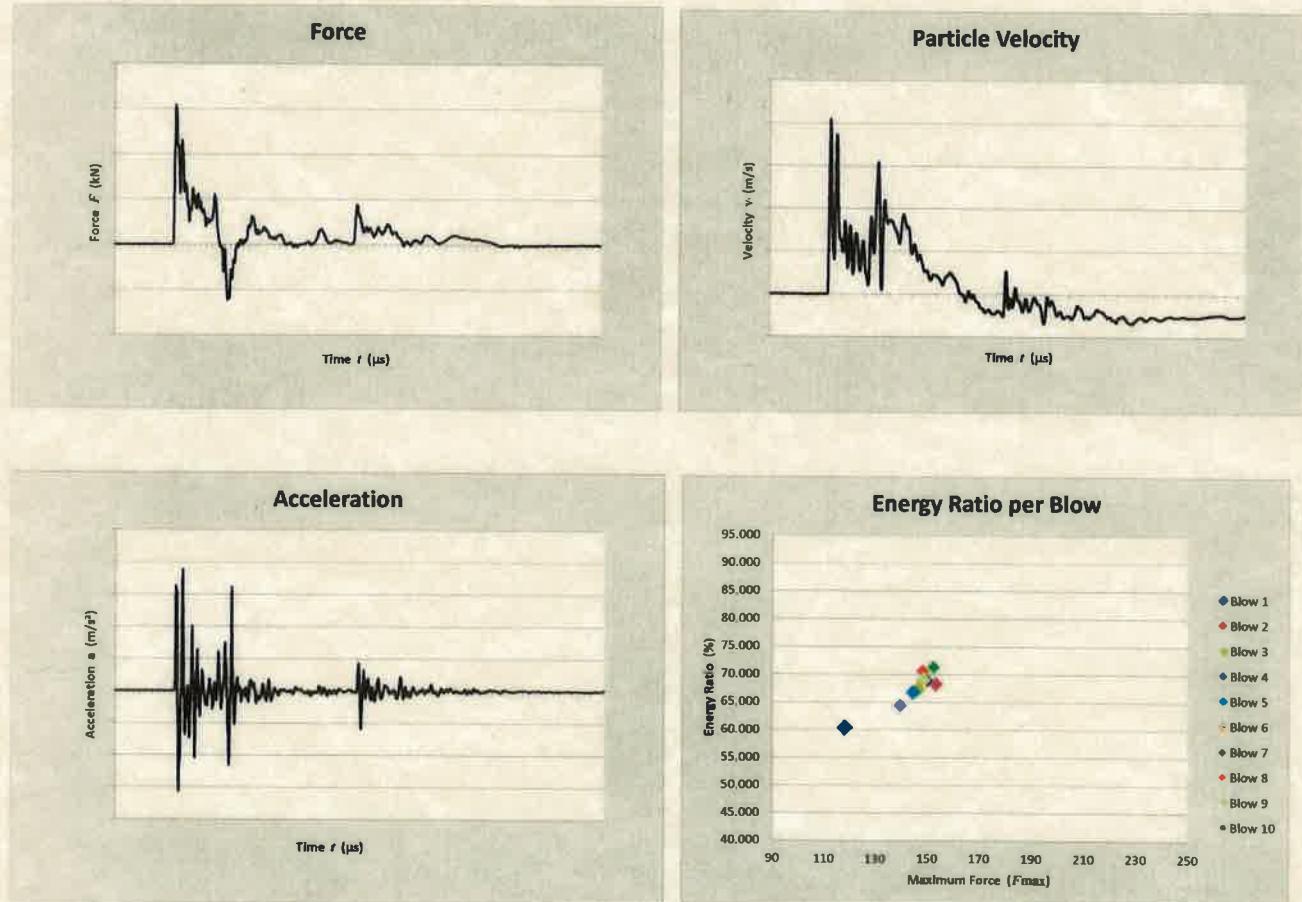
Fig. B.1 and B.2 BS EN ISO 22476-3 : 2005

Characteristics of the instrumented rod

Diameter $d_r = 0.052\text{ m}$
 Length of the instrumented rod 0.558 m
 Area $A = 11.61\text{ cm}^2$
 Modulus $E_a = 206843\text{ MPa}$

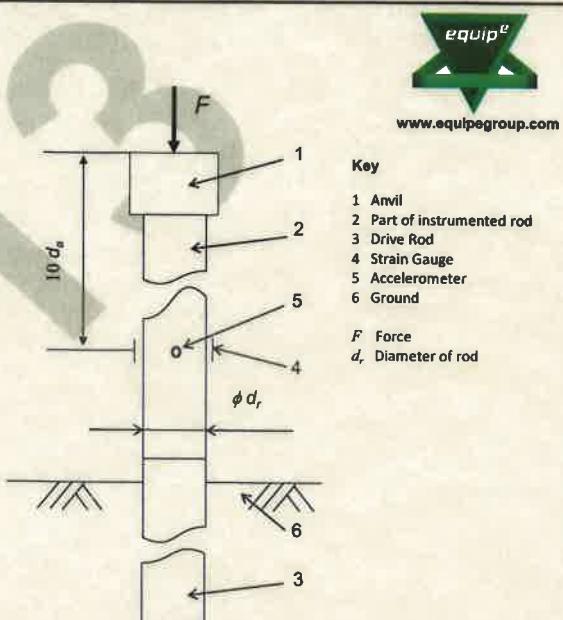
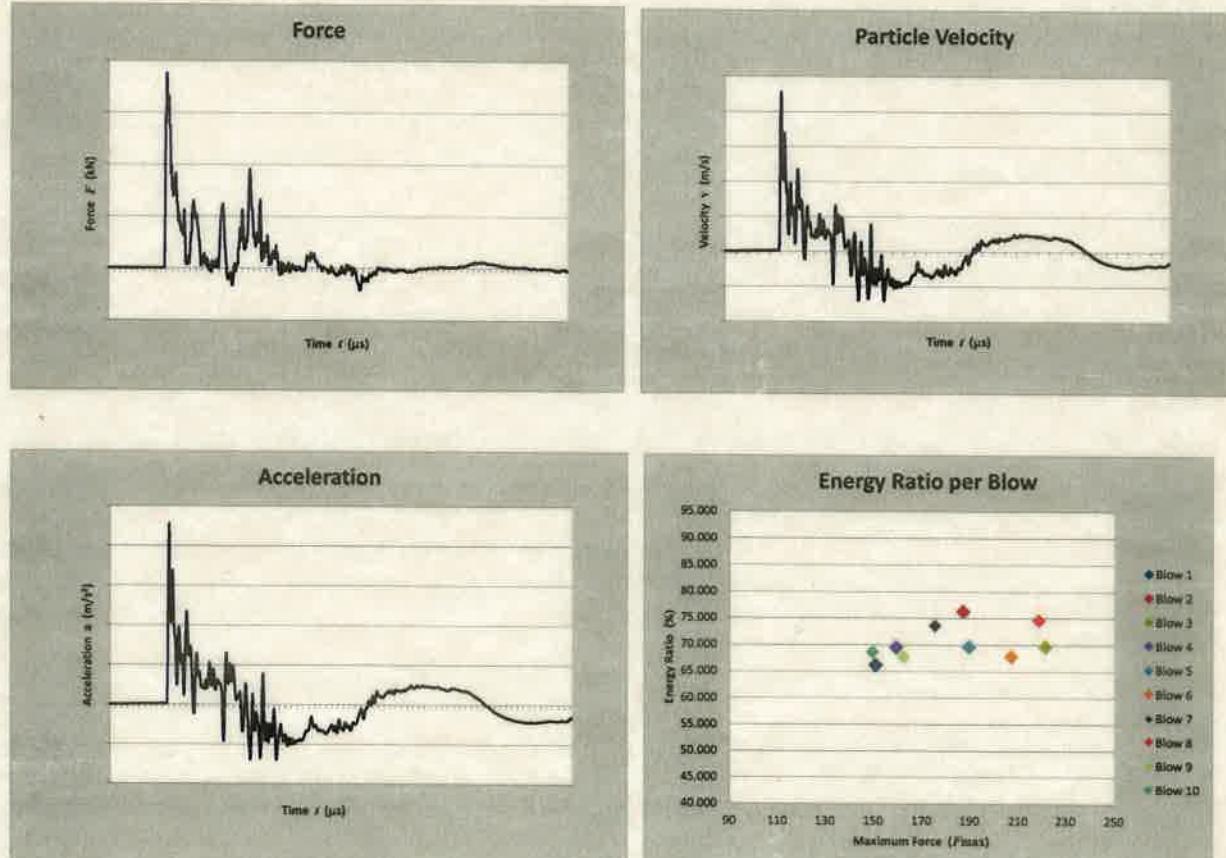
Fig. B.1 and B.2 BS EN ISO 22476-3 : 2005 + A1 : 2011

Hammer Energy Measurement Report

Type of Hammer SPT HAMMER
 Client STRUCTURAL SOILS
 Test No EQU822
 Test Depth (m) 10.50
 Date of Test 13 March 2013
 Valid until 13 March 2014
 Hammer ID EQU251
 Mass of the hammer $m = 63.5\text{kg}$
 Falling height $h = 0.76\text{m}$
 $E_{\text{theor}} = m \times g \times h = 473\text{J}$
Characteristics of the instrumented rod
 Diameter $d_r = 0.052\text{ m}$
 Length of the instrumented rod 0.558 m
 Area $A = 11.61\text{ cm}^2$
 Modulus $E_s = 206843\text{ MPa}$

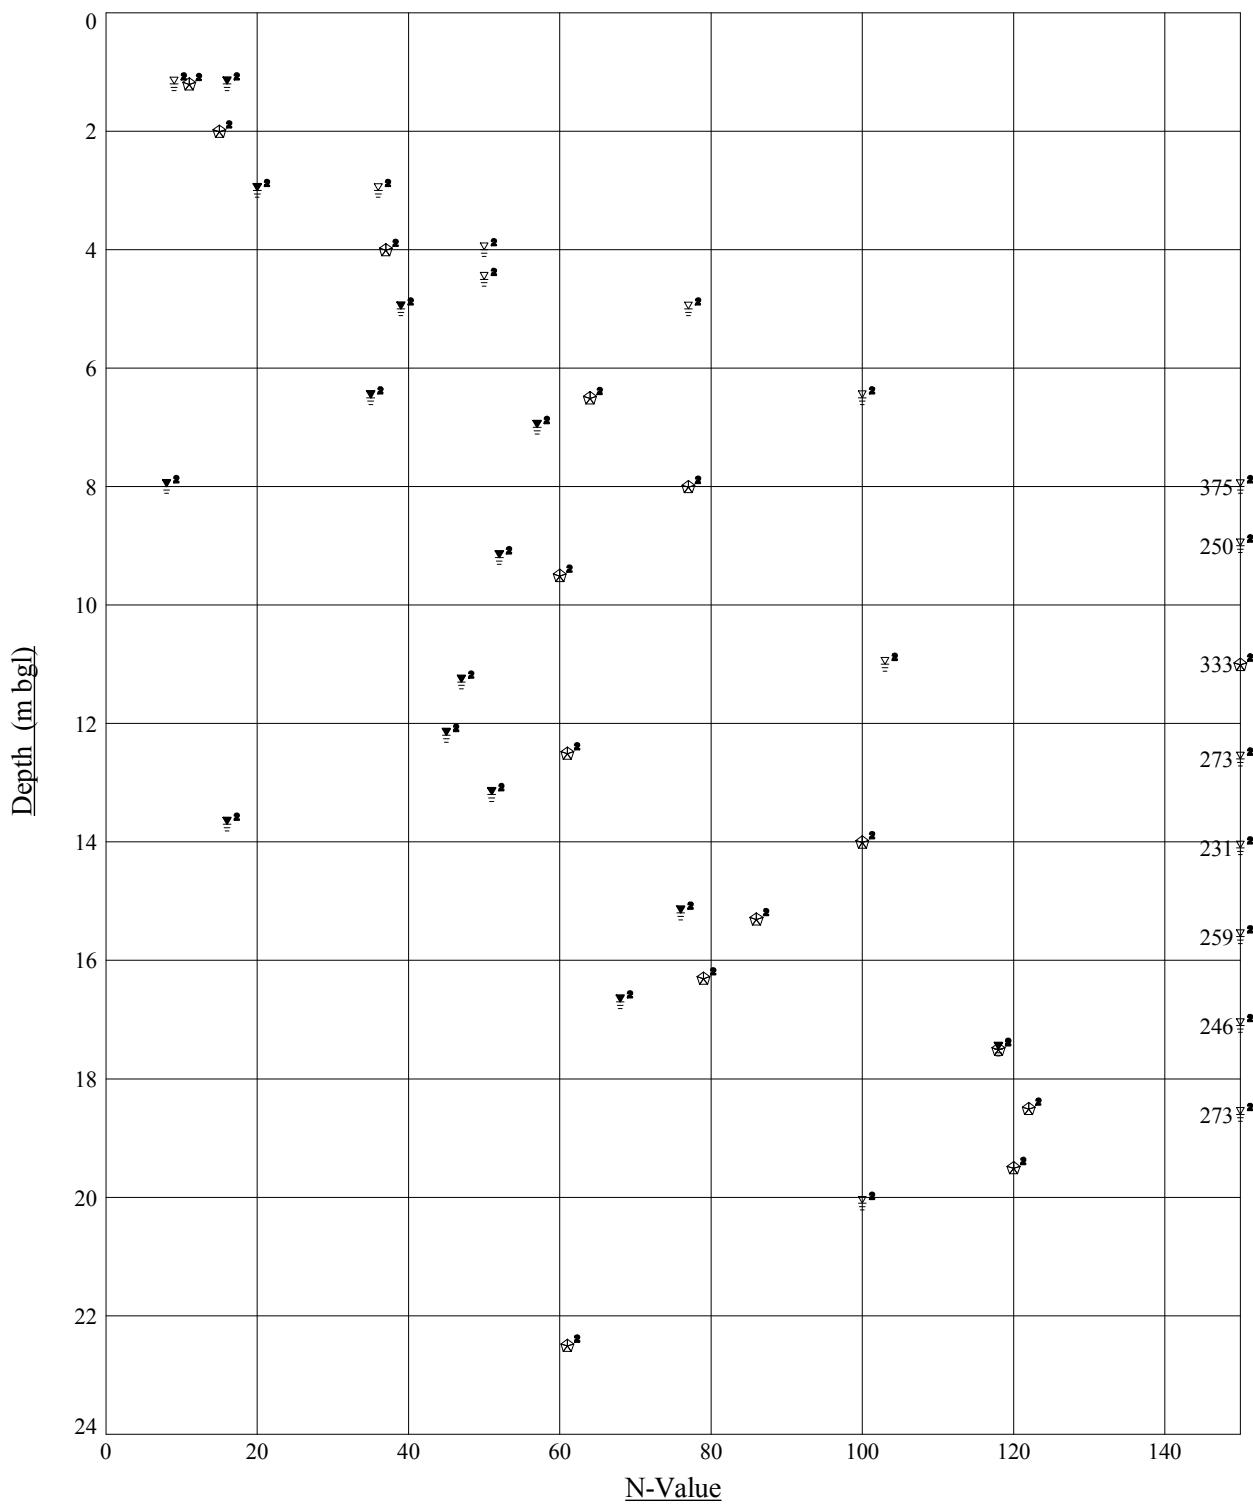
STANDARD PENETRATION TEST (SPT N-Value)

VS DEPTH

Key: \diamond = SWA-BH2A, \triangle = SWA-BH6A, \square = SWA-BH7

The SPT N-values are reported on the exploratory hole logs, on which the serial number of the hammers used is recorded. The full results are presented in tabular format on the Summary of Standard Penetration Tests in Appendix C, on which the normalised N_{60} values are also reported (equivalent N-value for a hammer delivering 60% of the theoretical drop energy). Plots showing both N and N_{60} values versus elevation are also included.

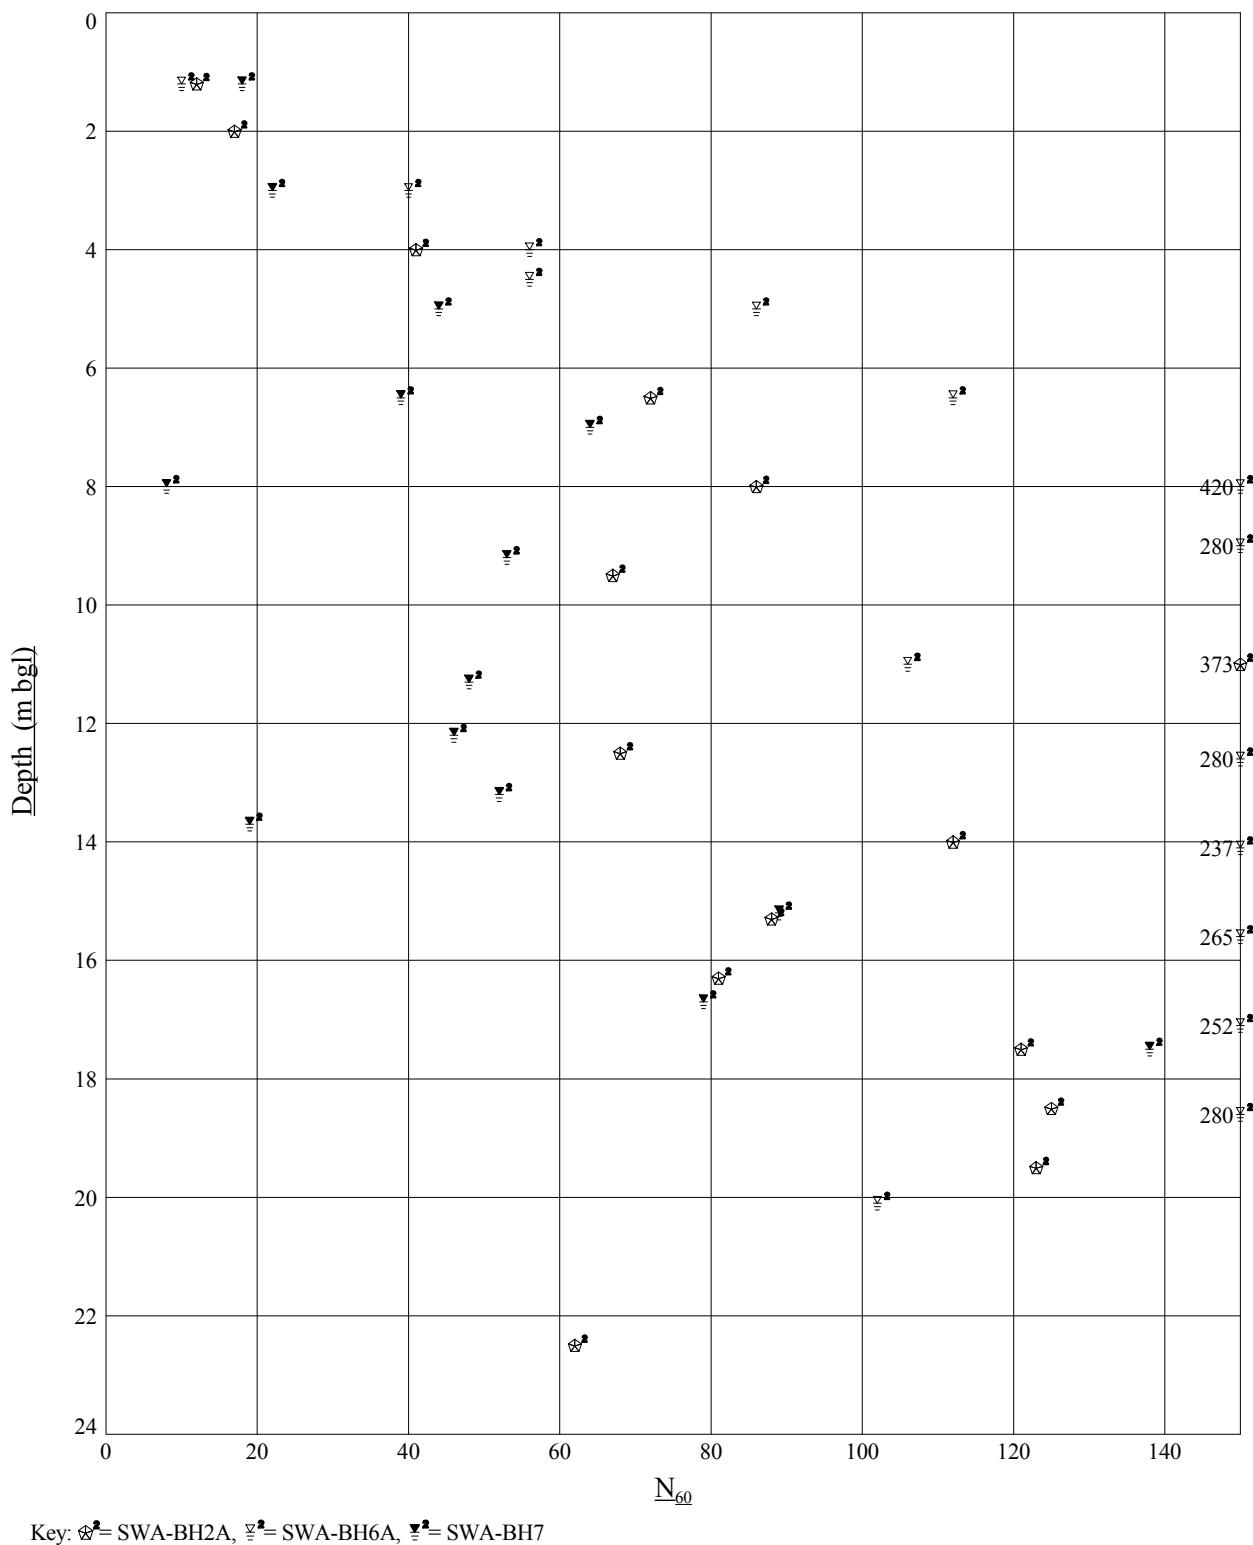
STANDARD PENETRATION TEST (SPT N_{60})

VS DEPTH
