Appendix 8.4 Geophysical Survey Report

HyNet Carbon Dioxide Pipeline DCO

**Geophysical Survey Report
HyNet CO2 Pipeline**

Magnitude Surveys Ref: MSSJ1172

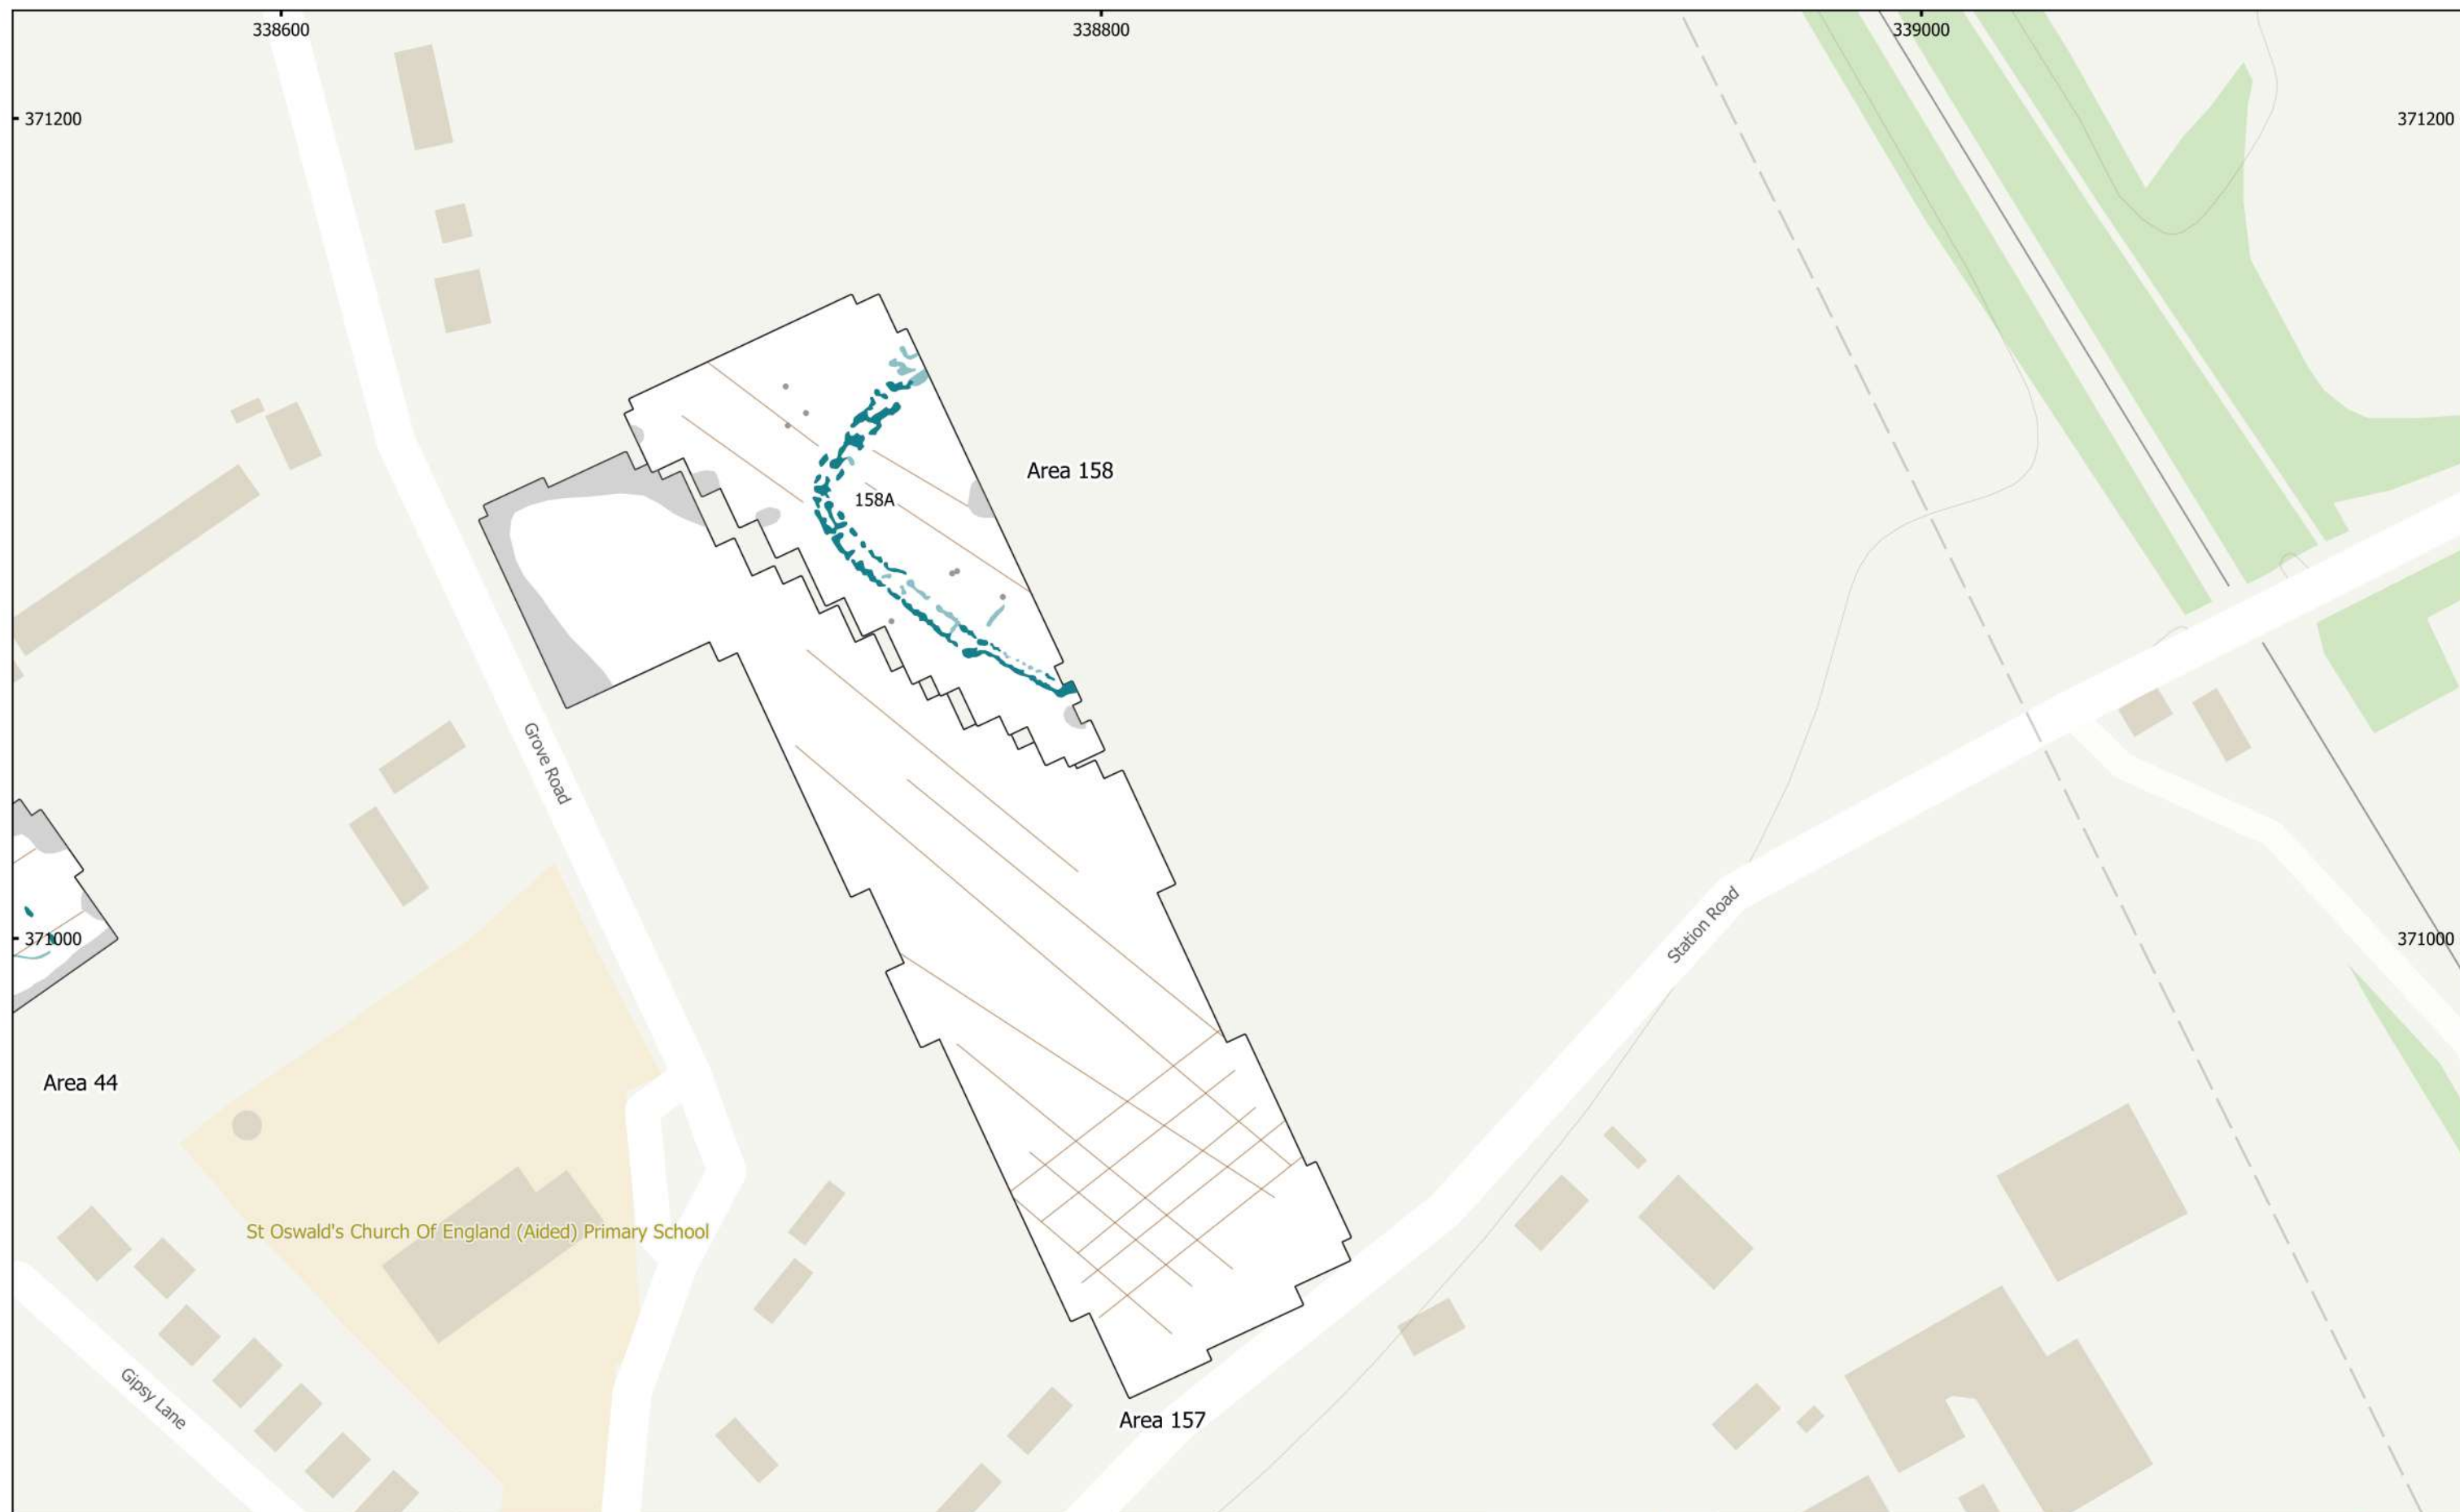
MSSJ1172 - HyNet CO2 Pipeline
Figure 172 - Magnetic Interpretation (Areas 44, 157 & 158)
1:1,500 @ A3
Copyright Magnitude Surveys Ltd 2022
Contains Ordnance Survey data © Crown Copyright and database right 2022

7.3.2.3. Undetermined (Weak & Strong) – Within Area 158 a strong fragmented curvilinear anomaly [158a], c. 300m in length, with clear cut edges, has been identified (Figure 172). The north-eastern end appears to align with a mapped field boundary, curving to follow the agricultural regime within the field (Figure 39). As such it is considered likely that this anomaly is agricultural in origin, likely a former track or similar feature. However, this anomaly does not align with any feature visible on available historical mapping or satellite imagery. As such its origin is uncertain.

7.3.2.5. Agricultural (Trend) – Throughout the length of the survey corridor, multiple weakly positive, parallel linear anomalies and striations have been identified, that appear to run concordantly with the alignment of recent ploughing visible in satellite imagery and will be caused by this activity. Further linear anomalies have been identified throughout the survey area, that do not appear to match the current agricultural regimes, but that are consistent with agricultural activity. Due to the small survey areas, it is difficult to always be certain of what agricultural activity caused them, and they therefore could be related to drainage features, ridge and furrow, or other agricultural activity (Figures 61, 64, 67, 88, 91, 94, 97, 112, 118, 121, 127, 136, 142, 145, 148, 151, 157, 160, 163, 169, 172, 175, 184, 187, 193, 196, 199, 202, 223, 226, 238, & 241).
