A38 Derby Junctions

**Appendix 8.3(a): Extended Phase 1
Habitat Survey and Preliminary Roost
Assessment for Bats – Site 25**

TECHNICAL NOTE

Project:	A38 Derby Junctions				
Title:	Extended Phase 1 Habitat Survey and Preliminary Roost Assessment for Bats – Site 25				
Doc ID:	HE514503-ACM-EBD-A38_SW_PR_ZZ-TN-EG-0005				
Date:	November 2018	Version:	P02	Status:	S4

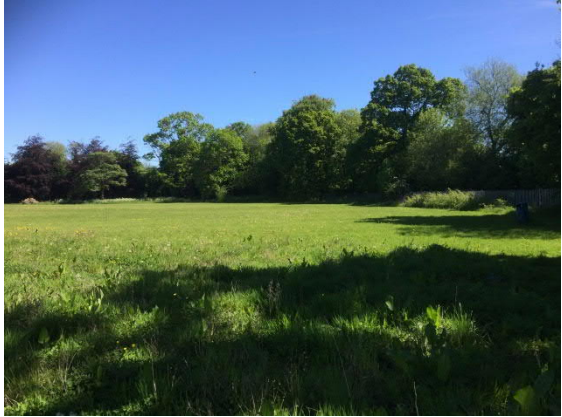
Target Note (TN)	Description	Photograph
1	TN1 is a fringe of broad-leaved woodland to the south-west of the site supporting planted mature trees such as copper beech, sycamore, horse-chestnut, alder, cherry, ash with a shrub layer including self-established elderberry, common hawthorn and bramble.

- **Broad-leaved woodland:** TN1 is a fringe of broad-leaved woodland to the south-west of the site supporting planted mature trees such as copper beech *Fagus sylvatica purpurea*, sycamore *Acer pseudoplatanus*, horse-chestnut *Aesculus hippocastanum*, alder *Alnus glutinosa*, cherry *Prunus sp.*, ash *Fraxinus excelsior* with a shrub layer including self-established elderberry *Sambucus nigra*, common hawthorn *Crataegus monogyna* and bramble *Rubus fruticosus* agg. Ground flora records included dominant common ivy *Hedera helix* with areas of stinging nettle *Urtica dioica*, dog's mercury *Mercurialis perennis*, wood avens *Geum urbanum*, hogweed *Heracleum sphondylium* with rare lords-and-ladies *Arum maculatum*.

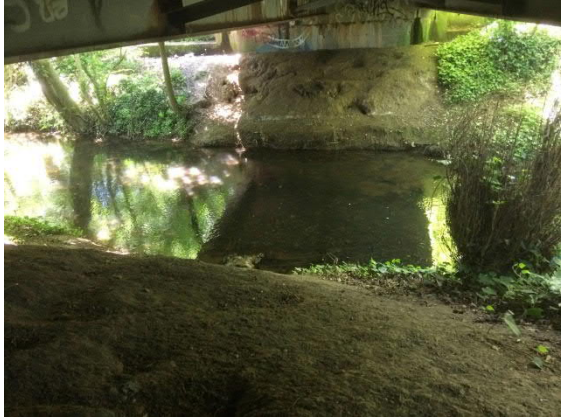
2	TN2 is a steel-span bridge with a concrete deck. The bridge crosses over the Markeaton Brook, a tributary of the River Derwent. Markeaton Brook flows in a south easterly direction towards the City of Derby.

- **Scrub:** Scrub species typically variously included bramble and raspberry *Rubus idaeus*.
 - **Running Water:** At TN2, there is a bridge over Markeaton Brook, a tributary of the River Derwent. Markeaton Brook flows in a south easterly direction towards the City of Derby. At this location, the brook had a wetted width of approximately 7m and had a water depth of approximately 0.5m. The channel bed here supported numerous features including boulders, cobbles and exposed gravel beds. The channel was heavily shaded by overhanging vegetation, including broad-leaved woodland and scrub and no channel vegetation was recorded.

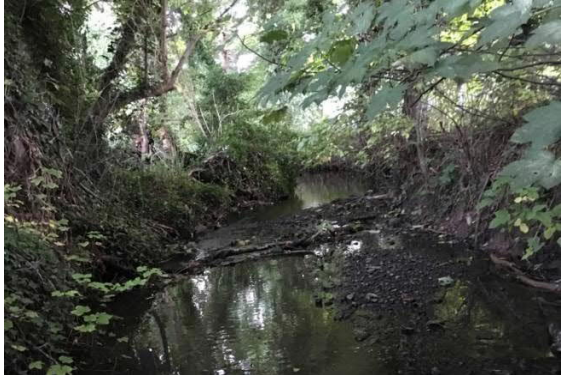
3	At TN3, the proposed redline crosses the Middle Brook. The Middle Brook is a small watercourse which runs through playing fields and discharges to the Markeaton Brook.

At TN3, the proposed Scheme boundary crosses the Middle Brook. The Middle Brook is a small watercourse which runs through playing fields and discharges to the Markeaton Brook. At TN3, the watercourse had a wetted width of approximately 3m, a bank full width of approximately 6m and had an average water depth of less than 0.2m. The channel was heavily shaded and therefore

very little in-channel or marginal vegetation was found. Some patches of sedge *Carex* sp. on the banks, with sparse emergent broad-leaved herbs such as rosebay willowherb *Chamerion angustifolium*, and some filamentous algae. There was also abundant freshwater sponge in the brook, and a significant coverage of sewage fungus associated with an outfall immediately downstream of the A38 culvert.
