A38 Derby Junctions

**Appendix 8.3(b): Extended Phase 1
Habitat Survey in 2017**

Extended Phase 1 Habitat Survey 2017 Report

Report Number: HE514503-ACM-EBD-A38_SW_PR_ZZ-RP-EG-004 P02 S4
August 2018

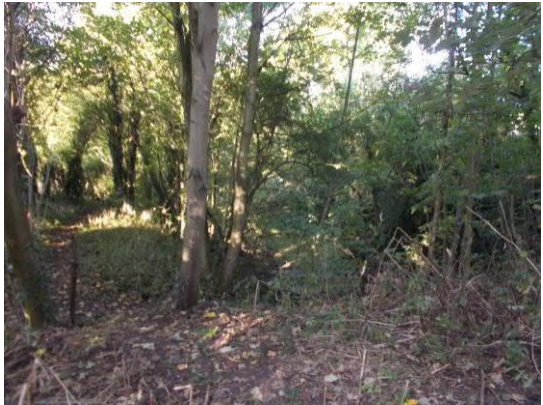
| N | Grid reference | Description | Photograph |
|---|---|--|--|
| 2 | SK 32234 35527 | Broadleaved Woodland. Species present were dominated by ash and ivy with occasional hazel (old coppice stools), hawthorn <i>Crataegus monogyna</i> and bramble. Stands of Himalayan balsam were also recorded. | |

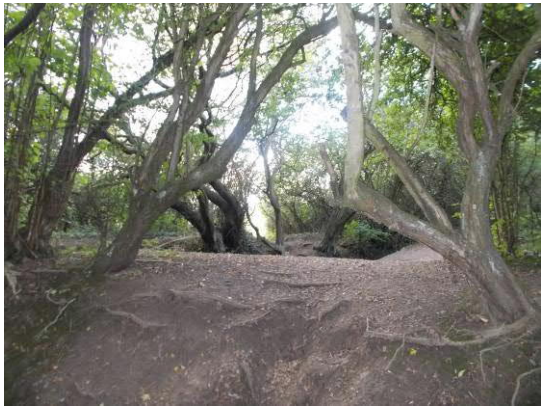
| N | Grid reference | Description | Photograph |
|---|---|--|--|
| 3 | SK 32260 35567 | Soil mound and bare soil around – likely due to disturbance caused as a result of high levels of access by public (dog walkers etc.) | |

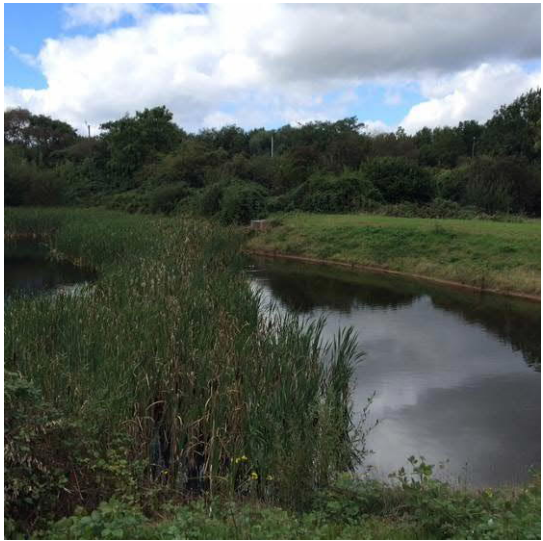
| N | Grid reference | Description | Photograph |
|---|---|--|--|
| 4 | SK 32418 35576 | Managed and mown semi-improved grassland surrounding balancing pond. Species present are typical of semi-improved grassland and include common bent, rough meadow grass, creeping buttercup. | |

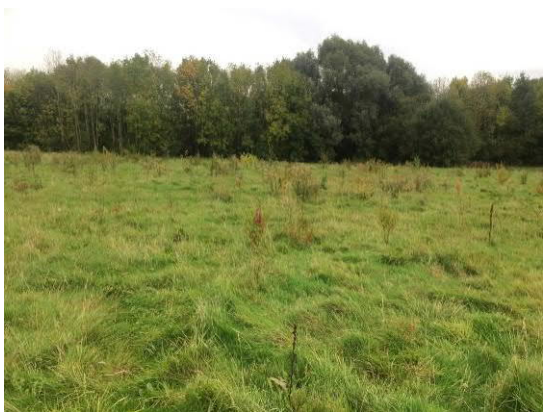
| N | Grid reference | Description | Photograph |
|---|---|--|--|
| 5 | SK 32306 35650 | Unmanaged species-poor semi-improved grassland areas within a much wider area of amenity grassland. Planted dogwood was also present. | |

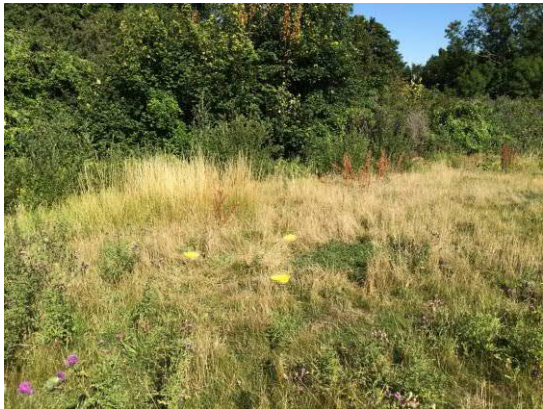
| N | Grid reference | Description | Photograph |
|---|---|--|--|
| 6 | SK 32484 35600 | Yorkshire fog and false oat grass with approximately 15% encroaching scrub, comprising mainly hawthorn. Approximately 50% of the area also comprised tall herb dominated by great willowherb, rosebay willowherb and ragwort <i>Senecio jacobaea</i> . | |

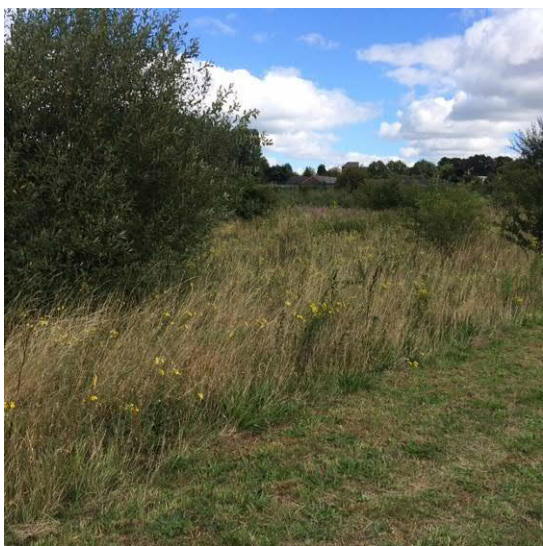
| N | Grid reference | Description | Photograph |
|---|---|---|--|
| 7 | SK 32443 35649 | In this approximate 1.1 ha area Yorkshire-fog dominates with lesser amounts of false oat grass and frequent meadow foxtail and great willowherb. Some hawthorn scrub is present. Tufted vetch, smooth tare and field horsetail <i>Equisetum arvense</i> are locally frequent, along with couch grass <i>Elytrigia repens</i> , and smooth meadow-grass. A range of species occurs in lesser amounts, including sweet vernal-grass <i>Anthoxanthum odoratum</i> , cock's-foot and common vetch. The presence of wild angelica <i>Angelica sylvestris</i> , common sedge <i>Carex nigra</i> , tufted hair-grass and hard rush <i>Juncus inflexus</i> indicates damp conditions. | |

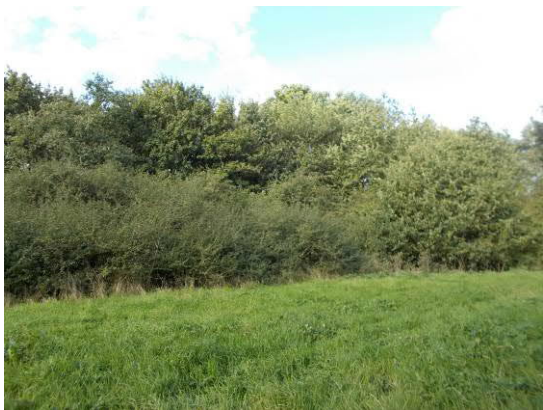
| N | Grid reference | Description | Photograph |
|---|---|---|--|
| 9 | SK 32381 35734 | Mature cherry <i>Prunus</i> sp. and blackthorn in scrub thicket with semi-improved grassland. | |

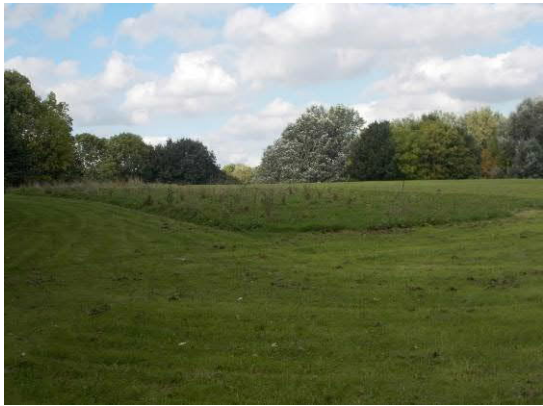
| N | Grid reference | Description | Photograph |
|---|---|---|--|
| 10 | SK 32307 35749 | Young tree and shrub plantation and unmanaged grassland within amenity grassland Creeping bent <i>Agrostis stolonifera</i> was recorded in high abundance in this area. Pedunculate oak, elder and blackthorn <i>Prunus spinosa</i> in planting. | |

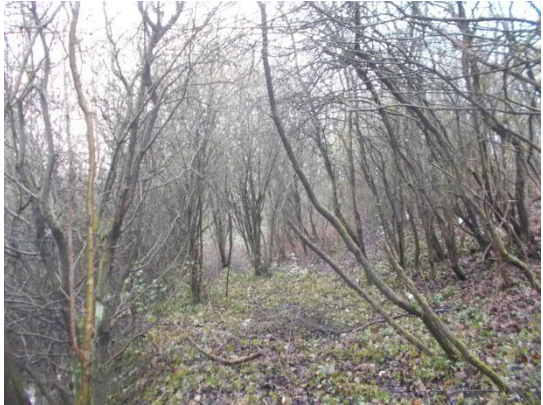
| N | Grid reference | Description | Photograph |
|---|---|---|--|
| 11 | SK 32530 35821 | This is an area of semi-mature, semi-natural woodland with a densely shaded, species- poor understorey. The species recorded include dogwood hawthorn, ash, ivy <i>Hedera helix</i> , Himalayan balsam, poplar species <i>Populus spp</i> , pedunculate oak bramble, crack-willow, elder and common nettle. | |

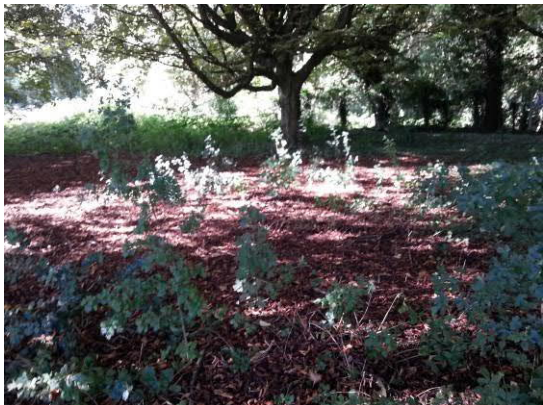
| N | Grid reference | Description | Photograph |
|---|---|---|--|
| 12 | SK 32637 35823 | Field layer under horse chestnut <i>Aesculus hippocastanum</i> trees: herb Bennett <i>Geum urbanum</i> , saplings field maple, hawthorn, holly and ash and bare ground. | |

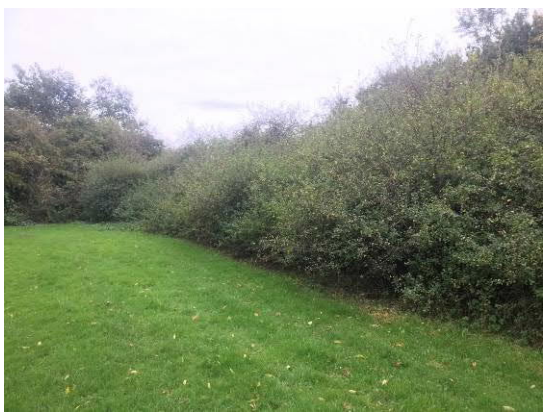
| N | Grid reference | Description | Photograph |
|---|---|--|--|
| 13 | SK 32481 35865 | Broadleaved woodland plantation: Species included beech, ash, pedunculate oak, bramble, blackthorn and horse chestnut. | |

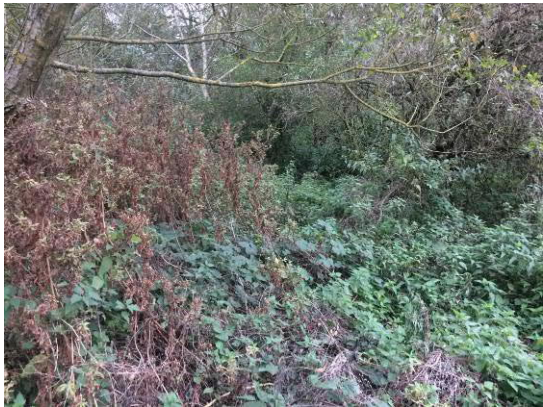
| N | Grid reference | Description | Photograph |
|---|---|--|--|
| 14 | SK 32476 35891 | Tall herbs along dry drain, species present included false-brome <i>Brachypodium sylvaticum</i> , rosebay willowherb, great willow herb, bramble, raspberry <i>Rubus idaeus</i> and nettle with occasional <i>Salix</i> sp. scrub. | |

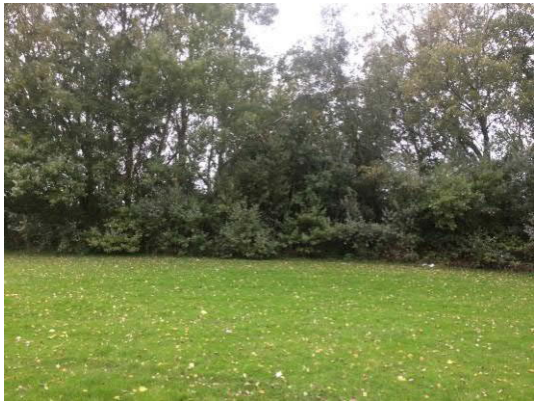
| N | Grid reference | Description | Photograph |
|---|---|--|--|
| 16 | SK 32173 35913 | Broad-leaved woodland with mature white poplar <i>Populus alba</i> present, along with Norway maple, ash, ivy, <i>Prunus</i> sp., blackthorn and pedunculate oak. | |

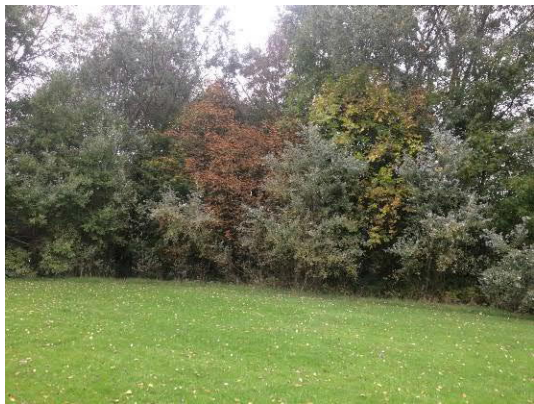
| N | Grid reference | Description | Photograph |
|---|---|---|---|
| 17 | SK 32189 35930 | Broadleaved woodland semi-natural. Species included Occasional: hazel, ash, blackthorn, willow sp., and wych elm <i>Ulmus glabra</i> , with ground habitat of common nettle, field woundwort <i>Stachys arvensis</i> , ivy and raspberry. | |

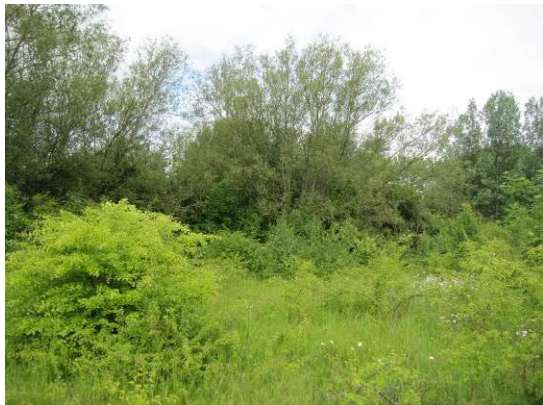
| N | Grid reference | Description | Photograph |
|---|---|---|---|
| 18 | SK 32630 35924 | This area forms part of the A38 Roundabout Local Wildlife Site. This physically isolated, approximate 0.40ha area lying between the A38 carriageways. It is neutral grassland that is suffering from extensive scrub encroachment due to lack of management. The grassland is drier at the eastern edge, where open herb-rich patches occur and this is replaced in the western half by a damper sward which is typically dominated by species such as meadowsweet, with other damp indicators such as soft-rush and wild angelica. Red fescue is dominant in much of the open sward, with lesser amounts of creeping bent, false oat-grass, cock's-foot, Yorkshire-fog and smooth meadow-grass. Herbs recorded include black knapweed <i>Centaurea nigra</i> , meadow vetchling, zigzag clover, oxeye daisy, spotted-orchid <i>Dactylorhiza fuchsii</i> , ribwort plantain, meadow buttercup, perforate St john's wort <i>Hypericum perforatum</i> . | |

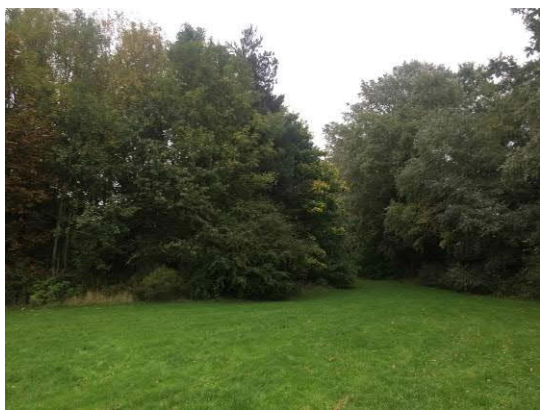
| N | Grid reference | Description | Photograph |
|---|---|---|--|
| 19 | SK 32507 35937 | Broad-leaved Woodland Plantation Dominant: ivy, Occasional: horse-chestnut, dogwood, hogweed, poplar species <i>Populus</i> spp., cherry <i>Prunus</i> sp., raspberry, black pine <i>Pinus nigra</i> . | |

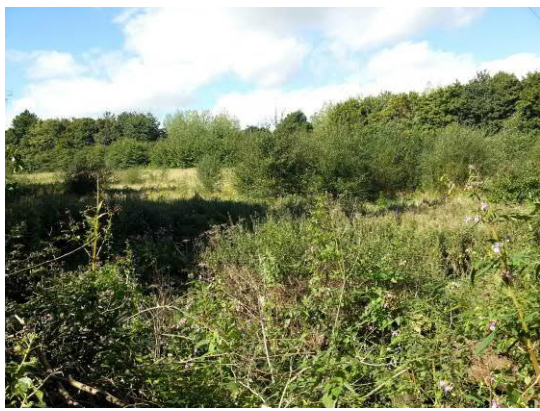
| N | Grid reference | Description | Photograph |
|---|---|---|--|
| 20 | SK 32774 35936 | This is an approximate 0.40 ha area of tall, unmanaged, neutral grassland that is dominated by Yorkshire-fog with locally dominant rosebay willowherb. Locally frequent species include false oat-grass red fescue and meadow buttercup. Occasional common bent, creeping bent meadow foxtail, cow parsley, cock's-foot hogweed perennial rye-grass, ribwort plantain smooth meadow-grass <i>Poa pratensis</i> occur. Smaller herbs are rarer, due to the tall coarse sward and include common mouse-ear, meadow crane's-bill, goat's-beard, selfheal and red clover. | |

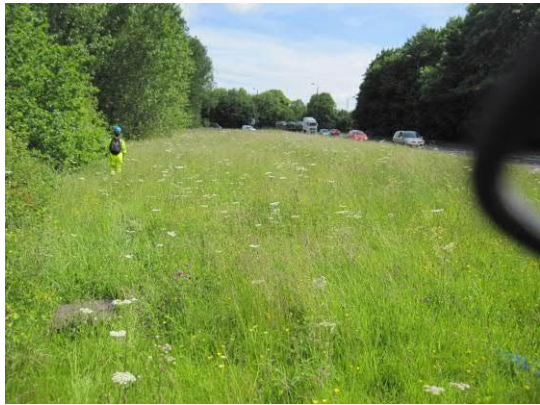
| N | Grid reference | Description | Photograph |
|---|---|--|--|
| 25 | SK 32826 36036 | This tall unmanaged grassland occurs by the Kingsway roundabout and covers approximate 0.32 ha in area. The area forms part of the A38 Roundabout LWS. It is dominated by false oat-grass, with abundant red clover and frequent cow parsley, red fescue, hogweed and Yorkshire-fog, with lesser amounts of common mouse-ear, creeping thistle, cock's-foot, ribwort plantain and smooth meadow-grass. It supports a herb component typical of neutral grassland, including meadow buttercup, creeping buttercup, goat's-beard, yarrow, common knapweed, oxeye daisy and tufted vetch. | |

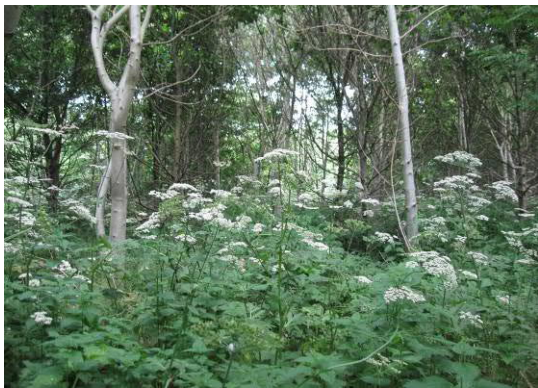
| N | Grid reference | Description | Photograph |
|---|---|--|--|
| 26 | SK 32816 36068 | This is an area of dense semi-mature broad-leaved woodland with poor species diversity in the understory. This woodland has a range of native and non-native tree and shrub species, including field maple, Norway maple, sycamore <i>Acer pseudoplatanus</i> , alder <i>Alnus glutinosa</i> , hawthorn, ash, poplar species, <i>Prunus</i> species, pedunculate oak, osier <i>Salix viminalis</i> , dog-rose <i>Rosa canina</i> , and bramble, overtopping a tall. species-poor ground-flora dominated by Himalayan balsam, common nettle and great willowherb. | |

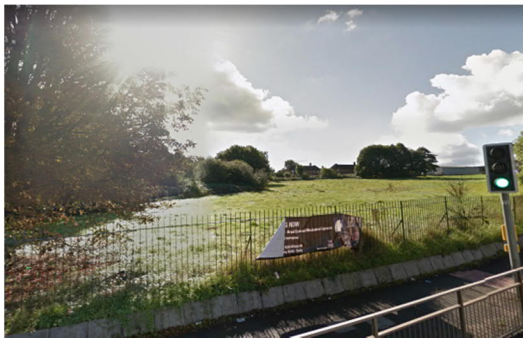
| N | Grid reference | Description | Photograph |
|---|---|--|--|
| 29 | SK 33364 36834 | This is an approximate 1.04 ha area of managed grassland within the grounds of the Territorial Army Site. It is largely grass-dominated, with herbs making up a much smaller proportion of the sward. There was a lot of grass thatch on the ground from mowing on Site. Red fescue is prominent in the sward with lesser amounts of common bent, false oat-grass, creeping thistle, meadow foxtail, cock's-foot, perennial rye-grass, couch grass and creeping bent. Herbs recorded include common knapweed, cleavers, selfheal, meadow vetchling local stands of fox-and-cubs and creeping cinquefoil. | |

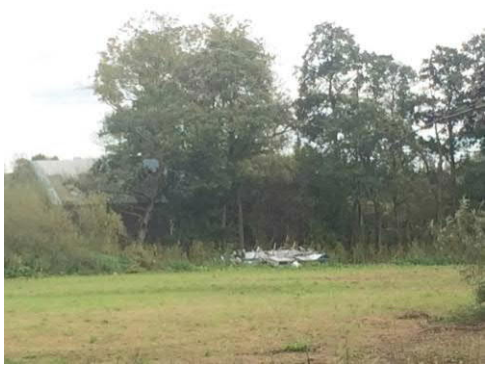
| N | Grid reference | Description | Photograph |
|---|---|--|--|
| 35 | SK 35980 39887 | Line of semi-mature trees with alder, Himalayan balsam, crack-willow, osier, common nettle. Dead trees with high potential bat roost features are present. | |

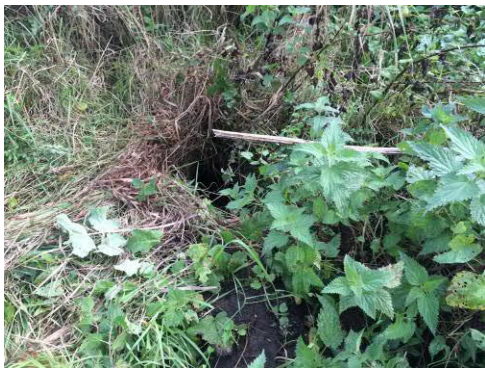
| N | Grid reference | Description | Photograph |
|---|---|--|--|
| 42 | SK 35853 40079 | Rabbit activity, several holes. Collapsed and active holes present. | |

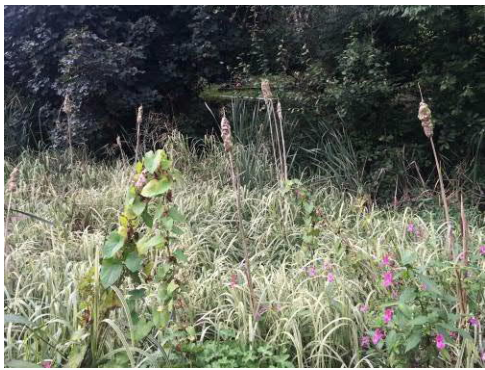
| N | Grid reference | Description | Photograph |
|---|---|--|--|
| 43 | SK 35847 40144 | Marshy grassland choked by reedmace, meadowsweet <i>Filipendula ulmaria</i> and ornamental non-native reed sweet grasses <i>Glyceria</i> spp. No open water present. | |

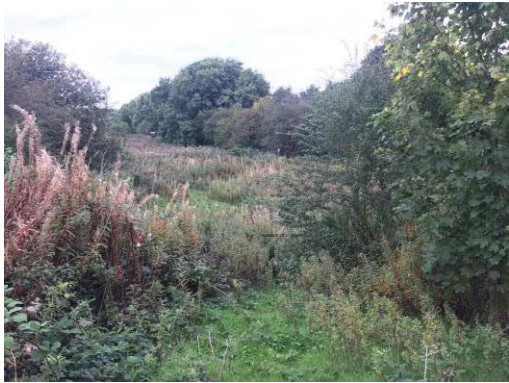
| N | Grid reference | Description | Photograph |
|---|---|---|--|
| 60 | SK 36311 40306 | Mosaic of disturbed ground which has established on a restored landfill site. Some areas were open, short rabbit grazed herb-dominated and other areas were taller and grass dominated. There were stands of scrub included bramble, rose, and willow; as well as large stands of ruderals such as rosebay willow herb, stinging nettle and wild teasel. The invasive non-native Japanese knotweed was growing along the western part of the area and Himalayan balsam was also | |

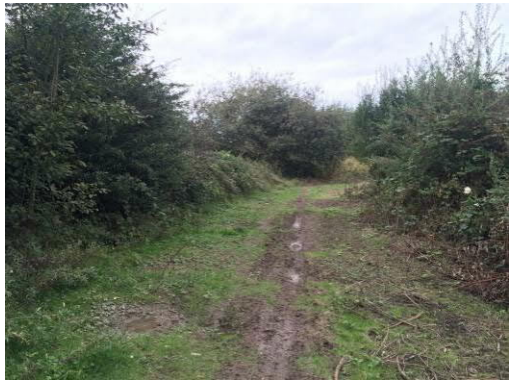
| N | Grid reference | Description | Photograph |
|---|---|---|--|
| 62 | SK 36212 40381 | Unmanaged, poor semi-improved grassland with some more species-rich areas of short rabbit-grazed grassland. Much vehicle disturbance. Extensive scrub encroachment. | |

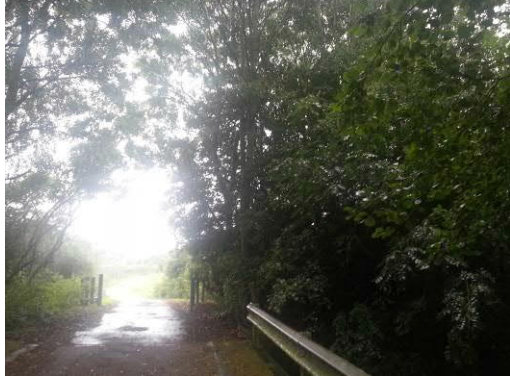
| N | Grid reference | Description | Photograph |
|---|---|---|--|
| 64 | SK 35981 40714 | Area of broad-leaved woodland dominated by ash, silver birch and hazel with a narrow, single lane, approximately 3-m wide, providing access to the STW buildings, with a metal gate blocking access to a concrete bridge going over the Bottle Brook. | |

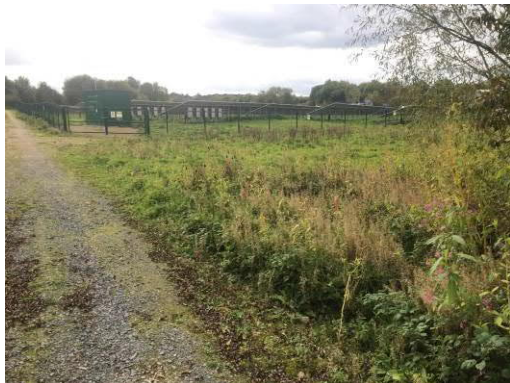
| N | Grid reference | Description | Photograph |
|---|---|---|--|
| 66 | SK 36136 40773 | Solar farm with managed semi-improved grassland. High levels of Himalayan balsam border this area. | |

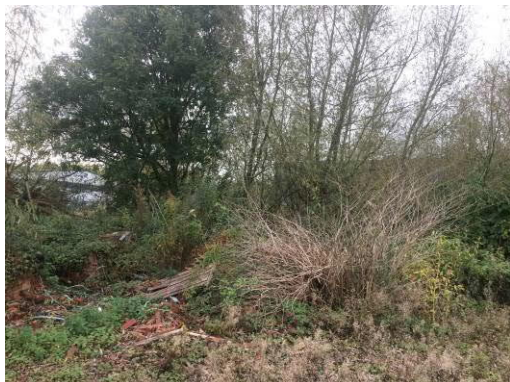
| N | Grid reference | Description | Photograph |
|---|---|---|--|
| 67 | SK 36088 40865 | Willow dominated woodland parcel. Woodland floor covered in common nettle and himalayan balsam. | |

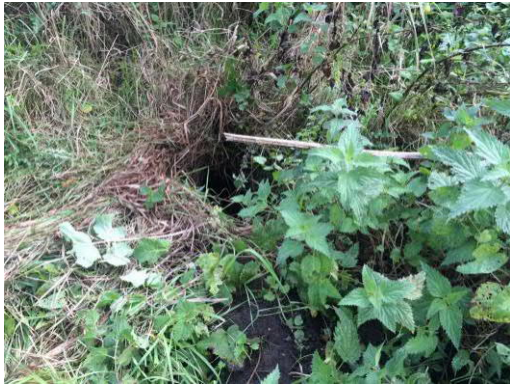
| N | Grid reference | Description | Photograph |
|---|---|--|--|
| 68 | SK 35871 40985 | Rabbit holes evident within semi-improved grassland between the River Derwent and Railway embankments. | |

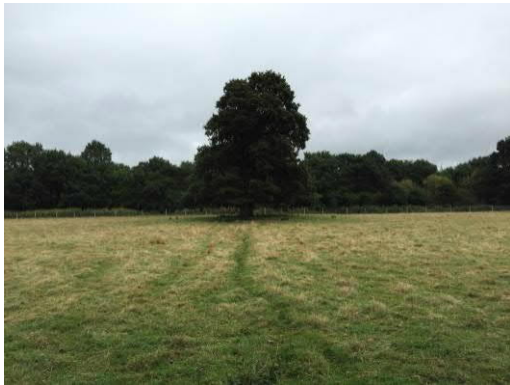
| N | Grid reference | Description | Photograph |
|---|---|--|--|
| 69 | SK 35729 41144 | Poor semi-improved grassland dominated this area and was grazed by sheep and cattle. Vegetation included abundant broad-leaved dock with crested dog's-tail, annual meadow-grass, rough meadow-grass, perennial rye-grass and creeping buttercup. | |

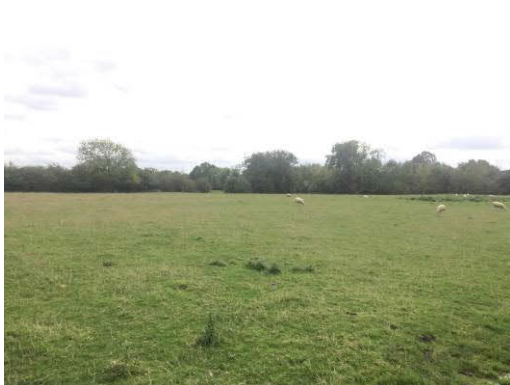
| N | Grid reference | Description | Photograph |
|---|---|--|--|
| 70 | SK 35882 41248 | Poor semi-improved grassland dominated this area and was grazed by sheep and cattle. Vegetation included abundant broad-leaved dock, with crested dog's-tail, annual meadow-grass, rough meadow-grass, perennial rye-grass and creeping buttercup. | |

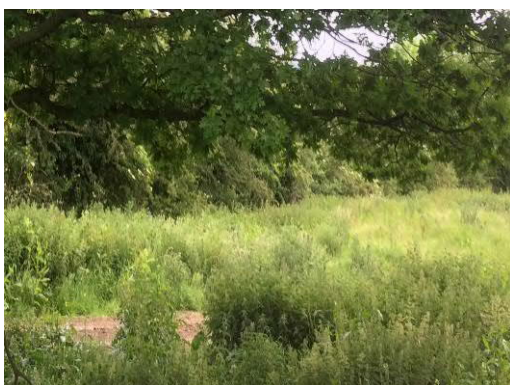
| N | Grid reference | Description | Photograph |
|---|---|--|--|
| 71 | | Yorkshire fog and false oat grass with occasional great willowherb, rosebay willowherb, ragwort and rare early-spotted orchids. | |

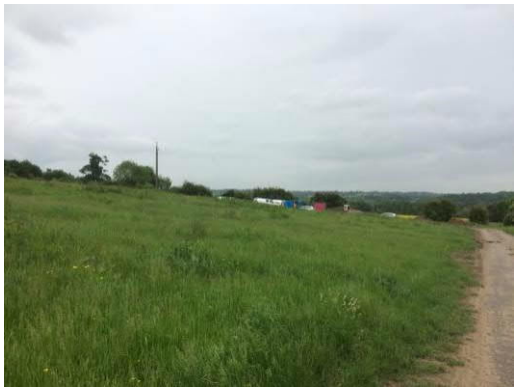
| N | Grid reference | Description | Photograph |
|---|---|--|---|
| 72 | | Perennial rye grass dominated pasture with abundant Yorkshire-fog. | |

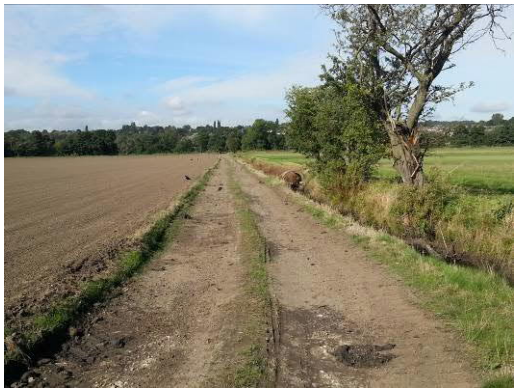
| N | Grid reference | Description | Photograph |
|---|---|--|---|
| 73 | | Turf farm. | |

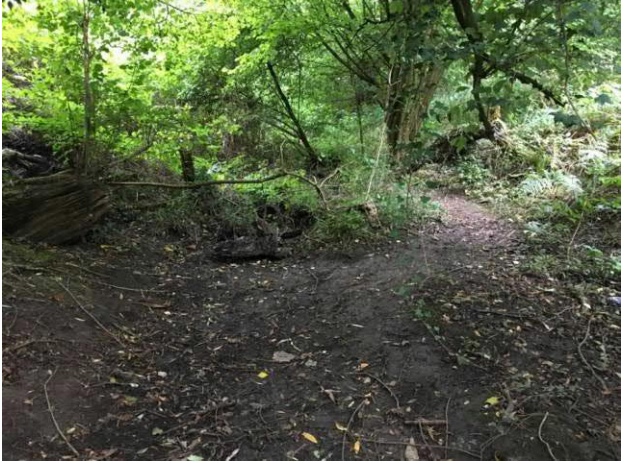
| Watercourse | Photograph |
|--|--|
| Bramble Brook: Dry northern channel upstream of A38 road bridge. | |

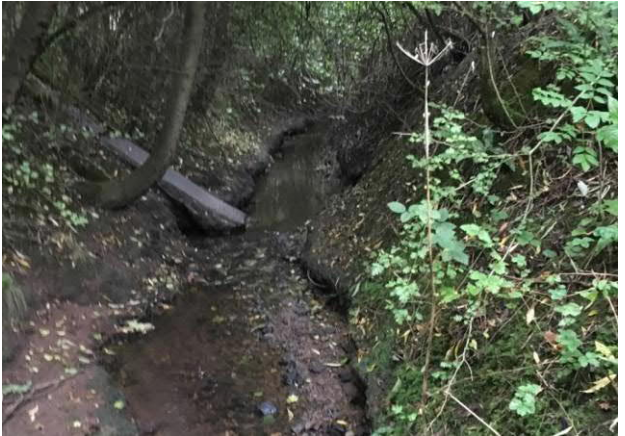
| Watercourse | Photograph |
|--|--|
| Bramble Brook: Shaded channel within Kingsway Junction south island. | |

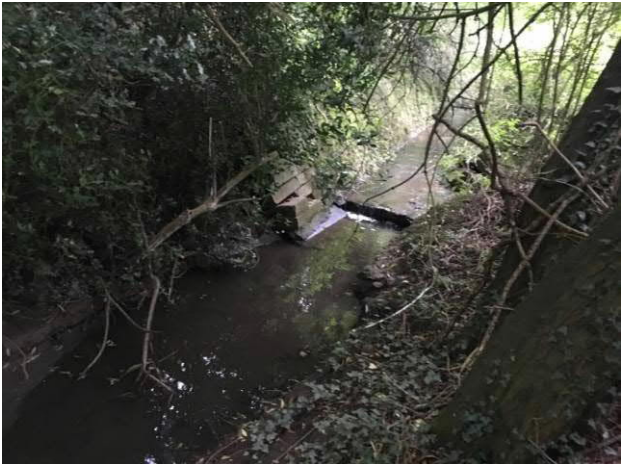
| Watercourse | Photograph |
|--|--|
| Bramble Brook: Bank Reinforcement within Kingsway Junction south island. | |

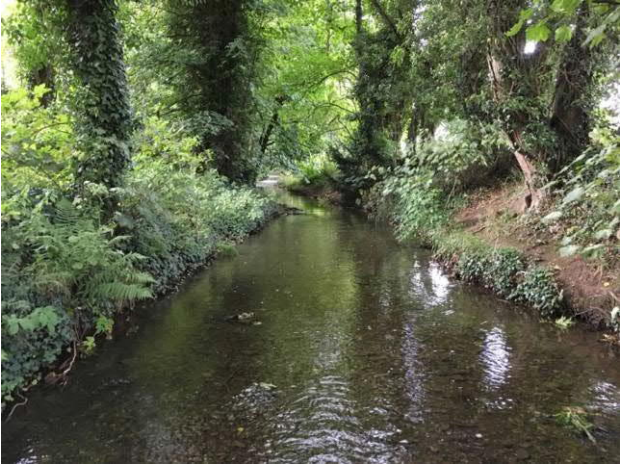
| Watercourse | Photograph |
|--|--|
| Markeaton Brook: General example of Brook Habitat. | |

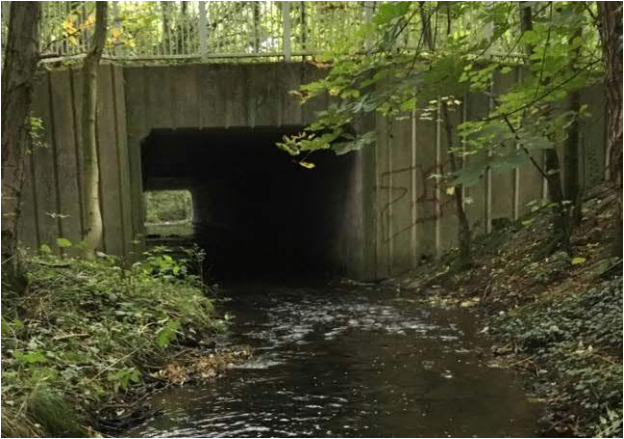
| Watercourse | Photograph |
|--|--|
| Markeaton Brook: Example of culverts. | |

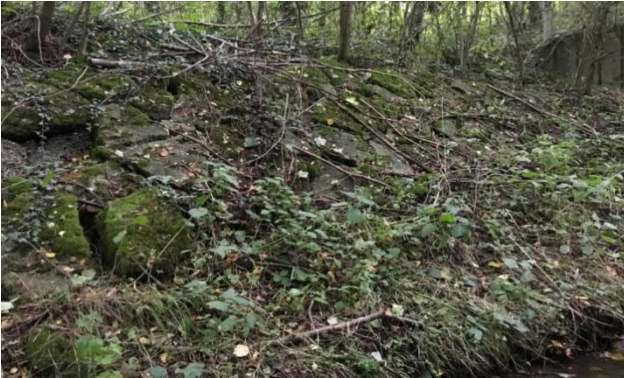
| Watercourse | Photograph |
|--|--|
| Markeaton Brook: Bank reinforcement found between culvert lengths. | |

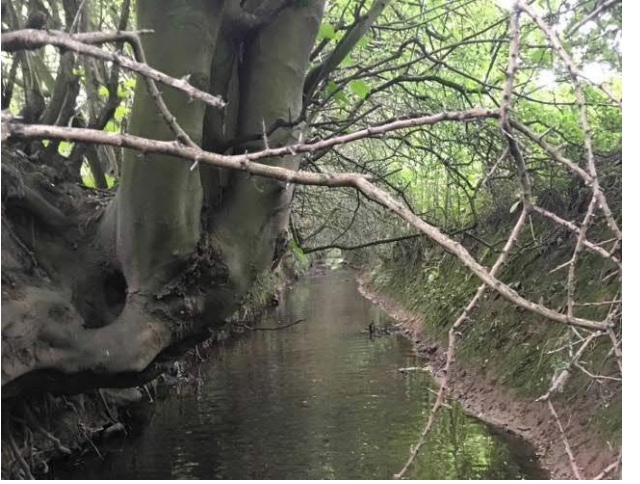
| Watercourse | Photograph |
|---|--|
| Boosemoor Brook: Shaded tree and scrub lined Channel. | |

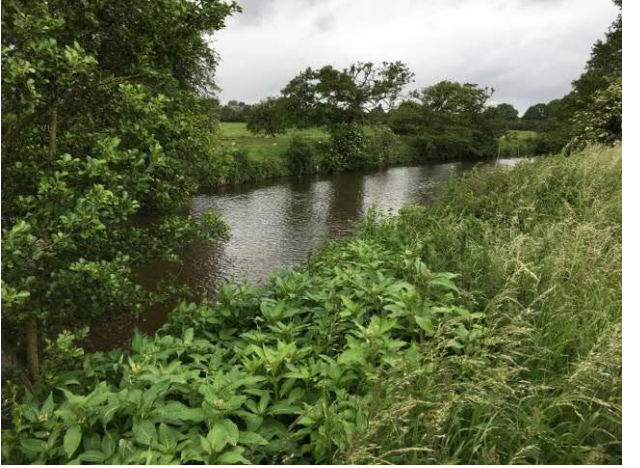
| Watercourse | Photograph |
|---|--|
| River Derwent: Example of river habitat. | |

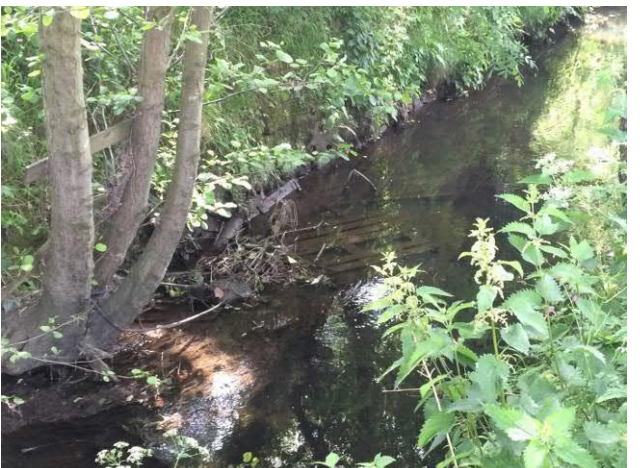
| Watercourse | Photograph |
|---|--|
| Bottle Brook: Example of brook habitat. | |
