A38 Derby Junctions

**Appendix 8.12a: White-clawed Crayfish
Survey in 2018**

White-clawed-Crayfish Survey Report

Report Number: HE514503-ACM-EBD-A38_SW_PR_ZZ-RP-EG-0019 P02 S4
November 2018

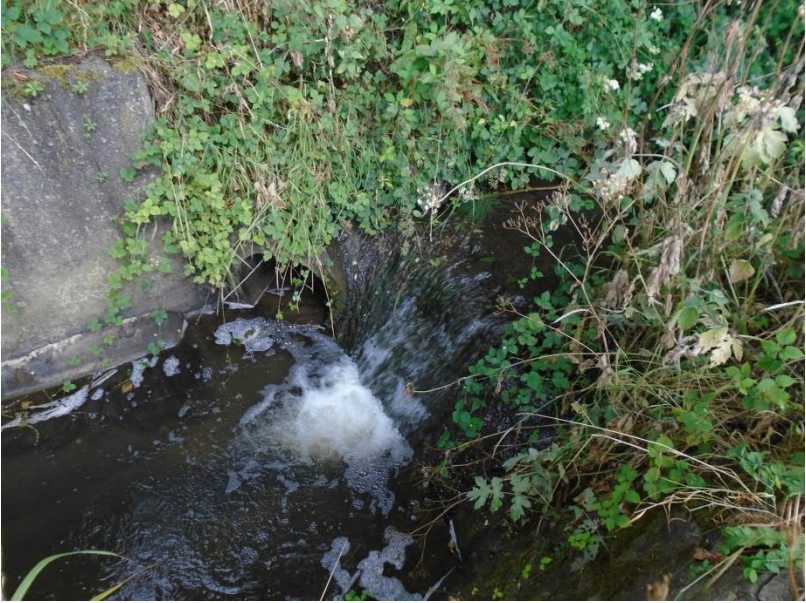
Plate number	Notes	Plates
1	Dam Brook Weir

40038), where previously white-clawed crayfish had been recorded (Figure 3 Appendix A). The weir was considered to form a potential temporary barrier to signal crayfish movement upstream of the structure. A site on the Boosemoor Brook, a tributary of Dam Brook upstream of the weir, was surveyed in 2015, but the channel had been modified. The site was considered to be poor habitat for white-clawed crayfish and none were found in the site (<100m) that could be accessed.

- 4.1.1 Signal crayfish were recorded during the 2018 survey, with one adult captured on Dam Brook upstream of the A61 weir in S1. This section is hydraulically linked to S2, with no known barriers to crayfish movement. The A61 weir (Plate 1 Appendix B) is not therefore considered to be a barrier to signal crayfish movement and signal crayfish are likely to be established throughout Dam Brook in areas of suitable habitat.

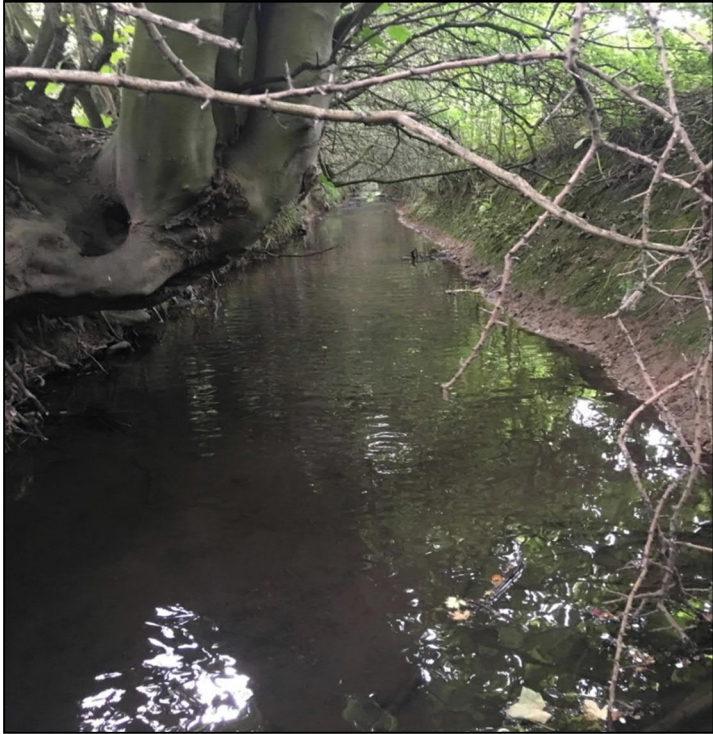
2	Dam Brook Survey Section 1

2.3.1 S1 had limited available refugia such as cobbles and bricks which could be searched manually, with the bed comprising of finer sediments including sand and silt. A 70m stretch between S1 and S2 of the Dam Brook channel could not be surveyed as it was significantly overgrown by bramble and hawthorn and the banks were high and steep which prevented safe access and egress.

Little Eaton Junction						
Site Name	Method	Visit 1 / Dates	Habitat Description	Survey 1 Findings	Visit 2 Date(s)	Survey 2 Findings
Dam Brook (S1) From – SK36510 40038 To – SK36602 39962	Refuge trap deployment (x14) and manual search (hand searching).	30 July	Straight (modified) section of brook located upstream of the A61 weir at SK 36499 40033. Banks trapezoidal with bed and bank reinforcement present immediately upstream of the weir. Fine bed sediments including sands and silt were dominant with limited in-channel and bank-toe refugia; however building materials such as bricks were rarely available. Overhanging scrub hawthorn and bramble was also present shading the channel with no marginal or bankside vegetation present.	No crayfish found during manual search.	10 August 2018	One signal crayfish male was recorded upstream of the Dam Brook weir (see Plates 4 and 5, Appendix B) at SK36534 40025. The animal was mature with carapace lengths being 35mm. The 3 rd right pereopod (leg) was missing, otherwise there was no sign of damage and the animal appeared healthy.

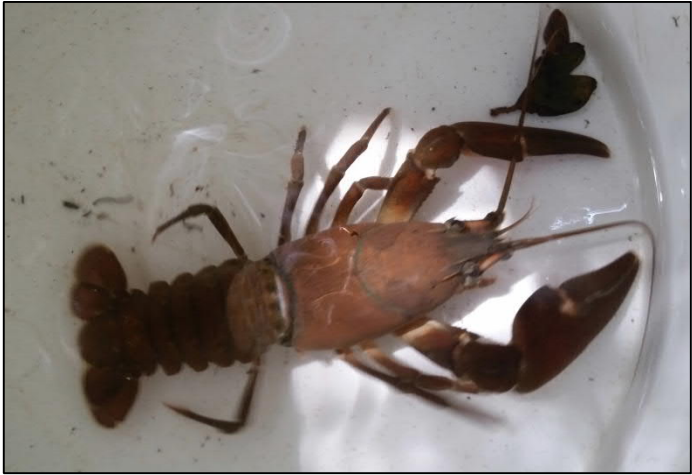
Plate number	Notes	Plates
3	Dam Brook Survey Section 2	 
4 & 5	Dam Brook Signal Crayfish Male

2.3.2 S2 was intermittently overgrown with bramble, willowherb hedge bindweed and common nettle which made some areas of channel impossible to survey. Whilst Dam Brook in S2 was overgrown, there were enough refugia available for manual search and this gave a good representation of the presence/ likely absence of white-clawed crayfish. Consequently, not accessing the overgrown areas is not considered to have affected the findings of this survey. Additionally, increased survey effort (i.e. both standardised manual searches and refuge trapping) was undertaken within both survey sections providing confidence in the survey results for S1 and S2 notwithstanding the above limitations.

Dam Brook (S2) From – SK36659 39917 To – SK36829 39823	Refuge Trap deployment (x16) and manual search (hand searching).	30 July	Straight section of brook with earth banks. Channel banks overgrown with common nettle, willow herb and bramble with individual stands of semi-mature alder and willow. Channel bed was dominated by large cobbles and boulders with finer gravels and sand beneath. Large refugia were often embedded by bed sediments and couldn't be searched. Building materials such as bricks also offered a range of in channel and bank toe refugia	No crayfish recorded during manual search	10 August 2018	No crayfish recorded during refuge trap collection.
