**A38 Derby Junctions**

**Appendix 8.12c: White-clawed Crayfish  
Survey in 2015**

## **White-Clawed Crayfish Survey Report**

**Report No: 47071319-URS-05-RP-EN-017**  
**May 2016**

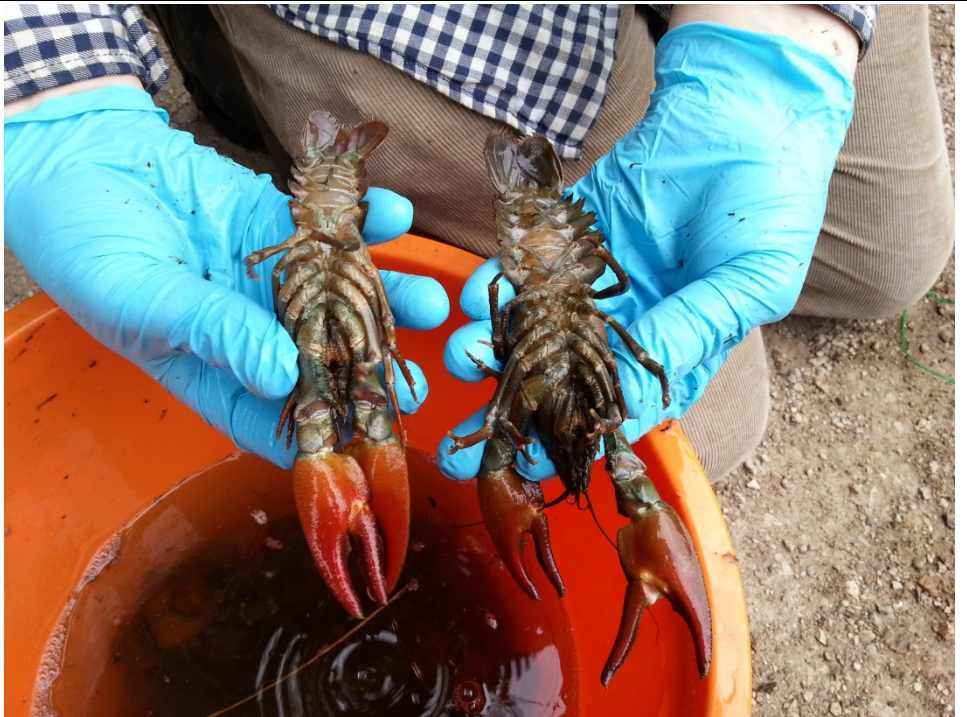
Plate number	Notes	Plate
1	Markeaton Lake north-western end (a1) (signal crayfish)

- 4.1.4 American signal crayfish were recorded from the survey with 23 adults captured from the inlet at the north-western end of Markeaton Lake (a1) indicating a well-established population. This location corresponds with the solitary signal crayfish record found from Cowley's study on 2012. No other signal crayfish were recorded from the surveys, but the population is likely to be present, at least at low abundance, in areas beyond where it was detected

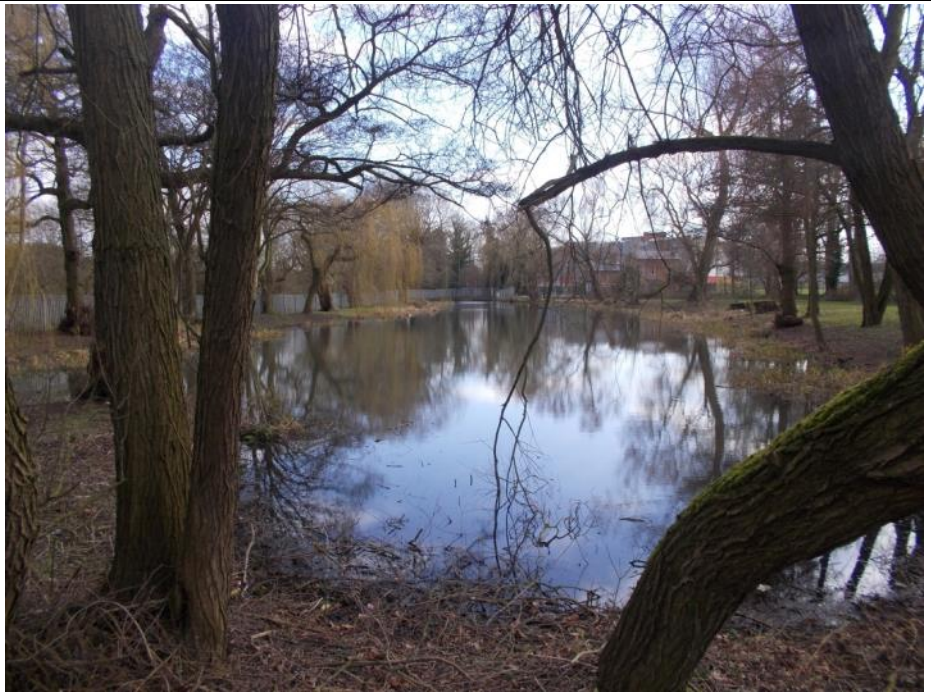
Plate number	Notes	Plate
3	Mill Pond 1 (looking from the north-western end) (a3)

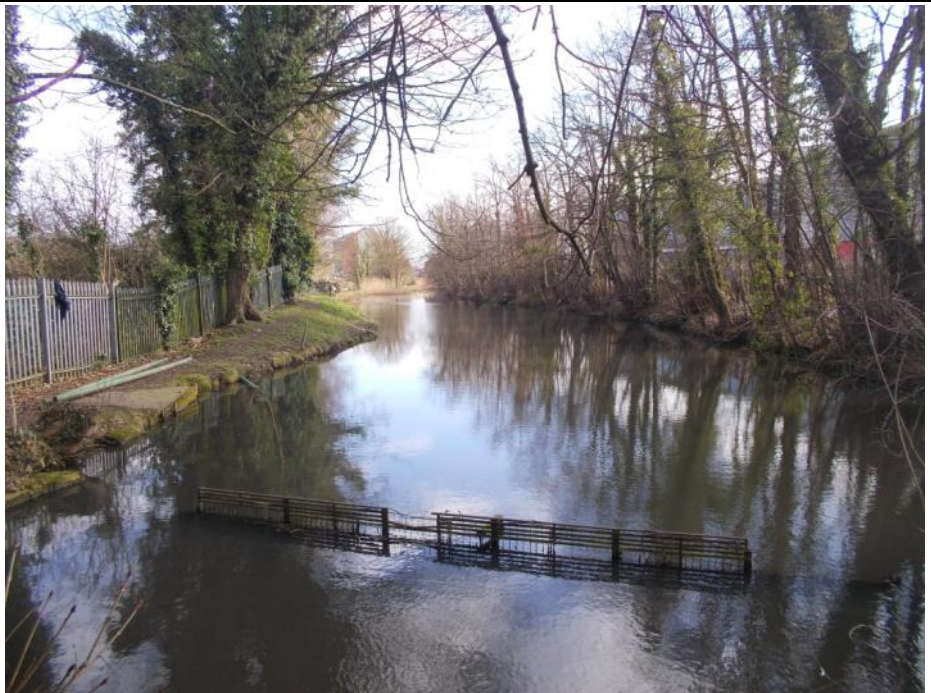
4	Mill Pond 2 Canal (looking from the south-eastern end) (a4)
