# **A303 Amesbury to Berwick Down**

### **Appendix 8.21 Hazel dormouse**

## **Dormouse Survey Report 2016-2017**

**HE551506-AA-EBD-SWI-SU-YE-000005**

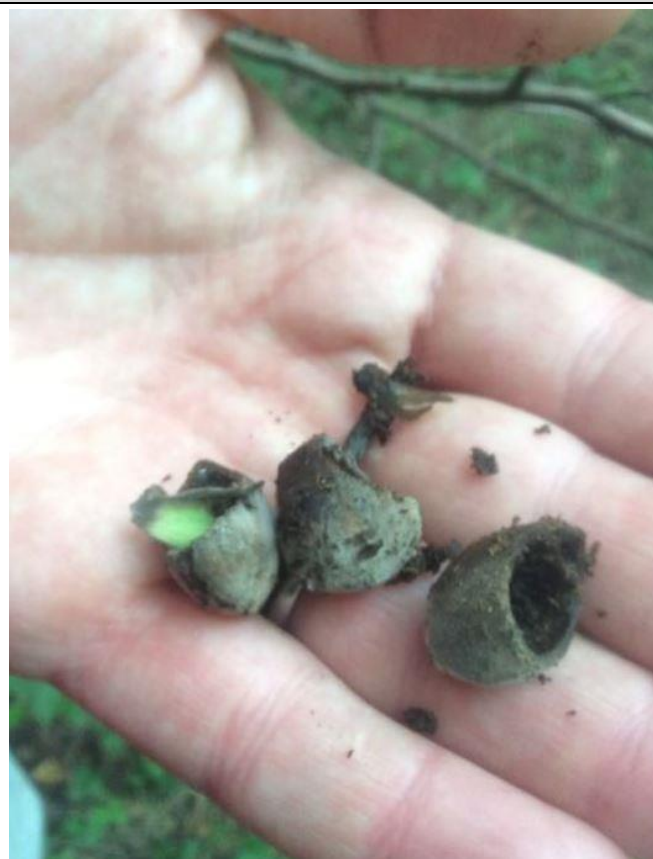
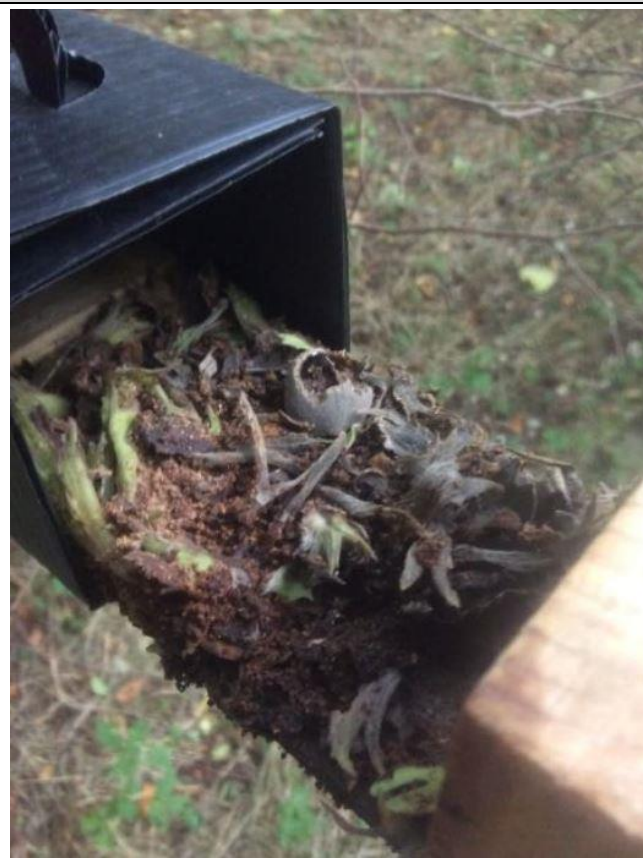
**Tube 4**

**Normanton Gorse/Wood; Visit 2**

- 3.1.1 No evidence of dormouse activity was found at any site during any visit. Dates of each visit and results are detailed in Table 3.
- 3.1.2 Evidence of wood mouse activity was identified at Winterbourne Stoke Hedgerows 1 and 2, "One Mile" Hedgerow, and Normanton Gorse/Wood. Photographs of this activity are provided in Table 6 in Appendix D.
