A303 Amesbury to Berwick Down

Appendix 10.4 Preliminary Sources Study Report

Preliminary Sources Study Report

HE551506-AA-HGT-SWI-RP-CX-000004

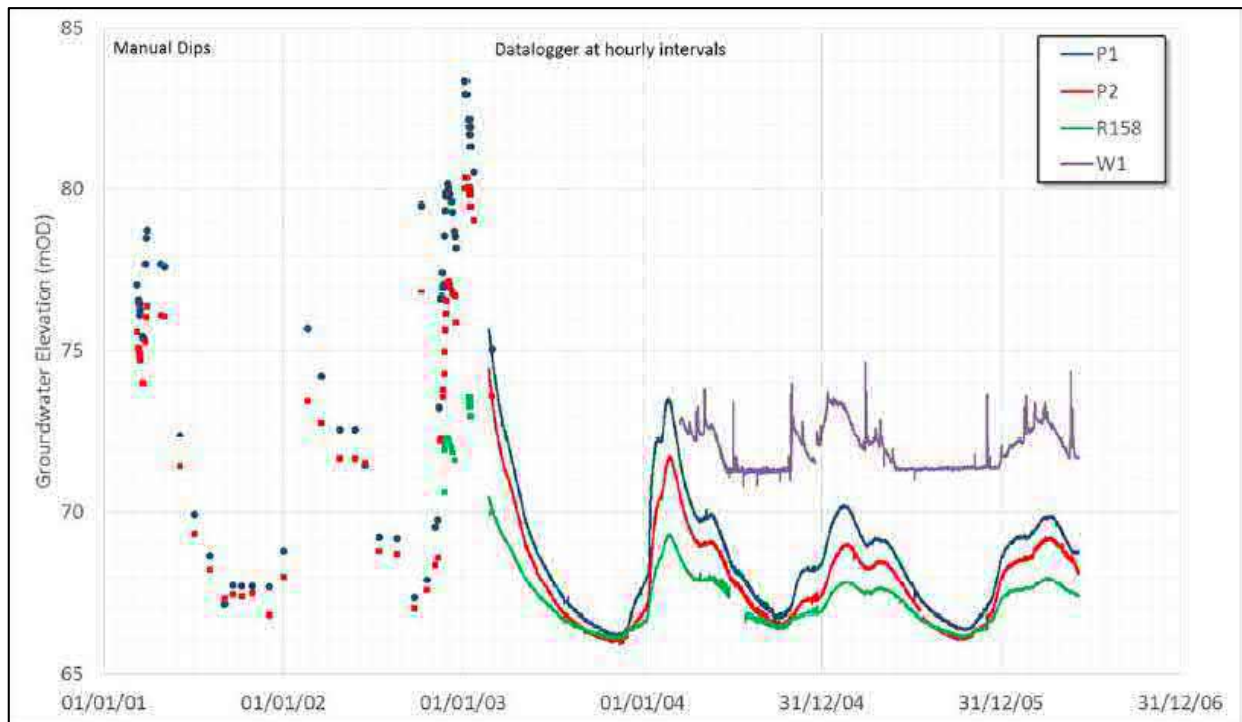
Figure 5-7 Groundwater level hydrographs for observation wells P1, P2, R158 and W1 from previous ground investigation monitoring (see also Figure 5-8)

- 5.7.8 Groundwater flow in the Chalk occurs principally in fractures and fissures. Much of the most permeable chalk has been subject to solution enlargement of existing discontinuities (of tectonic and sedimentological origin) by exposure to groundwater over a long period of time. The permeability of the chalk is generally high but spatially variable. In unconfined parts of the Chalk aquifer in southeast England (Salisbury Plain is such an area) permeability is generally lowest beneath interfluvial areas, and highest beneath river valleys and dry valleys.
- 5.7.9 Groundwater in the Chalk aquifer responds rapidly to recharge events at the surface and significant changes in groundwater level can occur over a short period of time. The low storage capacity of the Chalk leads to rapid and large rises in groundwater level in response to rainfall, see Figure 5-7. Note that the data logger

in borehole W1 was not able to record water levels below 71mAOD [2]. Fractures are highly transmissive but have a small volume and fill rapidly; the rock mass has low permeability and is already close to saturation.

- 5.7.10 Groundwater levels in the Chalk aquifer are highly seasonal, rising in response to annual recharge during the winter and declining during the summer when recharge is lower. The magnitude of fluctuations in groundwater level between seasonal high and low is greatest in interfluvial areas, reducing toward valleys where transmissivity is higher and discharge to the surface may act as a control on groundwater level³. The annual fluctuation is typically 8 to 10m beneath dry valleys (such as Stonehenge Bottom), rising to about 15m below topographic divides.
