M25 junction 28 improvement scheme

TR010029

Appendix 7.13: Dormouse survey

Hazel Dormice Survey Report: Junction 28 M25

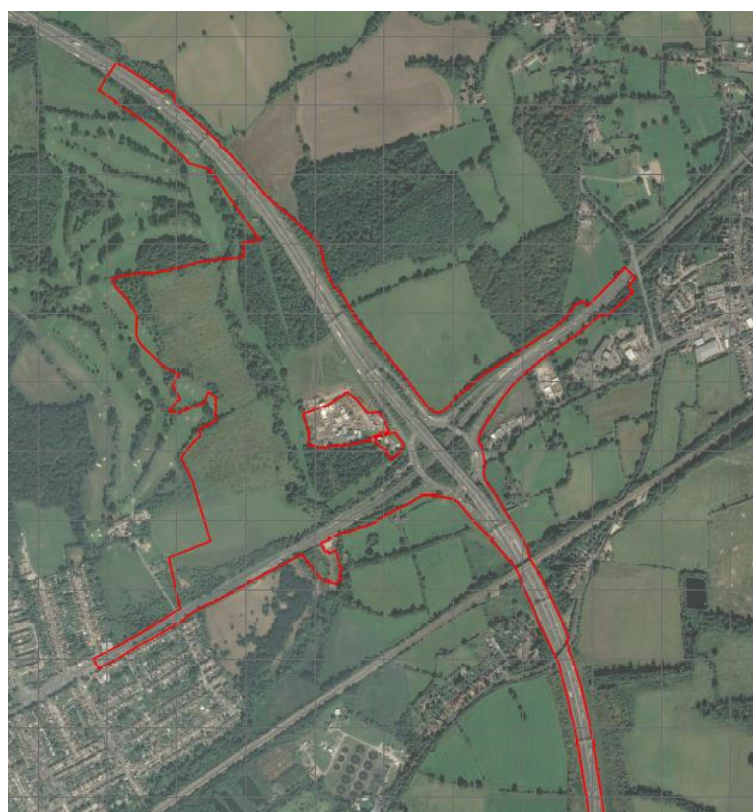
Figure 1: DCO boundary highlighted in red (ADAS general mapping tool 2019)

The original hazel dormouse survey did not cover the full Scheme extent as shown by the DCO boundary in Figure 1 due to access restrictions to the wider areas of the site such as to the south of the A12 . However further walkover surveys were completed in 2019 of land to the south of the A12 which identified that the area was unsuitable for hazel dormice due in part to recent landscaping works. Therefore, it is considered that all areas that had suitability for hazel dormice which would be directly impacted by the construction of the Scheme, as shown in Annex 1, was covered by the survey.
