M25 junction 28 improvement scheme

TR010029

9.125 Response to Gardens of Peace comments on ISH3 regarding the NMU Scheme

June 2021

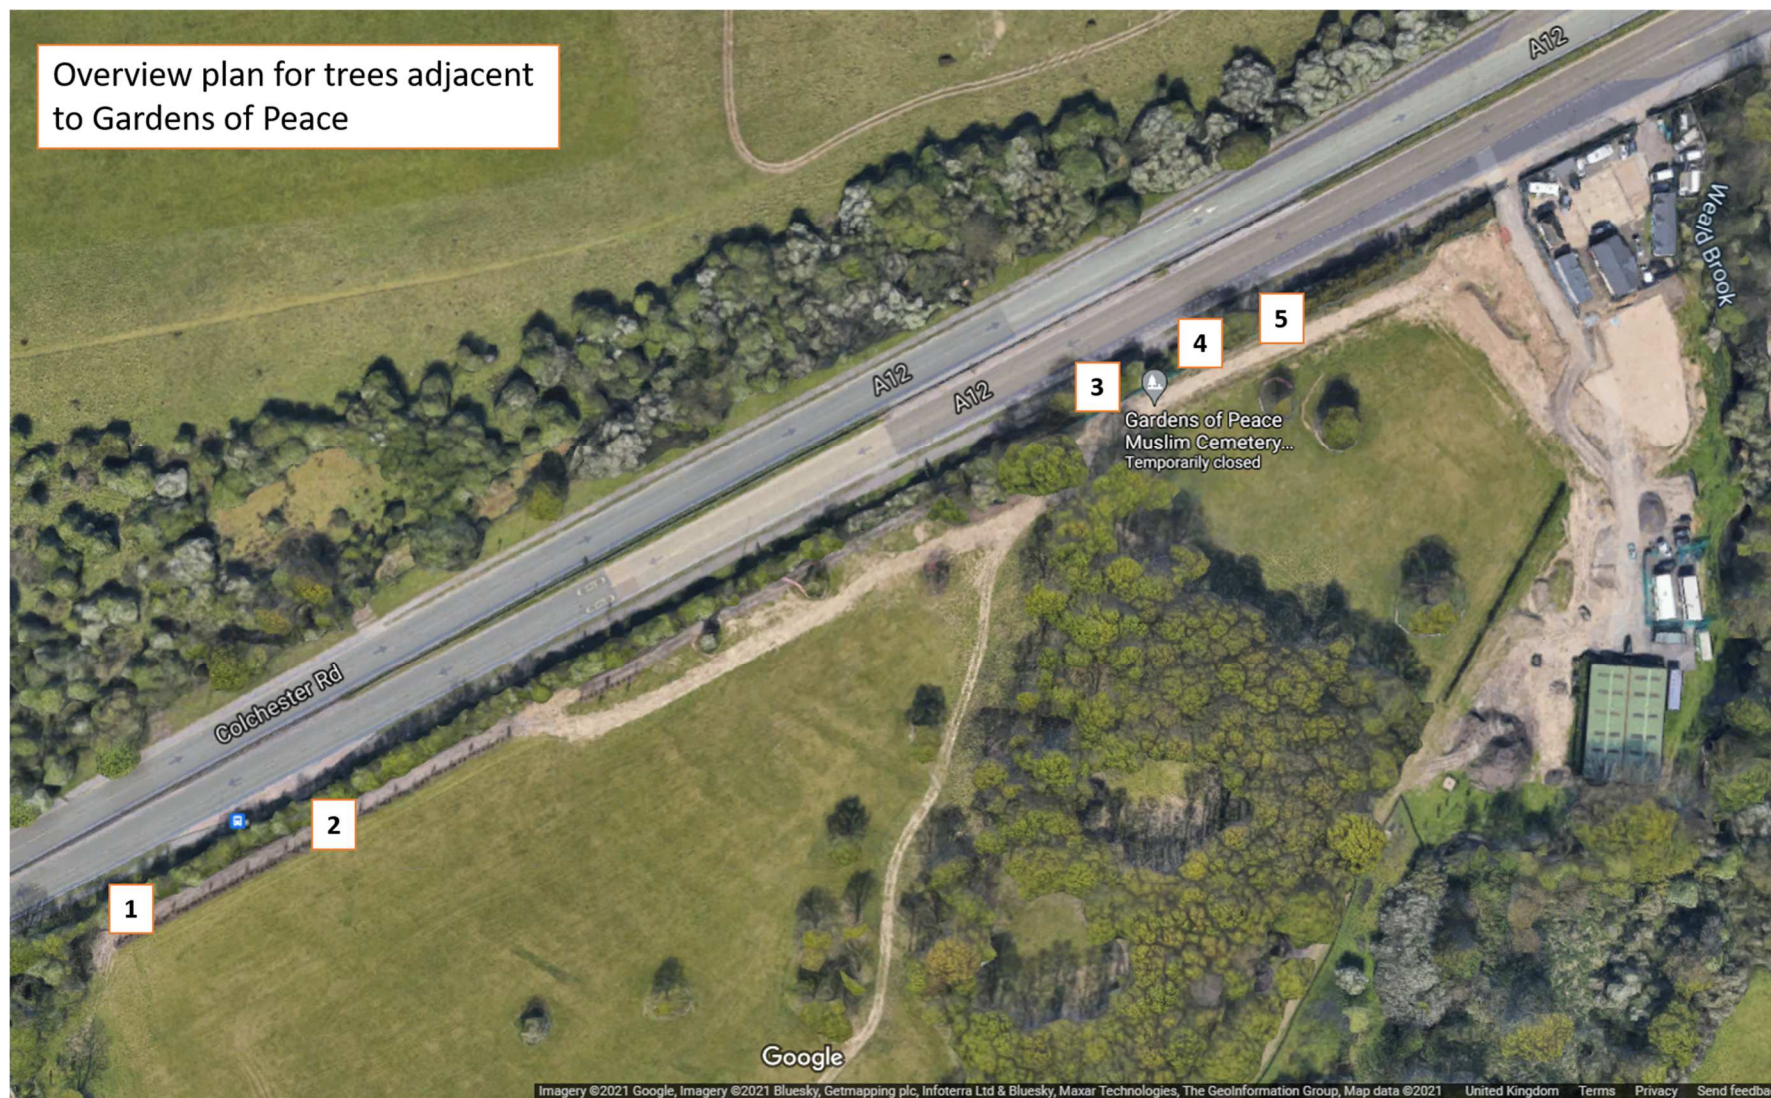
Figure 1.1: Overview plan (Photo source: Google imagery from 2021)

- 1.1.3 Figures 1.1 to 1.6 provide locations and images of the trees that are affected by the NMU scheme along the A12 eastbound heading towards the junction 28 roundabout. Further details of the trees are also included in Table 1.1.

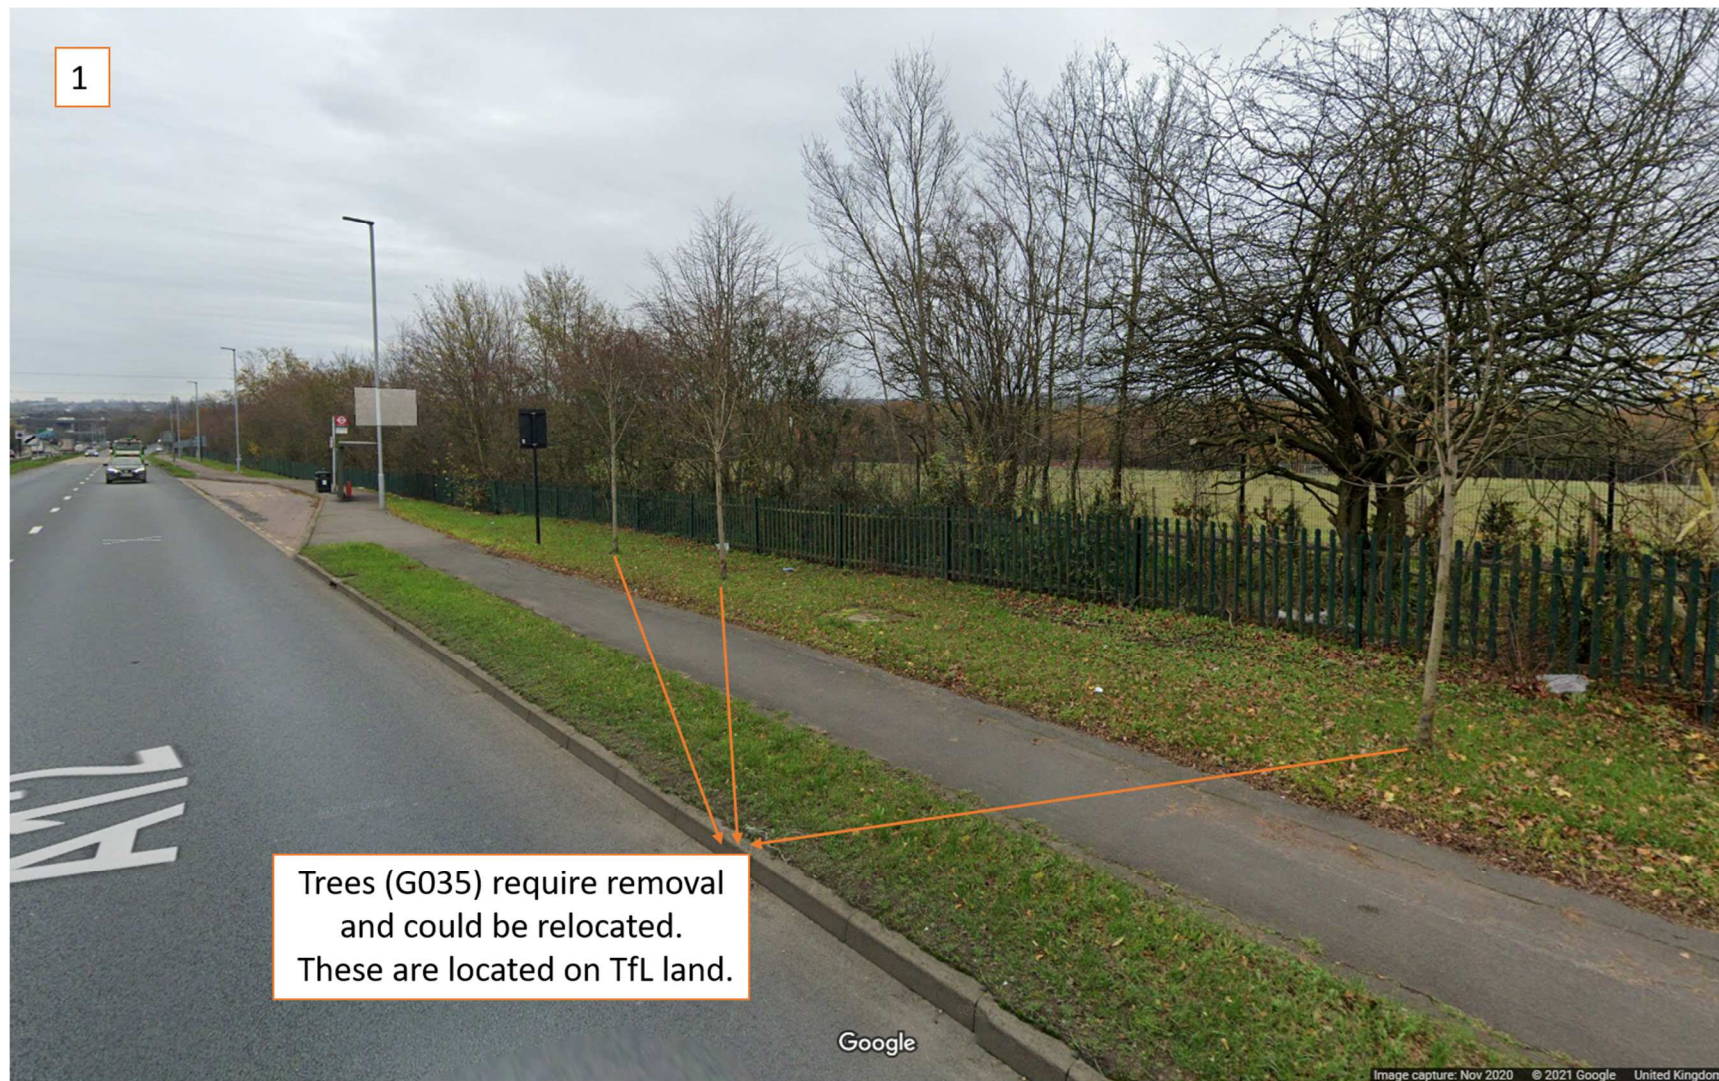
Figure 1.2: Point 1 - Looking north east along the A12, just west of the bus stop (Photo source: Google street view from Nov 2020, tree survey undertaken in March 2020)

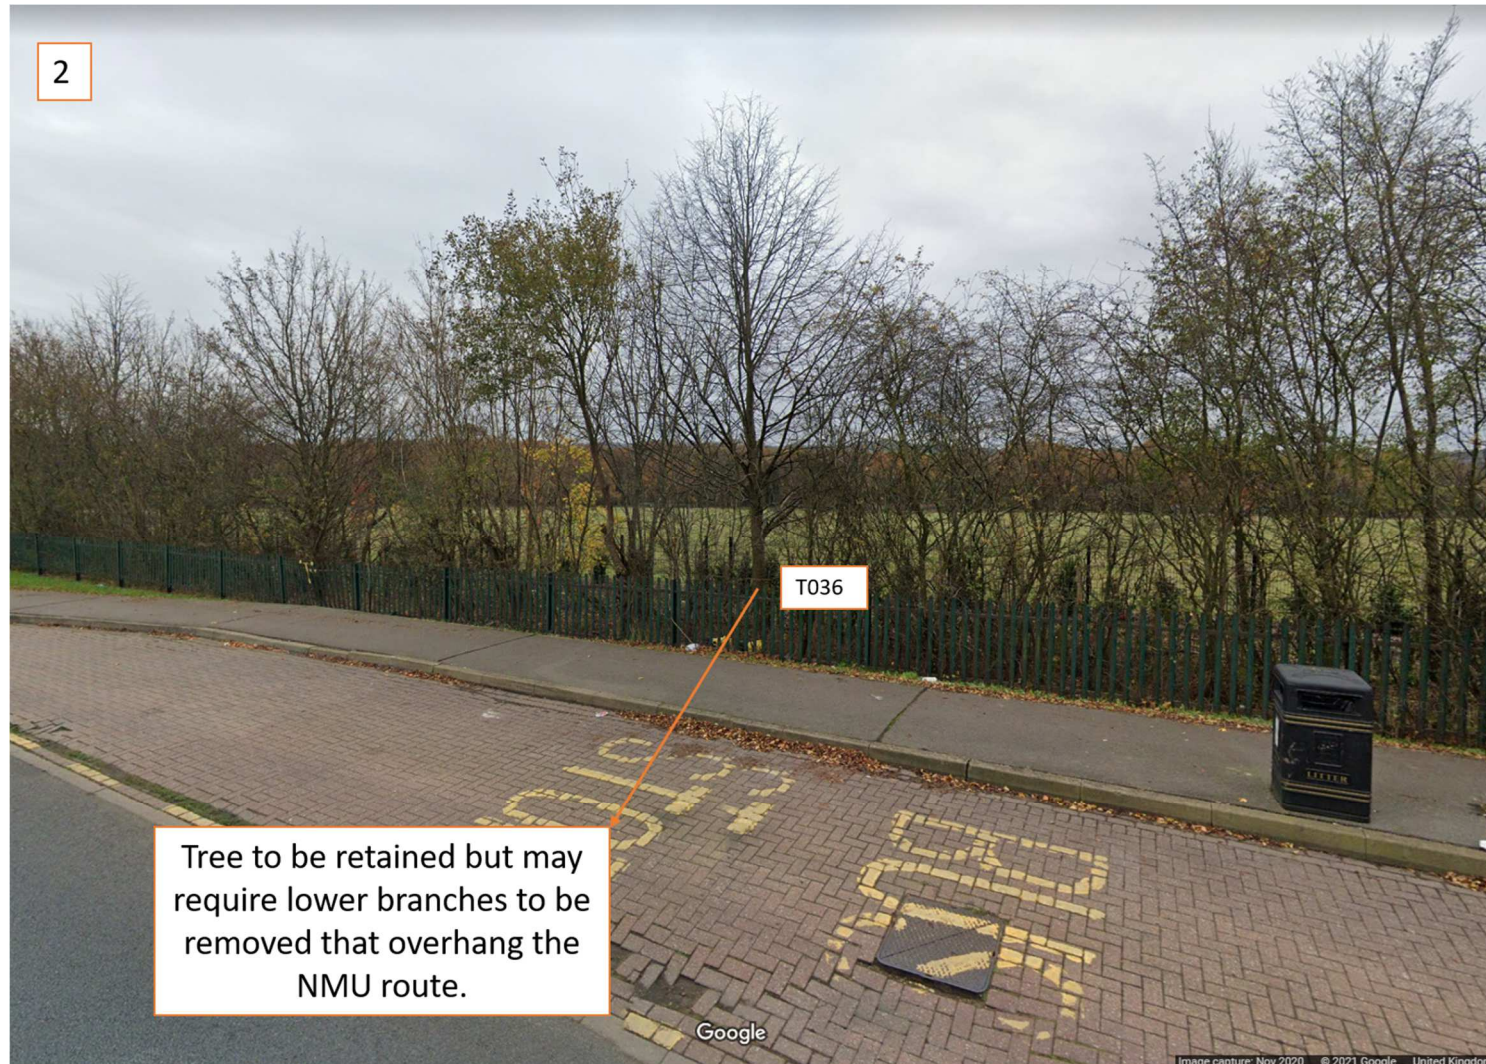
Figure 1.3: Point 2 - Looking south east along the A12, next to the bus stop (Photo source: Google street view from Nov 2020, tree survey undertaken in March 2020)

- 1.1.4 In summary, nine trees need to be removed along the A12 that are located on Transport for London's (TfL) land. One tree near the bus stop may need its lower branches to be removed that overhang the NMU route that is located on Gardens of Peace land. The potential to retain any of these trees is being reviewed as part of a detailed design process. Similarly, the potential to compensate for these losses with new tree planting along the verge is being considered and TfL is to be consulted on this matter.

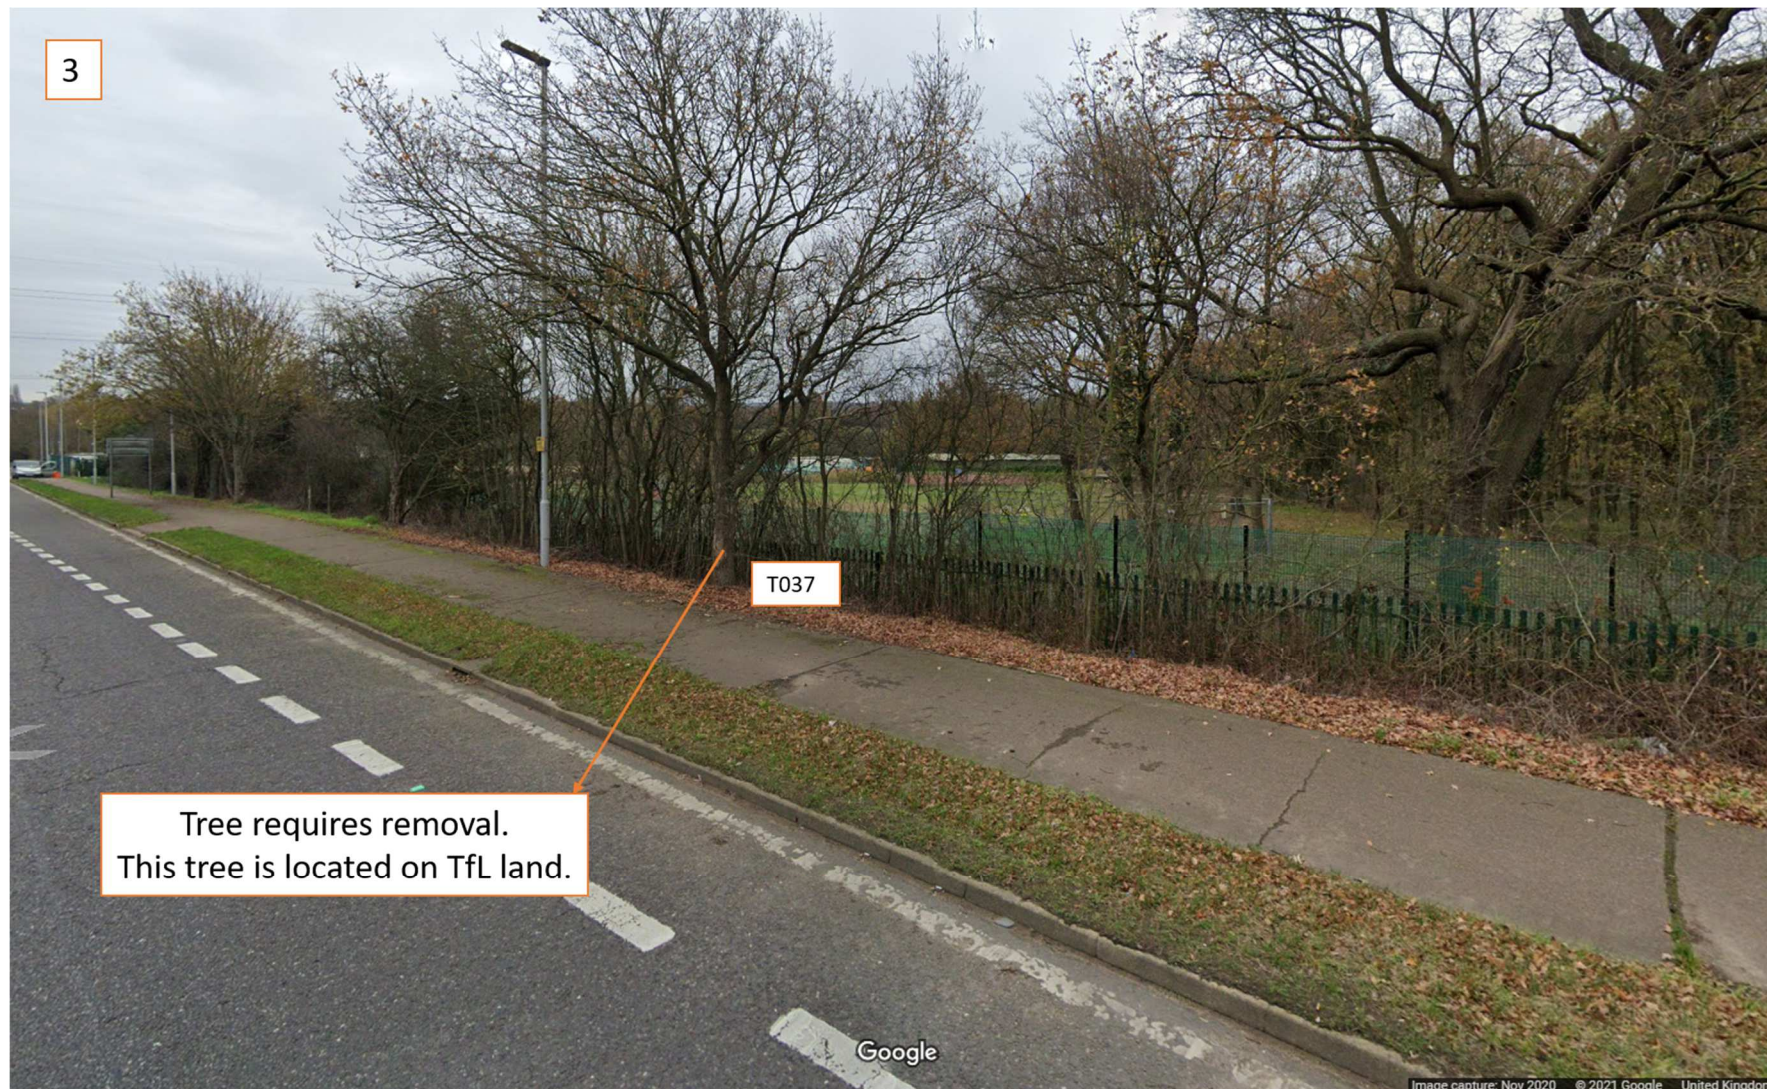
Figure 1.4: Point 3 - Looking south east along the A12, west of the caravan park (Photo source: Google street view from Nov 2020, tree survey undertaken in March 2020)

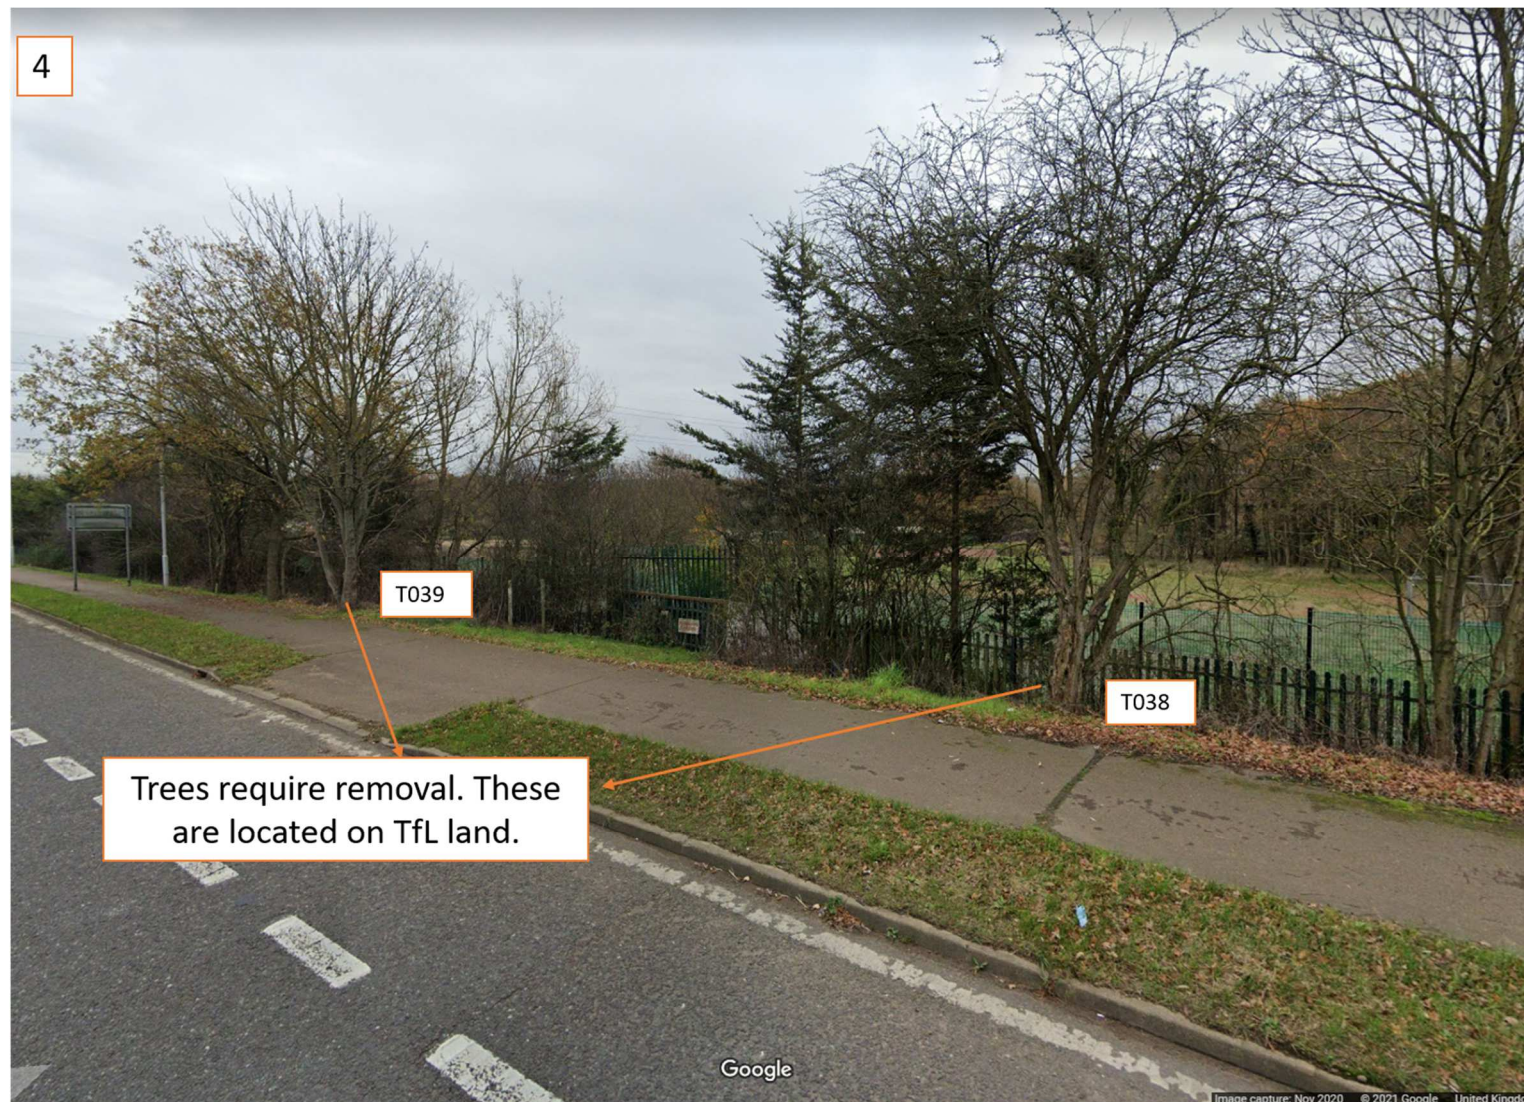
Figure 1.5: Point 4 - Looking south east along the A12, west of the caravan park (Photo source: Google street view from Nov 2020, tree survey undertaken in March 2020)

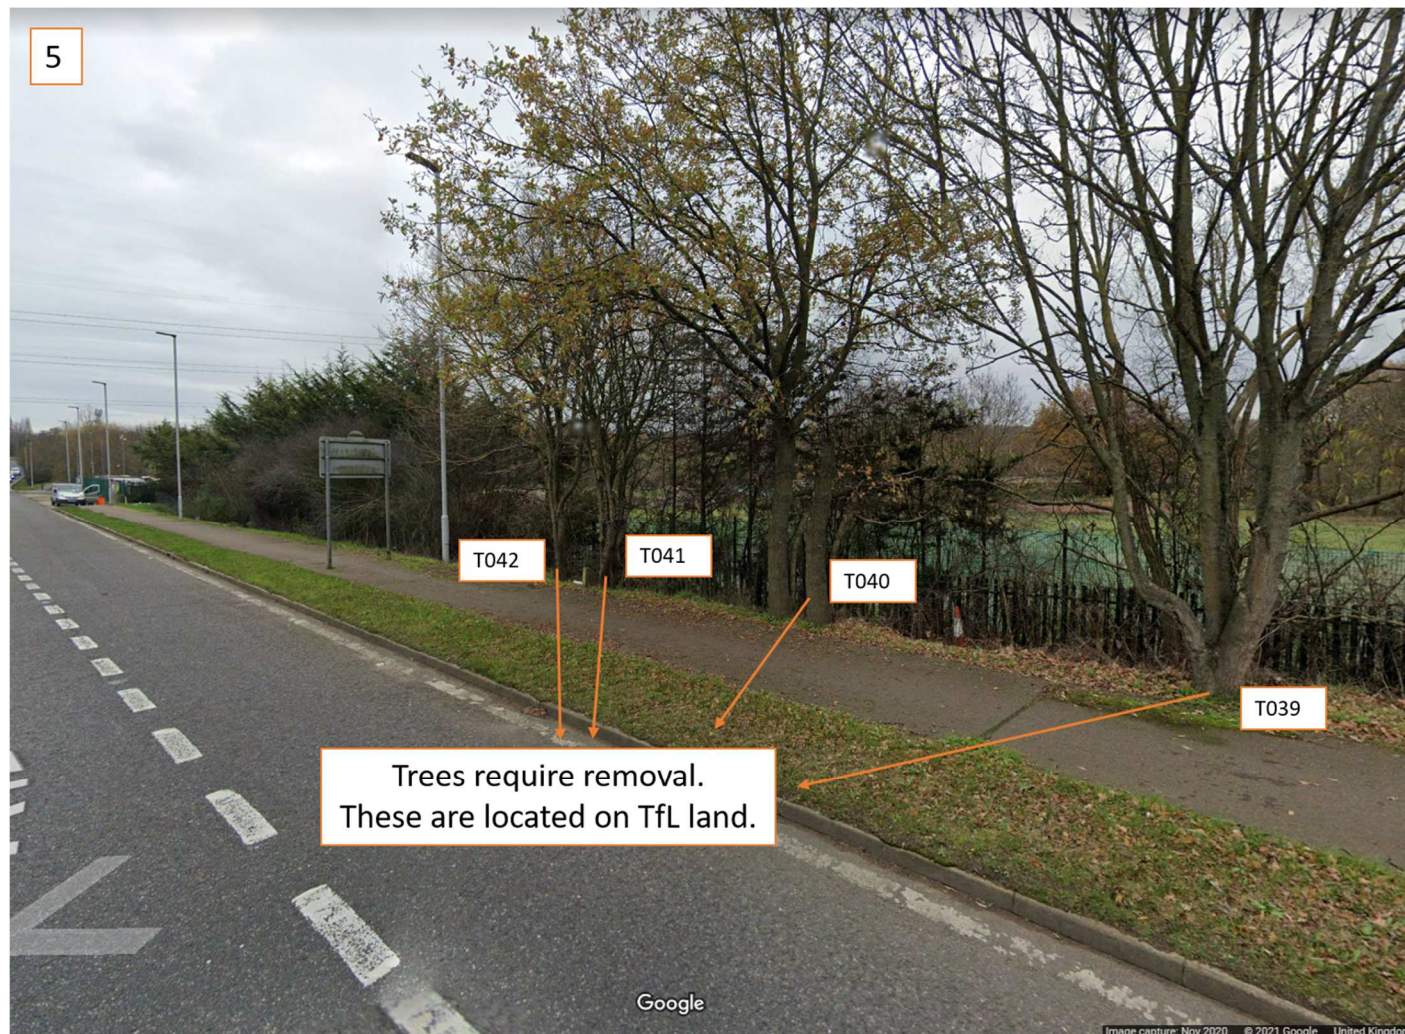
Figure 1.6: Point 5 - Looking south east along the A12, west of the caravan park (Photo source: Google street view from Nov 2020, tree survey undertaken in March 2020)
