# A47 Wansford to Sutton Dualling

Scheme Number: TR010039

Volume 6
6.3 Environmental Statement Appendices
Appendix 8.12 – Bat Emergence/Re-entry
Survey Report

# **ENVIRONMENTAL STATEMENT APPENDICES Appendix 8.12 - Bat Emergence/Re-entry Survey Report**

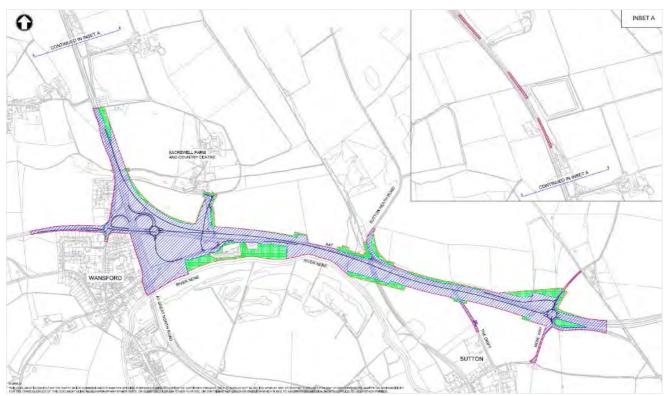
Figure 3.1 DCO boundary (red line) – all surveyed buildings and trees fall within a 50m buffer of this boundary.

The bat roost survey area comprised a 50m buffer around the DCO boundary shown on Highways England drawing 'A47 Wansford to Sutton PCF Stage 3 – Proposed DCO Redline Boundary with Permanent and Temporary Land Take', reproduced in figure 3.1 below.

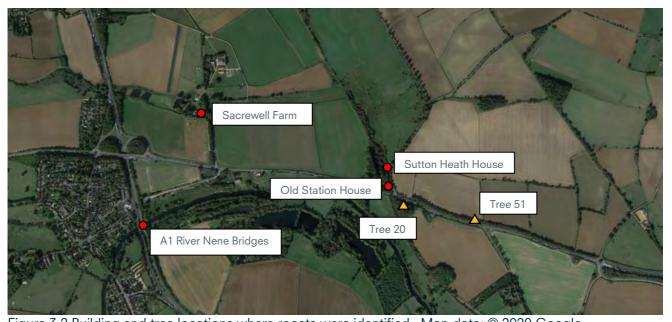
Figure 3.2 Building and tree locations where roosts were identified. Map data: © 2020 Google.

The location of all buildings and trees where bat roosts were identified is shown in figure 3.2.

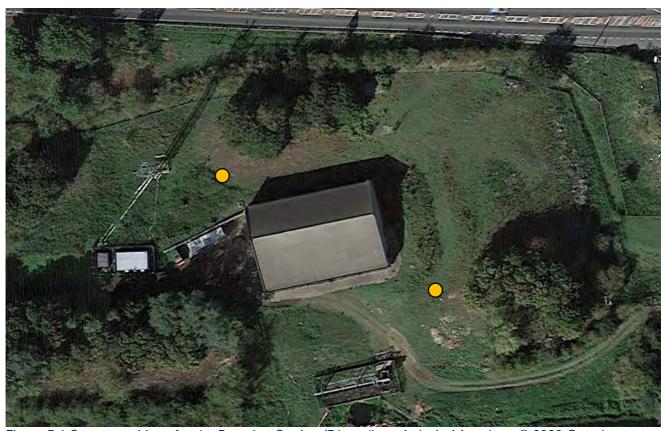
Figure 5.1 Survey positions for the Pumping Station (R1 - yellow circles). Map data: © 2020 Google.

Figures 5.1-5.6 below show the locations of surveyors and, where applicable, the infra-red camera and/or thermal imaging scope during the building surveys.

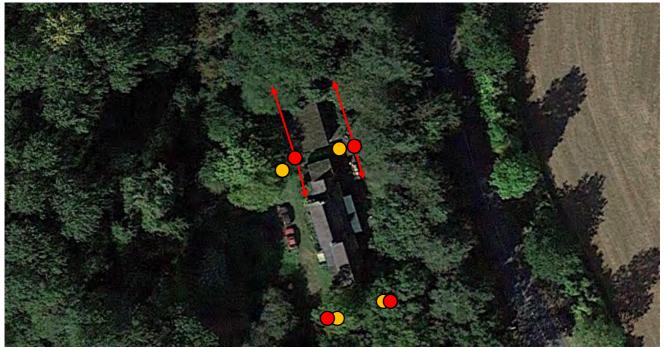
Figure 5.2 Survey positions for Old Station House (E1 and E2 – yellow circles), (R1 – red circles; red arrows show walked transect routes). Map data © 2020 Google.

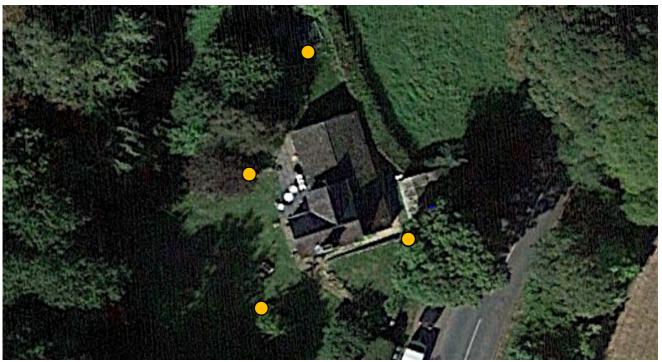
Figure 5.3 Survey positions for Sutton Heath House (yellow circles). Map data © 2020 Google.

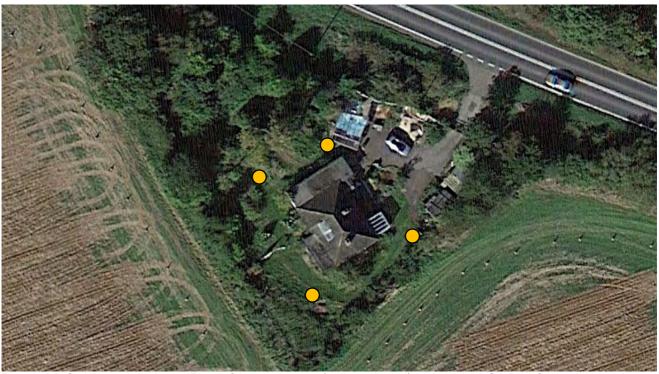
Figure 5.4 Survey positions for Deep Springs House (yellow circles). Map data © 2020 Google.

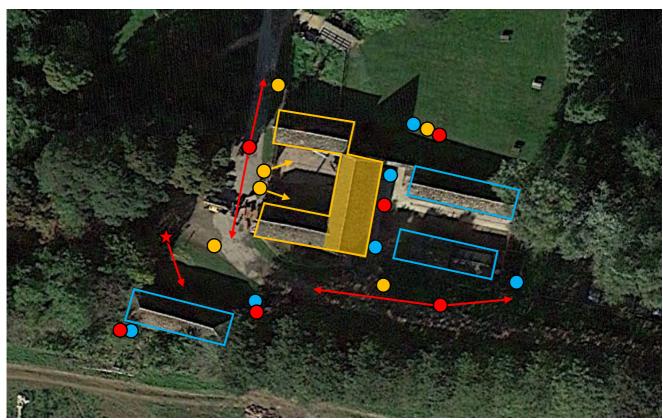
Figure 5.5 Surveyor positions for Sacrewell Barns (E1 & E2 – yellow circles, arrows show focal area), (E3 & R1 – blue circles), (R2 – red circles, arrows show transect routes; thermal imaging scope shown by red star, arrow shows focal area). Building group A outlined in yellow (main barn shaded yellow). Building group B outlined in blue. Map data © 2020 Google.

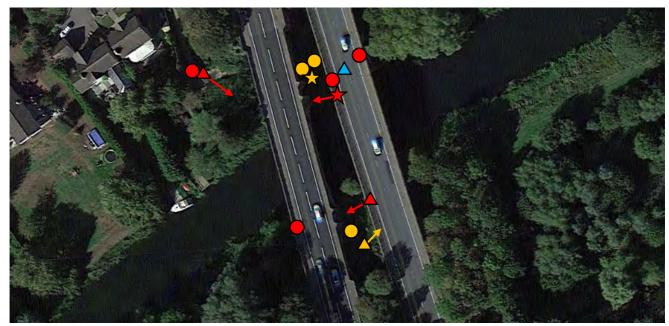
Figure 5.6 Surveyor positions for A1 River Nene Bridges (R1 & E2 – red circles show positions on top of bridges/behind Heras fencing; red triangle shows infra-red camera rig position; red star shows thermal imaging scope position), (R2 – yellow circles show position beneath bridges; yellow triangle shows infra-red camera rig position; yellow star shows thermal imaging scope position), (R3 – blue triangle shows infra-red camera position beneath roost access on underside of eastern bridge). Map data © 2020 Google.

An additional pre-dawn re-entry survey of the eastern A1 River Nene Bridge was undertaken on 28 July 2020, using only an infra-red video camera rig positioned to record bats returning to roost via the main roost access point identified on this bridge during a previous survey on 24 July 2020. The purpose of this additional survey was to attempt to obtain a more accurate count of the number of individuals making use of this roost.
