A47 Wansford to Sutton Dualling

Scheme Number: TR010039

6.3 Environmental Statement Appendices **Appendix 13.5 – Geomorphological assessment**

Appendix 13.5 - Geomorphological assessment

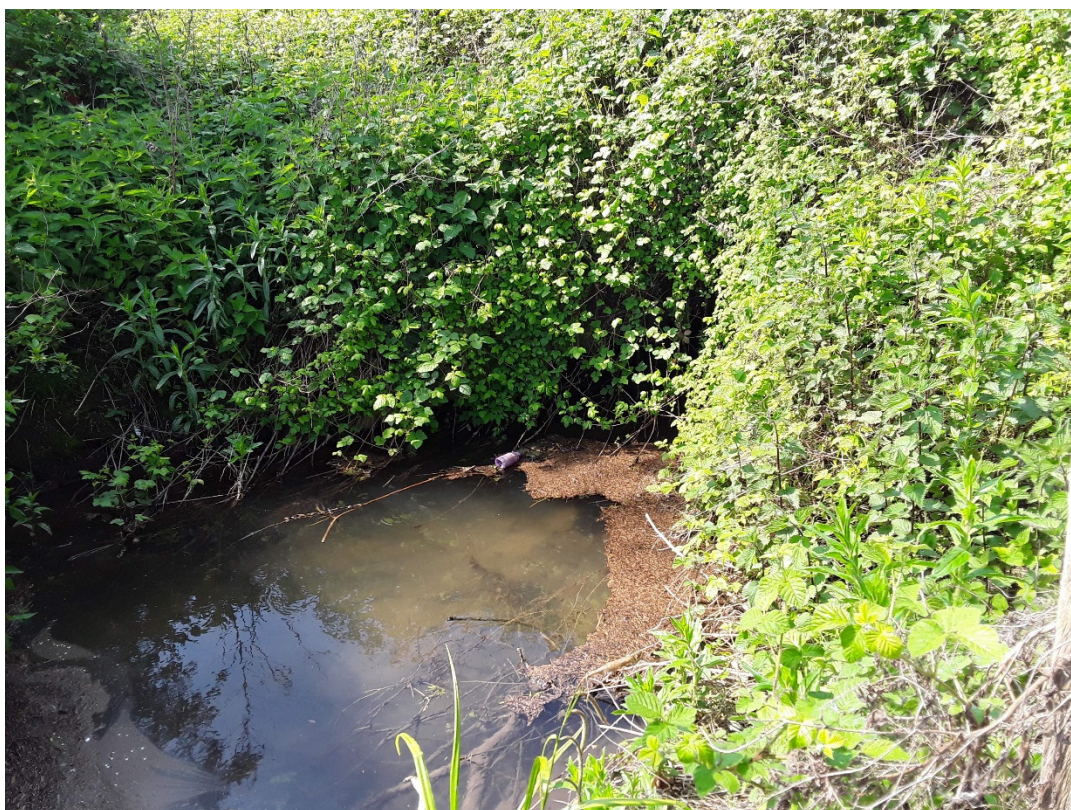
Caption 3.1 - downstream outlet of culvert under A1

- 3.4.3. At the upstream end, the culvert (approximately 2m in width) under the existing A1 road appears to be too small to allow successful conveyance of sediment, as

the downstream end was observed to be very silted up (Caption 3.1). The watercourse has been significantly straightened and over deepened, running for approximately 400m from the culvert until it enters a mill pond next to a historic working mill on Sacrewell Farm (Caption 3.2). The watercourse goes through a series of weirs, and sluices through the farm, maintained as part of the original working mill structures.

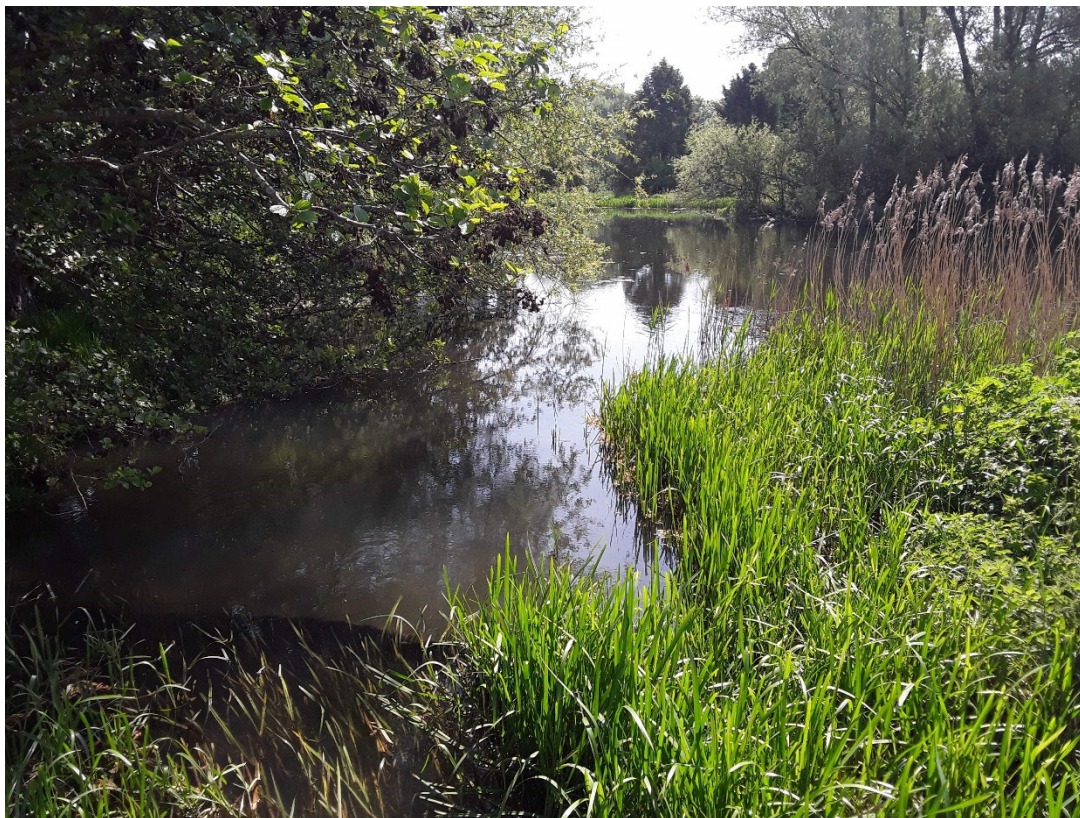
Caption 3.2 - Looking downstream at Sacrewell Farm mill pond.

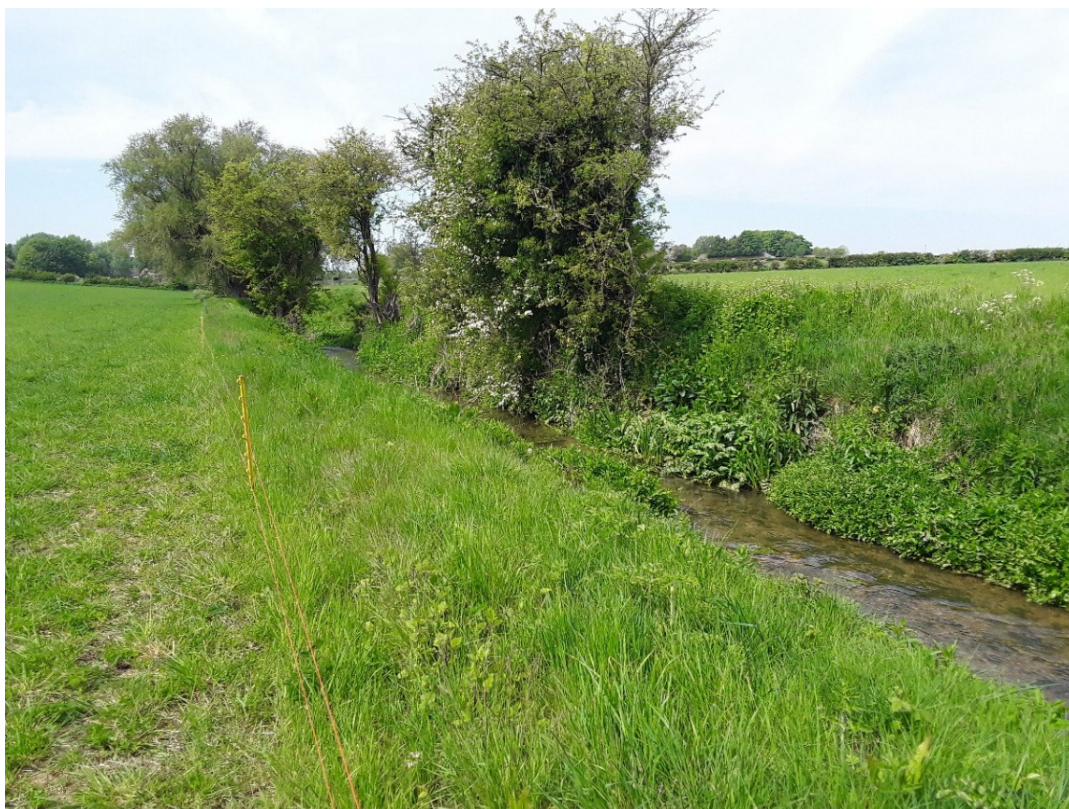
- 3.4.4. Downstream of the mill area, the watercourse continues flowing in an easterly direction through a straightened agricultural channel. This reach, while lacking sinuosity, bank erosion or other features of a natural pool riffle typology, has some evidence of gravel bedforms on the channel bed suggesting a partial recovery (Caption 3.3).
- 3.4.5. The channel turns at a 90 degree angle and flows due south, being met by another drain from the north. The channel continues to be a straightened ditch and becomes significantly over deepened and silted up. Historic mapping suggests that this channel realignment may be due to an old railway line, now dismantled.

Caption 3.3 - Straightened channel downstream of Sacrewell Farm.

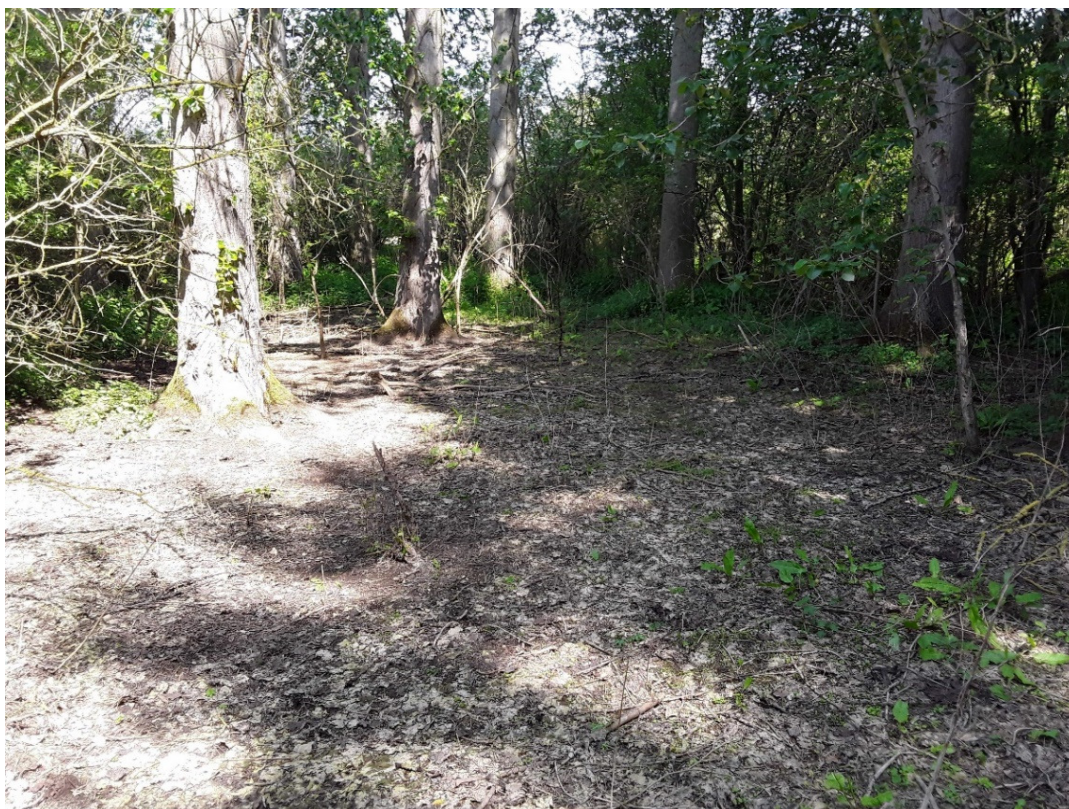
3.4.6. The channel enters a woodland as it approaches the A47, where the channel becomes shallower again. At the time of survey, recent evidence of out-of-bank flow on the right bank was observed (Caption 3.4.)

Caption 3.4 - Floodplain on right bank of channel, recently inundated.

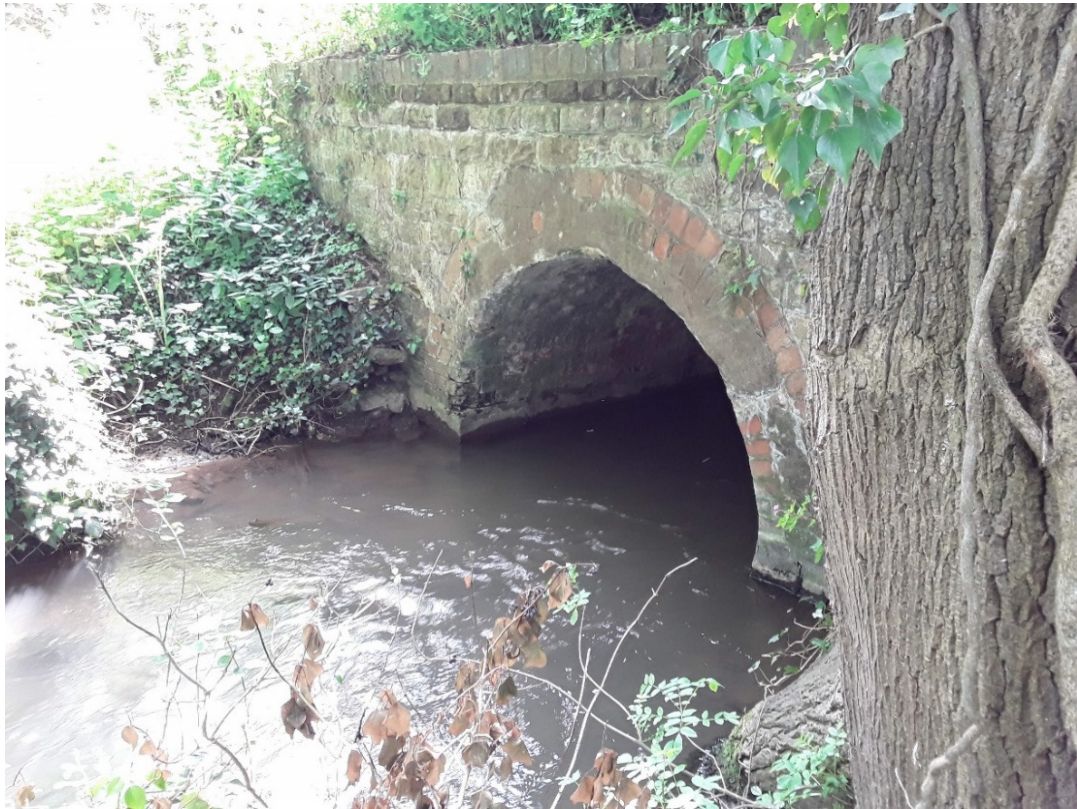
- 3.4.7. The culvert under the A47 is approximately 1.5m in diameter, and appears appropriately sized for the channel, with no blockages noticed (Caption 3.5). Downstream of the culvert, the channel runs in a relatively sinuous course until it reaches its confluence with the River Nene, where the survey ended (Caption 3.6).

Caption 3.5 - Existing culvert under the A47.

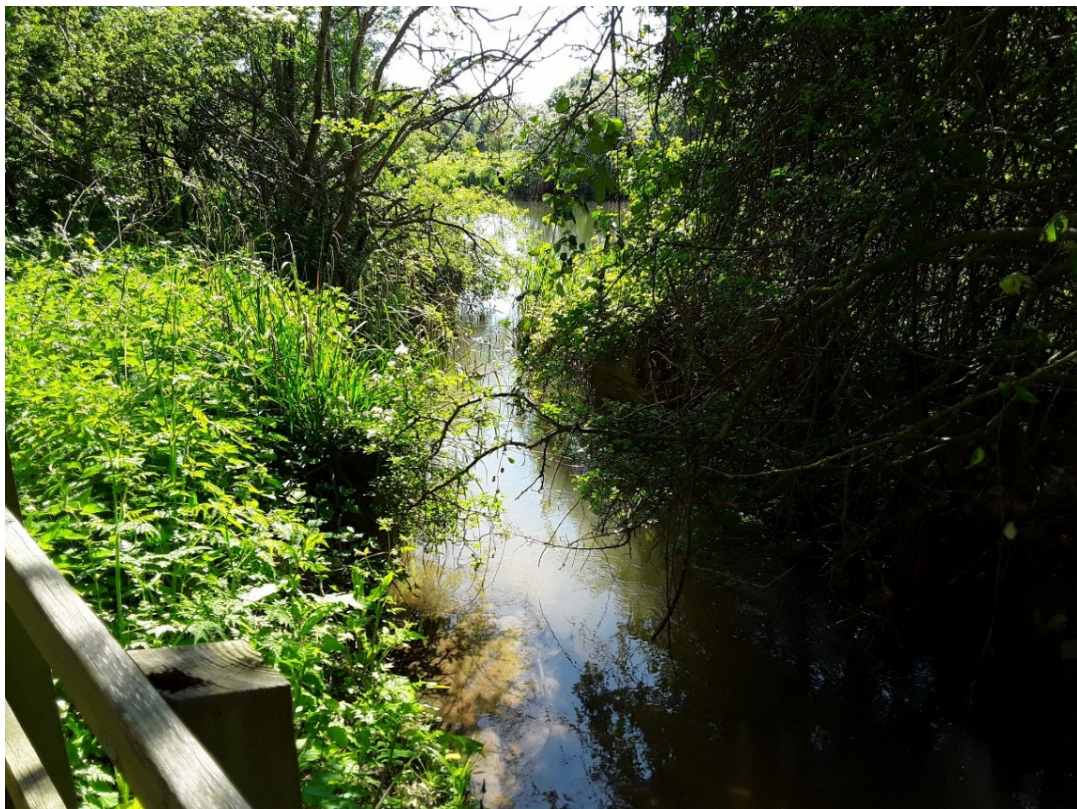
Caption 3.6 - Confluence with the River Nene.
