# A47 Blofield to North Burlingham Dualling

### **Appendix 8.10 – 2020 Bat Survey Report**

A47 Blofield to North Burlingham

# Bat Survey Report

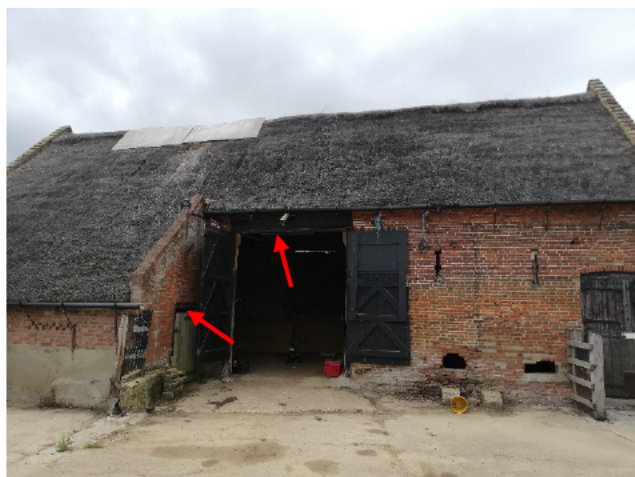
**Photo 1.** Poplar Farm – Suspected brown long-eared roost access/egress locations (barn doors are closed overnight) on east side of large thatched barn.

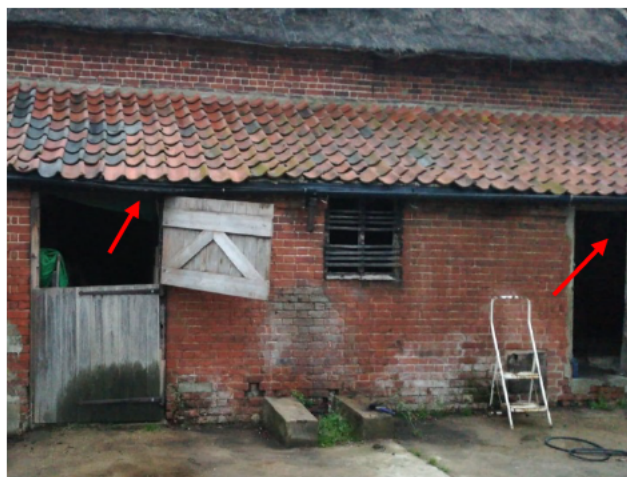
**Photo 2.** Poplar Farm – Common pipistrelle roost access/egress locations in building in north-east corner of courtyard to east of large thatched barn (upper stable door is closed overnight).

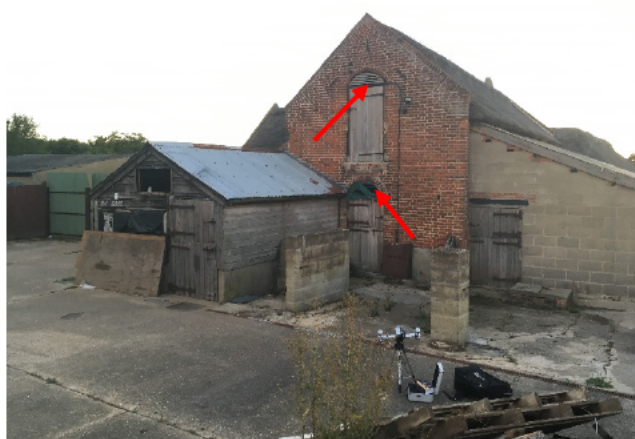
**Photo 3.** Poplar Farm – suspected common pipistrelle access/egress locations on eastern gable of building in north-east corner of courtyard to east of large thatched barn.

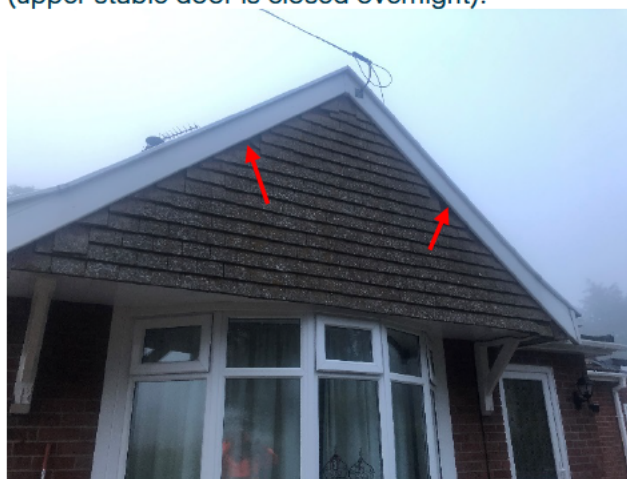
**Photo 4.** The Lindens – Location of common pipistrelle roosts beneath bargeboards on western gable end.

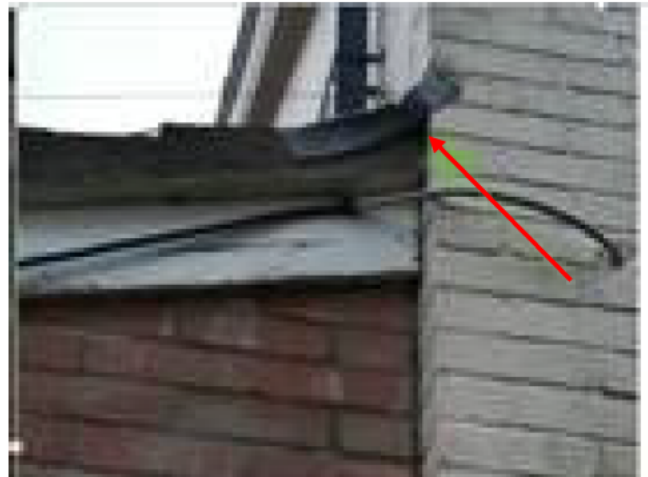
**Photo 6.** Hall Cottages – Location of common pipistrelle roost under lifted lead flashing on southern aspect of single-storey extension to the west of the property.

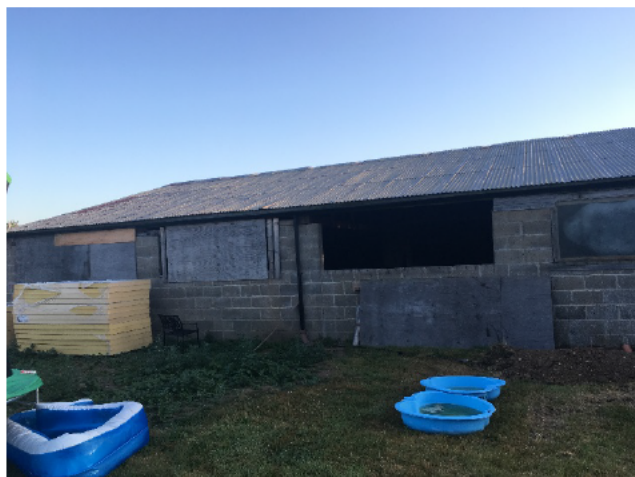
A total of four brown long-eared type droppings were found inside the building during the inspection. Two of these were clearly very old and two were darker and hence more recent, but were not fresh. None of the droppings was located beneath a suitable roosting feature and no insect feeding remains of any kind were found inside the building. The number and location of droppings found inside the building are consistent with rare, opportunistic investigation of the building by brown long-eared bats, which are known to roost in the adjacent buildings to the north.

Given that the building's construction (breeze blocks and corrugated sheet metal roof) is atypical for selection by roosting bats, that there are no obvious internal roosting opportunities, that very little evidence of roosting bats was identified inside the buildings and that brown long-eared bats are known to roost in the far more suitable thatched barn adjacent to the north, it is considered that Mr Durrant's barn does not support a brown long-eared bat roost.

**Photo 7.** Poplar Farm – southern elevation of Mr Durrant's barn showing open window opening and breeze block construction with sheet metal roof.

Mr Durrant's barn, to the south of Poplar Farm, is not considered to support a bat roost. However, given that four brown long-eared type bat droppings were found inside the building, any works to the roof of the building should avoid the period May-September inclusive when bats are active (the building is considered wholly unsuitable for bat hibernation due to the likelihood of fluctuating internal temperatures).

Should this not be feasible, works to the roof should be undertaken under the supervision of a suitably licensed bat ecologist, with a suitable bat box being erected on-site prior to works commencing to receive any bats in the unlikely event that they are found. If bats are found, works will need to cease and an EPS licence be obtained from Natural England.

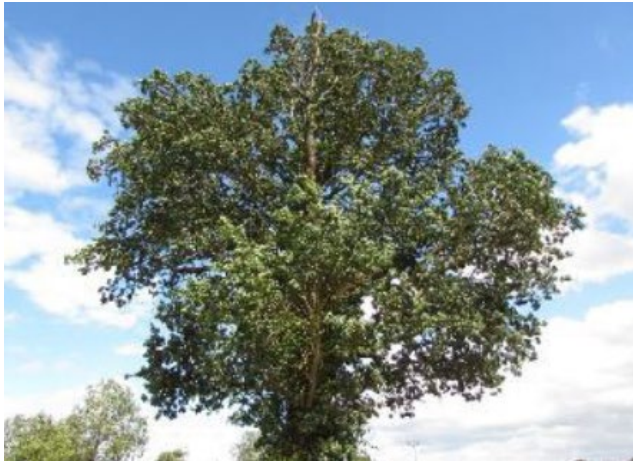
**Photo 7.** Tree T1.

Tree (and survey)	Survey Date (2020)	Description of Roosting Activity	Roosts Identified	Geographic Importance
T1 – E1	12 May	Soprano pipistrelle emerged from behind ivy at 21:21	Soprano pipistrelle day roost (One bat)	Local
T1 – R1	26 May	No re-entry recorded		
T1 – R2	9 June	No re-entry recorded
