A428 Black Cat to Caxton Gibbet improvements

9.24 Borrow Pits Excavation and Restoration Report

Regulation Reference:	Rule 8(1)(k)
Planning Inspectorate Scheme Reference	TR010044
Application Document Reference	TR010044/EXAM/9.24
Author	A428 Black Cat to Caxton Gibbet improvements Project Team, National Highways

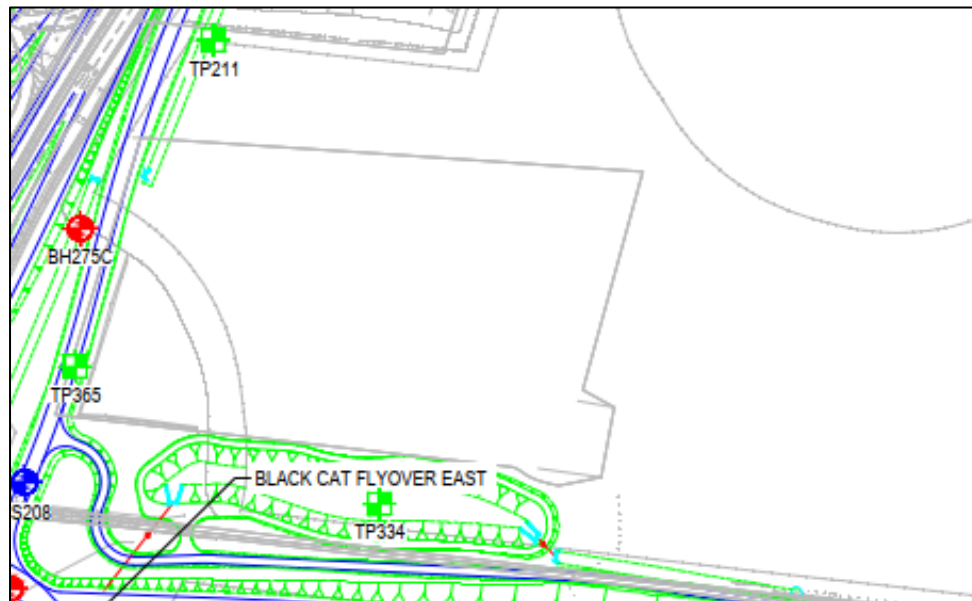
Figure 3-2: Site 14 Ground Investigation Locations

- 3.1.2 There were no trial pits excavated during the ground investigation specifically for this area. However, there is information available from trial pits and boreholes around the location, indicating the likely materials. These are TP211, TP334, TP365, BH275C and WS208. Please refer to the Appendices for details on the investigations undertaken.
- 3.1.3 The geology beneath this site comprises Made Ground over River Terrace Deposits. The Made Ground is assessed as possibly reworked quarry backfill. These overlie the Glacial Till (Oadby formation), with BH275C showing that the Oxford Clay Formation is located below the Glacial Till, which overlies the Kellaways Beds/Cornbrash at a depth of around 21.5m.

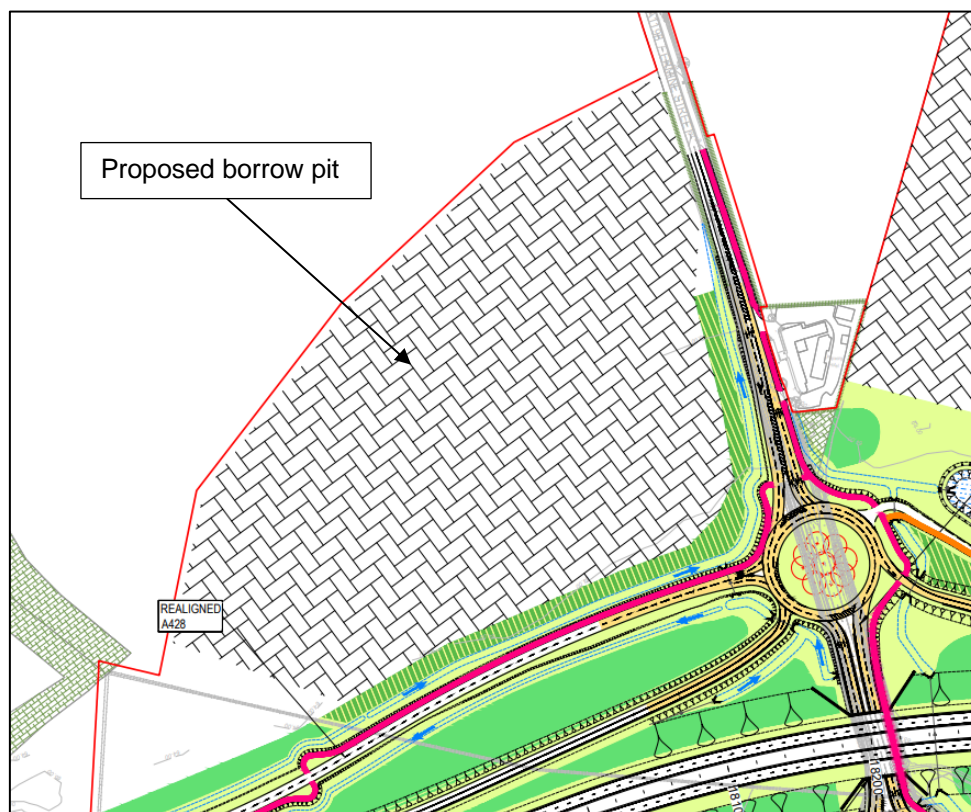
Figure 4-1: Site 3 Location Plan

- 4.1.1 The site (**Figure 4-1**) is situated on the land immediately west of the A1198 (Ermine Street) and north of the existing A428 (Cambridge Road). The site is approximately 14.8ha (148000m²) in size and located on ALC Grade 2 land.

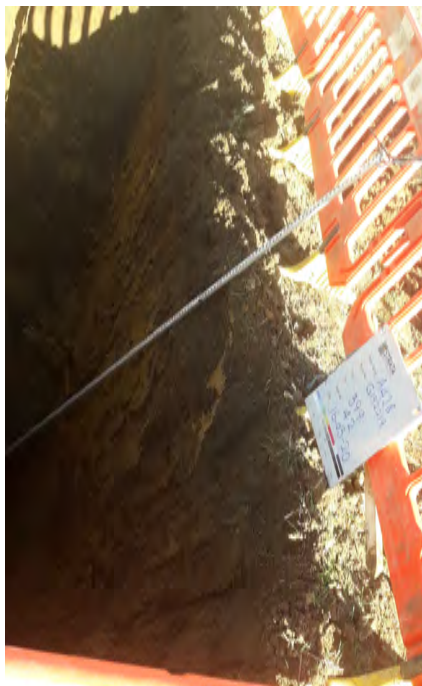
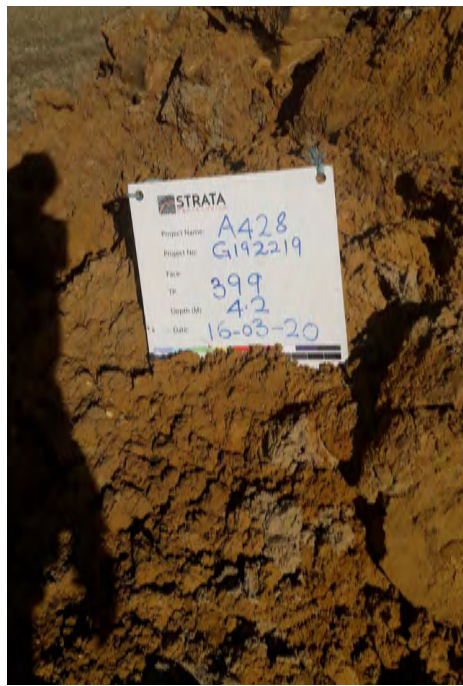
Trial Pit Photographs/Sketches

2.00 - 3.00	B3							
3.00	D5			3.00		Dense yellowish brown silty SAND. Sand is fine. [Glacial Till]	3	▼
3.00 - 4.00	B4			(1.20)				
4.00	D6			4.20		End of Trial Pit at 4.200m	4	
							5

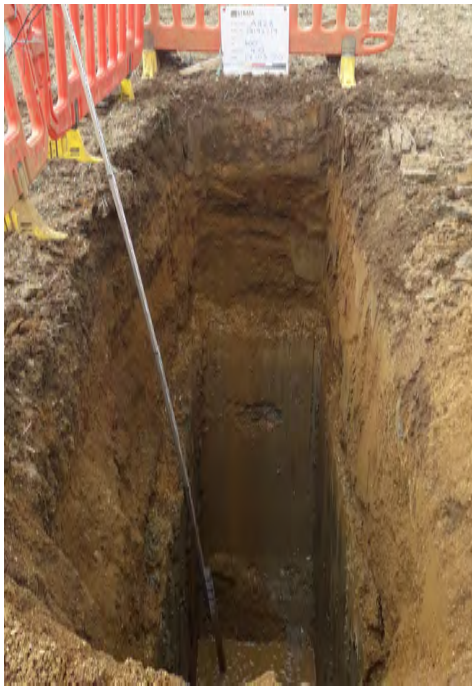
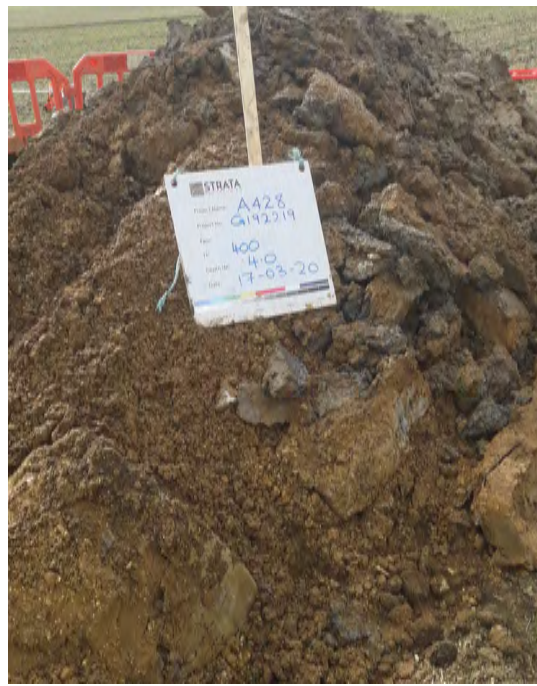
Trial Pit Photographs/Sketches

Logged from arisings due to exclusion zone restrictions.
Groundwater was encountered at 3.0 during excavation.
Limited hand shear vanes undertaken due to gravelly conditions
Backfilled upon completion using arisings

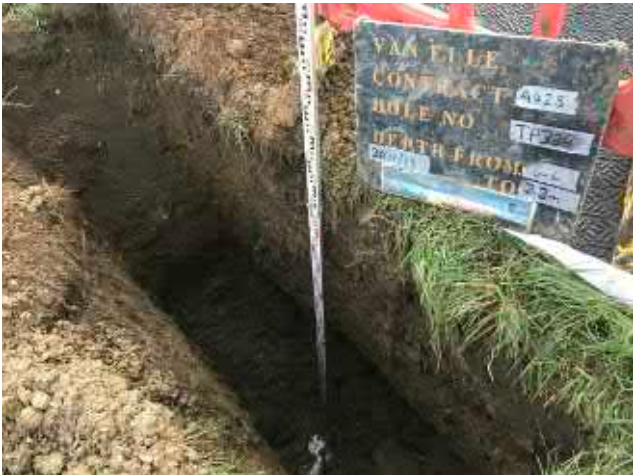
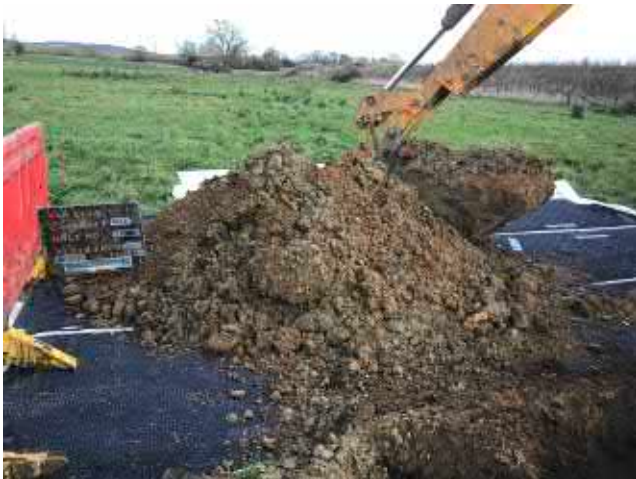
Trial Pit Photographs/Sketches

2.10 - 2.20	B6		17.43	2.10		[Made Ground]
2.20	D7		17.33	2.20		Orangish brown clayey SAND & GRAVEL. Sand is fine to coarse. Gravel is subangular to rounded fine to coarse of flint. [River Terrace Deposits]
						End of Trial Pit at 2.200m

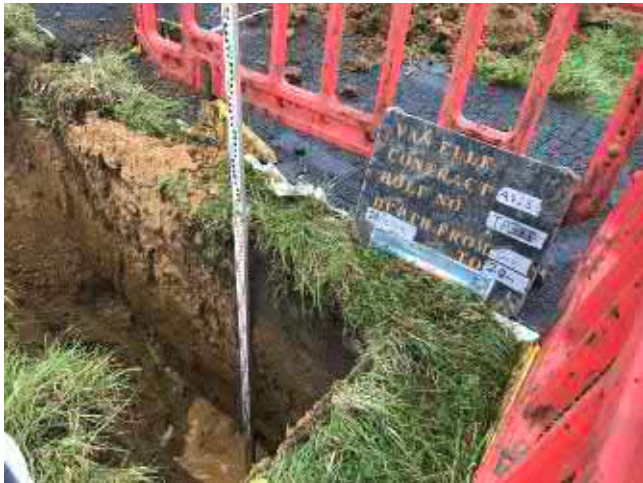
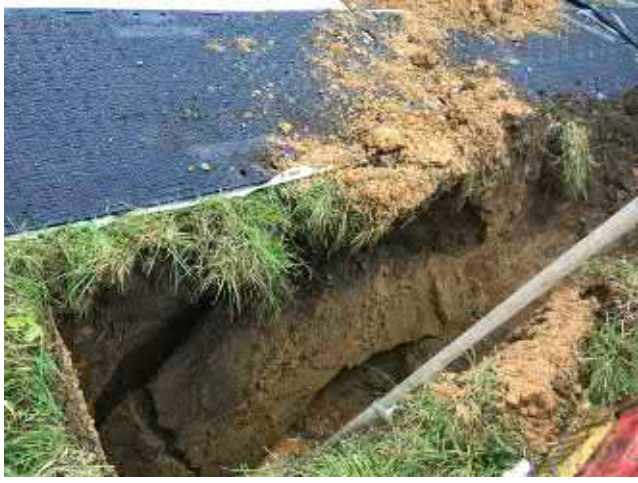
Trial Pit Photographs/Sketches

Logged from arisings due to exclusion zone restrictions.
Groundwater encountered at 1.5m during excavation, rising to 1.4m after 5mins.
Limited shear vanes done due to granular ground conditions.
Backfilled upon completion using arisings.

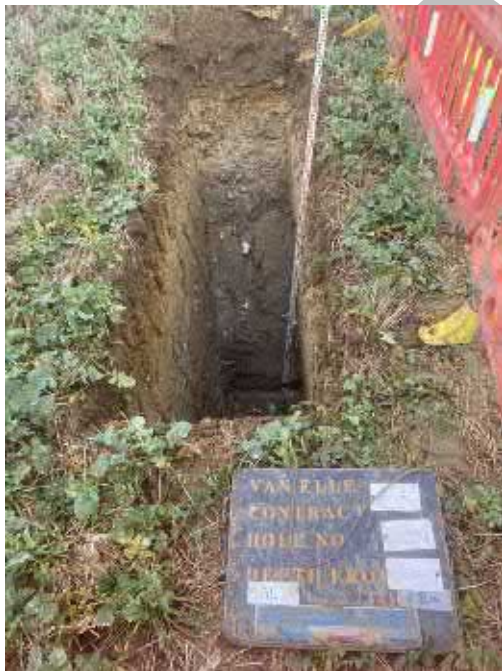
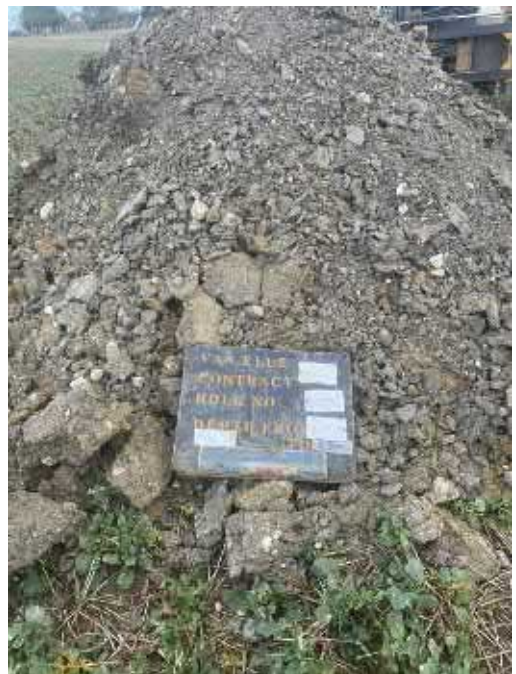
Trial Pit Photographs/Sketches

3.00 - 3.00: 4no. small rounded limestone boulders (<300mm) encountered.		3	
						End of Trial Pit at 3.300m			
								4	
								5

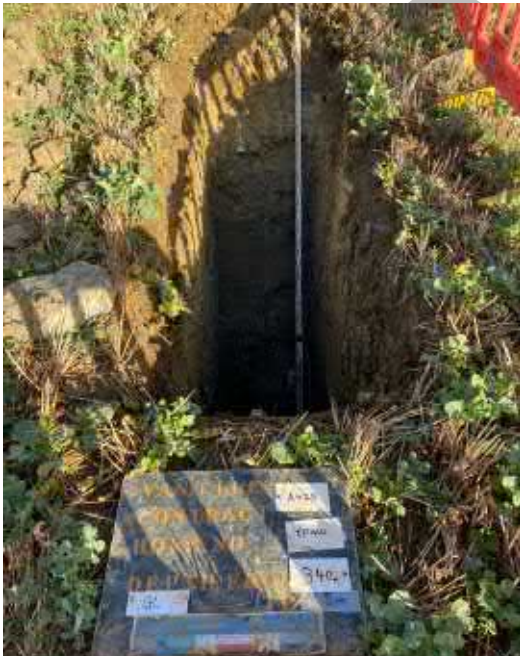
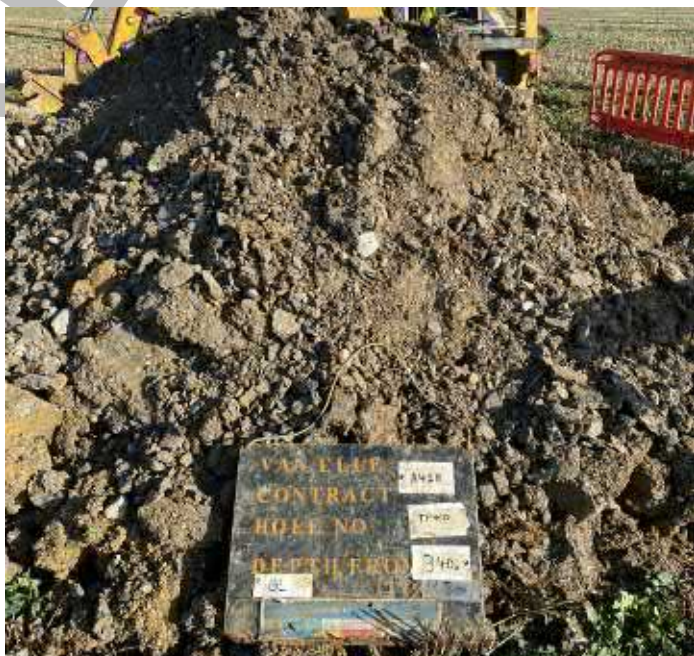
Trial Pit Photographs/Sketches

Logged from arisings due to exclusion zone restrictions.
No groundwater encountered during excavation.
Residual strength could not be undertaken or crumbled during testing shown as 0
Limited shear vanes undertaken due to gravelly ground conditions
Backfilled upon completion using arisings.

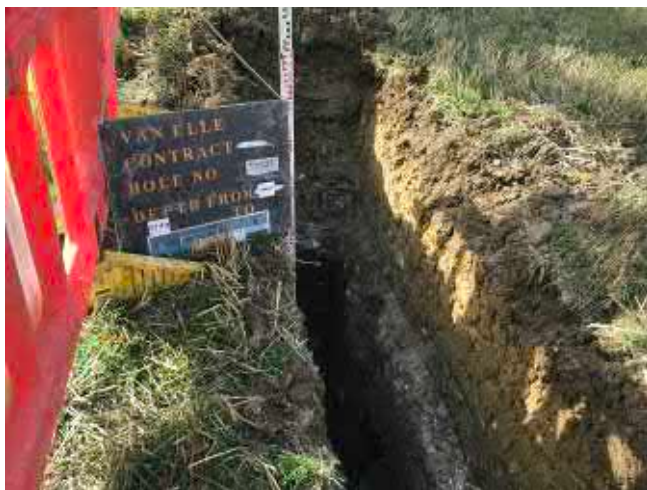
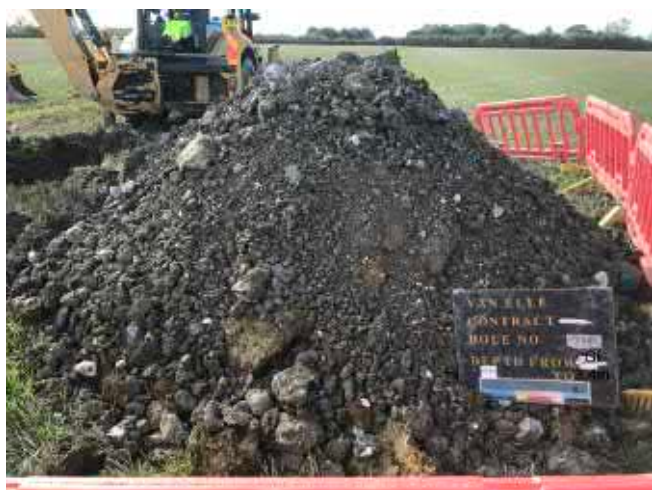
Trial Pit Photographs/Sketches

Logged from arisings due to exclusion zone restrictions.
No groundwater encountered during excavation.
Limited shear vanes undertaken due to gravelly ground conditions
Backfilled upon completion using arisings.

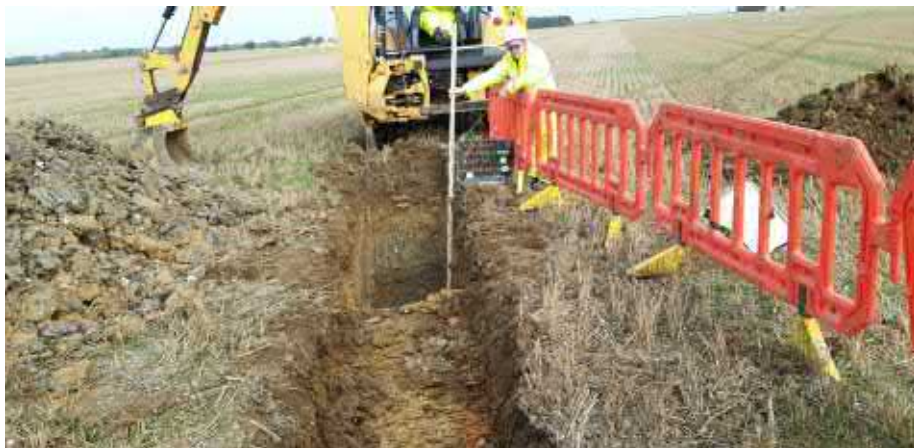
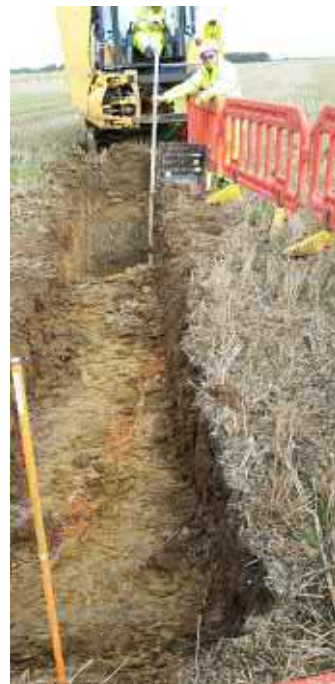
Trial Pit Photographs/Sketches

Dimensions of Trial Pit: Final Depth: 2.50m <div> <div> <div>←</div> <div>Length (m) 6.80m</div> <div>→</div> </div> <div> <div>↑</div> <div>Width (m) 0.75m</div> <div>↓</div> </div> <div> <div>Orientation: 000°</div> <div>←</div> </div> </div>				Remarks: Logged from arisings due to exclusion zone restrictions. Residual strength could not be undertaken or crumbled during testing shown as 0 No groundwater encountered during excavation Backfilled upon completion using arisings.			
				Water Strike			
Strike	Time (mins)	Rose to (m)	Remarks

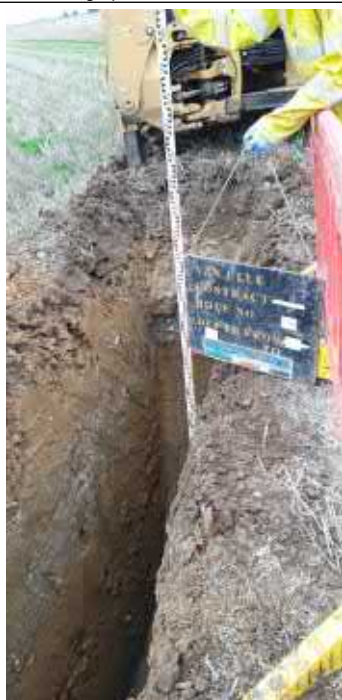
Dimensions of Trial Pit: Final Depth: 3.20m <div style="text-align: center; margin-top: 20px;"> <p style="margin: 0;">Length (m) 6.50m</p> <p style="margin: 0;">Width (m) 0.75m</p> <p style="margin: 0;">Orientation: 050°</p> </div> Inclination: 90°		Remarks: Logged from arisings due to exclusion zone restrictions. Land drain at 0.7m, trial pit extended. Residual strength could not be undertaken or crumbled during testing shown as 0 Limited shear vanes undertaken due to gravelly ground conditions No groundwater encountered during excavation. Backfilled upon completion using arisings.
--	--	--

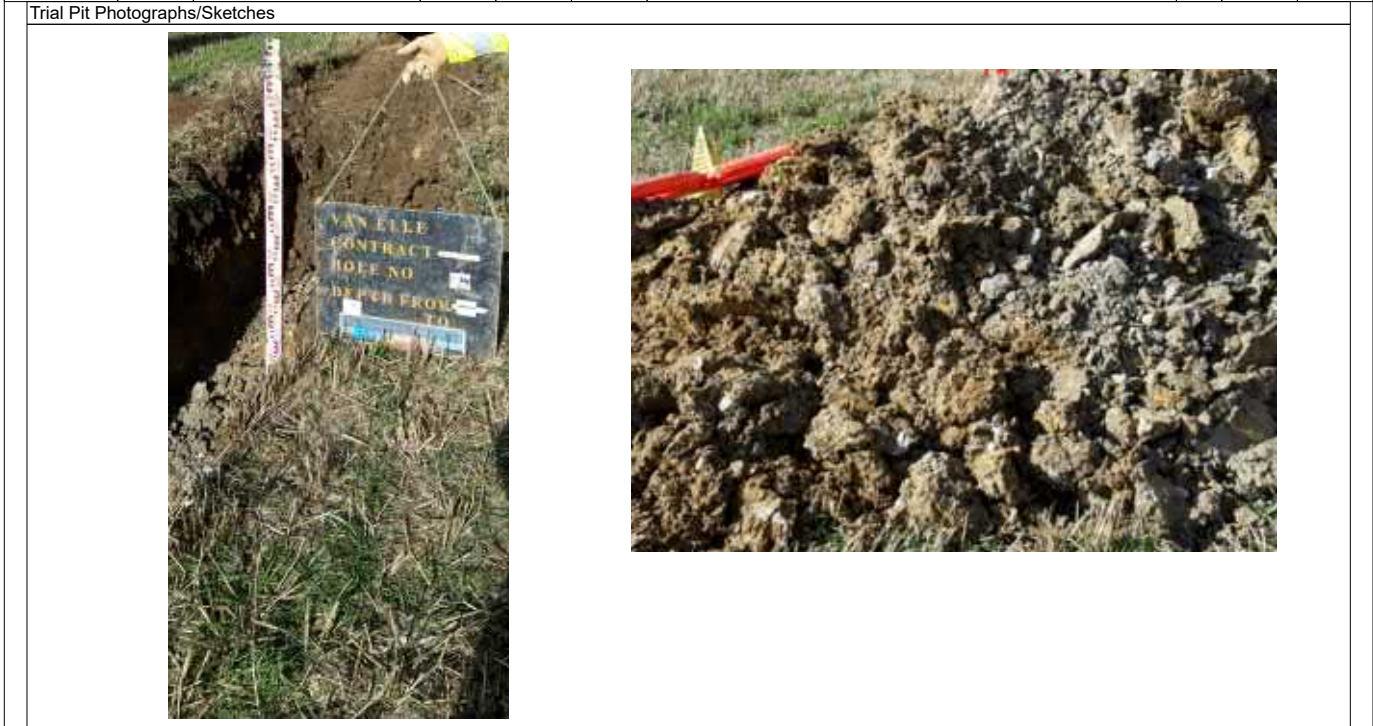
Dimensions of Trial Pit: Final Depth: 1.10m		Remarks: Logged from arisings due to exclusion zone restrictions. Residual strength could not be undertaken or crumbled during testing shown as 0 No groundwater encountered during excavation. Backfilled upon completion using arisings.
