# **A1 in Northumberland: Morpeth to Ellingham**

**Scheme Number: TR010041**

## **6.7 Environmental Statement – Appendix 7.5 Arboricultural Report**

**APPENDIX 7.5: ARBORICULTURAL REPORT**

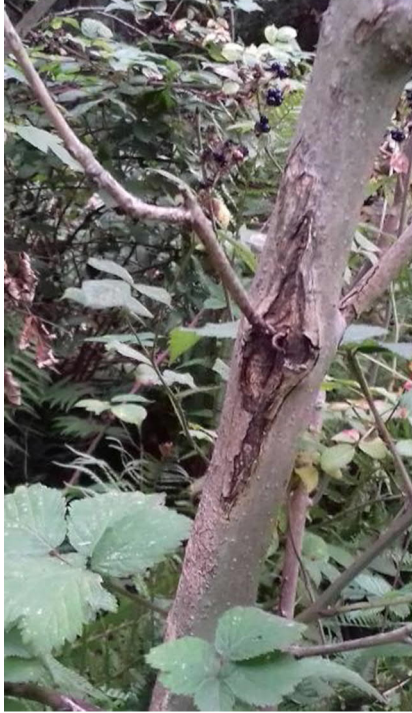
**Figure 2 Diamond Lesion**

- 5.1.3. A sign is taken to be a positive identification of a disease such as a fruiting body, whereas a symptom is a visual cue expressed by the host plant such as dead leaves or decay.

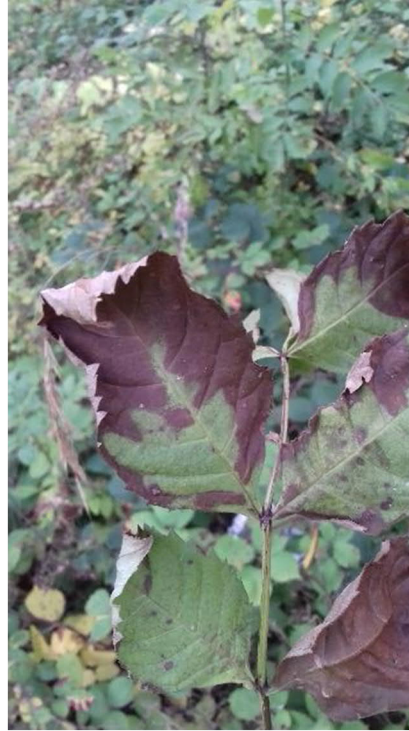
**Figure 4 Probable infected leaves**

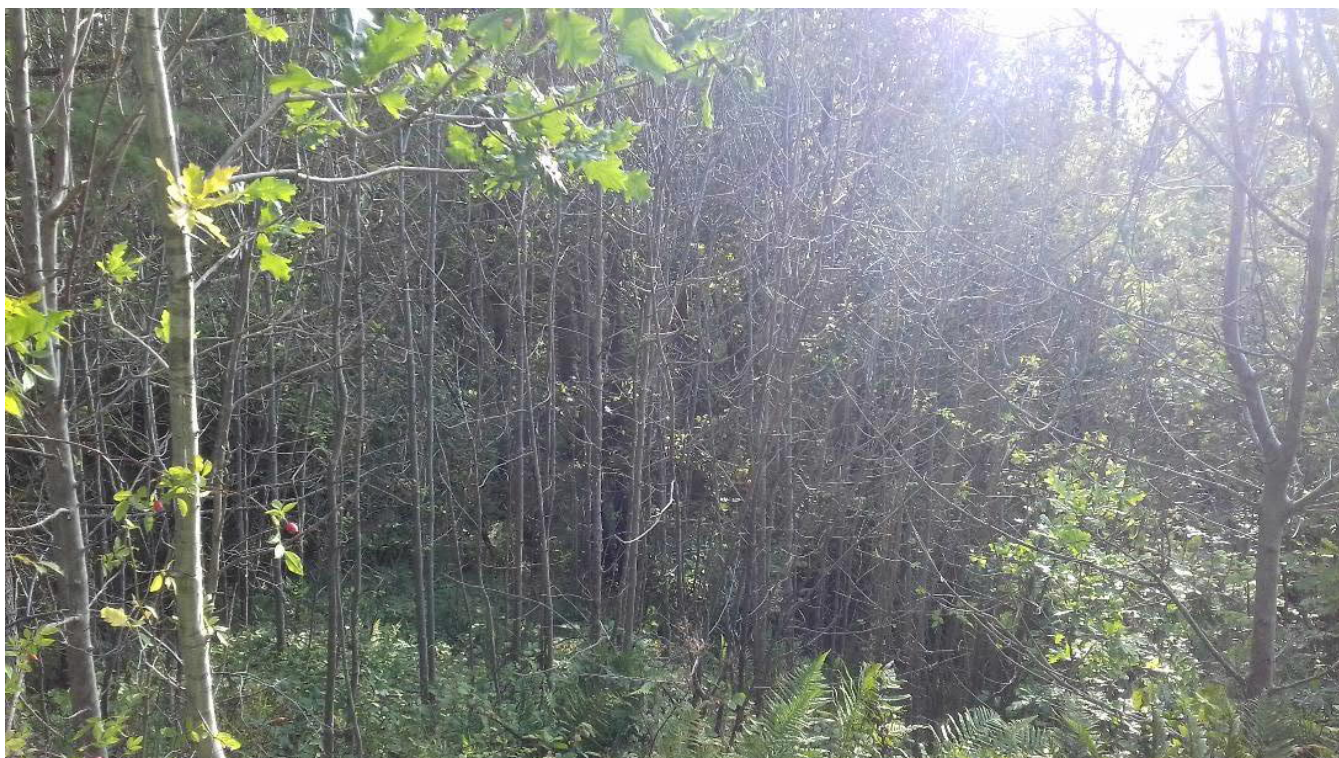
**Figure 8 Dead and Dying Ash Regeneration in North East Stand.**
