A1 in Northumberland: Morpeth to Ellingham

Scheme Number: TR010041

6.7 Environmental Statement – Appendix 9.7 Bat Roost Potential Survey Report 2017

Bat Roost Potential Survey Report 2017

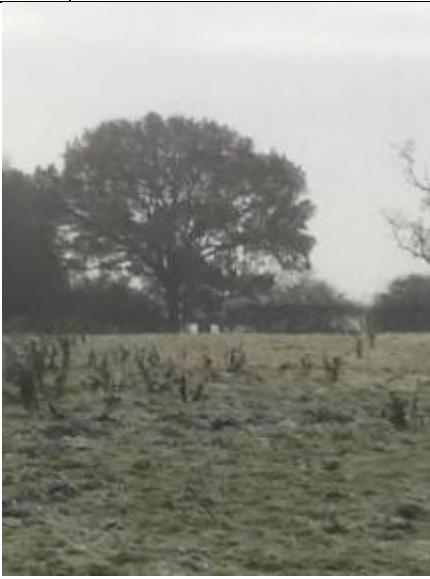
A1 Ecological Inspection of Trees and Woodlands			
SITE DETAILS			
Project Name:	A1 in Northumberland	Project Number:	B2104700
Site Name (if different):	Section A	Date of Inspection:	21 st -23 rd March 2016; 17 th – 19 th August 2016; 5 th – 6 th December 2016
Tree 1A Low bat roost potential

Description	Grid reference: NZ 18174 88257 Mature ash, approximately 15 m high and 1 m diameter at breast height.	
	Limitations	Restricted access due to the presence of horses in the field. The tree could not be fully assessed from one side.	
	Bat evidence	None recorded.

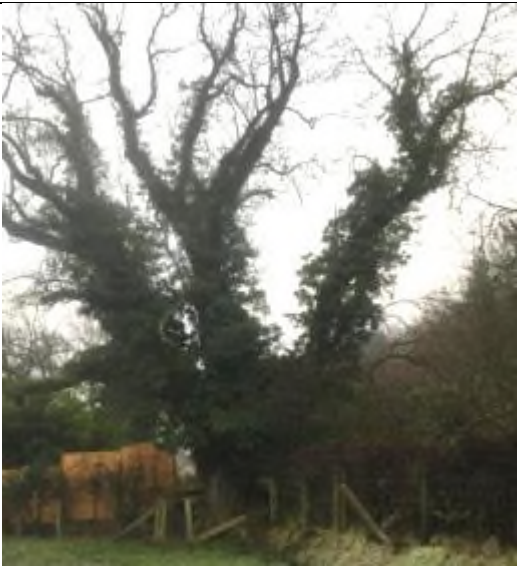
Tree 2A Moderate bat roost potential

Description	Grid reference: NZ 18162 88668 Mature ash, approximately 11 m high and 0.93 m diameter at breast height, with thick ivy coverage which was itself a potential bat roost feature and could have hidden other potential features.
	Limitations	None recorded.
	Bat evidence	None recorded.
Tree 3A Low bat roost potential

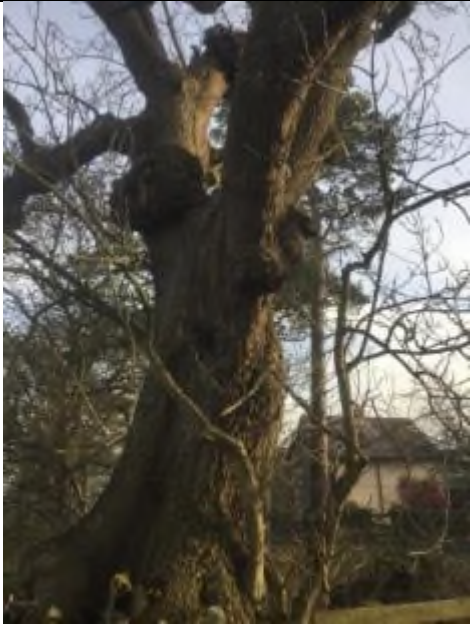
Description	Grid reference: NZ 18071 89681 Mature ash, approximately 14 m tall with a diameter at breast height of 1 m. Many dead and cut branches were present.
	Limitations	None recorded.
	Bat evidence	None recorded.
Tree 4A Low bat roost potential

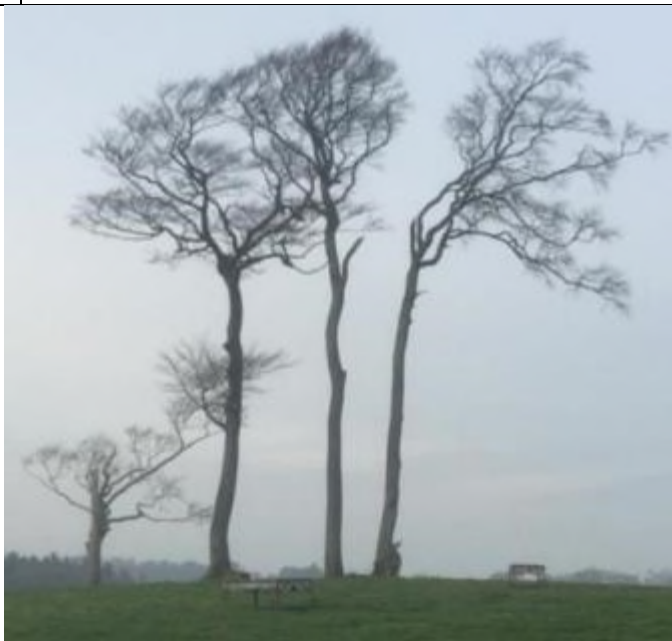
Description	Grid reference: NZ 18256 89956 Four mature beech trees, three were approximately 20 m high and 0.5 m diameter at breast height and one was approximately 5 m high and 0.5 m diameter at breast height. The smaller tree featured a large hole within a dead branch.
	Limitations	None recorded.
	Bat evidence	None recorded.

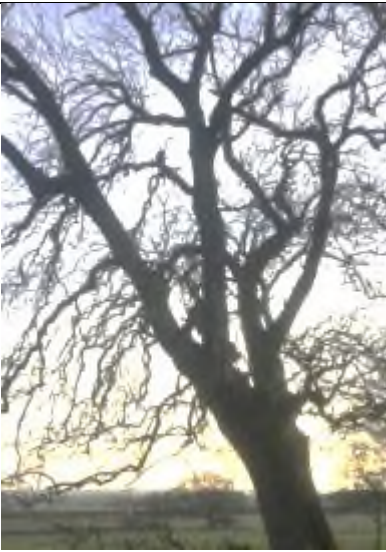
Tree 5A High bat roost potential

Description	Grid reference: NZ 18974 90119 Mature ash, approximately 16 m high and 1.06 m diameter at breast height, with three woodpecker holes, and dead and split branches. Knot holes were also present.
	Limitations	None recorded.
	Bat evidence	None recorded.
Tree 6A Moderate bat roost potential

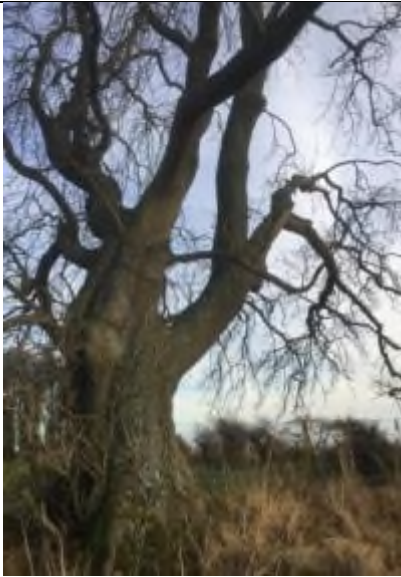
Description	Grid reference: NZ 18796 90161, in a line of trees with two negligible trees either side.

Mature ash, approximately 16 m high and 0.93 m diameter at breast height, with many rot holes, cavities in the bark and split branches.
	Limitations	None recorded.
	Bat evidence	None recorded.
Tree 7A Low bat roost potential

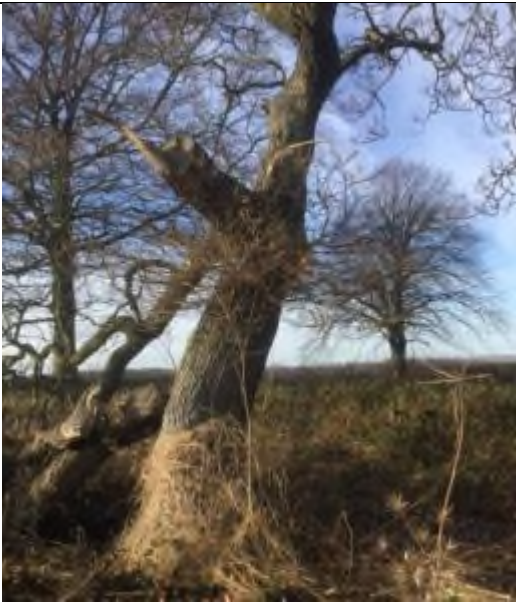
Tree 8A Low bat roost potential

Description	Grid reference: NZ 18555 90605 Dead oak, approximately 7 m high and 0.56 m diameter at breast height. Tree had dead branches arising from branch removal with an impact shattered limb. Rot holes were present in the trunk and on branches.
	Limitations	None recorded.
	Bat evidence	The features were investigated using an endoscope and no bat evidence was found.
Tree 9A Low bat roost potential

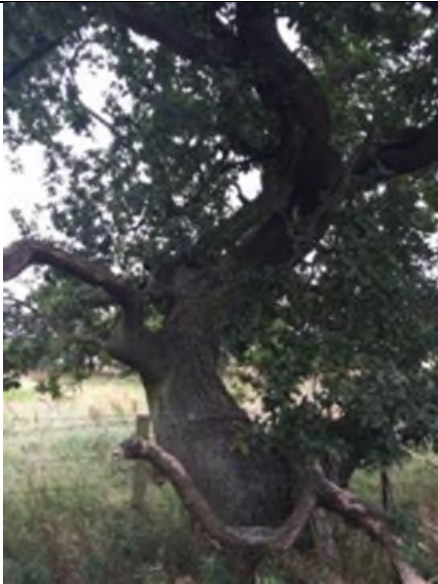
Description	Grid reference: NZ 18646 90888 Three mature oak trees approximately 10 m high and 1.4 m diameter at breast height. Split limbs, cracks in limbs and occasional lifted bark were observed. Tree was well connected to woodland and treeline to the east.
	Limitations	None recorded.
	Bat evidence	None recorded.
Tree 10A Low bat roost potential

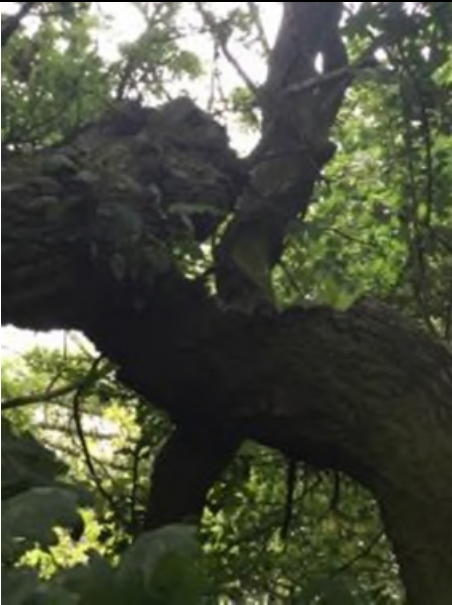
Description	Grid reference: NZ 18590 90908 Three oak trees were present within a 10 m area. One mature and two semi-mature, approximately 9 m high and 1 m diameter at breast height on average. A large split and smaller splits with further potential unseen entrances. There was good connecting habitat.
	Limitations	None recorded.
	Bat evidence	None recorded.

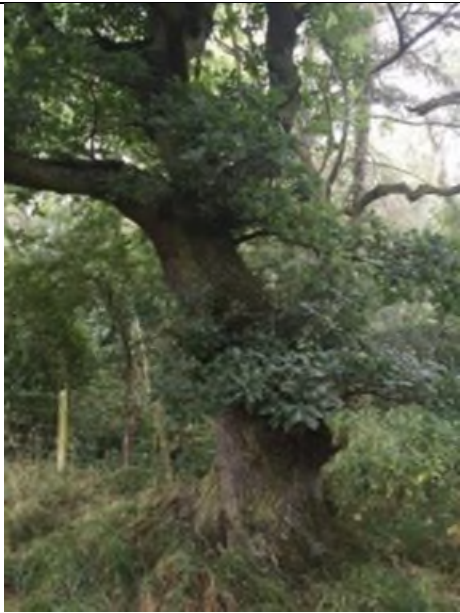
Tree 11A Low bat roost potential

Description	<p>Grid reference: NZ 18623 90908</p> <p>Two mature oaks adjacent to Tree 12A, approximately 10 m high and 1.2 m diameter at breast height. Some splits and lifted bark were observed. Survey required as these are unmanaged trees with large limbs near good connecting woodland habitat.</p>
	Limitations	None recorded.
	Bat evidence	None recorded.

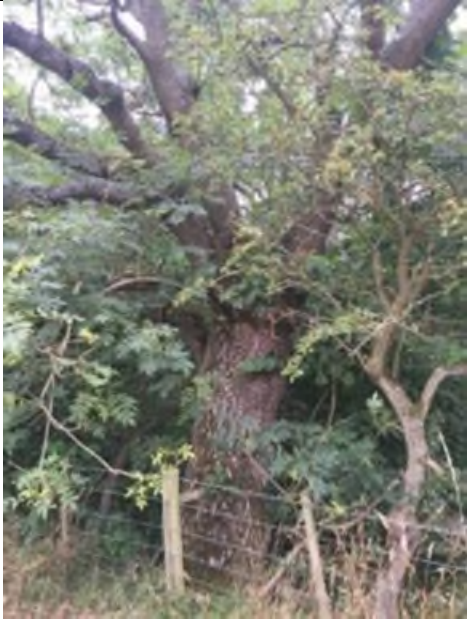
Tree 12A Low bat roost potential

Description	<p>Grid reference: NZ 18623 90908</p> <p>A mature ash adjacent to Tree 11A, approximately 9 m high and 1 m diameter at breast height. Five small callous rolls, three small splits, and one large split were observed. Woodland edge had good connecting habitat and was south-facing.</p>
	Limitations	None recorded.
	Bat evidence	None recorded.

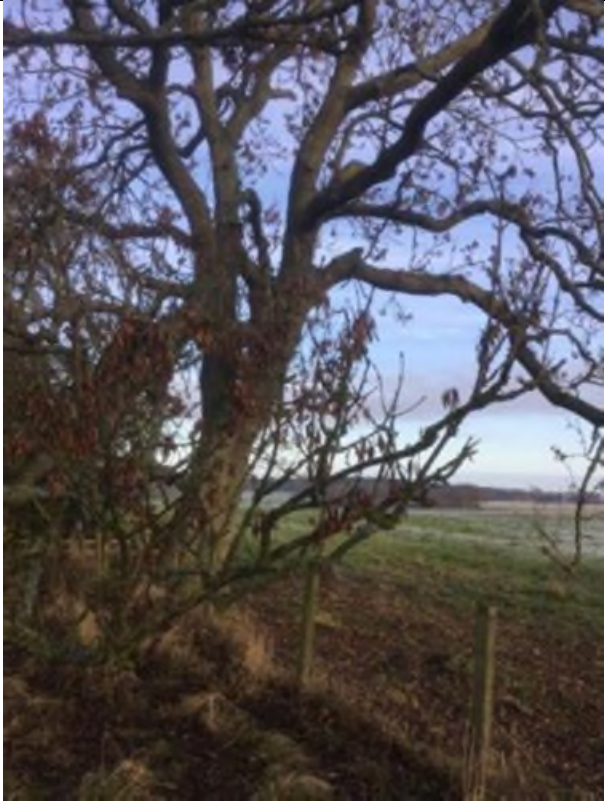
<p>Tree 13A</p> <p>Moderate bat roost potential</p>

Description	<p>Grid reference: NZ 18646 90913</p> <p>Mature ash, approximately 10 m high and 1 m diameter at breast height, with a woodpecker hole, split branch, dead branches and knot holes.</p>
	Limitations	None recorded.
	Bat evidence	None recorded.

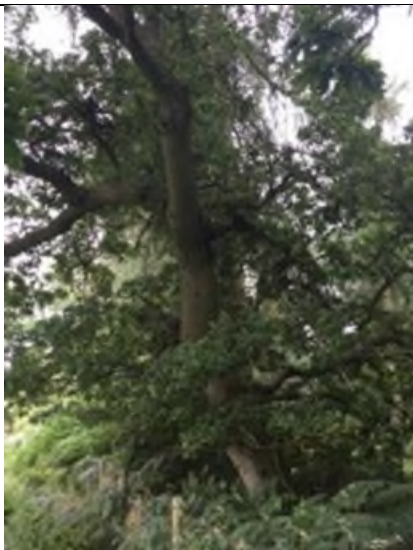
Tree 14A Low bat roost potential

Description	Grid reference: NZ 18648 90957 Two semi-mature oak trees approximately 10 m high with a diameter at breast height of 0.8 m. Small holes and splits were observed. The trees were 10 m apart.
	Limitations	None recorded.
	Bat evidence	None recorded.
Tree 15A Low bat roost potential

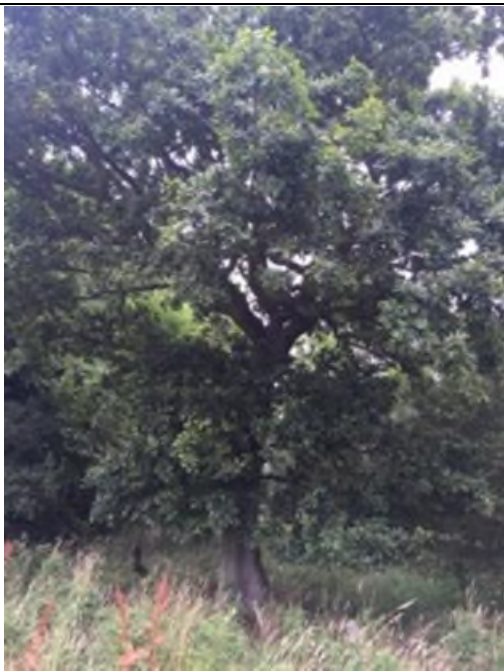
Description	Grid reference: NZ 18418 91265 A semi-mature oak tree approximately 10 m high with a diameter at breast height of 0.6 m. One small split was visible.
	Limitations	None recorded.
	Bat evidence	None recorded.
Tree 16A Moderate bat roost potential

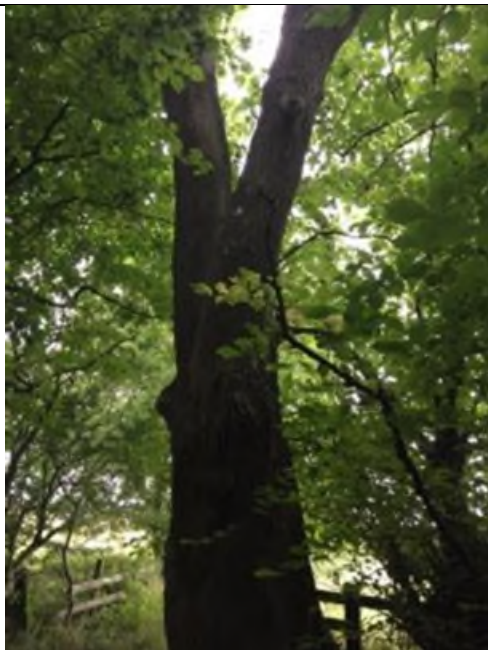
Description	Grid reference: NZ 18486 91266 A mature ash tree approximately 15 m high with a diameter at breast height of 1.5 m. Medium sized holes, splits and occasional lifted bark were observed. The tree was located on the woodland edge.
	Limitations	None recorded.
	Bat evidence	None recorded.

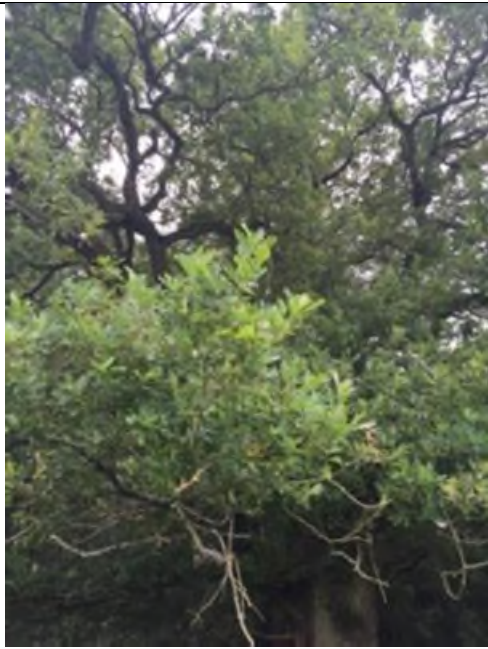
Tree 17A Low bat roost potential

Description	<p>Grid reference: NZ 18577 91264</p> <p>A mature oak with a diameter breast height of 0.9 m. A dead and hollow branch was observed, also some lifted bark and occasional splits and small holes. The tree was well connected on woodland edge.</p>
	Limitations	None recorded.
	Bat evidence	None recorded.
Tree 18A Low bat roost potential

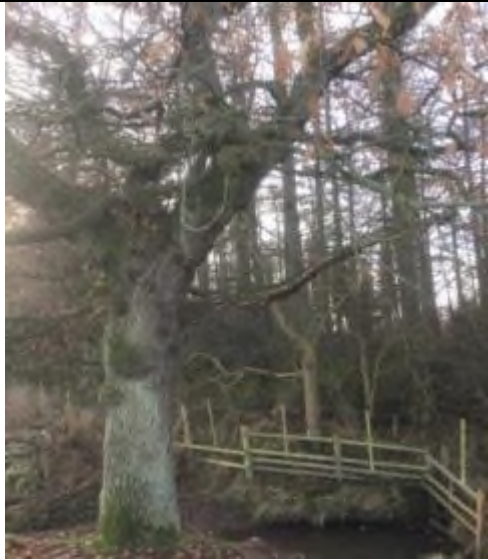
Description	Grid reference: NZ 18579 91269 A mature oak, approximately 10 m high with a diameter at breast height of 1 m. Dead branches, rot holes and split bark were present. The tree was located on a woodland edge.
	Limitations	None recorded.
	Bat evidence	None recorded.
Tree 19A Low bat roost potential

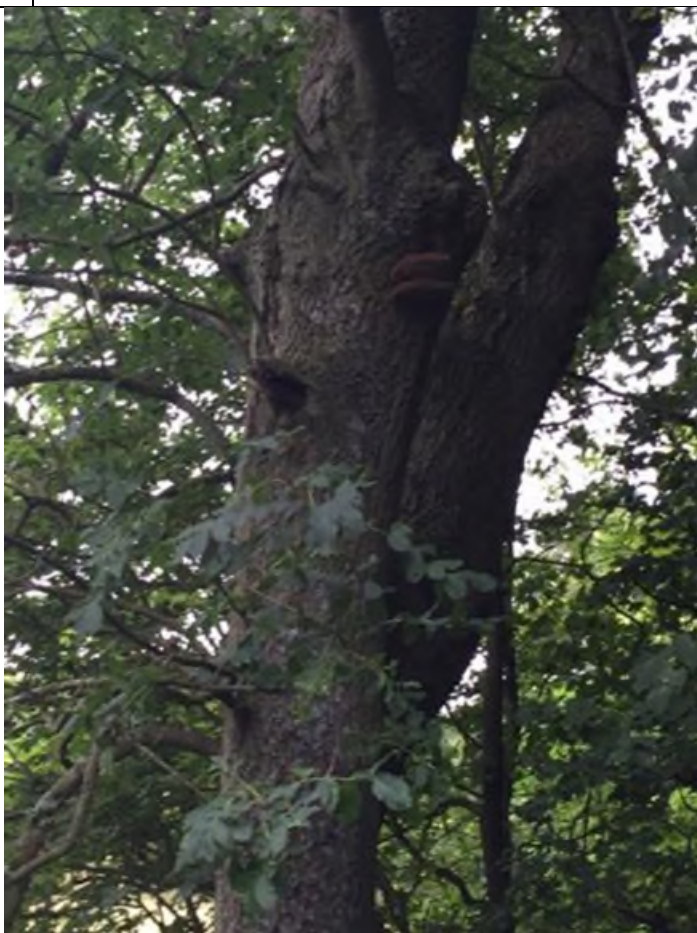
Description	Grid reference: NZ 18475 91288 A mature ash tree approximately 12 m high with a diameter at breast height of 1.2 m. Tree had fissures and lifted bark.
	Limitations	None recorded.
	Bat evidence	None recorded.

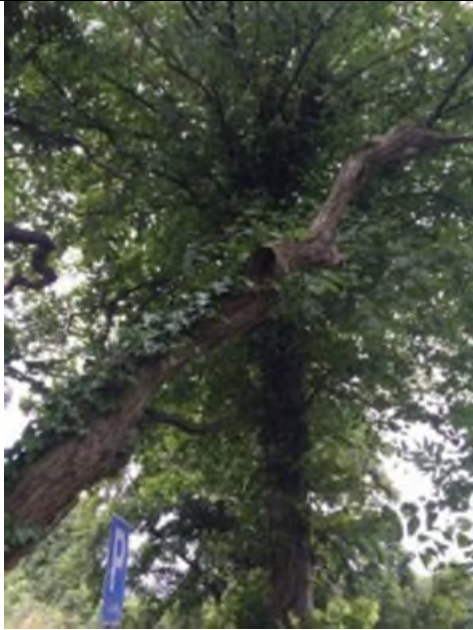
Tree 20A Low bat roost potential

Description	Grid reference: NZ 18547 91312 Two semi-mature oak trees; 9 m high and 6 m high with a diameter at breast height of 0.7 m and 0.6 m respectively. Ivy covered the tree. Small holes and splits, and some lifted bark were also observed.
	Limitations	None recorded.
	Bat evidence	None recorded.
Tree 21A Low bat roost potential

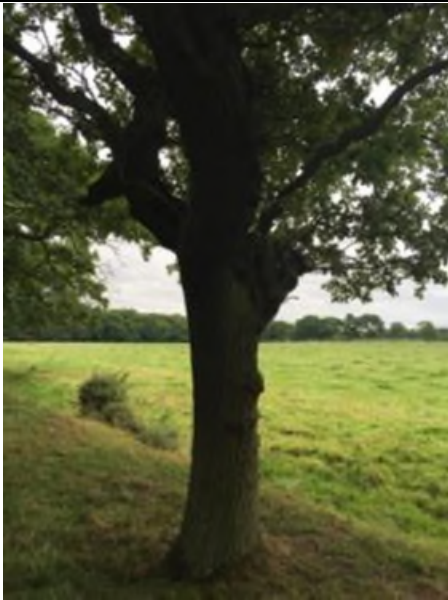
Description	Grid reference: NZ 18550 91320 A semi-mature oak tree approximately 7 m high with a diameter at breast height of 0.6 m. Small holes, splits, and some lifted bark was observed. A dead limb was also present.
	Limitations	None recorded.
	Bat evidence	None recorded.
Tree 22A Low bat roost potential

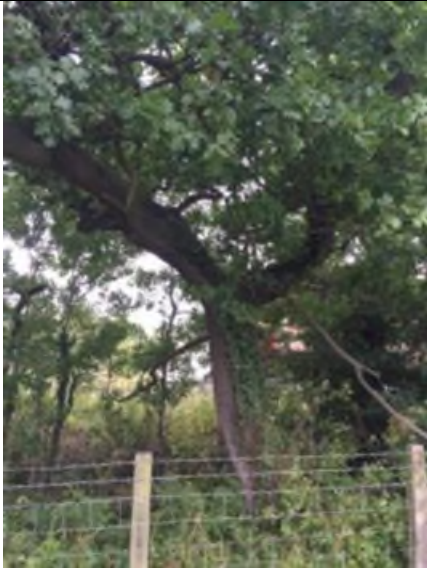
Description	Grid reference: NZ 18549 91326 A semi-mature oak tree approximately 7 m high with a diameter at breast height of 0.7 m. The tree had ivy covering small splits and holes and small dead limbs.
	Limitations	None recorded.
	Bat evidence	None recorded.

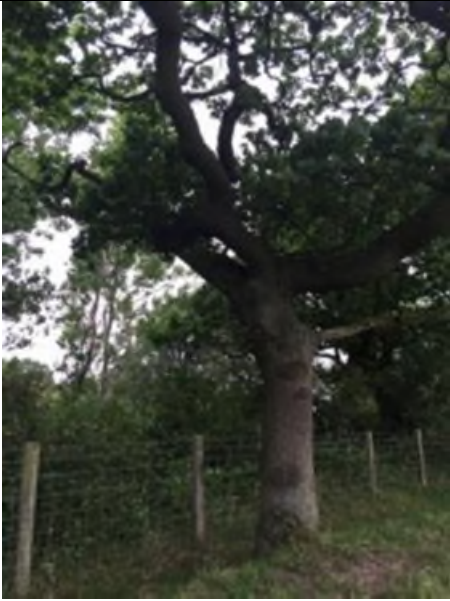
Tree 23A Low bat roost potential

Description	Grid reference: NZ 18548 91331 A semi-mature oak tree approximately 6 m high with a diameter at breast height of 0.6 m. Medium sized splits with occasional holes were observed.
	Limitations	None recorded.
	Bat evidence	None recorded.
Tree 24A Low bat roost potential

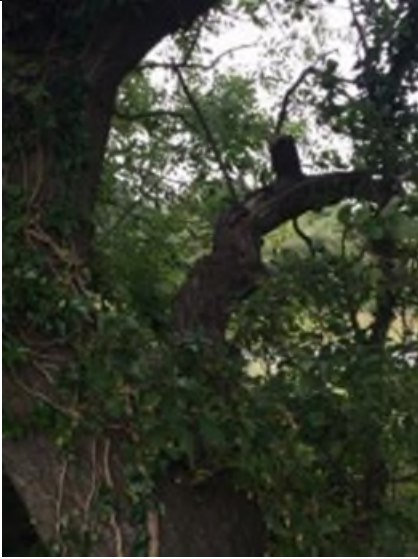
Description	Grid reference: NZ 18549 91347

Five oak trees, all semi-mature with heights between 6 m and 8 m. The trees all had a diameter at breast height of 0.7 m. Medium dead limbs, holes and splits were present.
	Limitations	None recorded.
	Bat evidence	None recorded.
Tree 25A Low bat roost potential

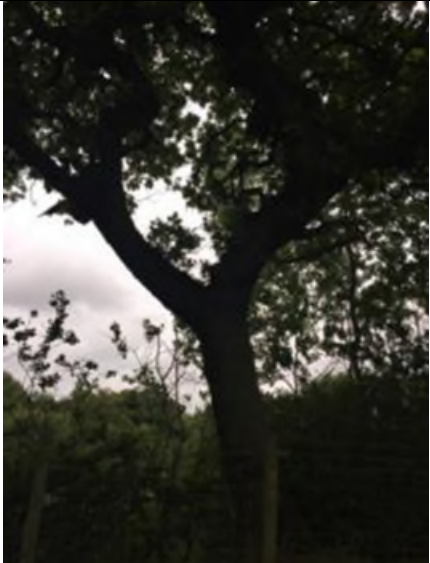
Description	Grid reference: NZ 18555 91373 Three semi-mature oak trees approximately 7 m high with a diameter at breast height of 0.8 m. Occasional holes and lifted bark were observed.
	Limitations	None recorded.
	Bat evidence	None recorded.

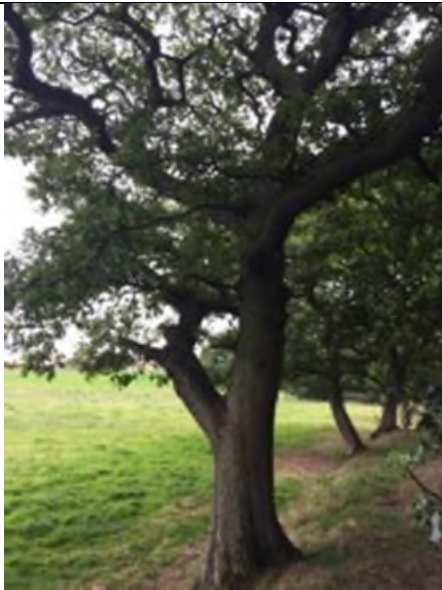
Tree 26A Low bat roost potential

Description	Grid reference: NZ 18555 91389 Two semi-mature oak trees approximately 8 m high with a diameter at breast height of 0.7 m. Dead limbs and occasional holes were present.
	Limitations	None recorded.
	Bat evidence	None recorded.
Tree 27A Low bat roost potential

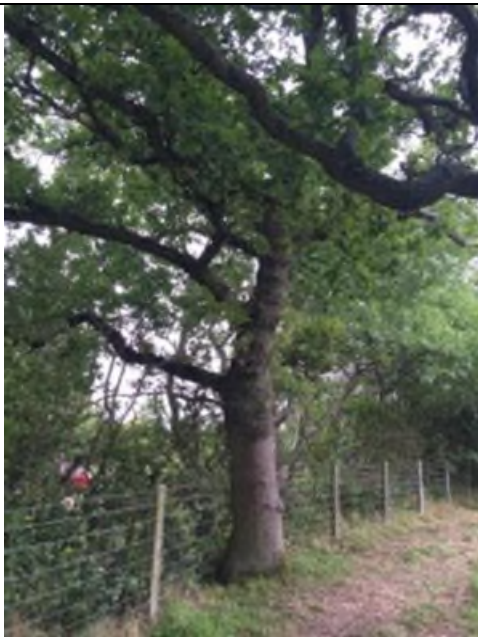
Description	Grid reference: NZ 18555 91406 A semi-mature oak located close to the A1, approximately 9 m high with a diameter at breast height of 0.7 m. Dead and hollow limbs observed, there was also good connectivity to surrounding habitat.
	Limitations	None recorded.
	Bat evidence	None recorded.
Tree 28A Low bat roost potential

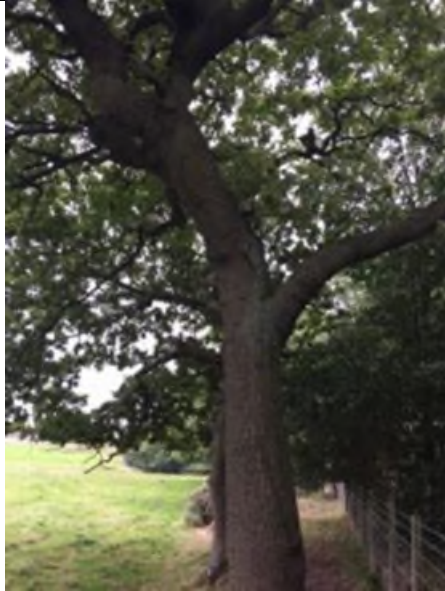
Description	Grid reference: NZ 18555 91430 Three semi-mature oaks located close to the A1 approximately 9 m high, with a diameter at breast height of 0.6 m. Dead limbs, splits and lifted bark were observed.
	Limitations	None recorded.
	Bat evidence	None recorded.

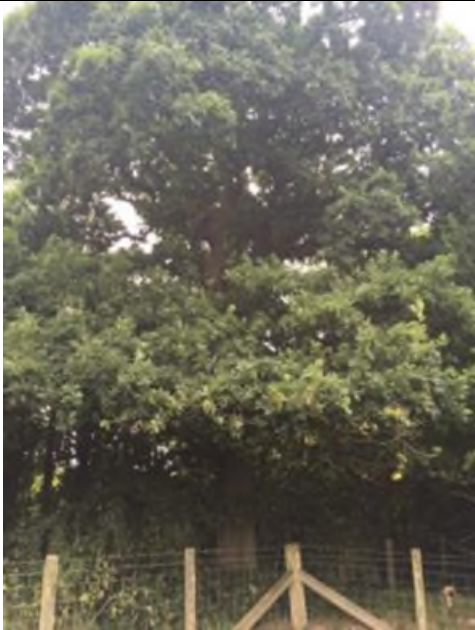
Tree 30A Low bat roost potential

Description	Grid reference: NZ 18571 91520 A mature oak located on a woodland edge approximately 9 m high with a diameter at breast height of 0.8 m. Small splits and occasional holes were observed along with lifted bark in places.
	Limitations	None recorded.
	Bat evidence	None recorded.

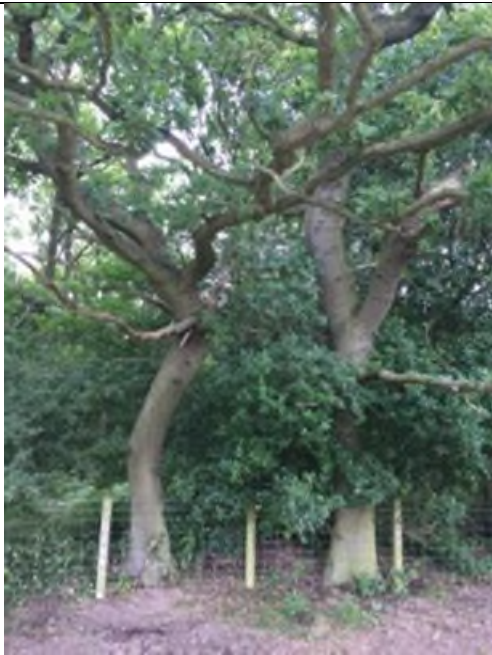
Tree 31A Low bat roost potential

Description	Grid reference: NZ 18591 91516 Two semi-mature oaks present within a treeline. The trees were approximately 10 m high with a diameter at breast height of 0.7 m. Occasional splits and holes were present. The trees were located on the woodland edge.
	Limitations	None recorded.
	Bat evidence	None recorded.

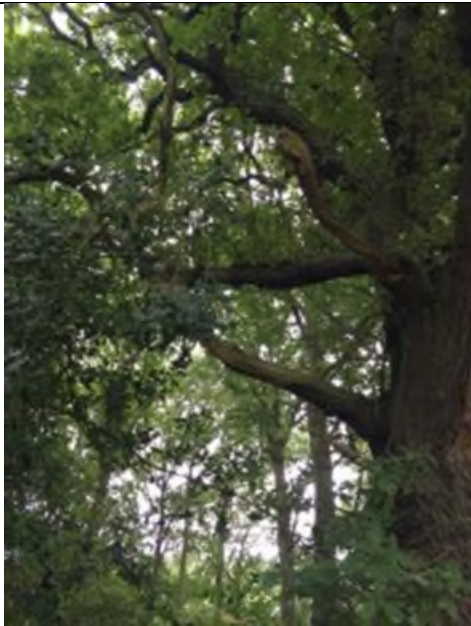
Tree 32A Low bat roost potential

Description	<p>Grid reference: NZ 18605 91523</p> <p>Two semi-mature oaks were present within a treeline approximately 11 m high with diameters at breast height of 0.6 m and 0.7 m. Low numbers of small splits and holes were present, there were also small sections of lifted bark</p>
	Limitations	None recorded.
	Bat evidence	None recorded.

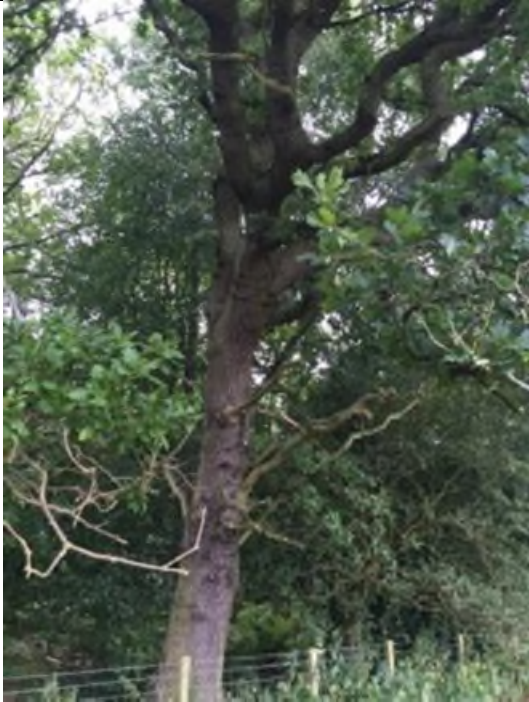
Tree 33A Low bat roost potential

Description	Grid reference: NZ 18625 91530 A semi-mature oak present in a treeline approximately 10 m high with a diameter at breast height of 0.8 m. Dead limbs, lifted bark and a small hole were observed.
	Limitations	None recorded.
	Bat evidence	None recorded.

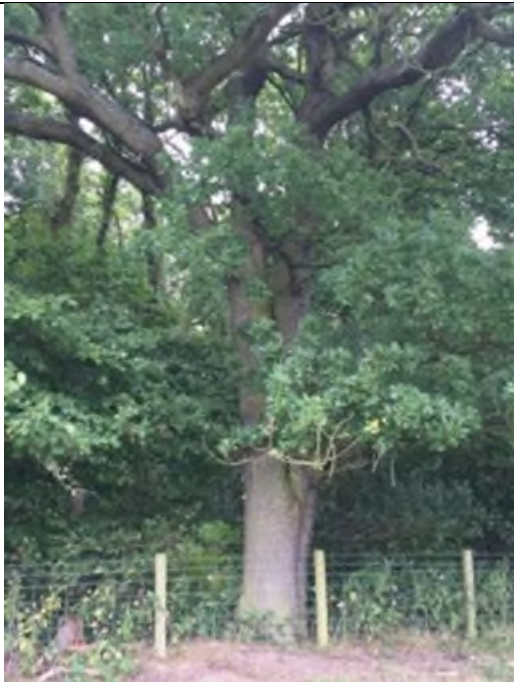
Tree 34A Low bat roost potential

Description	Grid reference: NZ 18643 91529 Two semi-mature oaks situated in a treeline approximately 11 m high with diameters at breast height of 0.8 and 0.6 m. Small splits and lifted bark observed.
	Limitations	None recorded.
	Bat evidence	None recorded.
Tree 35A Low bat roost potential

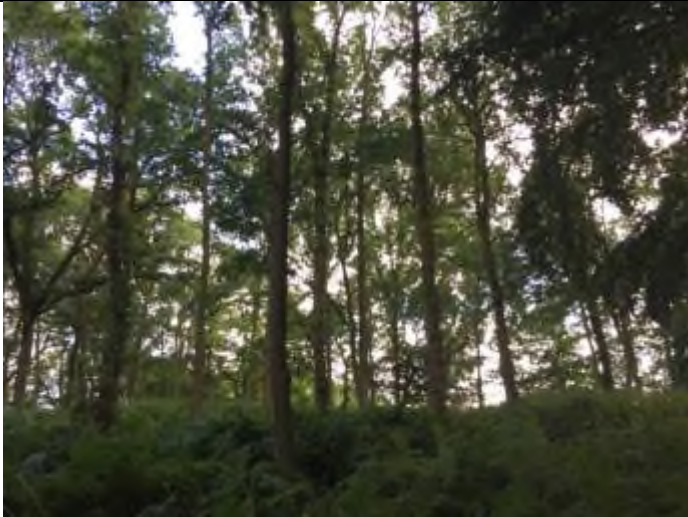
Description	Grid reference: NZ 18641 91589

A woodland containing semi-mature oak, beech and sycamore. Average height was approximately 20 m and average diameter at breast height was 0.7 m. No trees within the 100 m buffer were found to have higher than low bat roost potential.
	Limitations	None recorded.
	Bat evidence	None recorded.
Tree 36A High bat roost potential

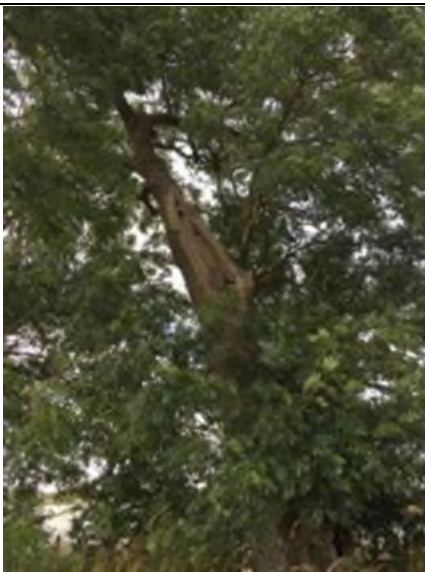
Description	Grid reference: NZ 18213 92308 Two mature ash trees which were within five metres of each other, both approximately 9 m high. One had a diameter at breast height of 1.1 m and the other had a diameter at breast height of 0.9 m. A large cavity and smaller holes were observed in the northern tree. The southern tree had callouses and small holes.
	Limitations	None recorded.
	Bat evidence	None recorded.

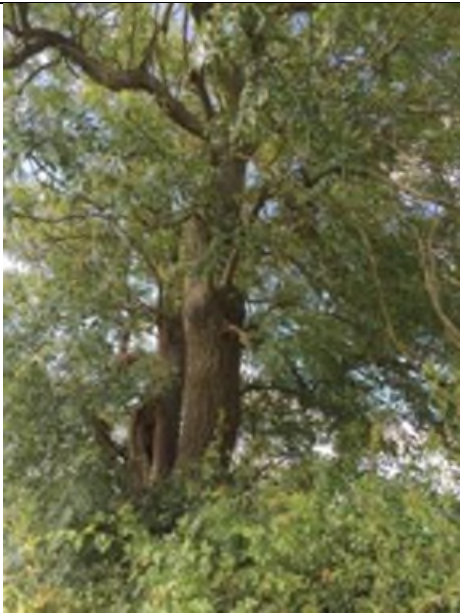
Tree 37A Low bat roost potential

Description	Grid reference: NZ 19116 92358 A mature ash tree of height 10 m and diameter at breast height of 1.5 m. A callous was present on the tree.
	Limitations	None recorded.
	Bat evidence	None recorded.
Tree 38A Moderate bat roost potential

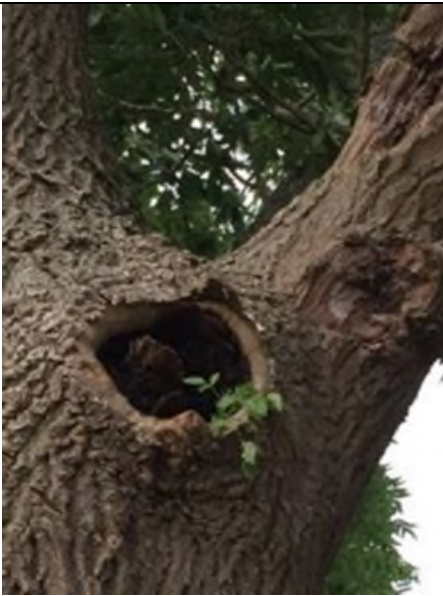
Description	Grid reference: NZ 18213 92373

A mature ash approximately 12 m high with a diameter at breast height of 1.4 m. Two large hollow branches with numerous holes were present and a large split. Good flight lines and connectivity were also observed.
	Limitations	None recorded.
	Bat evidence	None recorded.
Tree 39A Moderate bat roost potential

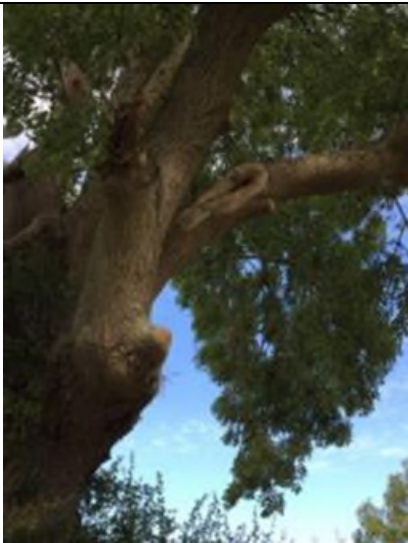
Description	Grid reference: NZ 17997 92388 A mature ash approximately 10 m high with a diameter at breast height of 1.1 m. A large, downward facing cavity with a small calloused hole and a split was observed. There was also a large hole at front of tree but surveyors were unable to see whether there was an associated cavity.
	Limitations	Surveyors unable to assess depth of cavity from ground inspection.
	Bat evidence	None recorded.

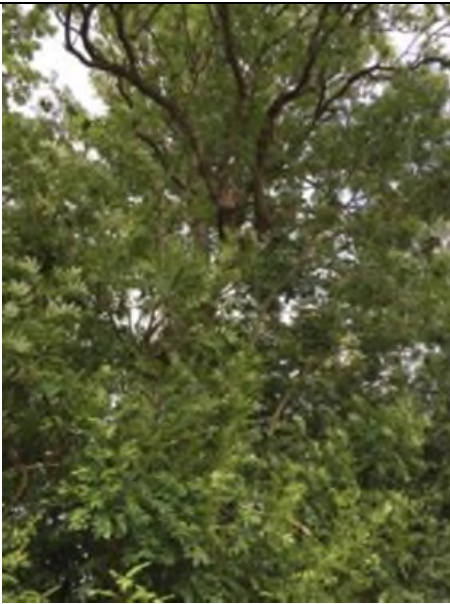
Tree 40A Low bat roost potential

Description	Grid reference: NZ 18211 92411 A semi-mature ash approximately 11 m high with a diameter at breast height of 1 m. One callous hole and a small split were observed.
	Limitations	None recorded.
	Bat evidence	None recorded.
Tree 41A Low bat roost potential

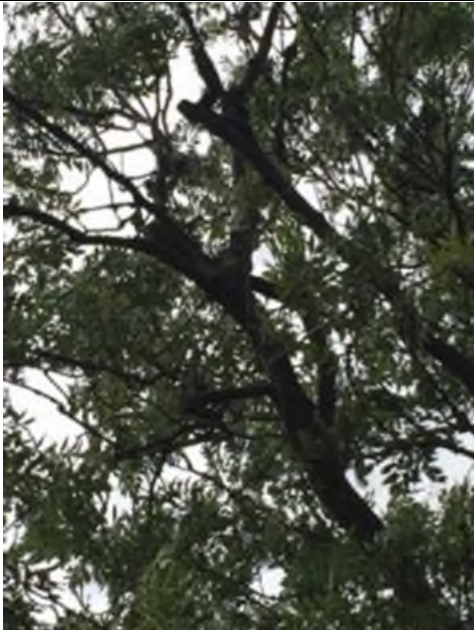
Description	Grid reference: NZ 18215 92422 A mature ash tree approximately 12 m high with a diameter at breast height of 1.2 m. Tree had a forked trunk.
	Limitations	None recorded.
	Bat evidence	None recorded.
Tree 42A Low bat roost potential

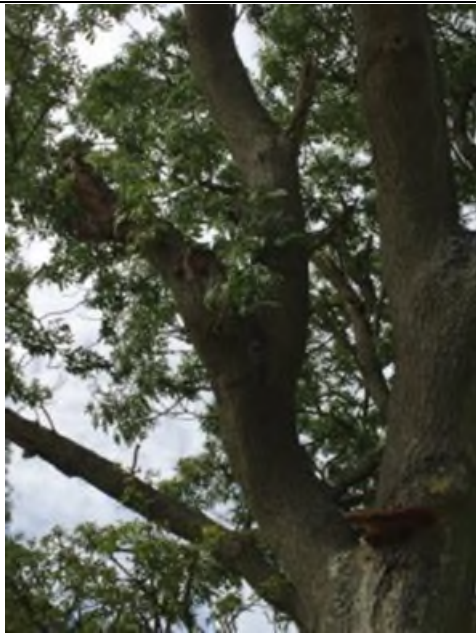
Description	Grid reference: NZ 18214 92438 A mature ash approximately 10 m high with a diameter at breast height of 1 m. A small hole was observed.
	Limitations	None recorded.
	Bat evidence	None recorded.

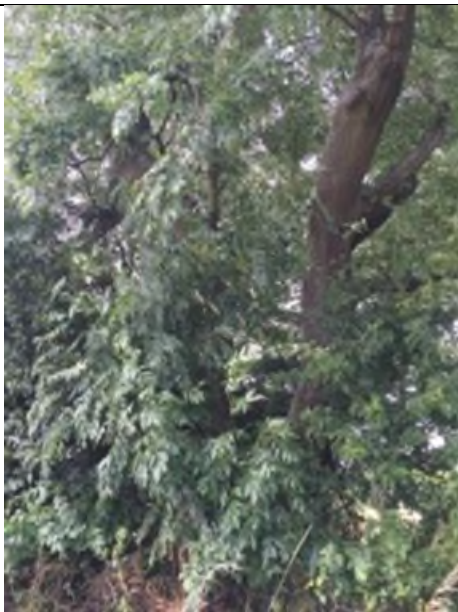
Tree 43A Low bat roost potential

Description	Grid reference: NZ 18217 92466 A four-stemmed mature ash tree approximately 12 m high and 0.75 m diameter at breast height.
	Limitations	None recorded.
	Bat evidence	None recorded.
Tree 44A Moderate bat roost potential

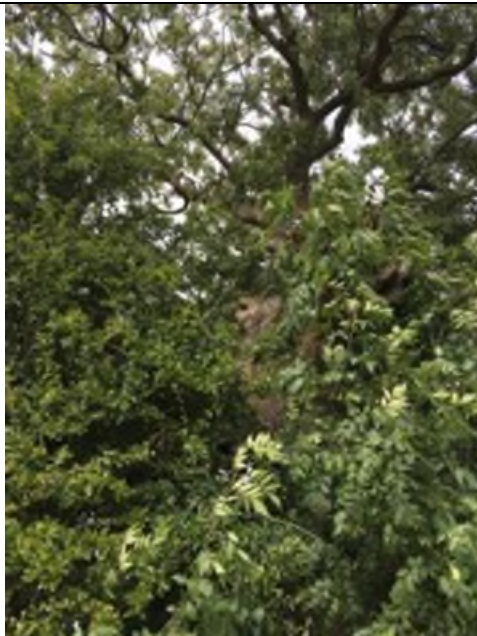
Description	Grid reference: NZ 18217 92488

A mature ash tree approximately 10 m high with a diameter at breast height of 1.1 m. A large hole was present from a fallen limb (tear out), there were also numerous splits and good connectivity with hedgerows.
	Limitations	None recorded.
	Bat evidence	None recorded.
Tree 45A High bat roost potential

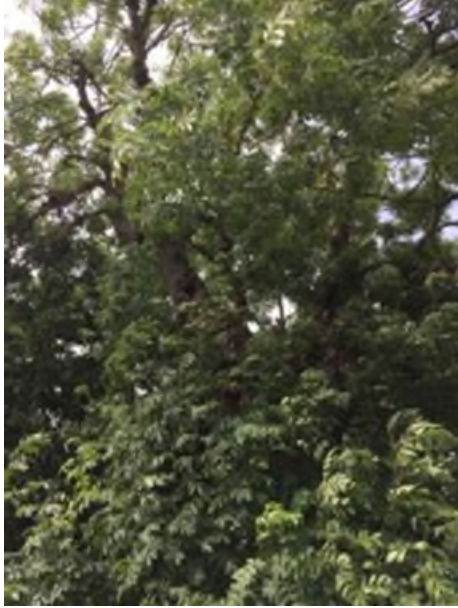
Description	Grid reference: NZ 18217 92510 A mature ash tree approximately 8 m high with a diameter at breast height of 1.1 m. The tree appeared to be dying, numerous holes and splits were observed with good habitat connectivity.
	Limitations	None recorded.
	Bat evidence	None recorded.

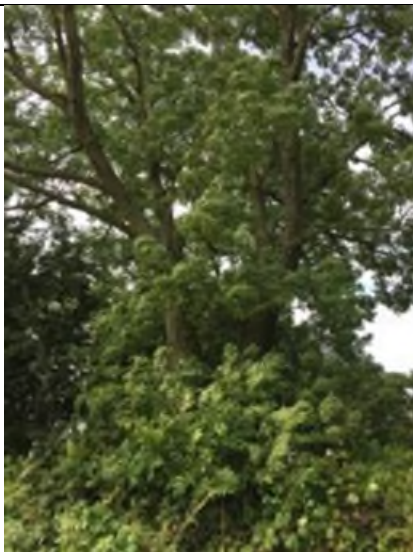
Tree 46A Low bat roost potential

Description	Grid reference: NZ 18221 92520 A semi-mature ash tree approximately 12 m high with a diameter at breast height of 1 m. Some holes and splits were observed.
	Limitations	None recorded.
	Bat evidence	None recorded.
Tree 47A Low bat roost potential

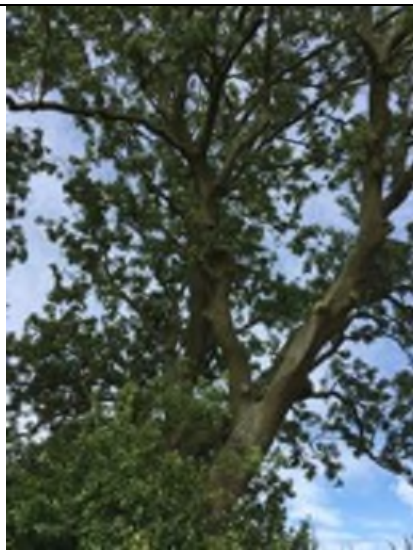
Description	Grid reference: NZ 18222 92525 (Part of a treeline with trees 40A – 46A) A double-stemmed mature ash tree approximately 12 m high with a diameter at breast height of 1.2 m. One of a line of

similarly large trees. A few knotholes were present and there was good connectivity along treeline.
	Limitations	None recorded.
	Bat evidence	None recorded.
Tree 48A Low bat roost potential

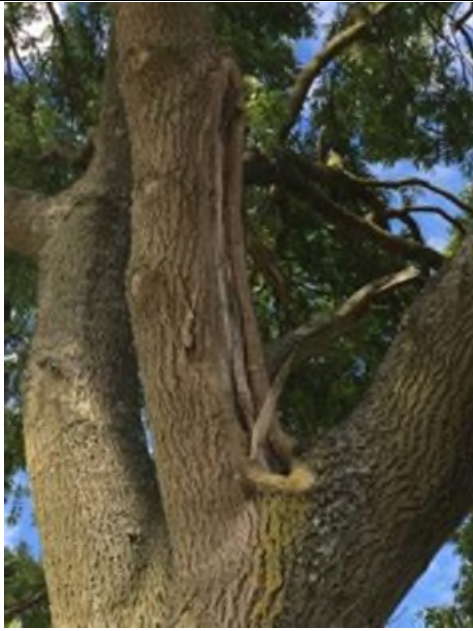
Description	Grid reference: NZ 18079 92599 A semi-mature ash tree approximately 11 m high with a diameter at breast height of 0.9 m. Minor splits and a hole were observed.
	Limitations	None recorded.
	Bat evidence	None recorded.

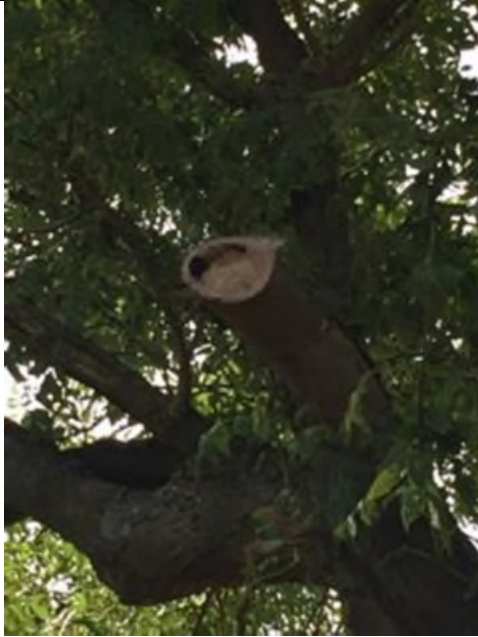
Tree 49A Low bat roost potential

Description	Grid reference: NZ 18087 92580 A semi-mature ash tree approximately 10 m high with a diameter at breast height of 0.9 m. Two small holes and splits were present.
	Limitations	None recorded.
	Bat evidence	None recorded.
Tree 50A Low bat roost potential

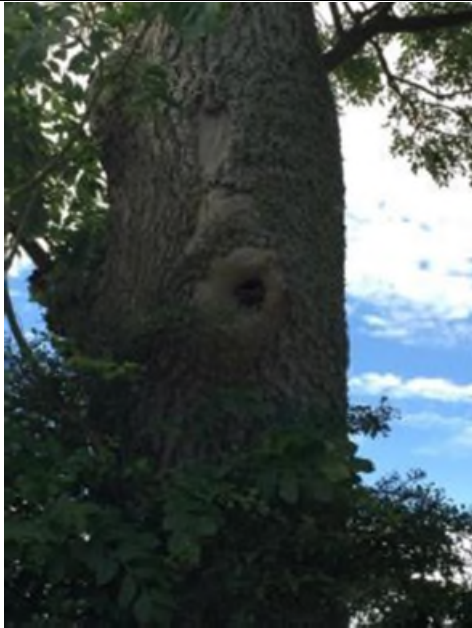
Description	Grid reference: NZ 18092 92569 A semi-mature ash tree approximately 10 m high with a diameter at breast height of 0.9 m. Small knot holes, splits and a small dead limb were observed.
	Limitations	None recorded.
	Bat evidence	None recorded.
Tree 51A Moderate bat roost potential

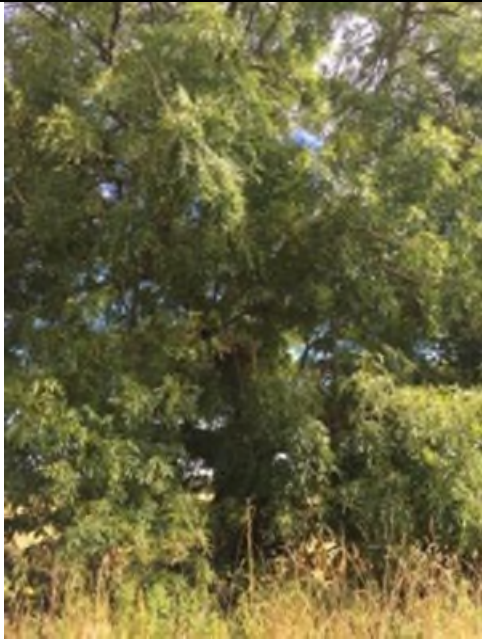
Description	Grid reference: NZ 18105 92547 A mature ash tree approximately 10 m high with a diameter at breast height of 1.1 m. A medium sized cavity was observed at a height of approximately 3 m and small splits were present.
	Limitations	None recorded.
	Bat evidence	None recorded.

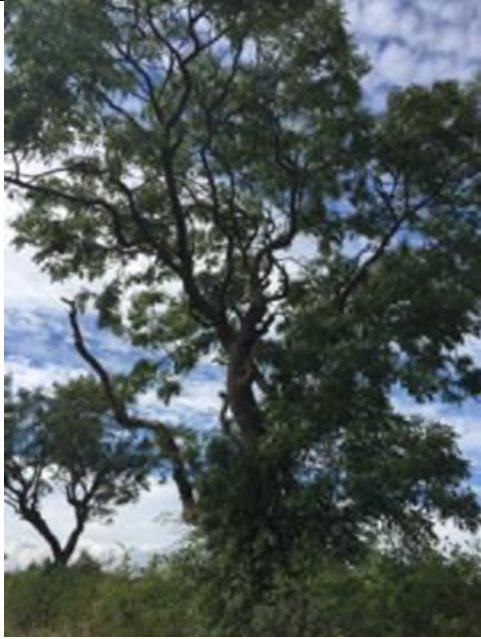
Tree 52A Low bat roost potential

Description	<p>Grid reference: NZ 18139 92517</p> <p>A semi-mature ash approximately 8 m high with a diameter at breast height of 0.7 m. Two dead limbs were present with small holes, although these were exposed with sparse foliage.</p>
	Limitations	None recorded.
	Bat evidence	None recorded.

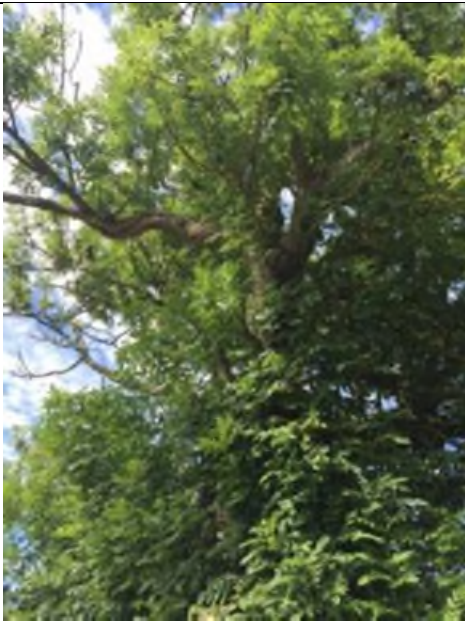
Tree 53A Moderate bat roost potential

Description	<p>Grid reference: NZ 18164 92519</p> <p>A semi-mature ash approximately 6 m high with a diameter at breast height of 0.7 m. A south-facing, medium sized fissure was present, also a small hole and a medium hollow limb.</p>
	Limitations	None recorded.
	Bat evidence	None recorded.
Tree 54A Moderate bat roost potential

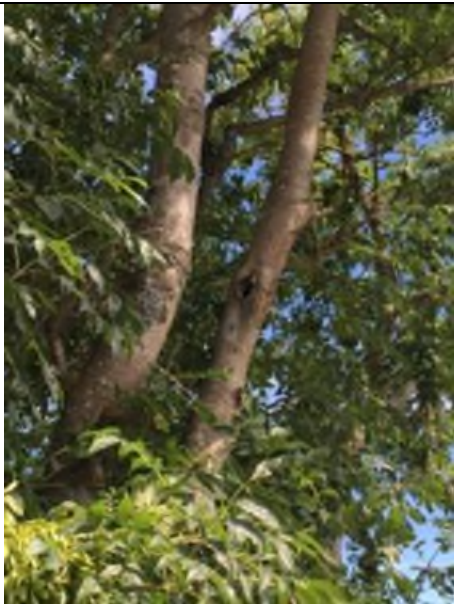
Description	Grid reference: NZ 18185 92528 A semi-mature ash tree approximately 7 m high with a diameter at breast height of 0.9 m. A large, hollow limb was observed with a number of potential entrance points. Evidence of disease also found which was not thought to be ash dieback.
	Limitations	None recorded.
	Bat evidence	None recorded.
Tree 55A Moderate bat roost potential

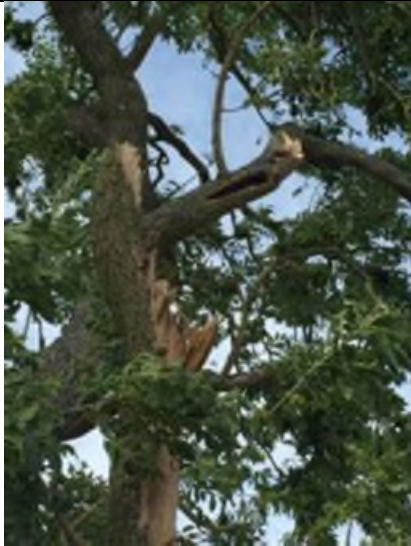
Description	Grid reference: NZ 18260 92551 A mature ash tree of approximately 10 m height with a diameter at breast height of 1 m. A large hole was present but this was quite low down. Dead limbs, splits and knotholes were also observed although tree was quite exposed.
	Limitations	None recorded.
	Bat evidence	None recorded.

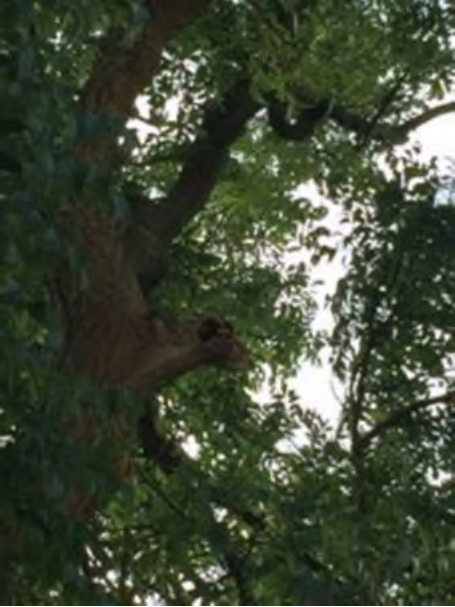
<p>Tree 56A</p> <p>Moderate bat roost potential</p>

Description	<p>Grid reference: NZ 18297 92570</p> <p>A mature ash approximately 12 m high with a diameter at breast height of 1.1 m. A calloused hole was observed at front of tree, however surveyors were unable to identify from ground level whether it was hollow. There were also numerous knotholes and good habitat connectivity.</p>
	Limitations	None recorded.
	Bat evidence	None recorded.
<p>Tree 57A</p> <p>Low bat roost potential</p>

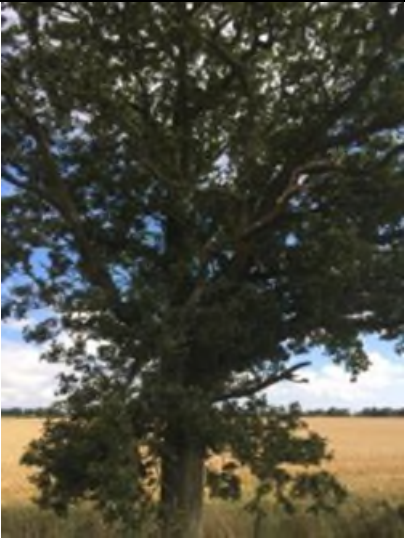
Description	Grid reference: NZ 18560 92584 A semi-mature oak tree approximately 9 m high with a diameter at breast height of 0.75 m. Tree had a dead limb which was quite exposed.
	Limitations	None recorded.
	Bat evidence	None recorded.
Tree 58A Low bat roost potential

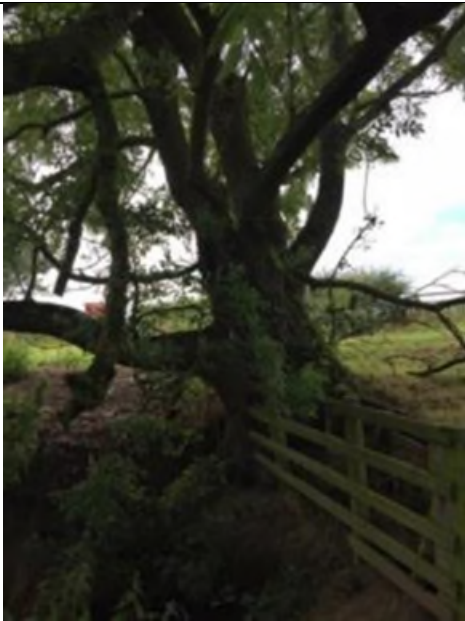
Description	Grid reference: NZ 18870 92572 One of two mature ash trees situated in close proximity. Tree was approximately 10 m high with a diameter at breast height of 2.5 m. A tear out caused by the loss of a large limb was present, however this was upwards facing and had no obvious gap.
	Limitations	None recorded.
	Bat evidence	None recorded.

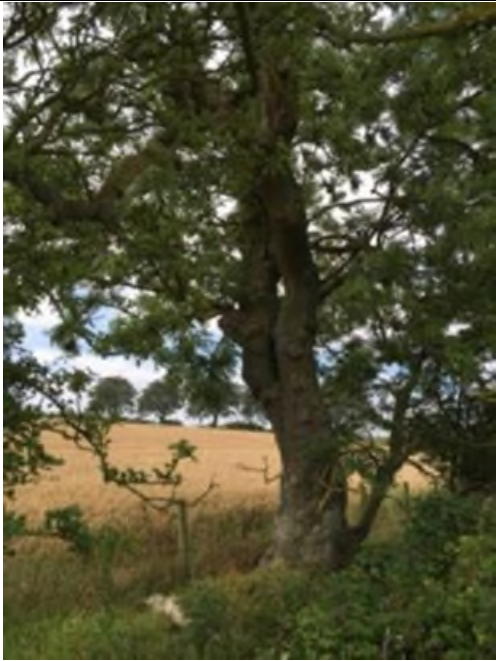
Tree 59A Moderate bat roost potential

Description	<p>Grid reference: NZ1894292545</p> <p>A mature ash tree with a height of approximately 8 m was present within a hedgerow. The tree had a diameter at breast height of 1 m. There was some lifted bark and the tree appeared to be decaying. A large hole was observed at the rear of the tree and a split limb was present with two hollows.</p>
	Limitations	None recorded.
	Bat evidence	None recorded.

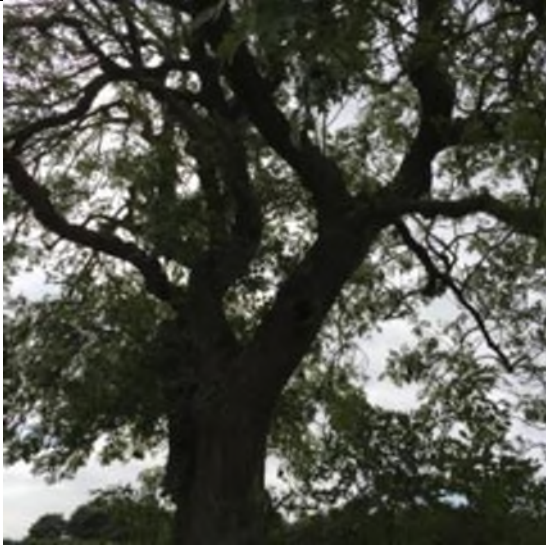
Tree 60A Moderate bat roost potential

Description	Grid reference: NZ 18942 92545 A mature ash present within a hedgerow. The tree's diameter at breast height was 2 m. Height was not recorded at the time of survey. A tear out caused by a fallen limb had resulted in the presence of large holes in the stem.
	Limitations	None recorded.
	Bat evidence	None recorded.
Tree 61A Low bat roost potential
