A1 in Northumberland: Morpeth to Ellingham

Scheme Number: TR010041

6.7 Environmental Statement – Appendix 9.7 Bat Roost Potential Survey Report 2017

Bat Roost Potential Survey Report 2017

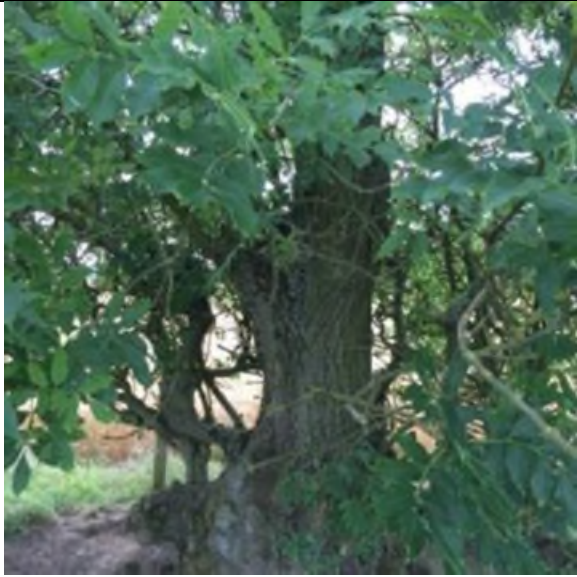
Description	Grid reference: NZ 18978 92530

A mature ash present within a hedgerow. The trees height was 10 m and its diameter at breast height was 1.5 m. A small split was observed but no other obvious field signs.
	Limitations	None recorded.
	Bat evidence	None recorded.
Tree 62A Moderate bat roost potential

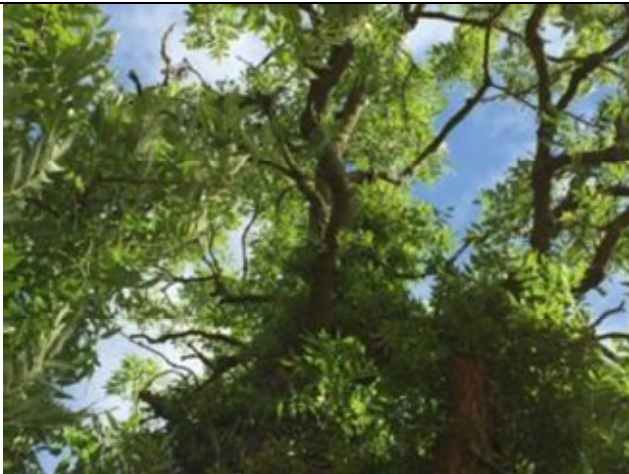
Description	Grid reference: NZ 19103 92496 Two mature ash trees with a height of 8 m and a diameter at breast height of 0.5 m and 1.5 m respectively. Numerous gaps near the base of the tree indicated that a hollow was present. There were also holes and a split observed in a limb.
	Limitations	Tree was ivy clad which restricted visibility.
	Bat evidence	None recorded.

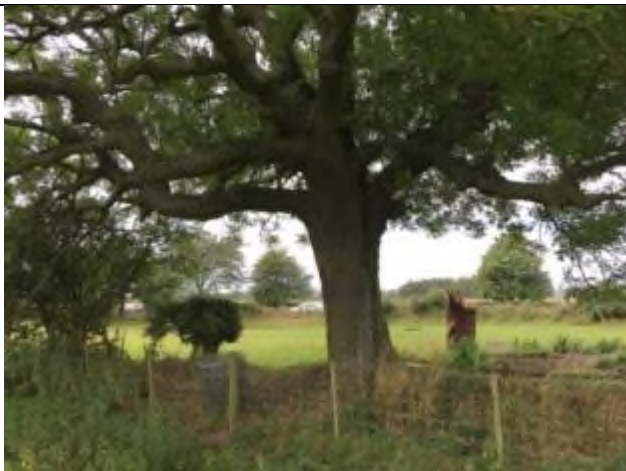
Tree 63A Moderate bat roost potential

Description	Grid reference: NZ 18900 92614 One of two mature ash trees in close proximity. The tree was approximately 10 m tall with a diameter at breast height of 1.2 m. A few splits and small holes were present as well as a knot hole.
	Limitations	Surveyors unable to view some holes and splits from ground observation.
	Bat evidence	None recorded.
Tree 64A Low bat roost potential

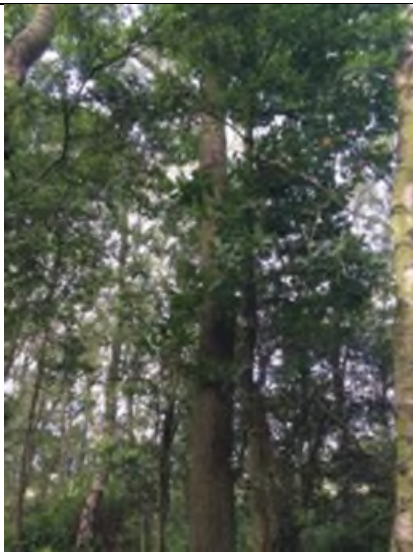
Description	Grid reference: NZ 18491 92678

Four similar oaks planted closely together in predominantly birch woodland. The trees were semi-mature approximately 16 m high with a diameter at breast height of 0.6 m.
	Limitations	None recorded.
	Bat evidence	None recorded.
Tree 65A Low bat roost potential

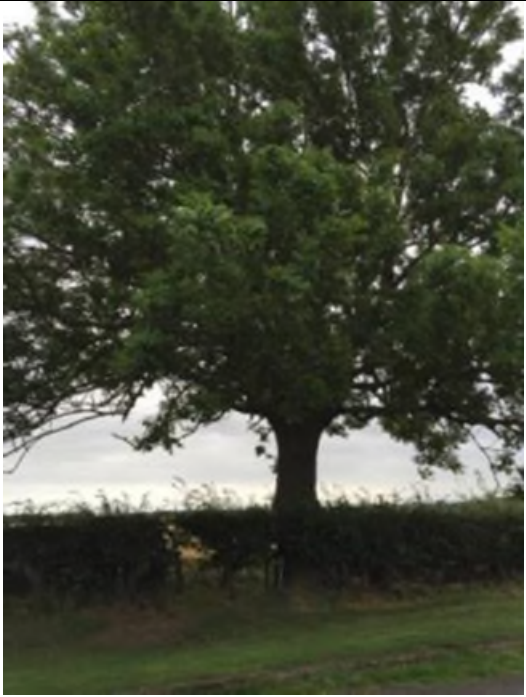
Description	Grid reference: NZ 18903 92756 A mature ash tree with a height of 12 m and a diameter at breast height of 1.2 m. A rot hole was observed on one of the branches.
	Limitations	None recorded.
	Bat evidence	None recorded.

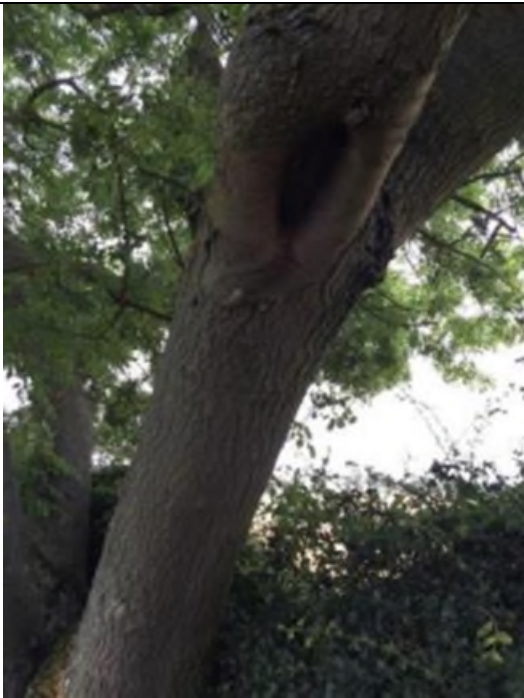
Tree 66A Low bat roost potential

Description	<p>Grid reference: NZ 18910 92783</p> <p>A mature ash tree approximately 12 m high with a diameter at breast height of 0.8 m. A shallow tear out was present, however after external surveying this did not appear to lead to a cavity.</p>
	Limitations	None recorded.
	Bat evidence	None recorded.

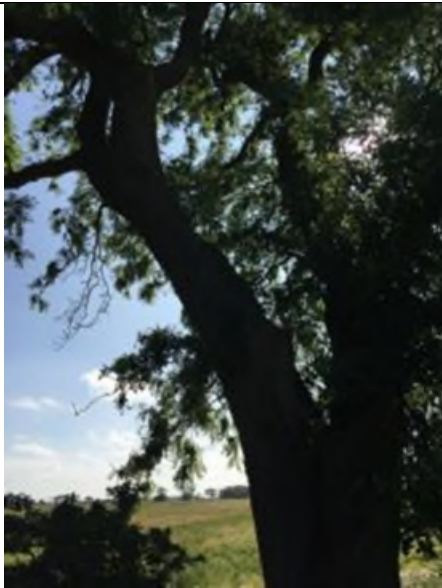
Tree 67A Low bat roost potential

Description	Grid reference: NZ 18842 93157 A mature ash tree with a height of 16 m and a diameter at breast height of 2 m.
	Limitations	None recorded.
	Bat evidence	None recorded.
Tree 68A Moderate bat roost potential

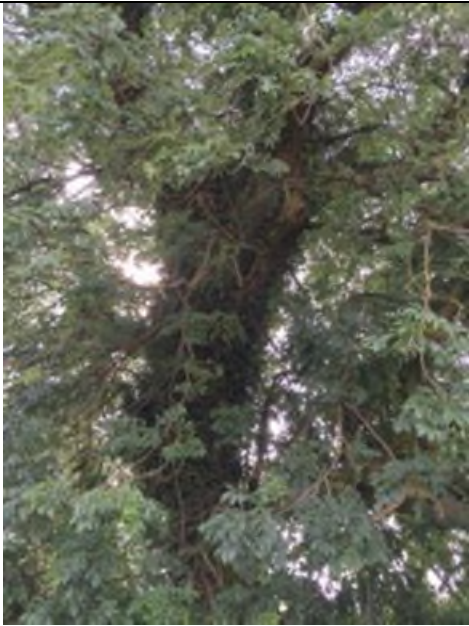
Description	Grid reference: NZ 18389 93454

A mature ash tree approximately 13 m high with a diameter at breast height of 1.5 m. A knothole and numerous splits were observed.
	Limitations	Tree was densely ivy clad so assessment was visually restricted.
	Bat evidence	None recorded.
Tree 69A Moderate bat roost potential

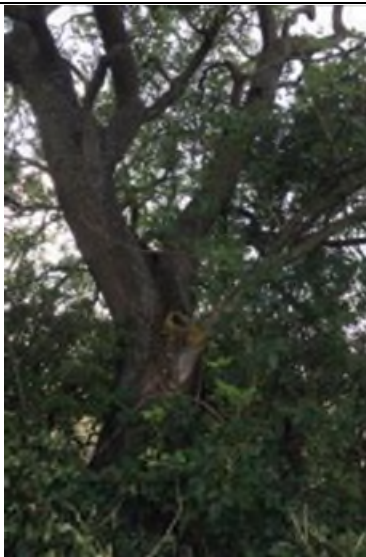
Description	Grid reference: NZ 18443 93497 A mature ash tree with a height of 12 m and a diameter at breast height of 1 m. A downward facing knothole was observed. Also, there was good connectivity with hedgerows and good flight lines.
	Limitations	None recorded.
	Bat evidence	None recorded.

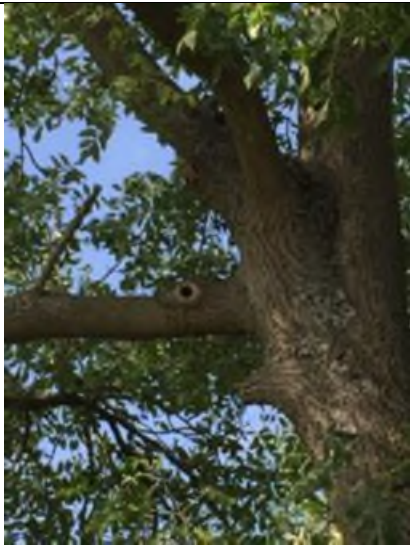
Tree 70A Moderate bat roost potential

Description	<p>Grid reference: NZ 18774 93489</p> <p>A semi-mature ash tree with a height of 16 m and a diameter at breast height of 1 m. Numerous knotholes were observed which were quite large. There was also a split limb and good habitat connectivity.</p>
	Limitations	None recorded.
	Bat evidence	None recorded.
Tree 71A Low bat roost potential

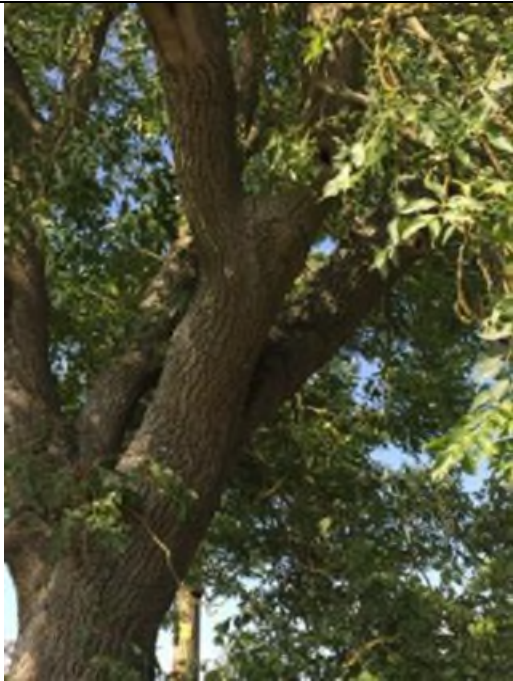
Description	Grid reference: NZ 18830 93486 A semi-mature ash tree with a height of 16 m and a diameter at breast height of 0.7 m. PRFs at height could not be ruled out.
	Limitations	None recorded.
	Bat evidence	None recorded.
Tree 72A Low bat roost potential

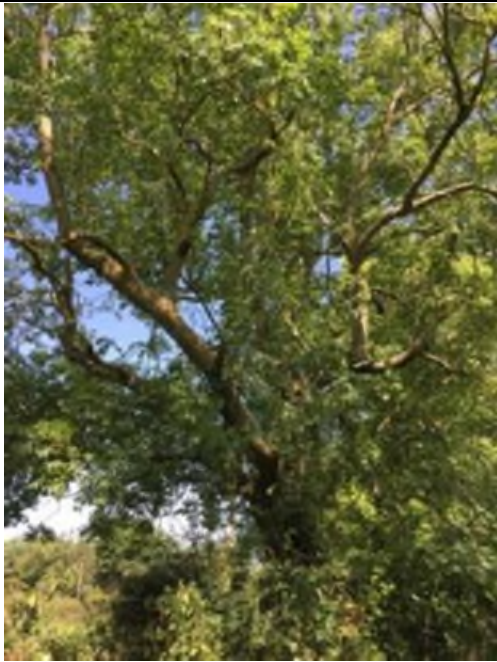
Description	Grid reference: NZ 18876 93484 An immature ash tree with a height of 16 m and a diameter at breast height of 0.7 m. PRFs at height could not be ruled out.
	Limitations	None recorded.
	Bat evidence	None recorded.

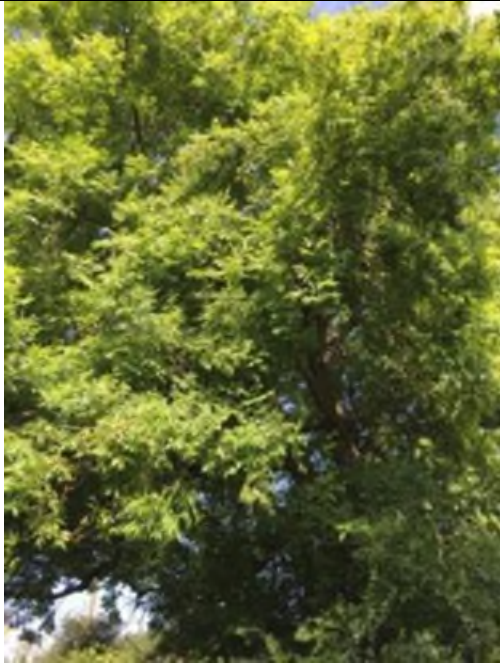
Tree 73A Low bat roost potential

Description	Grid reference: NZ 18881 93482 A mature ash tree with a height of approximately 16 m and a diameter at breast height of 1 m. The tree had a split limb with some lifted bark.
	Limitations	None recorded.
	Bat evidence	None recorded.

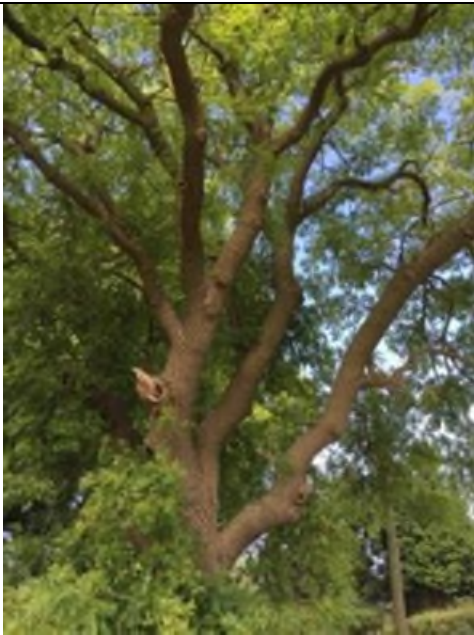
Tree 74A Low bat roost potential

Description	<p>Grid reference: NZ 18896 93478</p> <p>A mature ash tree with a height of approximately 10 m and diameter at breast height of 1 m. The tree was exposed and near a road. Small holes and a broken branch were observed.</p>
	Limitations	None recorded.
	Bat evidence	None recorded.

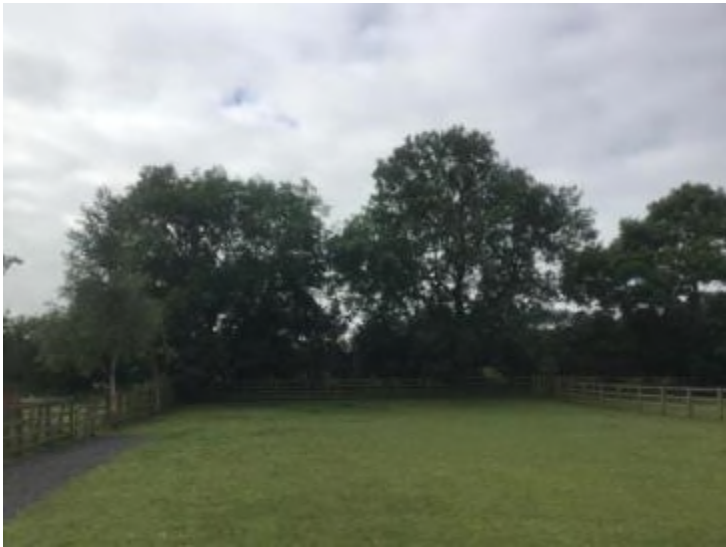
<p>Tree 75A</p> <p>Low bat roost potential</p>

Description	<p>Grid reference: NZ 18928 93448 (Part of treeline with Trees 76A, 77A, 78A, 79A and 80A)</p> <p>A mature ash tree approximately 13 m high with a diameter at breast height of 1 m. Lifted bark was observed.</p>
	Limitations	None recorded.
	Bat evidence	None recorded.

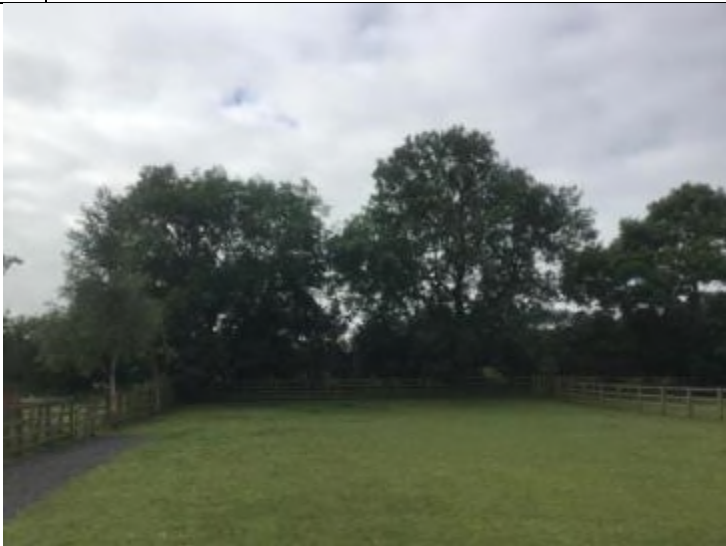
<p style="text-align: center;">Photo of treeline, photo of individual tree not available.</p>	
	Description	Grid reference: NZ 18943 93444 (Part of a treeline with Trees 75A, 76A, 77A, 79A and 80A) One of six ashes present in a treeline. The tree was a mature ash with a height of approximately 15 m and a diameter at breast height of 1.2 m. Upwards facing holes were present and split limbs at height.

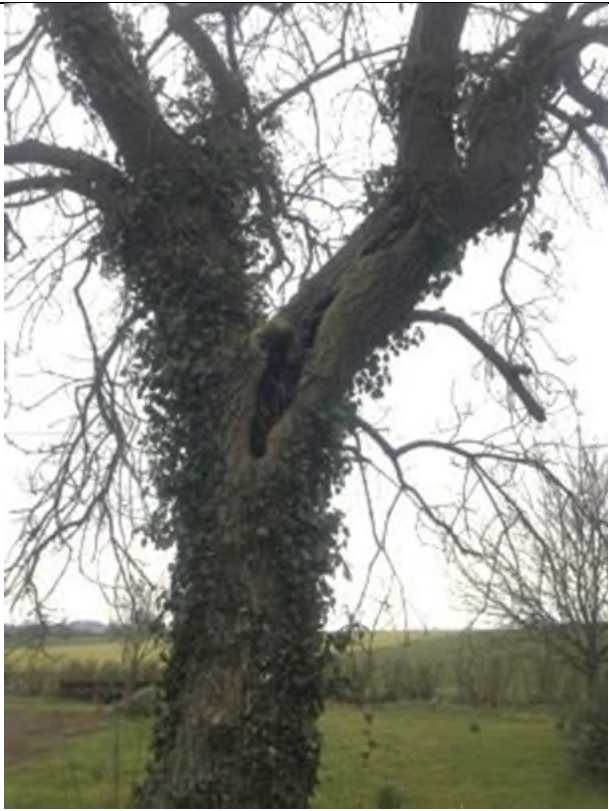
Description	Grid reference: NZ 18355 93842 Semi-mature ash tree situated in a farmhouse garden. Approximately 15 m high with a diameter at breast height of 0.75 m. Deep fissure in scaffold limb leading up to potential voids inside limb.
	Limitations	None recorded.
	Bat evidence	None recorded.

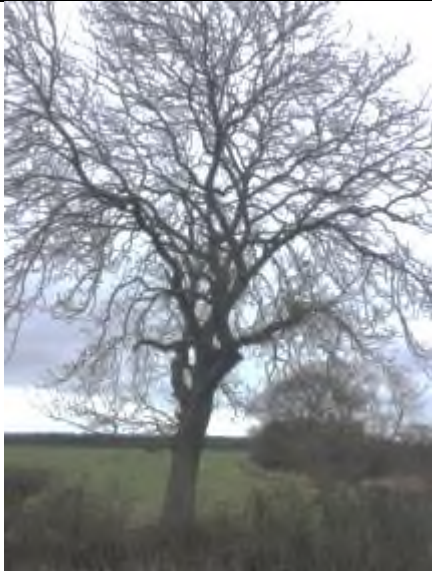
Description	<p>Grid reference: NZ 18516 95858</p> <p>Mature ash situated in a replanted defunct hedgerow, approximately 12 m high with a diameter at breast height of 0.6 m. East-facing rot pocket at 3.5 m and vertical crevice on western side leading to potential void.</p>
	Limitations	None recorded.
	Bat evidence	None recorded.
<p>Tree 118A</p> <p>Low bat roost potential</p>

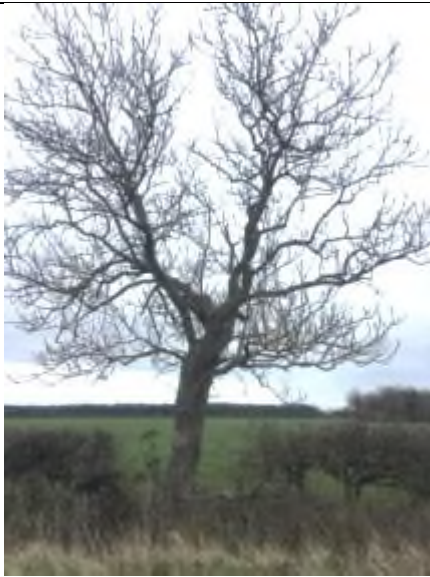
Description	Grid reference: NZ 19013 95808 Mature ash, approximately 14 m high with a diameter at breast height of 0.4 m. Crack in dead branch facing downwards.
	Limitations	None recorded.
	Bat evidence	None recorded.
Tree 119A Low bat roost potential

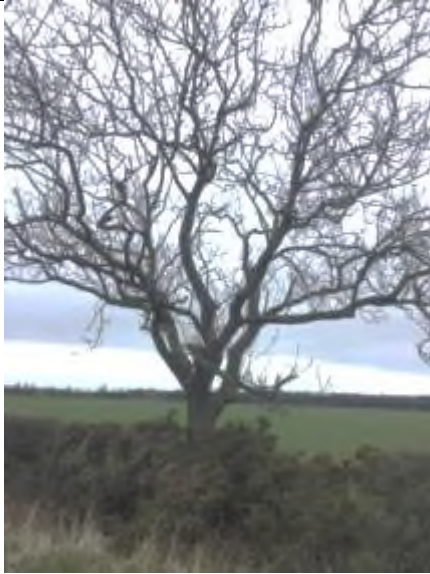
Tree 120A Low bat roost potential

Description	Grid reference: NZ 19011 95836 Semi-mature ash, approximately 10 m high with a diameter at breast height of 0.4 m. Twin trunks have rubbed / grown together, no cavity visible from northern side but may be visible from the south.
	Limitations	None recorded.
	Bat evidence	None recorded.

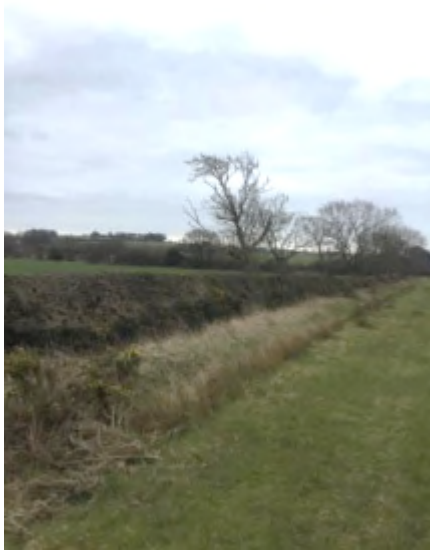
Description	Grid reference: NZ 19013 95878 Semi-mature ash approximately 10 m high with a diameter at breast height of 0.5 m. Rotten peg on eastern side at a relatively low level.
	Limitations	None recorded.
	Bat evidence	None recorded.
Tree 121A Low bat roost potential

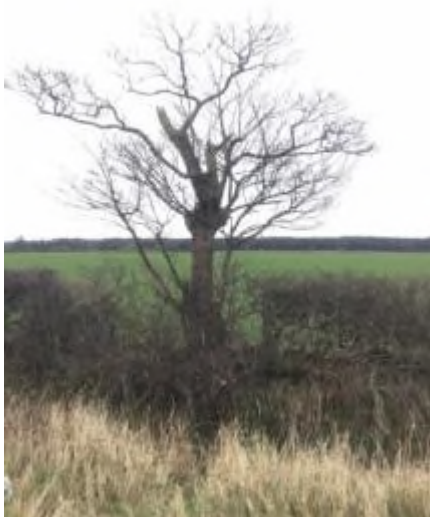
Two semi-mature sycamore trees, approximately 7 m high with a diameter at breast height of 0.2 m. Deep rot hole on eastern aspect and loose bark.
	Limitations	None recorded.
	Bat evidence	None recorded.
Tree 122A Moderate bat roost potential

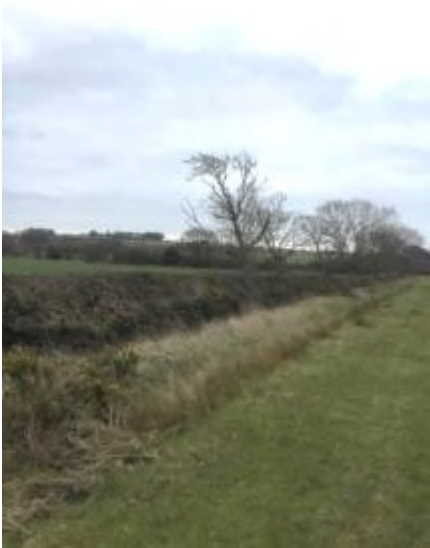
Tree 123A Low bat roost potential

Description	Grid reference: NZ 19013 95917 Semi-mature ash approximately 6 m high with a diameter at breast height of 0.3 m. Rotten core and broken limbs.
	Limitations	Surveyor not able to access southern aspect therefore a precautionary grading of moderate potential has been applied.
	Bat evidence	None recorded.

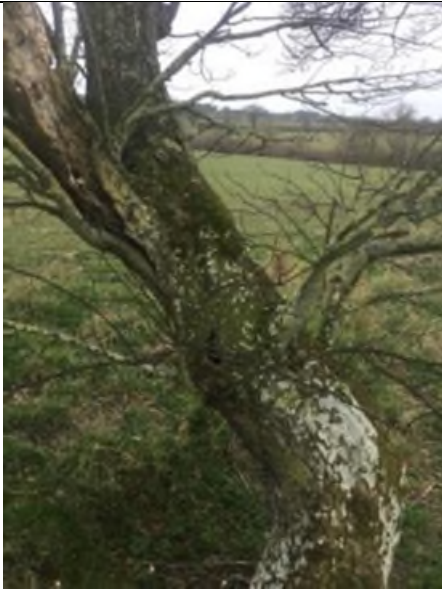
Description	Grid reference: NZ 19006 95974 Mature sycamore, approximately 14 m high with a diameter at breast height of 0.25 m. Rot holes and broken branches also present.
	Limitations	None recorded.
	Bat evidence	None recorded.
Tree 124A Low bat roost potential

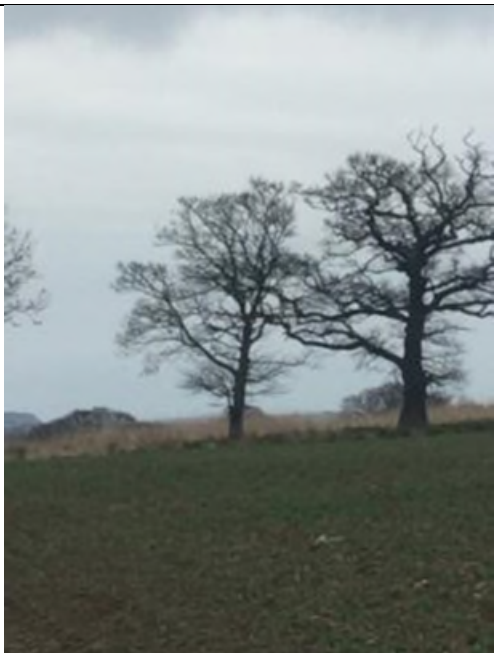
Semi-mature oak situated in a tree line, approximately 12 m high with a diameter at breast height of 0.6 m. A rot hole was present under a branch on the southern aspect.
	Limitations	None recorded.
	Bat evidence	None recorded.
Tree 125A Low bat roost potential

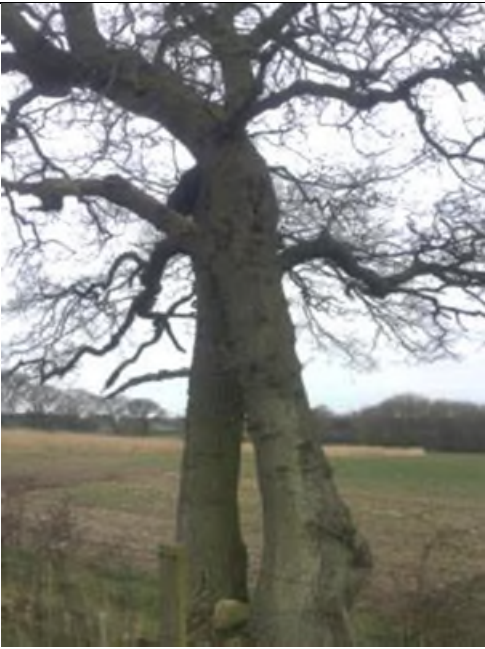
Tree 126A Low bat roost potential

Description	Grid reference: NZ 18340 96157 A mature sycamore situated in a tree line, approximately 9 m high with a diameter at breast height of 0.6 m. Rot hole at 1 m leading into rotten branch.
	Limitations	None recorded.
	Bat evidence	None recorded.

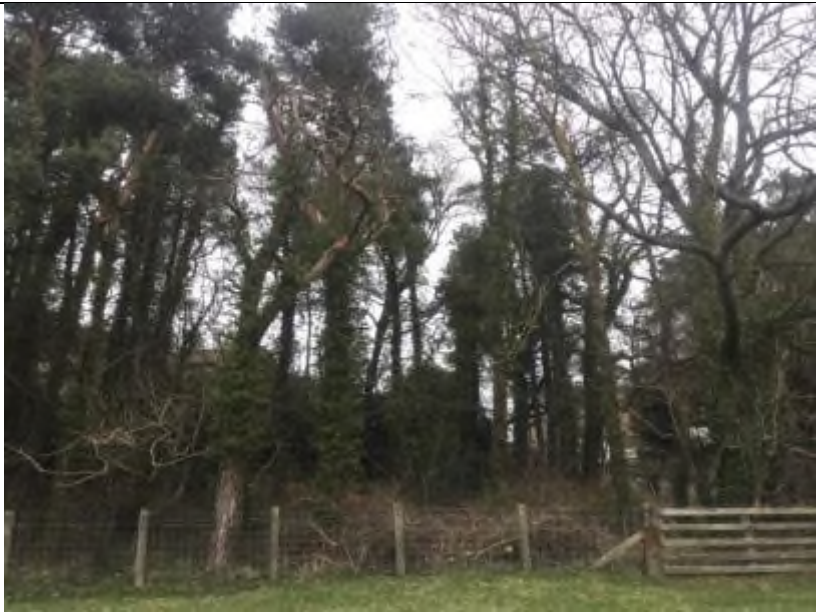
Tree 127A Low bat roost potential

Description	Grid reference: NZ 18699 96388 Mature Scots pine woodland with some ash, approximately 16 - 18 m high and 0.35 m diameter at breast height, on average. Ivy and broken branches present.
	Limitations	None recorded.
	Bat evidence	None recorded.
Tree 128A Moderate bat roost potential

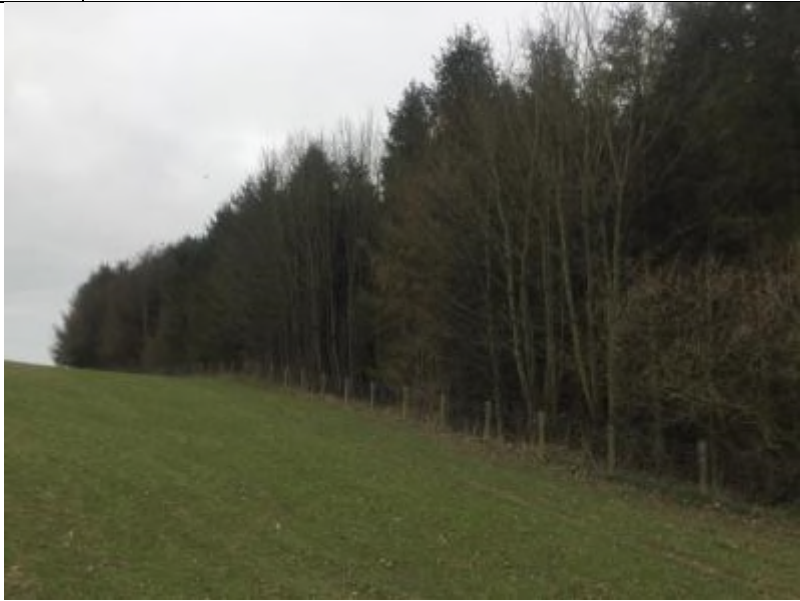
Description	Grid reference: NZ 18614 96515 Semi-mature to mature woodland containing predominantly larch in the centre but also oak, elder, sycamore and willow on the edges. Approximately 14 - 16 m high and 0.2 - 0.5 m diameter at breast height, on average. Broken and torn limbs and branches, and rot holes; but most trees were in good condition.
	Limitations	None recorded.
	Bat evidence	None recorded.

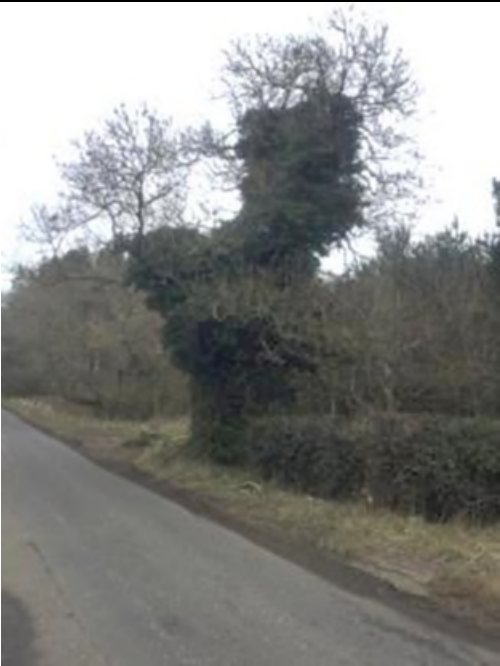
Description	<p>Grid reference: NZ 18396 96851</p> <p>Semi-mature sycamore, approximately 10 m tall with a diameter at breast height of 0.22 m . Thick ivy present.</p>
	Limitations	<p>None recorded.</p>
	Bat evidence	<p>None recorded.</p>
<p>Tree 131A</p> <p>Moderate bat roost potential</p>

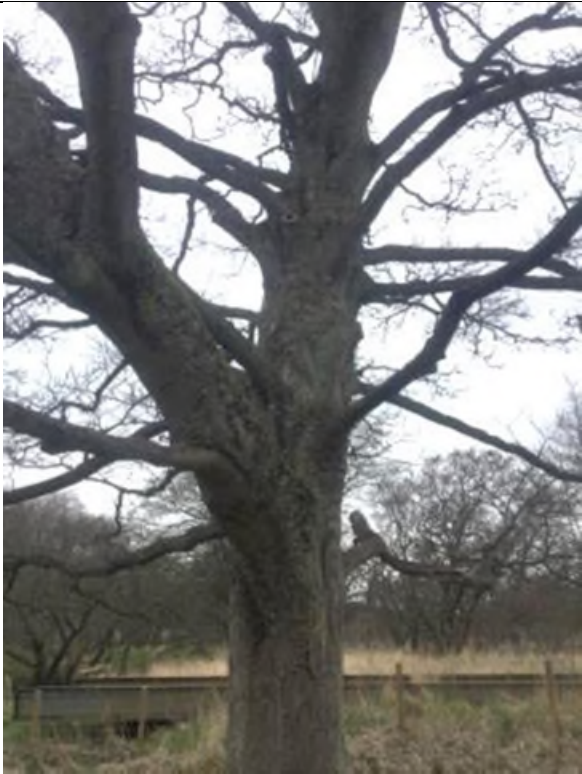
Description	Grid reference: NZ 17953 96941 Mature sycamore situated 4 m to the east of a stream, approximately 12 m high with a diameter at breast height of 0.7 m. Two rot holes on the south-western aspect.
	Limitations	None recorded.
	Bat evidence	None recorded.

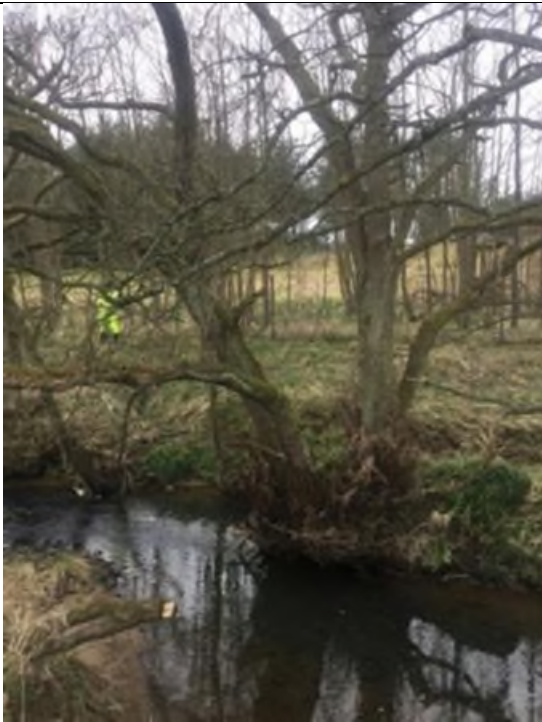
Description	<p>Grid reference: NZ 17926 96967</p> <p>Mature alder situated on a stream bank, approximately 13 m high with a diameter at breast height of 0.7 m. Rot hole 3 m up on western aspect.</p>
	Limitations	None recorded.
	Bat evidence	None recorded.

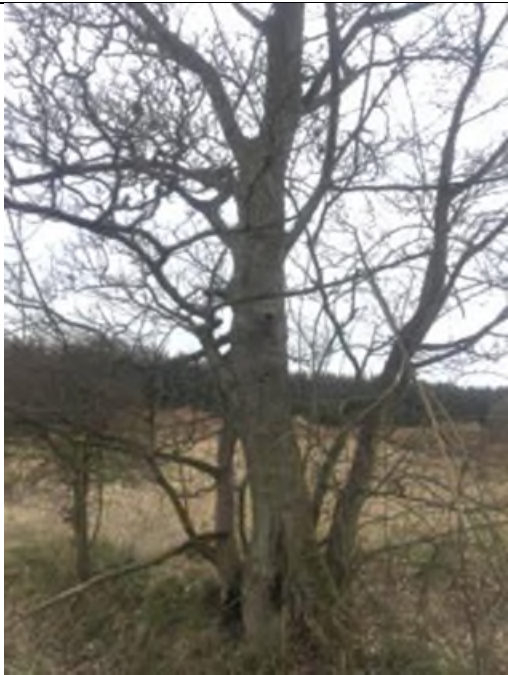
Tree 135A Low bat roost potential

Description	Grid reference: NZ 17875 96989 Semi-mature alder situated along a stream/ditch, approximately 12 m high with a diameter at breast height of 0.5 m. Cavity in small dead limb overhanging stream.
	Limitations	None recorded.
	Bat evidence	None recorded.

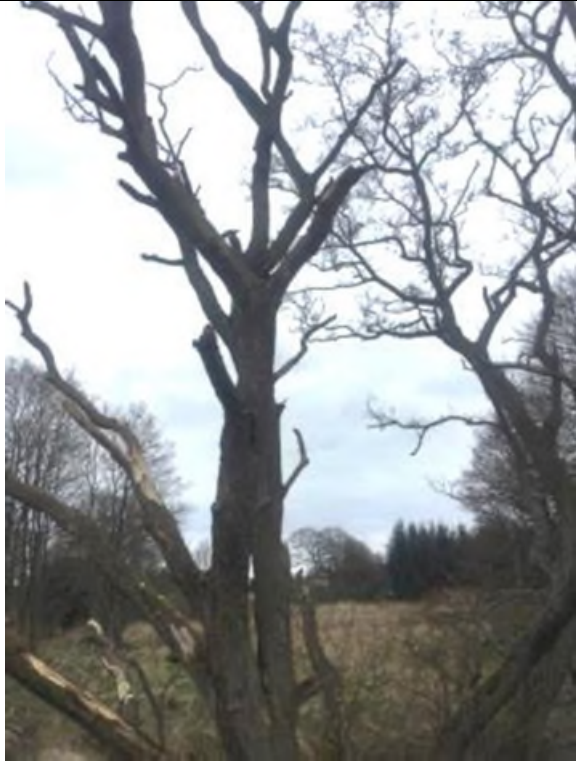
Description	<p>Grid reference: NZ 17909 97095</p> <p>Ancient alder present along a riverbank, approximately 12 m high and 0.75 m diameter at breast height. Tree decaying, woodpecker hole at 7 m.</p>
	Limitations	None recorded.
	Bat evidence	None recorded.

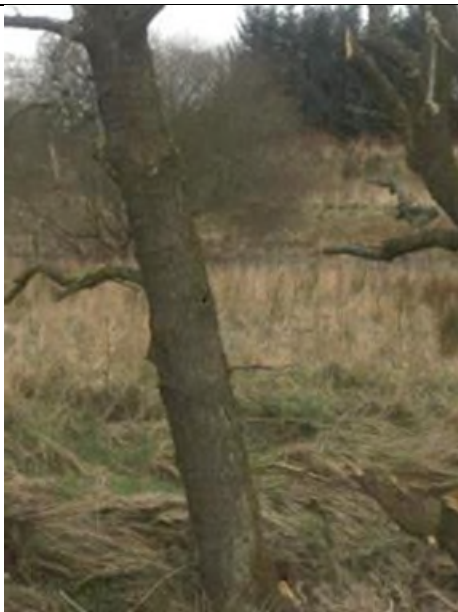
Tree 138A Low bat roost potential

Description	Grid reference: NZ 17905 97119 Semi-mature alder present along a riverbank, approximately 8 m high with a diameter at breast height of 0.4 m. Rot pocket at 2.5 m.
	Limitations	None recorded.
	Bat evidence	None recorded.

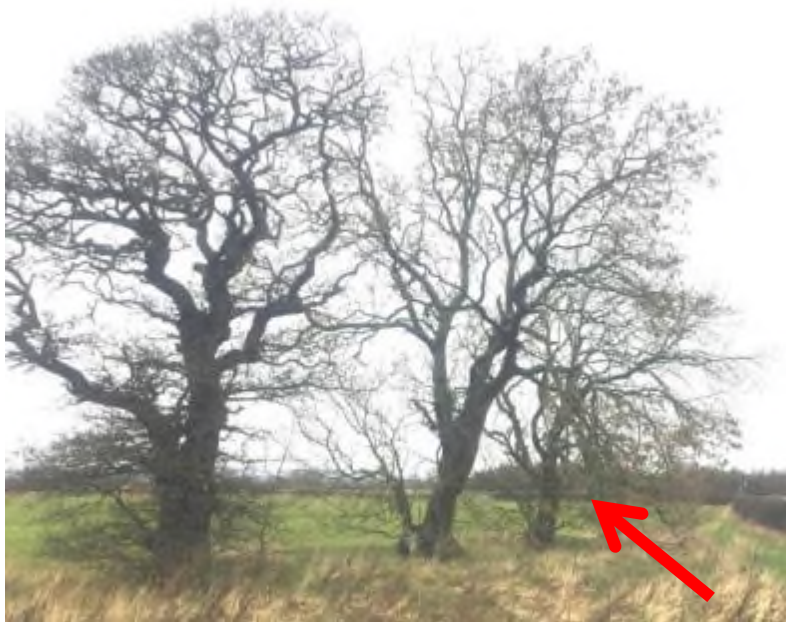
Description	Grid reference: NZ 17859 97145 Semi-mature alder present along a riverbank, approximately 8 m high with a diameter at breast height of 0.4 m. A rot pocket was present at a height of 2 m.
	Limitations	None recorded.
	Bat evidence	None recorded.
T200A Low bat roost potential

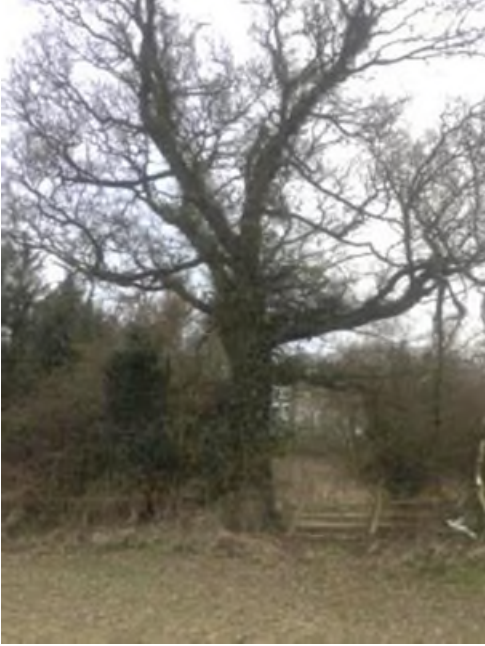
Description	<p>Grid reference: NZ 17548 97706</p> <p>Mature oak, approximately 10 m high and 0.9 m diameter at breast height. PRFs at height could not be ruled out.</p>	
Limitations	<p>None recorded.</p>	
Bat evidence	<p>None recorded.</p>	
<p>Tree 139A</p> <p>Low bat roost potential</p>

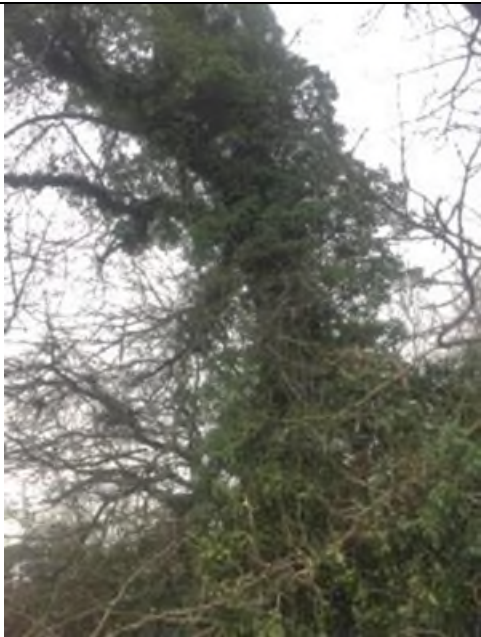
Tree 141A Low bat roost potential

Description	Grid reference: NZ 17395 98747 Mature oak present in a woodland, approximately 20 m high with a diameter at breast height of 0.8 m. A knot hole was present at a height of approximately 4 m on the southern aspect.
	Limitations	The area directly beneath the tree was obstructed by a collapsed building.
	Bat evidence	None recorded.

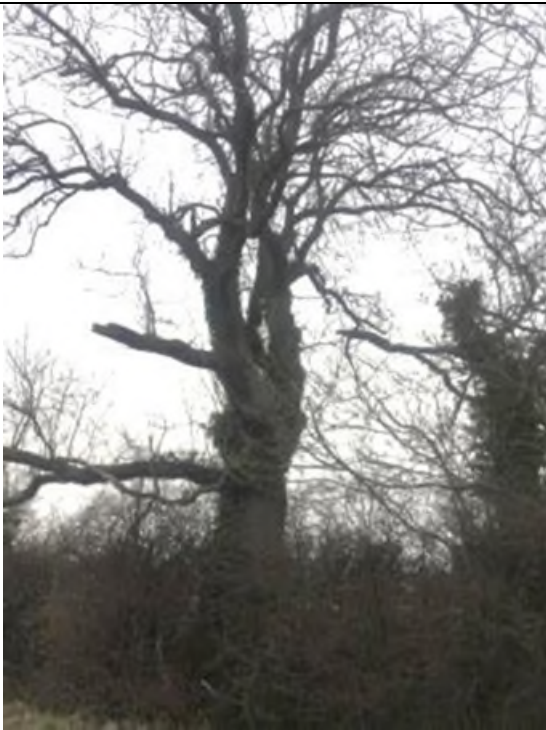
Description	<p>Grid reference: NZ 17401 98859</p> <p>Ancient ash situated in a hedgerow adjacent to A1, approximately 20 m high with a diameter at breast height of 1 m. Rot pockets were present on the eastern side of the trunk which appeared to be deep.</p>
	Limitations	None recorded.
	Bat evidence	None recorded.

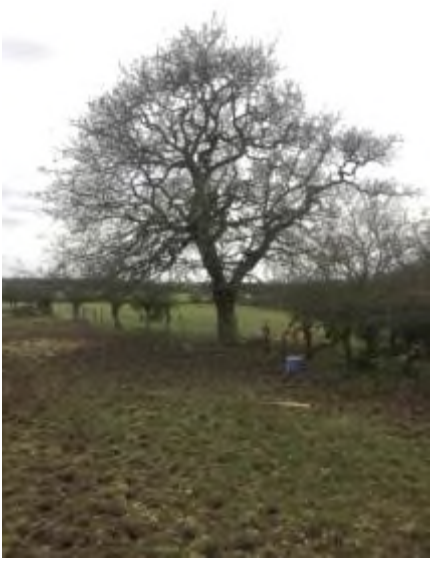
Description	<p>Grid reference: NZ 17453 99125</p> <p>Two semi-mature ash trees, approximately 12 m tall with a diameter of 0.3 m at breast height. Dense ivy was present on both trees.</p>
	Limitations	None recorded.
	Bat evidence	None recorded.
<p>Tree 144A</p> <p>Low bat roost potential</p>

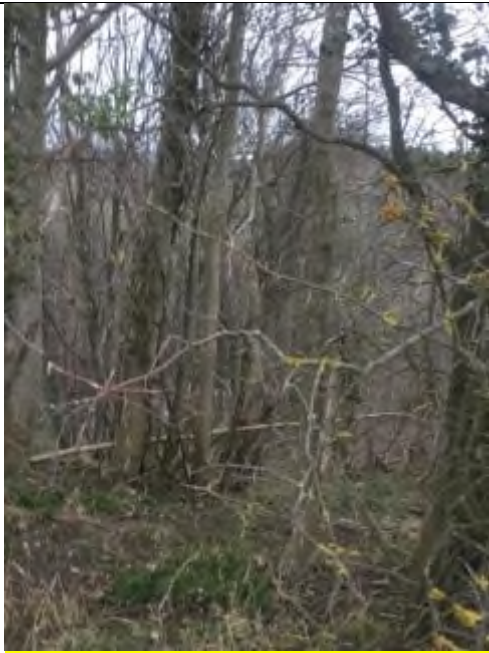
Description	Grid reference: NZ 17482 99416 Mature oak, approximately 16 m tall with a diameter of 0.9 m at breast height. Broken branches, split branches, knot hole with a dead peg, and other small knot holes present.
	Limitations	None recorded.
	Bat evidence	None recorded.
Tree 145 Low bat roost potential

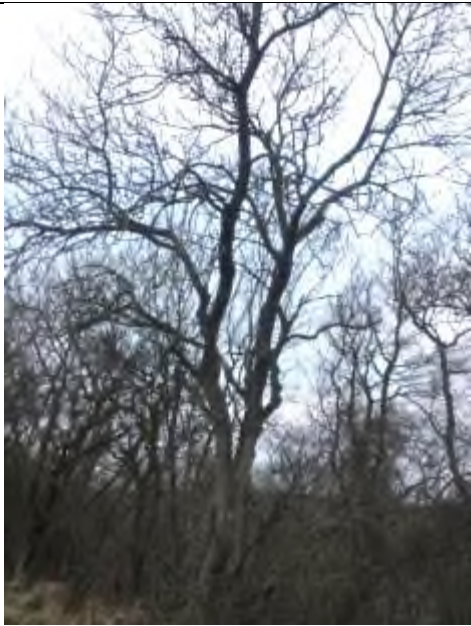
Tree 146 A Low bat roost potential

Description	Grid reference: NZ 17304 99697 Young birch, approximately 10 m tall with a diameter of 0.2 m at breast height. Crevice between the trunks which had rubbed together.
	Limitations	None recorded.
	Bat evidence	None recorded.

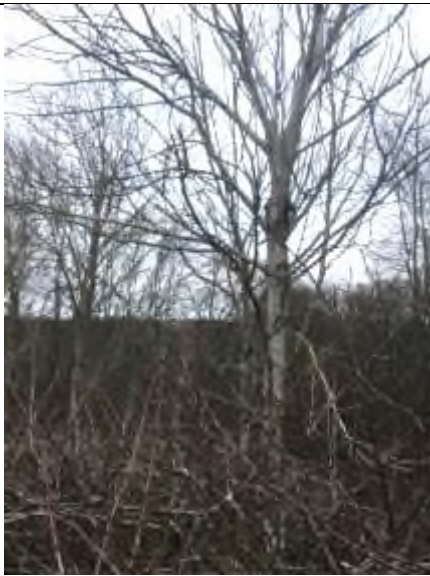
Description	Grid reference: NZ 17377 99699 Semi-mature ash, approximately 14 m tall with a diameter of 0.5 m at breast height. Frost crack present.
	Limitations	None recorded.
	Bat evidence	None recorded.
Tree 147A High bat roost potential

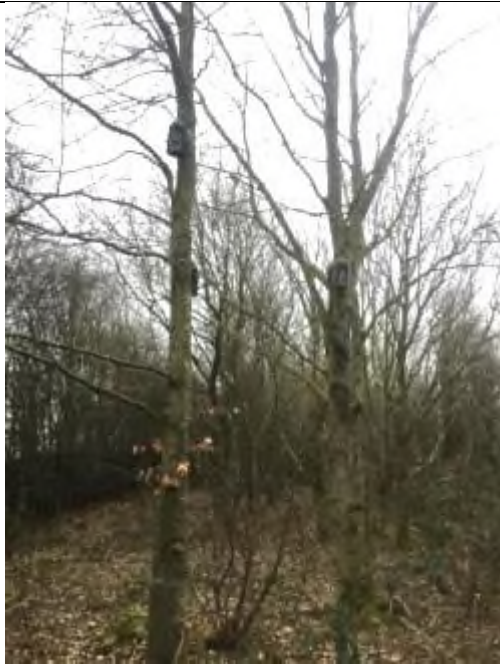
Two young ash trees, approximately 14 m tall with a diameter of 0.28 m at breast height. Two bat boxes on each tree.
	Limitations	None recorded.
	Bat evidence	None recorded.
Tree 148A High bat roost potential

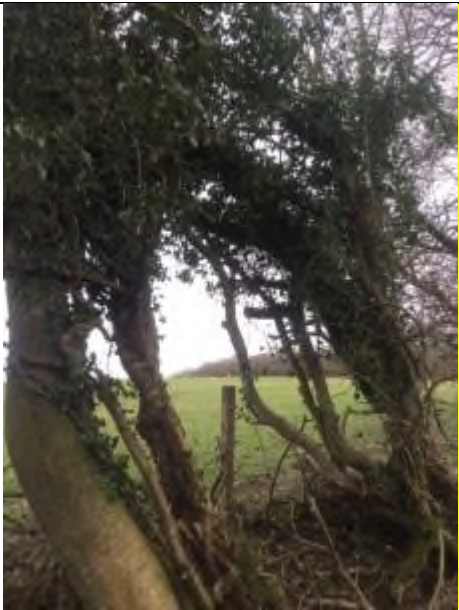
Tree 149A Low bat roost potential

Description	Grid reference: NZ 17469 99675 Two semi-mature beech and ash, approximately 14 m high with diameters at breast height of 0.3 m. Two bat boxes on each tree; part of Highways England monitoring scheme.
	Limitations	None recorded.
	Bat evidence	None recorded.

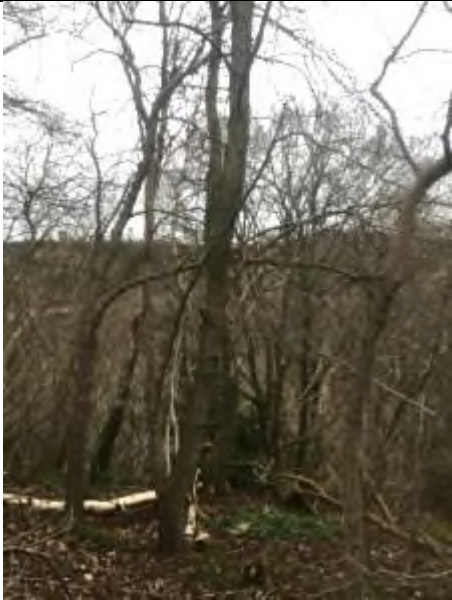
Description	Grid reference: NZ 17550 99789 Two semi-mature hawthorns and one semi-mature ash, between approximately 8 and 14 m tall. Both trees had a diameter of 0.3 m at breast height. Thick ivy was present on both trees.
	Limitations	None recorded.
	Bat evidence	None recorded.
Tree 150A Low bat roost potential

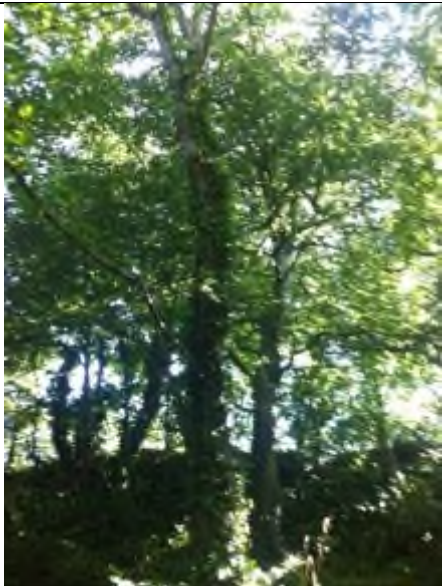
Description	Grid reference: NZ 17559 99805 Semi-mature ash, approximately 18 m tall with a diameter of 0.27 m at breast height. Crevice where branches had rubbed together.
	Limitations	None recorded.
	Bat evidence	None recorded.
Tree 151A Low bat roost potential

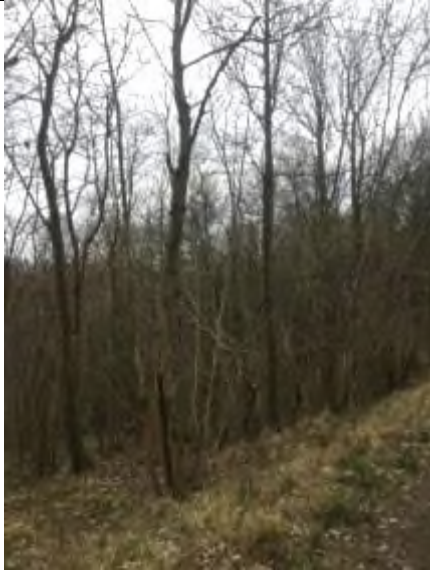
Tree 152A Moderate bat roost potential

Description	Grid reference: NZ 17356 99852 Semi-mature sycamore and ash treeline (2 and 3, respectively), approximately 18 m high with an average diameter of 0.45 m at breast height. Thick ivy was present on each tree.
	Limitations	None recorded.
	Bat evidence	None recorded.

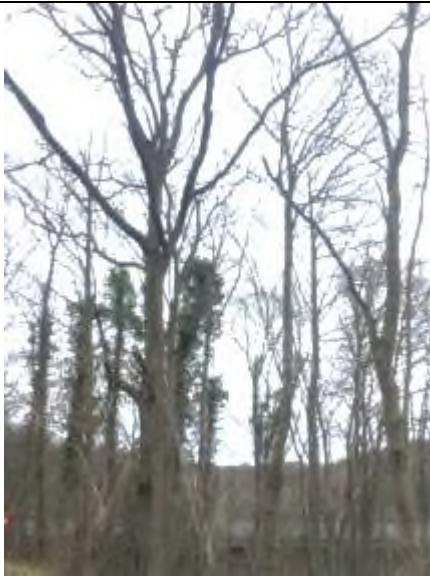
Description	Grid reference: NZ 17392 99894 Young ash, approximately 10 m tall with a diameter of 0.3 m at breast height. Large tear out of eastern side and hollow trunk.
	Limitations	None recorded.
	Bat evidence	None recorded.
Tree 153A Low bat roost potential

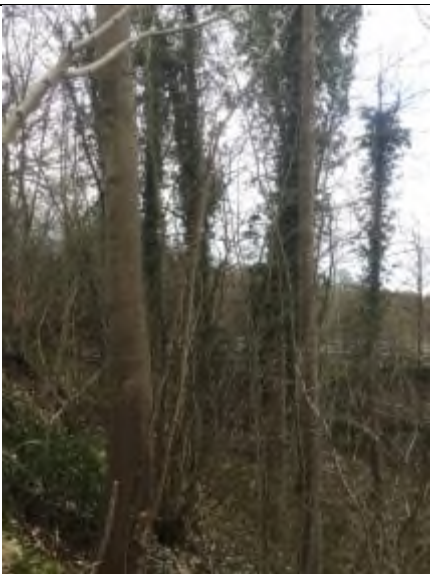
Approximately 18 m high with a diameter of 0.5 m at breast height. A knot hole was present along with broken and torn branches.
	Limitations	None recorded.
	Bat evidence	None recorded.
Tree 154 A Low bat roost potential

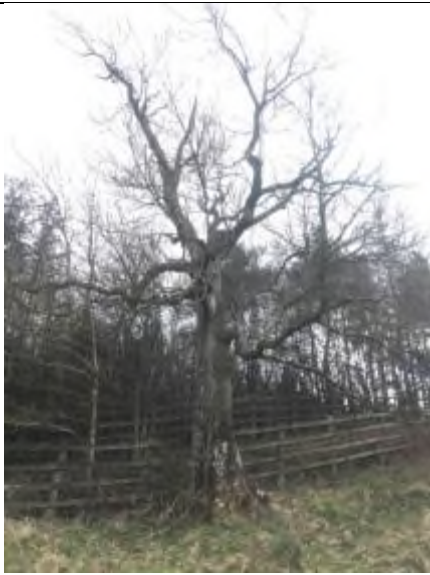
Tree 155A Low bat roost potential

Description	Grid reference: NZ 17419 99899 Two trees; a semi-mature ash and a semi-mature oak, approximately 16 m high with diameters at breast height of 0.3 m. Thick ivy cover was present on both trees.
	Limitations	None recorded.
	Bat evidence	None recorded.

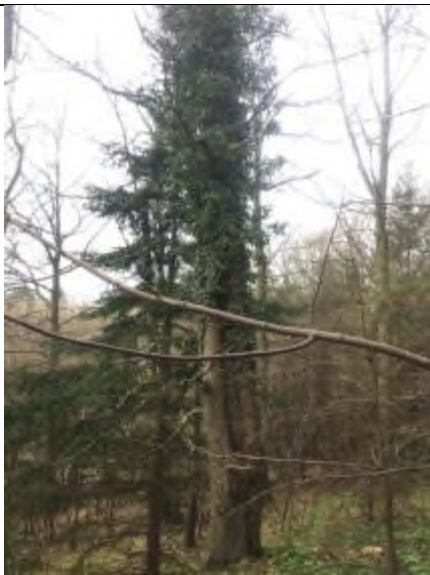
Description	Grid reference: NU 17433 00306 Mature ash, approximately 15 m tall with a diameter of 0.98 m at breast height. Broken and torn branches.
	Limitations	None recorded.
	Bat evidence	None recorded.
Tree 156A Moderate bat roost potential

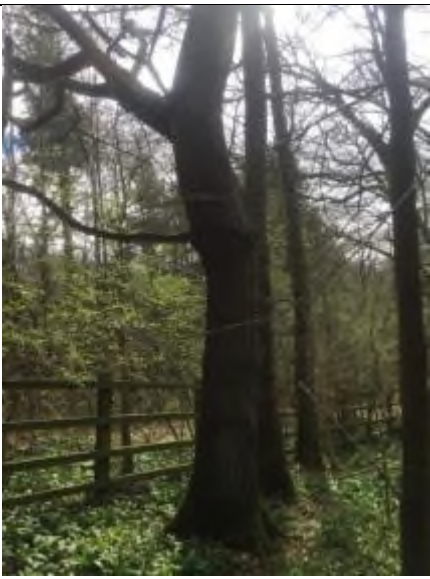
Tree 158A Low bat roost potential

Description	Grid reference: NU 17391 00577 A woodland with approximately 40 semi-mature ash, approximately 26 m high with a diameter of between 0.32 – 0.35 m at breast height, on average. Broken branches and one tree with a torn limb were present. Approximately 20 trees were covered in thick ivy.
	Limitations	None recorded.
	Bat evidence	None recorded.

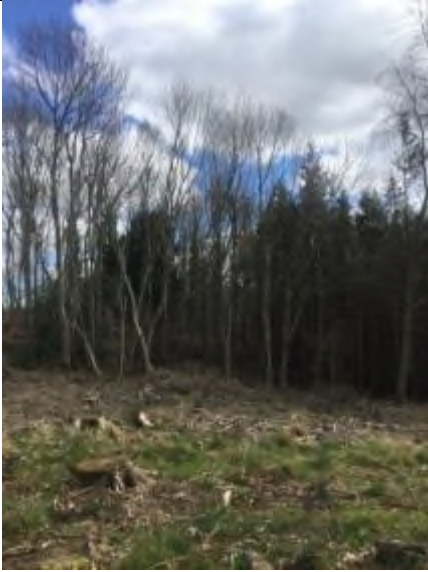
A1 Ecological Inspection of Trees and Woodlands			
SITE DETAILS			
Project Name:	A1 in Northumberland	Project Number:	B2104700
Site Name (if different):	Section B	Date of Inspection:	21 st -23 rd March 2016; 17 th – 19 th August 2016; 5 th – 6 th December 2016
Tree 1B Low bat roost potential

Description	Grid reference: NU 19775 15268 Mature ash, approximately 22 m tall and a diameter of 0.79 m at breast height. A tear out and a broken branch with large split at the end were present.	
	Limitations	None recorded.	
	Bat evidence	None recorded.

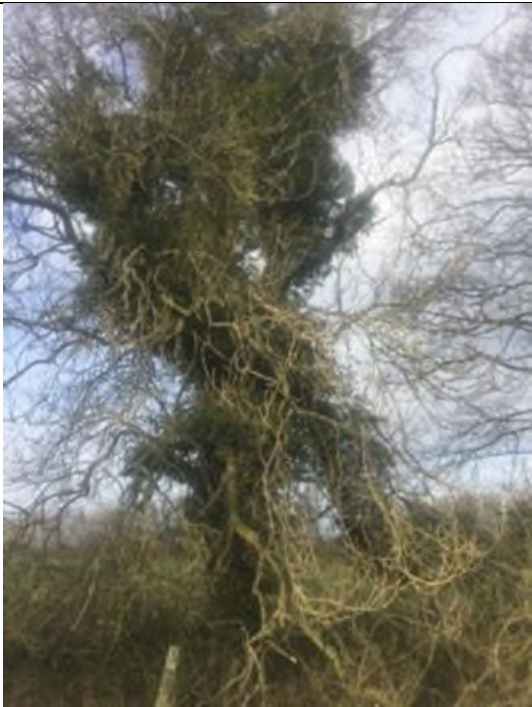
Description	Grid reference: NU 19513 15585 Mature ash situated in a tree line, approximately 20 m high with a diameter at breast height of 0.85 m. Dense ivy on all aspects and several small cracks on northern aspect.
	Limitations	None recorded.
	Bat evidence	None recorded.

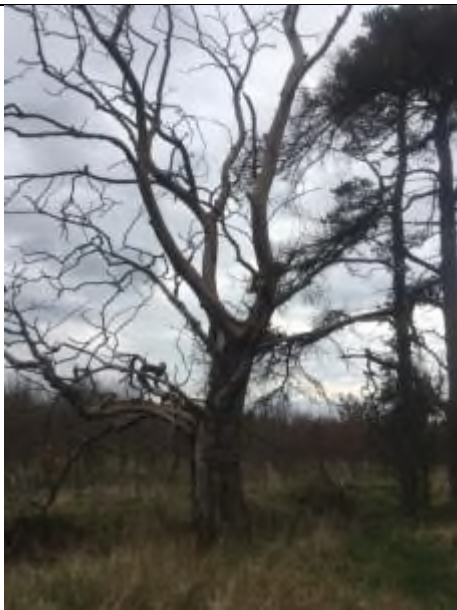
Tree 3B Moderate bat roost potential

Description	Grid reference: NU 19571 15834 Dead ash, approximately 20 m tall with a diameter of 0.86 m at breast height. Lifted bark was present up to a height of 8 m and a rot hole led to a cavity in the stem.
	Limitations	None recorded.
	Bat evidence	None recorded.
Tree 4B High bat roost potential

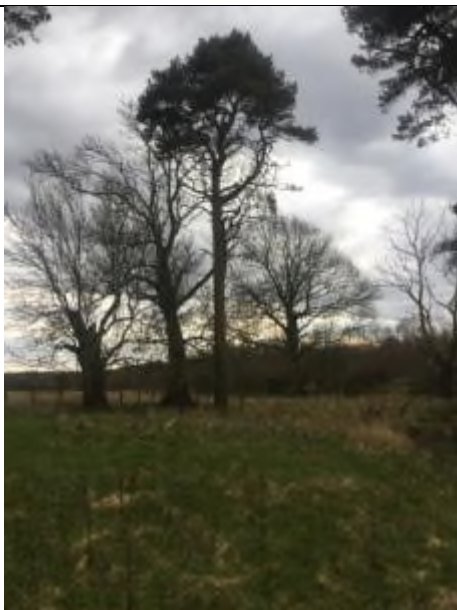
Description	Grid reference: NU 19601 15851 Six mature ash trees, approximately 24 m tall on average (one 14 m tall) with a diameter of between 0.8 m and 1.3 m at breast height. Rot holes, a fissure, a hollow trunk and broken limb were present.
	Limitations	None recorded.
	Bat evidence	None recorded.
Tree 5B High bat roost potential

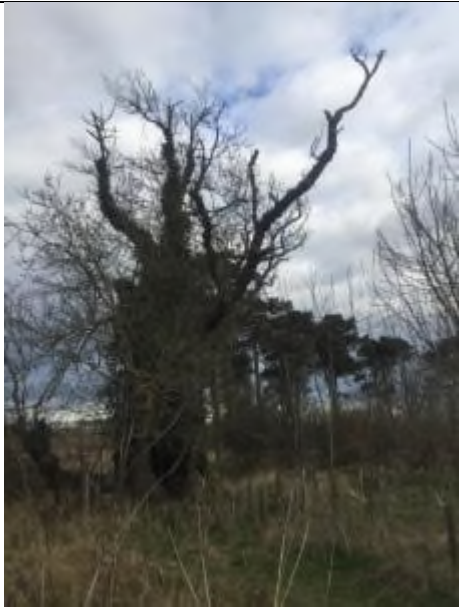
Description	Grid reference: NU 19517 15896 Over-mature ash, approximately 12 m tall with a diameter of 1 m at breast height. The tree had a hollow trunk and rot holes.
	Limitations	None recorded.
	Bat evidence	None recorded.
