A1 in Northumberland: Morpeth to Ellingham

Scheme Number: TR010041

6.7 Environmental Statement – Appendix 9.7 Bat Roost Potential Survey Report 2017

Bat Roost Potential Survey Report 2017

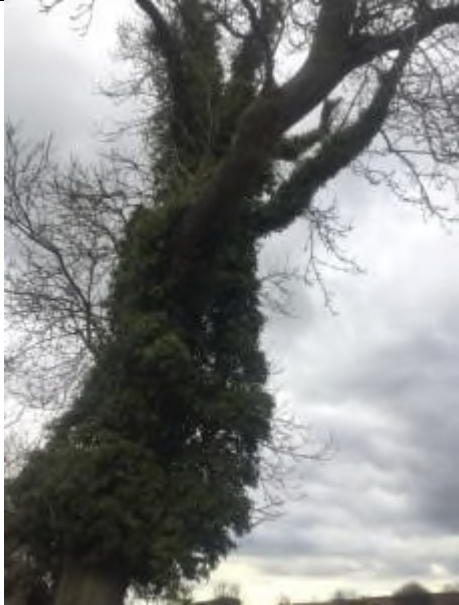
<p>Tree 6B</p> <p>High bat roost potential</p>

<p>Description</p>	<p>Grid reference: NU 19529 15902</p> <p>An over-mature ash, approximately 24 m tall with a diameter of 1.2 m at breast height. Thick-stemmed ivy and sideways-facing rot holes in limb.</p>
	<p>Limitations</p>	<p>None recorded.</p>
	<p>Bat evidence</p>	<p>None recorded.</p>
<p>Tree 7B</p> <p>Moderate bat roost potential</p>

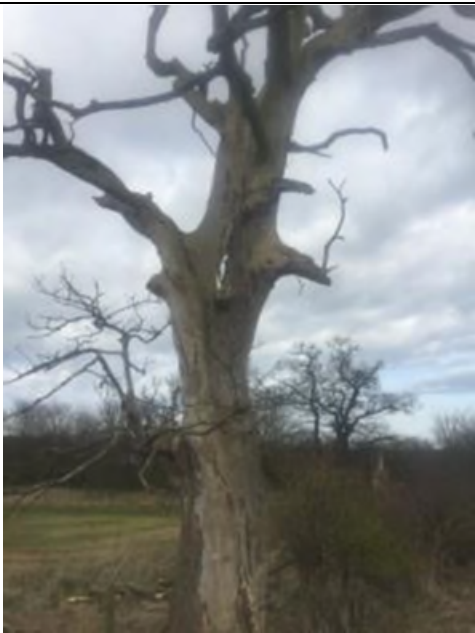
Description	Grid reference: NU 19389 15942 Standing dead tree present in a hedgerow, approximately 15 m high with a diameter at breast height of 1 m. Four small rot holes on the western aspect.
	Limitations	None recorded.
	Bat evidence	None recorded.
Tree 8B Moderate bat roost potential

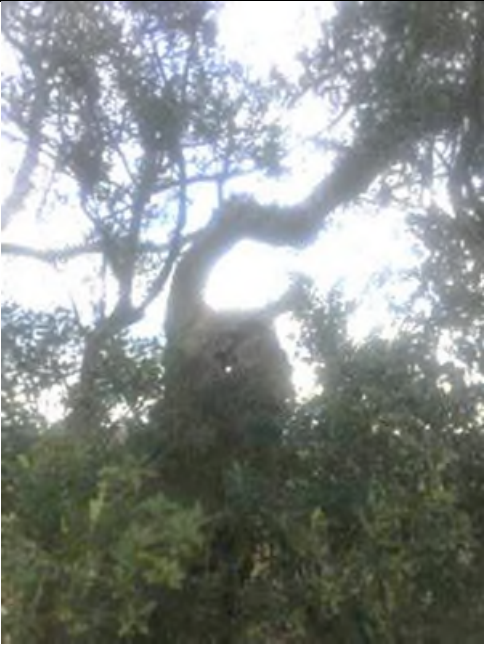
Description	Grid reference: NU 19246 16146 Ancient ash situated in a defunct hedgerow next to a stream, approximately 12 m tall with a diameter at breast height of 1 m. Deep internal rot, downward-facing rot pocket.
	Limitations	None recorded.
	Bat evidence	None recorded.

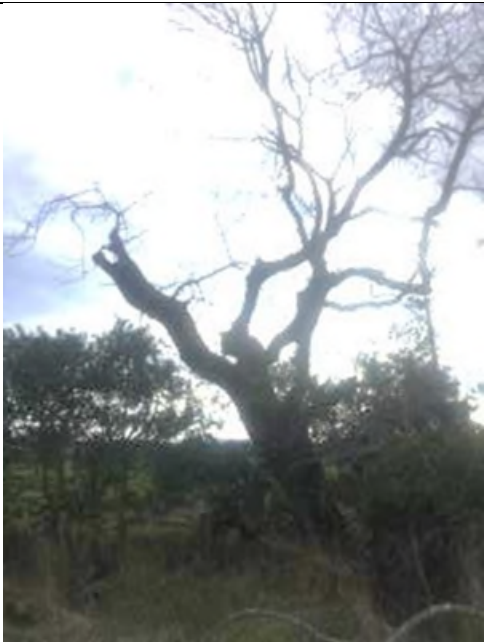
Tree 9B Moderate bat roost potential

Description	Grid reference: NU 19255 16144 Ancient ash situated in a hedgerow with a stream/ditch, approximately 15 m high and 0.75 m diameter at breast height. Lightning-struck with downward-facing hole.
	Limitations	None recorded.
	Bat evidence	None recorded.
Tree 10B Low bat roost potential

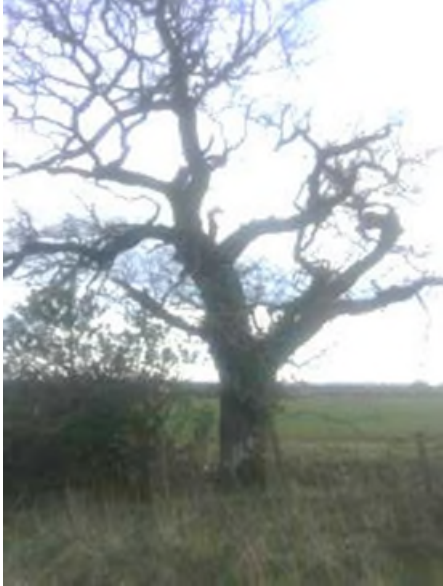
Description	Grid reference: NU 19266 16145 Ancient oak situated in a hedgerow and ditch, approximately 15 m tall with a diameter at breast height of 0.85 m. One obvious rot pocket and superficial ivy.
	Limitations	None recorded.
	Bat evidence	None recorded.
Tree 11B Low bat roost potential

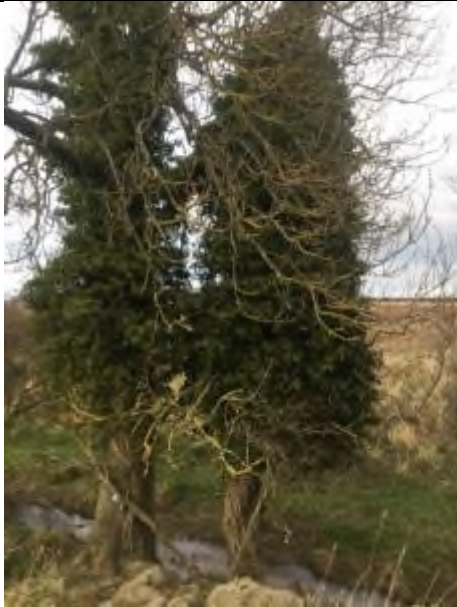
Description	Grid reference: NU 19469 16175 Two mature ash trees, approximately 12 and 16 m tall with a diameter of 0.66 m at breast height. Thick ivy stems, possibly obscuring other features.
	Limitations	None recorded.
	Bat evidence	None recorded.

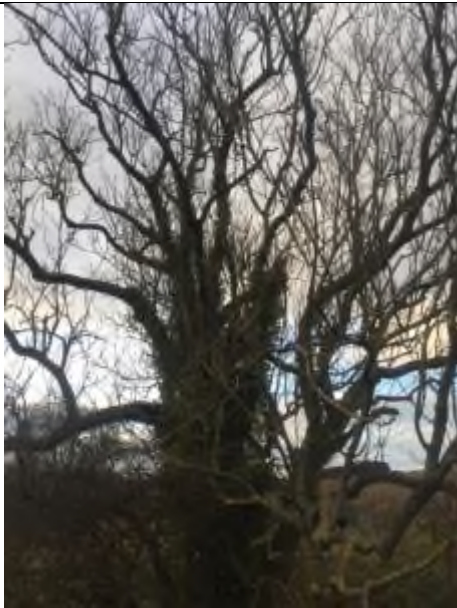
Tree 12B Moderate bat roost potential

Description	Grid reference: NU 19495 16178 Multi-stemmed mature ash, approximately 18 m tall with a diameter of 1.3 m at breast height. Sideways-facing rot holes, some thick ivy cover.
	Limitations	None recorded.
	Bat evidence	None recorded.
Tree 13B Low bat roost potential

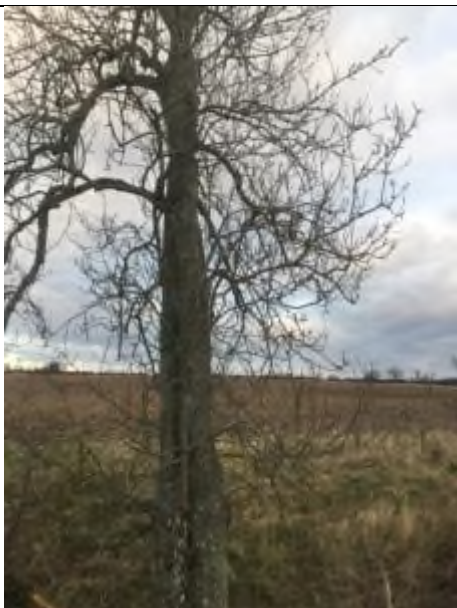
Description	Grid reference: NU 19425 16240 Mature ash, approximately 18 m tall and a diameter of 0.63 m at breast height. Cavities between dual trunks and small fissure but likely shallow.
	Limitations	None recorded.
	Bat evidence	None recorded.
Tree 14B Moderate bat roost potential

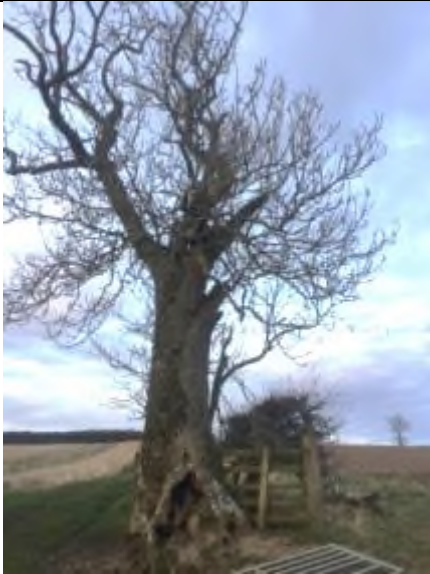
Description	Grid reference: NU 19421 16486 Mature ash, approximately 14 m tall with a diameter of 1.06 m at breast height. Hollow cavity in trunk at lower level, broken limb with probable cavity but facing up, and sideways-facing rot hole.
	Limitations	None recorded.
	Bat evidence	None recorded.

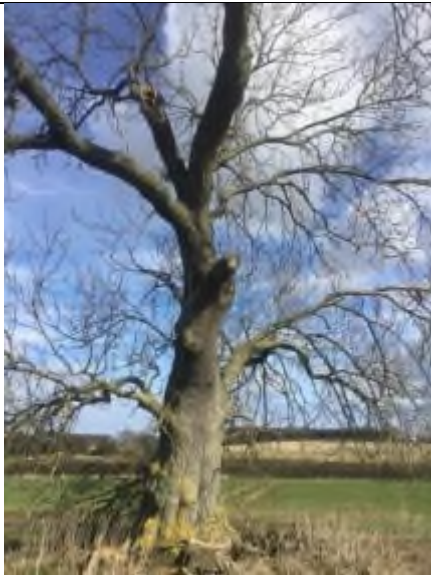
Tree 15B Moderate bat roost potential

Description	Grid reference: NU 19139 16514 Ancient ash present in a field, approximately 14 m high with a diameter at breast height of 0.5 m. Broken branches present, one leading to a rot hole.
	Limitations	None recorded.
	Bat evidence	None recorded.
Tree 16B Moderate bat roost potential

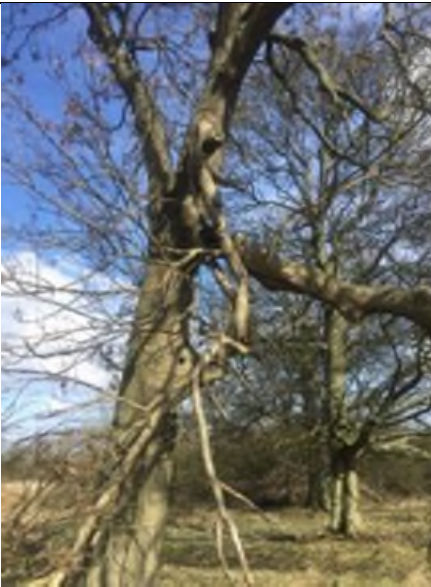
Description	Grid reference: NU 19088 16665 Mature ash present in a thicket, approximately 15 m high with a diameter at breast height of 0.6 m. Large split in scaffold limb and pruning cut present.
	Limitations	None recorded.
	Bat evidence	None recorded.
Tree 17B Moderate bat roost potential	No photo available	
	Description	Grid reference: NU 19125 16691 Mature beech tree situated within a thicket. The tree was approximately 25 m high with a diameter at breast height of 0.9 m. Two west facing rot holes were present at a height of 4 m and 7 m.
	Limitations	None recorded.
	Bat evidence	None recorded.

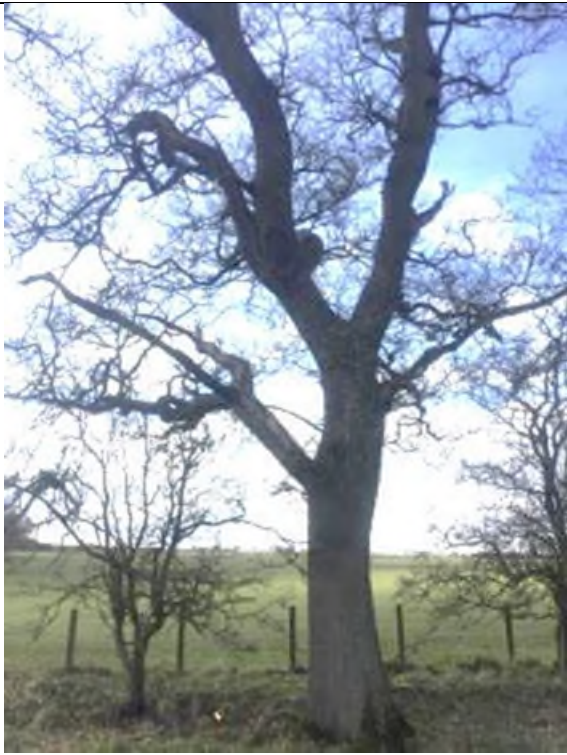
Description	Grid reference: NU 19084 16693 Mature oak present in a small remnant woodland, approximately 18 m high with a 0.75 m diameter at breast height. Long fissure in scaffold limb.
	Limitations	None recorded.
	Bat evidence	None recorded.

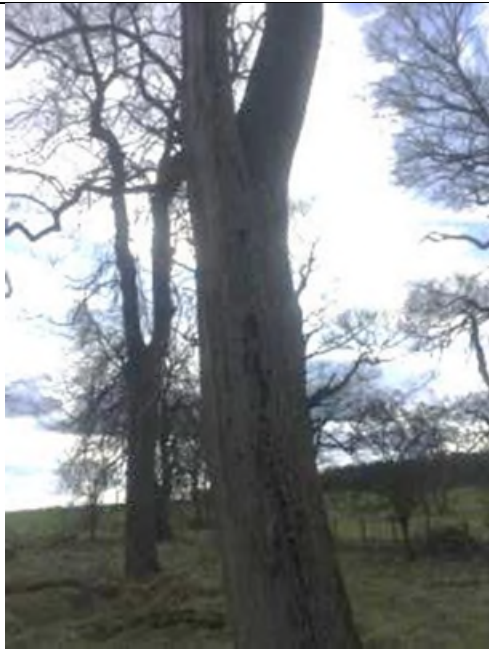
Tree 19B Moderate bat roost potential

Description	Grid reference: NU 19094 16715 Mature ash present in remnant woodland, approximately 22 m high with a 0.85 m diameter at breast height. Pockmarked bark and vertical fissures present with a possible crevice half way up main trunk.
	Limitations	None recorded.
	Bat evidence	None recorded.

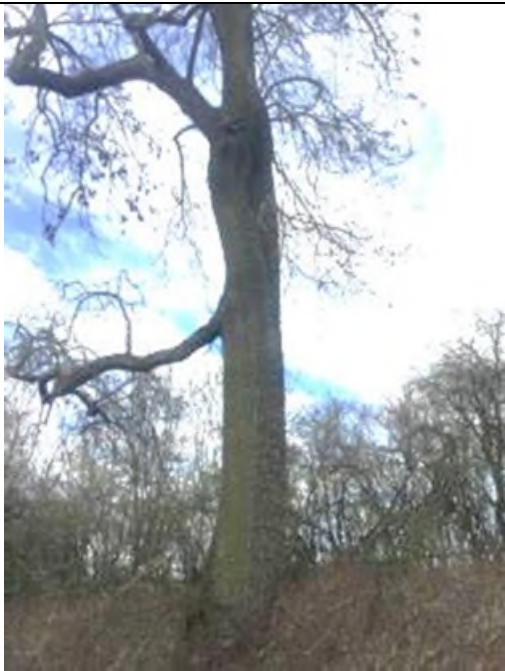
<p>Tree 20B</p> <p>Moderate bat roost potential</p>

Description	<p>Grid reference: NU 19139 16716</p> <p>Mature ash tree situated in a thicket. The tree was approximately 24 m high with a diameter at breast height of 0.7 m. Four south-facing rot holes at various heights.</p>
	Limitations	None recorded.
	Bat evidence	None recorded.

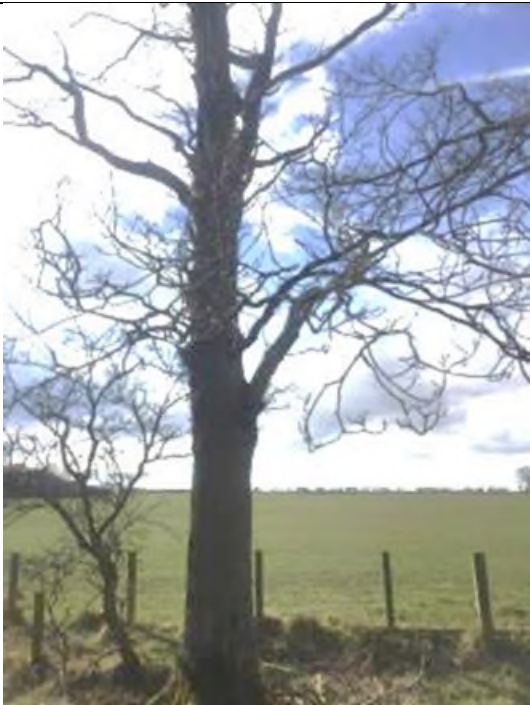
Description	Grid reference: NU 19074 16737 Mature oak present in a thicket, approximately 20 m high with a diameter at breast height of 0.6 m. A rot hole was present on the eastern aspect at a height of 4 m.
	Limitations	None recorded.
	Bat evidence	None recorded.

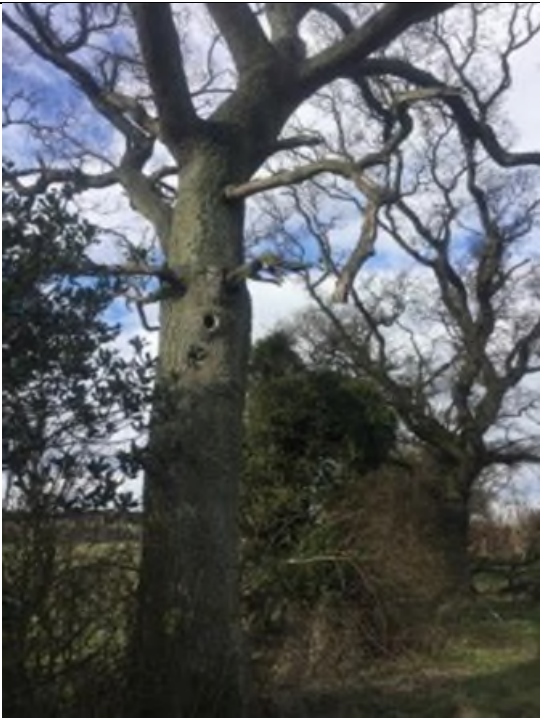
Tree 22B High bat roost potential

Description	Grid reference: NU 19058 16799 Ancient oak present in a thicket, approximately 18 m high and 0.75 m diameter at breast height. Large knot hole on southern aspect at 3.5 m on trunk.
	Limitations	None recorded.
	Bat evidence	None recorded.

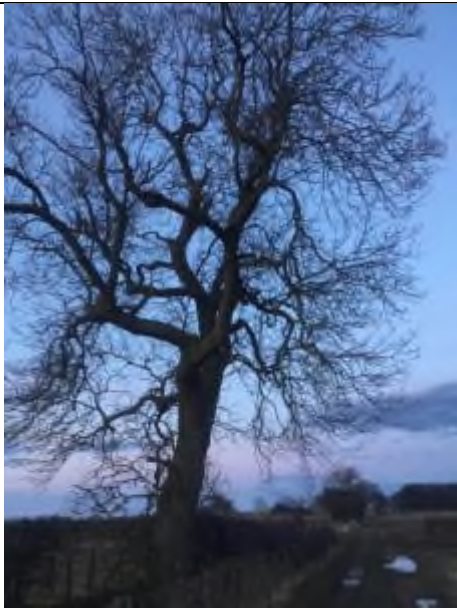
Tree 23B Low bat roost potential

Description	Grid reference: NU 19157 17357 Mature ash, approximately 26 m tall with a diameter of 1 m at breast height. The tree had a split bough and rot holes.
	Limitations	None recorded.
	Bat evidence	None recorded.
Tree 24B Low bat roost potential

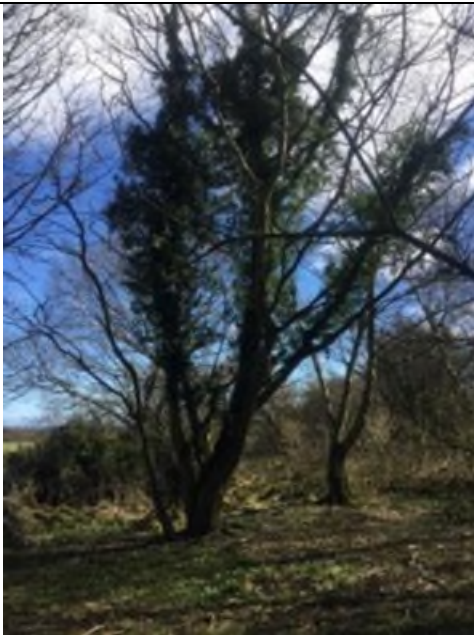
Description	Grid reference: NU 18664 18178 Mature ash, alder, sycamore, and oak woodland; some of which were multi-stemmed. The trees were approximately 20 m tall with an average diameter of 1.1 m at breast height. Thick ivy was present on many of the trees.
	Limitations	None recorded.
	Bat evidence	None recorded.
Tree 25B Moderate bat roost potential

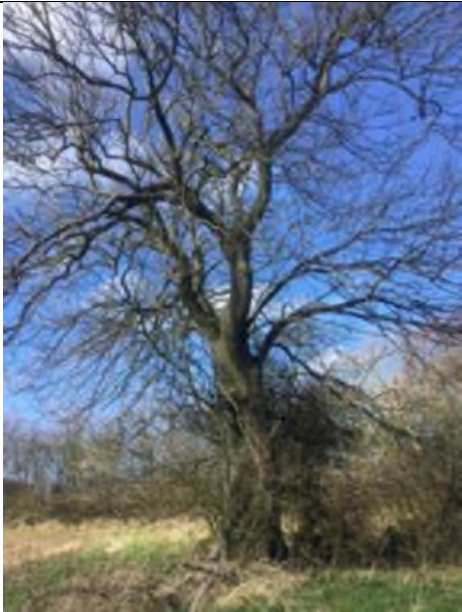
Description	Grid reference: NU 18690 18136 Mature ash, approximately 20 m tall with a diameter of 1.32 m at breast height. Broken branches and a knot hole were present near the top of the tree.
	Limitations	None recorded.
	Bat evidence	None recorded.

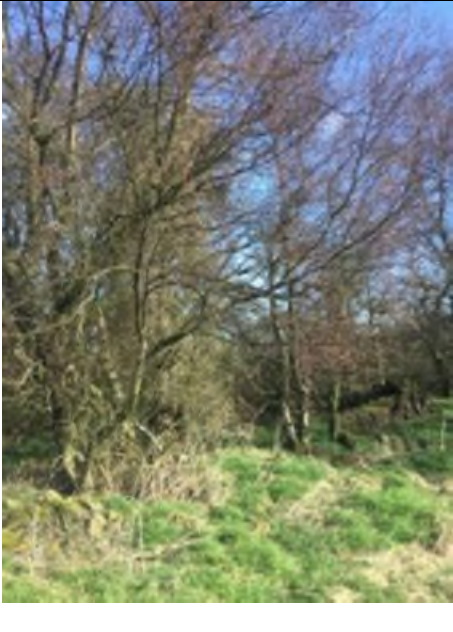
<p>Tree 26B</p> <p>Low bat roost potential</p>

Description	<p>Grid reference: NU 18699 18142</p> <p>11 mature birch trees in a row, approximately 14 m tall on average with a diameter of between 0.33 m and 0.7 m at breast height. Knot holes (relatively shallow) and open hollow trunks were present.</p>	
	Limitations	None recorded.	
	Bat evidence	None recorded.	
<p>Tree 27B</p> <p>Moderate bat roost potential</p>

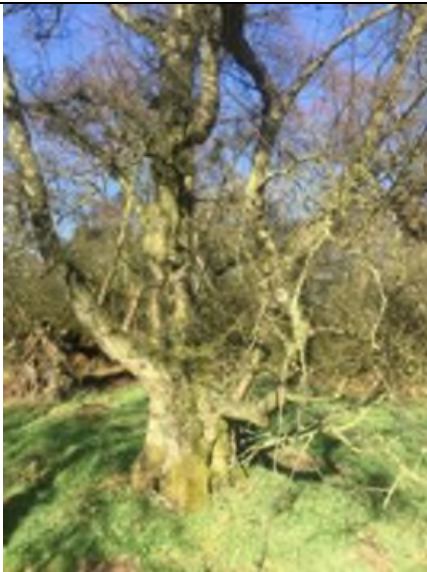
Description	Grid reference: NU 18721 18143 Mature birch, approximately 14 m tall with a diameter of 0.71 m at breast height. The tree had a hollow trunk.
	Limitations	None recorded.
	Bat evidence	None recorded.

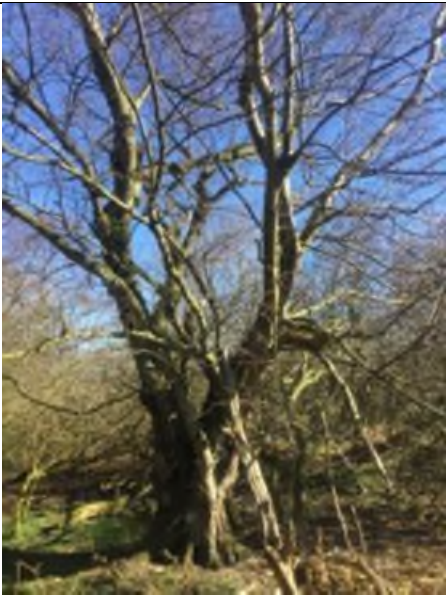
Tree 29B Low bat roost potential

Description	Grid Reference: NU 18721 18152 Mature multi-stemmed birch, approximately 14 m tall with a diameter of 1 m at breast height. The tree had broken branches and knot holes.
	Limitations	None recorded.
	Bat evidence	None recorded.
Tree 30B Low bat roost potential

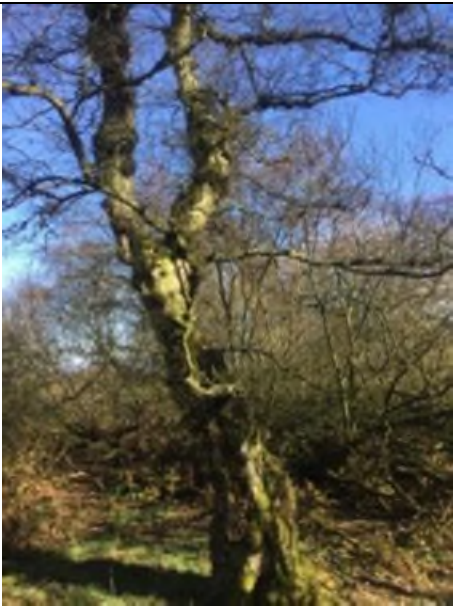
Description	Grid reference: NU 18719 18154 A mature birch, approximately 14 m tall with a diameter of 0.66 m at breast height. The tree had a hollow rotten trunk.
	Limitations	None recorded.
	Bat evidence	None recorded.
Tree 31B Moderate bat roost potential

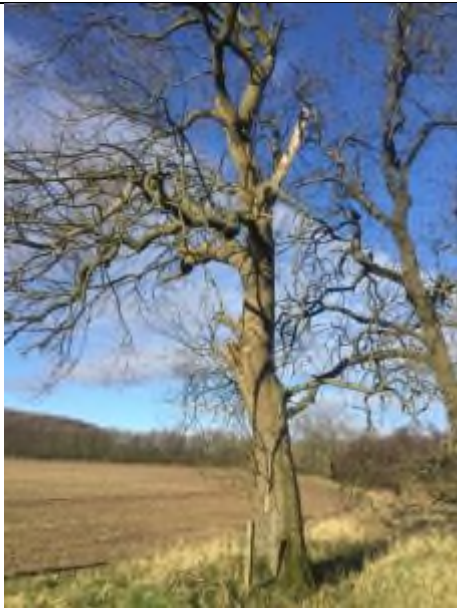
Description	Grid reference: NU 18799 18134 Mature ash, approximately 22 m tall with a diameter of 0.8 m at breast height. Multiple tear outs were present with rotten heartwood beneath creating crevices.
	Limitations	None recorded.
	Bat evidence	None recorded.

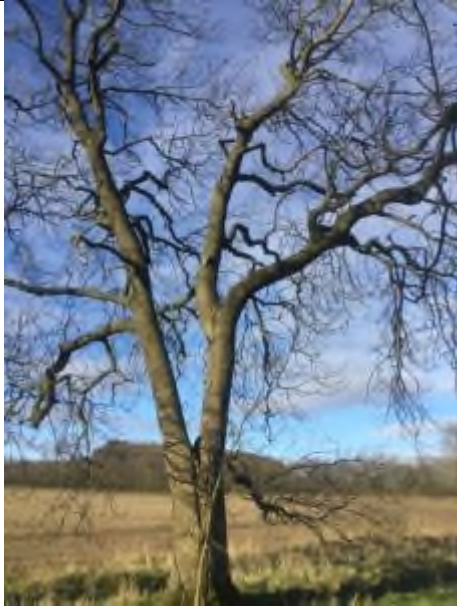
Tree 32B Low bat roost potential

Description	Grid reference: NU 18791 18141 Mature ash, approximately 22 m tall with a diameter of 1 m at breast height. Hollow core at base of twin trunks, crevice caused by rubbing branches. However, may be too exposed to be used by bats.
	Limitations	None recorded.
	Bat evidence	None recorded.

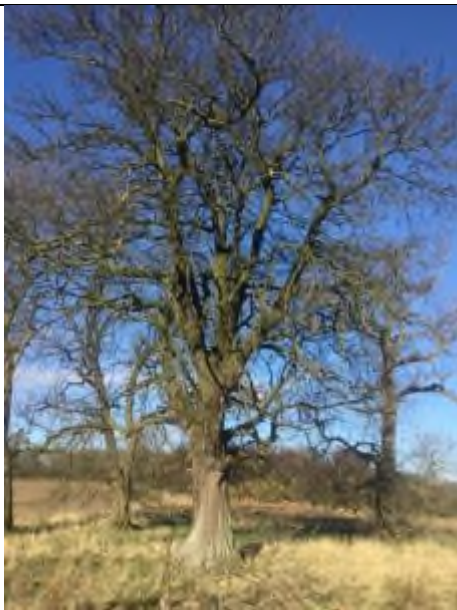
Tree 33B Low bat roost potential

Description	Grid reference: NU 18811 18144 Mature horse chestnut, approximately 20 m tall with a diameter of 1.1 m at breast height. The tree had split and broken branches.
	Limitations	None recorded.
	Bat evidence	None recorded.
Tree 34B Low bat roost potential

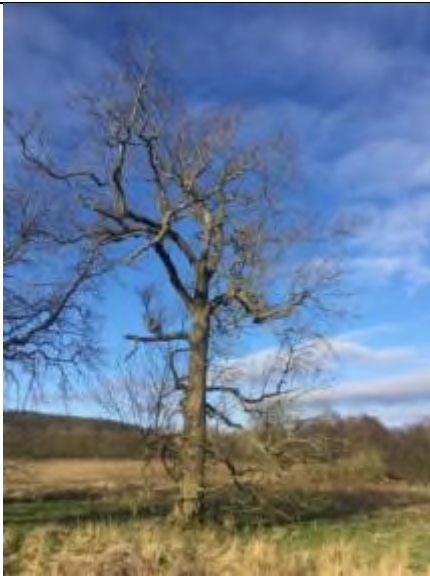
Description	Grid reference: NU 18796 18155 Mature ash, approximately 22 m tall with a diameter of 1 m at breast height. The tree had broken branches, a rotten trunk, and a small section of lifted bark.
	Limitations	None recorded.
	Bat evidence	None recorded.
Tree 35B Low bat roost potential

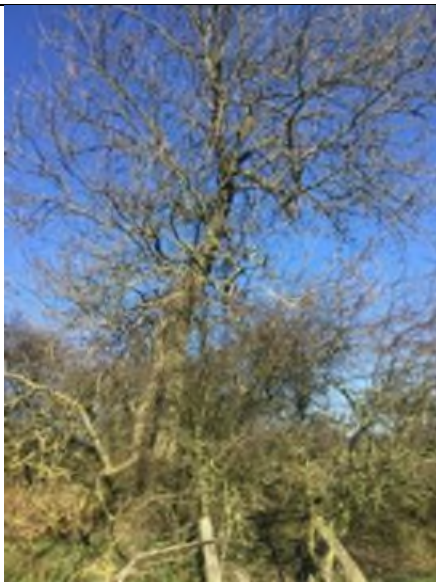
Description	Grid reference: NU 18735 18179 Mature ash, approximately 20 m tall with a diameter of 0.58 m at breast height. The tree had broken branches.
	Limitations	None recorded.
	Bat evidence	None recorded.

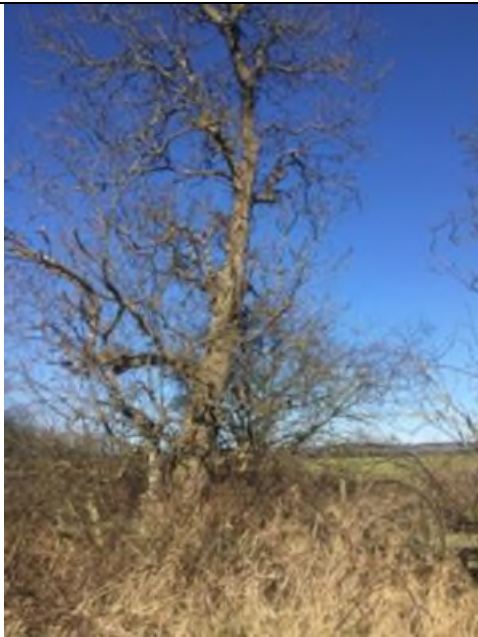
Tree 36B High bat roost potential

Description n	Grid reference: NU 187598 18191 Mature ash, approximately 20 m tall with a diameter of 1.2 m at breast height. The tree had an old tear out, a rotten hollow trunk, and rot holes.
	Limitations	None recorded.
	Bat evidence	None recorded.
Tree 37B Low bat roost potential

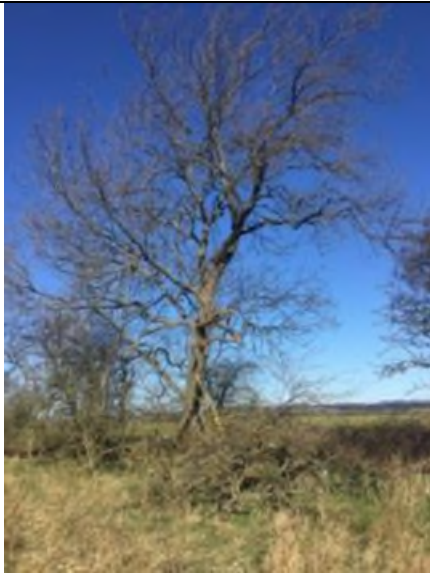
Description	Grid reference: NU 18780 18188 A mature ash, approximately 20 m tall with a diameter of 0.69 m at breast height. The tree had broken and split limbs.
	Limitations	None recorded.
	Bat evidence	None recorded.
Tree 38B Low bat roost potential

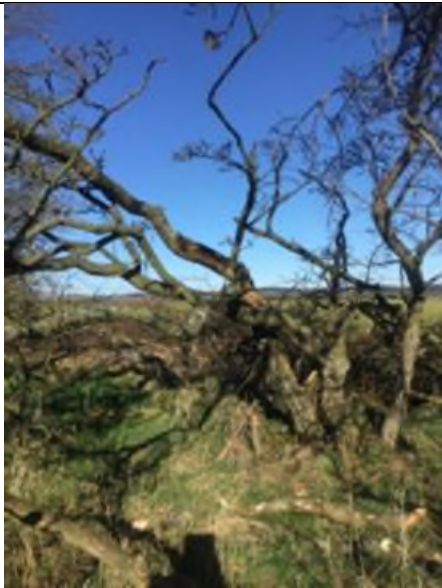
Description	Grid reference: NU 18799 18195 Mature hawthorn, approximately 5 m tall with a diameter of 0.36 m at breast height. The tree had a split, rotten trunk.
	Limitations	None recorded.
	Bat evidence	None recorded.

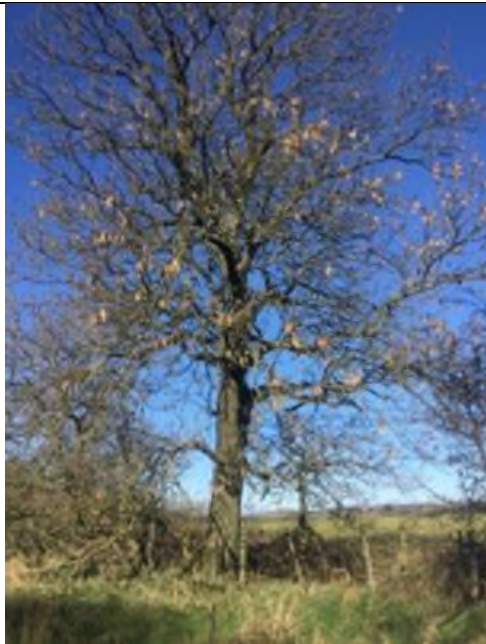
Tree 39B Low bat roost potential

Description	Grid reference: NU 18801 18191 Mature ash, approximately 20 m tall with a diameter of 0.68 m at breast height. The tree had broken, dead branches, a small knot hole and a fissure on a branch on the northern aspect.
	Limitations	None recorded.
	Bat evidence	None recorded.

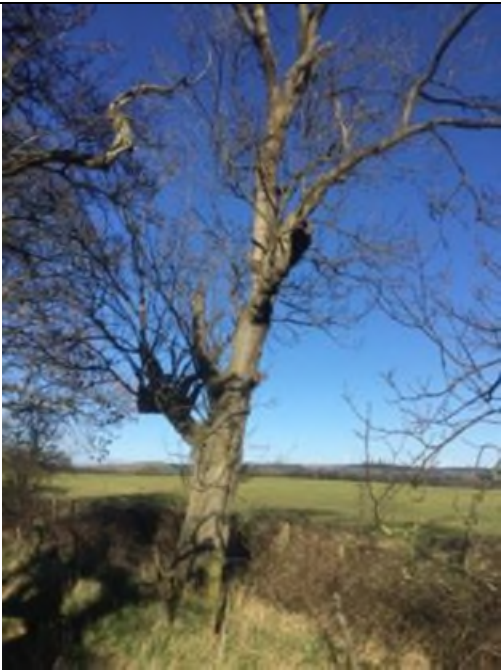
Tree 40B Low bat roost potential

Description	Grid reference: NU 18813 18192 Mature ash, approximately 16 m tall with a diameter of 0.85 m at breast height. Some dead and broken branches were present on the tree.
	Limitations	None recorded.
	Bat evidence	None recorded.

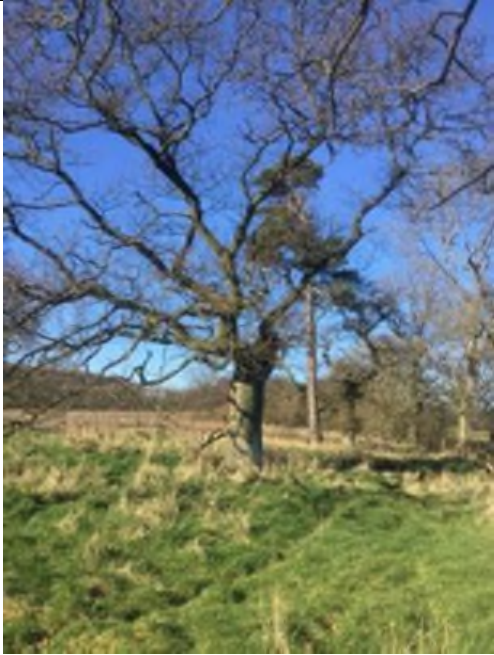
Tree 42B High bat roost potential

Description	Grid reference: NU 18837 18183 Mature oak, approximately 20 m tall with a diameter of 1.2 m at breast height. A large tear out was present, as well as a crevice caused by rubbing branches, a hazard beam in a limb on the eastern side of the tree with side-facing opening, a knot hole on the northern aspect and lifted bark.
	Limitations	None recorded.
	Bat evidence	None recorded.

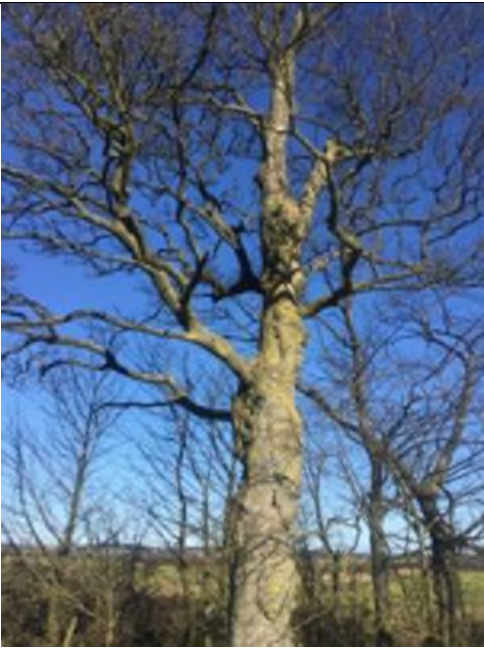
Tree 43B Low bat roost potential

Description	Grid reference: NU 18849 18193 A mature sycamore, approximately 20 m tall with a diameter at breast height of 0.8 m. A tear-out was present on the southern aspect of at an approximate height of 8 m.
	Limitations	None recorded.
	Bat evidence	None recorded.

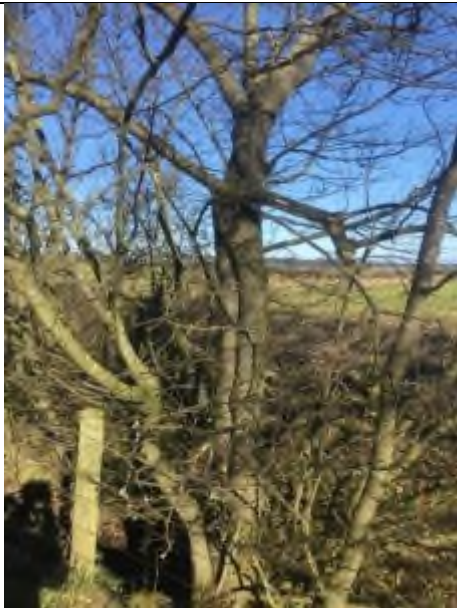
Tree 44B Low bat roost potential

Description	Grid reference: NU 18849 18195 Mature wych elm, approximately 12 m tall with a diameter of 0.25 m at breast height. A frost crack was present leading to a crevice at the top as well as a small knot hole.
	Limitations	None recorded.
	Bat evidence	None recorded.

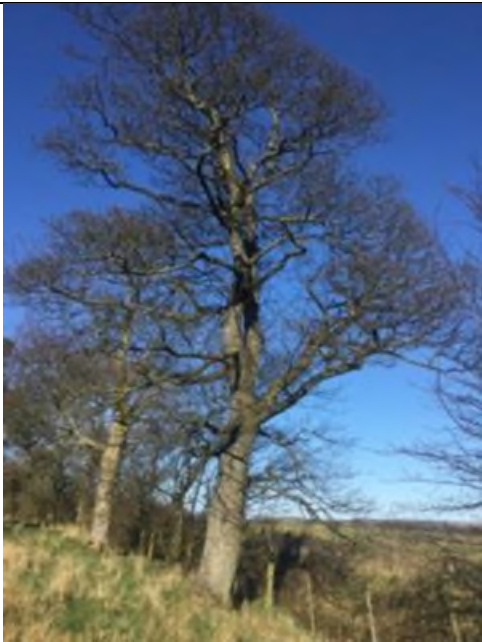
Tree 45B Low bat roost potential

Description	Grid reference: NU 18860 18191 Mature horse chestnut, approximately 20 m tall with a diameter of 0.72 m at breast height. Small rot holes were present next to broken branches as well as a hollow trunk with a low entrance.
	Limitations	None recorded.
	Bat evidence	None recorded.

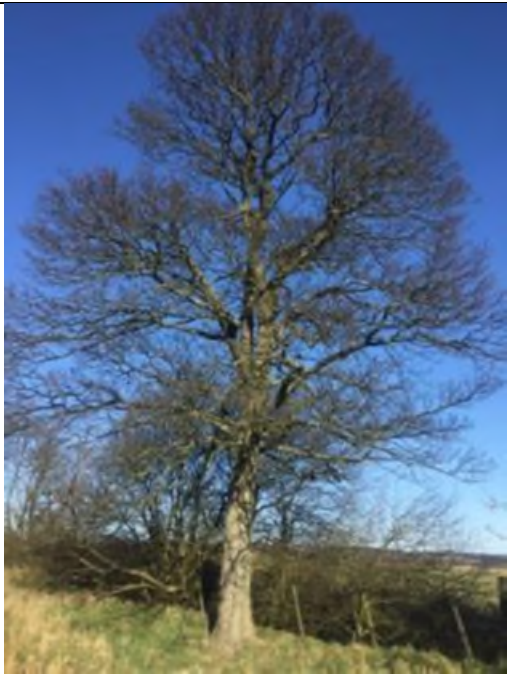
Tree 46B Low bat roost potential

Description	Grid reference: NU 18888 18193 Mature horse chestnut, approximately 22 m tall with a diameter of 0.63 m at breast height. A tear-out was present near the top of the tree and a broken branch with a small crevice behind on the eastern aspect.
	Limitations	None recorded.
	Bat evidence	None recorded.

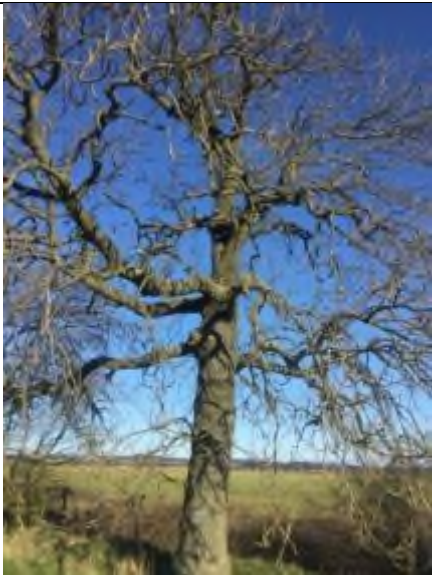
Tree 47B Low bat roost potential

Description n	Grid reference: NU 18912 18195 Mature ash, approximately 16 m tall with a diameter of 0.68 m at breast height. A tear out on the southern aspect was present which has created a shallow crevice.
	Limitations	None recorded.
	Bat evidence	None recorded.
T202B Moderate bat roost potential

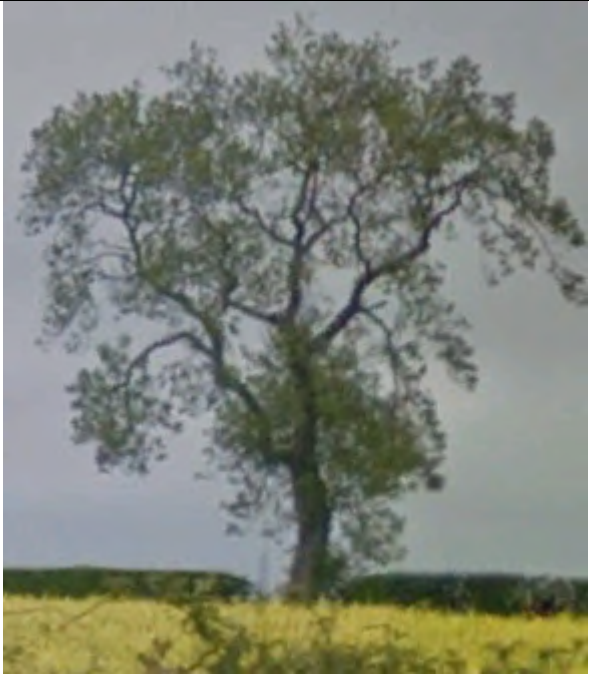
<p style="text-align: center;">Image taken from Google Earth Pro</p>	
	Description	Grid reference: NU 18099 19809 Mature ash, approximately 14 m high with a diameter at breast height of 0.8 m. No potential features were observed from a distance but the size of the tree suggested at features may have been present.
	Limitations	Surveyed from the road, viewed from a distance so potential features could not be ruled out.

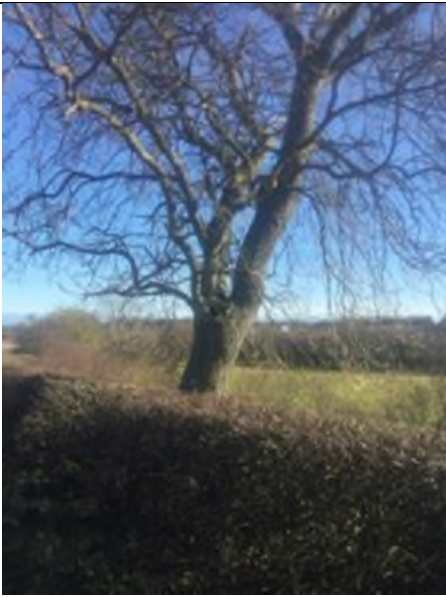
Tree 49B Low bat roost potential

Description	Grid reference: NU 17808 20087 Mature ash present in a hedgerow, approximately 14 m high with a 0.75 m diameter at breast height. A rot hole with staining was present.
	Limitations	None recorded.
	Bat evidence	None recorded.
T201B Low bat roost potential

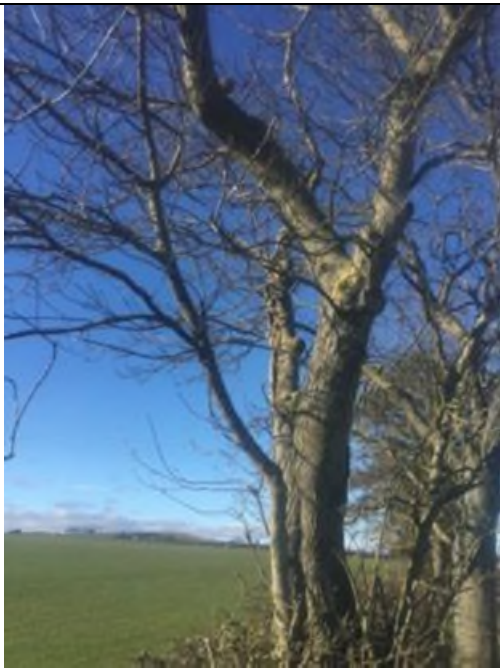
Description	<p>Grid reference: NU 17750 20188</p> <p>Semi-mature ash present in a hedgerow, approximately 12 m high with a 0.75 m diameter at breast height. A rot pocket was present at the point where the stem split, and a tear out facing south with rot led to void up in trunk. Smaller rot holes and minor crevices were also present.</p>
	Limitations	None recorded.
	Bat evidence	None recorded.

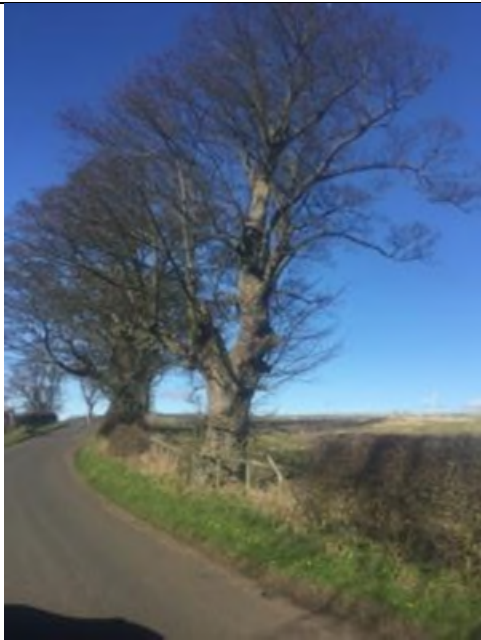
Tree 51B Low bat roost potential

Description	Grid reference: NU 17274 20397 Ancient sycamore in hedgerow, approximately 15 m high with a diameter at breast height of 1.3 m. A rot pocket was present on the eastern-facing limb leading to a potential void.
	Limitations:	None recorded.
	Bat evidence:	None recorded.

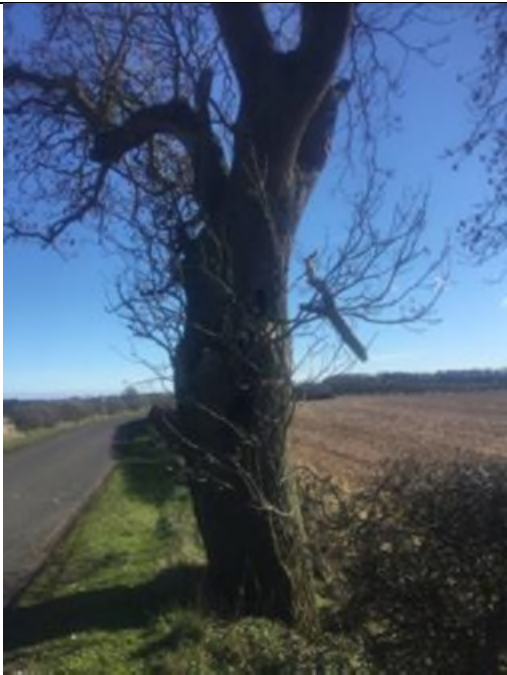
Tree 52B Moderate bat roost potential

Description	Grid reference: NU 17270 20399 Ancient ash in hedgerow, approximately 15 m high with a diameter at breast height of 1.2 m. Fissure present in trunk leading to potential voids.
	Limitations	None recorded.
	Bat evidence	None recorded.

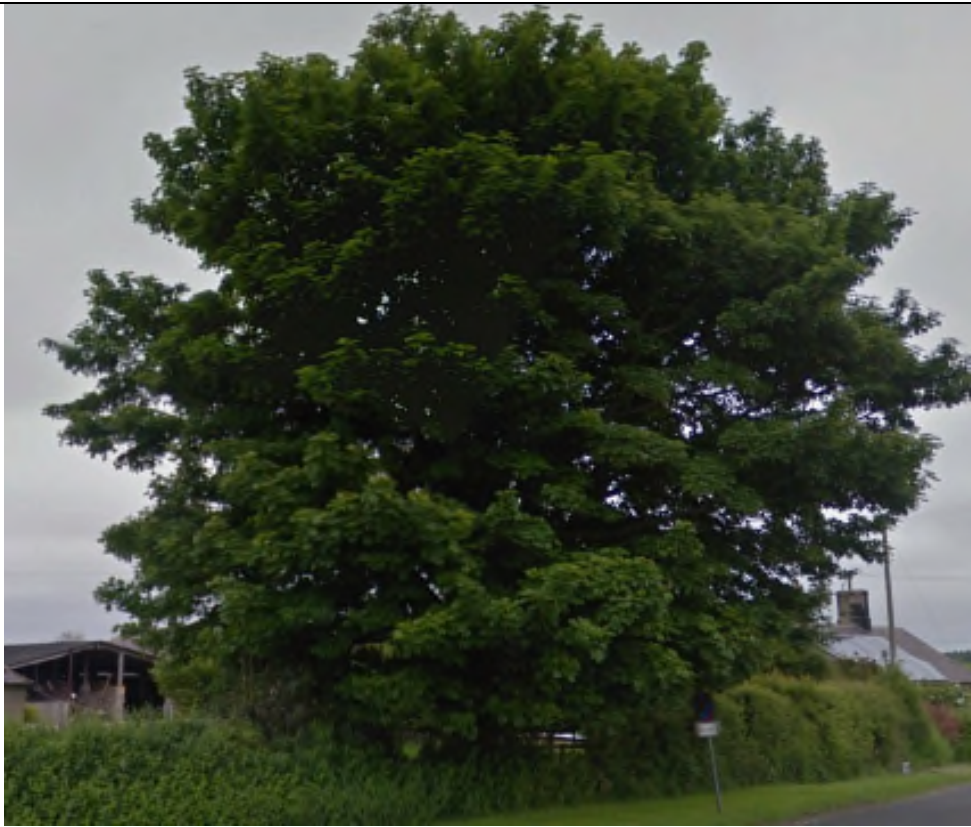
Image taken from Google Earth Pro	
	Description	<p>Grid reference: NU 17758 20625</p> <p>Mature horse chestnut tree, approximately 16 m high and 0.8 m diameter at breast height. No features were observed from the southern side, but the size of the tree suggests that features may have been present on the northern aspect that could not be viewed.</p>
	Limitations	Surveyed from the road, so the northern aspect could not be viewed.
	Bat evidence	None recorded.

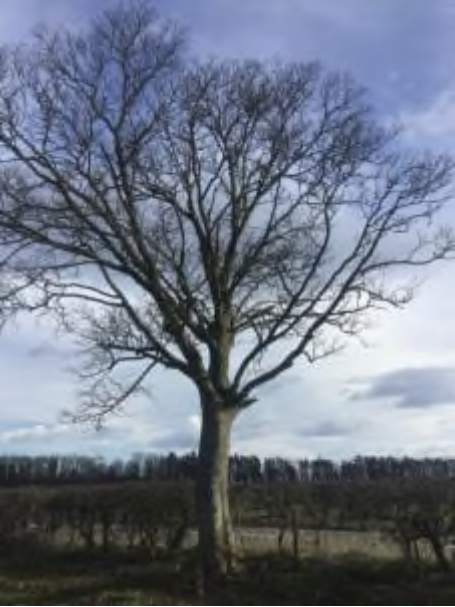
<p>Tree 53B</p> <p>Low bat roost potential</p>

Description	<p>Grid reference: NU 17962 20636</p> <p>Mature sycamore, approximately 16 m tall with a diameter of 0.6 m at breast height. A broken branch with sideways-facing rot hole was present.</p>
	Limitations	None recorded.
	Bat evidence	None recorded.
<p>Tree 54B</p> <p>Low bat roost potential</p>

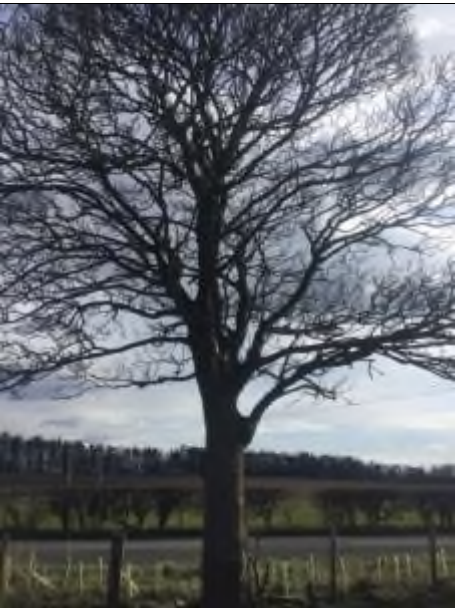
Description	Grid reference: NU 18076 20675 Mature London Plane, approximately 16 m tall with a diameter of 0.72 m at breast height. A rot hole was present, it was probably shallow and blocked, but could not be fully inspected from ground level.
	Limitations	None recorded.
	Bat evidence	None recorded.
Tree 55B Moderate bat roost potential

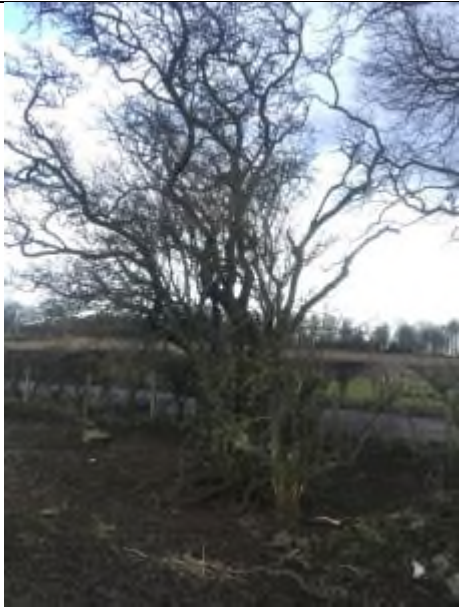
Description	Grid reference: NU 18108 20685 Mature hawthorn, approximately 12 m tall with a diameter of 1.34 m at breast height. A tear-out with a very small cavity above was present, not suitable for more than one or two bats.
	Limitations	None recorded.
	Bat evidence	None recorded.

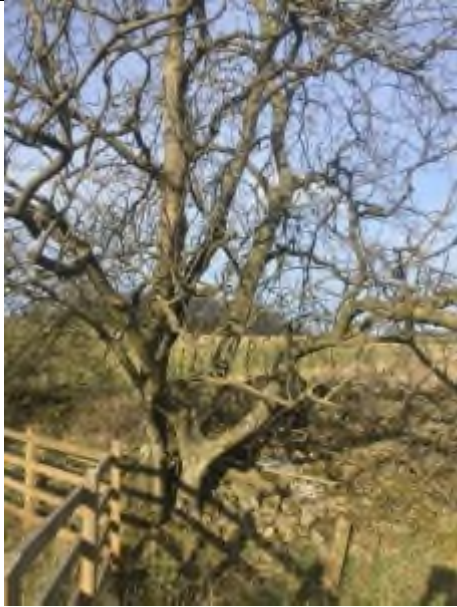
Tree 56B Low bat roost potential

Description	Grid reference: NU 17604 21033 Mature ash, approximately 16 m tall with a diameter of 1.3 m at breast height. A sideways-facing rot hole was present on the southern aspect as well as some welds where limbs rub together.
	Limitations	None recorded.
	Bat evidence	None recorded.

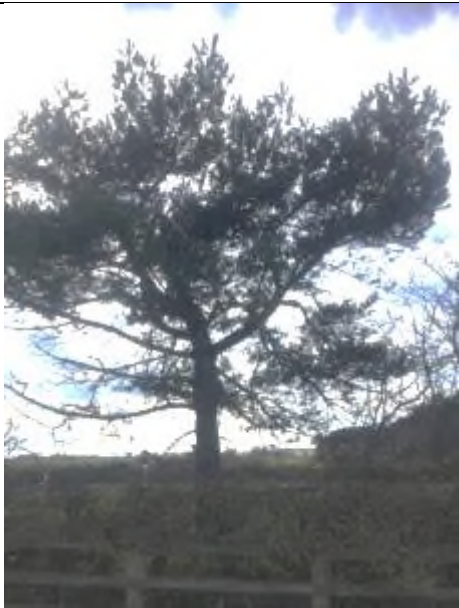
Tree 57B Low bat roost potential

Description	Grid reference: NU 17552 21142 Semi mature scots pine, approximately 12 m tall with a diameter of 0.35 m at breast height. Natural fluting in bark creating a crevice, at a height of 4 m on the north side of the stem.
	Limitations	None recorded.
	Bat evidence	None recorded.

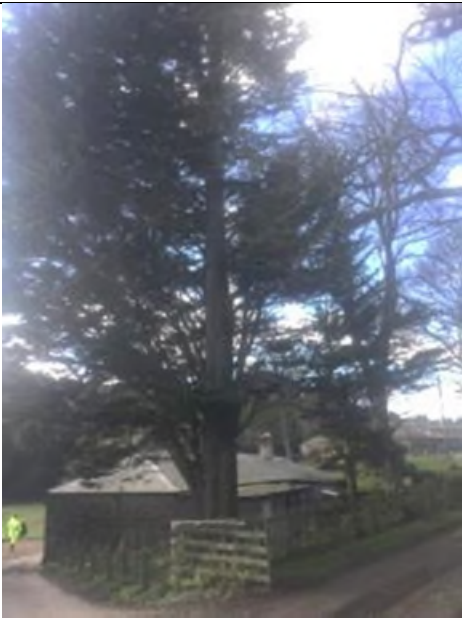
Tree 58B Moderate bat roost potential

Description	Grid reference: NU 17395 21293 Ancient cypress tree situated within a garden, approximately 20 m high with diameter at breast height of 1.2 m. A large fissure was present on the northern aspect of the trunk.
	Limitations	None recorded.
	Bat evidence	None recorded.

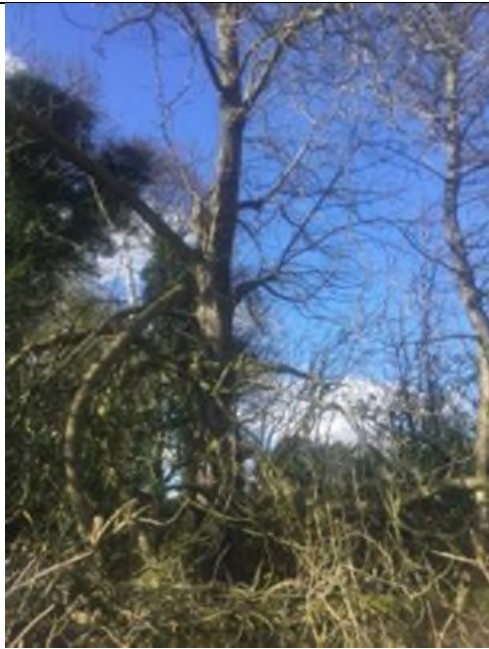
Tree 59B Low bat roost potential

Description	Grid reference: NU 17390 21341 Mature horse chestnut tree situated on a field edge. The tree was approximately 15 m high with a diameter at breast height of 0.7 m. Several fissures were present on the eastern aspect.
	Limitations	None recorded.
	Bat evidence	None recorded.

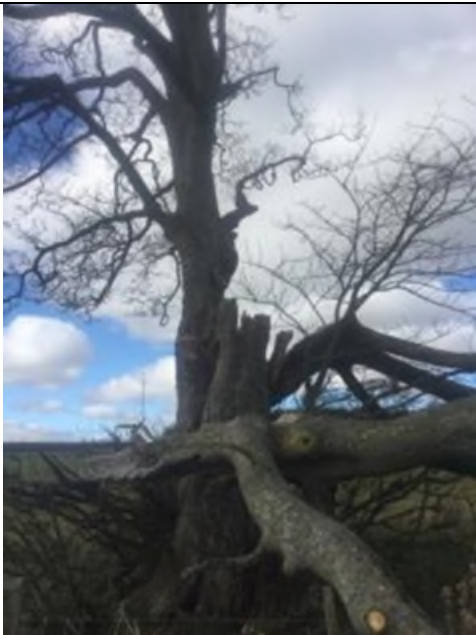
Tree 60B Moderate bat roost potential

Description	<p>Grid reference: NU 17041 21341</p> <p>Ancient sycamore situated on a field boundary, approximately 16 m high with a diameter at breast height of 1.4 m. Several cracks and fissures were present where the stem had collapsed.</p>
	Limitations	None recorded.
	Bat evidence	None recorded.

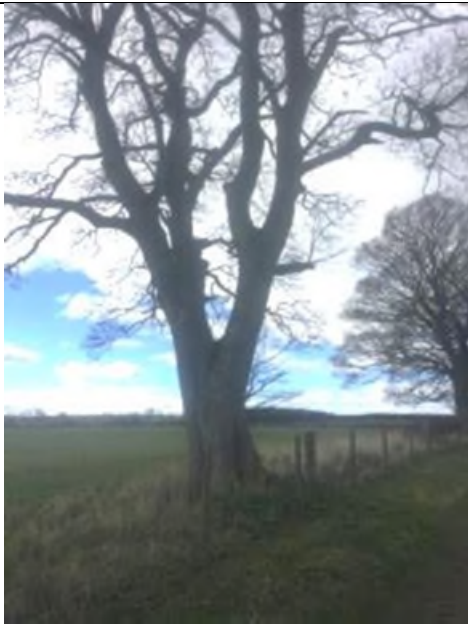
Tree 61B Moderate bat roost potential

Description	Grid reference: NU 16781 21370 Mature sycamore situated on a field boundary. The tree was approximately 20 m high with a diameter at breast height of 1.1 m. Several rot holes were present on all aspects.
	Limitations	None recorded.
	Bat evidence	None recorded.
Tree 62B Moderate bat roost potential

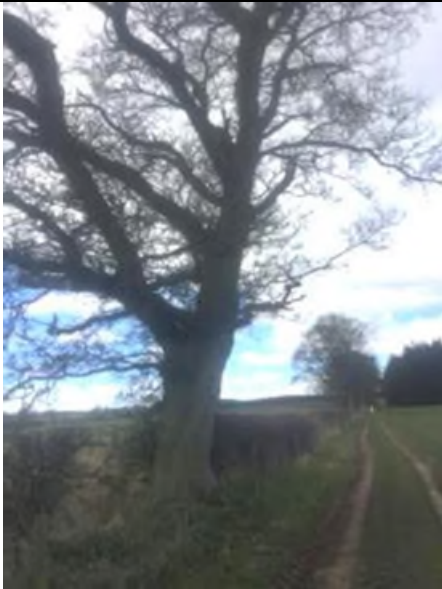
Description	Grid reference: NU 16928 21387 Mature oak situated on a field boundary. The tree was approximately 16 m high with a diameter at breast height of 0.8 m. Several hazard beams were present in the limbs on all aspects of the tree.
	Limitations	None recorded.
	Bat evidence	None recorded.
Tree 63B Moderate bat roost potential

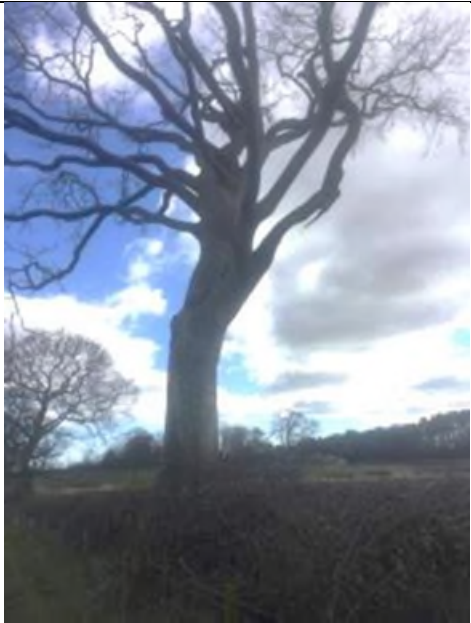
Description	Grid reference: NU 16960 21390 Mature alder situated on a field boundary. The tree was approximately 14 m high with a diameter at breast height of 0.7 m. Several long rot holes were present in the stem, on all aspects of tree.
	Limitations	None recorded.
	Bat evidence	None recorded.

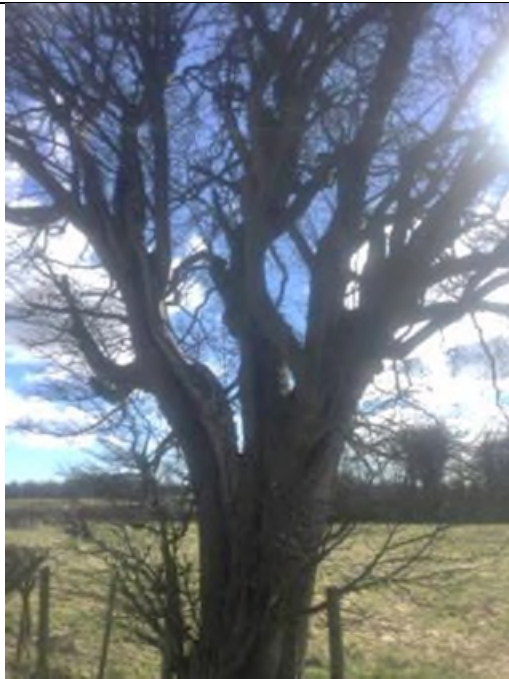
Tree 65B High bat roost potential

Description	Grid reference: NU 17293 21424 Ancient sycamore situated in a defunct hedgerow, approximately 12- 14 m high with a diameter at breast height of 1.2 m. Multiple deep fissures to northwest trunk and scaffold limbs. Longitudinal cracks along underside of smaller branches were widespread.
	Limitations	None recorded.
	Bat evidence	None recorded.
Tree 66B
