A1 in Northumberland: Morpeth to Ellingham

Scheme Number: TR010041

6.7 Environmental Statement – Appendix 9.7 Bat Roost Potential Survey Report 2017

Bat Roost Potential Survey Report 2017

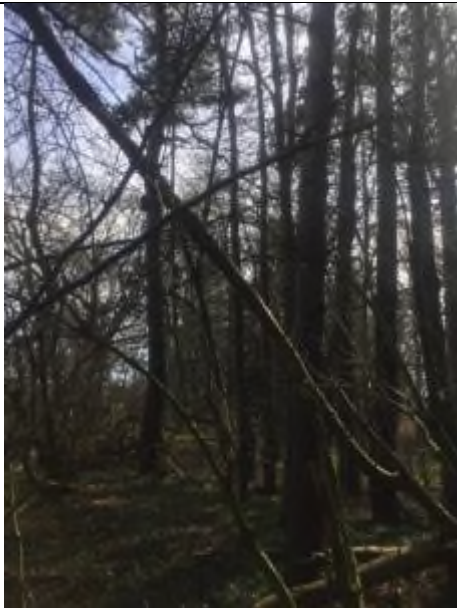
High bat roost potential

Description	Grid reference: NU 17164 21836 Mixed semi-mature scots pine, beech, silver birch, horse chestnut, alder and oak, approximately 20 m tall with an average diameter of 0.3 m at breast height. Nine bat boxes were present on three trees - labelled A1 IHS, box ref 84 and 93, date inspected (illegible).
	Limitations	None recorded.
	Bat evidence	None recorded.

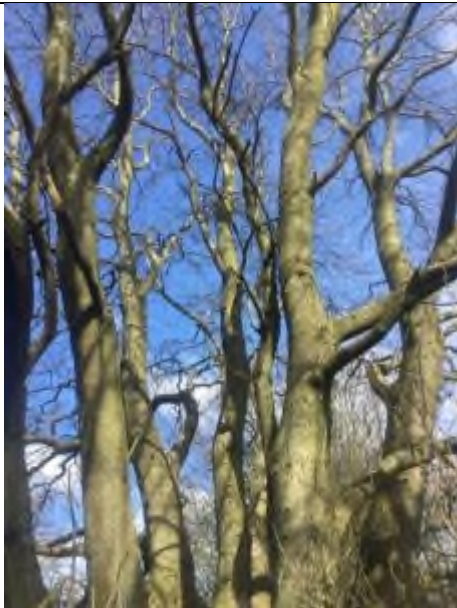
Tree 67B Low bat roost potential

Description	Grid reference: NU 17191 21929 Mature sweet chestnut tree within woodland, approximately 18 m tall with a multi-stemmed diameter of 2.8 m at breast height. Dead branches were present but no cavities were recorded. A weld caused by the stems rubbing together was present.
	Limitations	None recorded.
	Bat evidence	None recorded.

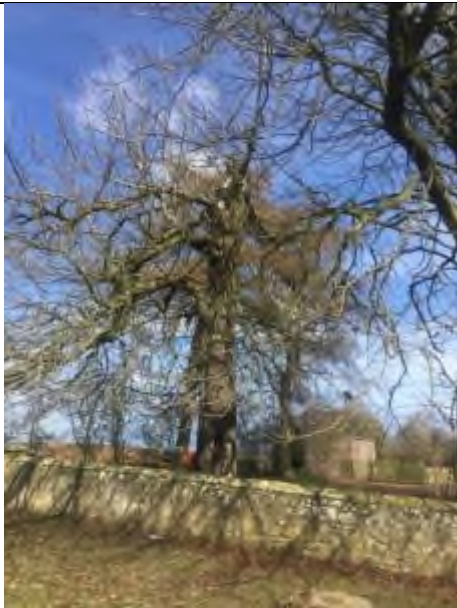
Tree 68B Moderate bat roost potential

Description	<p>Grid reference: NU 17150 21938</p> <p>Mature horse chestnut tree, approximately 14 m tall with a diameter at breast height of 0.7 m. The tree had a hollow trunk and holes allowing access, the cavity was likely open at the top.</p>
	Limitations	None recorded.
	Bat evidence	None recorded.

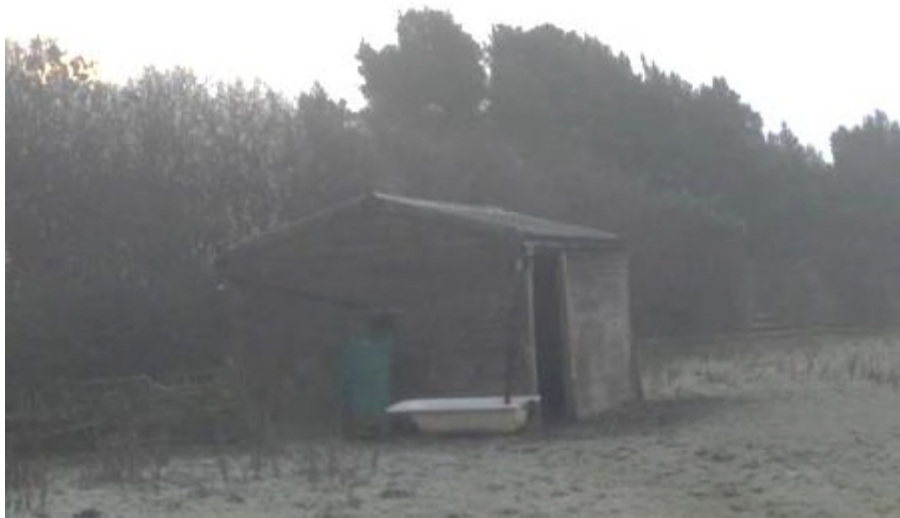
Description	Grid reference: NZ 18169 88361 A modern single-storey stable, approximately 2.5 m high, 3 m long and 3 m wide. The building was constructed from wood with a two-pitched roof covered with roofing felt. The surrounding land was grazed pasture and hedgerows.	
	Features of bat potential	None recorded.

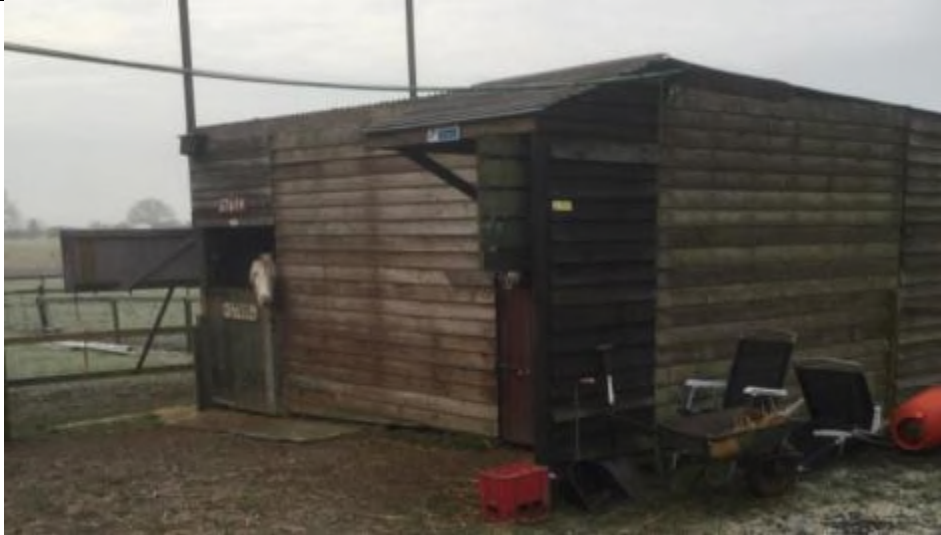
Description	<p>Grid reference: NZ 18130 88471</p> <p>A modern single-storey stable, approximately 2.5 m high, 3 m long and 5 m wide. The building was constructed from wood with a flat corrugated metal roof.</p> <p>The surrounding land was grazed pasture and hedgerows.</p>
	Features of bat potential	None recorded.
	Limitations	None recorded.
	Bat evidence	None recorded.

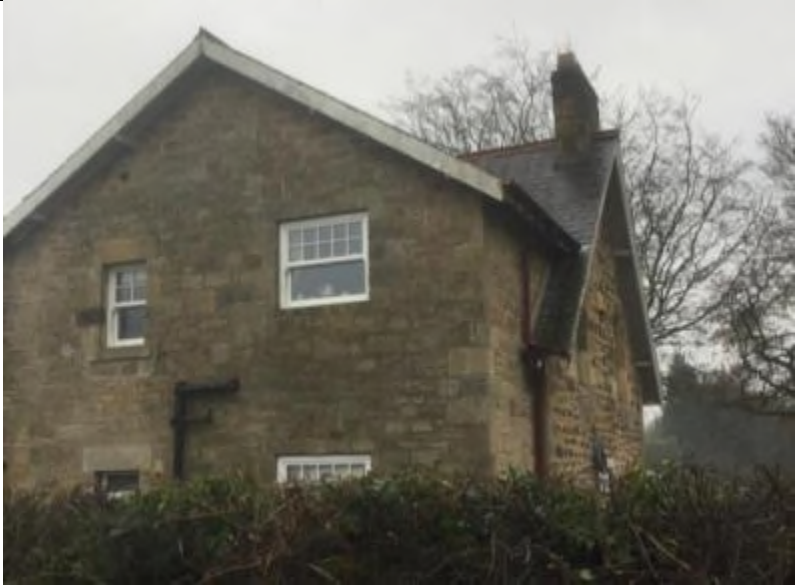
Description	<p>Grid reference: NZ 18200 88667</p> <p>A detached three-storey dwelling, less than 100 years old. The building was approximately 15 m high, 20 m long and 20 m wide, and was constructed from stone with both uPVC and wooden-framed windows. The roof comprised both double pitched and single pitched sections covered with slates.</p> <p>The surrounding land was grazed pasture, woodland and road.</p>
	Features of bat potential	<p>There were some cracks in the stonework and missing/slipped/raised tiles. A soffit box was present, and it was possible that the eaves provided access for bats into the roof void.</p>
	Limitations	<p>The building was assessed from a distance due to access restrictions.</p>

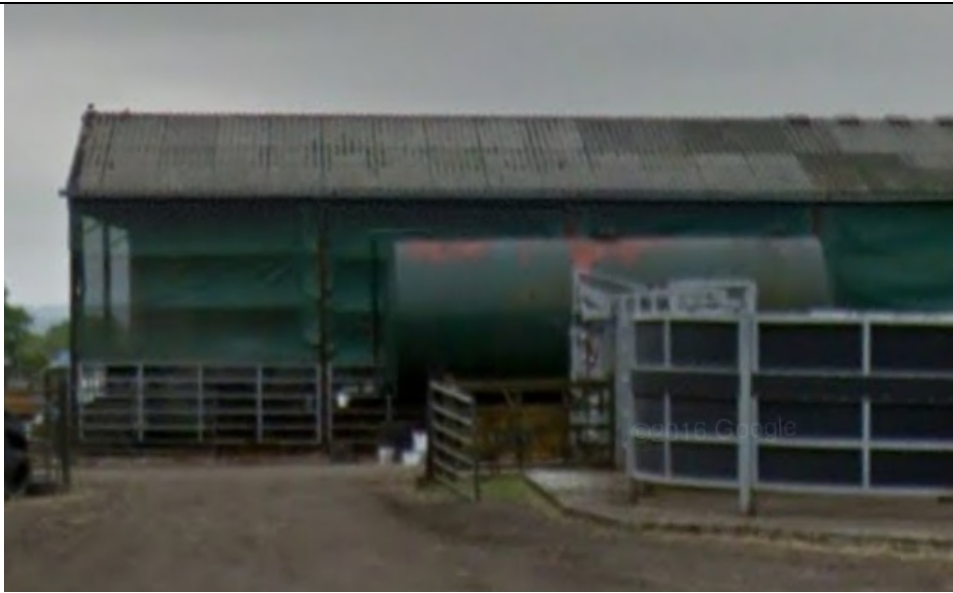
B5A Negligible bat roost potential

Photo from Google Earth (May 2016; Accessed December 2016)	
	Description	Grid reference: NZ 18158 89615 A modern single-storey farm outbuilding used for storage/cattle. The building was approximately 10 m high, 25 m long and 10 m wide, and was constructed from wood and breeze blocks. The roof was two-pitched and covered with of corrugated asbestos cement. The surrounding land was pasture, farm buildings and woodland.
	Features of bat potential	None recorded.
	Limitations	None recorded.
	Bat evidence	None recorded.

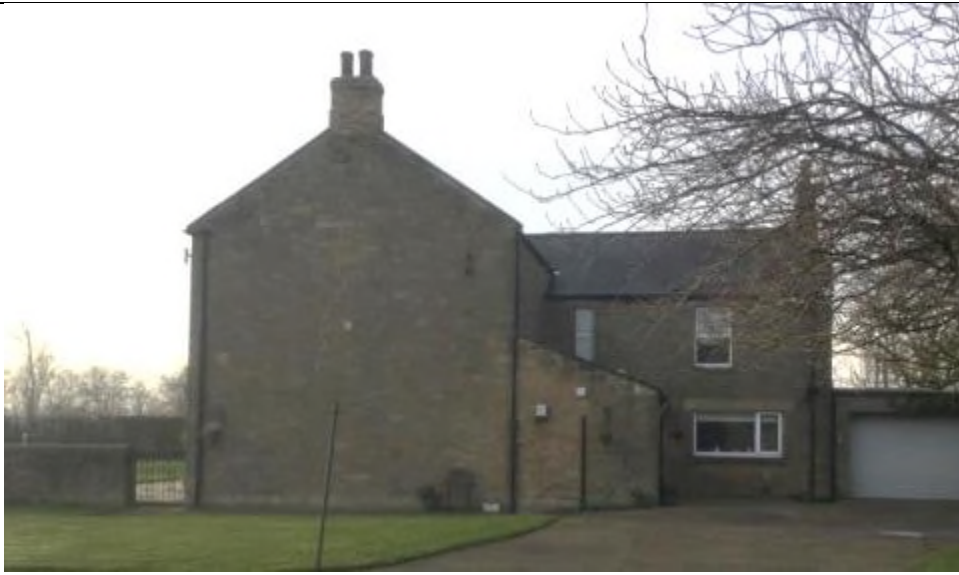
B7A Negligible bat roost potential

Description	<p>Grid reference: NZ 18081 89649</p> <p>A three-storey detached dwelling, more than 100 years old. The building was approximately 12 m high, 10 m long and 11 m wide, and was constructed from stone with UPVC framed windows. The roof was two-pitched, with additional single-pitched extensions. In general the roof was covered with slates. The garage roof was flat and covered with corrugated metal sheeting. In general the building was well-maintained.</p> <p>The surrounding land was pasture and farm buildings.</p>
	Features of bat potential	<p>None recorded.</p>
	Limitations	<p>None recorded.</p>
	Bat evidence	<p>None recorded.</p>

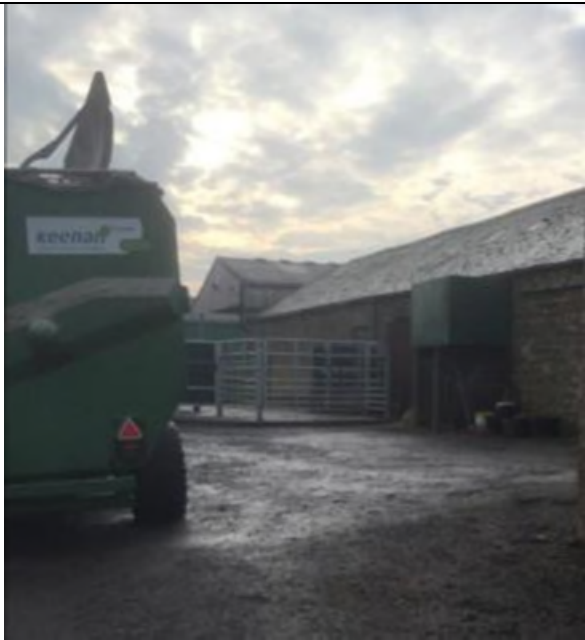
Description	<p>Grid reference: NZ 18127 89651</p> <p>A single-storey detached farm outbuilding, less than 100 years old. The building was approximately 5 m high, 20 m long and 10 m wide, and was constructed from stone with a two-pitched slate roof.</p> <p>The surrounding land was pasture and farm buildings.</p>
	Features of bat potential	<p>There were some cracks in the stonework, some missing, slipped and raised roof tiles and slipped and raised ridge tiles. The eaves provided access for bats.</p>
	Limitations	<p>None recorded.</p>
	Bat evidence	<p>None recorded.</p>

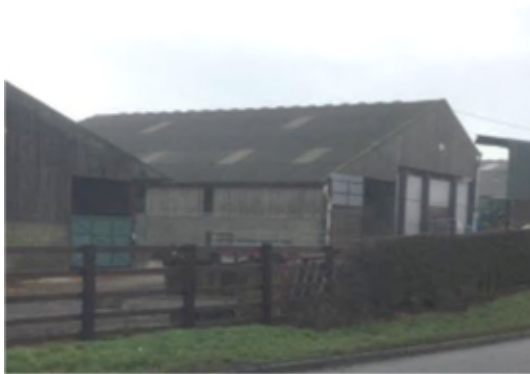
B9A Negligible bat roost potential

Description	<p>Grid reference: NZ 18160 89671</p> <p>A modern single-storey farm outbuilding used for storage/cattle. The building was approximately 10 m high, 25 m long and 10 m wide, and was constructed from wood and breeze blocks. The roof was two-pitched and covered with corrugated metal sheeting.</p> <p>The surrounding land was pasture, farm buildings and woodland.</p>
	Features of bat potential	None recorded.
	Limitations	None recorded.
	Bat evidence	None recorded.

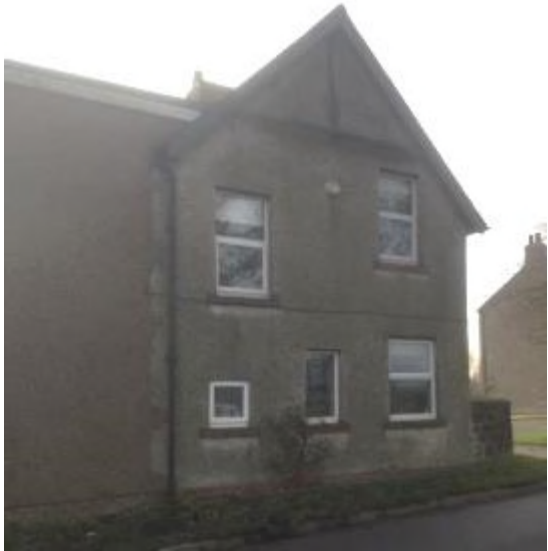
B10A Low bat roost potential

Description	<p>Grid reference: NZ 18108 89671</p> <p>A detached three-storey dwelling, less than 100 years old. The building was approximately 10 m high, 10 m long and 8 m wide, and was constructed from brick and render, with UPVC framed windows. The roof was partly two-pitched, covered with slates, and partly flat, covered with felt.</p> <p>The surrounding land was pasture and farm buildings.</p>
	Features of bat potential	<p>Fascia boards and barge boards were present, and a wall cavity was likely. The eaves provided access for bats.</p>
	Limitations	<p>None recorded.</p>
	Bat evidence	<p>None recorded.</p>

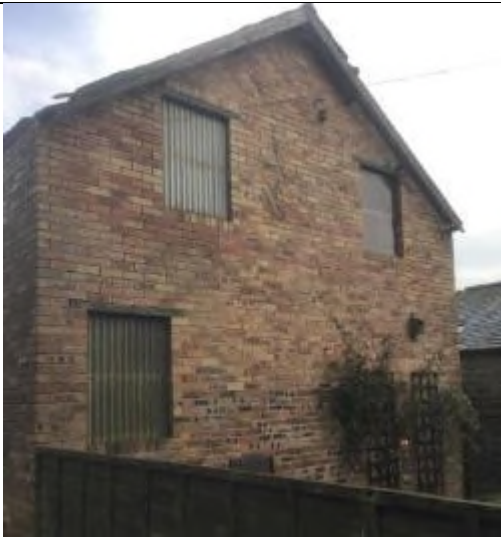
B13A Moderate bat roost potential

Description	<p>Grid reference: NZ 18128 89679</p> <p>A detached two-storey building, less than 100 years old. The building was disused; the previous use was unknown. The building was approximately 10 m high, 10 m long and 8 m wide, and was constructed from brick with wooden-framed windows, some boarded with corrugated metal. The roof was two-pitched and covered with tiles, but partly covered with corrugated metal.</p> <p>The surrounding land was pasture and farm buildings.</p>
	Features of bat potential	<p>There were some cracks in the brickwork and gaps under the fascia boards and around the windows. Some windows were broken, boarded up with holes apparent. There were missing, slipped and raised roof tiles and ridge tiles which presented gaps in the roof. The eaves provided access for bats.</p>
	Limitations	<p>None recorded.</p>
	Bat evidence	<p>None recorded.</p>

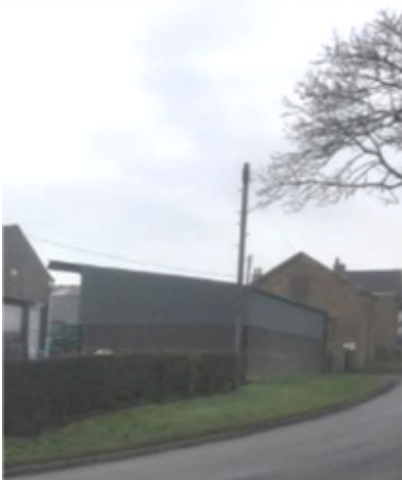
B14A Negligible bat roost potential

Description	<p>Grid reference: NZ 18151 89687</p> <p>A modern single-storey farm outbuilding used for storage/cattle. The building was approximately 10 m high, 25 m long and 10 m wide, and was constructed from wood and breeze blocks. The roof was single-pitched and covered with corrugated metal sheeting.</p> <p>The surrounding land was pasture, farm buildings and woodland.</p>
	Features of bat potential	None recorded.
	Limitations	None recorded.
	Bat evidence	None recorded.

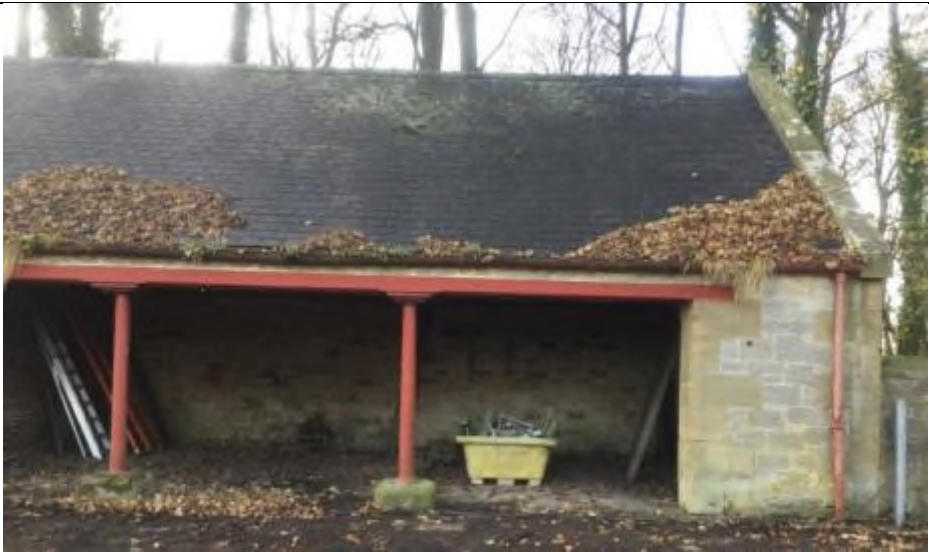
B16A Low bat roost potential

Description	<p>Grid reference: NZ 18908 90191</p> <p>A single-storey building used for storage, approximately 100 years old. The building was approximately 5 m high, 13 m long and 7 m wide, and was constructed from stone with one open side. The roof was two-pitched with slates and coping stones.</p> <p>The surrounding land was pasture, arable fields and woodland.</p>
	Features of bat potential	<p>Some roof tiles were raised, and gaps at the eaves provided access for bats.</p>
	Limitations	<p>None recorded.</p>
	Bat evidence	<p>None recorded.</p>

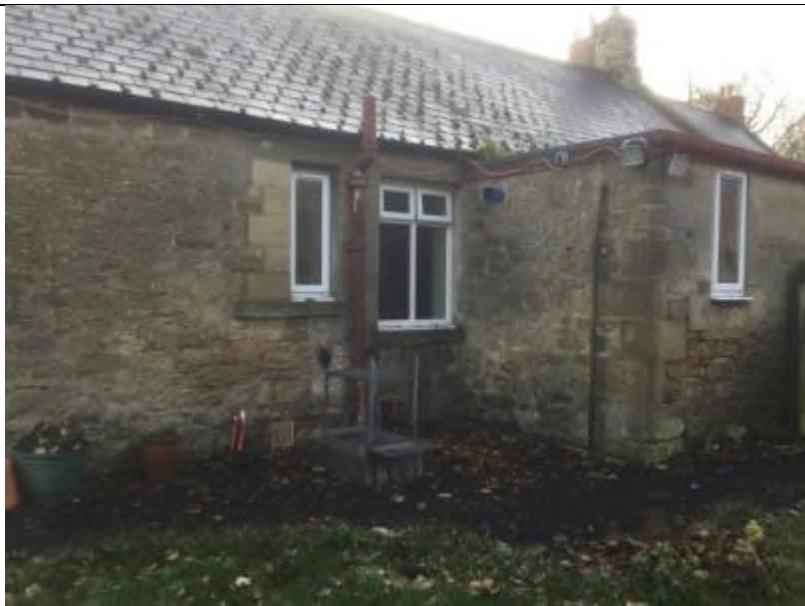
Description	<p>Grid reference: NZ 18959 90196</p> <p>A single-storey disused detached cottage, approximately 100 years old. The building was approximately 8 m high, 10 m long and 7 m wide, and was constructed from stone with UPVC framed windows. The roof was two-pitched and covered with slates and coping stones.</p> <p>The surrounding land is pasture, arable fields and woodland.</p>
	Features of bat potential	There were some cracks in the stonework, and gaps at the eaves provided access for bats.
	Limitations	None recorded.
	Bat evidence	None recorded.

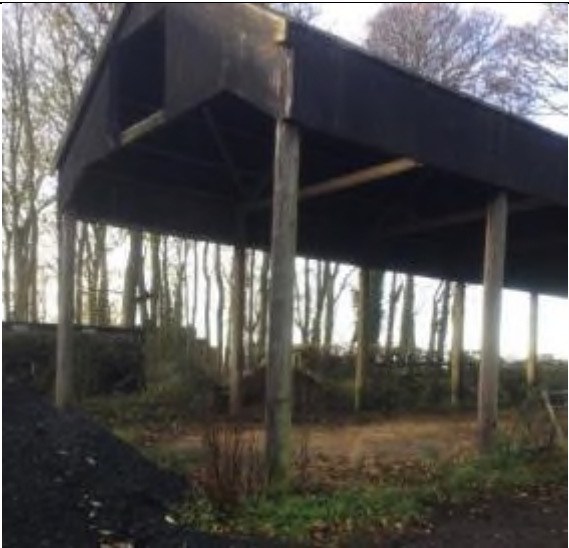
B19A Negligible bat roost potential

Description	Grid reference: NZ 18910 90243 A single-storey modern barn used for storage, approximately 7 m high, 18 m long and 6 m wide. The building was open-sided with a two-pitched corrugated metal roof supported by wooden struts. The surrounding land was pasture, arable fields and woodland.
	Features of bat potential	None recorded.
	Limitations	None recorded.
	Bat evidence	None recorded.

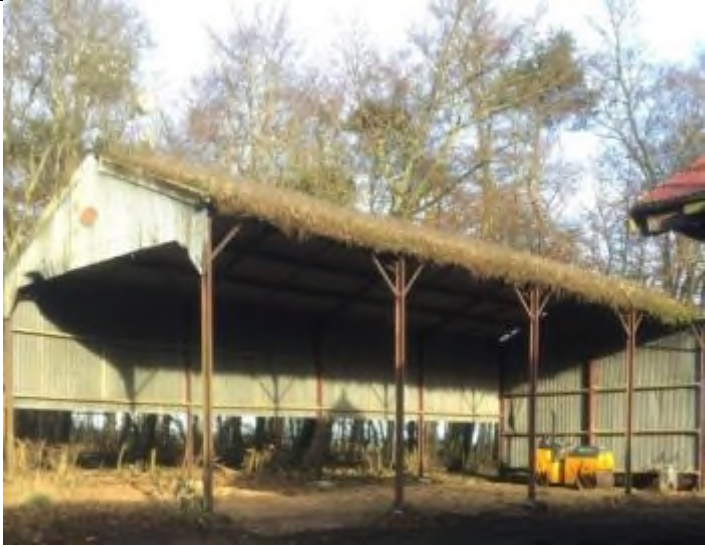
B20A Negligible bat roost potential

Description	Grid reference: NZ 18931 90254 A single-storey modern barn used for storage, approximately 7 m high, 18 m long and 7 m wide. The building was constructed on corrugated metal and was open on two sides, with a two-pitched corrugated metal roof. The surrounding land was pasture, arable fields and woodland.
	Features of bat potential	None recorded.
	Limitations	None recorded.
	Bat evidence	None recorded.

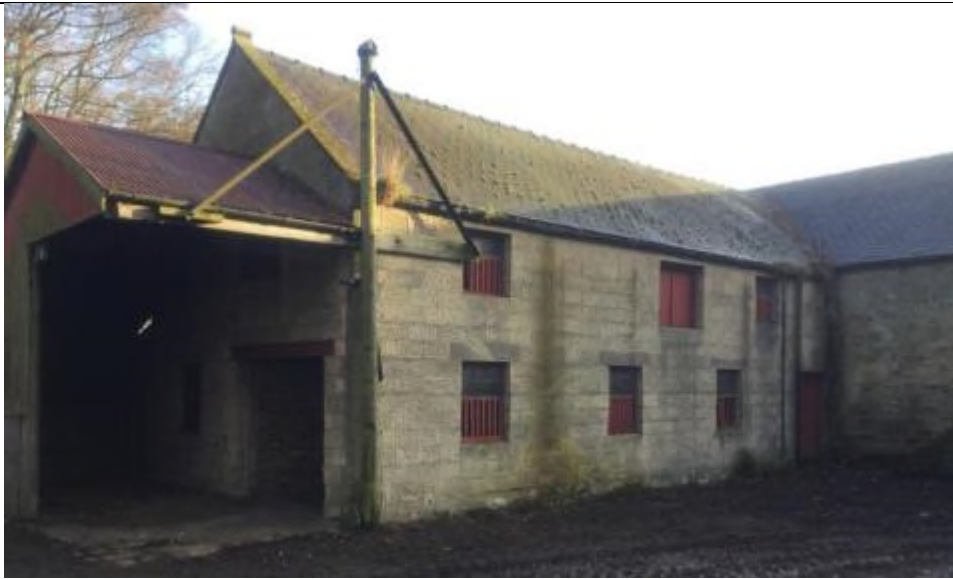
B21A Confirmed bat roost

Description	Grid reference: NZ 18929 90232 A single-storey disused barn which consisted of older and newer parts. The older part of the building was approximately 100 years old. The building was approximately 6 m high, 16 m long and 20 m wide (at its widest point). The building was constructed from stone with wooden-framed windows. The roof was multi-pitched and covered with slate and corrugated metal. Coping stones were present at the gable end. The surrounding land was pasture, arable fields and woodland.
	Features of bat potential	There were some slipped roof tiles, and gaps at the eaves provided access for bats.
	Limitations	None recorded.
	Bat evidence	Approximately 20 droppings were recorded at the older part of the building running parallel with the central ridge board. Evidence of the buildings use as a feeding perch was observed with butterfly and moth wings present in a line along the ground beneath the central roof beam.

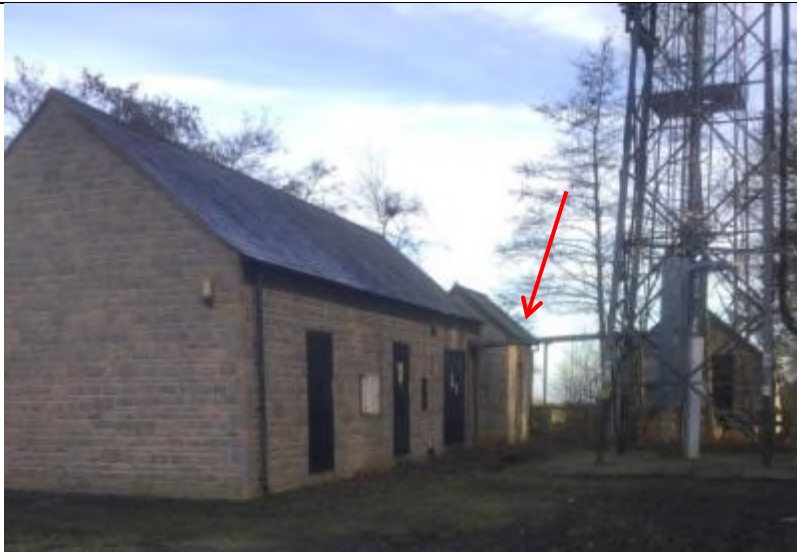
B23A Negligible bat roost potential

Description	Grid reference: NZ 18914 90298 A single-storey modern building used to store telecom equipment. The building was approximately 5 m high, 2 m long and 4 m wide. The building was constructed from stone. The roof was two-pitched and covered with slates. The surrounding land was pasture, arable fields and woodland.
	Features of bat potential	None recorded.
	Limitations	None recorded.
	Bat evidence	None recorded.

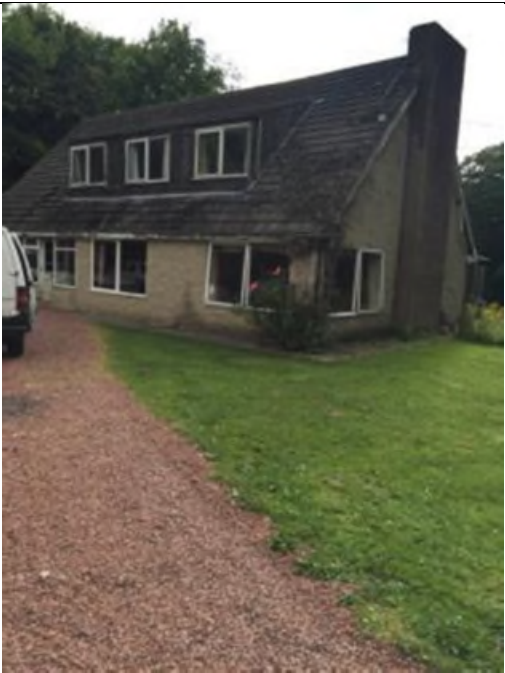
B25A High bat roost potential.

Description	<p>Grid reference: NZ 18670 91678</p> <p>A two-storey residential house approximately 80 years old, and approximately 7 m high, 12 m long and 5 m wide. The walls were constructed from sandstone and the two-pitched roof was covered with slate. The windows had wooden frames.</p> <p>The surrounding land featured woodland and grassland.</p>
	Features of bat potential	<p>There were numerous features with potential to support roosting bats. Gaps led into the soffit boxes, and slightly damaged fascias and barge boards were present. There were also occasional cracks in the stonework, small gaps in the mortar and areas of raised lead flashing. The roof tiles were generally in good repair as the roof had been re-tiled approximately 40 years ago.</p>
	Limitations	None recorded.
	Bat evidence	None recorded.

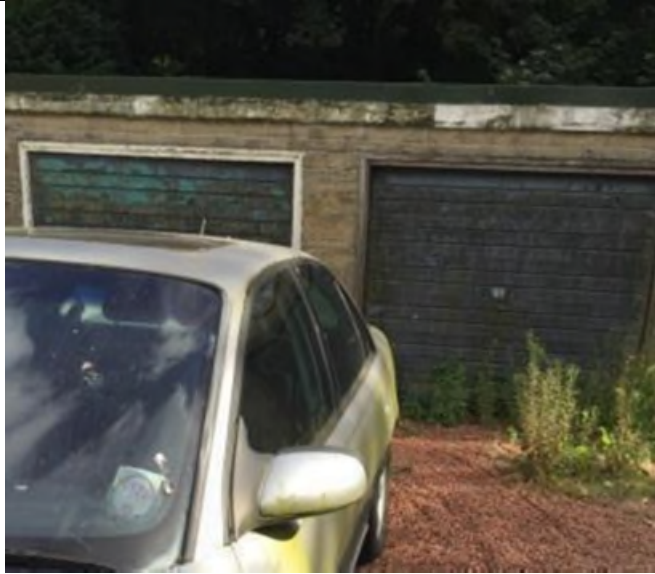
Description	<p>Grid reference: NZ 18679 91679</p> <p>A single-storey garage approximately 50 years old. The building was approximately 3 m high, 8 m long, and 4 m wide. The building was constructed from sandstone with a corrugated metal, flat roof and fascias.</p> <p>The surrounding land included woodland and grassland.</p>
	Features of bat potential	The garage had wooden barge boards which were fairly intact with occasional small gaps behind. No obvious gaps in the mortar or roofing felt could be found.
	Limitations	None recorded.
	Bat evidence	None recorded.

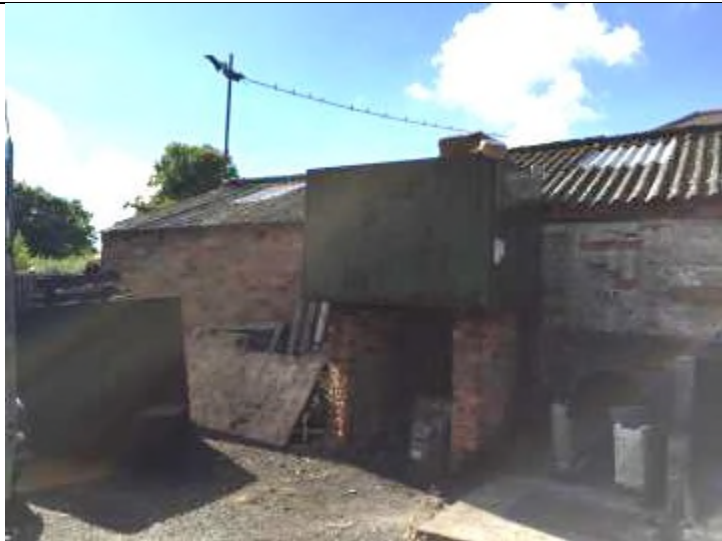
B28A Moderate bat roost potential.

Description	Grid reference: NZ 18658 91751 A single-storey commercial shed approximately 80 years old. The building was 3 m high, 10 m long and 4 m wide. The walls were brick and the two-pitched roof was covered with corrugated asbestos cement with lead flashing and skylights.
	Features of bat potential	Numerous opportunities existed for bats to enter the building. These included three permanently open doors, holes in brickwork and the roof, and gaps around door frames. The interior ceiling comprised the asbestos roof without a roof void and the thin wooden beams were broadly unsuitable for roosting bats.
	Limitations	None recorded.
	Bat evidence	None recorded.

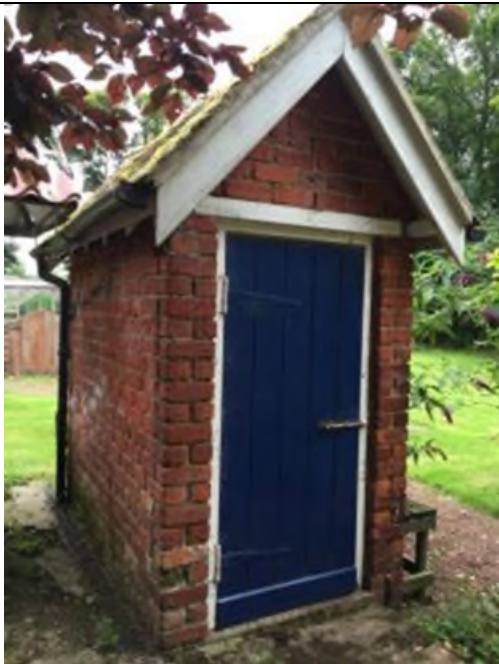
B29A Moderate bat roost potential.

Description	<p>Grid reference: NZ 18756 91758</p> <p>Single-storey small outbuilding, approximately 90 years old, with a two-pitched roof with a gable end. The roof was covered with tiles. Wooden fascias and barge boards were present on the roof. The building was used for storage purposes. The building was approximately 4 m long, 2 m wide and 2.5 m high with one door and small air vent on south side.</p> <p>There were extensive grounds surrounding the building with woodland and arable habitats nearby.</p>
	Features of bat potential	<p>Occasional gaps in brickwork where bricks and mortar were missing.</p>
	Limitations	<p>None recorded.</p>
	Bat evidence	<p>None recorded.</p>

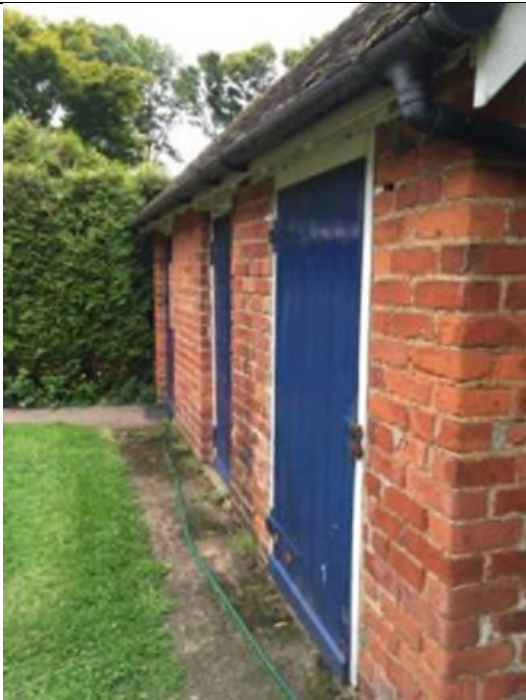
B30A Moderate bat roost potential.

Description	<p>Grid reference: NZ 18758 91759</p> <p>Single-storey small outbuilding, approximately 90 years old, with two-pitched roof with gable ends. The roof was covered with tiles. Wooden fascias and barge boards were present. The building was used for storage purposes. The building was approximately 5 m long, 3.5 m wide and 2.5 m high with three wooden doors on the western side.</p> <p>There were extensive grounds surrounding the building with woodland and arable habitats nearby.</p>
	Features of bat potential	The old outbuilding had tiles and wooden fascias/ barge boards with occasional gaps, and occasional gaps in mortar.
	Limitations	None recorded.
	Bat evidence	None recorded.

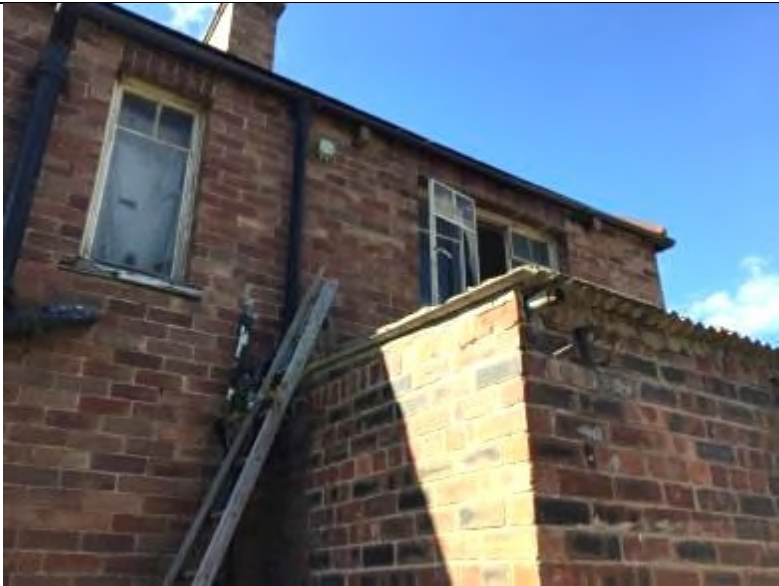
B31A Moderate bat roost potential.

Description	Grid reference: NZ 18658 91765 A two-storey building which was commercially used for storage. The building was approximately 80 years old. The approximate height was 6 m, length 12 m, and width 6 m. The walls were constructed from brick, and window frames were wooden on the ground floor and uPVC on the upper floor. The two-pitched roof was covered with tiles. An extension had a flat roof which was covered with corrugated asbestos cement. Soffit boxes were present on the northern side, and tightly fitting lead flashing was present.
	Features of bat potential	The wooden-framed ground floor windows were in part broken with some with large gaps around the frames. There were gaps in the chimney mortar and in the mortar in the western wall.
	Limitations	None recorded.
	Bat evidence	None recorded.

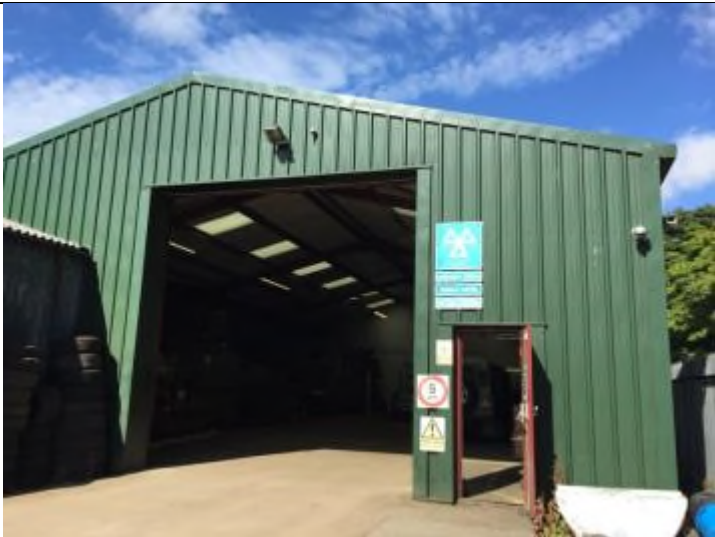
Description	Grid reference: NZ 18681 91766 A single-storey garage used for car repair services. It was approximately 30 years old and approximately 7 m high, 40 m long, and 35 m wide. The building was constructed from metal with an asbestos and metal two-pitched roof with lead flashing and concrete barge boards.
	Features of bat potential	None recorded.
	Limitations	None recorded.
	Bat evidence	None recorded.

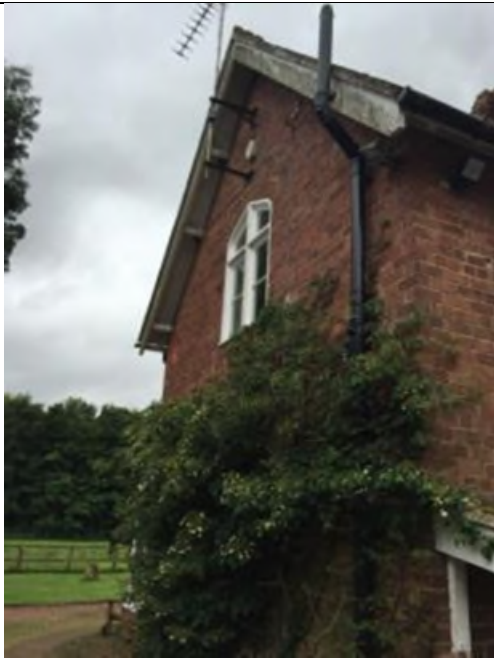
B33A High bat roost potential.

Description	<p>Grid reference: NZ 18747 91771</p> <p>A two-storey residential house with brick walls, wooden window frames, air vents and a uPVC framed conservatory. The building was approximately 7 m high, 15 m long and 15 m wide. The roof was of a mixed design with a dormer and was covered with tiles. Fascias and barge boards were present.</p> <p>The building had large grounds and surrounding land use was arable.</p>
	Features of bat potential	The building featured many small mortar gaps, some loose lead flashing, occasional loose, missing, or raised tiles on the roof, air vents and a gap at the adjoining barge boards.
	Limitations	None recorded.
	Bat evidence	None recorded. Anecdotal evidence of high bat activity by owner.

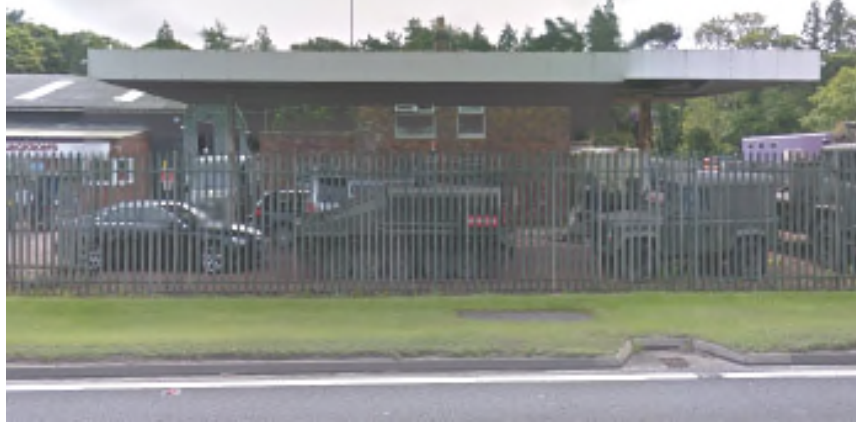
B34A
Negligible
bat roost
potential.

Photo taken from Google Earth (June 2016; Accessed December 2016)

Description	Grid reference: NZ18644 91776 Metal canopy from former petrol station approximately 16 m long, 4.5 m high and 8 m wide. The building was constructed from metal and some plastic.
Features of bat potential	None recorded.
Limitations	None recorded.
Bat evidence	None recorded.

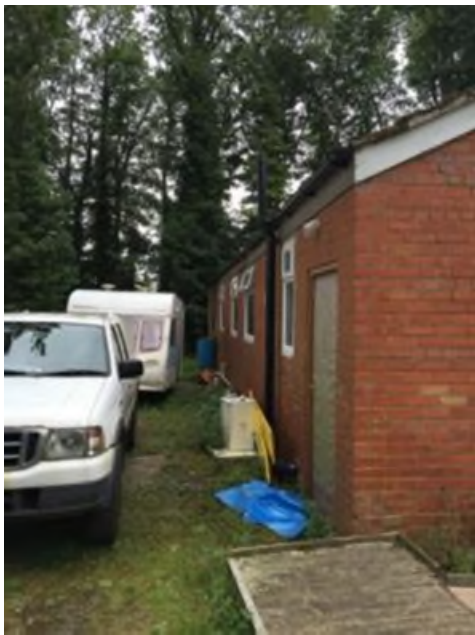
B36A Low bat roost potential.

Description	<p>Grid reference: NZ 18779 91785</p> <p>A single-storey office building, approximately 25 years old. The building was approximately 4 m high, 12 m long and 6 m wide. Walls were brick with uPVC window frames and the roof was two-pitched and tiled with a skylight. Fascias and barge boards were present, and there was an east facing, open room. Tightly fitting lead flashing was present around the chimney.</p> <p>There were extensive grounds surrounding the building with woodland and arable habitats nearby.</p>
	Features of bat potential	<p>Small gaps around beams in open room, there were some mortar gaps beneath the fascia, the fascia had some gaps, the window frames and skylight had possible gaps and there were some raised roof and ridge tiles.</p>
	Limitations	<p>None recorded.</p>
	Bat evidence	<p>None recorded.</p>

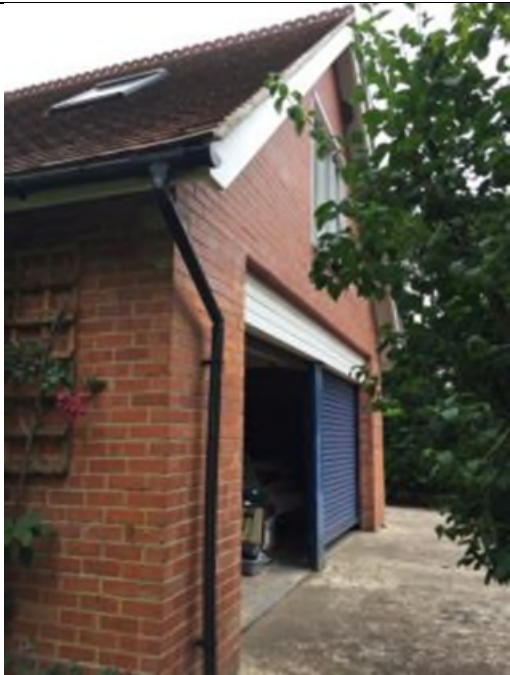
B37A Low bat roost potential.

Description	<p>Grid reference: NZ 18745 91792</p> <p>A garage with a residential second storey, approximately 30 years old. The approximate height of the building was 7 m, width 10 m and length 9 m. The building was brick with wooden window frames and the roof was gabled and covered with tiles. Fascias and barge boards were present.</p> <p>There were extensive grounds surrounding the building with woodland and arable habitats nearby.</p>
	Features of bat potential	Occasional, small mortar gaps, occasional raised tiles near a skylight gaps next to the wall of an alcove.
	Limitations	None recorded.
	Bat evidence	None recorded.

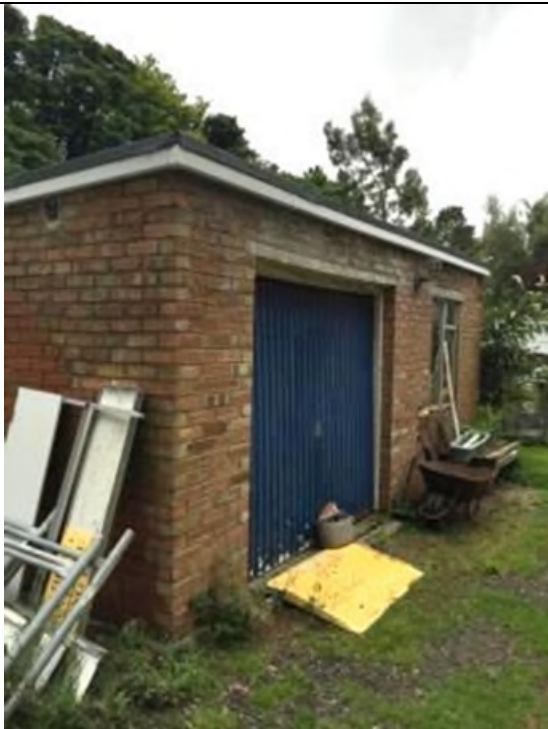
B38A Low bat roost potential.

Description	<p>Grid reference: NZ 18763 91793</p> <p>A single-storey storage building approximately 40 years old. The building was approximately 2.5 m high, 10 m long and 10 m wide and was constructed from brick with wooden window frames, and uPVC fascias. A flat roof was present which was covered by felt.</p> <p>The building was surrounded by grounds, woodland and arable habitat.</p>
	Features of bat potential	There were occasional holes in the brickwork, a gap surrounding the fascias approximately 1 to 3 cm wide and occasional holes in window frames and in the metal door.
	Limitations	None recorded.
	Bat evidence	None recorded.

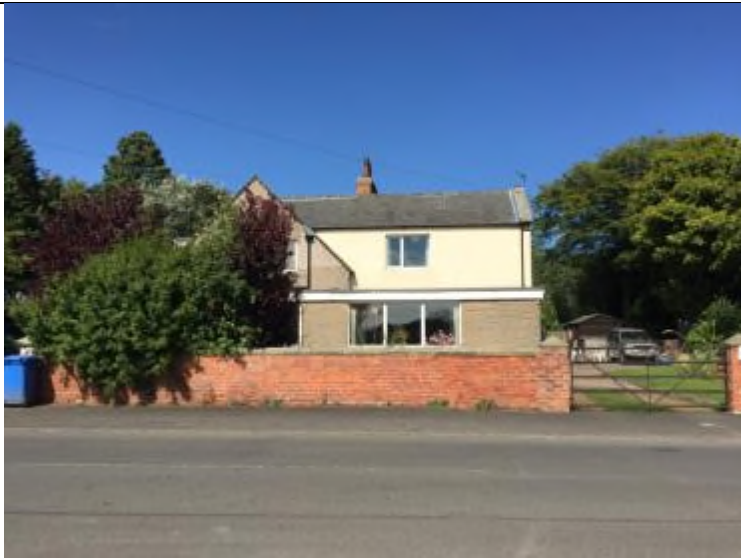
B39A Moderate bat roost potential.

Description	<p>Grid reference: NZ 18849 92340</p> <p>Semi-detached two-storey residential building approximately 50 years old. The building was approximately 6 m high, 25 m long, and 12 m wide. The walls were constructed from sandstone with some tile cladding, and the window frames were uPVC. The two-pitched roof with a two-pitched dormer were covered with slate and a flat-roof extension was also present. Fascias, soffit boxes and barge boards were present, as was tightly fitting lead flashing.</p> <p>The surrounding land featured arable fields.</p>
	Features of bat potential	Small gaps behind the fascias were present.
	Limitations	None recorded.
	Bat evidence	None recorded.

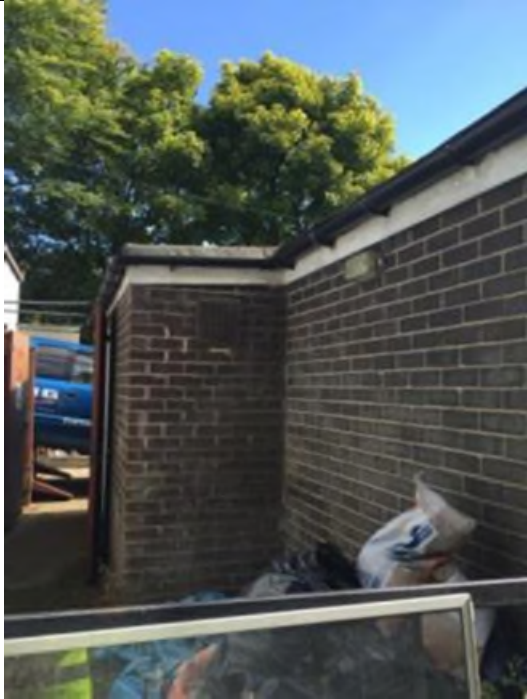
B40A Low bat roost potential

Description	Grid reference: NZ 18860 92357 Brick outbuilding approximately 40 years old, 7m long, 3m high and 7m wide with a flat bituminous felt roof. The building was used as a garage/ storage adjacent to the main house.
	Features of bat potential	Wooden barge boards were intact with occasional small gaps behind.
	Limitations	None recorded.
	Bat evidence	None recorded.

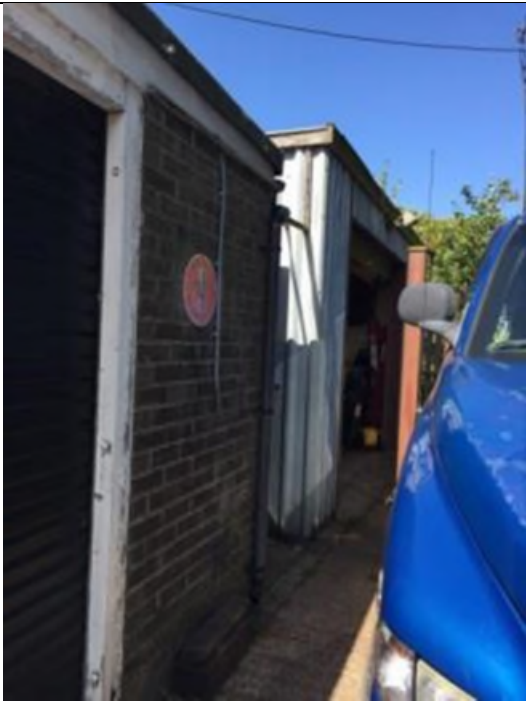
B41A Negligible bat roost potential

Description	Grid reference: NZ 18851 92358 Corrugated metal storage building/ garage with a flat roof. The building was approximately 7 m long, 2.5 m high and 5 m wide, and was approximately 20 years old.
	Features of bat potential	None recorded.
	Limitations	None recorded.
	Bat evidence	None recorded.

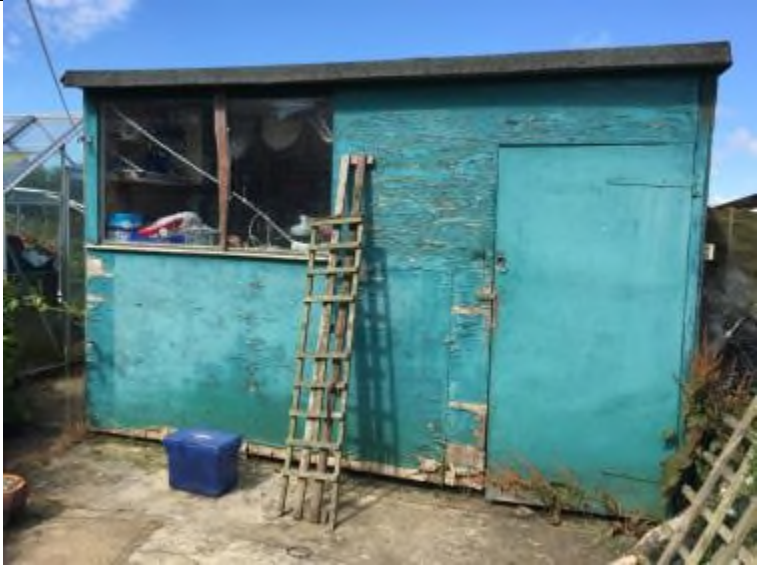
B43A Low bat roost potential

Description	<p>Grid reference: NZ 18961 92384</p> <p>A single-storey shed used for storage, approximately 40 years old, and approximately 2 m high, 4 m long, and 3 m wide. The building had a flat felt roof and wooden window frames.</p> <p>The surrounding land featured arable fields.</p>
	Features of bat potential	<p>Very small gaps were present under the roofing felt.</p>
	Limitations	<p>None recorded.</p>
	Bat evidence	<p>None recorded.</p>

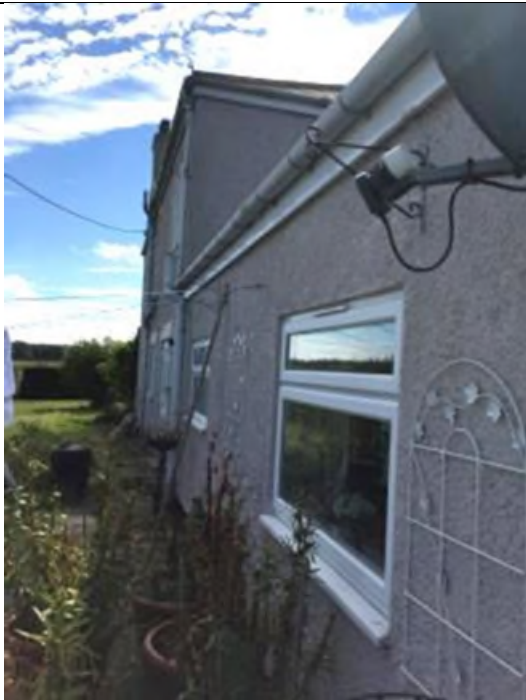
B44A Moderate bat roost potential

Description	<p>Grid reference: NZ 18955 92368</p> <p>A two-storey residential house, approximately 40 years old. The building was approximately 7 m high, 20 m long, and 12 m wide. The window frames were uPVC and the two-pitched, hipped roof was covered with slate with a flat-roofed extension. Soffit boxes, barge boards and tightly fitting lead flashing were also present.</p> <p>The surrounding land generally comprised arable fields.</p>
	Features of bat potential	<p>There were raised tiles and small gaps under roof edging on eastern side.</p>
	Limitations	<p>None recorded.</p>
	Bat evidence	<p>None recorded.</p>

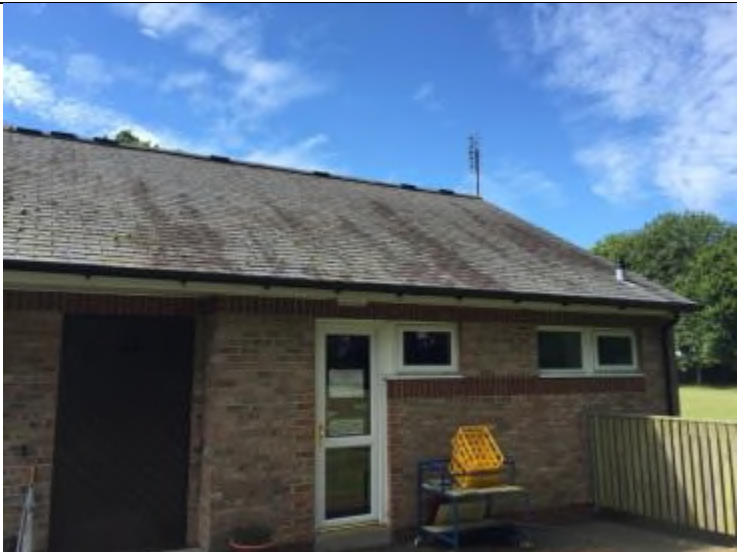
B45A Moderate bat roost potential

Description	<p>Grid reference: NZ 18890 92369</p> <p>The single-storey building was in use as a primary school, and was approximately 25 years old. The school was approximately 5 m high, 25 m long, and 24 m wide. The walls were brick, and window and skylight frames were uPVC. The two-pitched roof was covered with slate and a flat roof section was present.</p> <p>The surrounding land generally comprised arable fields.</p>
	Features of bat potential	<p>Although the school was relatively new, the barge boards, fascias and soffit boxes had potential to provide roosting opportunities for bats. Additionally, there were at least thirteen air vents on the roof which were approximately 30 cm by 5 cm, some raised roof tiles and cavity walls were present.</p>
	Limitations	<p>None recorded.</p>
	Bat evidence	<p>None recorded.</p>

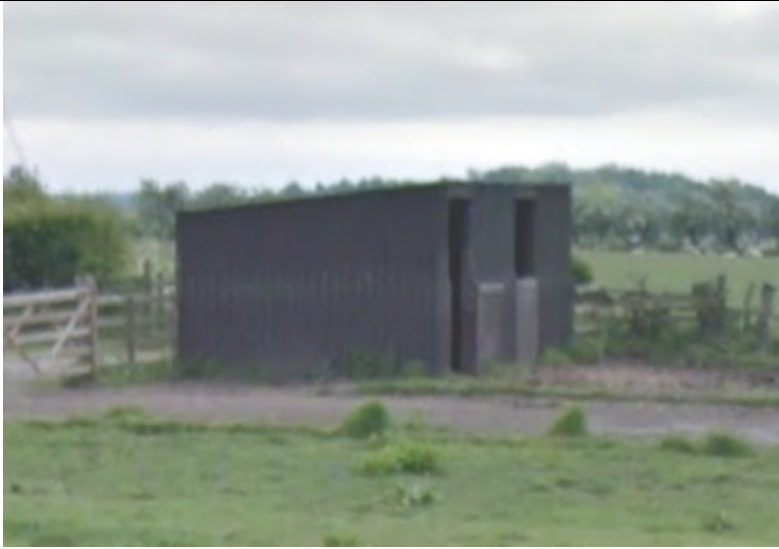
B46A Negligible bat roost potential.

Photo taken from Google Earth (June 2016; Accessed December 2016)	
	Description	Grid reference: NZ 18896 92652 A stable which was approximately 10 years old, single-storey and in use. Height was 2 m, length 4 m and width 3 m. Walls and roof were covered with corrugated metal sheeting. The surrounding land featured arable fields and pasture.
	Features of bat potential	None recorded.
	Limitations	None recorded.
	Bat evidence	None recorded.

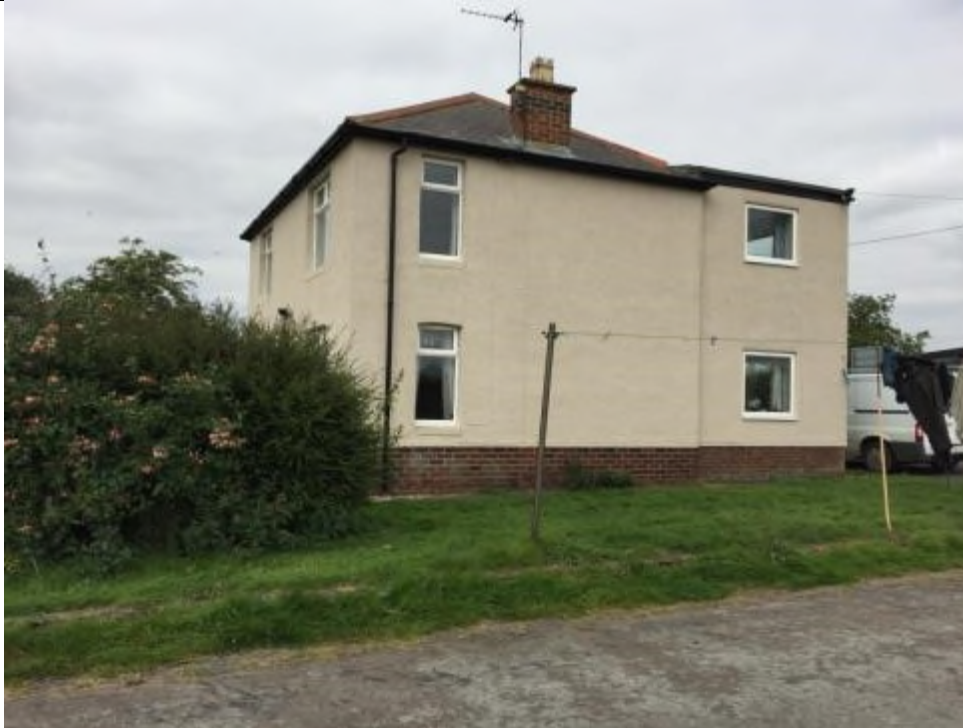
B47A Moderate bat roost potential

Description	<p>Grid reference: NZ 18888 92725</p> <p>A two-storey, residential building built around 1960s and subsequently extended. Height was 8 m, length 8 m and width 8 m. Walls were brick with some tile cladding and window frames were uPVC. Roof was slate and hipped with a flat roof extension.</p> <p>The surrounding land featured arable fields.</p>
	Features of bat potential	<p>Birds nesting in eaves were indicative of a large gap under guttering.</p>
	Limitations	<p>Owners were not present so surveyors could only view the front of the building.</p>
	Bat evidence	<p>None recorded.</p>

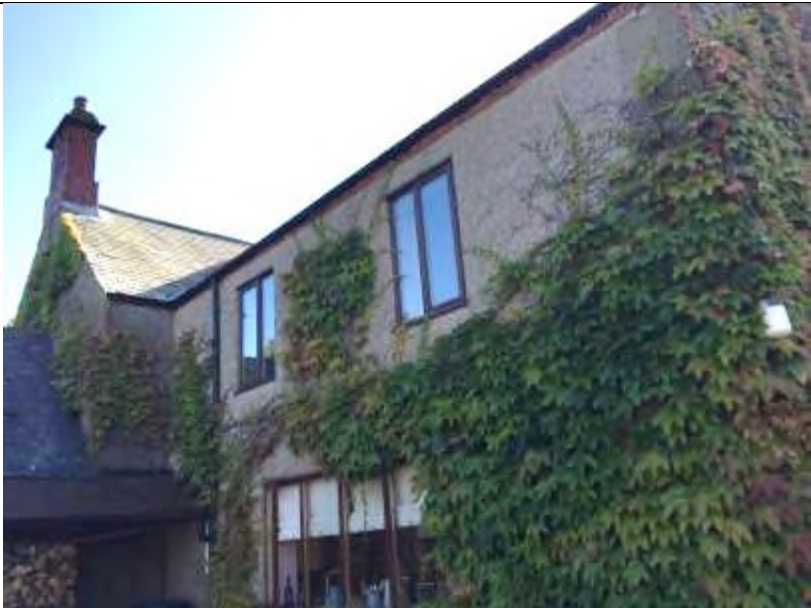
Description	<p>Grid reference: NZ 18871 93415</p> <p>A two-storey dwelling, approximately 80 years old, with a multi-pitched roof covered with slates. The building also had a small extension to the south and a balcony terrace. The building was constructed from sandstone and brick, and was approximately 24 m long, 6 m high, and 17 m wide (at its widest point). The house also had wooden cladding and climbing ivy, and the window frames were wooden. Tightly sealed lead flashing was present on the roof.</p> <p>The dwelling was adjacent to a 40 year old mixed plantation, and the surrounding land featured arable fields and farm buildings.</p>
	Features of bat potential	<p>The building was generally in good repair, however there were occasional small gaps under the fascias. The house also had wooden cladding, some of which was loose, that could provide further roosting opportunities. There were also some cracks in the brickwork and numerous loose roof tiles.</p>
