A1 in Northumberland: Morpeth to Ellingham

Scheme Number: TR010041

6.7 Environmental Statement – Appendix 9.7 Bat Roost Potential Survey Report 2017

Bat Roost Potential Survey Report 2017

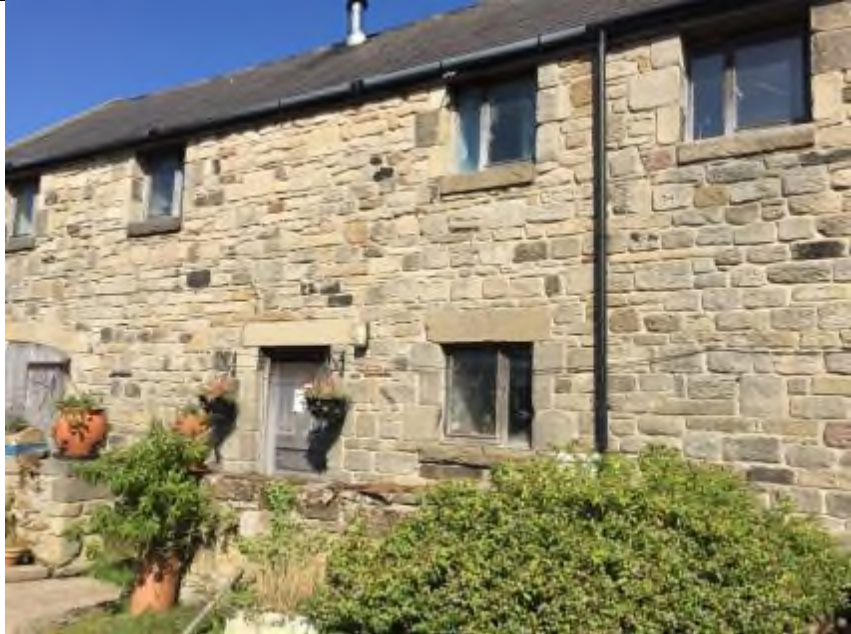
Description	<p>Grid reference: NZ 18849 93428</p> <p>A residential two-storey building of height 6 m, length 16 m and width 4 m. The walls were constructed from sandstone with some tile cladding and windows had wooden frames. The two-pitched roof was covered with slate.</p> <p>The surrounding land featured arable fields and farm buildings.</p>
	Features of bat potential	<p>Lots of gaps were present along roof edging. The fascia board under guttering had a hole underneath with some staining. According to owner, starlings nest here.</p>
	Limitations	<p>None recorded.</p>
	Bat evidence	<p>None recorded.</p>

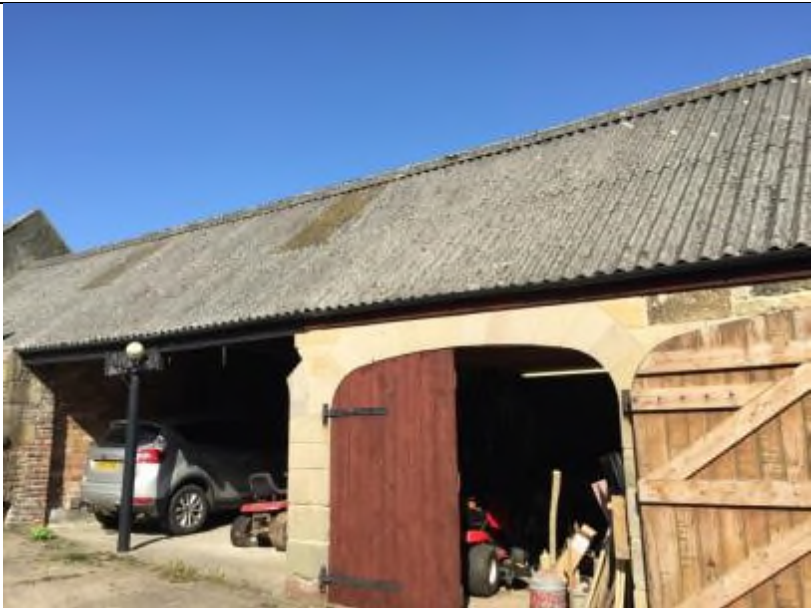
B52A Moderate bat roost potential

Description	<p>Grid reference: NZ 18887 93430</p> <p>Sandstone and brick storage shed / workshop and garage adjoining building to the north. The building was approximately 80 years old, a mix of two-storey and single-storey. The roof was two-pitched and covered by corrugated asbestos with wooden beams and ceiling, and no apparent roof void. The building was approximately 8 m long, 5 m high and 4 m wide.</p> <p>The surrounding land featured arable fields and farm buildings.</p>
	Features of bat potential	<p>The building had an open fronted garage with no obvious roosting opportunities. There were a few small gaps between the mortar and the fascia boards. The ground floor had a wooden ceiling, and timber framed workshop on the second floor, and an asbestos covered roof.</p>
	Limitations	<p>None recorded.</p>
	Bat evidence	<p>None recorded.</p>

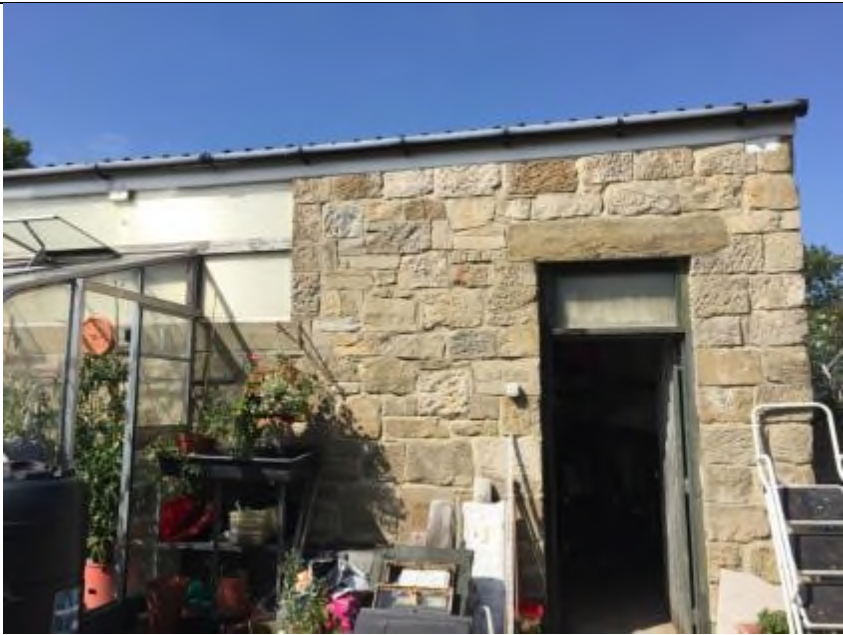
B53A Low bat roost potential

Description	<p>Grid reference: NZ 18823 93434</p> <p>Single-storey outbuilding used for storage, approximately 80 years old. The building was constructed from sandstone and breezeblocks, and had a wooden ceiling and corrugated asbestos roof. The building was located to the north-west of a farm complex, and adjacent to the main domestic dwelling. The building was approximately 6 m long, 5 m wide and 3 m high.</p> <p>The surrounding land featured arable fields and farm buildings.</p>
	Features of bat potential	<p>Some gaps were present between corrugated roof and bricks. Potential void between wooden ceiling and roof.</p>
	Limitations	<p>None recorded.</p>
	Bat evidence	<p>None recorded.</p>

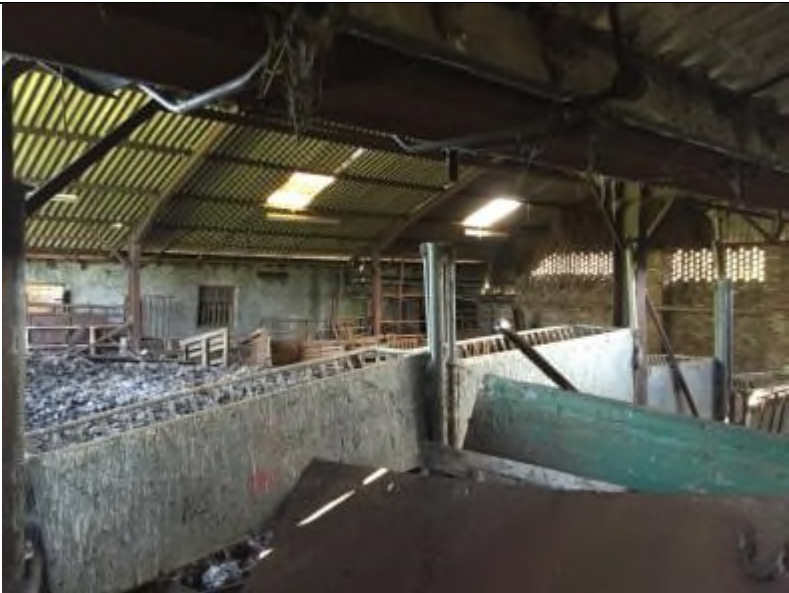
Description	<p>Grid reference: NZ 18869 93443</p> <p>Large single-storey farm building approximately 80 years old used for housing livestock and farm equipment. The building was approximately 15 m long, 5 m high and 10 m wide, constructed from a mix of breezeblock and brick walls, with a two-pitched roof with metal beam support frame, covered with corrugated asbestos.</p> <p>The surrounding land featured arable fields and farm buildings.</p>
	Features of bat potential	<p>Some cracks and mortar gaps were present, small nesting birds in brick cavities.</p>
	Limitations	<p>None recorded.</p>
	Bat evidence	<p>None recorded.</p>

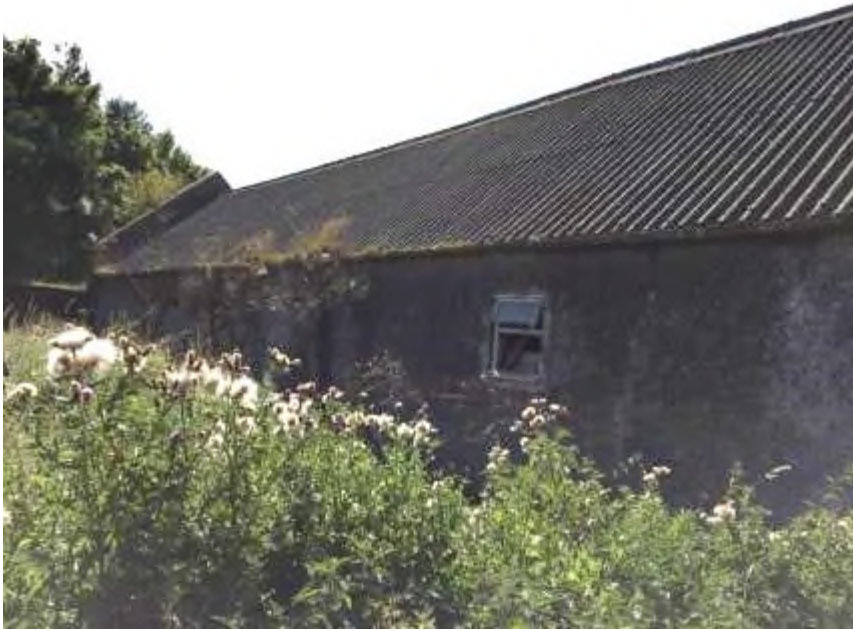
Description	<p>Grid reference: NZ 18888 93453</p> <p>A two-storey storage shed / workshop, approximately 80 years old. The building had brick walls with cladding which was loose in some places, and a two-pitched, corrugated asbestos roof with wooden beams and ceiling. The windows had wooden frames, and some frames were absent leaving open brickwork. The building was approximately 10 m long, 5 m high and 5 m wide.</p> <p>The surrounding land featured arable fields and farm buildings.</p>
	Features of bat potential	<p>The building had a broken window, numerous medium and small gaps in the mortar next to the eaves and window on the east-facing side (shown in the photo), which could provide roosting opportunities. On the north-facing side potential entrance points were also present around the only door and a boarded up window. Within the building itself the roof had two Perspex skylights. The ground floor had a wooden ceiling and timber framed storage racks throughout, potentially providing roosting opportunities.</p>

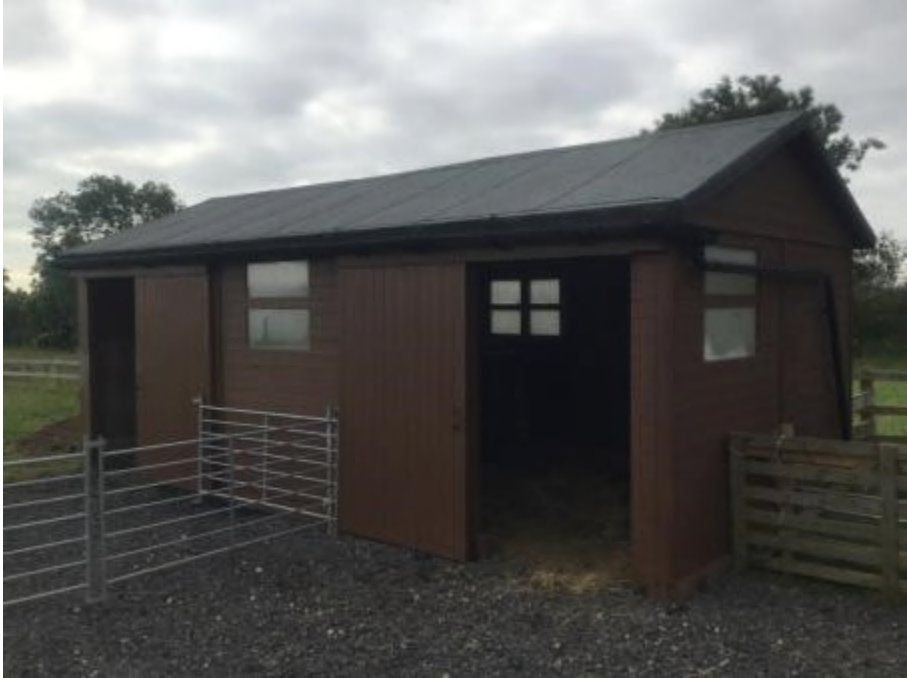
Bat evidence	None recorded.
B56A Negligible bat roost potential

Description	<p>Grid reference: NZ 18966 93468</p> <p>A single-storey wooden stable less than 5 years old. The building was 3 m high, 8 m long, and 3m wide. The roof was two-pitched and covered with bitumen felt. The building was wooden and the windows were PCA sheeting.</p> <p>Surrounding land use was paddocks.</p>
	Features of bat potential	None recorded.
	Limitations	None recorded.
	Bat evidence	None recorded.

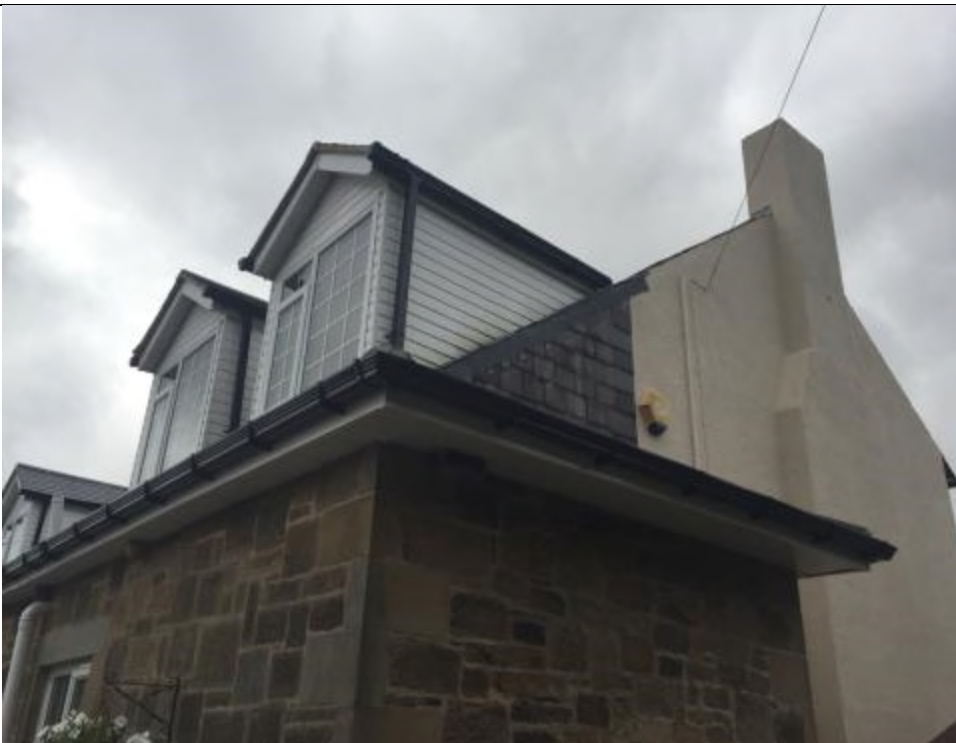
Moderate bat roost potential	Description	<p>Grid reference: NZ 18944 93525</p> <p>A two-storey sandstone farmhouse, approximately 30 years old. The building was 7 m high, 15 m long and 8 m wide. The window frames were uPVC and slate cladding was present on part of the gable end as shown. The multi-pitched roof and dormer windows were covered with slate. Soffit boxes, fascias and barge boards were present.</p> <p>The building was surrounded by paddocks.</p>
	Features of bat potential	<p>Roof repairs were visible with some small gaps still present, and small gaps were present in the stonework and mortar. Fascias were also present with some gaps found particularly at the rear of the building. Some gaps were present between the roof tiles and the adjoining lead flashing.</p>
	Limitations	<p>None recorded.</p>
	Bat evidence	<p>None recorded.</p>

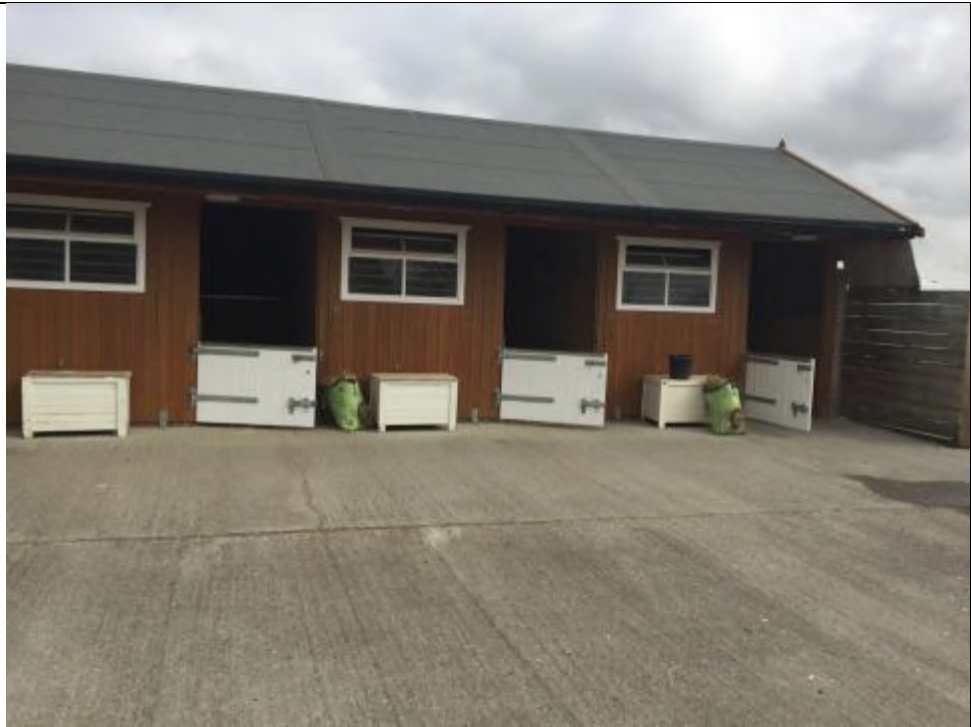
Description	<p>Grid Reference: NZ 18942 93566</p> <p>A modern wooden stable, built within the last five years, with a two-pitched, felt covered roof. The building was approximately 25 m by 20 m long in an 'L' shape, 4 m high and 4 m wide.</p> <p>The stables were surrounded by paddocks.</p>
Features of bat potential	<p>Some cracks were present in the wood, and small voids were present in the roof due to ventilation strips.</p>
Limitations	<p>None recorded.</p>
Bat evidence	<p>None recorded.</p>

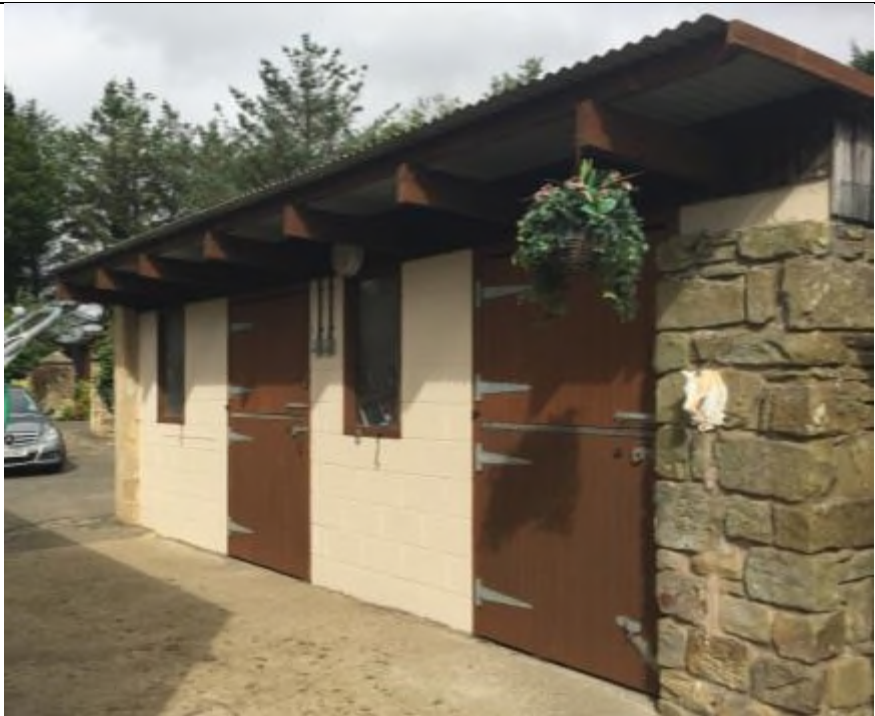
Description	<p>Grid reference: NZ 18953 93547</p> <p>A newly built, single-storey, storage building of approximate height 4m, length 7 m and width 4m. The building was constructed from breeze blocks and sandstone and the roof was corrugated metal.</p> <p>The surrounding land featured paddocks and stables.</p>
	Features of bat potential	A few small cracks in the structure.
	Limitations	None recorded.
	Bat evidence	None recorded.
B61A Negligible bat roost potential	No photo available	
	Description	<p>Grid reference: NZ 18952 93551</p> <p>A fairly new kennel, approximately 8 m long and 5 m wide. The kennel was constructed from corrugated metal with a flat corrugated metal roof. No roof void was present.</p>

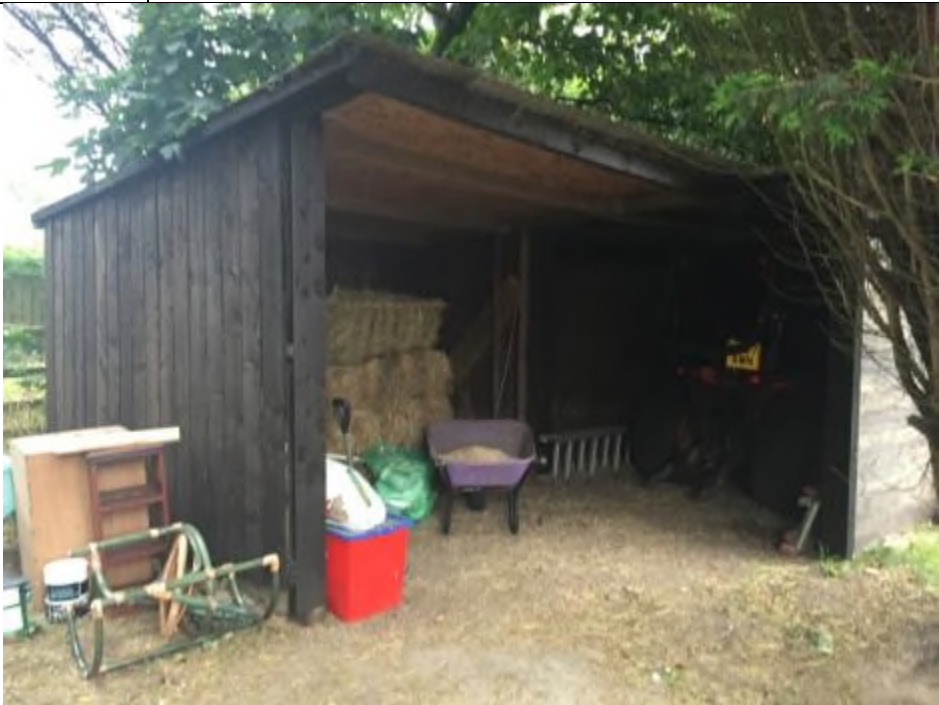
Features of bat potential	None recorded.
	Limitations	None recorded.
	Bat evidence	None recorded.
B62A Low bat roost potential

Description	<p>Grid Reference: NZ 18930 93573</p> <p>A single-storey open-fronted wooden shed constructed with a wooden ceiling and flat corrugated metal roof. The shed was used for storage of stable equipment and hay bales. The building was approximately 10 years old and approximately 6 m plus 2 m long in an 'L' shape, 2.5 m high and 3 m wide.</p> <p>The surrounding land featured broadleaved plantation woodland and paddocks.</p>
	Features of bat potential	There were large gaps between the wooden boarding which were very open. Anecdotal evidence of bat sightings in fields behind.

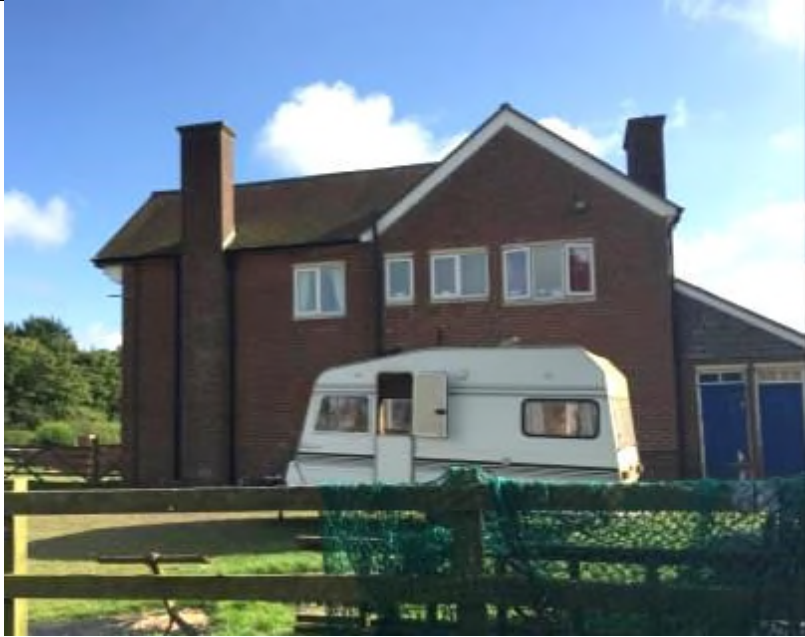
Description	<p>Grid reference: NZ 18885 93656</p> <p>A two-storey residential building approximately 50 years old. The approximate height was 8 m, length 20 m, and width 10 m. The building was brick with weatherboarding on the gable of an extension. The window frames were uPVC. The multi-pitched roof was covered with tiles and in overall good condition. Some tightly fitting lead flashing.</p> <p>The surrounding land features coniferous plantation woodland, arable fields and paddocks.</p>
	Features of bat potential	Some gaps behind weatherboarding, small gaps under fascias and barge boards and a house martin entered underneath soffit box indicating a gap.
	Limitations	None recorded.
	Bat evidence	None recorded.

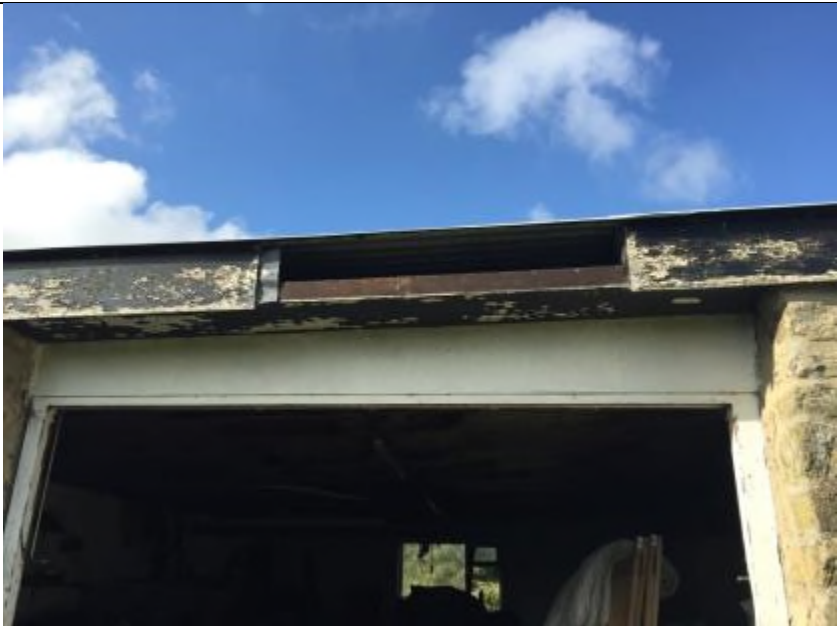
Description n	Grid reference: NZ 18874 93674 A single-storey open-fronted outhouse / storage building approximately 80 years old. The building was approximately 3 m high, 8 m long, and 5 m wide. The walls were sandstone and the roof was covered with corrugated metal / cement with wooden beams underneath. The windows had wooden frames. The surrounding landscape featured arable fields and paddocks, and a coniferous plantation woodland.
	Features of bat potential	There was a void behind the soffit box, and a gap in the soffit; according to the owner a bat has previously been found in the gap.
	Limitations s	None recorded.
	Bat evidence	None recorded.

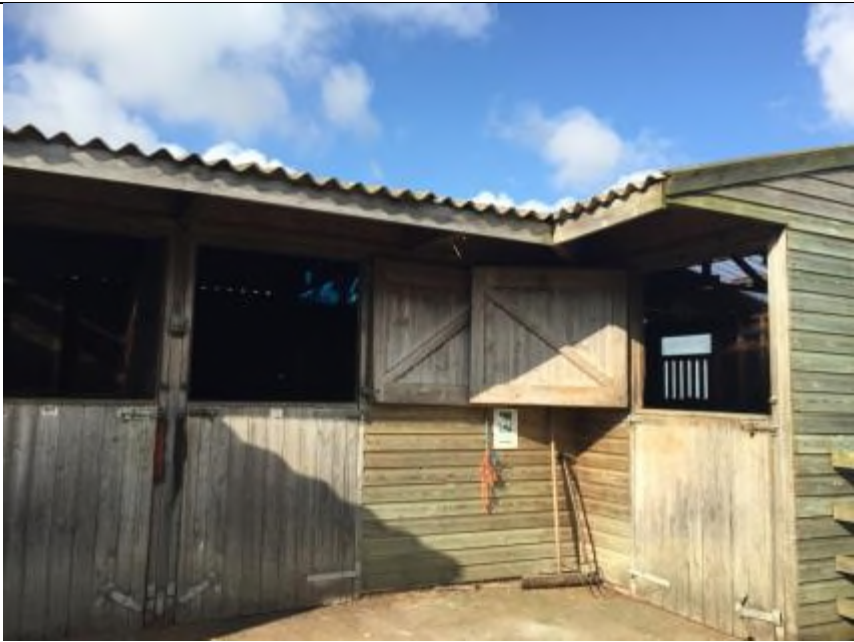
<p>B66A</p> <p>Moderate bat roost potential</p>

Description	<p>Grid reference: NZ 18888 93685</p> <p>A single-storey stable approximately 10 years old. The building was approximately 3 m high, 20 m long and 5 m wide. The walls were wooden, and the windows had wooden frames and were open. The roof was covered with corrugated metal.</p> <p>The surrounding land featured arable fields and paddocks, and a coniferous plantation woodland.</p>
	Features of bat potential	Gaps were present behind fascias. Barge boards and joists had created cavities suitable for bats. Numerous birds' nests were present.
	Limitations	None recorded.
	Bat evidence	None recorded.

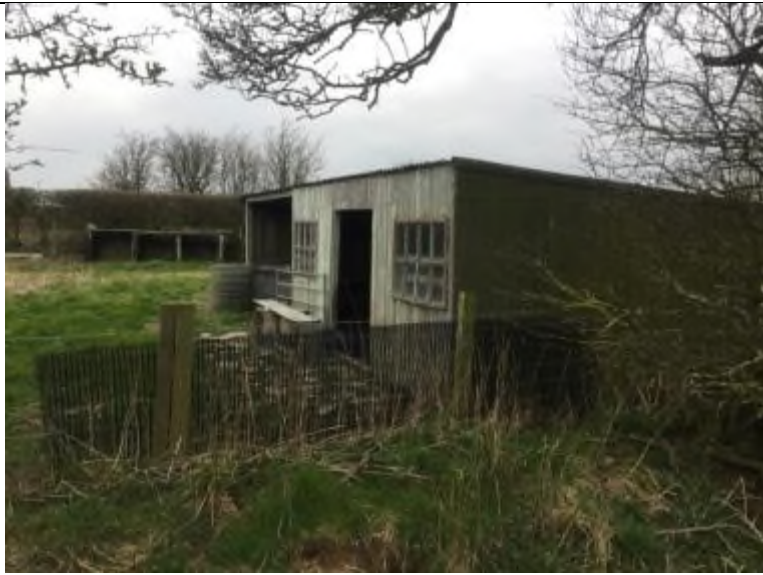
Description	<p>Grid reference: NZ 18961 94210</p> <p>A single-storey wooden stable with a flat corrugated asbestos cement roof. The stable was approximately 2 m tall, 6 m long and 3 m wide, and approximately 15 years old. The stable had wooden window frames.</p> <p>Land around the stable was arable and grazed land.</p>
	Features of bat potential	None recorded.
	Limitations	None noted.
	Bat evidence	None recorded.

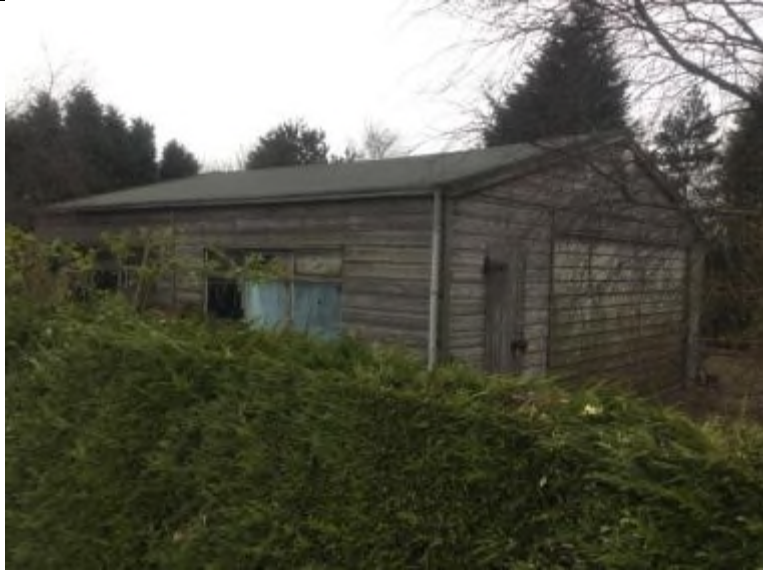
Description	<p>Grid reference: NZ 18965 94288</p> <p>A single-storey wooden shed with a two-pitched roof covered with bitumen felt. The shed had wooden window frames and barge boards. The building was approximately 3 m tall, 7 m long and 5 m wide, and approximately 15 years old.</p> <p>The shed was surrounded by gardens and arable farmland and grazed land.</p>
	Features of bat potential	None recorded.
	Limitations	None noted.
	Bat evidence	None recorded.

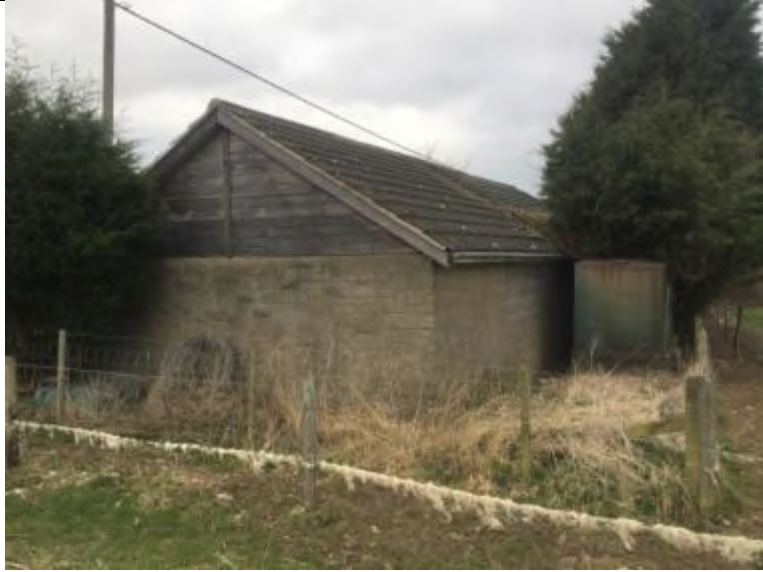
Description	<p>Grid reference: NZ 18971 94367</p> <p>A single-storey brick dwelling with wooden cladding on the gable end. The building was approximately 30 to 40 years old, and was approximately 4 m high, 10 m long, and 5 m wide. The building had soffit boxes and barge boards. The two-pitched roof was covered with 'pan tile' style concrete tiles.</p> <p>The building was adjacent to a dirt bike track and areas used for grazing and storage.</p>
	Features of bat potential	<p>Gaps were observed in the barge boards and mortar. However, the gaps were not large enough for bats.</p>
	Limitations	<p>The building could only be assessed from the southern and eastern aspects.</p>
	Bat evidence	<p>None recorded.</p>

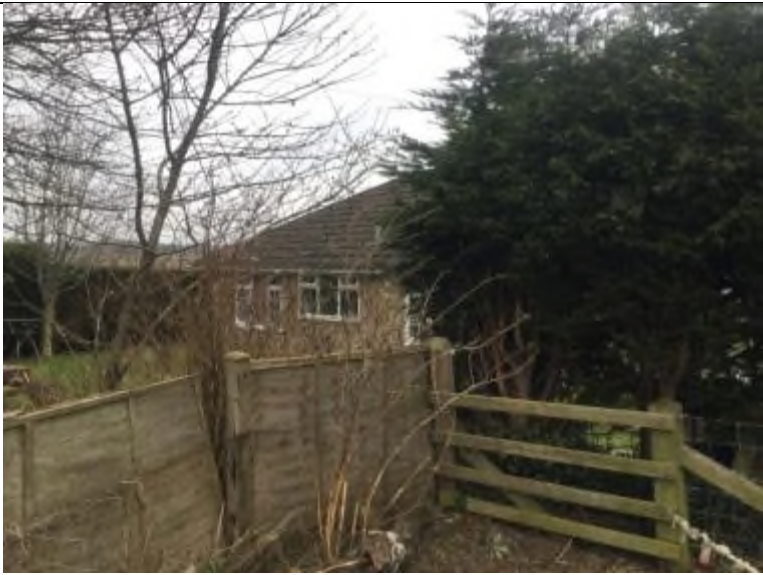
B71A Low bat roost potential

Description	<p>Grid reference: NZ 18957 94376</p> <p>A single-storey brick dwelling with a two-pitched, hipped roof. The building was approximately 30 years old, and approximately 4 m high, 15 m long and 10 m wide. The roof comprised pan tile-effect tiles. The windows were uPVC and soffit boxes were present.</p> <p>The building was adjacent to a dirt bike track and areas used for grazing and storage.</p>
	Features of bat potential	<p>None recorded.</p>
	Limitations	<p>The building could only be viewed from the southern end.</p>
	Bat evidence	<p>None recorded.</p>

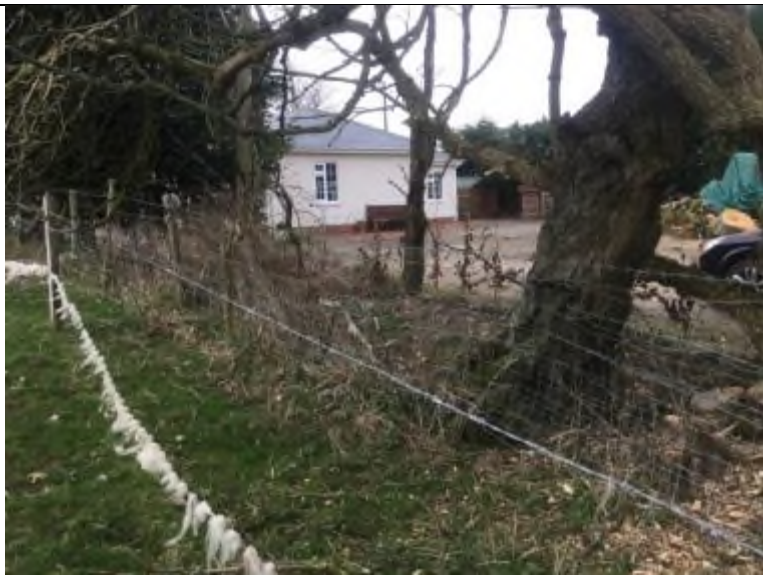
B72A Negligible bat roost potential

Description	<p>Grid reference: NZ 18960 94397</p> <p>A single-storey detached dwelling; approximately 10 years old, and approximately 4 m high, 11 m long, and 12 m wide. The building was prefabricated with rendered walls. The roof was two-pitched and hipped with slate, or slate-effect, tiles. The windows were framed with uPVC and a soffit box was present.</p> <p>The building was adjacent to a dirt bike track and areas used for storage.</p>
	Features of bat potential	None recorded.
	Limitations	The building could only be inspected from the northern side.
	Bat evidence	None recorded.

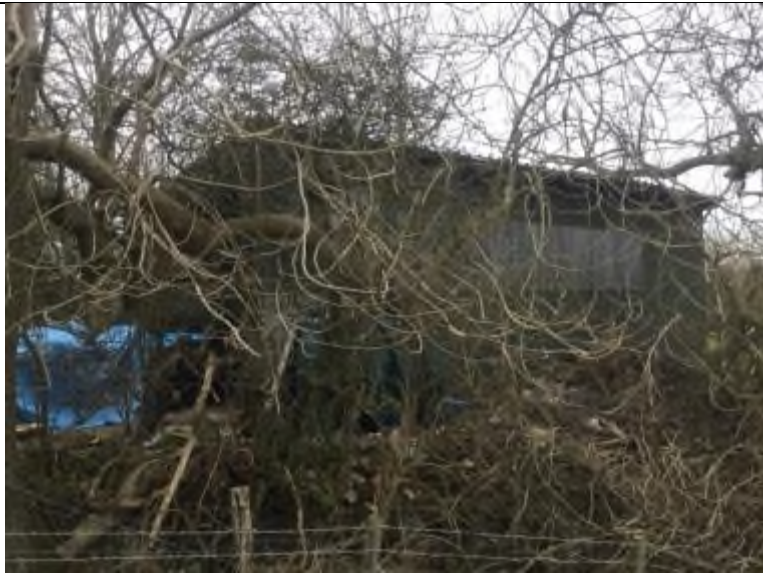
Description	<p>Grid reference: NZ 18974 94442</p> <p>An open-fronted single-storey corrugated metal garage with a two-pitched metal roof. The garage was approximately 4 m tall, 6 m wide and 8 m long, and approximately 10 years old.</p> <p>The building was adjacent to a dirt bike track and areas used for grazing and storage.</p>
	Features of bat potential	<p>None recorded.</p>
	Limitations	<p>None noted.</p>
	Bat evidence	<p>None recorded.</p>

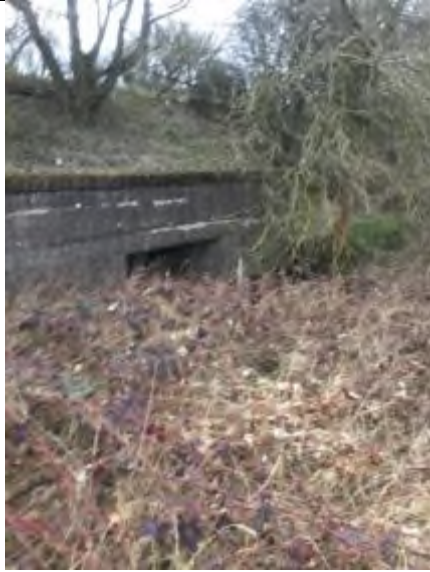
B74A Negligible bat roost potential

Description	<p>Grid reference: NZ 18967 94566</p> <p>Concrete culvert underneath the A1, between 30 and 60 years old. Approximately 2 to 3 m tall, 2.5 m wide and 30 m long.</p> <p>The culvert entrance was surrounded by a drainage ditch overgrown with brambles.</p>
	Features of bat potential	None recorded.
	Limitations	The culvert could only be viewed from a distance due to the barrier of dense bramble. However, the culvert may be used by bats commuting under the A1.
	Bat evidence	None recorded.

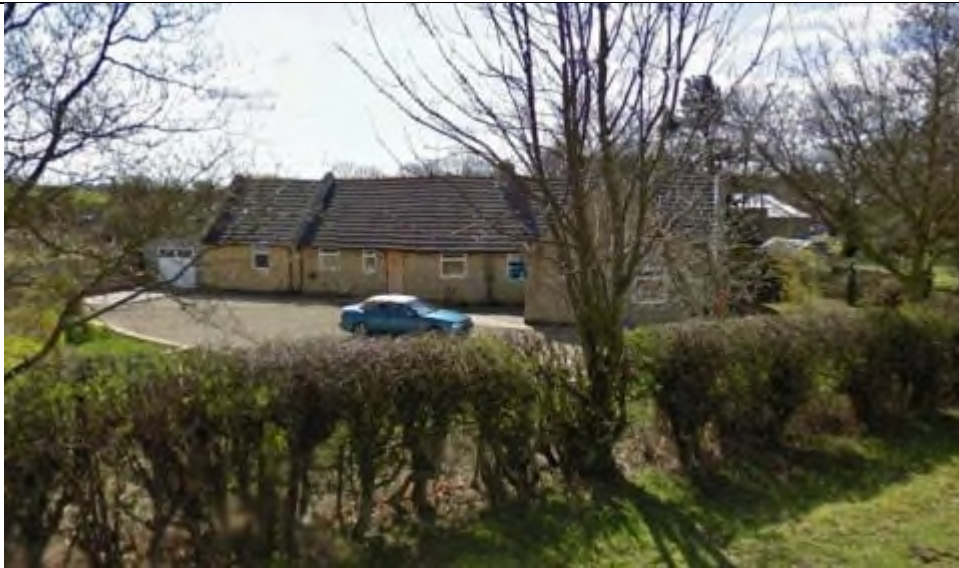
Image taken from Google Earth Pro	
	Description	<p>Grid reference: NZ 18924 94732</p> <p>A modern single-storey detached dwelling, approximately 25 m long and 13 m wide. The dwelling had stone walls and a multi-pitched roof with interlocking tiles. The windows were uPVC.</p> <p>The surrounding land featured arable and grazed fields, hedgerows and a stream.</p>
	Features of bat potential	None were observed, but features may have been present on the southern and eastern aspects of the building that could not be viewed.
	Limitations	Surveyed from the road, viewed from a distance and no view of the southern or eastern sides.
	Bat evidence	None recorded.

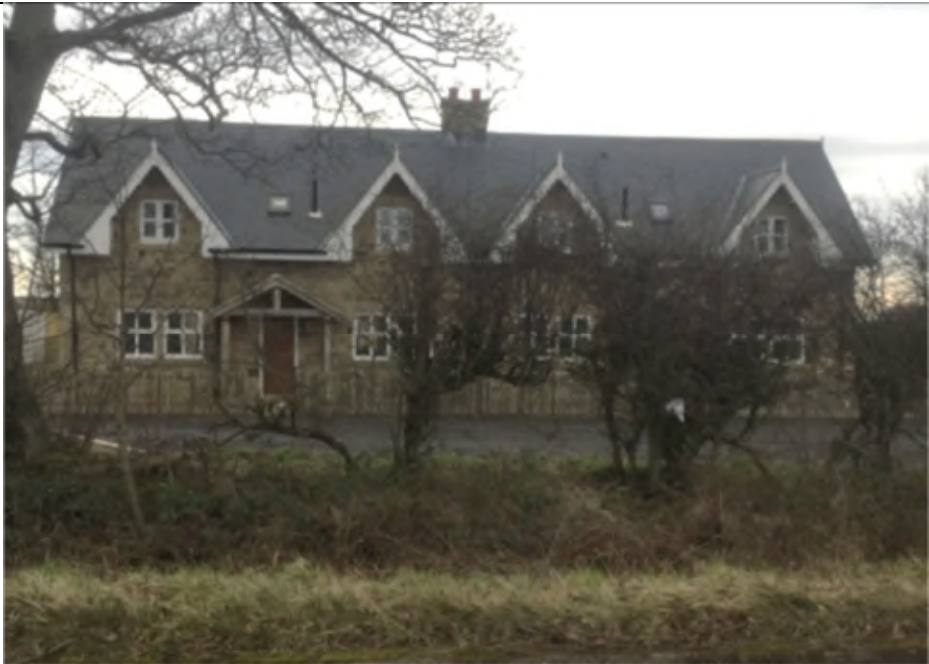
Description	<p>Grid reference: NZ 18960 94783</p> <p>A two-storey semi-detached dwelling built in 2010, approximately 20 m long and 10 m wide. The building had stone walls and the roof was double-pitched with dormer windows and covered with slate. The windows were uPVC. Barge boards and soffit boxes were present, and lead flashing was located around the chimney and in the joins between the roof and the dormer windows.</p> <p>The surrounding land featured arable and grazed fields, hedgerows and a stream.</p>
	Features of bat potential	<p>None were observed, and although features may have been present on south-eastern and northern aspects of the building that could not be viewed, this is considered unlikely due to the buildings age.</p>
	Limitations	<p>Surveyed from the road, no view of the south-eastern and northern sides.</p>
	Bat evidence	<p>None recorded.</p>

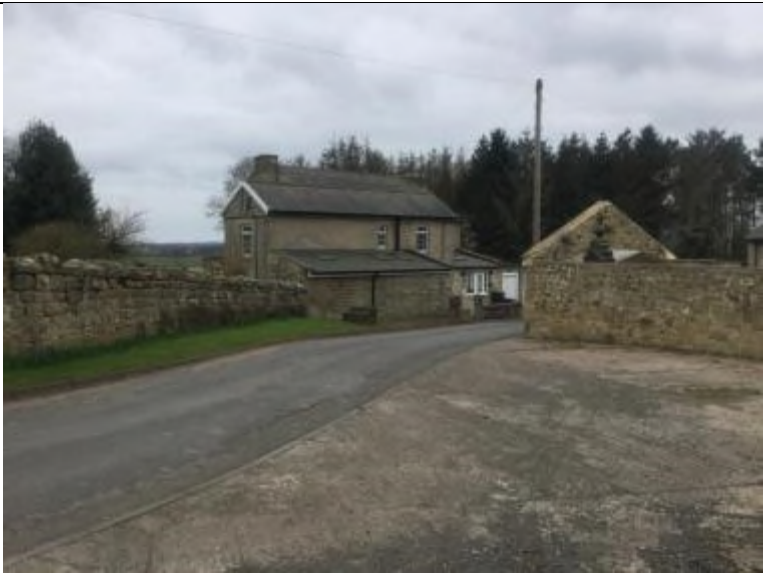
Description	<p>Grid reference: NZ 18780 96364</p> <p>Three-storey detached dwelling with brick and stone walls and a multi-pitched, slate roof. The dwelling was approximately 8 m high, 19 m long, and 26 m wide. The building had uPVC framed windows, and a soffit box (on the extension only), fascias and barge boards were present. Tightly-fitting lead flashing was present around the ground floor.</p> <p>The building was surrounded by a farm and woodland.</p>
	Features of bat potential	Slipped roof tiles were noted.
	Limitations	None noted.
	Bat evidence	No bat evidence was observed during the inspection of the building. The owners of the dwelling were not aware of any bat roosts.

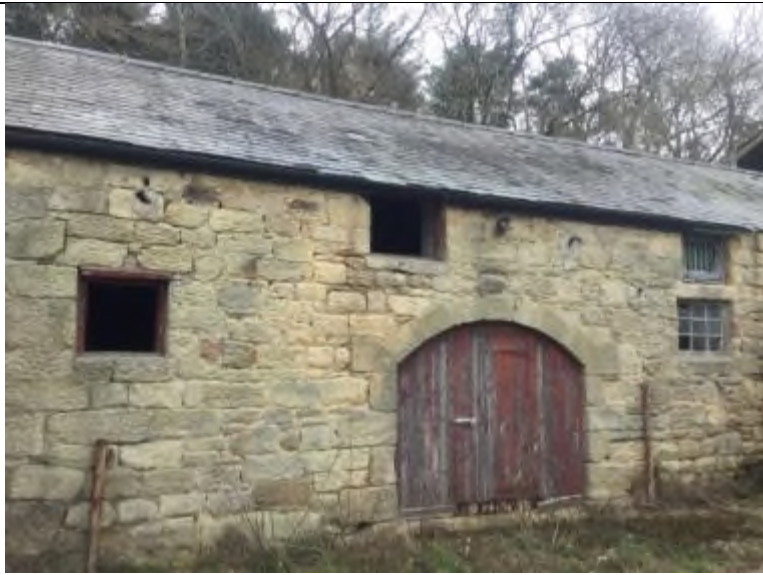
Description	<p>Grid reference: NZ 18764 96419</p> <p>Two-storey stone barn, likely constructed in the 18th century and occasionally used for storage. The barn was approximately 5 m tall, 26 m long, and 7 m wide. The roof was two-pitched and was covered with a mixture of slates and asbestos concrete sheets. The barn had wooden window frames; some were without glass. Windows allowed light to enter the building. Fascias were present on parts of the building, and tightly-fitting lead flashing was present in the roof valley where the barn forms an 'L' shape.</p> <p>The barn was surrounded by farm buildings and woodland.</p>
	Features of bat potential	<p>It was noted that there were several missing and slipped roof tiles. There were gaps in the mortar beneath the ridge and the window lintels and between stonework.</p> <p>Holes were also observed in the building where joists were previously attached to building.</p>

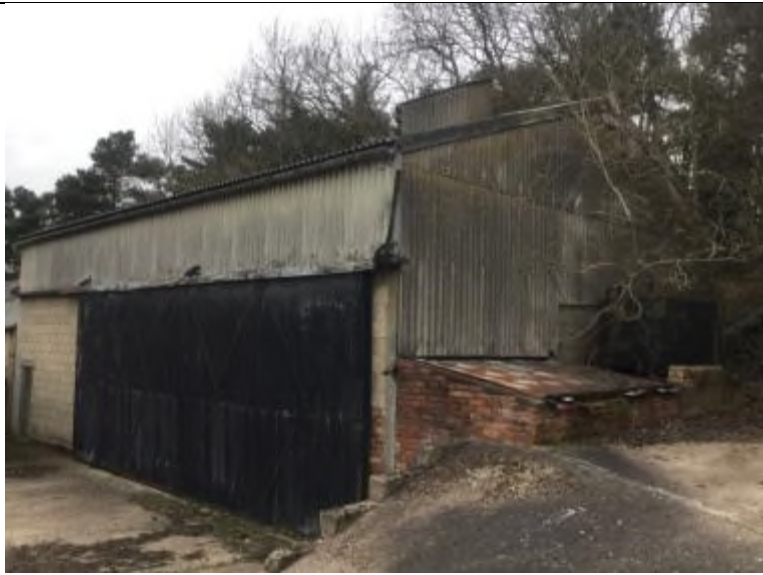
Description	Grid reference: NZ 18796 96418 Semi-detached single-storey barn constructed approximately 20 years ago. The building was approximately 6 m tall, 6 m long and 10 m wide. The barn was made of three materials; breeze blocks, red brick and corrugated asbestos concrete sheeting. The building had a two-pitched roof made from corrugated asbestos concrete. The building was surrounded by farm and woodland.
	Features of bat potential	Small gaps in mortar and overlapping tiles were observed but these were closely inspected and no evidence of, or substantial potential for, roosting bats was identified.
	Limitations	None noted.
	Bat evidence	No bat evidence was observed during the inspection of the building. The owners of the barn were not aware of any bat roosts.

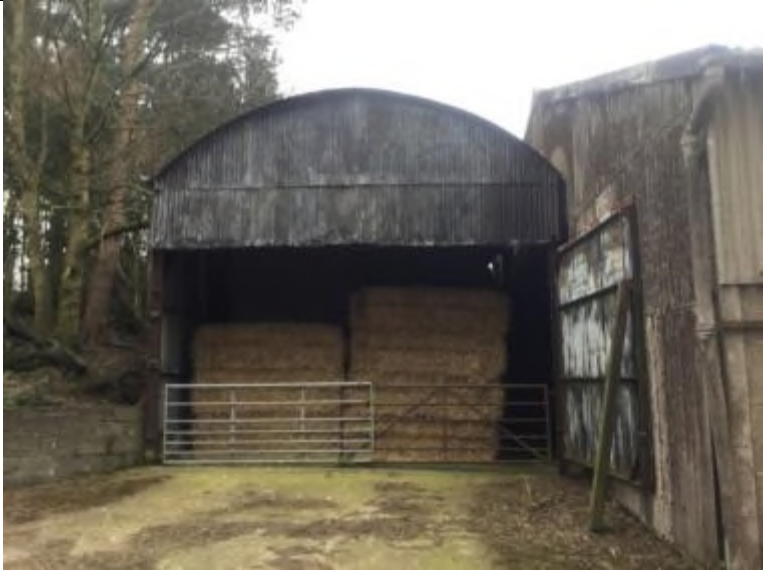
Description	<p>Grid reference: NZ 18761 96428</p> <p>An open-fronted, corrugated metal barn with a curved roof, used for storing straw. The barn was approximately 6 m tall, 10 m long and 5 m wide, and was approximately 30 years old.</p> <p>The barn was surrounded by a farm and woodland.</p>
	Features of bat potential	None recorded.
	Limitations	None noted.
	Bat evidence	None recorded.

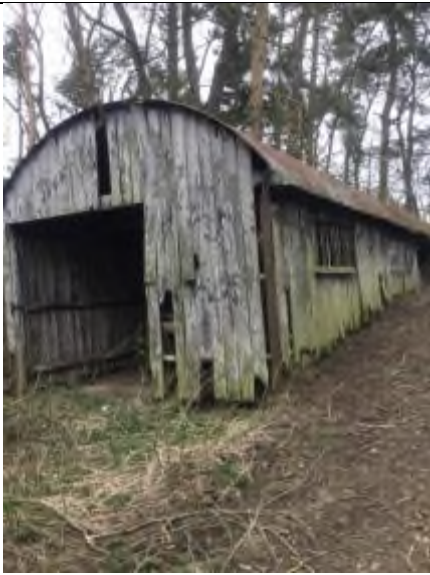
B80A Negligible bat roost potential

Description	<p>Grid reference: NZ 18732 96426</p> <p>A disused single-storey saw mill constructed approximately 60 years ago. The building had wooden walls and a curved corrugated metal roof. The building was approximately 3.5 m tall, 16 m long and 4 m wide. The mill had wooden window frames however there was no glass in the frames.</p> <p>The building was surrounded by farm buildings and woodland.</p>
	Features of bat potential	<p>There were cracks in the wall. However, these were large and exposed.</p> <p>The barn was open at the front and side providing bats with access to the interior but no suitable crevices were identified inside.</p>
	Limitations	<p>None noted.</p>
	Bat evidence	<p>No bat evidence was observed during the inspection of the building. The owners of the barn were not aware of any bat roosts.</p>

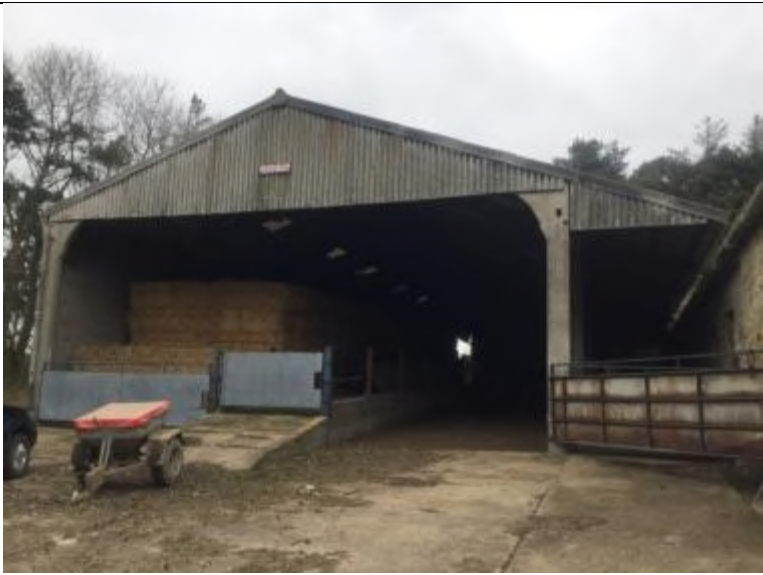
Description	<p>Grid reference: NZ 18751 96410</p> <p>A single-storey working barn constructed from breeze blocks and corrugated asbestos concrete sheeting, approximately 20 years old. The barn was approximately 8 m high, 27 m long and 16 m wide. The barn roof was two-pitched.</p> <p>The building was surrounded by farm and woodland.</p>
	Features of bat potential	<p>No potential bat roost features were recorded.</p> <p>The barn was open at the front providing bats with access to the interior.</p>
	Limitations	<p>None noted.</p>
	Bat evidence	<p>No bat evidence was observed during the inspection of the building. The owners of the barn were not aware of any bat roosts.</p>

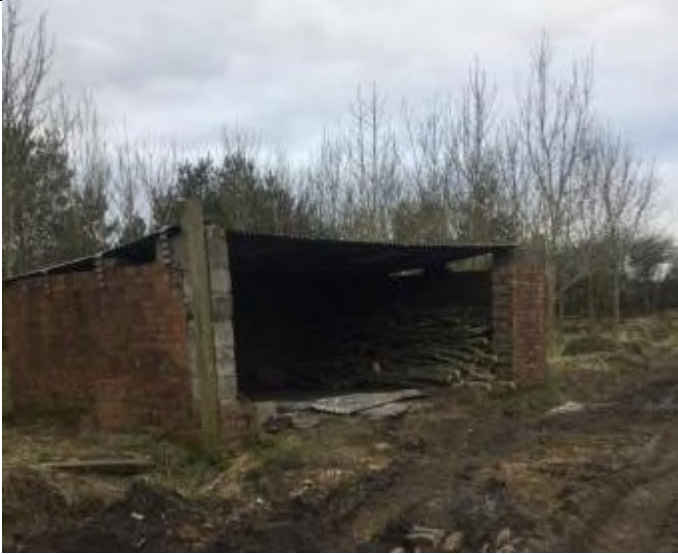
Description	<p>Grid reference: NZ 17575 97957</p> <p>An open-fronted single-storey red brick log shed with a single pitch corrugated metal roof, approximately 40 years old. The building was approximately 2.5 m tall, 3 m long, and 6 m wide.</p> <p>The building was adjacent to a woodland strip.</p>
	Features of bat potential	Cracks were recorded in the mortar between breeze blocks and brick work but these were closely inspected and found to be generally too small or open to support roosting bats.
	Limitations	None noted.
	Bat evidence	No evidence of roosting bats was identified.

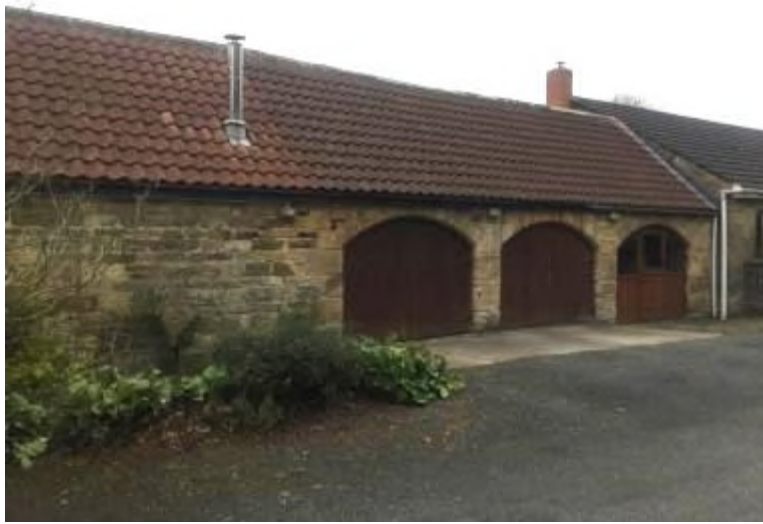
B84A Confirmed bat roost

Description	<p>Grid reference: NZ 17314 98710</p> <p>A single-storey stone garage, less than 20 years old, with pan-tile roof. The building was approximately 4.5 m high, 20 m long and 6 m wide. The building had barge boards behind guttering and wooden window frames.</p> <p>The surrounding land featured residential and farm buildings, arable fields and private gardens.</p>
	Features of bat potential	<p>Gaps were recorded beneath barge boards and behind gutters on eastern aspect and some on western aspect.</p>
	Limitations	<p>None noted.</p>
	Bat evidence	<p>Anecdotal evidence from a neighbour identified that a pipistrelle roost was present in the northernmost section of the garage. No physical evidence was found during the survey.</p>

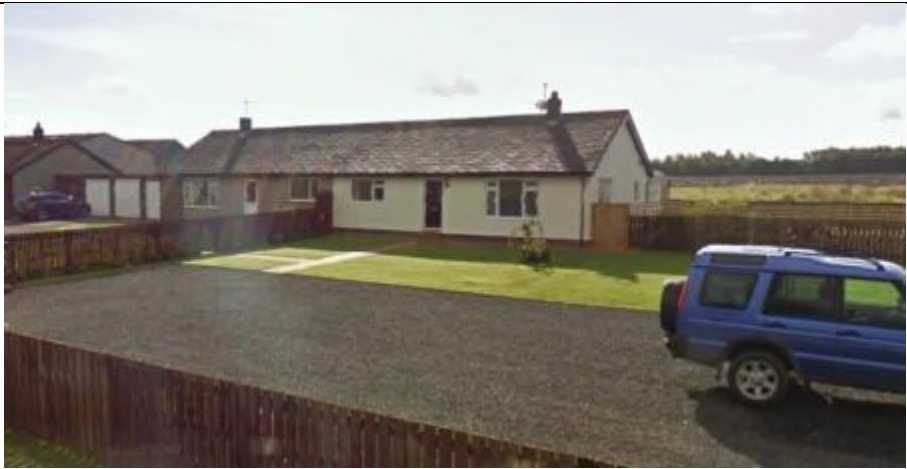
B106A Moderate bat roost potential

<p style="text-align: center;">Image taken from Google Earth Pro</p>	
	Description	<p>Grid reference: NZ 17189 98677</p> <p>A block of two terraced single-storey dwellings with brick and rendered walls and two-pitched tiled roofs. The building was approximately 22 m long and 10 m wide, and the windows were uPVC. Soffit boxes and barge boards were present, and lead flashing was located around the chimneys.</p> <p>The surrounding land featured woodland, arable fields and hedgerows.</p>
	Features of bat potential	<p>None were observed, but features may have been present on the southern aspect of the building that could not be viewed.</p>
	Limitations	<p>Surveyed from the road, no view of the southern side.</p>
	Bat evidence	<p>None recorded.</p>

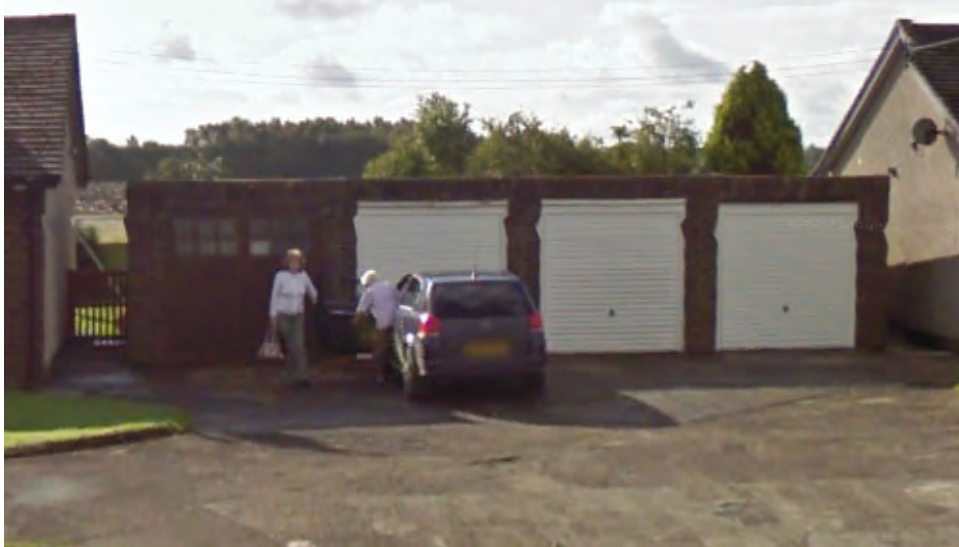
B105A Negligible bat roost potential

Image taken from Google Earth Pro	
	Description	<p>Grid reference: NZ 17206 98679</p> <p>A single-storey garage, approximately 11 m long and 6 m wide. The garage had brick walls and a flat felt-covered roof. The garage doors were constructed of metal, and one was wooden with glass panes.</p> <p>The surrounding land featured woodland, arable fields and hedgerows.</p>
	Features of bat potential	None were observed, but features may have been present on the southern aspect of the building that could not be viewed.
	Limitations	Surveyed from the road, no view of the southern side.
	Bat evidence	None recorded.

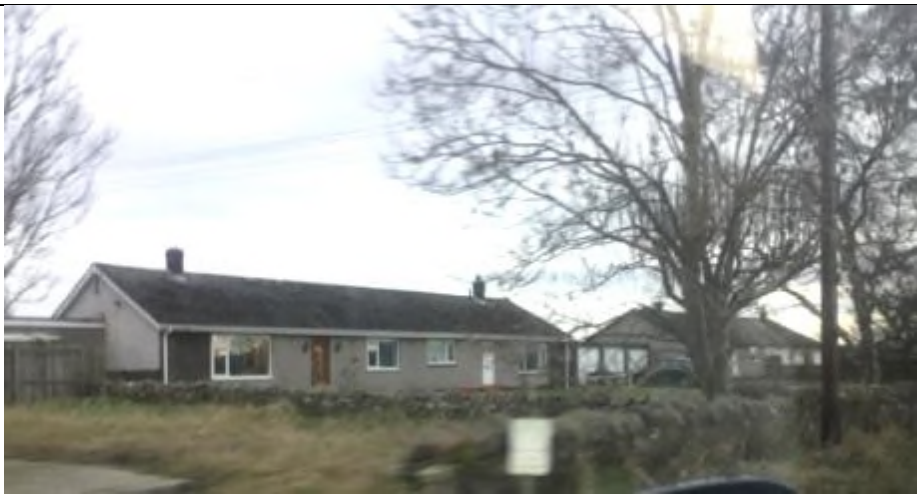
B104A Moderate bat roost potential

Description	<p>Grid reference: NZ 17222 98684</p> <p>A block of two terraced single-storey dwellings with brick and rendered walls and double-pitched tiled roofs. The building was approximately 22 m long and 10 m wide, and the windows were framed by uPVC. Soffit boxes and barge boards were present, and lead flashing was located around the chimneys.</p> <p>The surrounding land featured woodland, arable fields and hedgerows.</p>
	Features of bat potential	<p>None were observed, but features may have been present on the southern aspect of the building.</p>
	Limitations	<p>Surveyed from the road, no view of the southern side.</p>
	Bat evidence	<p>None recorded.</p>
