A1 in Northumberland: Morpeth to Ellingham

Scheme Number: TR010041

6.7 Environmental Statement – Appendix 9.7 Bat Roost Potential Survey Report 2017

Bat Roost Potential Survey Report 2017

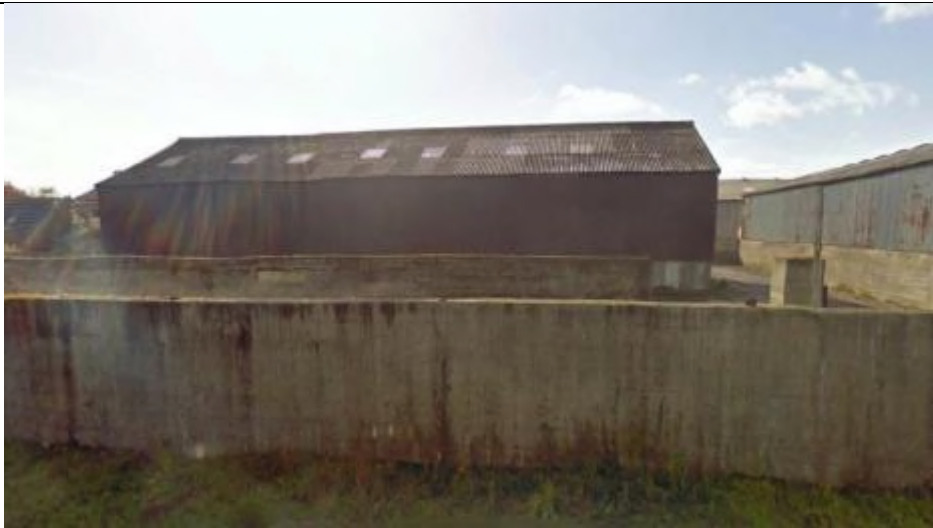
B102A Negligible bat roost potential

Image taken from Google Earth Pro	
	Description	<p>Grid reference: NZ 17276 98701</p> <p>A modern single-storey farm outbuilding, approximately 29 m long and 13 m wide. The building was constructed of breeze blocks and wood, and the roof was two-pitched and covered with corrugated cement sheets with skylights.</p> <p>The surrounding land featured woodland, arable fields and hedgerows.</p>
	Features of bat potential	None recorded.
	Limitations	Surveyed from the road, no view of the southern side.
	Bat evidence	None recorded.

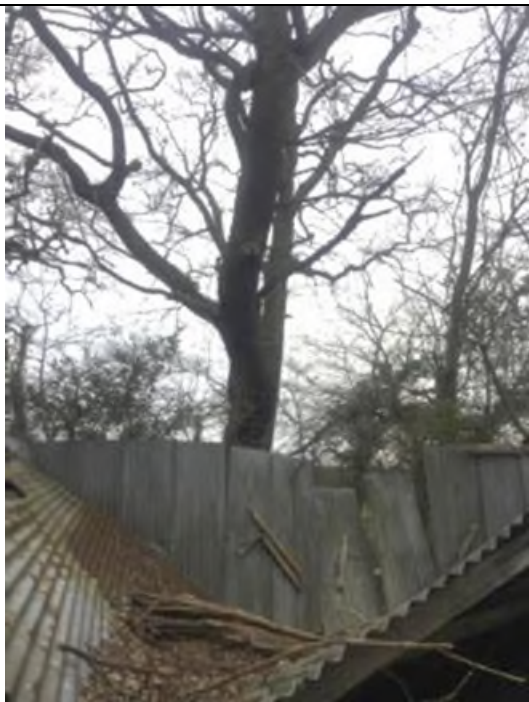
B100A Negligible bat roost potential

Description	<p>Grid reference: NZ 17394 98747</p> <p>Derelict wooden shed with a collapsed roof covered with corrugated metal. The building was approximately 15 m long and 6 m wide.</p> <p>The surrounding landscape featured woodland and farmland.</p>
	Features of bat potential	<p>There was no roof void and the building provided little shelter as it was exposed to the elements.</p>
	Limitations	<p>None recorded.</p>
	Bat evidence	<p>None recorded.</p>

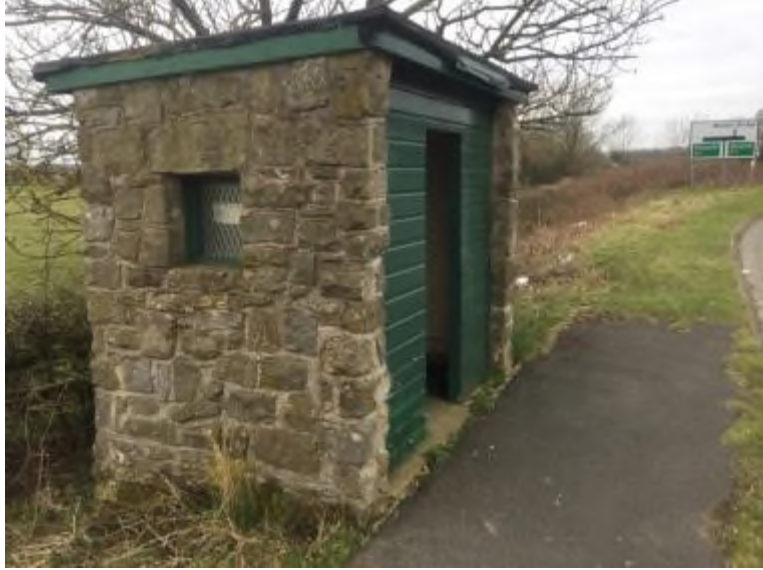
B85A Negligible bat roost potential

Description	<p>Grid reference: NZ 17502 98797</p> <p>Single-storey 20 year old bus shelter, approximately 2 m tall, 2 m wide and 3 m long. The building's walls were made from stone-faced breeze blocks while the flat roof was covered with bitumin roofing felt. The building had windows with wooden frames and fascias.</p> <p>The building was surrounded by grazed pasture and a minor road. The A1 was approximately 70 m west of the building.</p>
	Features of bat potential	<p>A missing section of roofing felt was recorded on the building's southwest corner but its exposed position with adjacent minor road and nearby A1 reduced potential substantially.</p>
	Limitations	<p>None noted.</p>
	Bat evidence	<p>None recorded.</p>

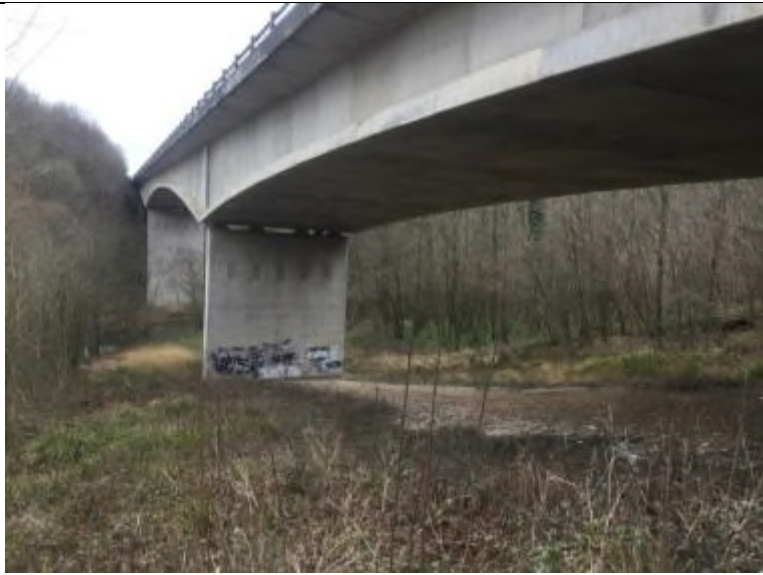
B86A Moderate bat roost potential

Description	<p>Grid reference: NZ 17442 99885</p> <p>The A1 concrete road bridge over the River Coquet, approximately 30 years old. The bridge had three spans and was approximately 16 m tall, 14 m wide and 70 m long.</p> <p>There was woodland either side of the bridge.</p>
	Features of bat potential	<p>The bridge had expansion gaps at either end of the northern span.</p>
	Limitations	<p>Classified as having moderate bat roost potential as a precaution, as the expansion gaps could not be accessed for inspection.</p>
	Bat evidence	<p>None recorded.</p>

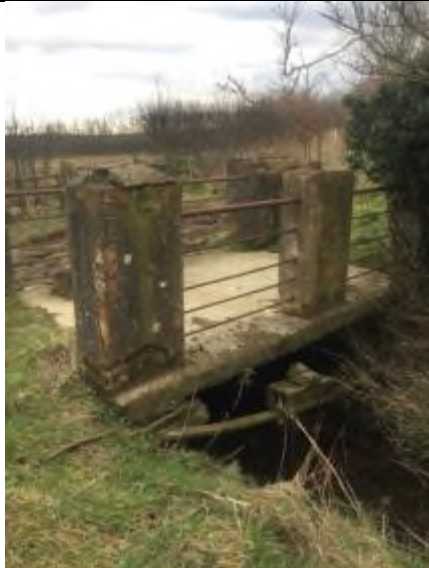
A1 Ecological Inspection of Buildings and Structures			
SITE DETAILS			
Project Name:	A1 in Northumberland	Project Number:	B2104700
Site Name (if different):	Section B	Date of Inspection:	21 st -23 rd March 2016; 17 th – 19 th August 2016; 5 th – 6 th December 2016
B1B Low bat roost potential

Description	Grid reference: NU 19625 15631 Concrete culvert; approximately 30 years old. The culvert was approximately 1 m tall, 60 m long and 2 m wide. The land surrounding the culvert was arable and young plantation.	
	Features of bat potential	Although it was not inspected internally there were likely to be cracks inside the culvert, based on the culverts age and external condition.	
	Limitations	None noted.	
	Bat evidence	None recorded.

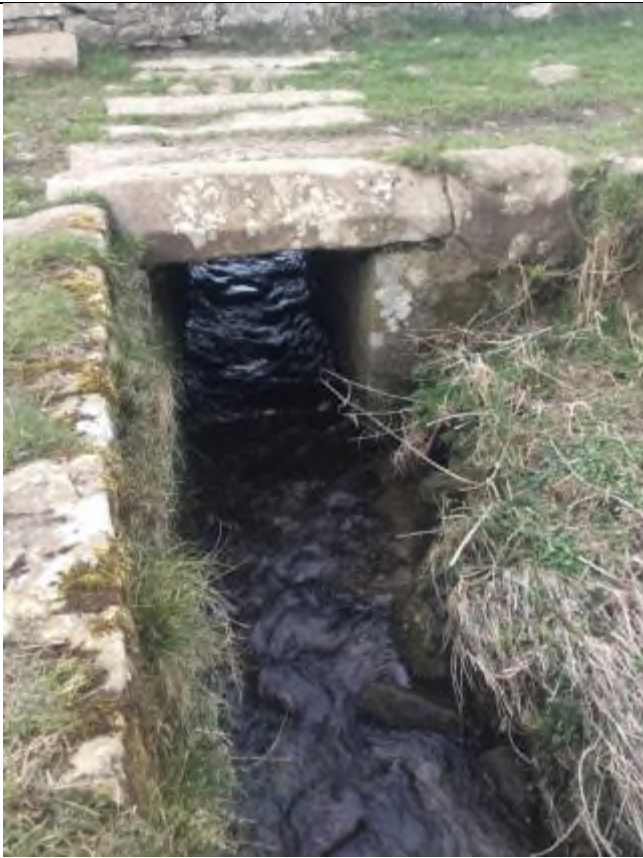
B2B Negligible bat roost potential

Description	Grid reference: NU 19389 16469 Stone culvert with stone slabs forming its deck. Approximately 90 cm tall, 80 cm wide and 3.5 m long. Land surrounding the culvert is grazed pasture.
	Features of bat potential	Gaps between stonework were observed in the culvert's roof but these provided little shelter and the level of the stream was considered likely to rise such that potential gaps would not be suitable for use by roosting bats.
	Limitations	None noted.
	Bat evidence	None recorded.

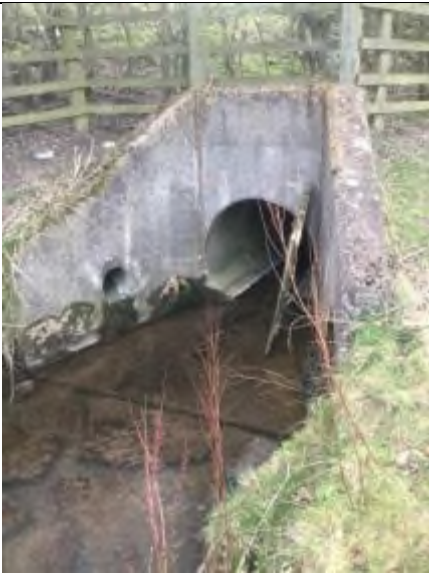
B3B Negligible bat roost potential

Description	<p>Grid reference: NU 19216 16629</p> <p>Concrete culvert approximately 30 years old. The culvert was approximately 1 m tall, 1 m wide and 30 m long.</p> <p>Land surrounding the culvert was grazed pasture.</p>	
	Features of bat potential	None recorded.	
	Limitations	None noted.	
	Bat evidence	None recorded.

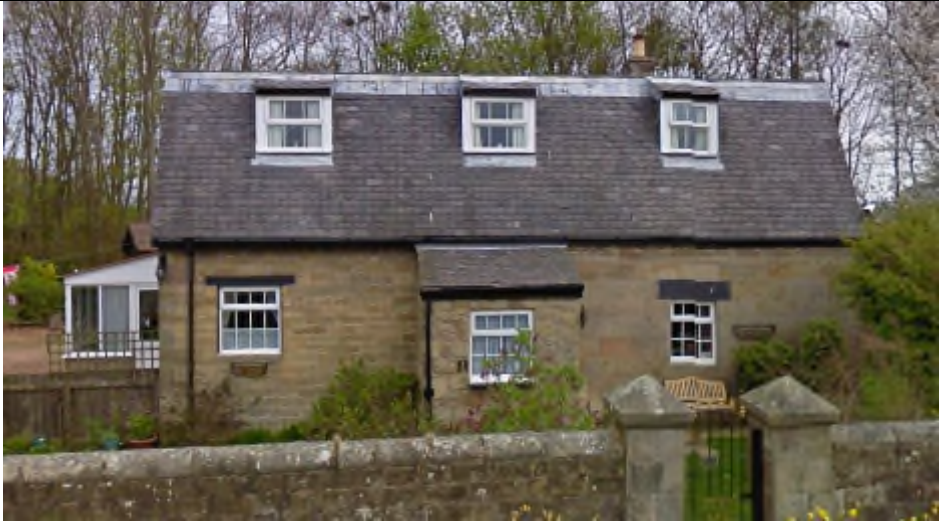
B4B Moderate bat roost potential

<p style="text-align: center;">Photo from Google Earth (April 2011; Accessed December 2016)</p>	
	Description	<p>Grid reference: NU 17818 20034</p> <p>A two-storey residential cottage approximately 150 years old with a modern Dutch pitch barn style roof. The cottage was approximately 6 m high, 12 m long and 9 m wide, constructed from stone and had a slate covered roof with some cladding. The windows were uPVC.</p> <p>The surrounding land use was residential garden and woodland, with roads to the east and west.</p>
	Features of bat potential	<p>Gaps present in porch fascia, and lead flashing was open to western aspect along the roof top.</p>
	Limitations	<p>None noted.</p>
	Bat evidence	<p>None recorded.</p>

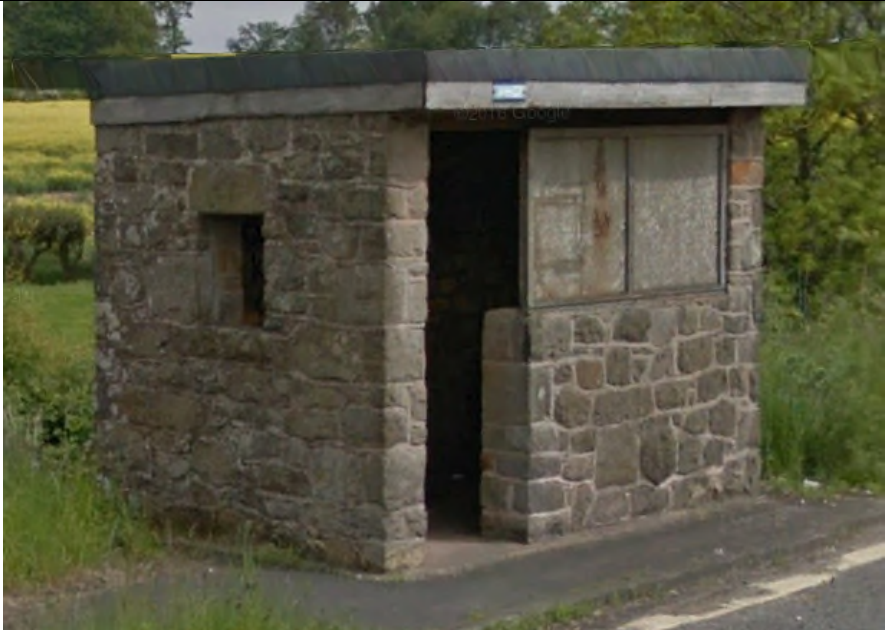
<p>B105B</p> <p>Low bat roost potential</p>	<div style="text-align: center;">

<table><tr> <td style="width: 20%; padding: 5px;">Description</td><td style="padding: 5px;"> <p>Grid reference: NU 17776 20415</p> <p>Stone bus-shelter with a flat bitumen felt-covered roof. The building was approximately 3 m long and 2 m wide.</p> <p>The surrounding land featured farmland and hedgerows.</p> </td></tr></table>

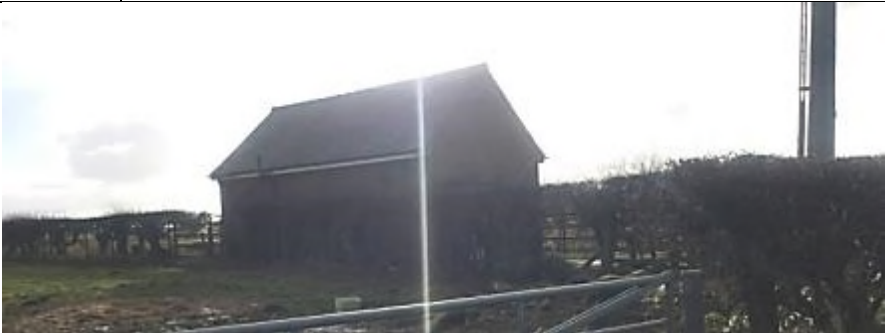
Description	<p>Grid reference: NU 17455 20423</p> <p>A single-storey barn, approximately 4 m high, 10 m long and 5 m wide. The building was constructed of red brick with a two-pitched, slate covered roof.</p> <p>The surrounding land was grazed pasture and hedgerows.</p>
	Features of bat potential	None recorded.
	Limitations	None recorded.
	Bat evidence	None recorded.
B103B Negligible bat roost potential

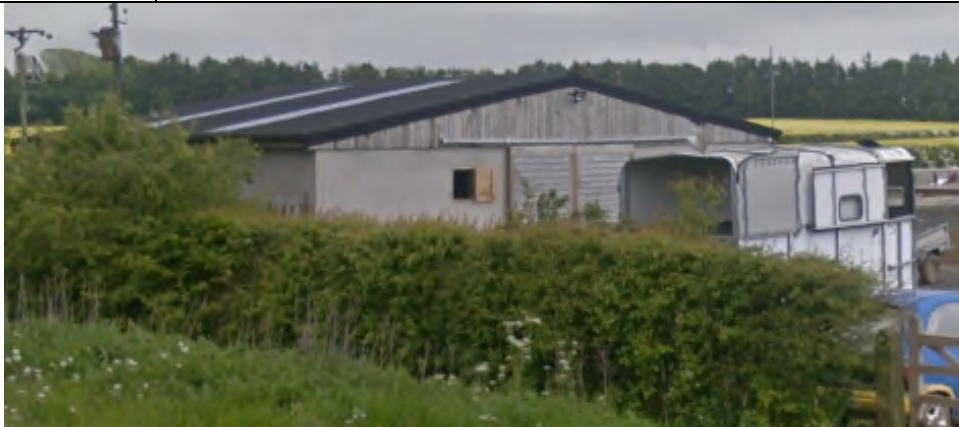
<p style="text-align: center;">Image taken from Google Earth Pro</p>	
	Description	<p>Grid reference: NU 17827 20609</p> <p>Rendered breeze-block and wooden clad stable built within the last 10 years, approximately 14 m long by 14 m wide. The two-pitched roof was covered with corrugated bitumen sheets.</p> <p>The surrounding land featured farmland and hedgerows.</p>
	Features of bat potential	None recorded.
	Limitations	None recorded.

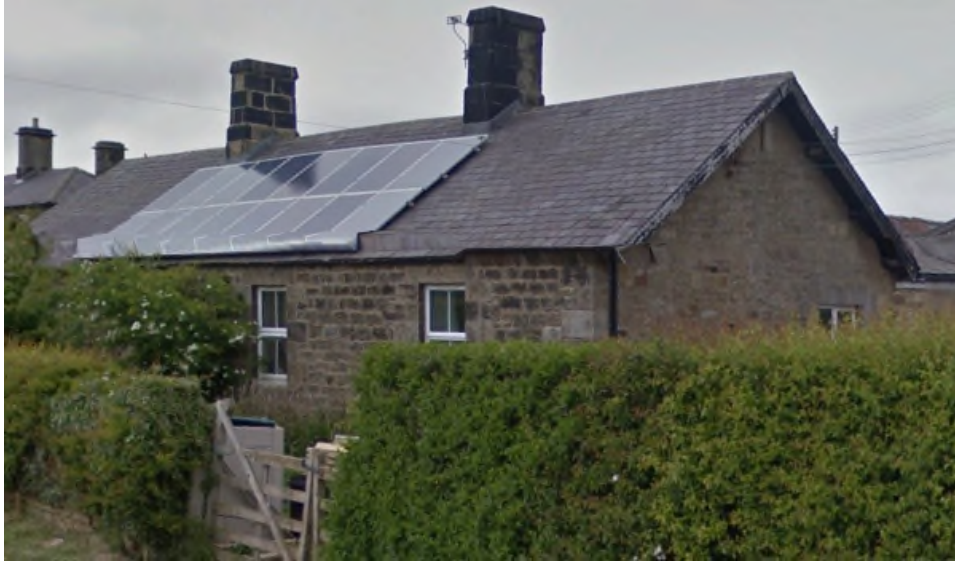
<p style="text-align: center;">Image taken from Google Earth Pro</p>	
	Description	<p>Grid reference: NU 17787 20638</p> <p>Single-storey detached stone dwelling, which appeared to be well-maintained. The dwelling was approximately 17 m long and 10 m wide. The roof was two-pitched and slate-covered. Two stone extensions were located on the northern side with single-pitched, slate-covered roofs without roof voids. The windows had uPVC frames, lead flashing was present around the chimneys, solar panels were present on the southern roof pitch and barge boards were also present.</p> <p>The surrounding land featured farmland and hedgerows.</p>
	Features of bat potential	There was an overhang at the gable ends and the eaves. Additionally, features may have been present on the northern aspect of the building that could not be viewed.
	Limitations	Surveyed from the road so no view of the northern aspect.

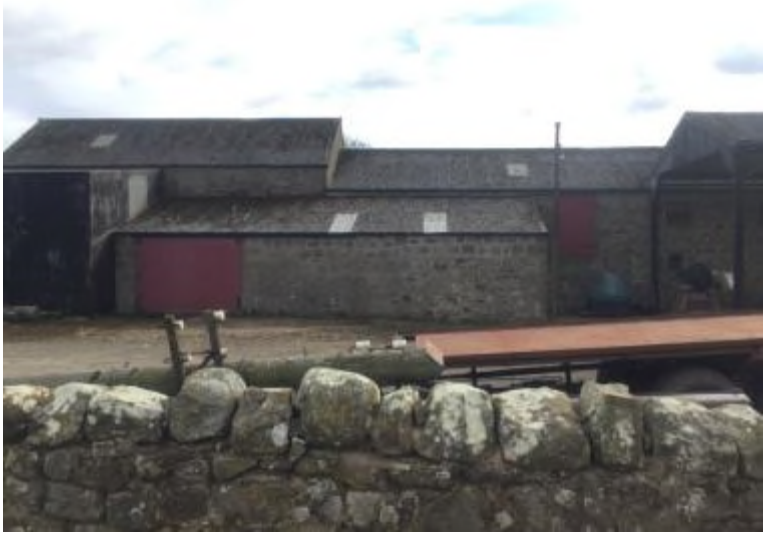
B6B Low bat roost potential

Description	<p>Grid reference: NU 17743 20678</p> <p>Old, two storey, detached barn. The building was constructed from stone. The roof was double pitched and covered with corrugated asbestos cement sheets with pitched extensions. The roof material overlapped the building's gable ends. There were no windows.</p> <p>The building was 12 m tall and 50 m long.</p> <p>The land surrounding the building was grazed pasture.</p>
	Features of bat potential	<p>Small cracks and low level mortar gaps were observed.</p>
	Limitations	<p>None noted.</p>
	Bat evidence	<p>None recorded.</p>

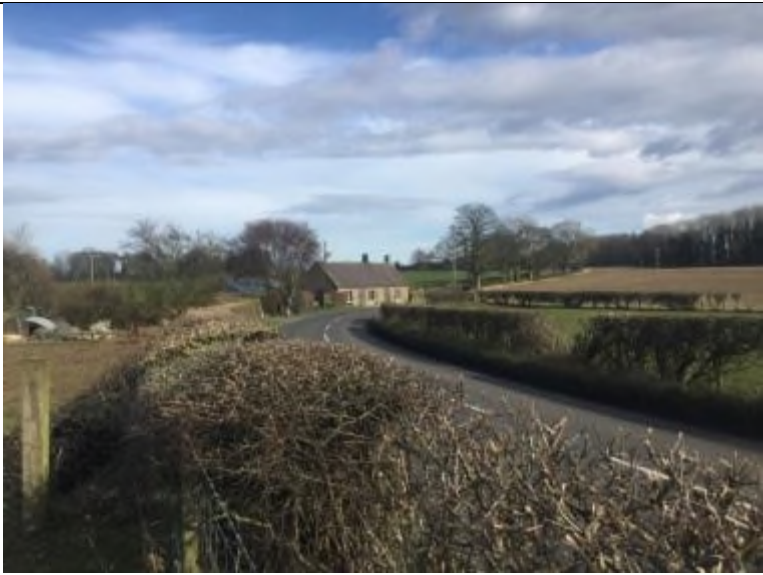
B8B Moderate bat roost potential

Description	<p>Grid reference: NU 18225 20693</p> <p>Stone detached dwelling. The single storey building was approximately 15 m long and 6 m wide. The building's two pitched roof was covered with slate. The building's windows were uPVC.</p> <p>A smallholding surrounded the building on three sides. A minor road was present to the south.</p>
	Features of bat potential	<p>The dwelling's owner (Mr Douglas) reported a crack going into the loft. There was some missing mortar between the ridge tiles.</p>
	Limitations	<p>None noted</p>
	Bat evidence	<p>None recorded. Owner reported bats flying around house.</p>

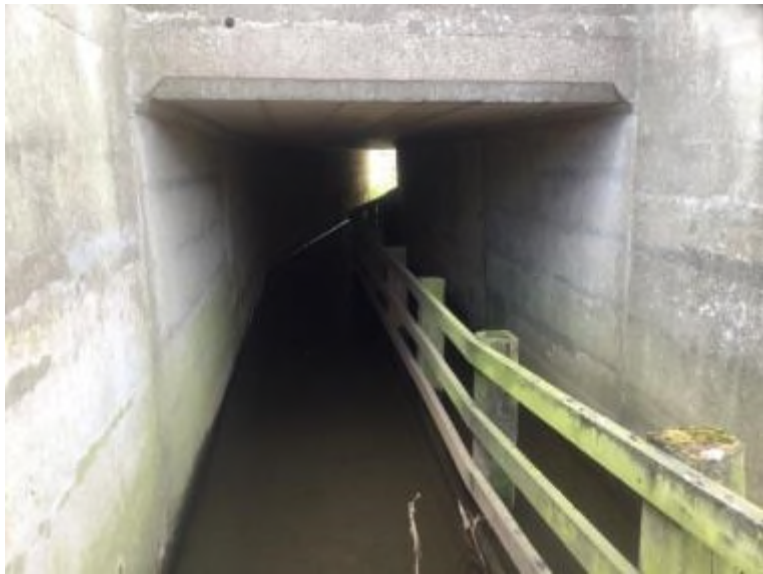
B9B Negligible bat roost potential

Description	Grid reference: NU 17605 21027 Concrete culvert allowing a stream to flow under the A1. The structure was approximately 30 m long, 2 m high, and 2 m wide. The land surrounding the culvert was grazed pasture and arable.
	Features of bat potential	No obvious cracks were observed in the concrete. Negligible potential for bat roost. However, the culvert had high potential to be used by commuting bats to cross under the A1.
	Limitations	None noted.
	Bat evidence	None recorded.

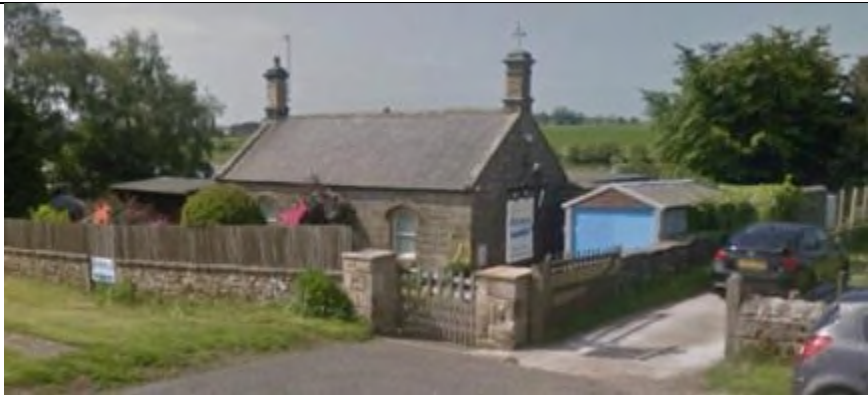
B100B Low bat roost potential (dwelling) - Negligible bat roost potential other structures

<p style="text-align: center;">Image taken from Google Earth Pro</p>	
	Description	<p>Grid reference: NU 17554 21051</p> <p>Single-storey, well maintained, stone dwelling with associated kennels and modern pre-fabricated garage. The dwelling had a two-pitched roof, covered with slate and windows with wooden frames. The dwelling was approximately 11 m in length and width.</p> <p>The surrounding land comprised grazed pasture and hedgerows.</p>
	Features of bat potential	Small gaps under ridge tiles and beneath coping stones.
	Limitations	No access to the rear of the property as dogs were loose.
	Bat evidence	None recorded but additional features and evidence at the rear of the property could not be ruled out.

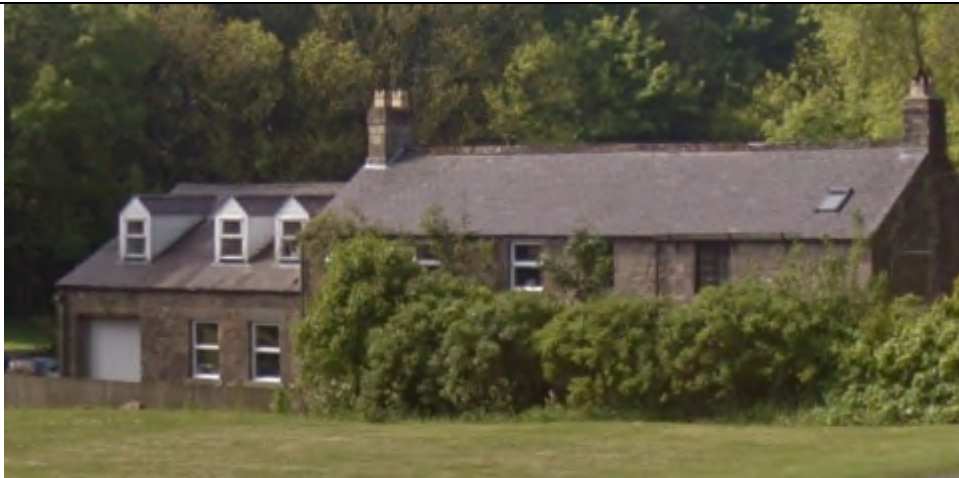
B10B Confirmed roost

<p style="text-align: center;">Photo from Google Earth (June 2016; Accessed December 2016)</p>	
	Description	<p>Grid reference: NU 17420 21255</p> <p>A two-storey house approximately 100 years old. The house measured 6 m high, 18 m long and 12 m wide. The house was constructed from stonework. The roof was two-pitched and covered with slates. The windows had wooden frames.</p> <p>The surrounding land use was residential and pasture.</p>
	Features of bat potential	<p>Gaps were present between the top of the eastern wall and the roof tiles. There was also a large gap above the garage door potentially leading into a roof void. Gaps were present under the flashing around the dormer extensions on eastern aspect.</p>
	Limitations	<p>None noted.</p>
	Bat evidence	<p>None recorded. Anecdotal evidence of bats emerging from owner.</p>

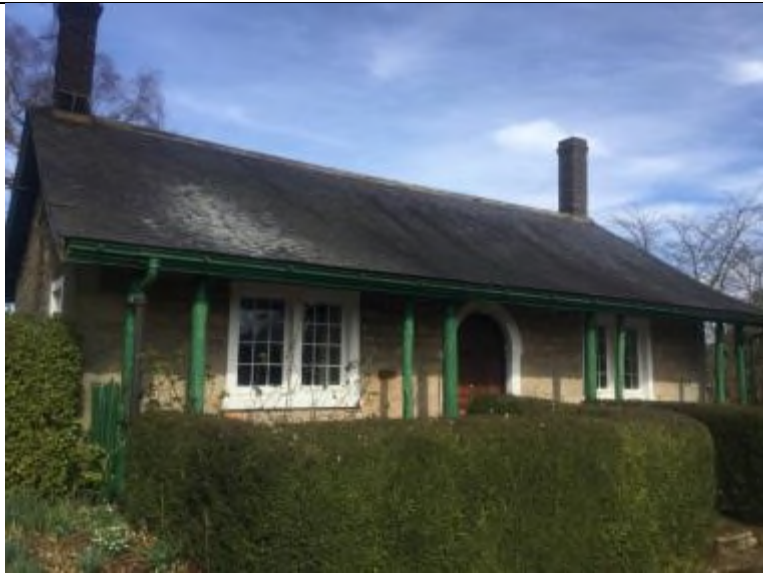
B11B High bat roost potential

Description	<p>Grid reference: NU 17170 21936</p> <p>Victorian era detached dwelling constructed from sandstone and bricks. The roof was double pitched in a mansard style and covered with slates. The gable end had wooden cladding and overhanging slates on an extension. The window frames were wooden.</p> <p>The dwelling was 6 m tall, 11 m long and 7 m wide.</p> <p>The land surrounding the building was a mixture of woodland and grazed pasture.</p>
	Features of bat potential	<p>A small gap was noted in the mortar on the northeastern end of the building. The soffit box on the overhung roof had gaps present.</p> <p>Raised tiles were observed that provided potential access for bats. There was also missing mortar beneath the building's ridgetiles.</p>
	Limitations	<p>None noted.</p>
	Bat evidence	<p>None recorded.</p>
