A1 in Northumberland: Morpeth to Ellingham

6.8 Environmental Statement – Appendix 11.1 Preliminary Sources Study Report

Alnwick to Ellingham

Preliminary Sources Study Report
HAGDMS No. 29384

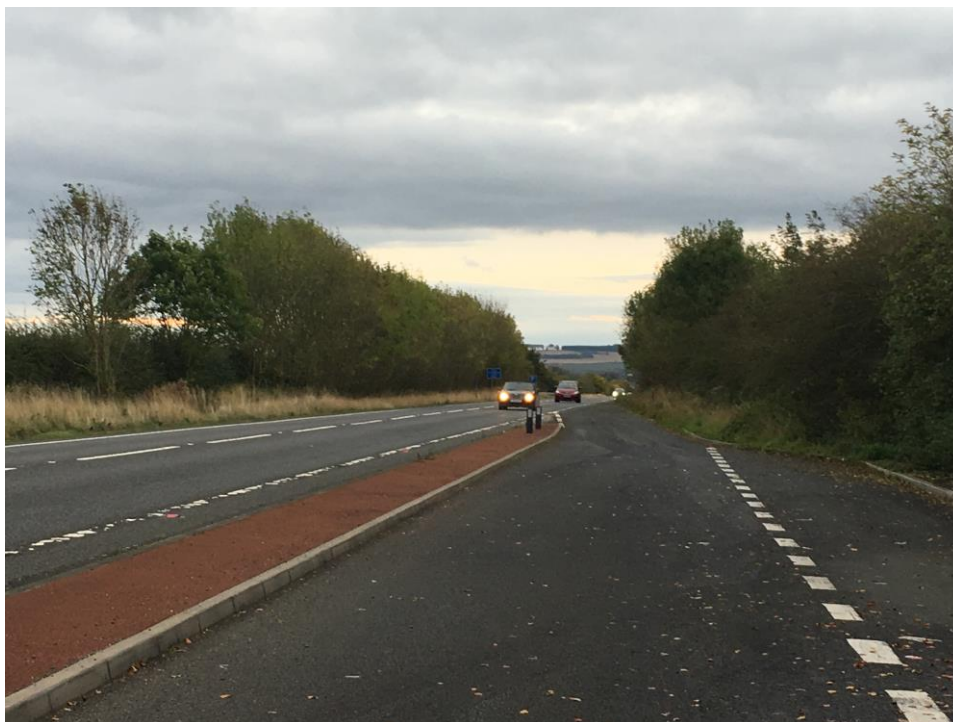
Plate 3-2 Stop 1 on the west side of the A1 looking south. The carriageway is at-grade with the surrounding area.

Geological mapping and borehole information shows superficial deposits are up to 3m thick and overlie the Oxford Limestone Member and Alston Formation at this point.

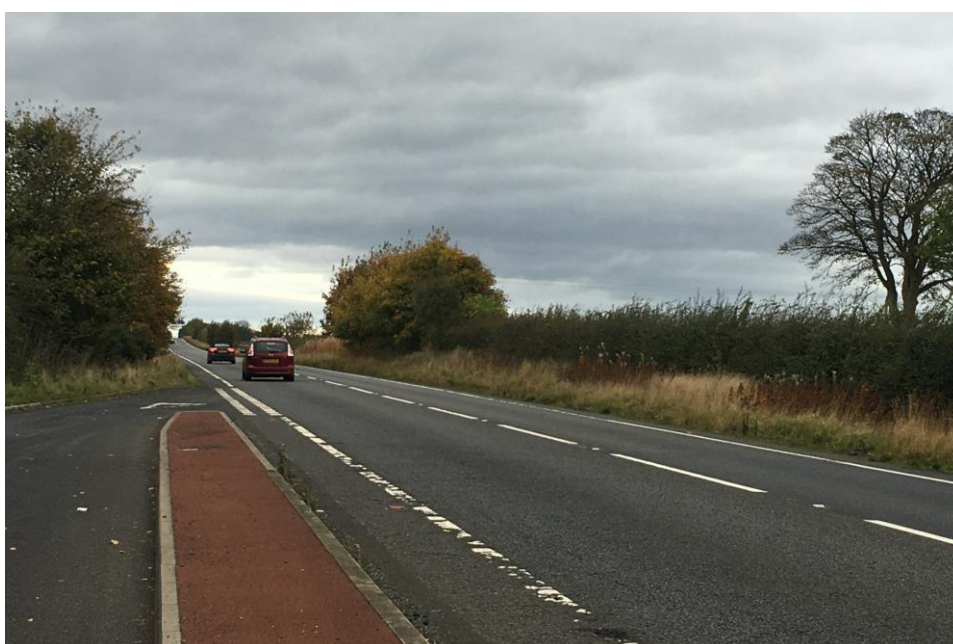
Plate 3-3 Stop 1 on the west side of the A1 looking north.

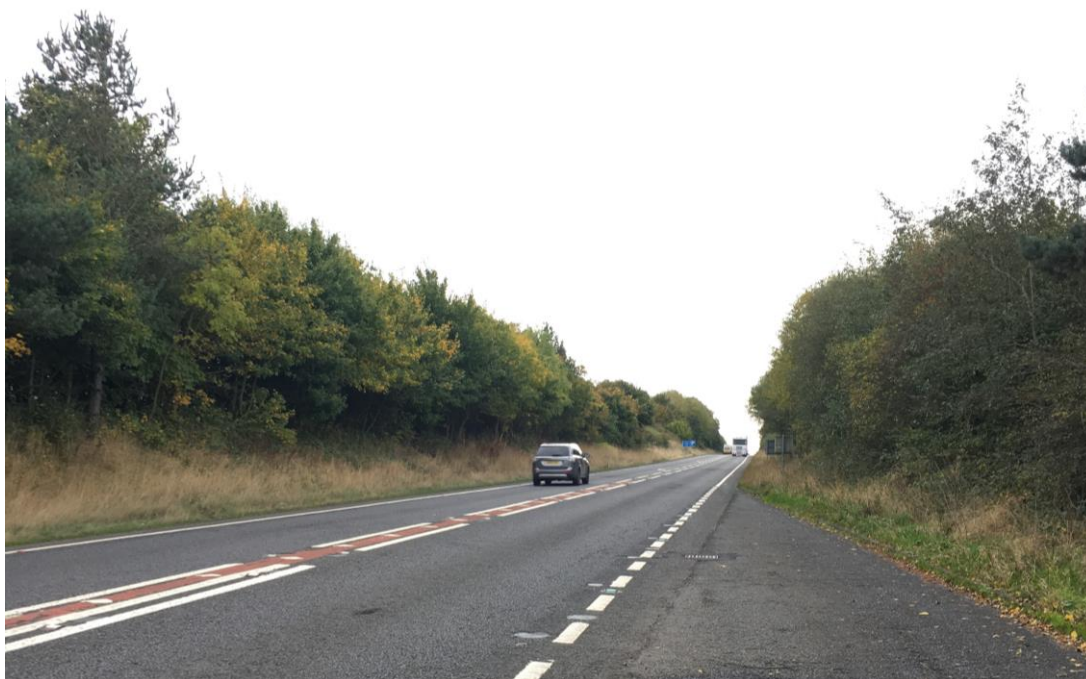
Plate 3-4 Stop 2 in a lay-by on the west side of the A1. This photo is looking south, brow of the hill in distance.

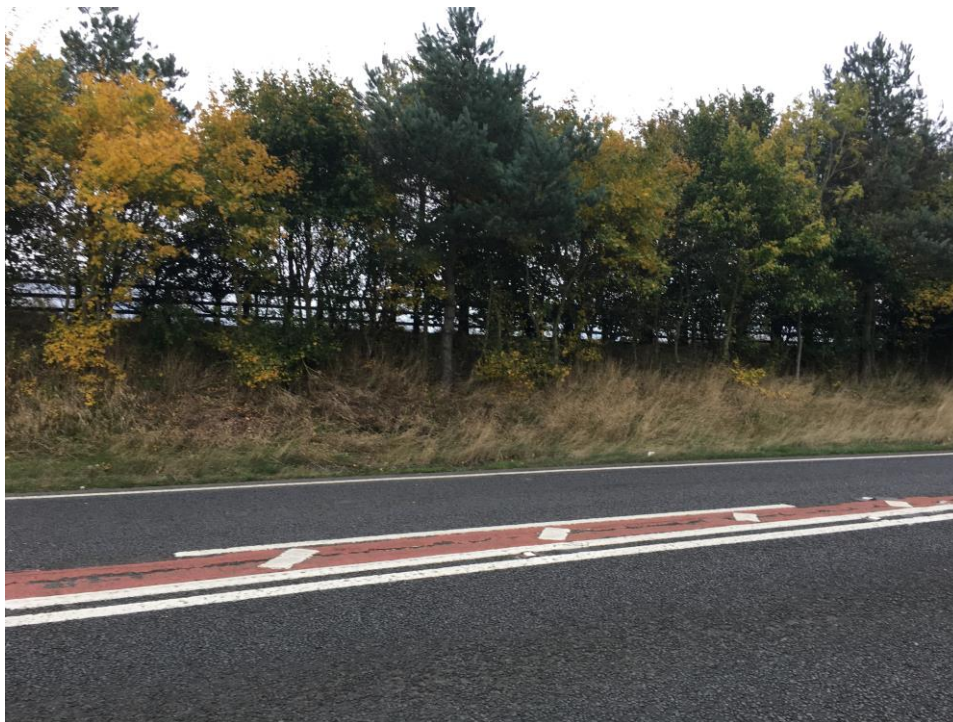
Plate 3-5 Stop 2 showing the shallow cutting on the east side of the carriageway opposite the lay-by.

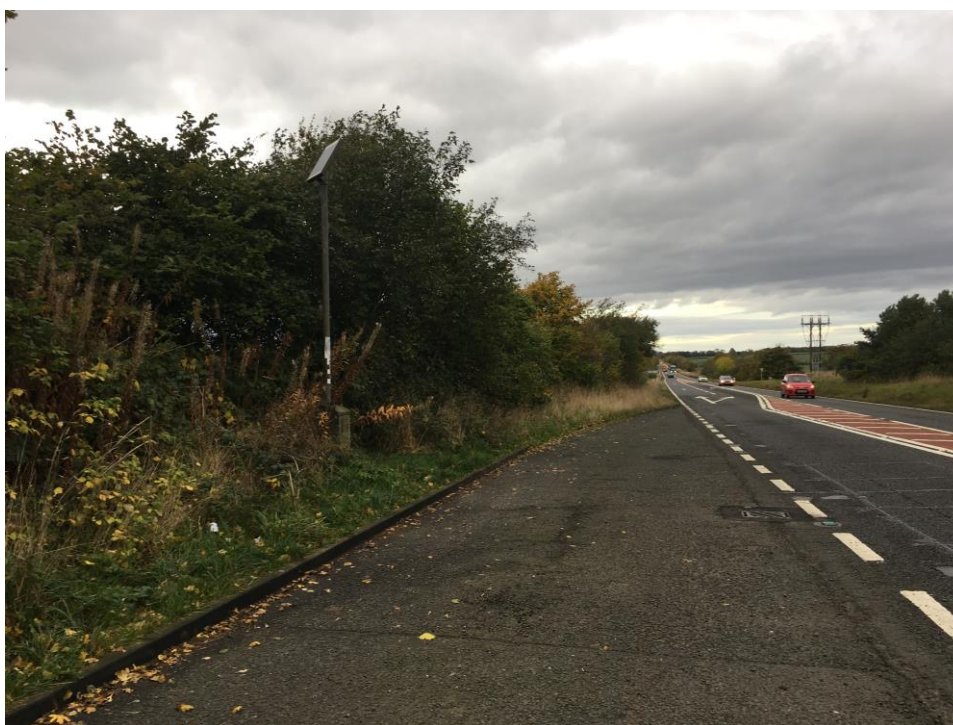
Plate 3-6 Stop 2 View downhill from the lay-by towards the north.

The A1 is around 85m AOD at this point (Plate 3-6) and at-grade with the surroundings.

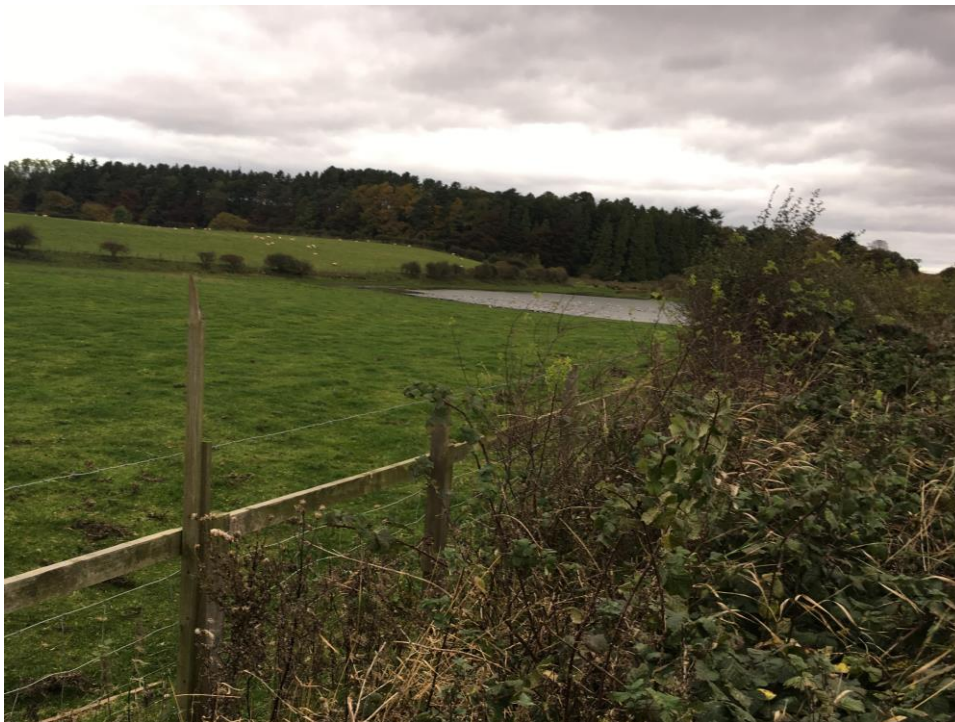
Plate 3-7 Stop 3 View to the north-west of agricultural land and pond west of the carriageway.

Alluvium and glaciofluvial deposits are identified above glacial till on geological maps and in borehole logs close to Stop 3 (BGS). The Alston Formation is the bedrock unit.

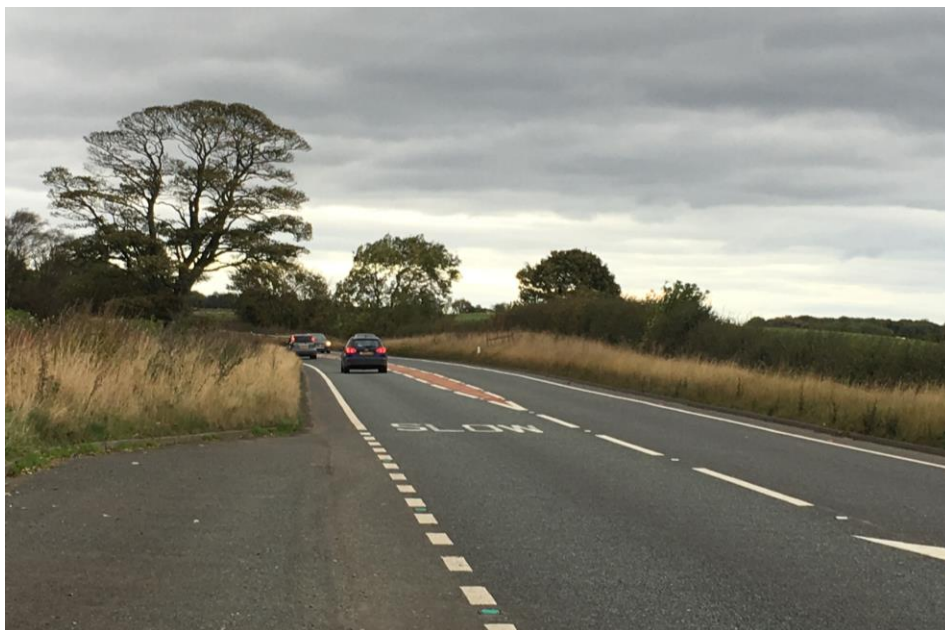
Plate 3-8 Stop 3 View north along the carriageway from the lay-by. Carriageway is on a shallow (<2m) embankment.

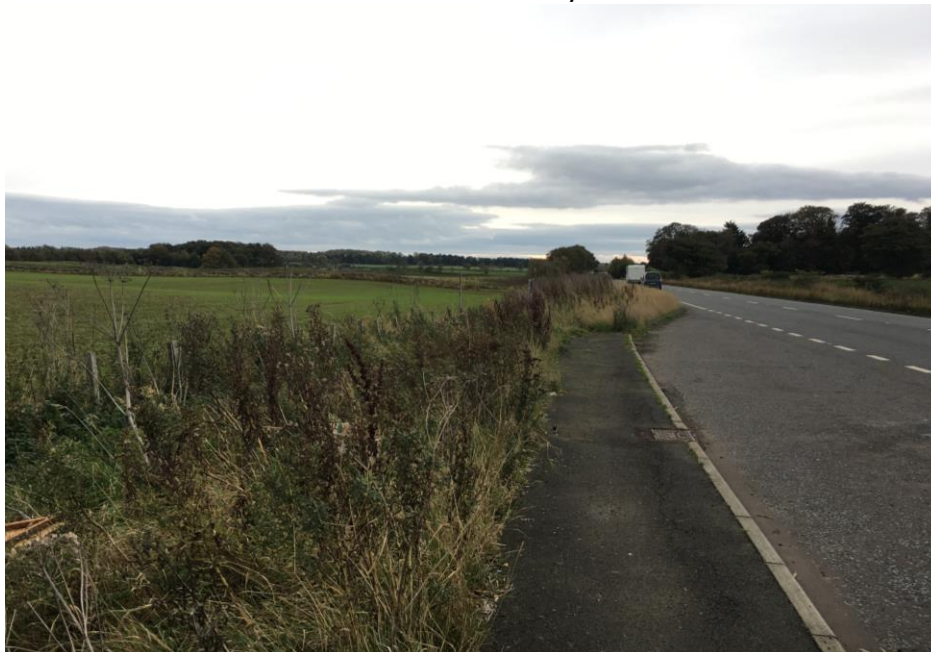
Plate 3-9 Stop 4 in a lay-by on the southbound side of the carriageway looking south.

Stop 4 is located in a lay-by on the southbound side of the carriageway near East Linkhall. The route is on asymmetrical embankment at this point with the east side at-grade (Plate 3-9) and the west side on a small embankment up to 2m high (Plate 3-10).

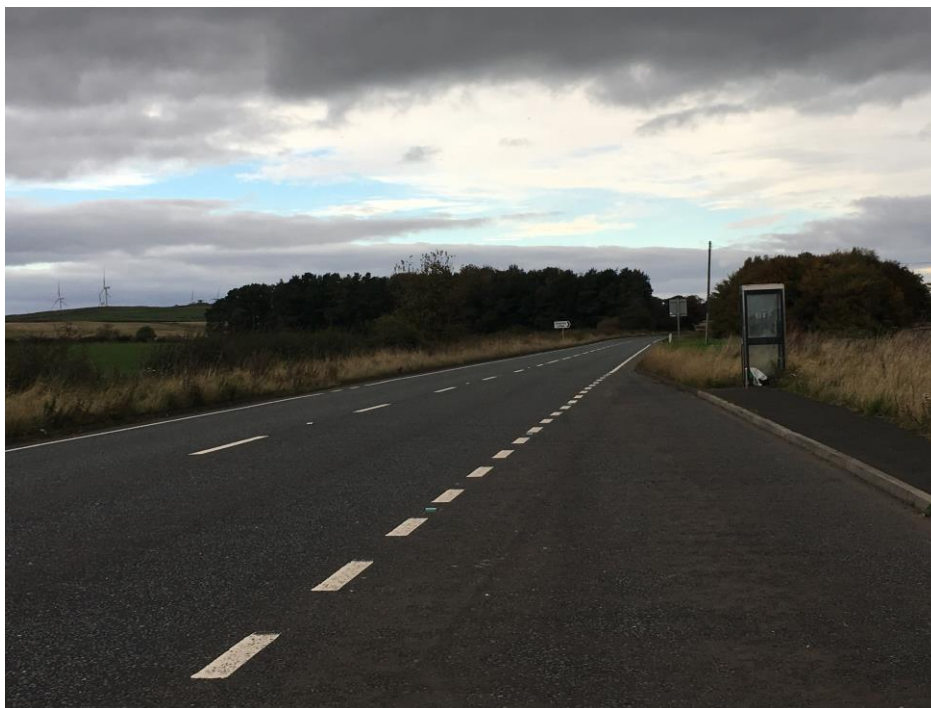
Plate 3-10 Stop 4 in the lay-by on the southbound side of the carriageway looking north.

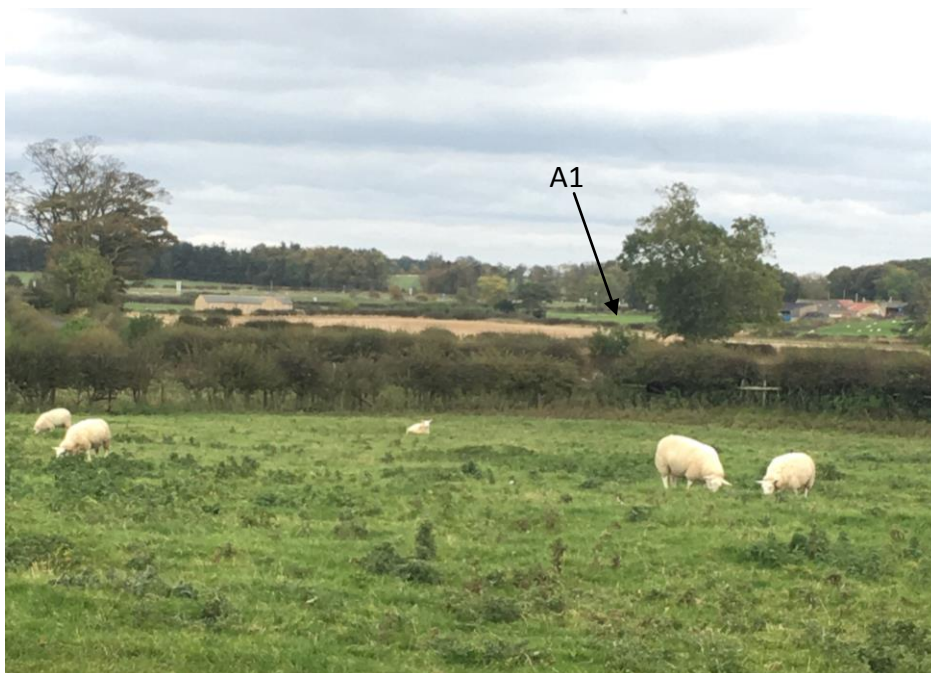
Plate 3-11 Stop 5 looking towards the A1 in the southeast direction from the footpath.

Glaciofluvial and glacial till deposits overlies the Alston Formation in this location.

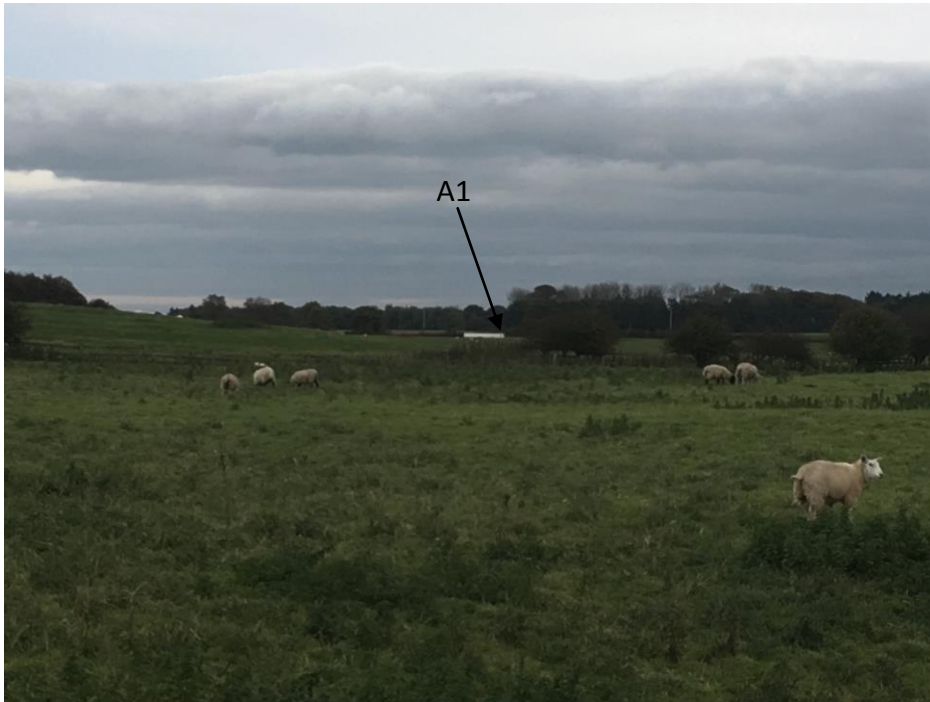
Plate 3-12 Stop 5 looking north east towards the A1 from the footpath. Topography is gently undulating and the surrounding agricultural land is at-grade with the carriageway.

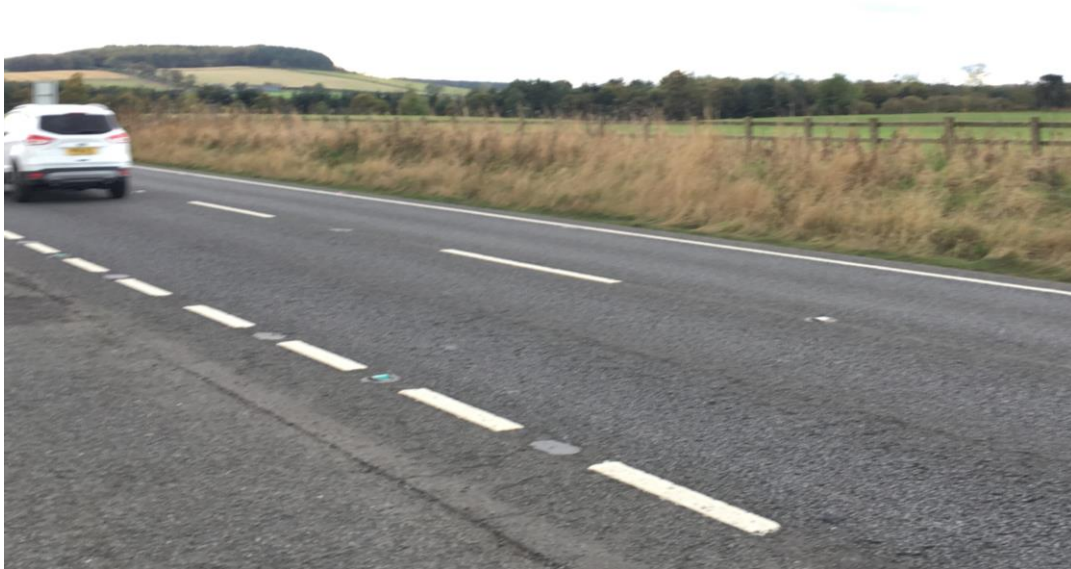
Plate 3-13 Stop 6 looking south west towards agricultural land.

Stop 6 is in a lay-by on the southbound side of the A1 near Rock Lough House. The road is in a small cutting of up to 2m deep north of Stop 6 (Plate 3-13). The cutting height decreases to the south. Plate 3-14 shows the cutting is approximately 2m high opposite the lay-by and Plate 3-15 shows it to be at-grade with the surrounding fields to the south.

The cutting is expected to be in glacial till which is found to be over 3.5m deep in a nearby exploratory hole (TPA13). The slopes are covered in grass and initial inspection suggests they are stable at the gradient estimated to be 1V:2H. According to the geological map, bedrock below Stop 6 is the Tyne Limestone Formation.

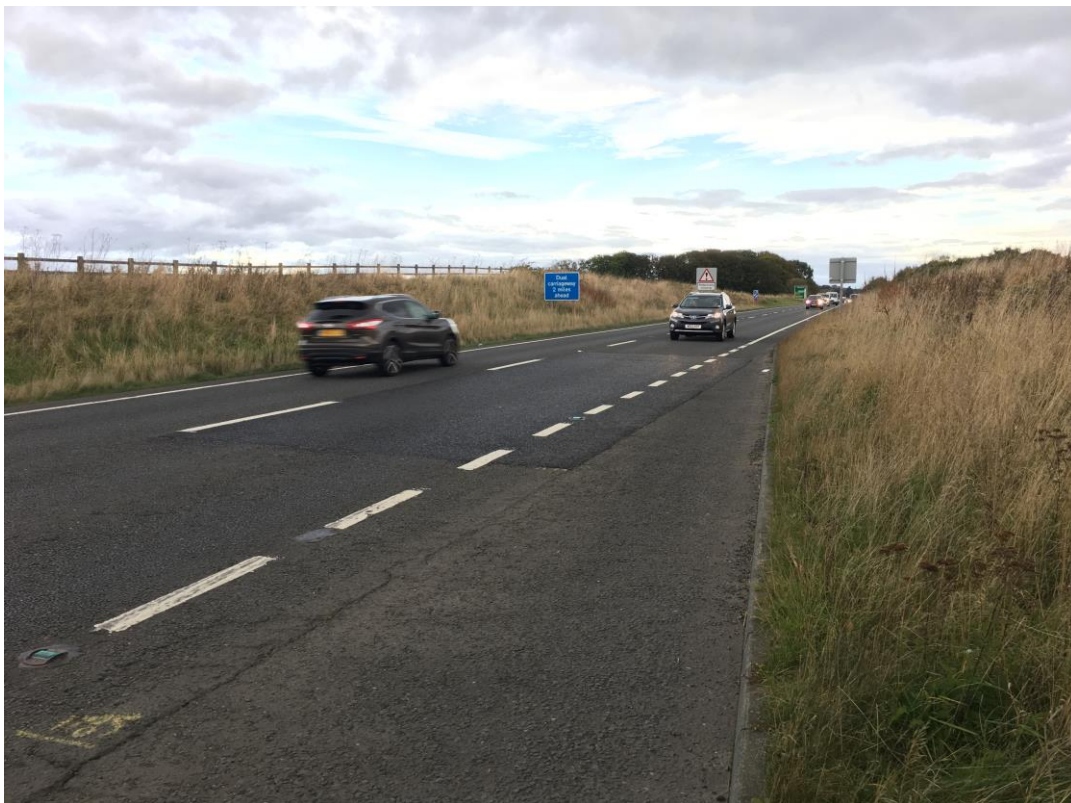
Plate 3-14 Stop 6 Looking north from the lay-by on the southbound side of the carriageway. In shallow cutting 2m deep.

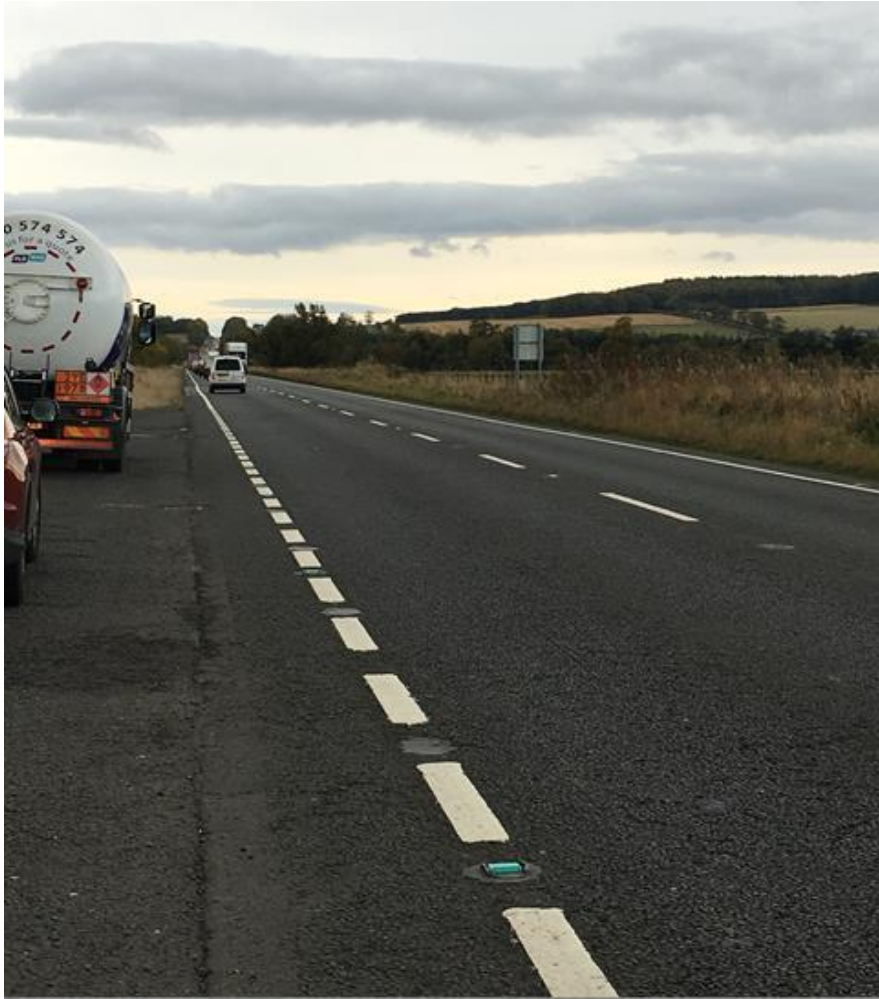
Plate 3-15 Stop 6 looking south from the lay-by on the east side of the carriageway.

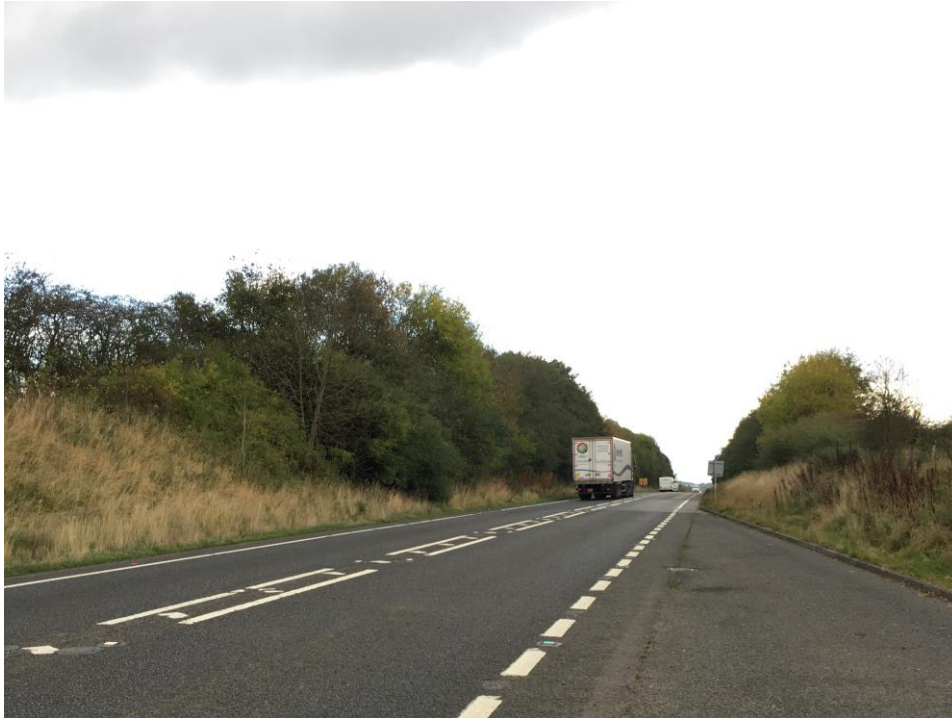
Plate 3-16 Stop 7 looking north from the lay-by on the southbound side of the carriageway.

Stop 7 is a lay-by on the southbound carriageway near Heckley Fence. Plate 3-16 and Plate 3-17 show the west side of the road is in cutting. The height decreases from an estimated 3.5m north of the lay-by (Plate 3-16) to 2m opposite the lay-by (Plate 3-17). Slope gradients are estimated to be 1V:2H and an initial inspection did not identify any signs of instability.

Based on the available borehole and mapping data (BGS) the slopes are cut into glacial till which is in excess of 3.5m thick and overlies the Tyne Limestone Formation.

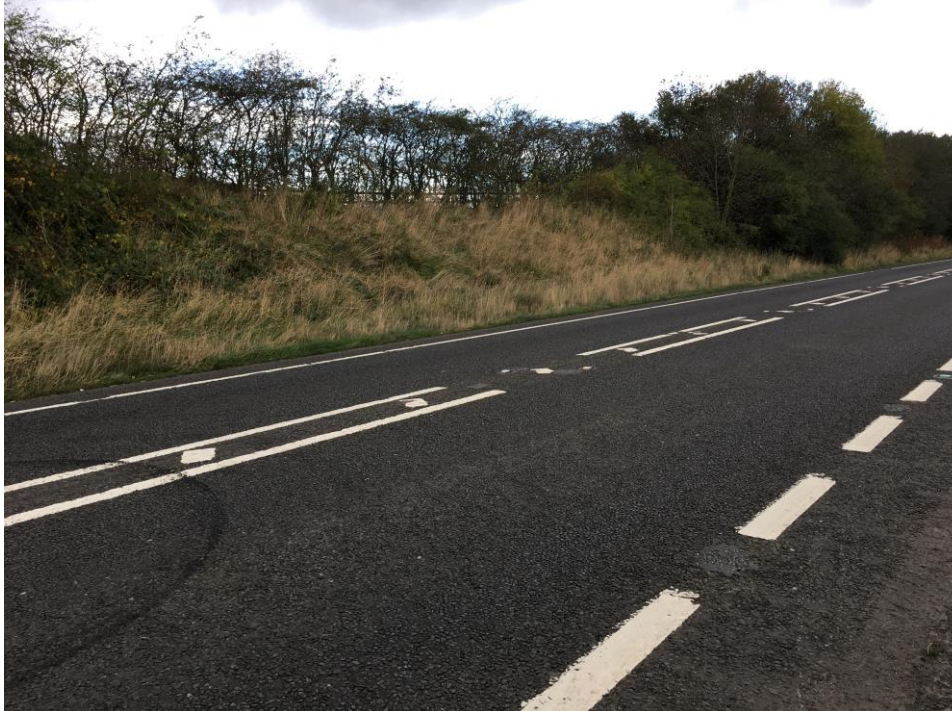
Plate 3-17 Stop 7 showing the cutting on the west side of the carriage way opposite the lay-by. Cutting is up to 2m high with a gradient estimated at 1V:2H.

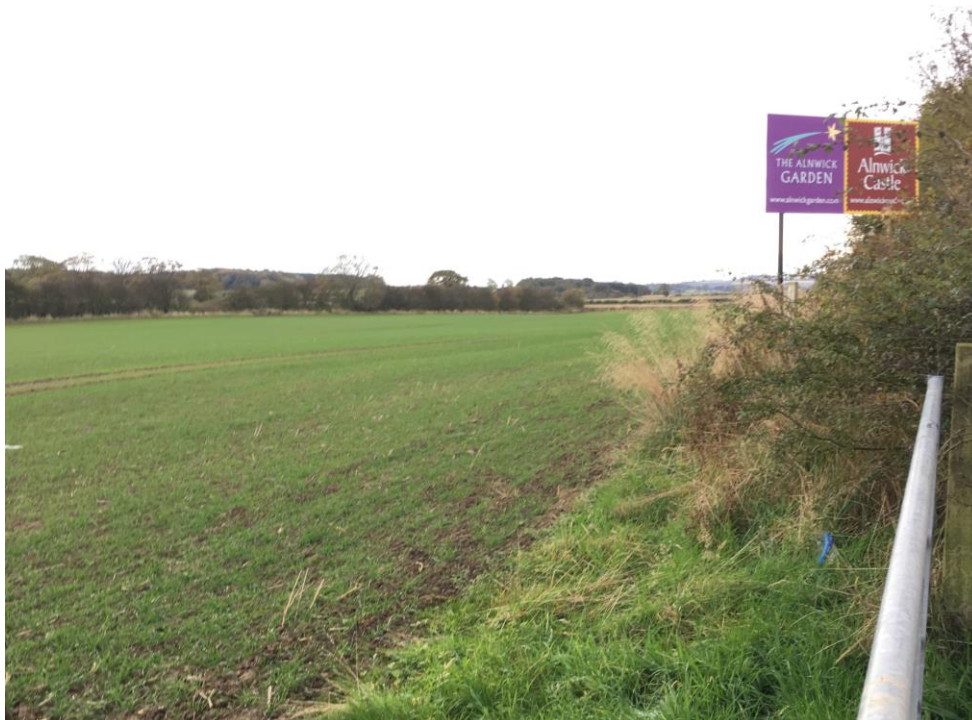
Plate 3-18 Stop 7 looking south-east from the lay-by on the southbound side of the carriageway over agricultural land. The road is on a slight embankment (around 1m) above the adjacent land on the east.

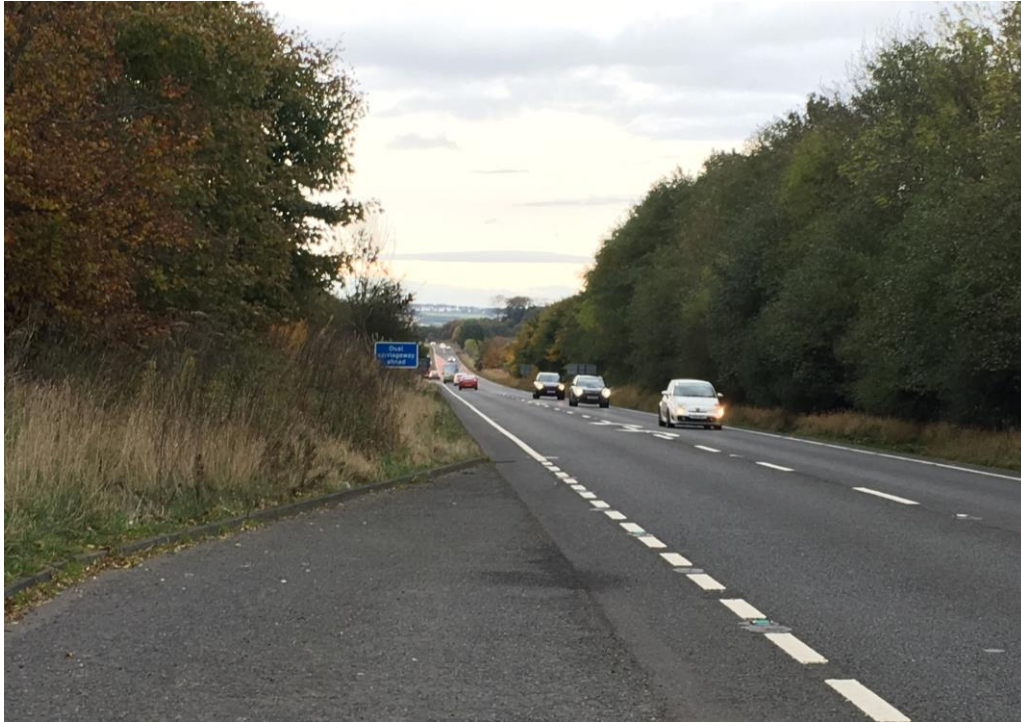
Plate 3-19 Stop 8 Looking south towards the dualled section of carriageway from a lay-by on the southbound side.

Plate 3-19 shows that the road falls to the south and mature trees line both sides of the road leading up to the lay-by. The road is in a small cutting up to 1m deep on the west side of the road opposite the lay-by (Plate 3-20). North of Stop 8 the ground continues to rise and the carriageway is at-grade (Plate 3-21).

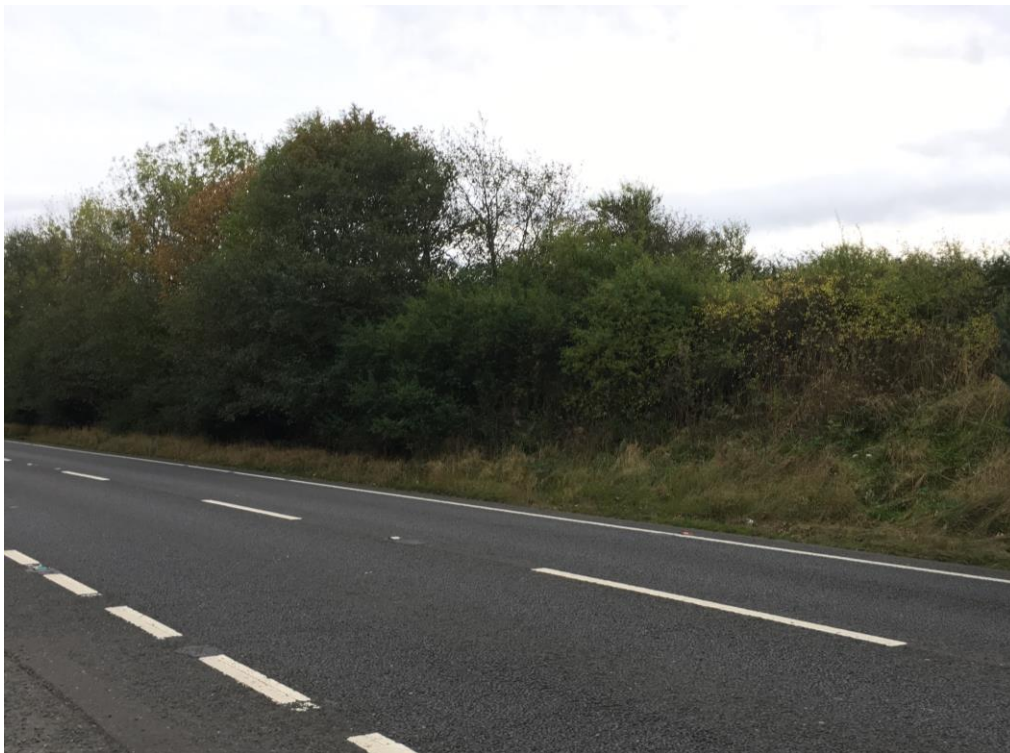
Plate 3-20 Stop 8 opposite the lay-by the carriageway is in cutting (up to 2m) and the vegetation is predominantly shrubs.

Cuttings are expected to be in glacial till as nearby boreholes show glacial till is more than 6m thick (BH4). Bedrock in this location is the Alston Formation.

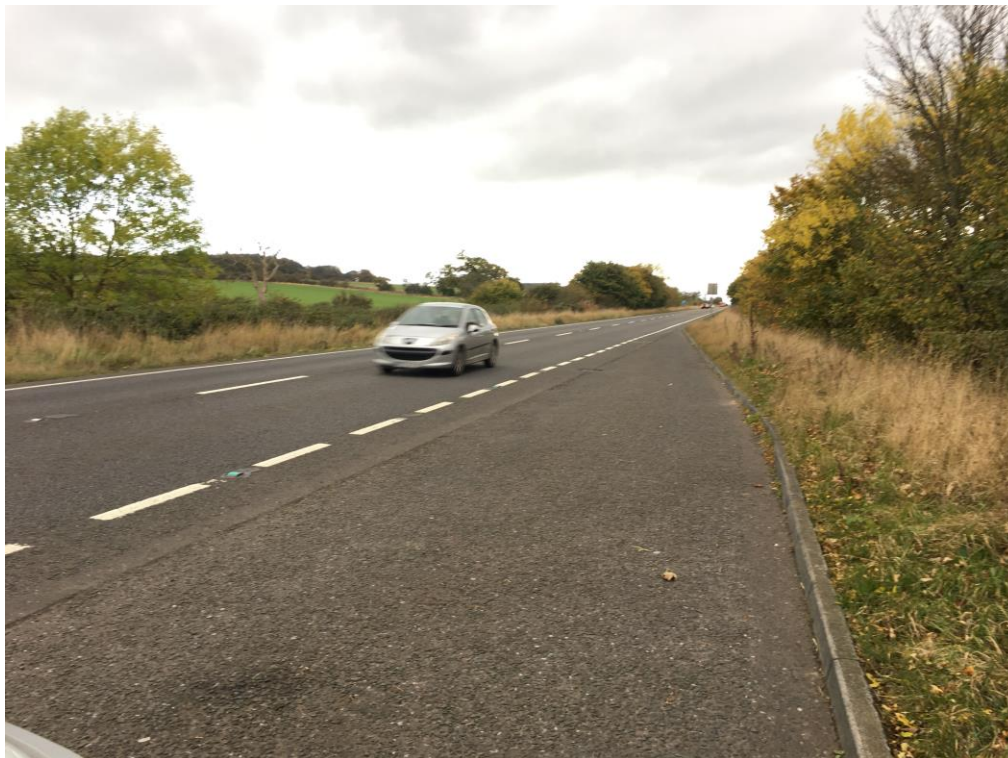
Plate 3-21 Stop 8 looking north from the lay-by on the southbound side of the carriageway
