A12 Chelmsford to A120 widening scheme

TR010060

6.3 ENVIRONMENTAL STATEMENT APPENDIX 7.5 GEOPHYSICAL SURVEY PHASE 1 REPORT – PART 3

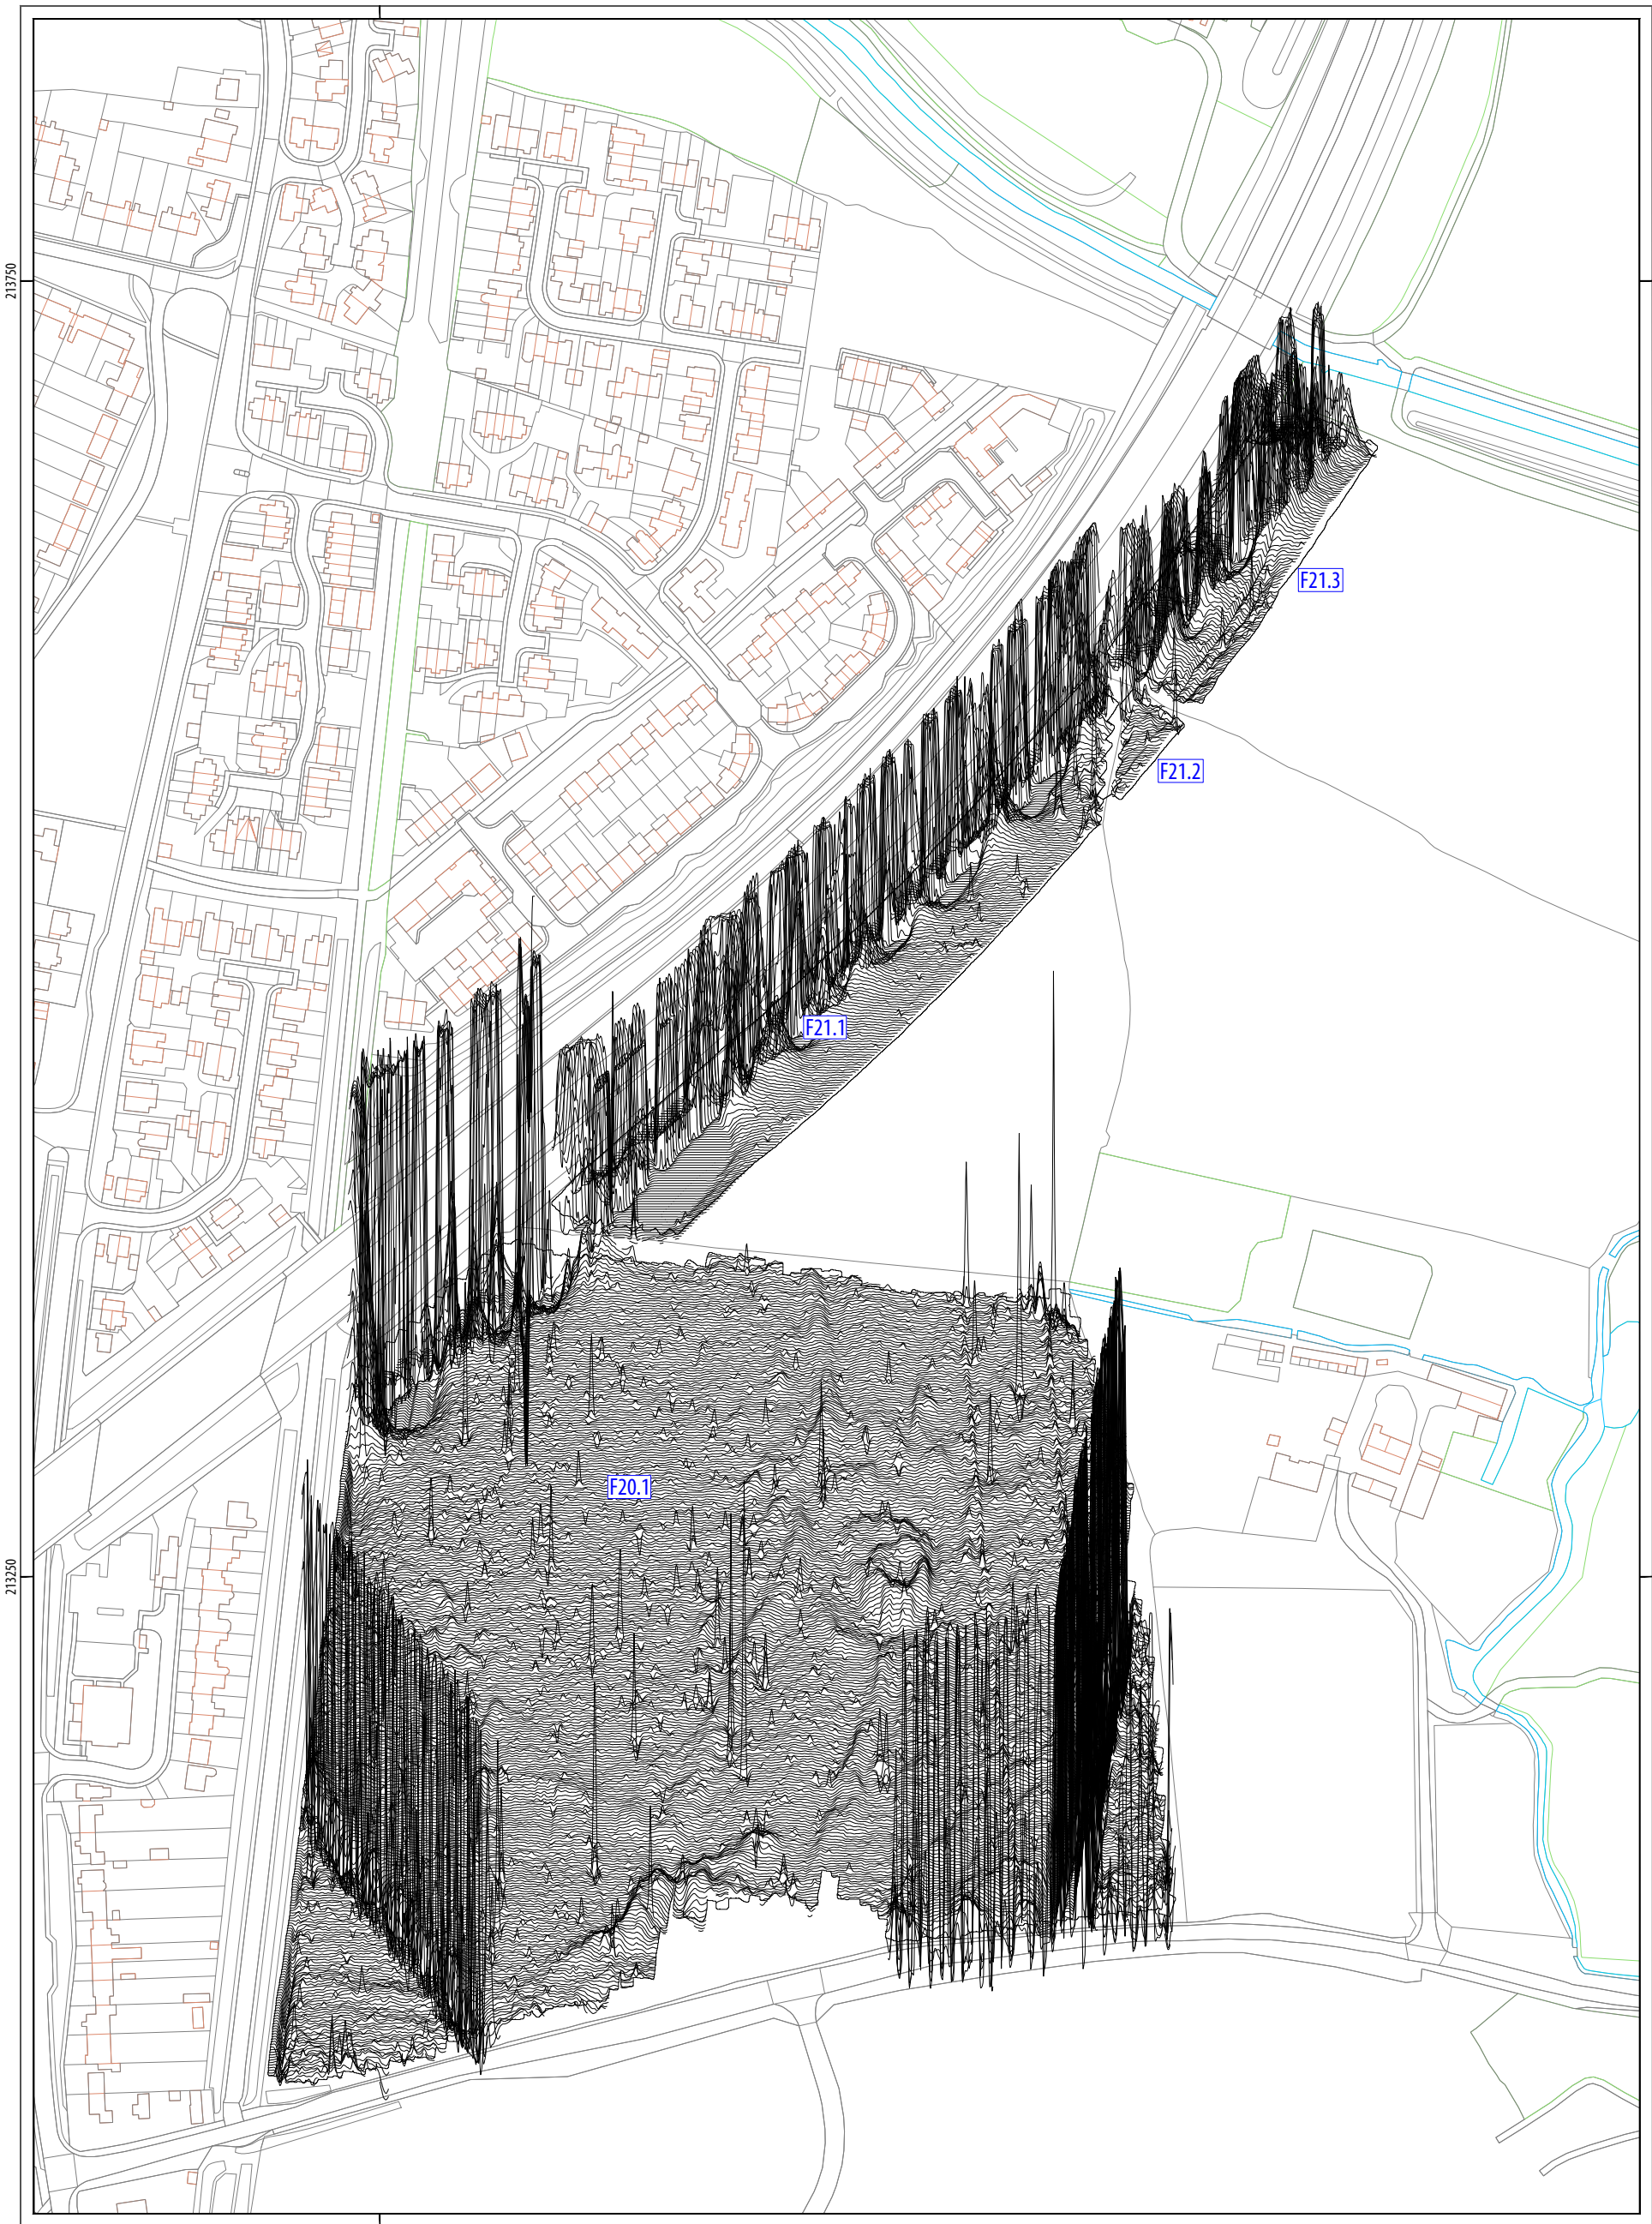
ILLUS 62 XY trace plot of minimally processed magnetometer data; Sector 18
