A46 Coventry Junctions (Walsgrave) Scheme number: TR010066

Appendix 6.3 Assessment Report for Archaeological Watching Brief

ASSESSMENT REPORT FOR ARCHAEOLOGICAL WATCHING BRIEF

An archaeological watching brief was undertaken by Headland Archaeology (UK) Ltd during the excavation of three ground investigation test pits, ahead of proposed upgrade works to the A46/B4082 roundabout on the A46 Coventry Eastern Bypass. No archaeological remains were observed during the works.

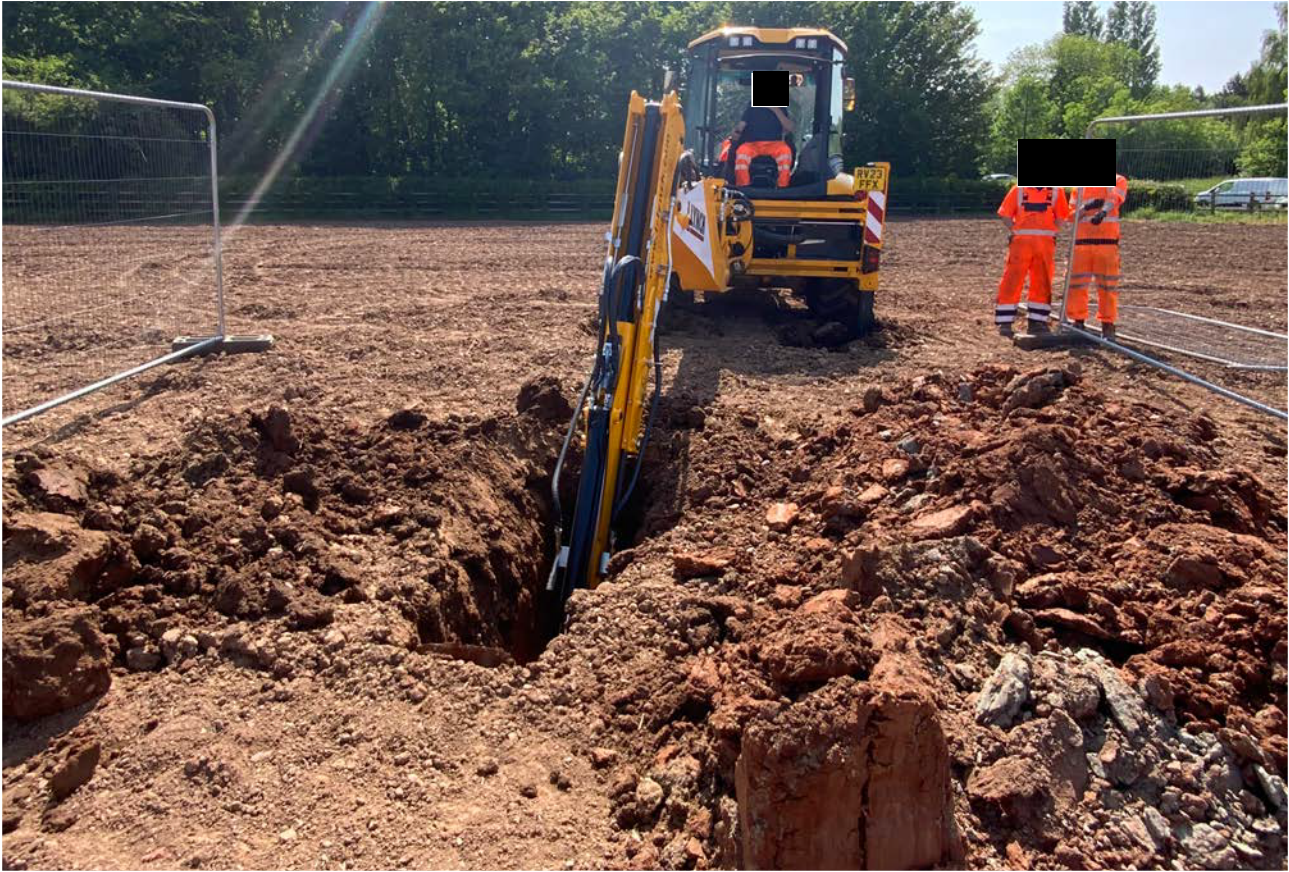
ILLUS 2 Looking north-east at TP1 under excavation

In TP1 the topsoil (010001) was a 0.20m mid-orangish brown, plastic silty clay, with angular and rounded stones inclusions. This lay over a subsoil (010002) 0.11m thick which was a firm mid-yellowish brown silty clay, with rounded stone inclusions. Below this the natural geology (010003) comprised of a firm mid-reddish orange clay and was observed to a depth of 2.21m below ground level (BGL).

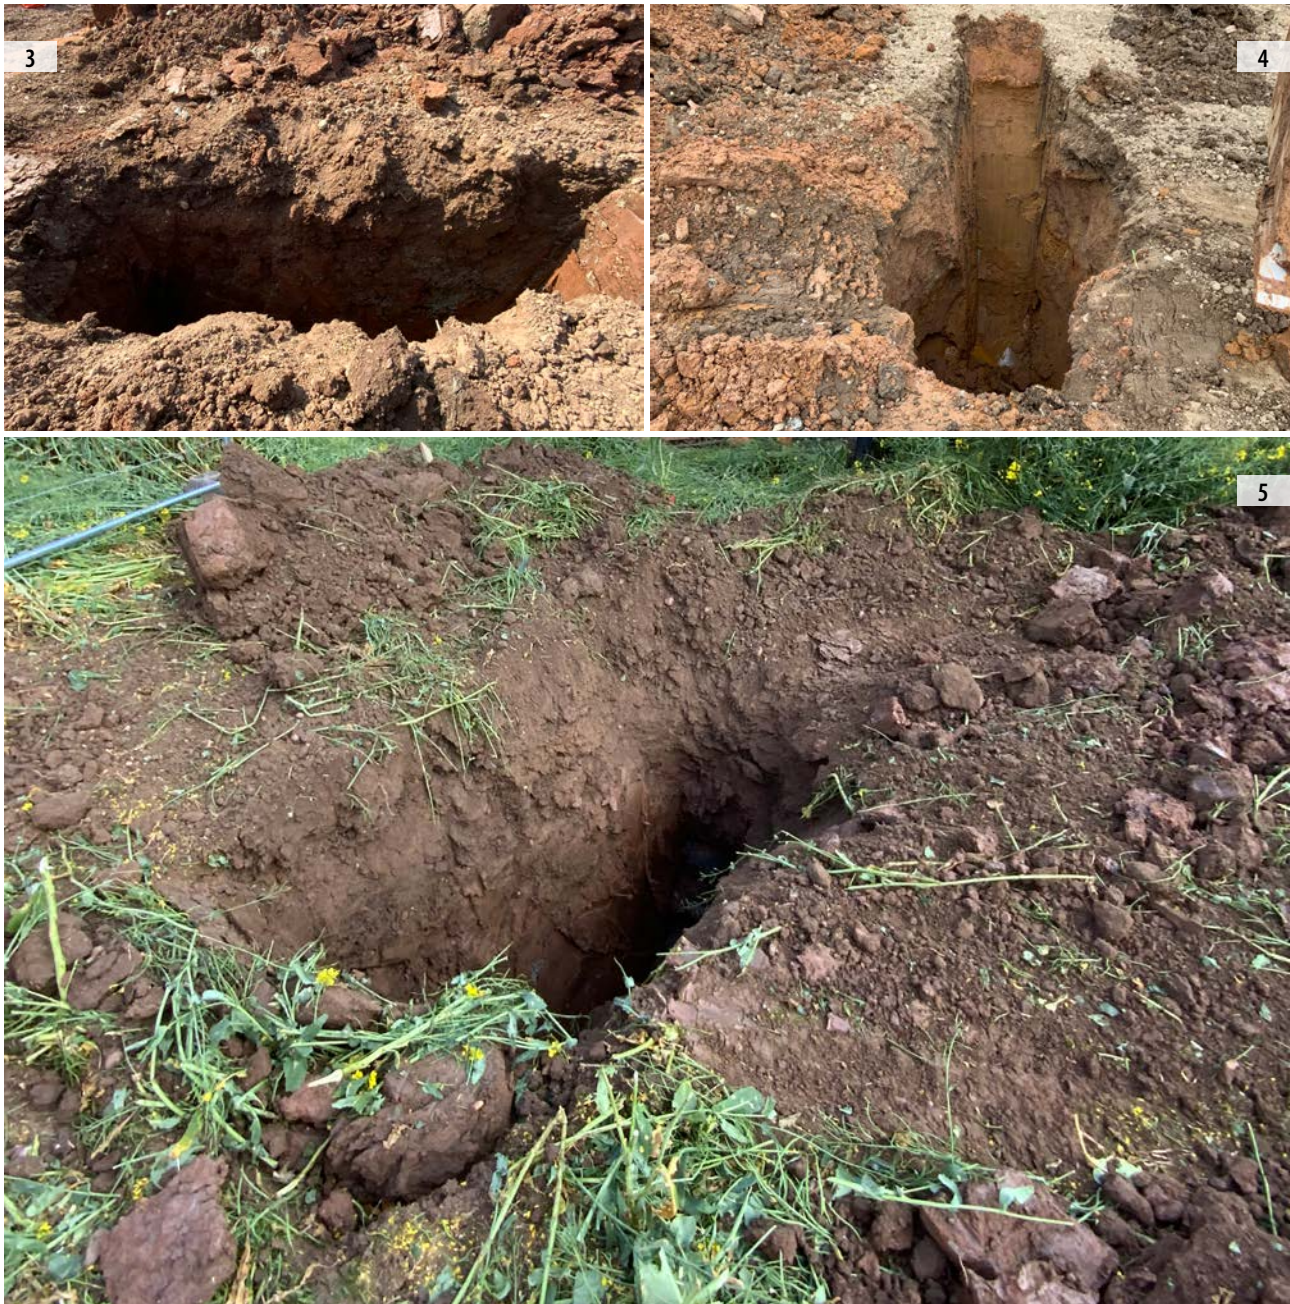
ILLUS 3 Looking south-west at north-east facing section through TP1 **ILLUS 4** Looking west at TP2 **ILLUS 5** Looking south-east at TP3

Test pits 1 and 2 (TP1 and TP2) – located in the same cropped field, shared the same sequence of deposits and to similar depths below ground.

The topsoil (020001) in TP2 was 0.15m thick and the same as in TP1. It overlay the same subsoil (020002) material as in TP1 but with modern brick and rubbish present. It was 0.30m thick. The natural geology

(020005) was recorded to 2.5m BLG below this, and was a firm mid-reddish orange clay with angular stones. Near its interface with the subsoil there was a fairly regular band of mid-brownish yellow silty sand.

TP3 was under grass with deeper and better developed soils. The topsoil (030001) was a 0.44m thick mid-greyish brown, plastic silty clay with angular and rounded stone inclusions. Below which the 0.23m thick subsoil (030002) was a firm mid-yellowish brown silty clay, with rounded stones. The natural geology (030003) was a firm mid-reddish orange clay. It was observed to the final excavated depth of 2.4m BGL.

No archaeological features or deposits were observed.
