# **A46 Coventry Junctions (Walsgrave) Scheme number: TR010066**

### **Appendix 6.4 Archaeological Trial Trenching Survey Report**

# A46 COVENTRY JUNCTIONS UPGRADE (WALSgrave JUNCTION) STAGE 3

## Archaeological Trenching Report

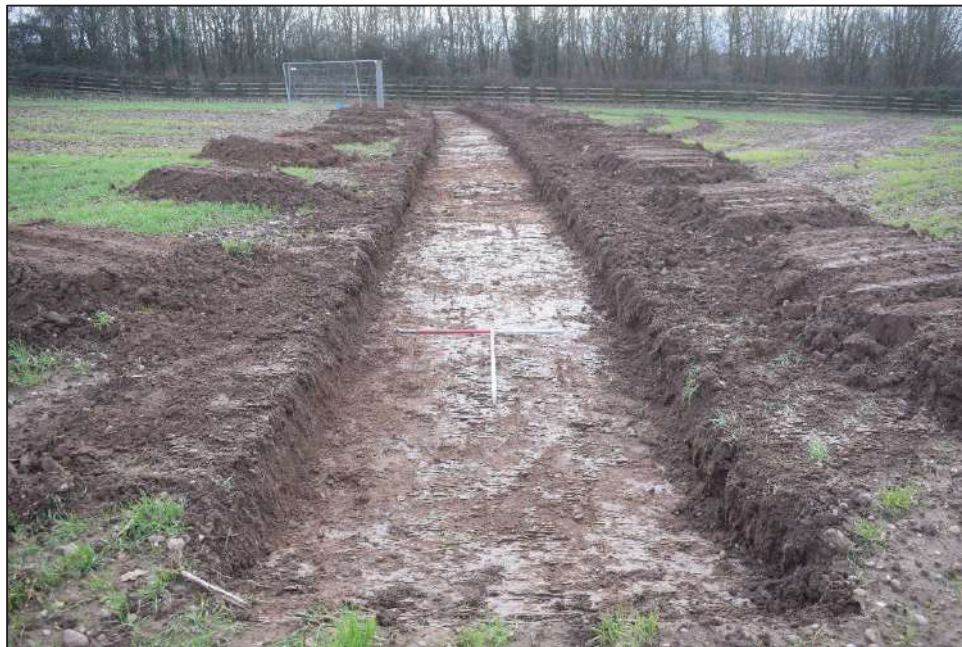
Plate 1: Trench 1 facing east

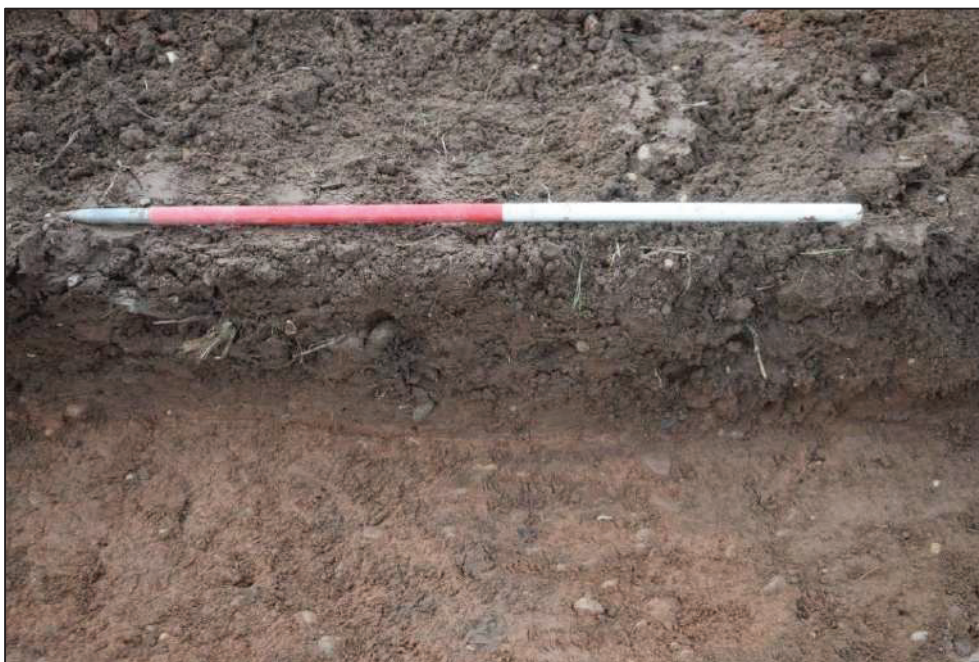
1.2). The natural sub-stratum was encountered at heights ranging from 71.72m aOD to 72.54m aOD. This was overlain by a topsoil 0.30m deep, of mid greyish-brown silty clay, with frequent sub-angular, small to medium sized stones and infrequent lumps of modern CBM (101). The topsoil was encountered at heights ranging from 72.05m aOD to 72.61m aOD.

Plate 2: Trench 1 south facing representative section

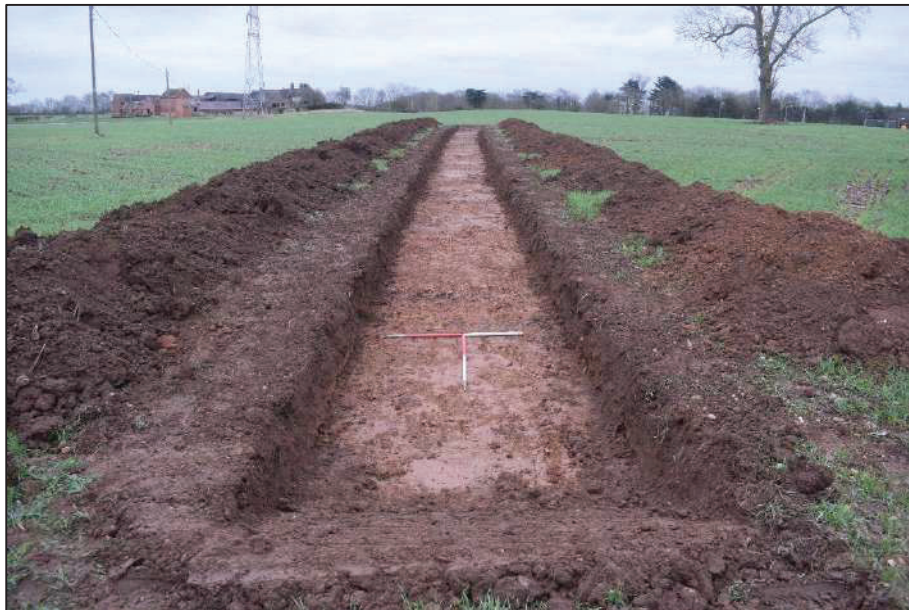
Plate 3: Trench 2 facing north-west

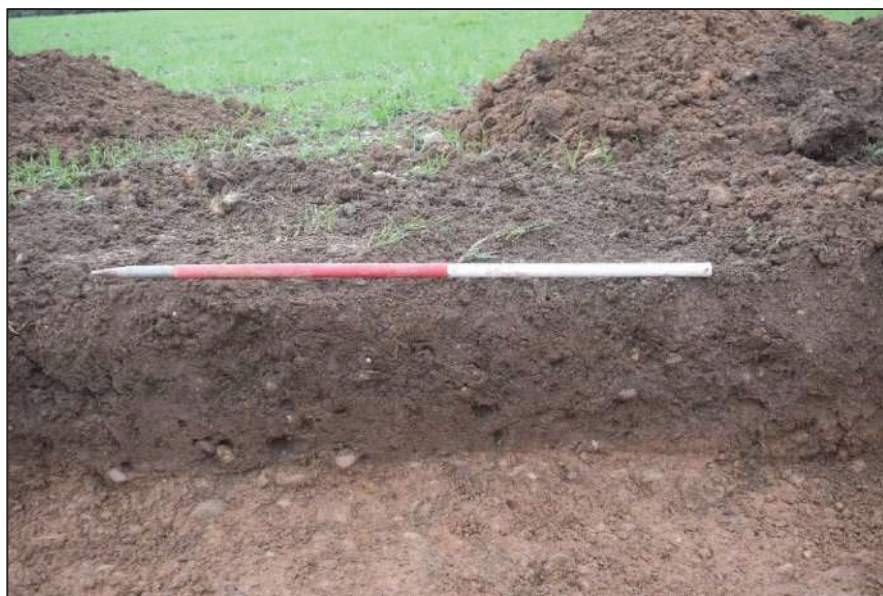
- 4.2.6. The earliest deposit encountered in Trench 2 was a natural sub-stratum formed of reddish-brown silty sandy clay, with patches of rounded, small to medium sized gravels throughout (202) (Figure 8, Section 1.1). The natural sub-stratum was encountered at heights ranging from 71.94m aOD to 73.77m aOD. This was overlain by a topsoil, 0.30m deep, of mid greyish-brown silty clay, with frequent sub-angular, small to medium sized stones and infrequent lumps of modern CBM (201). The topsoil was encountered at heights ranging from 72.05m aOD to 73.77m aOD.

Plate 4: Trench 2 representative section facing east

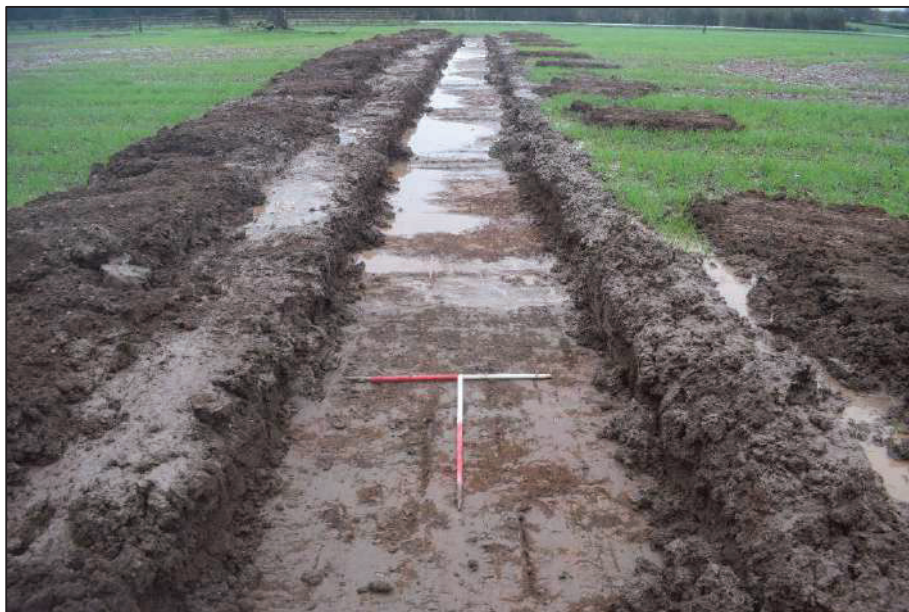
Plate 5: Trench 3 facing north

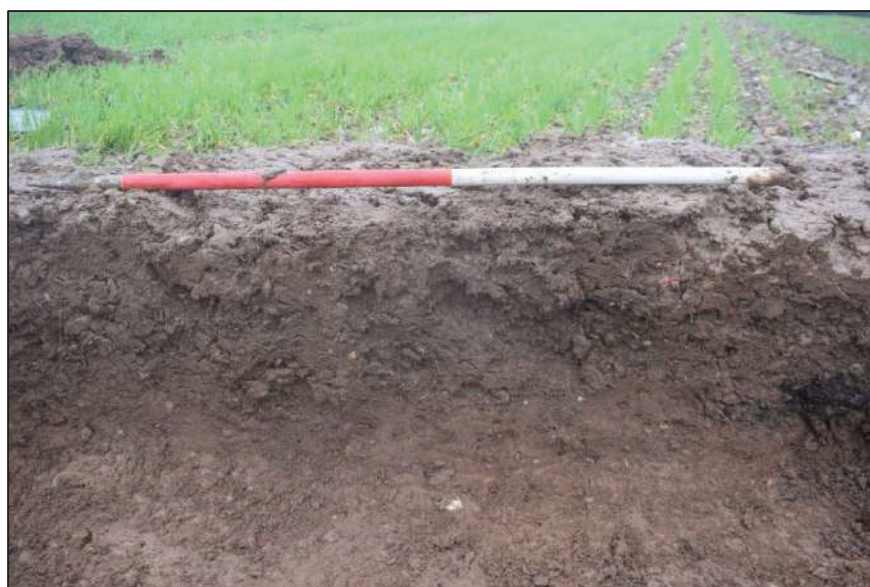
- 4.2.7. The earliest deposit encountered in Trench 3 was a natural sub-stratum formed of reddish-brown silty sandy clay, with patches of rounded, small to medium sized gravels throughout (302) (Figure 10, Section 3.13). The natural sub-stratum was encountered at heights ranging from 72.97m aOD to 74.21m aOD. This was overlain by a topsoil, 0.30m deep, of mid brown silty clay, with frequent sub-angular, small to medium sized stones and infrequent lumps of modern CBM (301). The topsoil was encountered at heights ranging from 73.47m aOD to 74.73m aOD.

Plate 6: Trench 3 representative section facing east

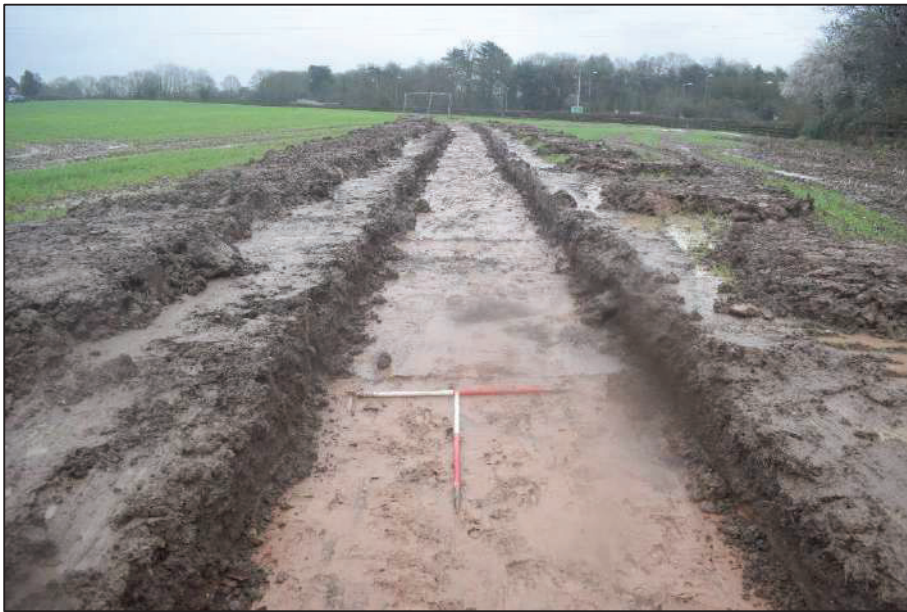
Plate 7: Trench 4 facing south

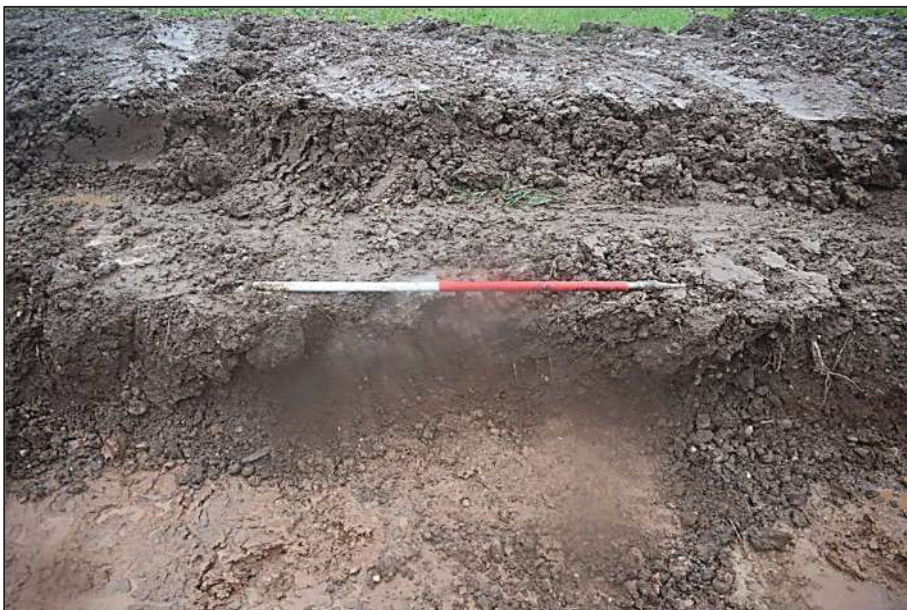
- 4.2.8. The earliest deposit encountered in Trench 4 was a natural sub-stratum formed of yellow-brown sandy clay, with patches of small, rounded pebbles throughout (402) (Figure 10, Section 3.14). The natural sub-stratum was encountered at heights ranging from 75.11m aOD to 75.43m aOD. This was overlain by a topsoil, 0.28m deep, of firmly compacted mid brown silty clay, with occasional, small to medium sized stones and rounded pebbles (401). The topsoil was encountered at heights ranging from 75.54m aOD to 75.76m aOD.

Plate 8: Trench 4 representative section facing north

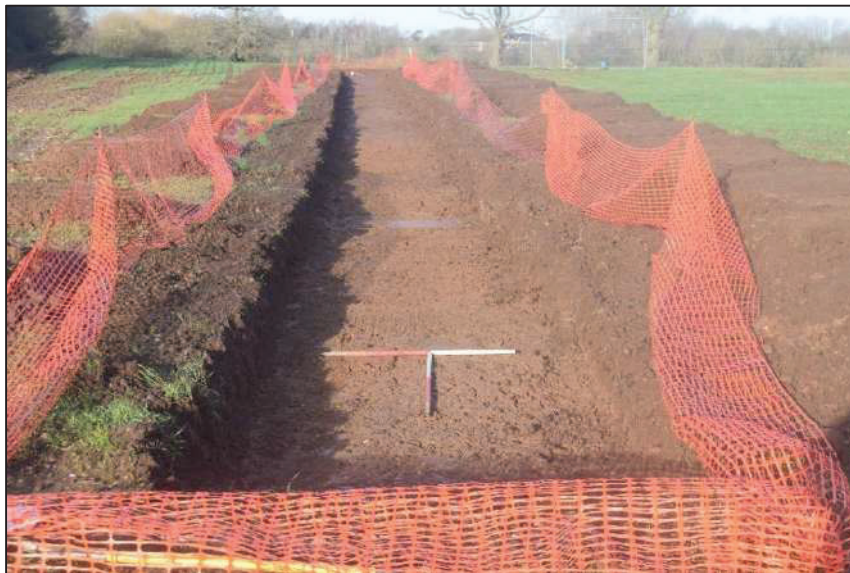
Plate 9: Trench 5 facing north

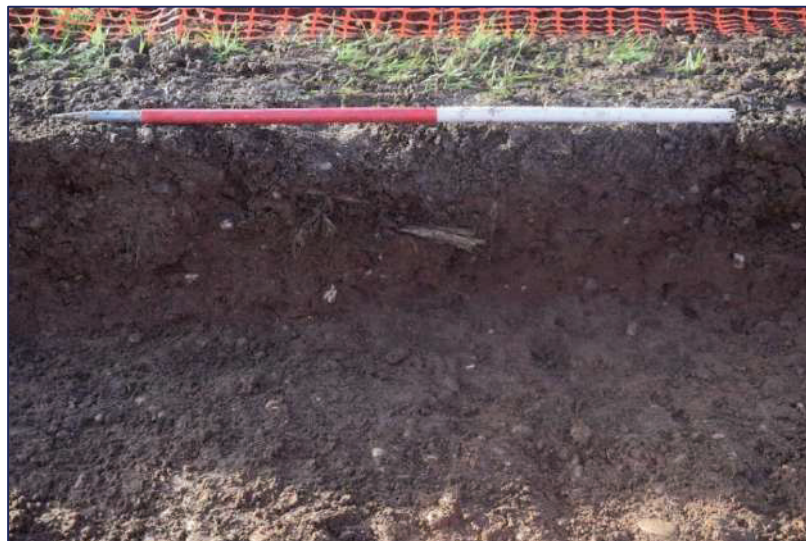
- 4.2.9. The earliest deposit encountered in Trench 5 was a natural sub-stratum formed of soft, mid brownish-grey silty clay, with very frequent small to medium sized stones throughout (503) (Figure 8, Section 1.3). The natural sub-stratum was encountered at heights ranging from 74.21m aOD to 75.16m aOD. This was overlain by a subsoil, 0.12m thick, of soft mid greyish-brown silty clay, with occasional, small to medium sized stones (502). This was in turn sealed by a topsoil, of friable mid greyish-brown silty clay, with frequent sub-angular and sub-rounded small to medium stones (501). The topsoil was revealed to a depth of 0.15m and was encountered at heights ranging from 74.30m aOD to 75.56m aOD.

Plate 10: Trench 5 representative section facing west

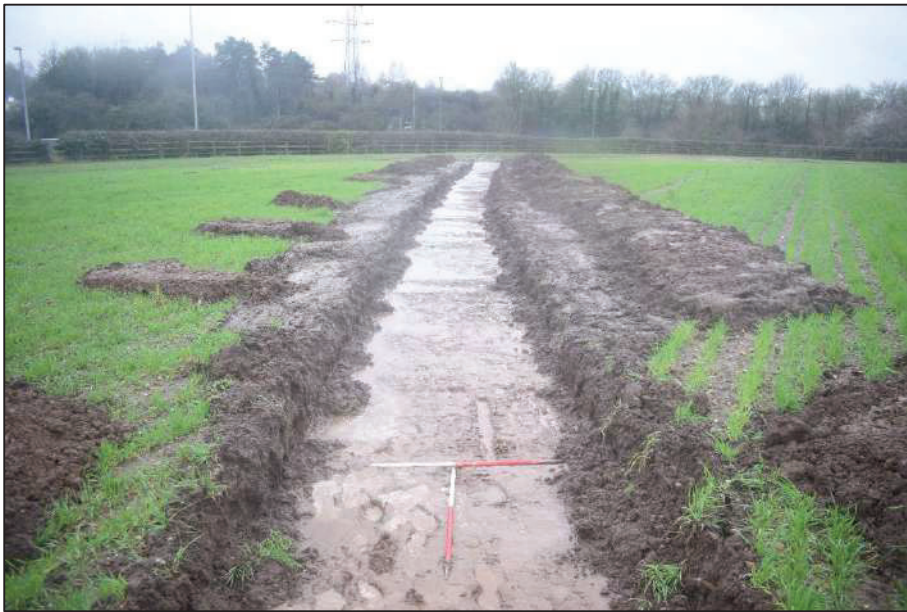
Plate 11: Trench 6 facing north

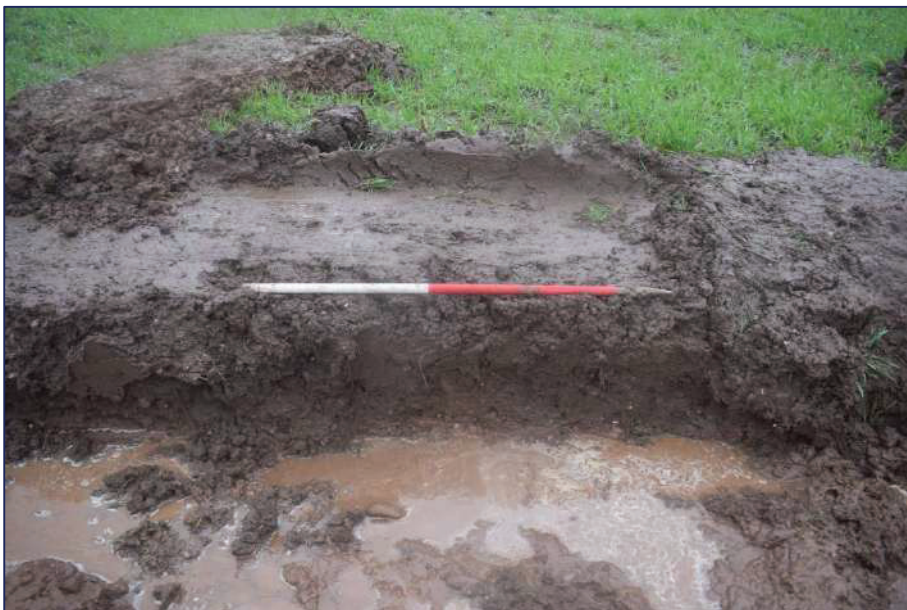
- 4.2.10. The earliest deposit encountered in Trench 6 was a natural sub-stratum formed of yellow-brown sandy clay, with patches of small rounded, small to medium sized gravels throughout (602) (Figure 10, Section 3.15). The natural sub-stratum was encountered at heights ranging from 74.33m aOD to 75.83m aOD. This was overlain by a topsoil, 0.32m deep, of mid brown sandy clay, with frequent sub-angular, small sized stones (601). The topsoil was encountered at heights ranging from 73.47m aOD to 76.03m aOD.

Plate 12: Trench 6 representative section, facing west (waterlogged)

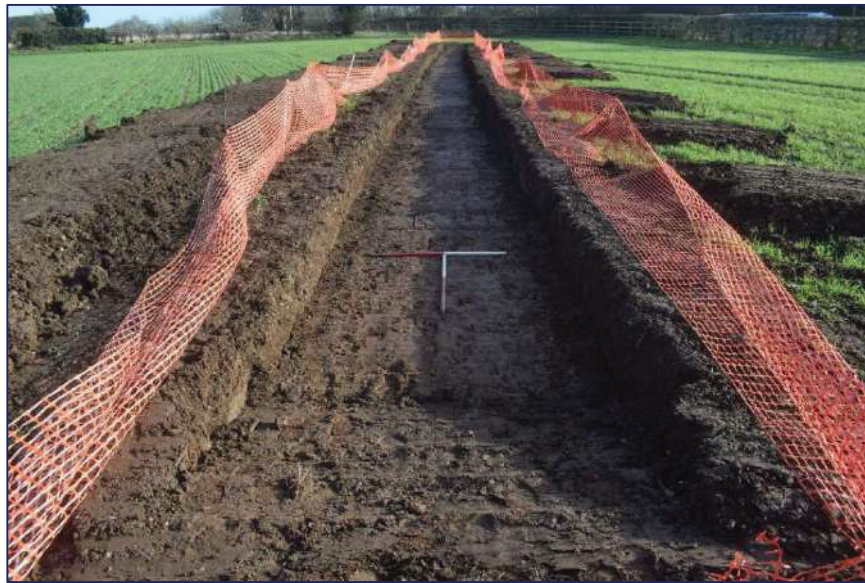
Plate 13: Trench 7 facing South-east

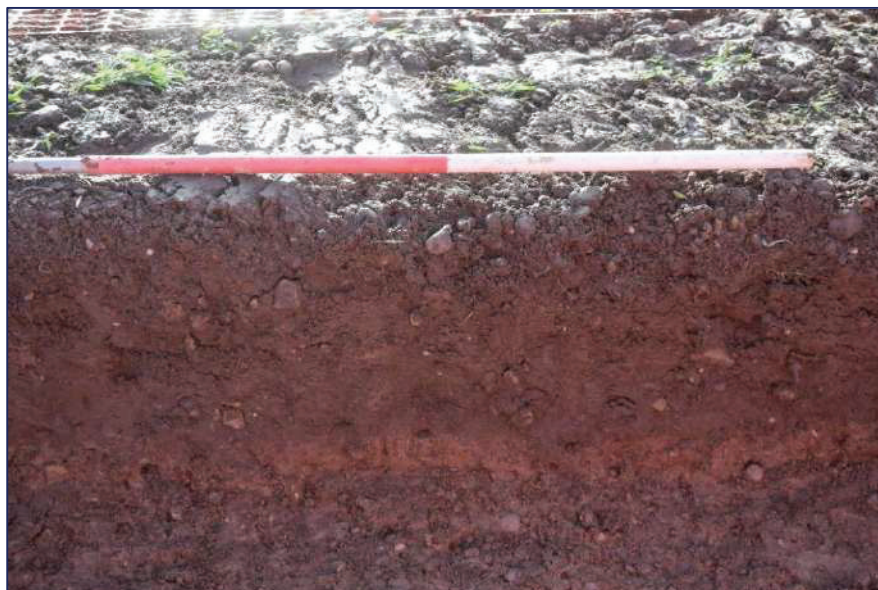
- 4.2.11. The earliest deposit encountered in Trench 7 was a natural sub-stratum formed of soft mid brown-grey silty clay, with frequent small to medium sized gravels throughout (703) (Figure 8, Section 1.4). The natural sub-stratum was encountered at heights ranging from 75.01m aOD to 76.35m aOD. This was overlain by a subsoil, 0.14m deep, of soft mid greyish brown silty clay, with occasional small to medium sized stones (702). Sealing this was a topsoil, 0.20m deep, of friable mid greyish-brown silty clay (701). The topsoil was encountered at heights ranging from 78.12m aOD to 78.73m aOD.

Plate 14: Trench 7 representative section facing north-west

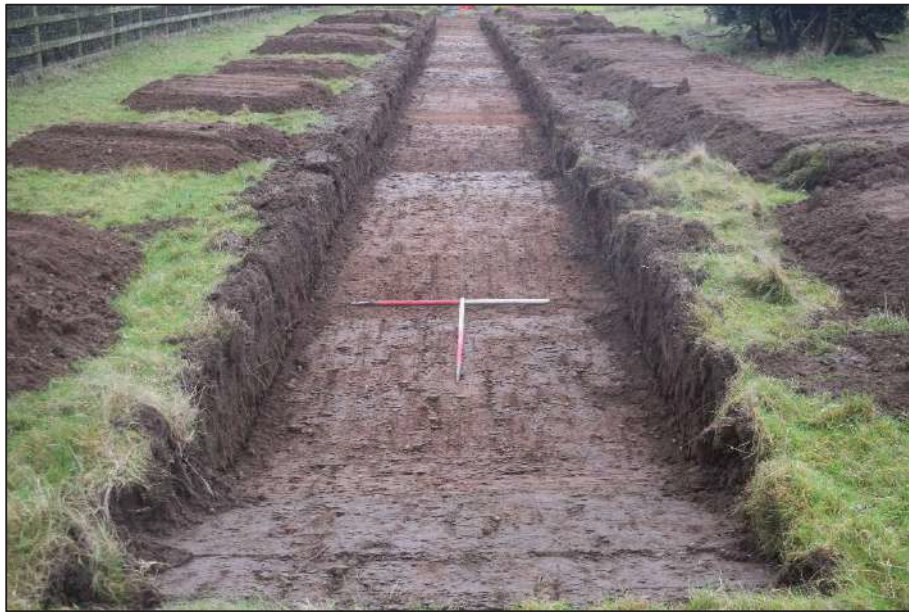
- 4.2.12. The earliest deposit encountered in Trench 8 was a natural sub-stratum formed of a compact mid reddish-brown silty sand with patches of small rounded, stones (802) (Figure 10, Section 4.2). The natural sub-stratum was encountered at heights ranging from 77.27m aOD to 78.33m aOD. This was overlain by a topsoil, 0.40m deep, of dark grey-brown sandy silt, with frequent sub-rounded, small sized stones (801). The topsoil was encountered at heights ranging from 77.61m aOD to 78.79m aOD.

Plate 15: Trench 8 facing north-east

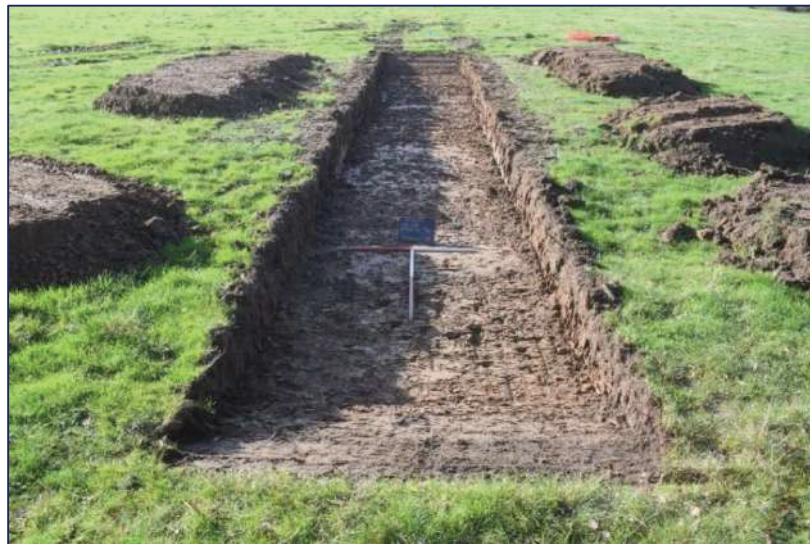
- 4.3.1. Field 2 was located directly south of the River Sowe, which resulted in a high water table, as a result the majority of the field was waterlogged. This was evidenced in the presence of a high amount of standing water in Trench 10. Field 2 contained one 15m trench (Trench 10, Figure 5), with Trench 9 being descope.

Plate 16: Trench 10 facing north-east

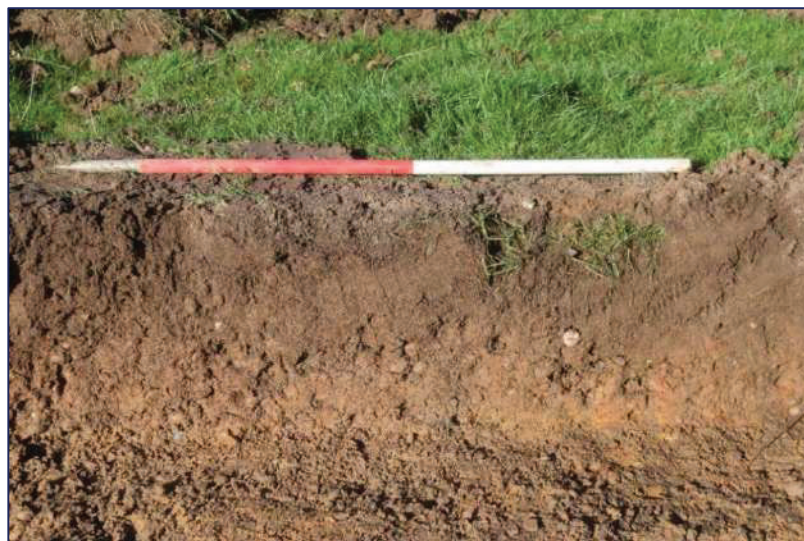
- 4.3.3. Trench 10 contained no archaeological features. The earliest deposit encountered was a natural sub-stratum formed of mid greyish-brown soft/sticky silty clay with very frequent and small to medium sized rounded stones throughout (1003) (Figure 8, Section 1.5). The natural sub-stratum was encountered at heights ranging from 72.32m aOD to 72.37m aOD. This was overlain by a subsoil of friable, mid brownish-grey sandy silty, with frequent rounded, small to medium sized stones (1002). This was sealed by a topsoil, 0.18m deep, of friable mid greyish-brown sandy silt, heavily rooted with grass (1001). The topsoil was encountered at heights ranging from 72.55m aOD to 72.77m aOD.

Plate 17: Trench 10 representative section facing north-west

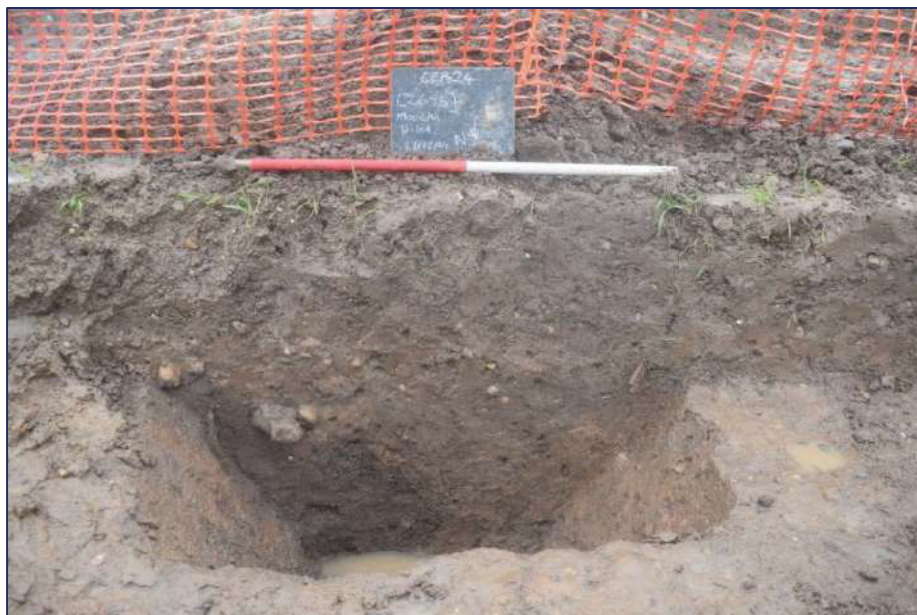
Plate 18: Ditch [2605], south facing section

- 4.4.23. There was one archaeological feature visible in Trench 26, a north to south oriented ditch [2605]. The ditch was steep sided, with a sharp break of slope, and flat base as far as visible (Figure 10, Section 4.1). It measured 1.34m long, 1.80m wide, and was excavated to a depth of 0.80m before plastic shotgun cartridges were encountered. It was deemed unsafe to continue excavation due to potential for any discarded live cartridges. The ditch fill (2604) shared the same dimensions as [2605], and comprised a friable, mid greyish-brown, with yellowish-brown mottling, and frequent small, sub-angular stones. The fill also included other modern debris consisting of twine, blue degraded plastic, broken bricks, in addition to the plastic shotgun shells.

- 4.4.4. There was one archaeological feature, a ditch [2605] present in Trenches 21, 24 and 26 (Figure 6). The location of the ditch corresponds with the locations of a parish boundary identified on historic mapping (HE604820-OIL-EHR-00-SP-LH-30002). Trenches 21 and 24 held groundwater due to the high water table, therefore the potential feature was only investigated in Trench 26.

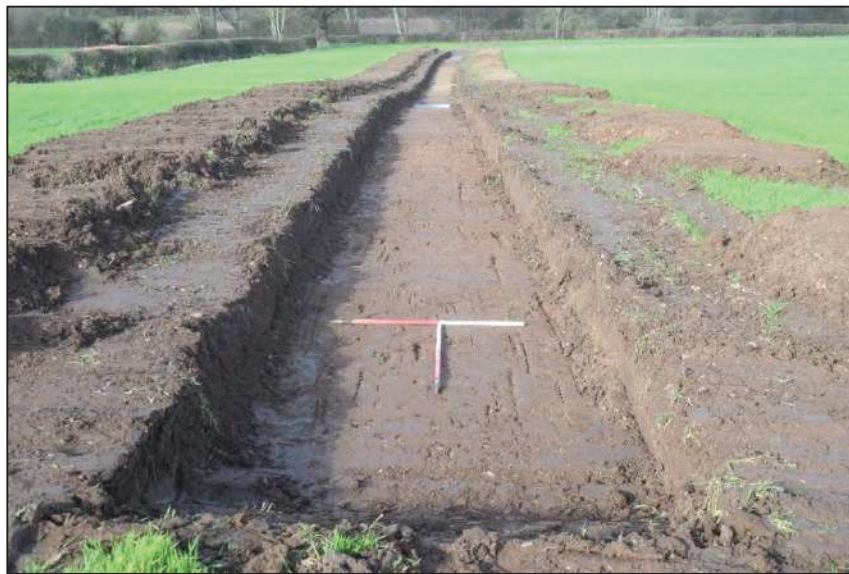
Plate 19: Trench 11 facing north

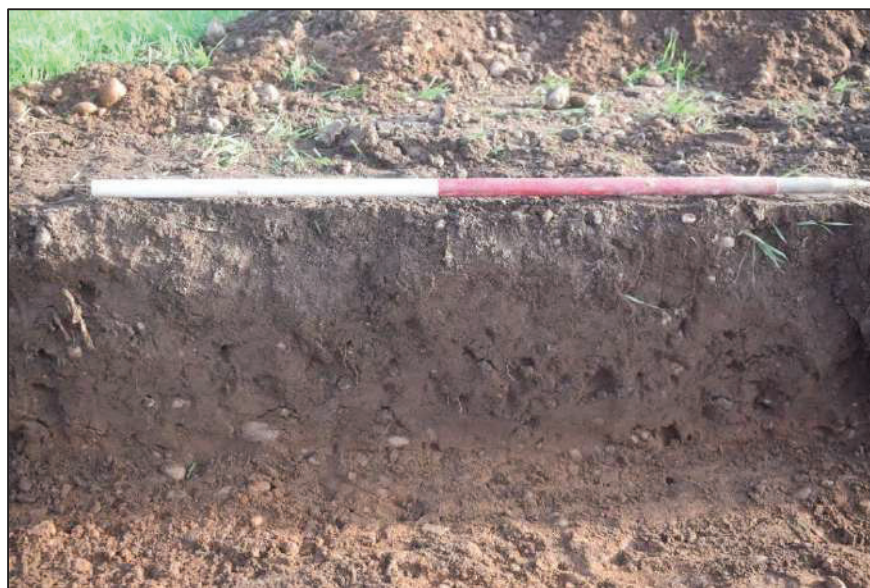
- 4.4.5. Trench 11 measured 100m and contained no archaeological features. The earliest deposit encountered was a natural sub-stratum formed of soft, mid reddish-brown silty sand with very frequent small to medium sized sub-rounded stones and gravels throughout (1102) (Figure 9, Section 2.15). The natural sub-stratum was revealed to a depth of 0.08m and was encountered at heights ranging from 72.70m aOD to 77.83m aOD. The natural sub-stratum was overlain by a topsoil, 0.32m deep, of friable, mid greyish-brown sandy silt, with occasional small to medium sized sub-rounded stones (1101). The topsoil was encountered at heights ranging from 73.20m aOD to 78.29m aOD.

Plate 20: Trench 11 representative section facing west

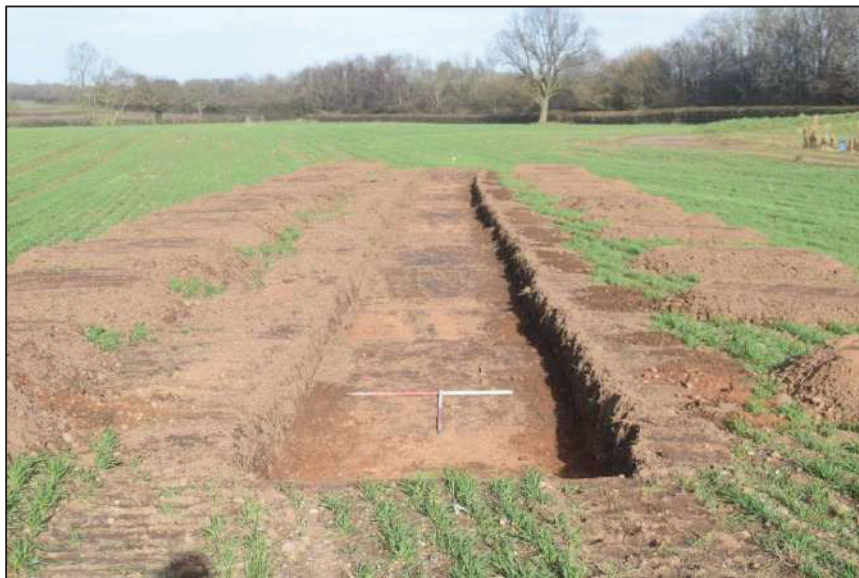
Plate 21: Trench 12 facing north-east

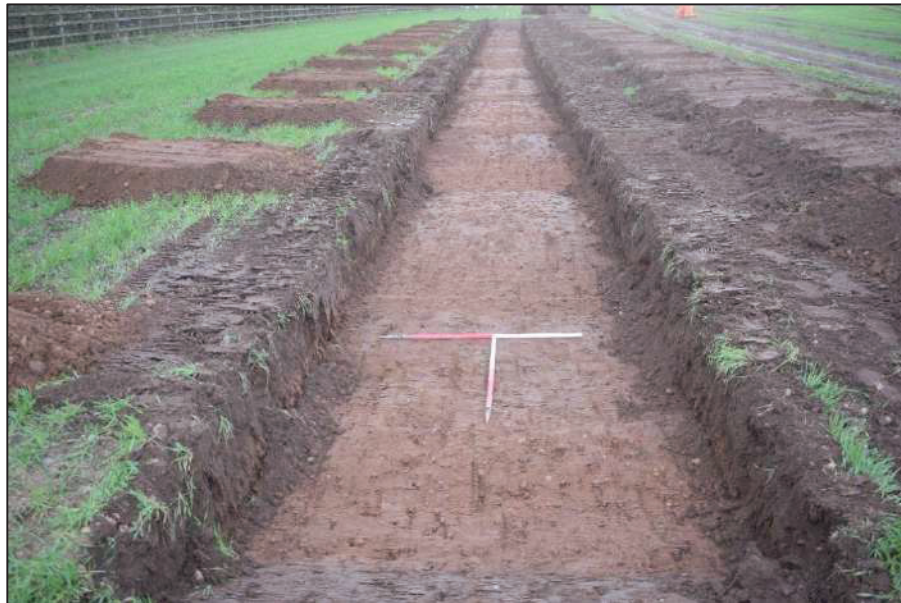
Plate 23: Trench 13 facing south-west

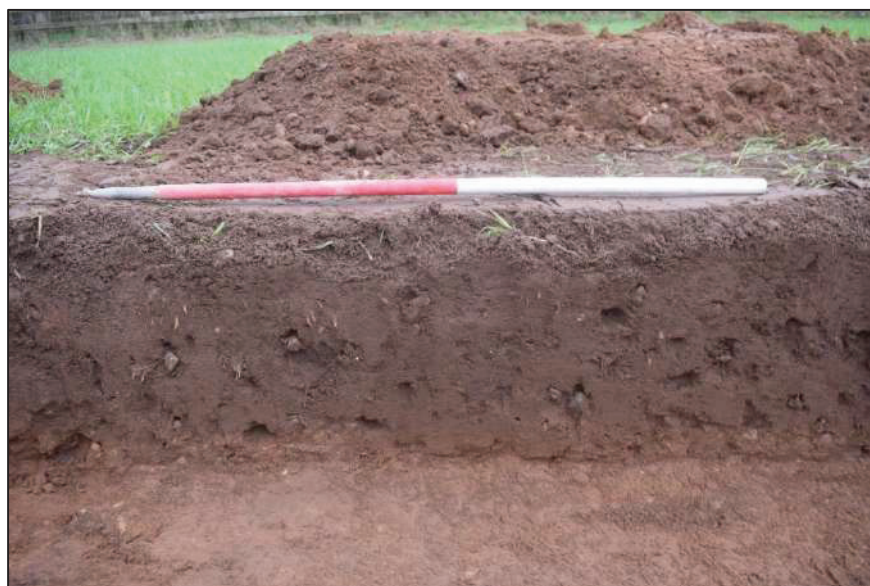
- 4.4.7. The earliest deposit encountered in Trench 13 was a natural sub-stratum formed of mid reddish-brown, soft sand yellow brown sandy clay, with frequent, small to medium sized rounded and sub-rounded stones throughout (1302) (Figure 9, Section 2.19). The natural sub-stratum was encountered at heights ranging from 76.39m aOD to 77.94m aOD. This was overlain by a topsoil, 0.34m deep, of friable dark grey-brown sandy clayey silt, with frequent, small to medium sized stones (1301). The topsoil was encountered at heights ranging from 76.70m aOD to 78.31m aOD.

Plate 24: Trench 13 representative section facing south-east

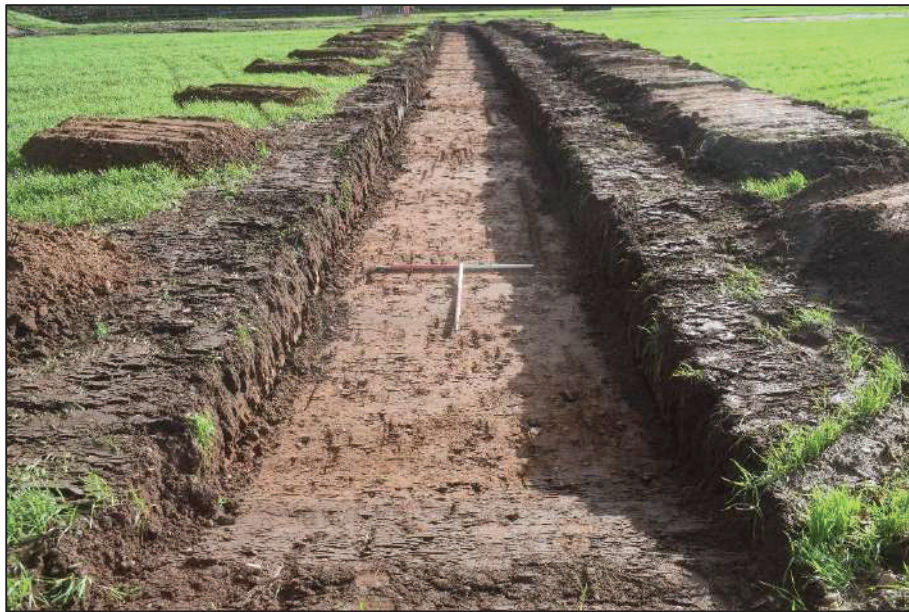
Plate 25: Trench 14 facing south-east

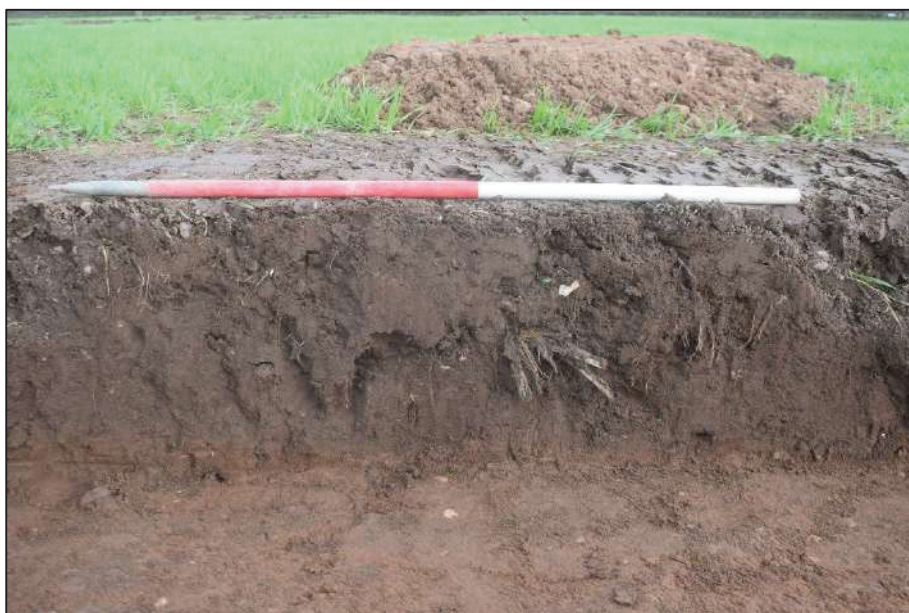
- 4.4.8. The earliest deposit encountered in Trench 14 was a natural sub-stratum formed of a soft, mid red-brown soft sand, with frequent, small, rounded pebbles throughout (1402) (Figure 9, Section 2.18). The natural sub-stratum was encountered at heights ranging from 77.66m aOD to 77.75m aOD. This was overlain by a topsoil, 0.34m deep, of friable dark grey-brown sandy clayey silt, with frequent, small to medium sized stones (1401). The topsoil was encountered at heights ranging from 78.02m aOD to 78.21m aOD.

Plate 26: Trench 14 representative section facing north-east

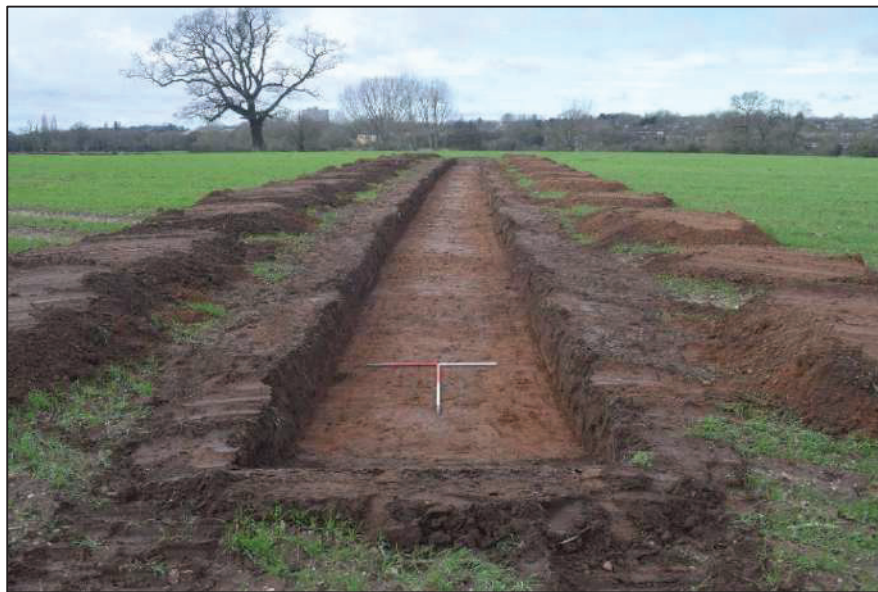
Plate 27: Trench 15 facing east

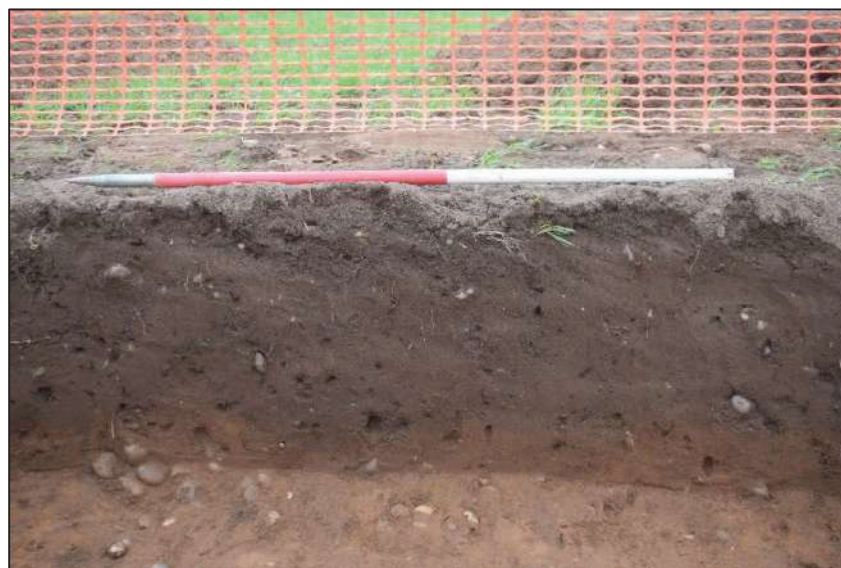
- 4.4.9. The earliest deposit encountered in Trench 15 was a natural sub-stratum formed of mid reddish-brown sandy silt, with frequent small, sub-rounded stones throughout (1503) (Figure 8, Section 1.7). The natural sub-stratum was encountered at heights ranging from 77.66m aOD to 77.81m aOD. This was overlain by a subsoil, 0.18m deep, of firmly compacted dark brown silty sand, with occasional, small to medium sized sub-rounded stones (1502). This was sealed by a topsoil, measuring 0.20m deep, of loose dark greyish-brown silty sand with occasional medium sized sub-rounded stones and rooting (1501). The topsoil was encountered at heights ranging from 78.14m aOD to 78.25m aOD.

Plate 28: Trench 15 representative section facing north

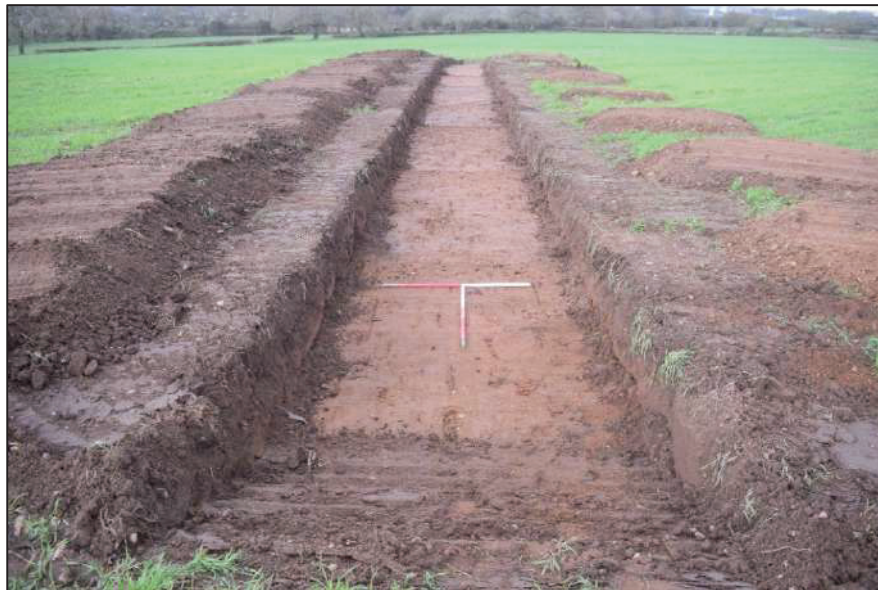
Plate 29: Trench 16 facing north-east

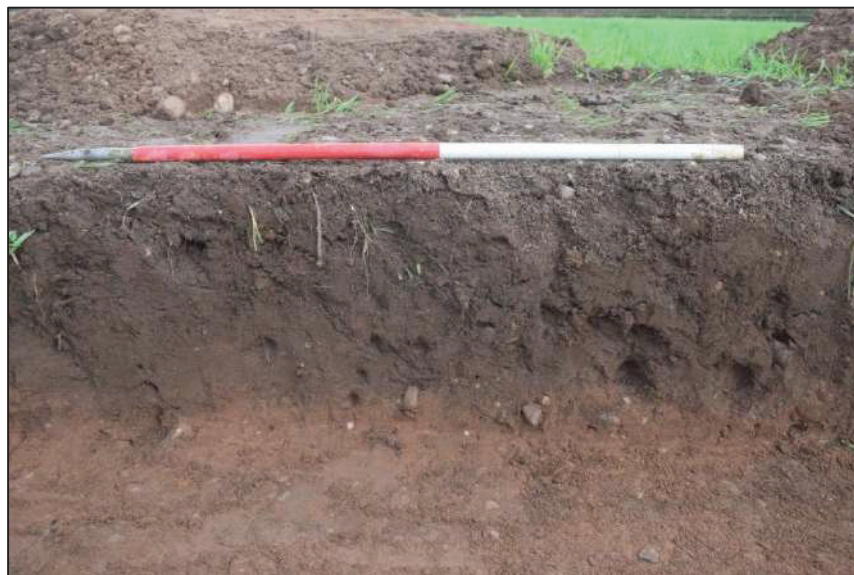
- 4.4.10. The earliest deposit encountered in Trench 16 was a natural sub-stratum formed of mid reddish-brown, with frequent, small to medium, rounded stones throughout (1602) (Figure 9, Section 2.16). The natural sub-stratum was encountered at heights ranging from 75.96m aOD to 77.51m aOD. This was overlain by a topsoil, 0.34m deep, of friable dark grey-brown, sandy silt, with frequent, small to medium sized rounded stones (1601). The topsoil was encountered at heights ranging from 75.54m aOD to 76.35m aOD.

Plate 30: Trench 16 representative section facing north-west

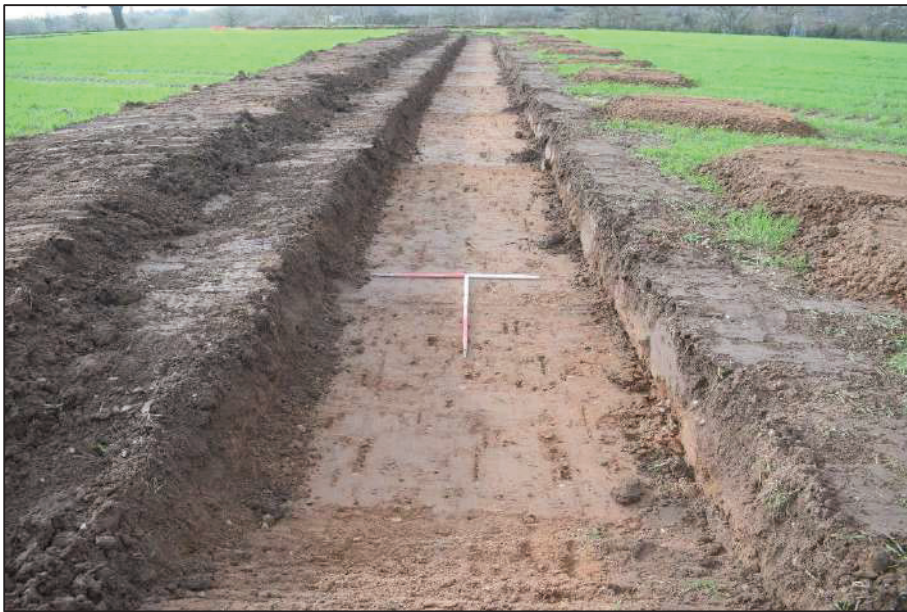
Plate 31: Trench 17 facing west

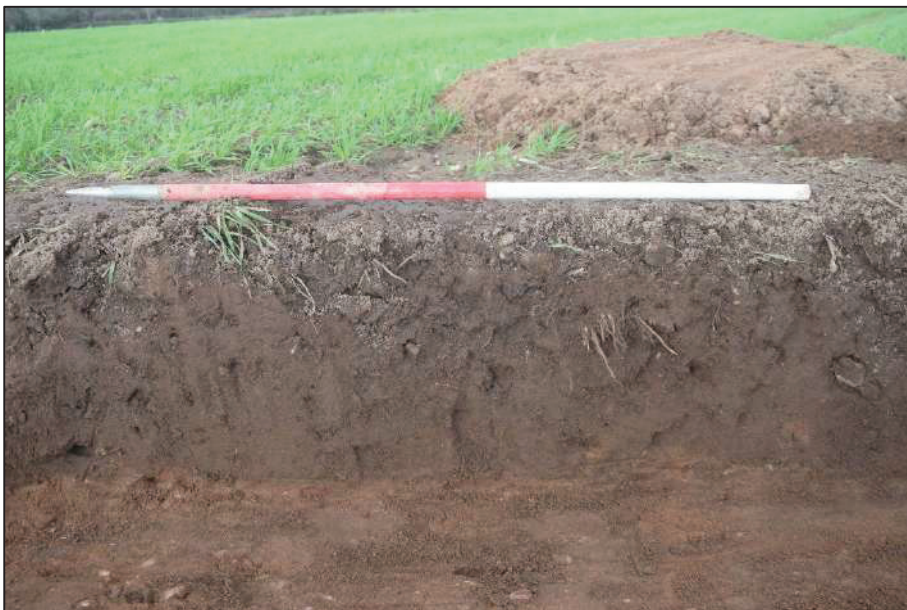
- 4.4.11. The earliest deposit encountered in Trench 17 was a natural sub-stratum formed of mid reddish-brown sandy silt, with frequent small, sub-rounded stones throughout (1702) (Figure 9, Section 2.17). The natural sub-stratum was encountered at heights ranging from 77.32m aOD to 77.58m aOD. This was overlain by a topsoil (1701), 0.28m deep, of friable dark grey-brown, sandy silt, with frequent, small to medium sized rounded stones. The topsoil was encountered at heights ranging from 77.73m aOD to 77.76m aOD.

Plate 32: Trench 17 representative section facing north

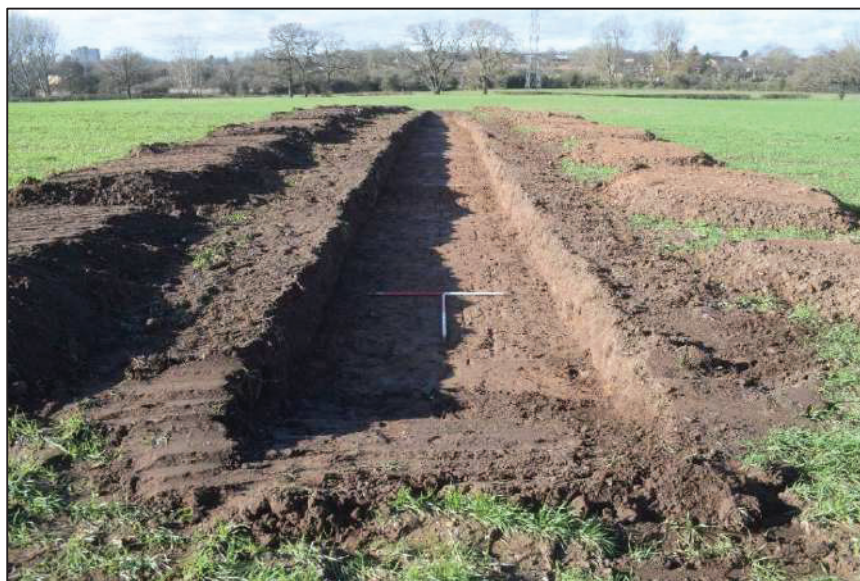
Plate 33: Trench 18 facing south-west

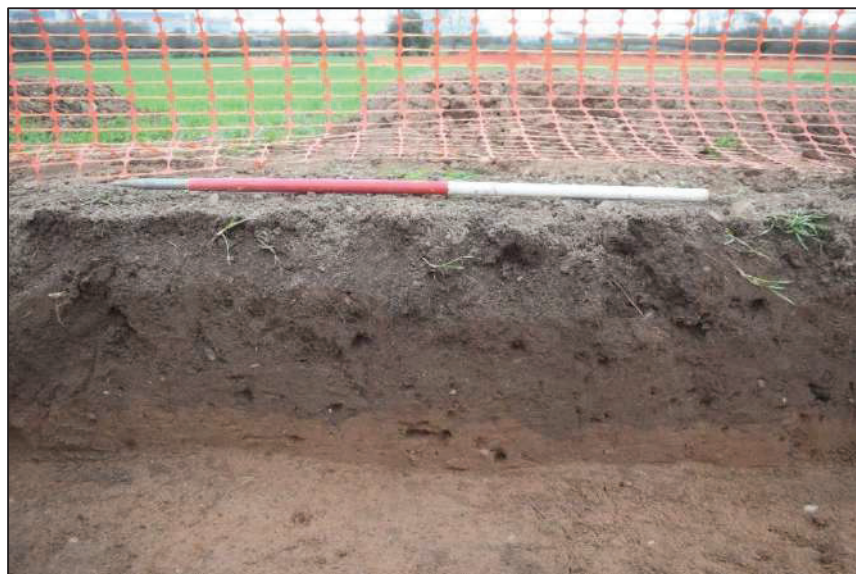
- 4.4.12. The earliest deposit encountered in Trench 18 was a natural sub-stratum formed of mid reddish-brown sandy silt, with frequent small, sub-rounded stones throughout (1803) (Figure 8, Section 1.8). The natural sub-stratum was encountered at heights ranging from 75.53m aOD to 77.03m aOD. This was overlain by a subsoil, 0.12m deep, of firmly compacted dark brown silty sand, with occasional, small to medium sized sub-rounded stones (1802). This was sealed by a topsoil, measuring 0.08m deep, of loose dark greyish-brown silty sand with occasional medium sized sub-rounded stones and rooting (1801). The topsoil was encountered at heights ranging from 75.85m aOD to 77.39m aOD.

Plate 34: Trench 18 representative section facing north-east

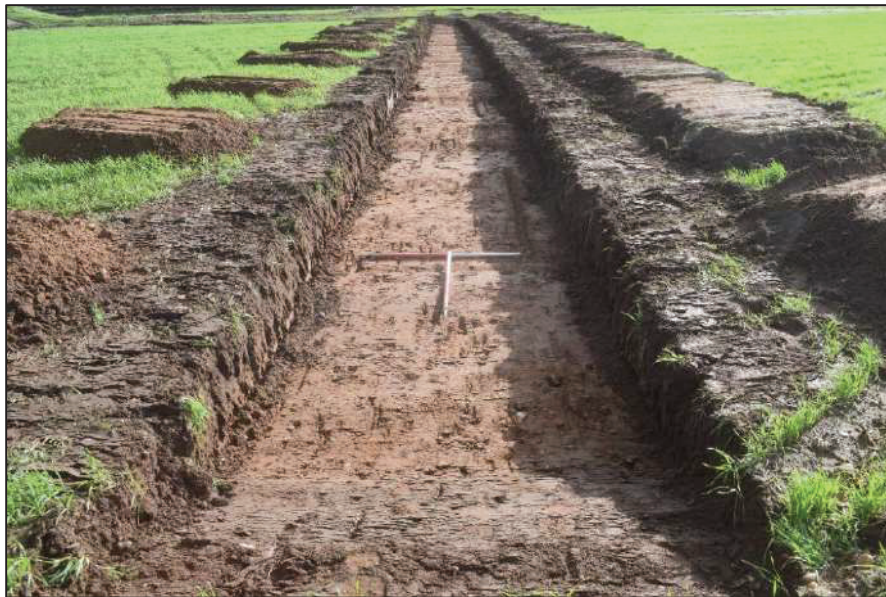
Plate 35: Trench 19 facing south-east

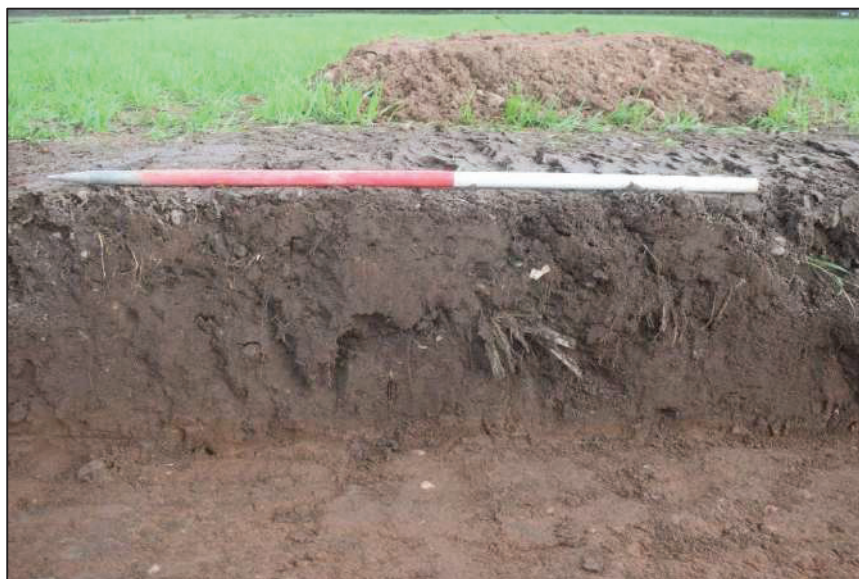
- 4.4.13. The earliest deposit encountered in Trench 19 was a natural sub-stratum formed of mid reddish-brown sandy silt, with frequent small, sub-rounded stones throughout (1902) (Figure 9, Section 2.17). The natural sub-stratum was encountered at heights ranging from 76.55m aOD to 77.25m aOD. This was overlain by a topsoil, 0.30m deep, of friable dark grey-brown, sandy silt, with frequent, small to medium sized rounded stones (1901). The topsoil was encountered at heights ranging from 77.02m aOD to 77.71m aOD.

Plate 36: Trench 19 representative section facing north-west

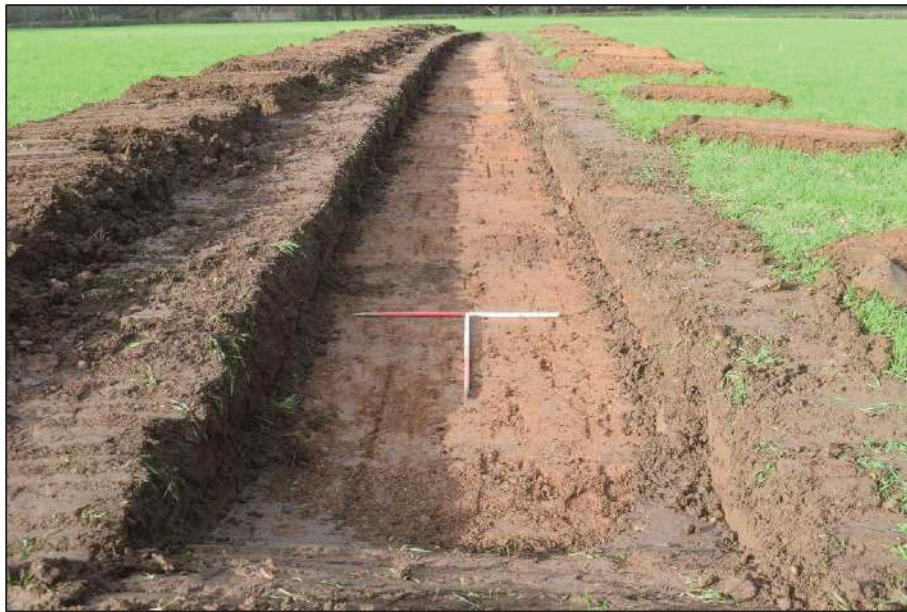
Plate 37: Trench 20 facing north
