# **A46 Coventry Junctions (Walsgrave) Scheme number: TR010066**

### **Appendix 6.4 Archaeological Trial Trenching Survey Report**

# A46 COVENTRY JUNCTIONS UPGRADE (WALSgrave JUNCTION) STAGE 3

## Archaeological Trenching Report

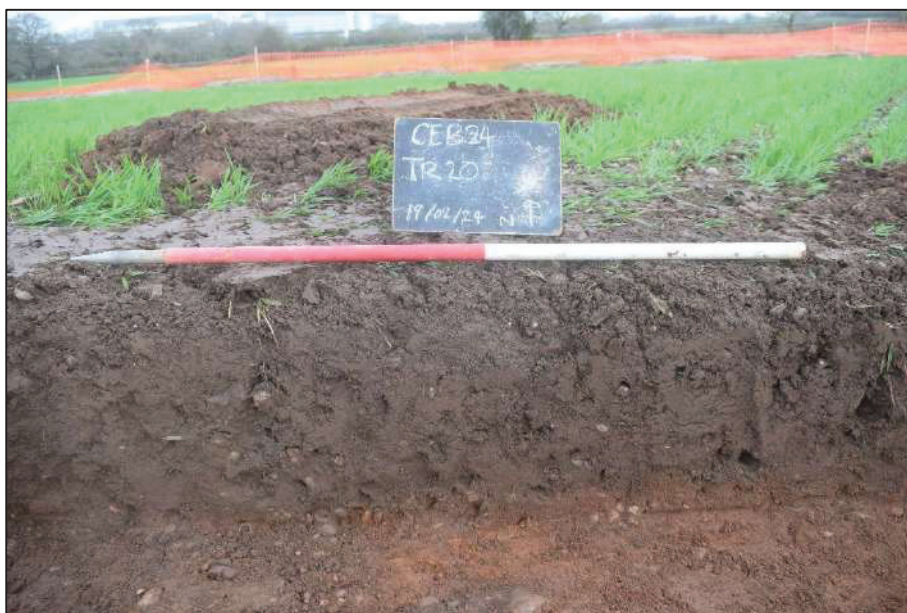
- 4.4.14. The earliest deposit encountered in Trench 20 was a natural sub-stratum formed of mid reddish-brown sandy silt, with frequent small, sub-rounded stones throughout (2002) (Figure 9, Section 2.20). The natural sub-stratum was encountered at heights ranging from 76.55m aOD to 77.25m aOD. This was overlain by a topsoil, 0.34m deep, of friable mid greyish-brown, sandy silt, with frequent, small to medium sized rounded stones (2001). The topsoil was encountered at heights ranging from 77.02m aOD to 77.71m aOD.

Plate 38: Trench 20 representative section facing south

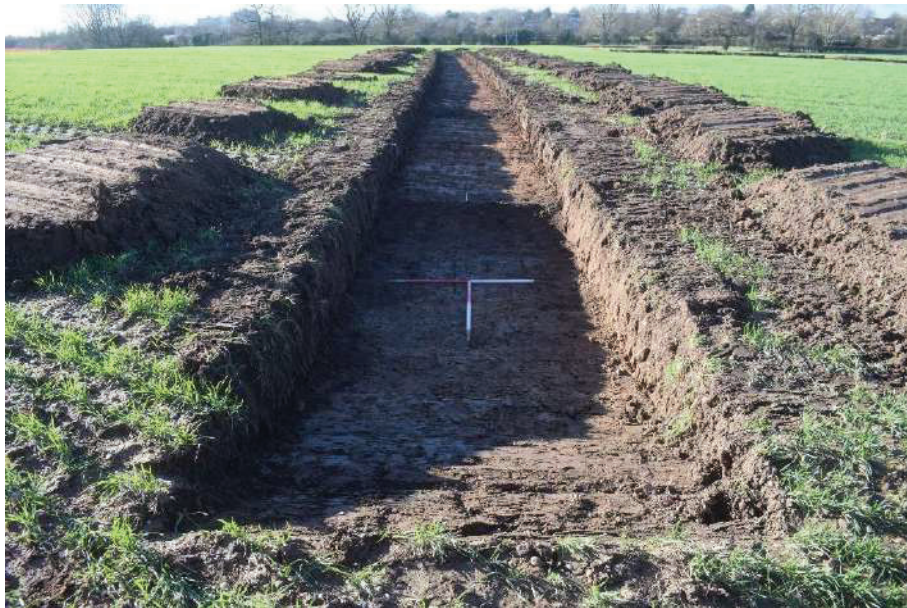
- 4.4.16. Trench 21 contained a north to south oriented ditch at the east end of the trench (Figure 6). The ditch was cut in to the natural sub-stratum but was not investigated due to waterlogged conditions. The ditch was also present in Trenches 24 and 26, it was investigated in Trench 26 (see below). The ditch was overlain by a subsoil, 0.18m deep, of firmly compacted mid greyish-brown silty sandy clay, with frequent, small to medium sized sub-rounded stones (2102). This was sealed by a topsoil, measuring 0.08m deep, of loose mid greyish-brown silty sandy clay, with occasional medium sized sub-rounded stones and rooting (2101). The topsoil was encountered at heights ranging from 75.61m aOD to 75.77m aOD.

Plate 39: Trench 21 facing east

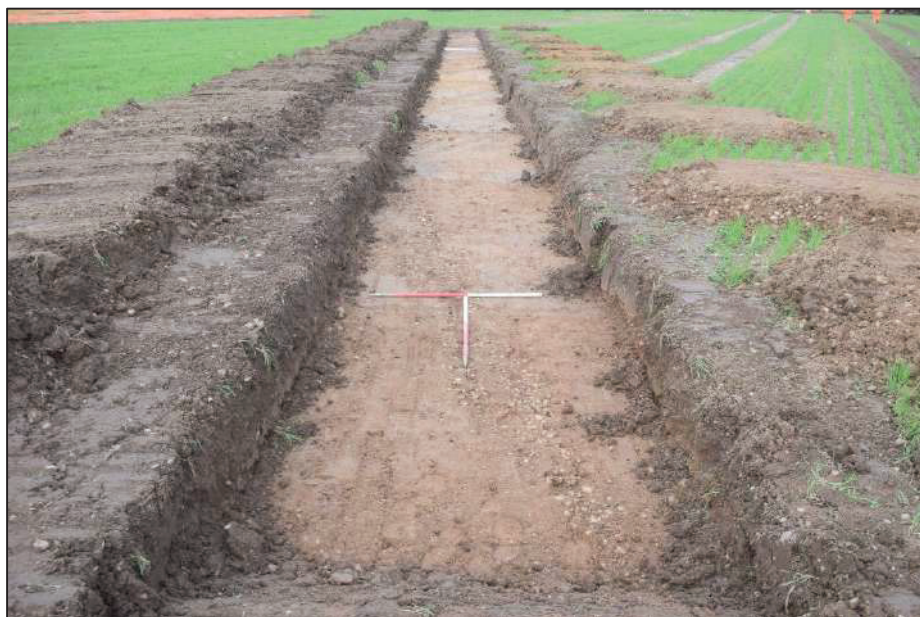
Plate 41: Trench 22 facing north

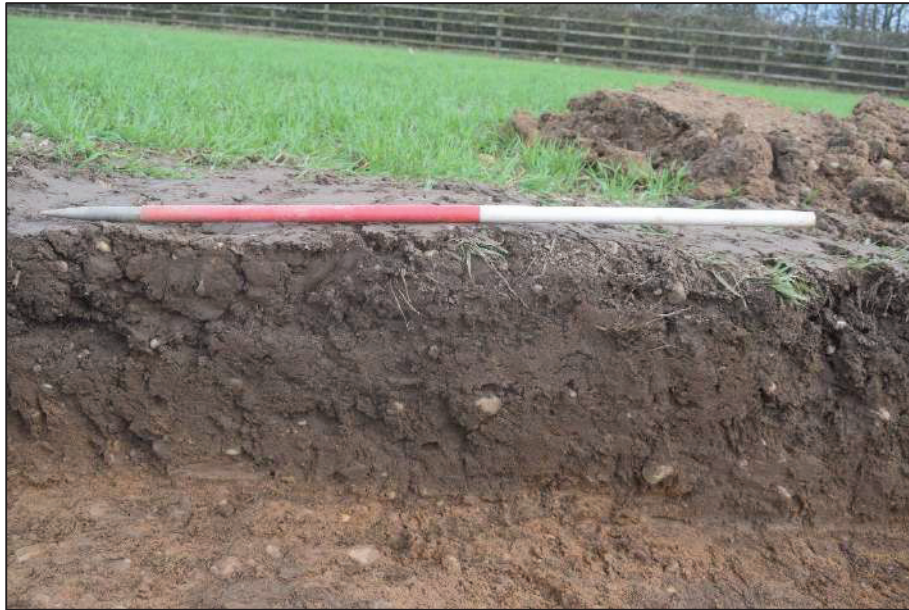
- 4.4.17. The earliest deposit encountered in Trench 22 was a natural sub-stratum formed of mid reddish-brown sandy, clayey silt, with frequent small, sub-rounded stones throughout (2202) (Figure 8, Section 2.22). The natural sub-stratum was encountered at heights ranging from 75.20m aOD to 76.00m aOD. This was overlain by a topsoil, 0.34m deep, of friable dark greyish-brown, sandy clayey silt, with frequent, small to medium sized rounded stones (2201). It was encountered at heights ranging from 75.56m aOD to 76.44m aOD.

Plate 42: Trench 22 representative section facing east

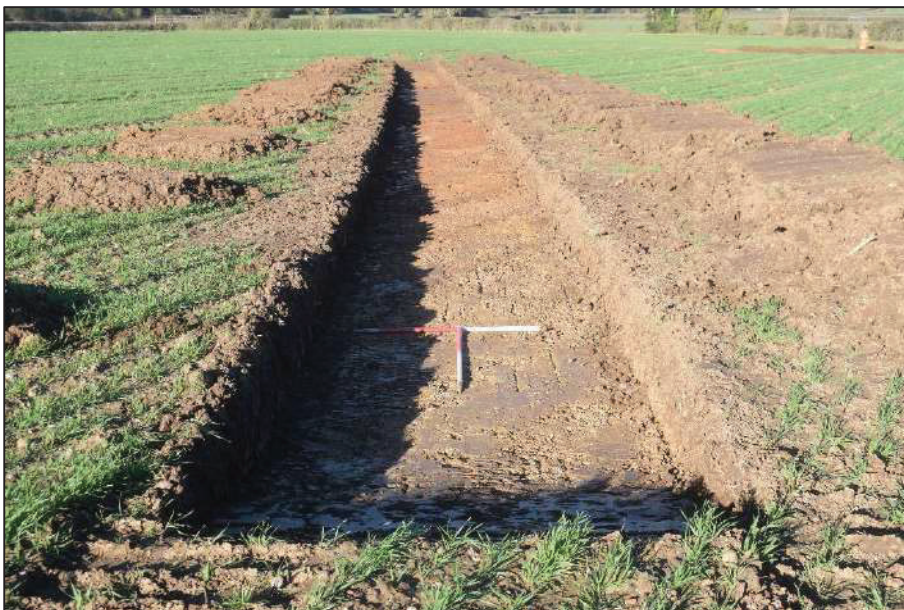
Plate 43: Trench 23 facing east

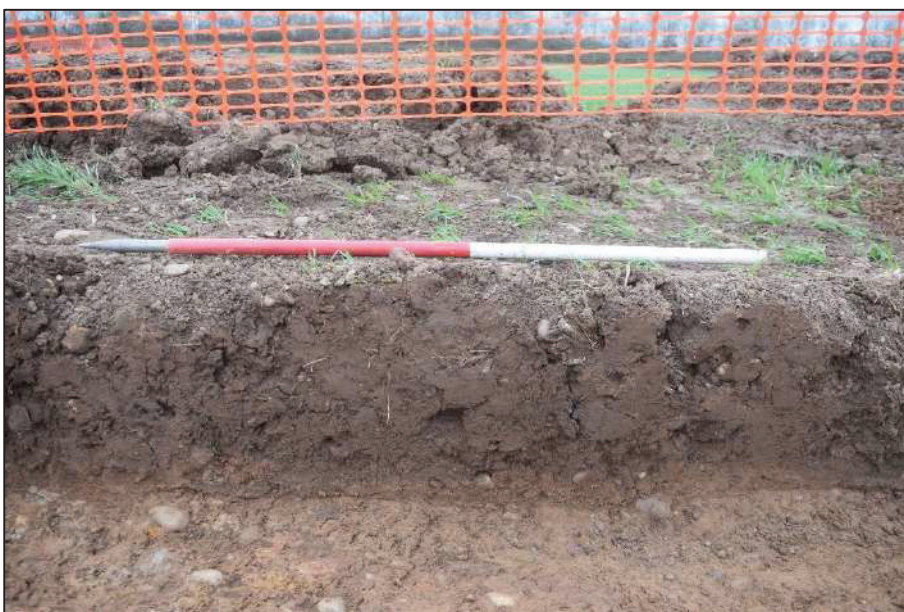
- 4.4.18. The earliest deposit encountered in Trench 23 was a natural sub-stratum formed of a firm mid yellowish-brown mottled sandy clay, with frequent patches of small, sub-rounded stones throughout (2303) (Figure 8, Section 1.10). The natural sub-stratum was encountered at heights ranging from 73.53m aOD to 74.43m aOD. This was overlain by a subsoil, 0.16m deep, of firmly compacted mid greyish-brown silty sandy clay, with frequent, small to medium sized sub-rounded stones (2302). This was sealed by a topsoil, measuring 0.17m deep, of firm mid greyish-brown silty sandy clay, with occasional medium to large sized sub-rounded stones and rooting (2301). The topsoil was encountered at heights ranging from 75.61m aOD to 75.77m aOD.

Plate 44: Trench 23 representative section facing north

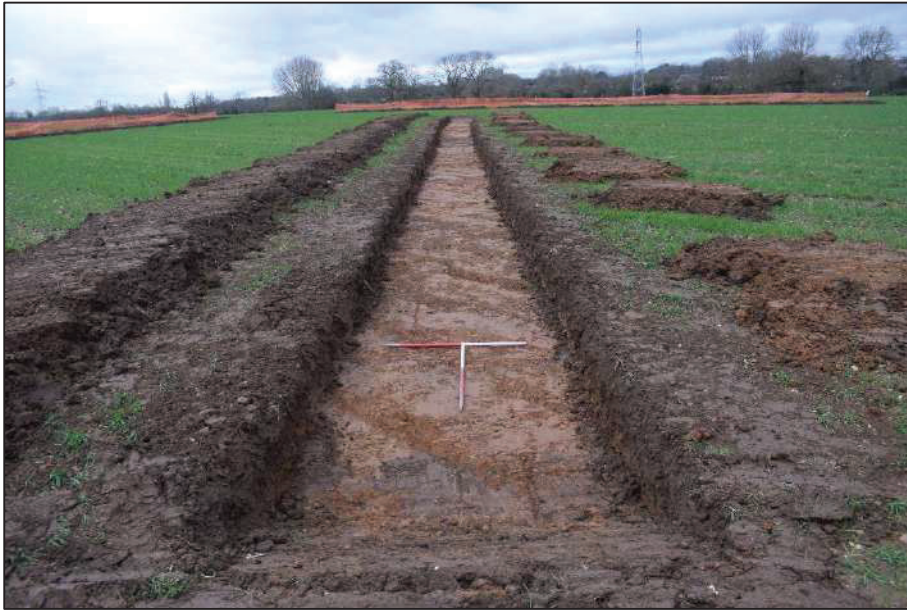
- 4.4.20. Trench 24 contained a north to south oriented ditch in the centre of the trench (Figure 6). The ditch was also present in Trenches 21 and 26, it was investigated in Trench 26 (see below). This was overlain by a subsoil, 0.18m deep, of friable mid greyish-brown silty sandy clay, with frequent, small to medium sized sub-angular stones (2402). This was sealed by a topsoil, measuring 0.20m deep, of friable mid greyish-brown silty sandy clay, with occasional medium to large sized sub-rounded stones and rooting (2401). The topsoil was encountered at heights ranging from 74.96m aOD to 75.04m aOD.

Plate 45: Trench 24 facing north

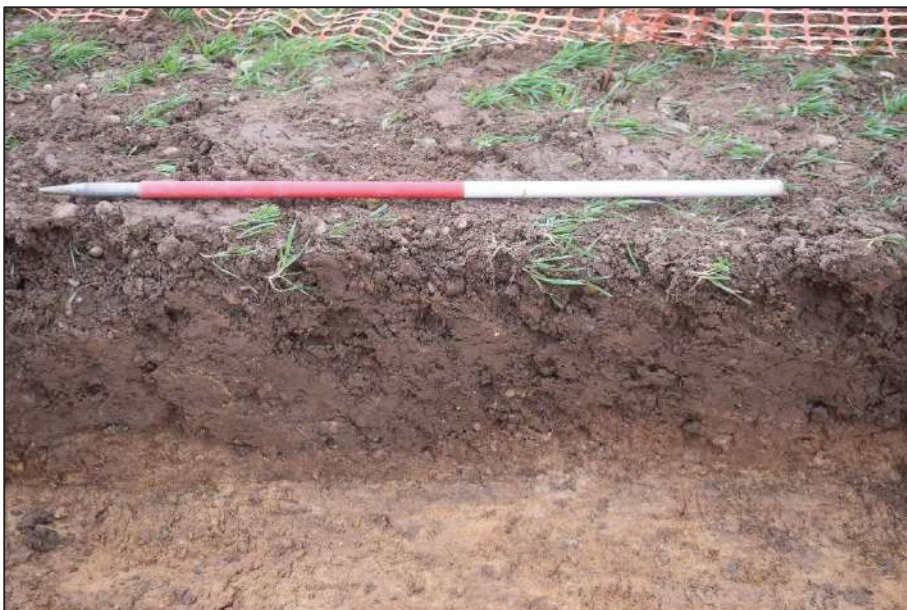
Plate 46: Trench 24 representative section facing west

- 4.4.19. The earliest deposit encountered was a natural sub-stratum formed of a firm light greyish-yellow silty clay, with frequent small, sub-rounded stones throughout (2403) (Figure 8, Section 1.11). The natural sub-stratum was encountered at heights ranging from 74.51m aOD to 74.61m aOD. The ditch was cut in to the natural sub-stratum but was not investigated due to waterlogged conditions.

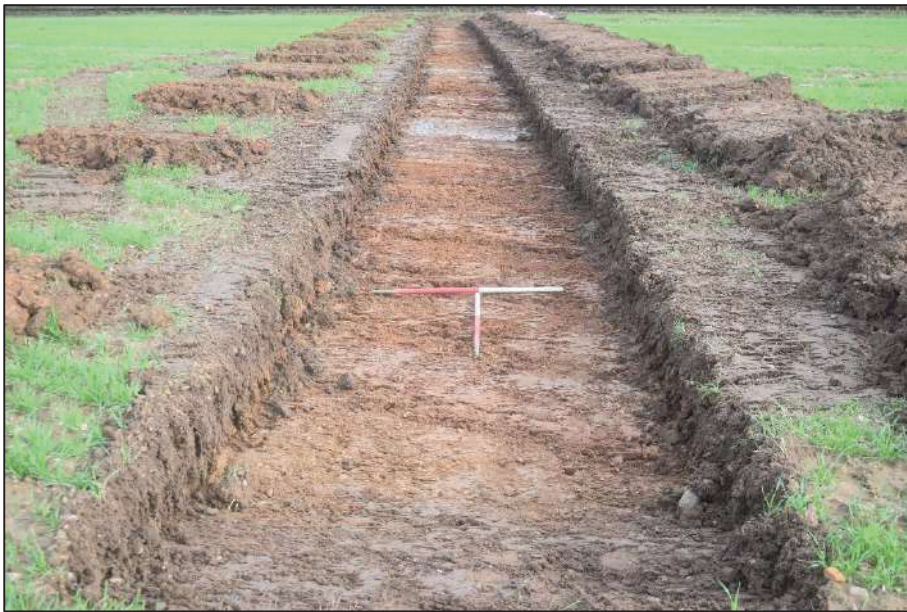
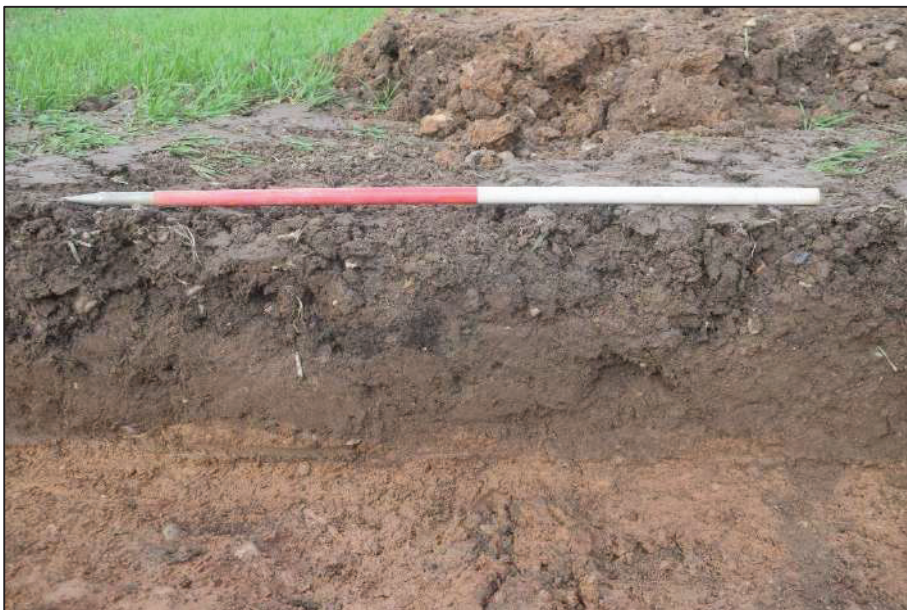
- 4.4.21. The earliest deposit encountered in Trench 25 was a natural sub-stratum formed of mid reddish-brown sandy clayey silt, with frequent small to medium, sub-rounded stones (2502) (Figure 9, Section 3.1). The natural sub-stratum was encountered at heights ranging from 74.43m aOD to 75.18m aOD. This was overlain by a topsoil, 0.36m deep, of firmly compacted dark grey-brown sandy clayey silt, with frequent, small to medium sized sub-rounded stones (2501). The topsoil was encountered at heights ranging from 75.54m aOD to 75.51m aOD.

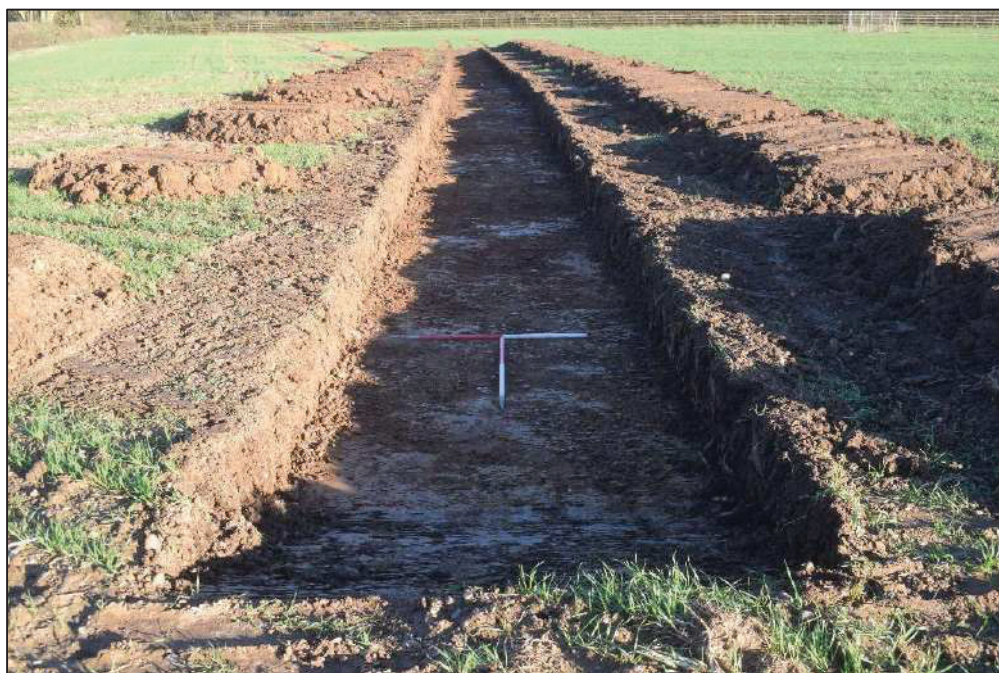
Plate 49: Trench 26 facing south, south-east

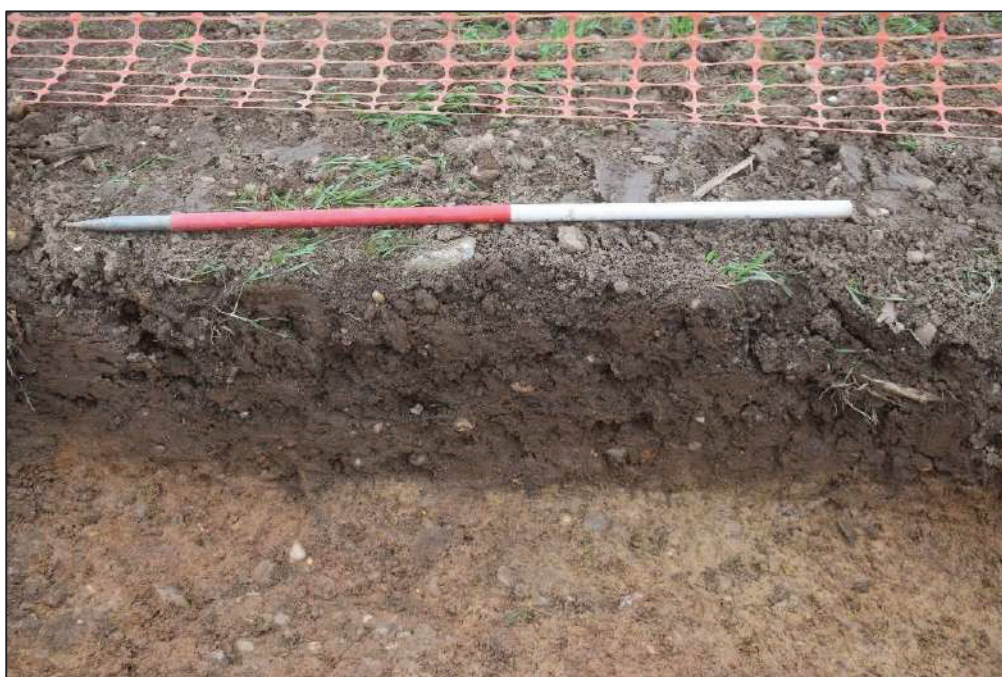
Plate 50: Trench 26 representative section facing east, north-east

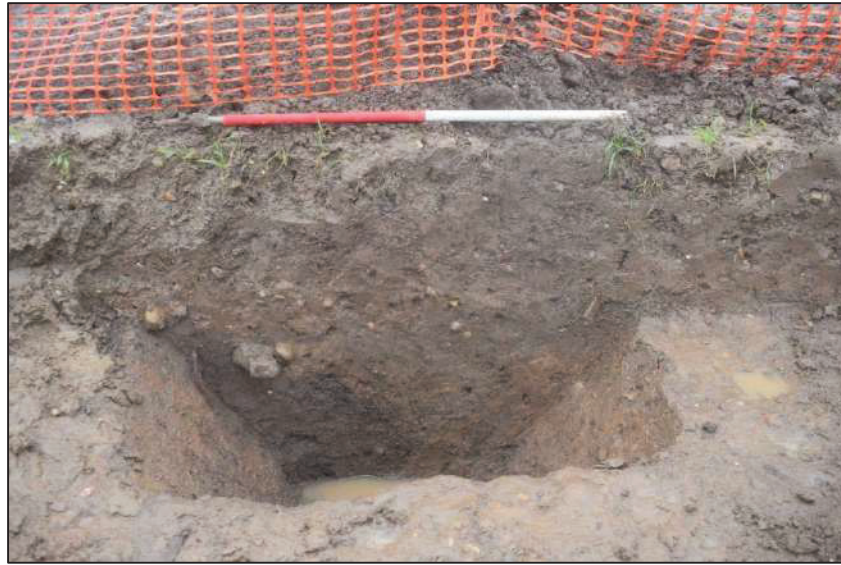
Plate 51: Ditch [2605] facing south

- 4.4.23. There was one archaeological feature visible in Trench 26, a north to south oriented ditch [2605]. The ditch was steep sided, with a sharp break of slope, and flat base as far as visible (Figure 10, Section 4.1). It measured 1.34m long, 1.80m wide, and was excavated to a depth of 0.80m before plastic shotgun cartridges were encountered. It was deemed unsafe to continue excavation due to potential for any discarded live cartridges. The ditch fill (2604) shared the same dimensions as [2605], and comprised a friable, mid greyish-brown, with yellowish-brown mottling, and frequent small, sub-angular stones. The fill also included other modern debris consisting of twine, blue degraded plastic, broken bricks, in addition to the plastic shotgun shells.

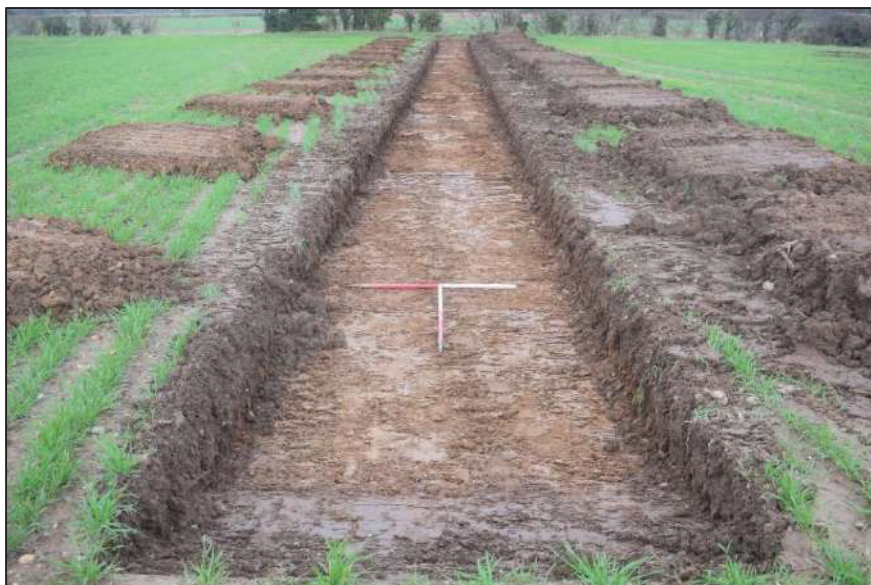
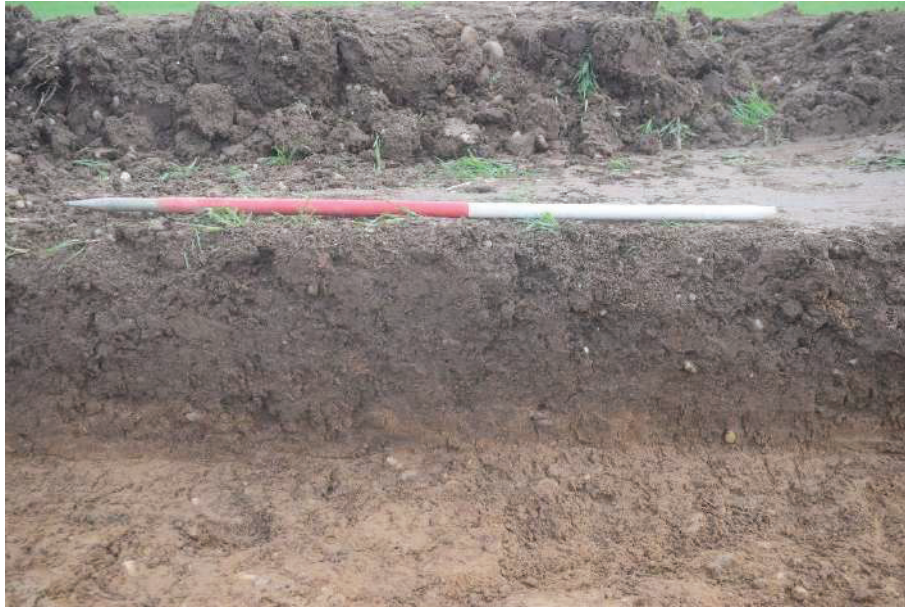
- 4.4.26. The earliest deposit encountered in Trench 27 was a natural sub-stratum formed of mid yellow-grey mottled firm clay, with patches of reddish-brown sandy clay, and frequent small to medium, rounded and sub-rounded stones (2702) (Figure 9, Section 3.2). The natural sub-stratum was encountered at heights ranging from 73.56m aOD to 73.68m aOD. This was overlain by a topsoil, 0.34m deep, of firmly compacted dark grey-brown sandy clayey silt, with frequent, small to medium sized rounded and sub-rounded stones (2701). The topsoil was encountered at heights ranging from 73.76m aOD to 73.94m aOD.

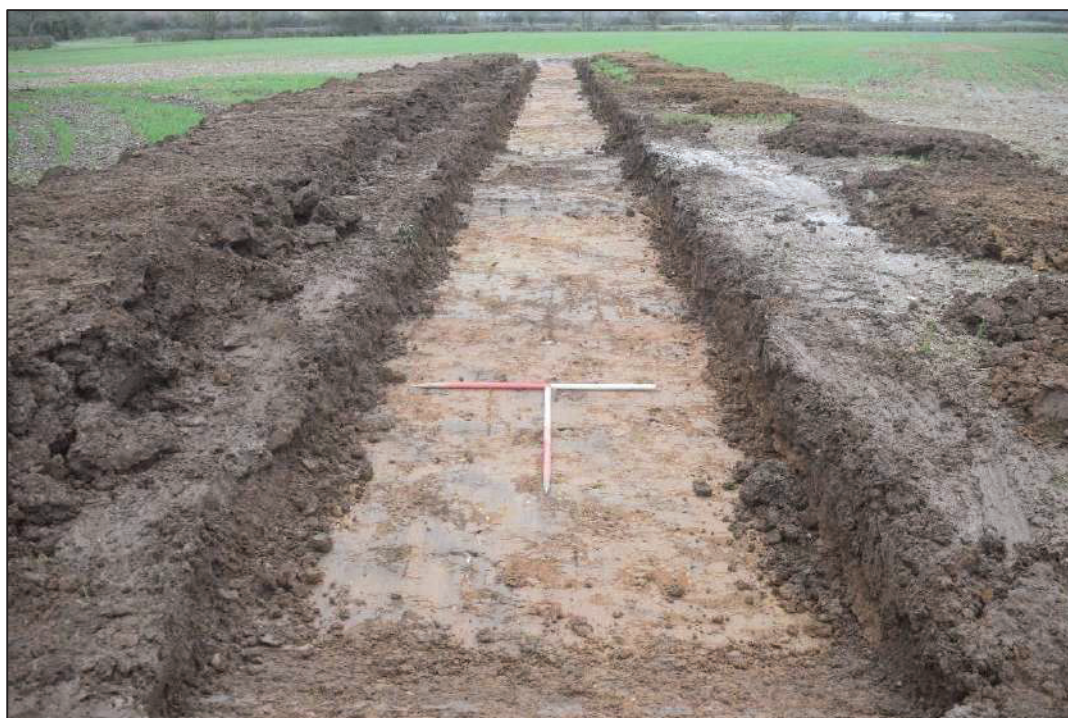
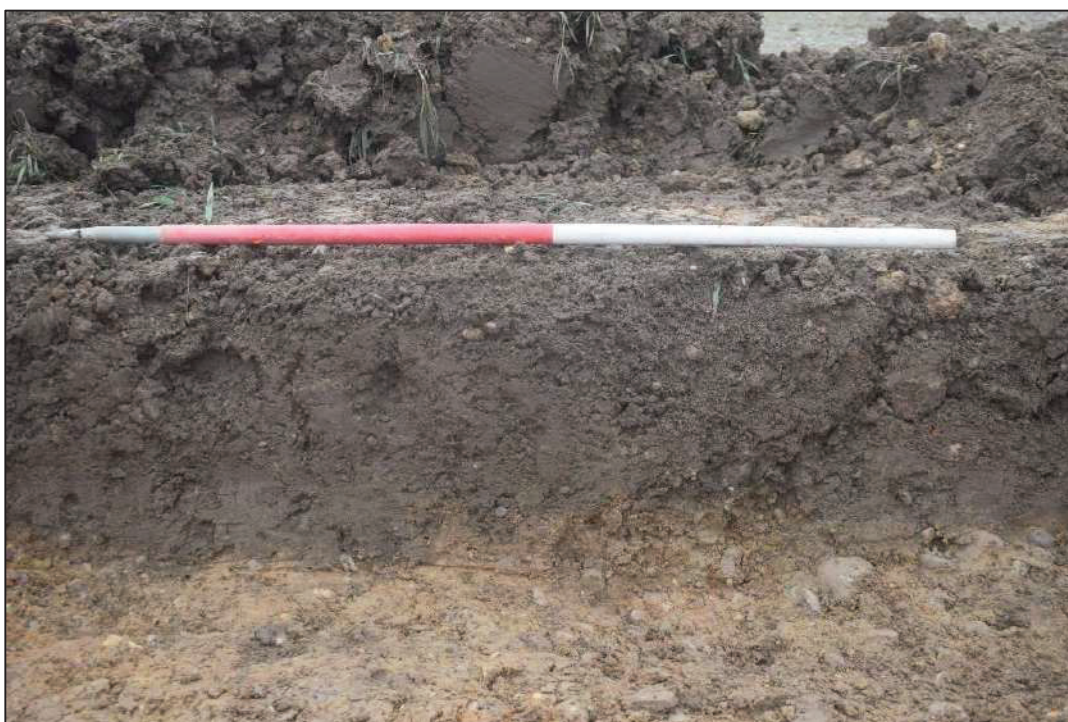
- 4.5.4. The earliest deposit encountered in Trench 28 was a natural sub-stratum formed of a friable, mid grey-yellow silty clay, with very frequent flecks of manganese and small sub-rounded stones (2802) (Figure 9, Section 3.9). The natural sub-stratum was encountered at heights ranging from 72.82m aOD to 73.36m aOD. This was overlain by a topsoil, 0.28m deep, of soft dark grey-brown, silty clay, with frequent small to medium sized, sub-rounded stones (2801). The topsoil was encountered at heights ranging from 73.10m aOD to 73.64m aOD.

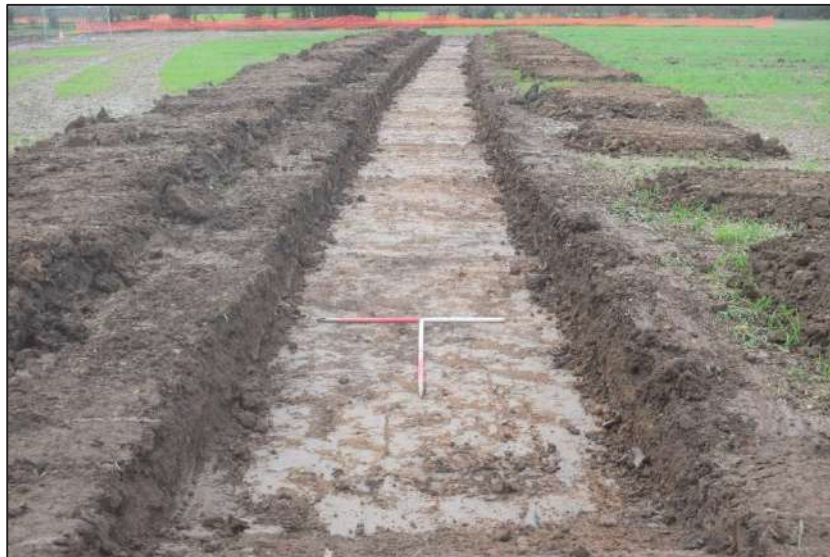
Plate 56: Trench 29 facing west

- 4.5.5. The earliest deposit encountered in Trench 29 was a natural sub-stratum formed of a friable but compact, mid grey-yellow sandy clay, with very frequent small to medium sub-rounded stones (2903) (Figure 9, Section 3.1). The natural sub-stratum was encountered at heights ranging from 73.37m aOD to 74.09m aOD. This was overlain by a subsoil, 0.10m deep, of compact mid grey-sandy clayey silt, with frequent flecks of manganese and CBM throughout (2902). This was sealed by a topsoil, 0.26m deep, of soft dark reddish-brown silty clay, with frequent small to medium rounded and sub-rounded stones and CBM (2901). The topsoil was encountered at heights ranging from 73.89m aOD to 74.49m aOD.

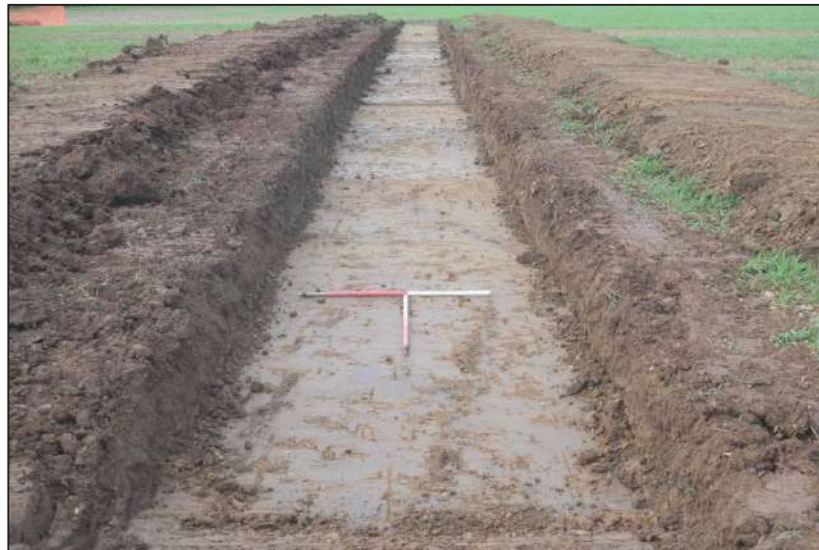
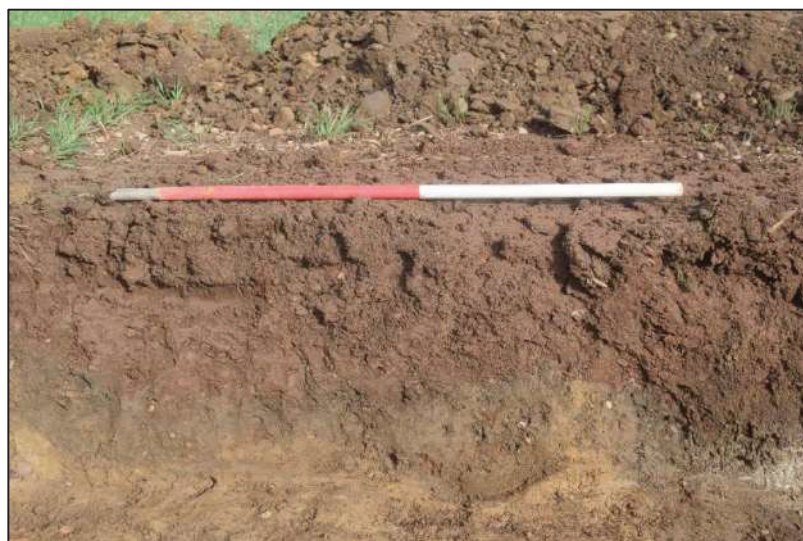
- 4.5.6. The earliest deposit encountered in Trench 30 was a natural sub-stratum formed of a friable but compact, mid grey-yellow sandy clay, with very frequent small to medium sub-rounded stones (3003) (Figure 9, Section 3.11). The natural sub-stratum was encountered at heights ranging from 72.86m aOD to 73.63m aOD. This was overlain by a subsoil, 0.14m deep, compact, mid grey, sandy clayey silt, with frequent flecks of manganese and CBM throughout (3002). This was sealed by a topsoil, 0.34m deep, of soft dark-reddish brown silty clay, with frequent small to medium rounded and sub-rounded stones and CBM (3001). The topsoil was encountered at heights ranging from 73.01m aOD to 74.04m aOD.

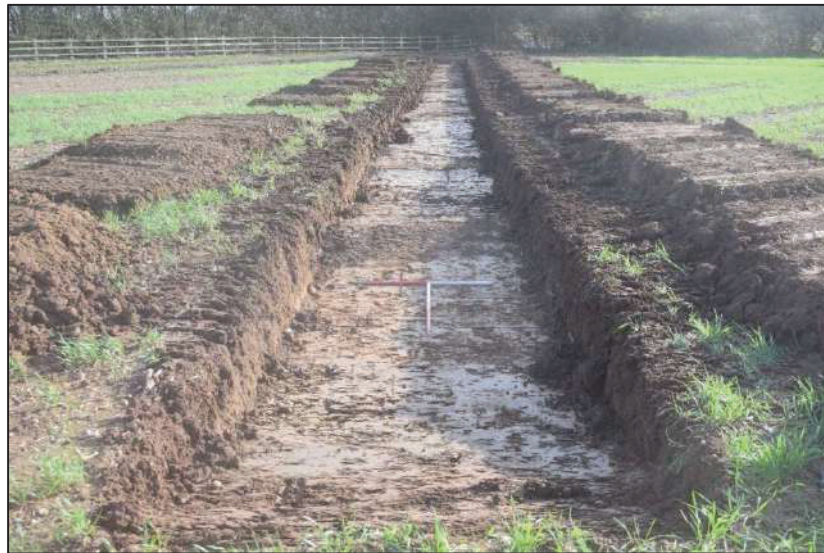
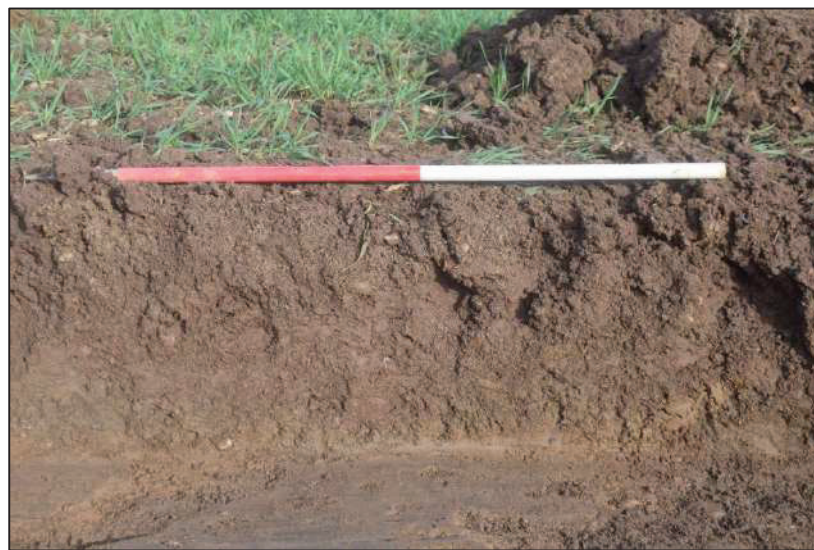
- 4.5.7. The earliest deposit encountered in Trench 31 was a natural sub-stratum formed of a friable but compact, mid grey-yellow sandy clay, with very frequent small to medium sub-rounded stones (3103) (Figure 10, Section 3.12). The natural sub-stratum was encountered at heights ranging from 73.73m aOD to 74.66m aOD. This was overlain by a subsoil, 0.12m deep, of compact mid grey, sandy clayey silt, with frequent flecks of manganese and CBM throughout (3102). These were sealed by a topsoil, 0.16m deep, of soft dark reddish-brown silty clay, with frequent small to medium rounded and sub-rounded stones and CBM (3101). The topsoil was encountered at heights ranging from 74.19m aOD to 74.97m aOD.

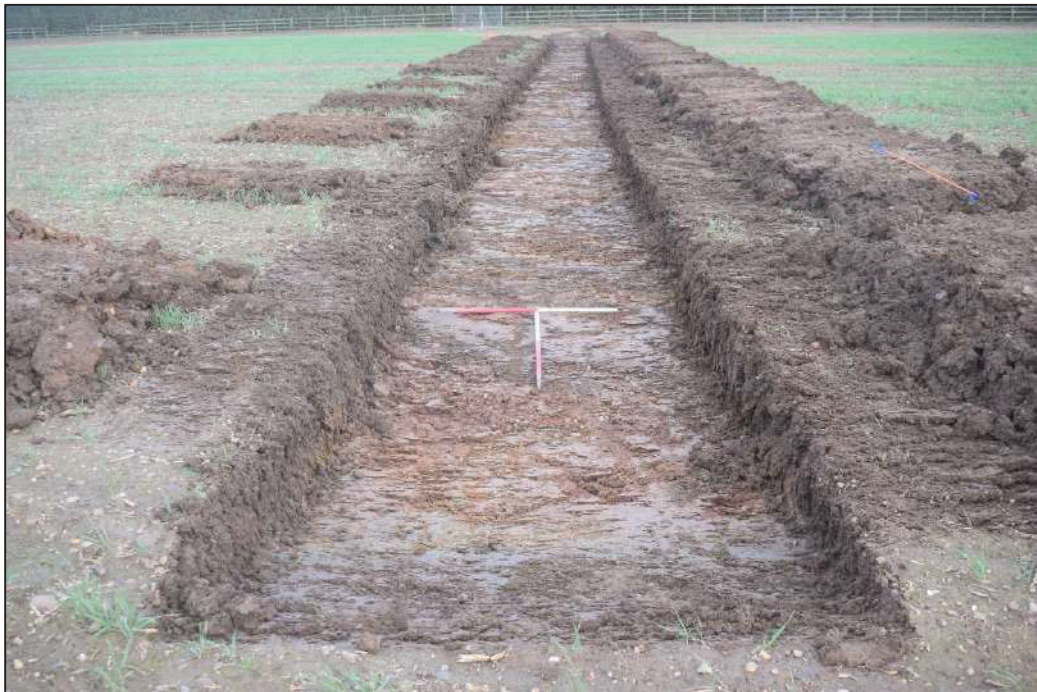
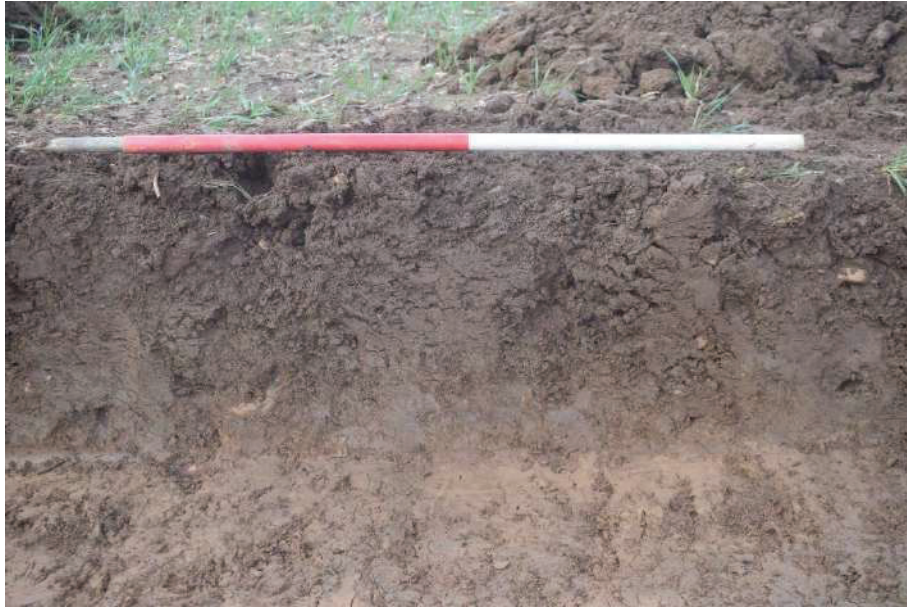
- 4.5.8. The earliest deposit encountered in Trench 32 was a natural sub-stratum formed of a friable but compact, mid grey-yellow sandy clay, with very frequent small to medium sub-rounded stones (3203) (Figure 10, Section 3.16). The natural sub-stratum was encountered at heights ranging from 73.35m aOD to 73.94m aOD. This was overlain by a subsoil, 0.12m deep, of compact mid grey, sandy clayey silt, with frequent flecking of manganese and CBM throughout (3202). This was sealed by a topsoil, 0.18m deep, of soft dark greyish-brown silty clay, with frequent small to medium rounded and sub-rounded stones and CBM (3201). The topsoil was encountered at heights ranging from 73.70m aOD to 74.33m aOD.

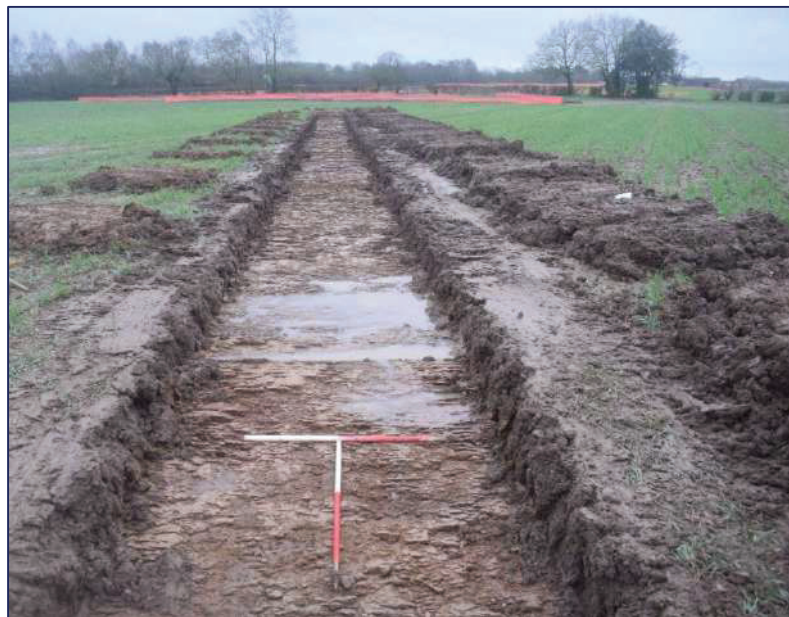
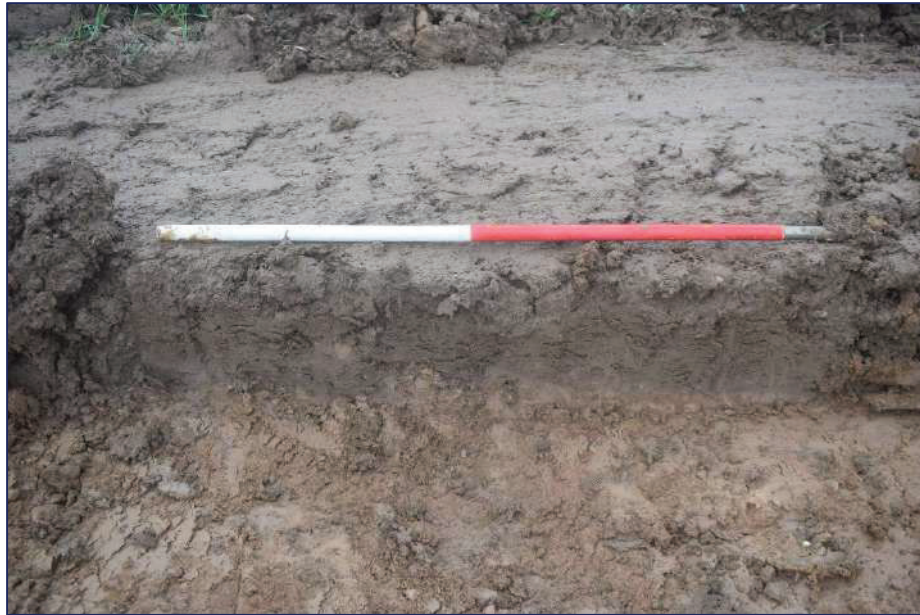
- 4.5.9. The earliest deposit encountered in Trench 33 was a natural sub-stratum formed of yellow-brown sandy clay, with frequent stone inclusions (3302) (Figure 9, Section 3.8). The natural sub- was encountered at heights ranging from 72.68m aOD to 73m aOD. This was overlain by a topsoil, 0.26m deep, of firmly compacted mid brown sandy clay (3301). The topsoil was encountered at heights ranging from 73.02m aOD to 73.54m aOD.

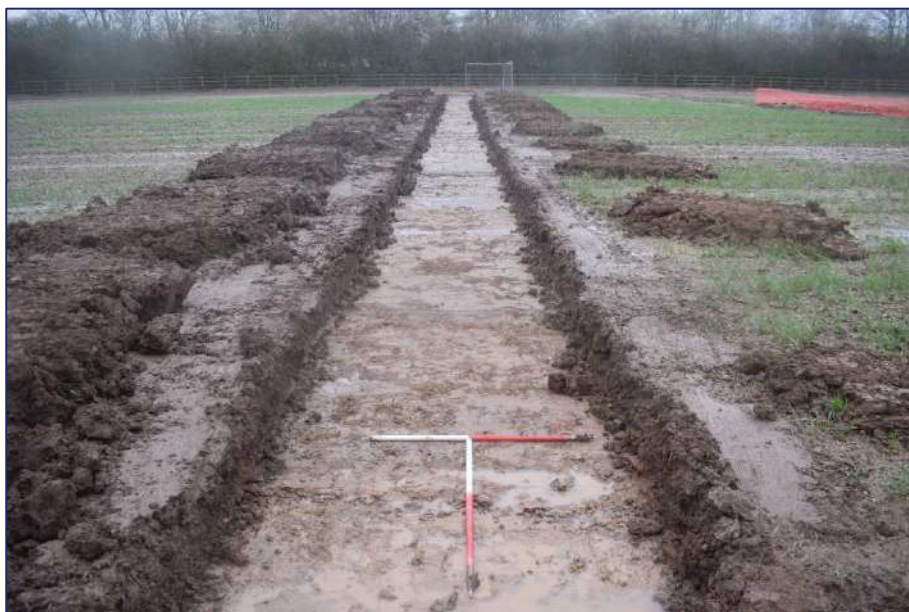
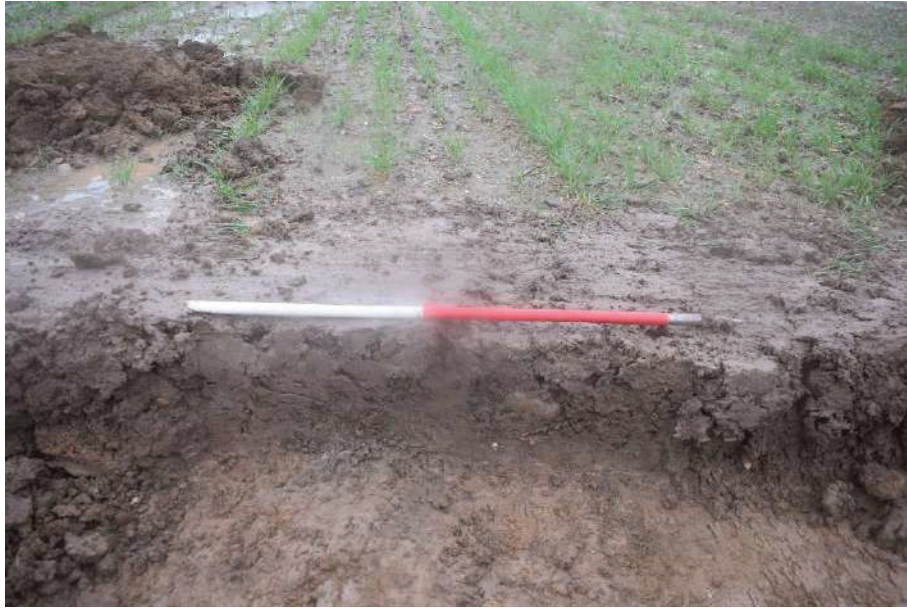
- 4.5.10. The earliest deposit encountered in Trench 34 was a natural sub-stratum formed of yellow-brown sandy clay, with patches of small, rounded pebbles throughout (3402) (Figure 9, Section 3.7). The natural sub-stratum was encountered at heights ranging from 73.45m aOD to 74.09m aOD. This was overlain by a topsoil, 0.30m deep, of firmly compacted mid brown silty clay, with occasional, small to medium sized stones inclusions (3401). The topsoil was encountered at heights ranging from 73.70m aOD to 74.54m aOD.

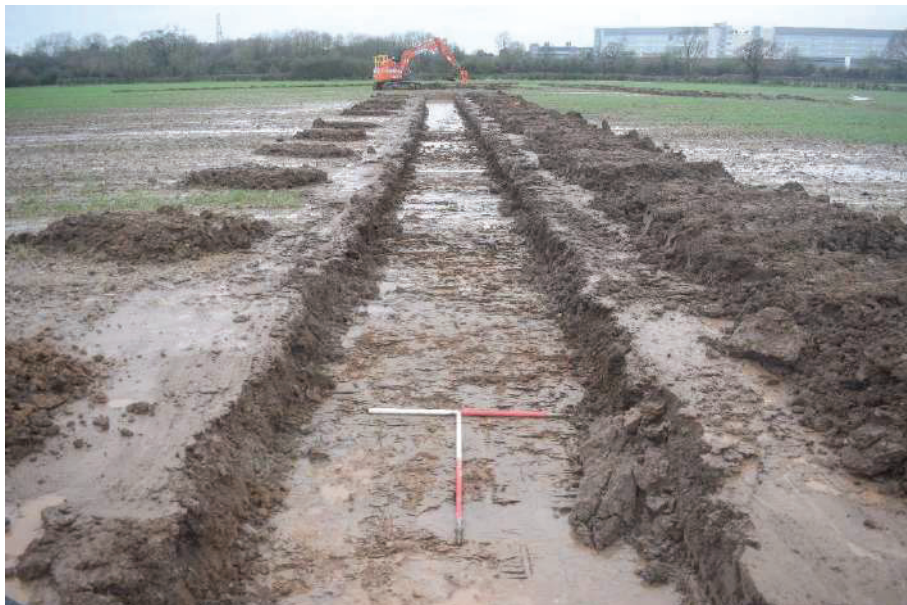
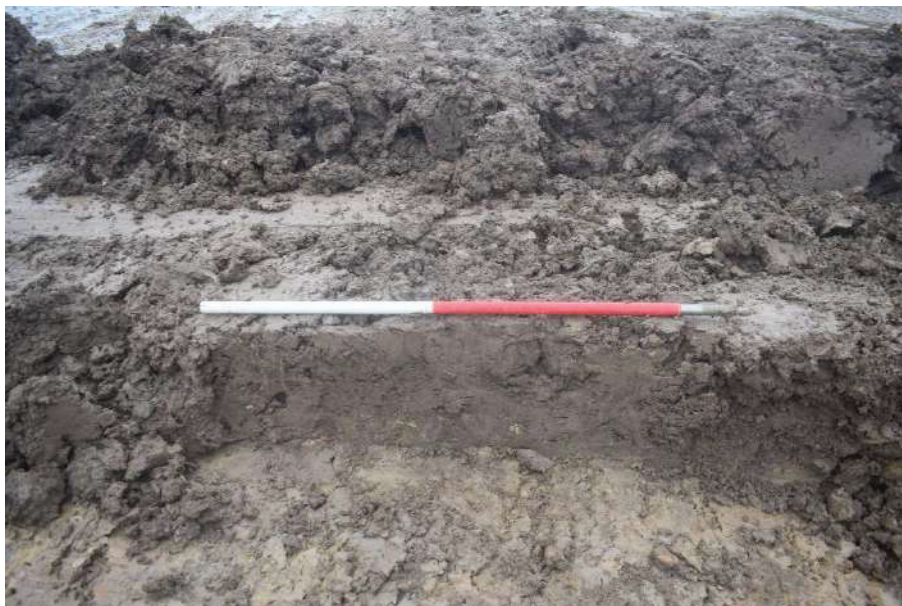
- 4.5.11. The earliest deposit encountered in Trench 35 was a natural sub-stratum formed of yellow-brown sandy clay, with patches of small, rounded pebbles throughout (3502) (Figure 9, Section 3.5). The natural sub-stratum was encountered at heights ranging from 73.39m aOD to 73.69m aOD. This was overlain by a topsoil (3501), 0.28m deep, of firmly compacted mid brown sandy clay, with occasional, small to medium sized stones and rounded pebbles. The topsoil was encountered at heights ranging from 73.76m aOD to 74.28m aOD.

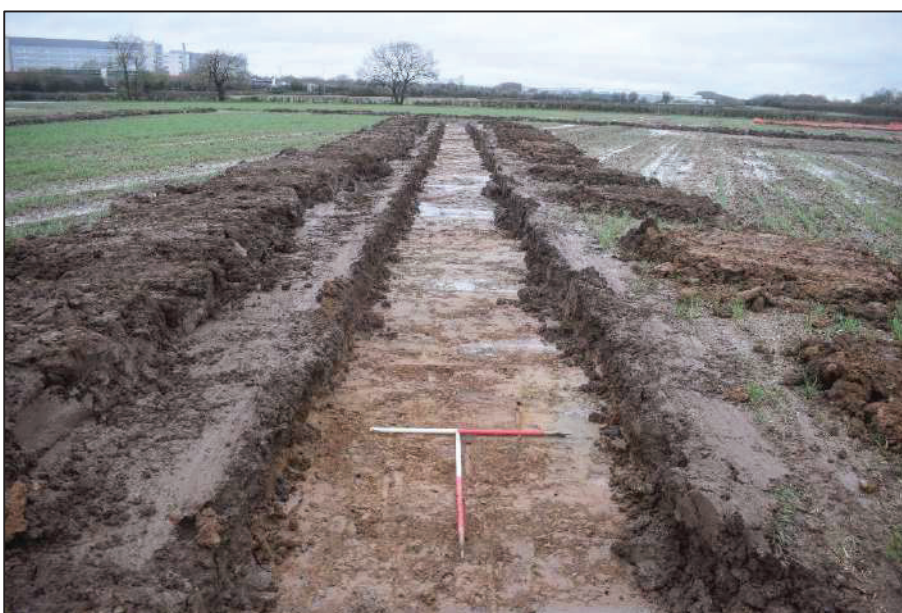
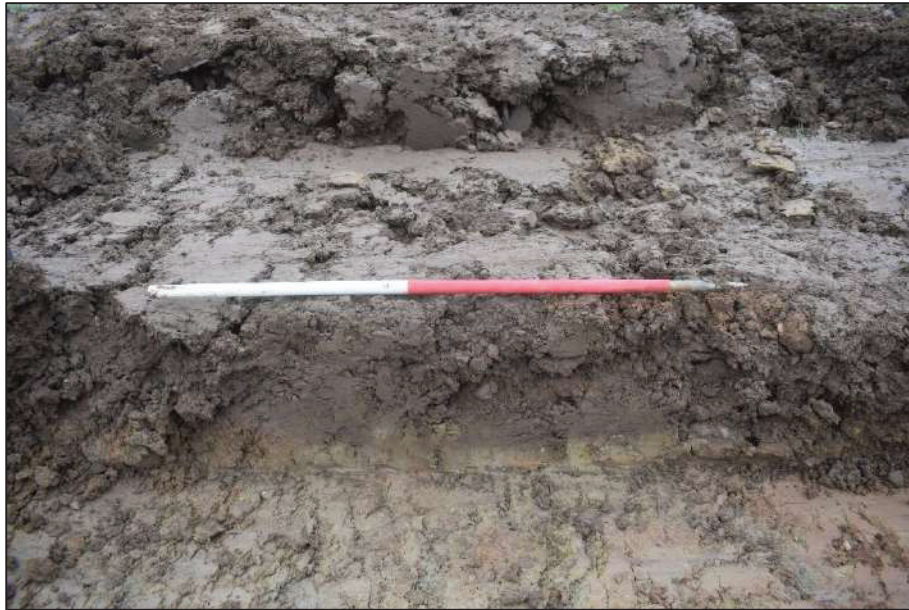
- 4.5.12. The earliest deposit encountered in Trench 36 was a natural sub-stratum formed of yellow-brown sandy clay, with patches of small, rounded pebbles throughout (3602) (Figure 9, Section 3.6). The natural sub-stratum was encountered at heights ranging from 73m aOD to 73.40m aOD. This was overlain by a topsoil (3601), 0.32m deep, of firmly compacted mid brown sandy clay, with occasional, small to medium sized stones. The topsoil was encountered at heights ranging from 73.28m aOD to 73.74m aOD.

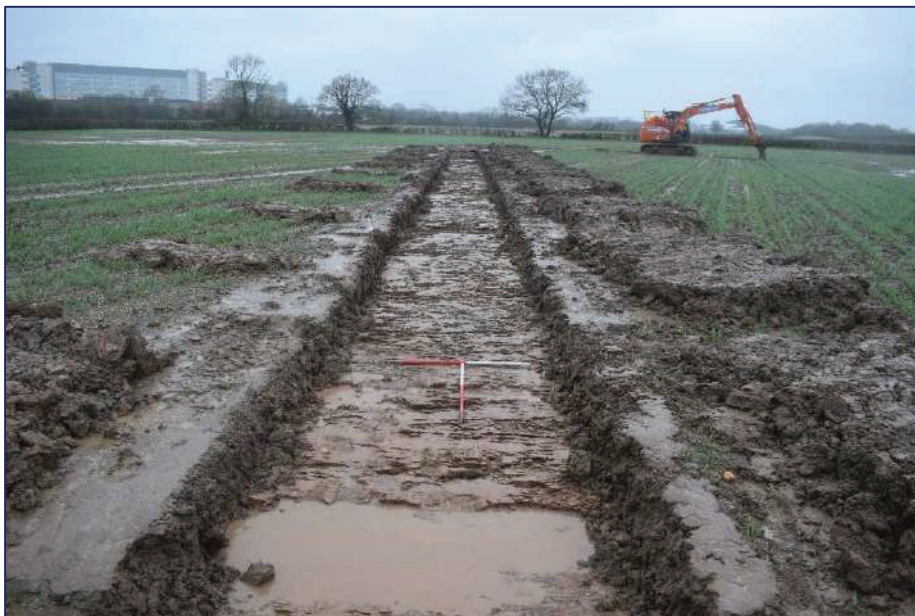
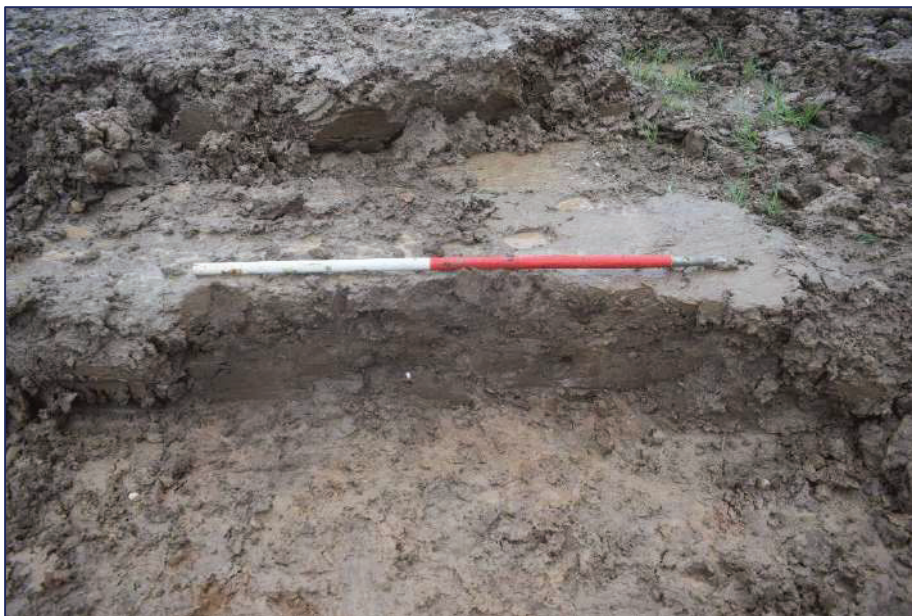
- 4.5.13. The earliest deposit encountered in Trench 37 was a natural sub-stratum formed of yellow-brown sandy, silty clay, with patches of small, rounded pebbles throughout (3702) (Figure 9, Section 3.4). The natural sub-stratum was encountered at heights ranging from 72.71m aOD to 72.90m aOD. This was overlain by a topsoil (3701), 0.25m deep, firmly compacted, of mid brown sandy clay, with frequent small pebbles. The topsoil was encountered at heights ranging from 72.99m aOD to 73.28m aOD.
