# **A46 Coventry Junctions (Walsgrave) Scheme number: TR010066**

### **Appendix 6.4 Archaeological Trial Trenching Survey Report**

# A46 COVENTRY JUNCTIONS UPGRADE (WALSgrave JUNCTION) STAGE 3

## Archaeological Trenching Report

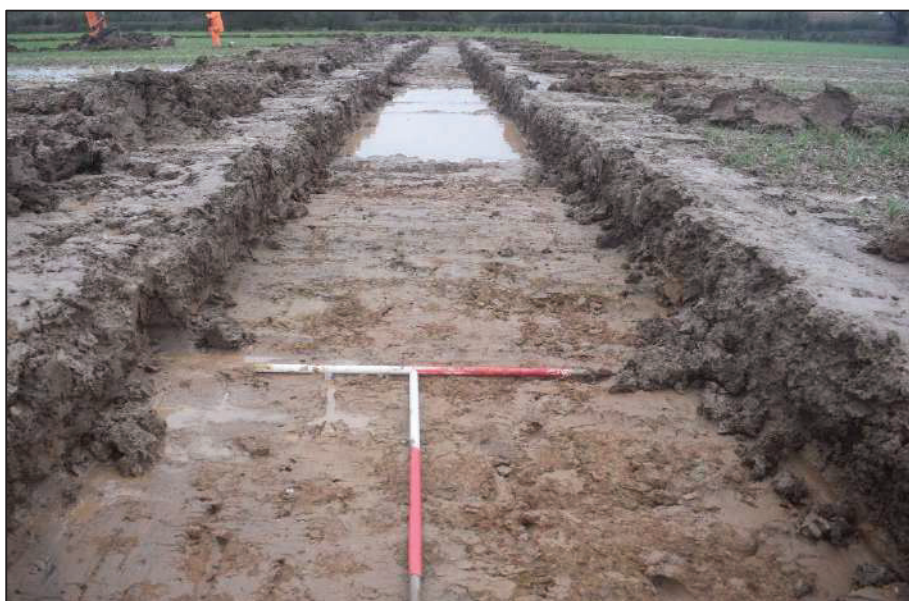
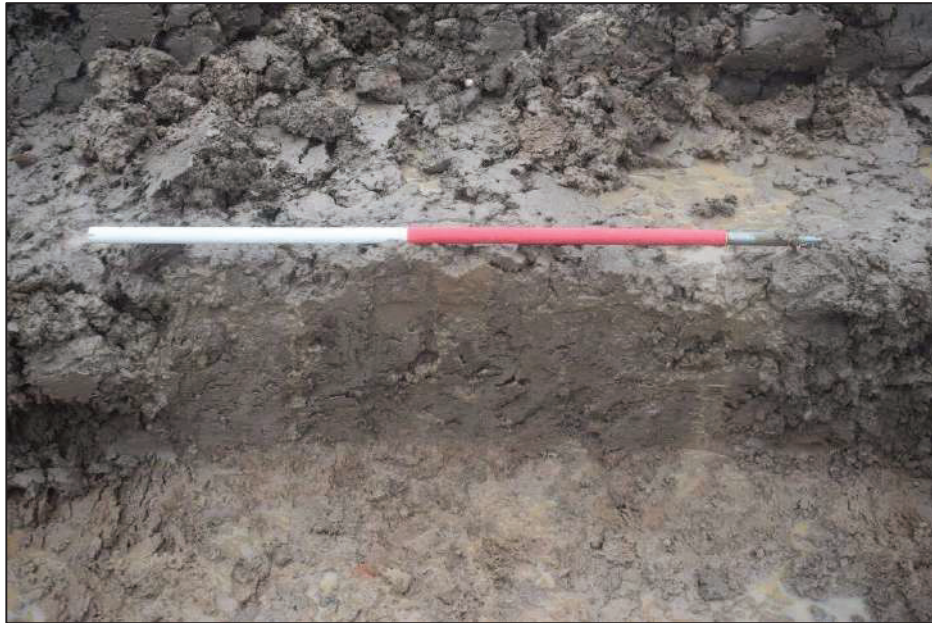
- 4.5.14. The earliest deposit encountered in Trench 38 was a natural sub-stratum formed of yellow-brown sandy, silty clay, with frequent small, rounded pebbles throughout (3802) (Figure 9, Section 3.3). The natural sub-stratum was encountered at heights ranging from 72.80m aOD to 73.40m aOD. This was overlain by a topsoil, 0.30m deep, of firmly compacted mid brown silty clay, with frequent stone inclusions (3801). The topsoil was encountered at heights ranging from 73.07m aOD to 73.77m aOD.

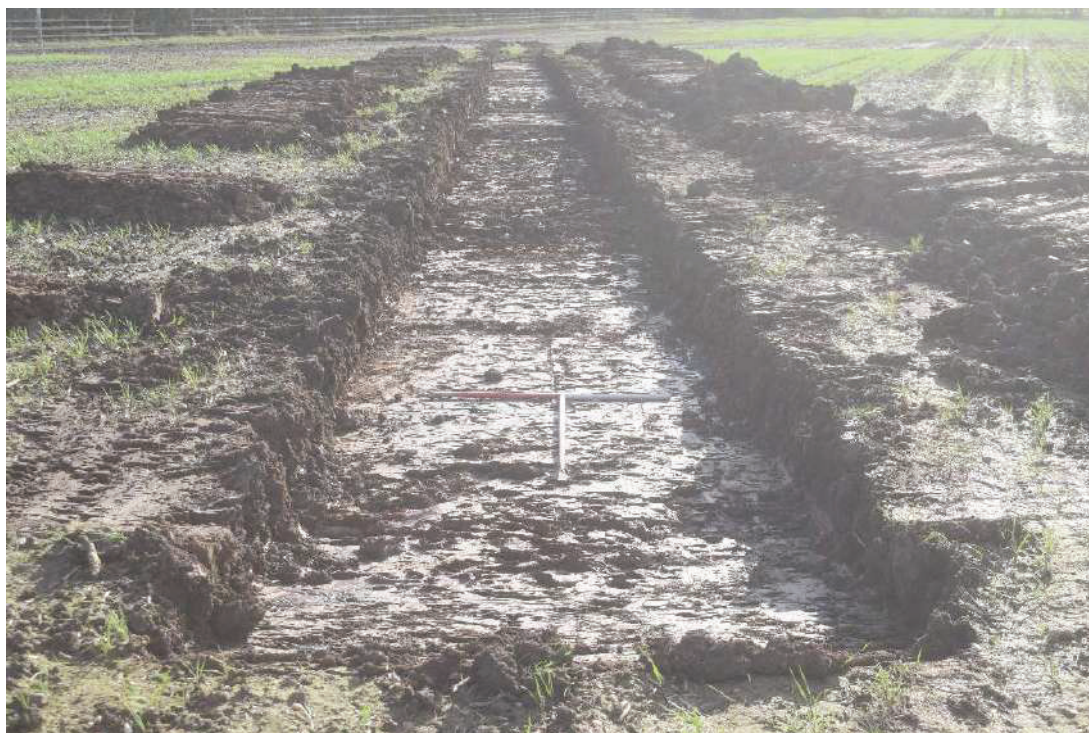
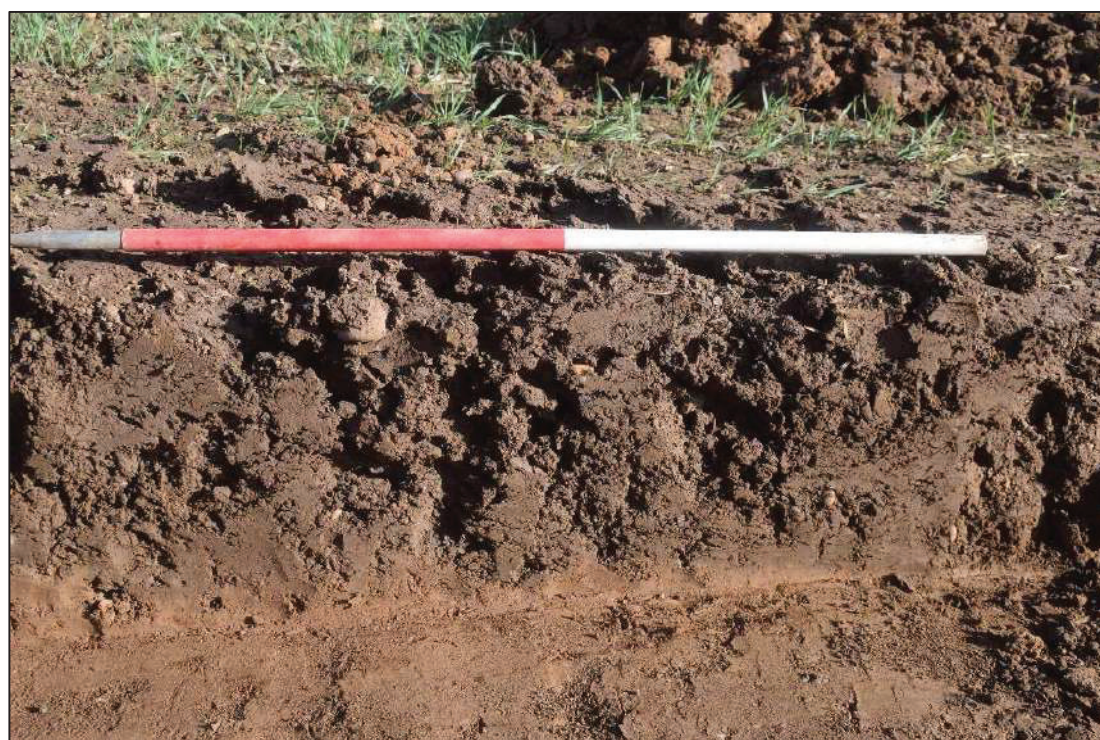
- 4.5.15. The earliest deposit encountered in Trench 39 was a natural sub-stratum formed of a friable but compact, mid reddish-brown clay, with very frequent flecks of manganese and infrequent patches of medium sub-rounded stones and gravels (3903). The natural sub-stratum was encountered at heights ranging from 73.51m aOD to 73.79m aOD. This was overlain by a subsoil, 0.14m deep, of compact mid grey, sandy clayey silt, with frequent flecks of manganese and CBM throughout (3902). This was sealed by a topsoil, 0.16m deep, of mid brown-grey silty clay, with frequent small to medium rounded and sub-rounded stones and CBM (3901). The topsoil was encountered at heights ranging from 74.09m aOD to 74.17m aOD.

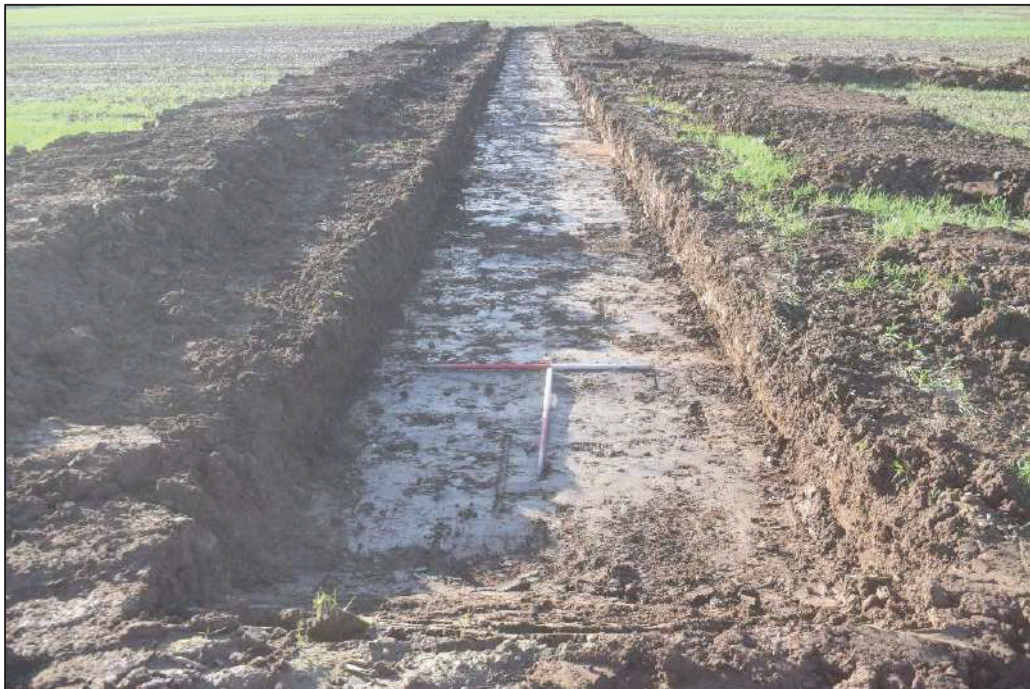
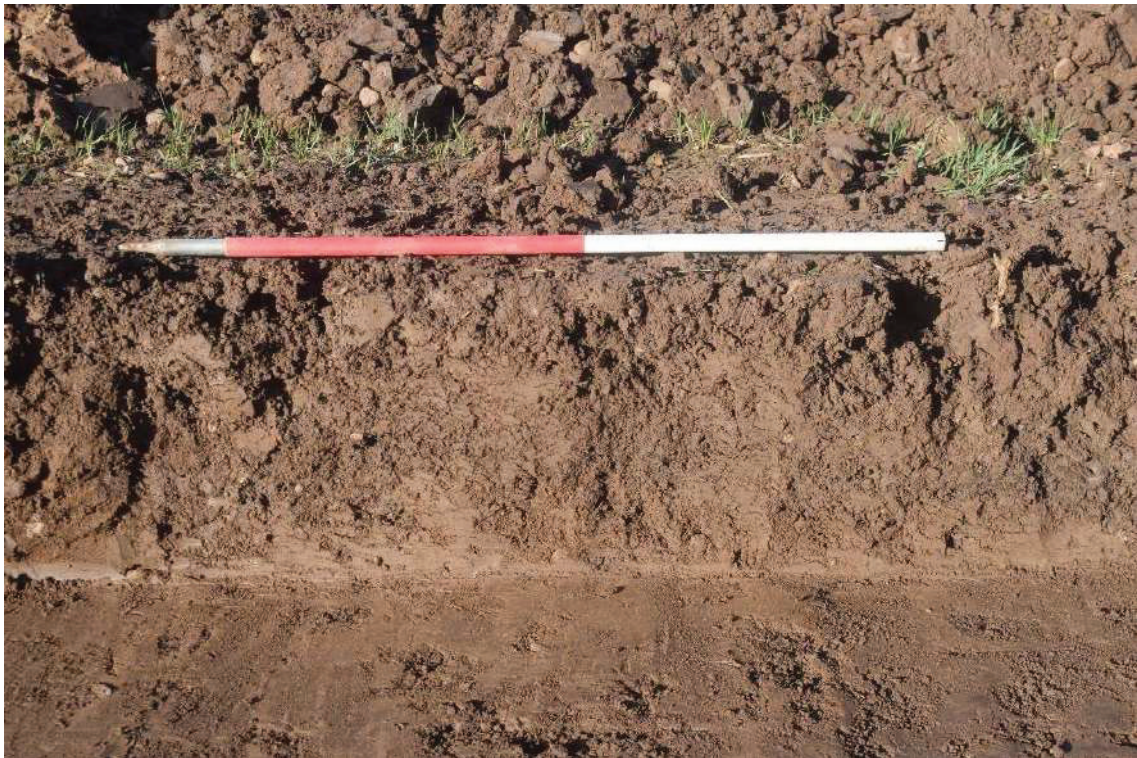
- 4.5.16. The earliest deposit encountered in Trench 40 was a natural sub-stratum formed of a friable but compact, mid yellow-brown clay, with very frequent flecks of manganese and infrequent patches of medium sub-rounded stones and gravels (4003) (Figure 8, Section 2.6). The natural sub-stratum was encountered at heights ranging from 73.22m aOD to 74.26m aOD. This was overlain by a subsoil, 0.14m deep, of compact mid grey, sandy clayey silt, with occasional small, rounded stones (4002). This was sealed by a topsoil, 0.20m deep, of mid brown-grey silty clay, with occasional small to medium rounded and sub-rounded stones and CBM (4001). The topsoil was encountered at heights ranging from 73.46m aOD to 74.73m aOD.

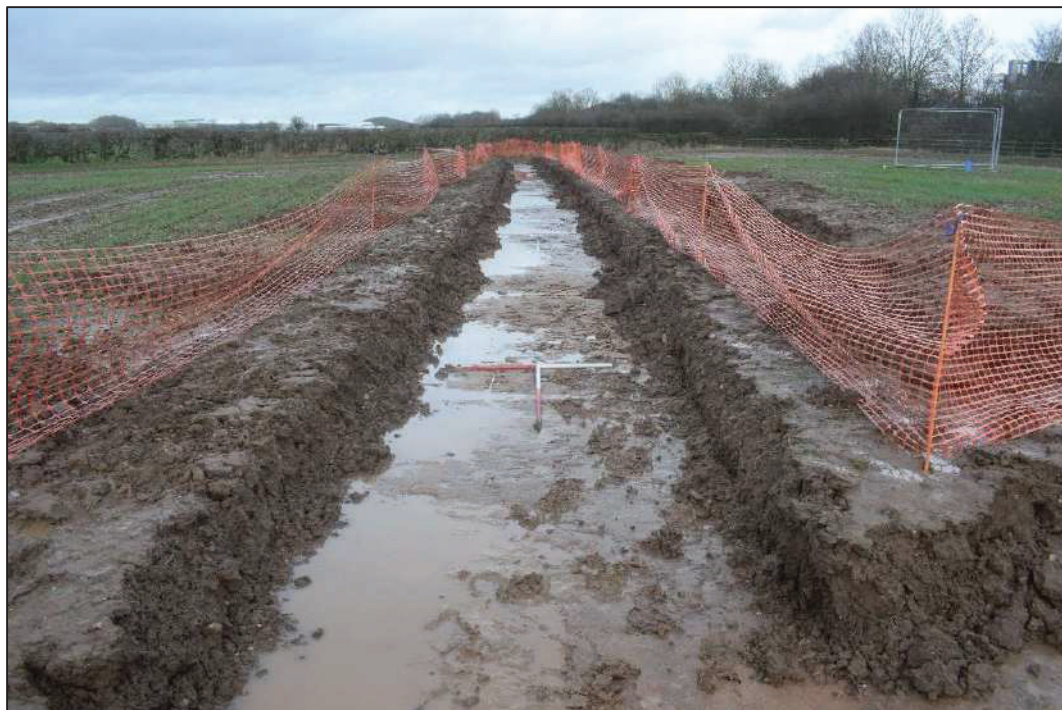
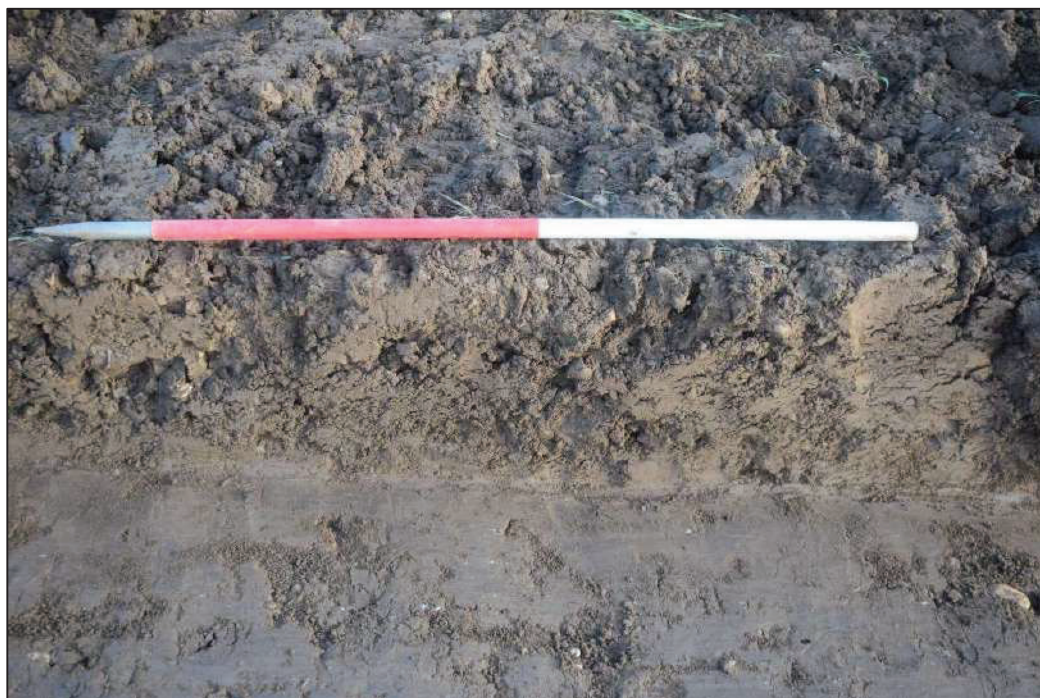
- 4.5.17. The earliest deposit encountered in Trench 41 was a natural sub-stratum formed of a firm, mid yellow-brown clay, with very frequent flecks of manganese and infrequent patches of medium sub-rounded stones (4103) (Figure 9, Section 2.7). The natural sub-stratum was encountered at heights ranging from 73.67m aOD to 73.71m aOD. This was overlain by a subsoil, 0.14m deep, of compact mid grey, sandy clayey silt, with frequent flecks of manganese and CBM throughout (4102). This was sealed by a topsoil, 0.17m deep, of mid brown-grey silty clay, with frequent small to medium rounded and sub-rounded stones and CBM (4101). The topsoil was encountered at heights ranging from 73.94m aOD to 74.11m aOD.

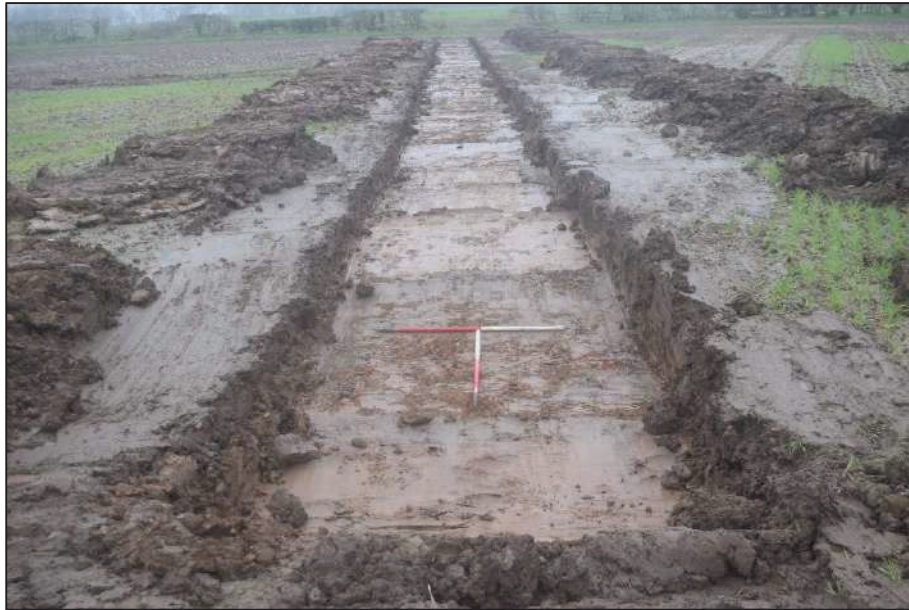
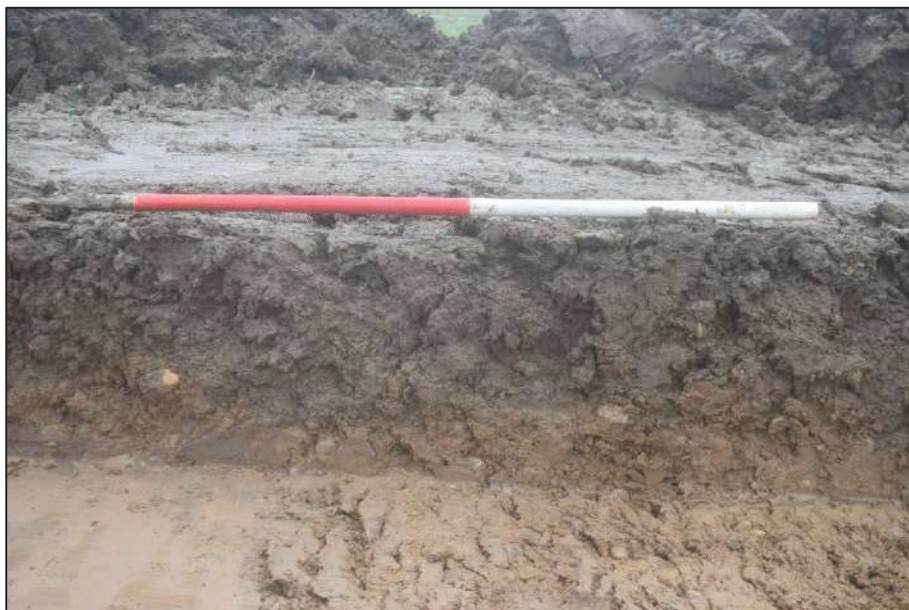
- 4.9.6. The earliest deposit encountered in Trench 61 was a natural sub-stratum formed of stiff mid reddish-brown clay with occasional small to medium sized rounded stones (6102) (Figure 10, Section 3.18). The natural sub-stratum was encountered at heights ranging from 75.11m aOD to 76.49m aOD This was overlain by a topsoil, 0.30m deep, of friable, mid brown-grey silty clay, with occasional small to medium rounded and sub-rounded stones (6101). The topsoil was encountered at heights ranging from 76.23m aOD to 76.77m aOD.

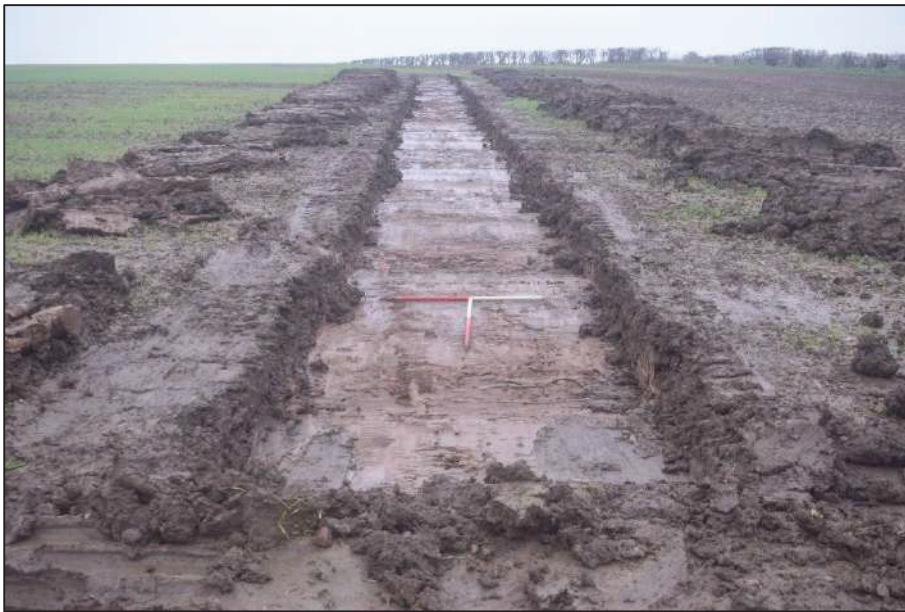
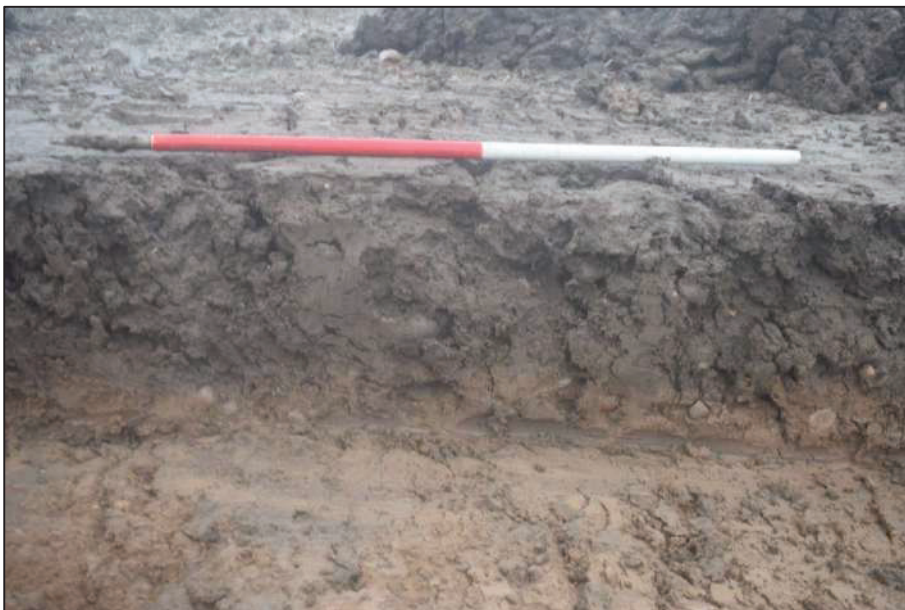
- 4.9.7. The earliest deposit encountered in Trench 62 was a natural sub-stratum formed of stiff mid reddish-brown clay with occasional small to medium sized rounded stones (6202) (Figure 10, Section 3.17). The natural sub-stratum was encountered at heights ranging from 77.08m aOD to 79.37m aOD. This was overlain by a topsoil, 0.32m deep, of friable mid brown-grey silty clay, with occasional small to medium rounded and sub-rounded stones (6201). The topsoil was encountered at heights ranging from 77.37m aOD to 79.74m aOD.

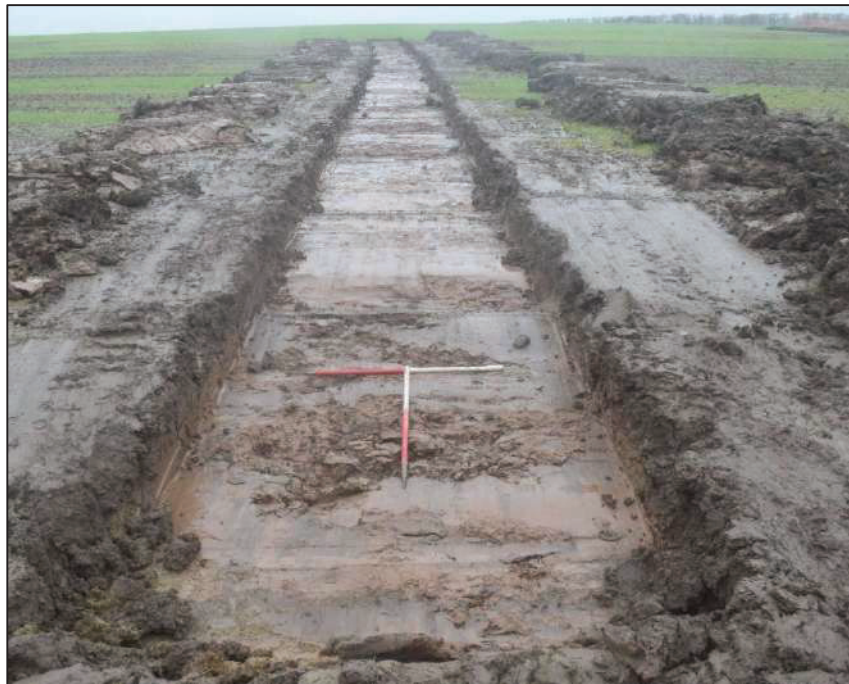
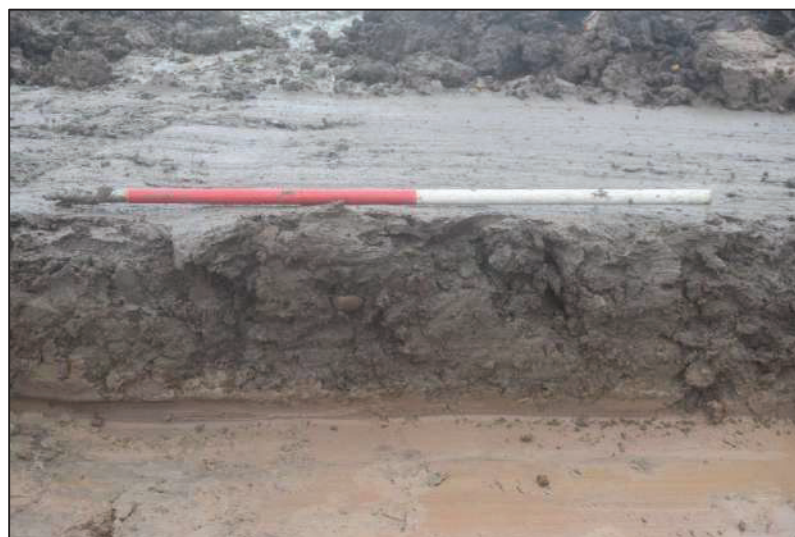
- 4.9.8. The earliest deposit encountered in Trench 63 was a natural sub-stratum formed of stiff mid reddish-brown clay with occasional small to medium sized rounded stones (6302) (Figure 10, Section 3.19). The natural sub-stratum was encountered at heights ranging from 75.94m aOD to 78.31m aOD. This was overlain by a topsoil, 0.30m deep, of friable, mid brown-grey silty clay, with occasional small to medium rounded and sub-rounded stones (6301). The topsoil was encountered at heights ranging from 76.24m aOD to 78.74m aOD.

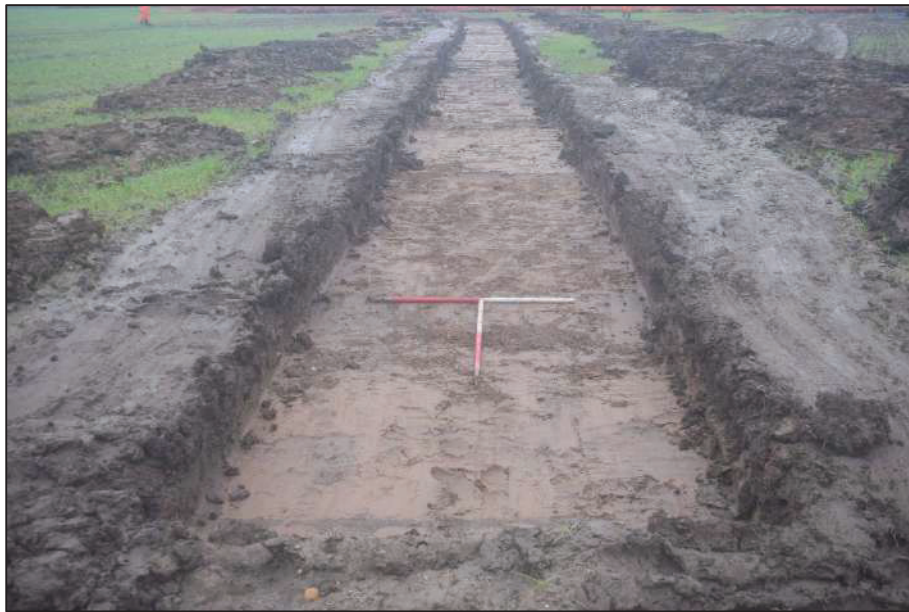
Plate 88: Trench 64 facing south

- 4.9.9. The earliest deposit encountered in Trench 64 was a natural sub-stratum formed of stiff mid reddish-brown clay with occasional small to medium sized rounded stones (6402) (Figure 10, Section 4.3). The natural sub-stratum was encountered at heights ranging from 77.03m aOD to 77.25m aOD. This was overlain by a topsoil, 0.30m deep, of soft, mid brown-grey silty clay, with occasional small to medium rounded and sub-rounded stones (6401). The topsoil was encountered at heights ranging from 77.28m aOD to 77.62m aOD.

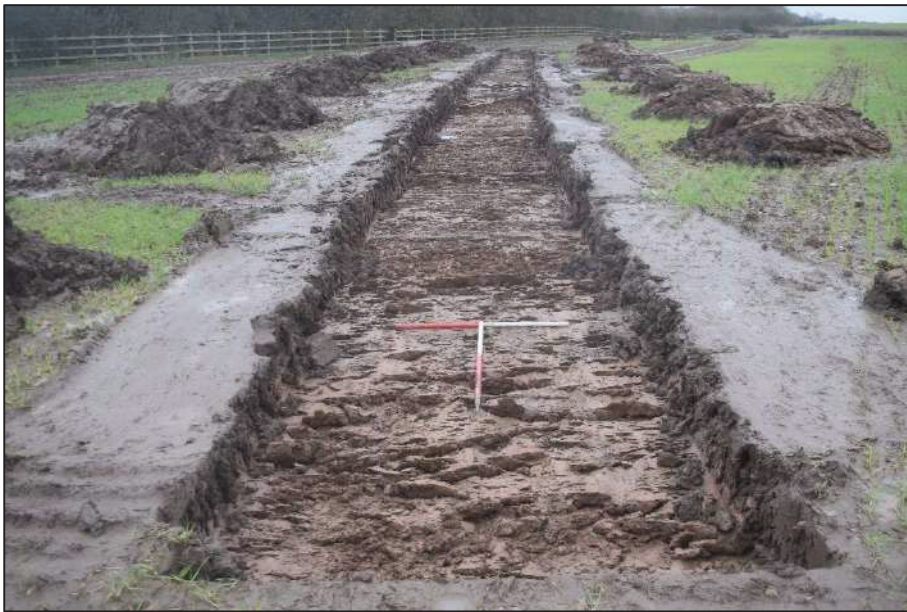
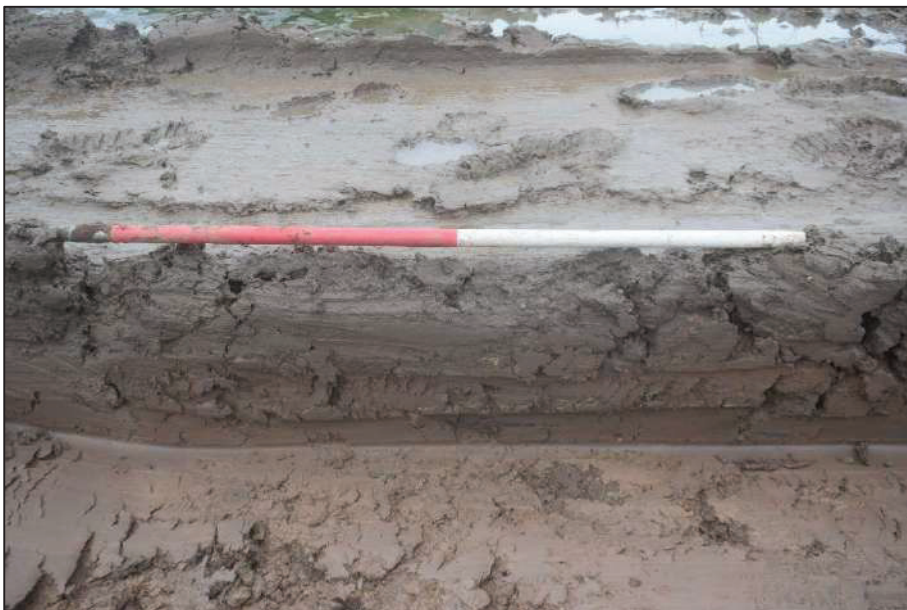
- 4.9.10. The earliest deposit encountered in Trench 65 was a natural sub-stratum formed of firm mid reddish-brown clay with occasional small to medium sized rounded stones (6502) (Figure 10, Section 4.4). The natural sub-stratum was encountered at heights ranging from 76.89m aOD to 77.45m aOD. This was overlain by a topsoil, 0.30m deep, of soft, mid brown-grey silty clay, with occasional small to medium rounded and sub-rounded stones (6501). The topsoil was encountered at heights ranging from 77.28m aOD to 77.76m aOD.

Plate 90: Trench 65 facing south

Plate 91: Trench 65 representative section facing west

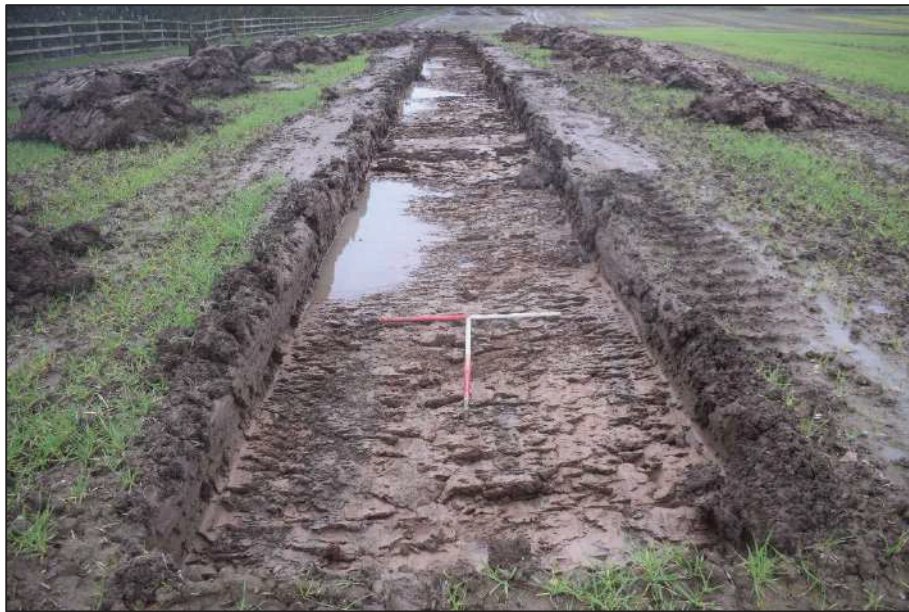
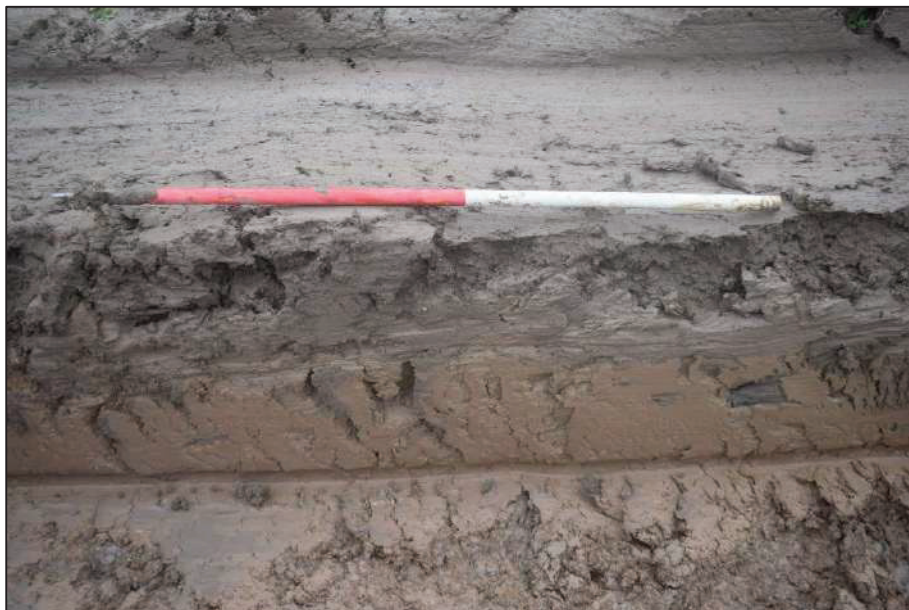
- 4.9.11. The earliest deposit encountered in Trench 66 was a natural sub-stratum formed of firm mid reddish-brown clay with occasional small to medium sized rounded stones (6602) (Figure 10, Section 4.5). The natural sub-stratum was encountered at heights ranging from 76.72m aOD to 77.56m aOD. This was overlain by a topsoil, 0.30m deep, of sticky, mid brown-grey silty clay, with occasional small to medium rounded and sub-rounded stones (6601). Topsoil was encountered at heights ranging from 77.30m aOD to 77.93m aOD.

Plate 92: Trench 66 facing south

Plate 93: Trench 66 representative section facing west

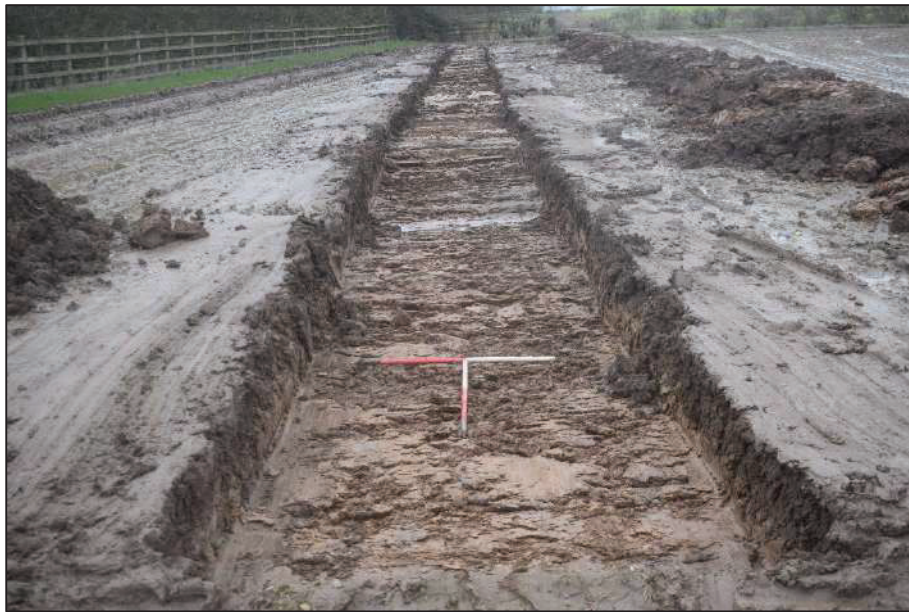
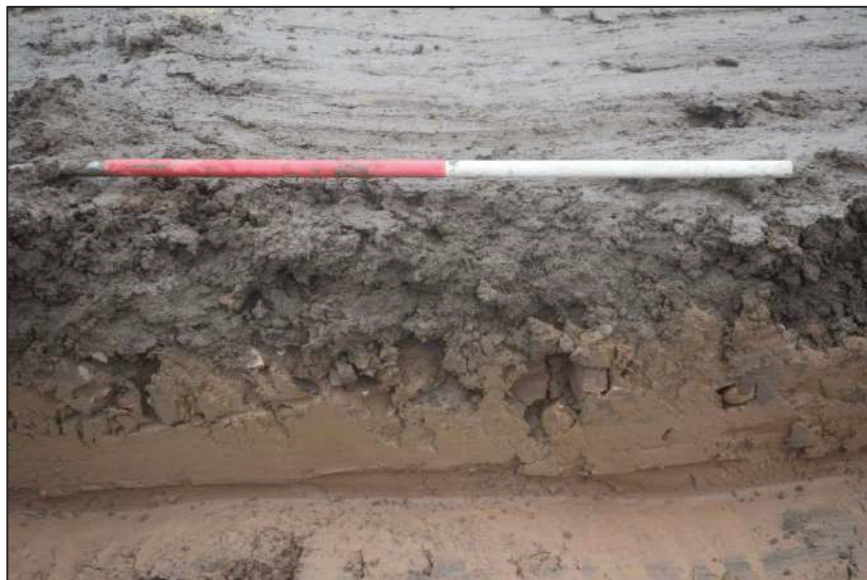
- 4.9.12. The earliest deposit encountered in Trench 67 was a natural sub-stratum formed of firm mid reddish-brown clay with occasional small to medium sized rounded stones (6702) (Figure 10, Section 4.6). The natural sub-stratum was encountered at heights ranging from 76.83m aOD to 77.28m aOD. This was overlain by a topsoil, 0.30m deep, of firmly compacted mid brown silty clay, with occasional, small to medium sized stones and rounded pebbles (6701). The topsoil was encountered at heights ranging from 77.21m aOD to 77.64m aOD.

Plate 94: Trench 67 facing south

Plate 95: Trench 67 representative section facing east

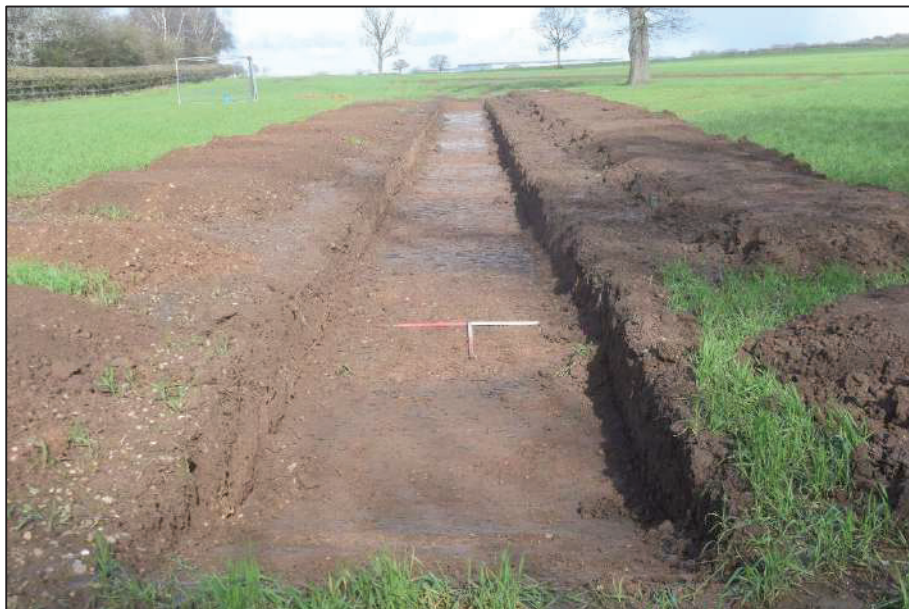
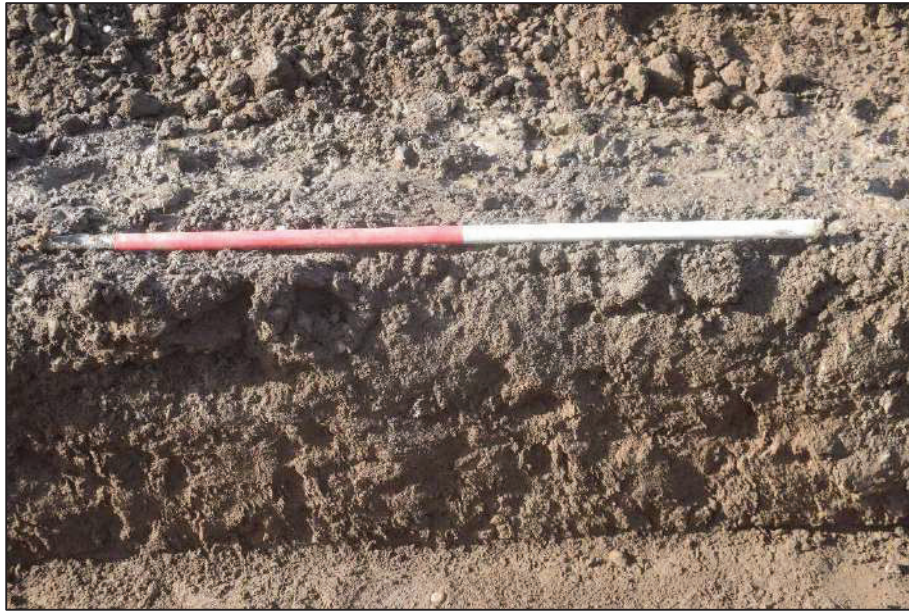
- 4.10.5. The earliest deposit encountered in Trench 42 was a natural sub-stratum formed of friable mid brownish-grey silty sand (4203) (Figure 10, Section 4.7). The natural sub-stratum was encountered at heights ranging from 76.00m aOD to 76.70m aOD. This was overlain by a subsoil, 0.30m deep, of friable mid brownish-grey sandy silt, with occasional, small, rounded stones (4202). This was sealed by a topsoil, a friable mid brownish-grey, silty clay with frequent medium sized rounded and sub-angular stones (4201). The topsoil was encountered at heights ranging from 76.43m aOD to 77.07m aOD.

Plate 96: Trench 42 facing east

Plate 97: Trench 42 representative section facing north

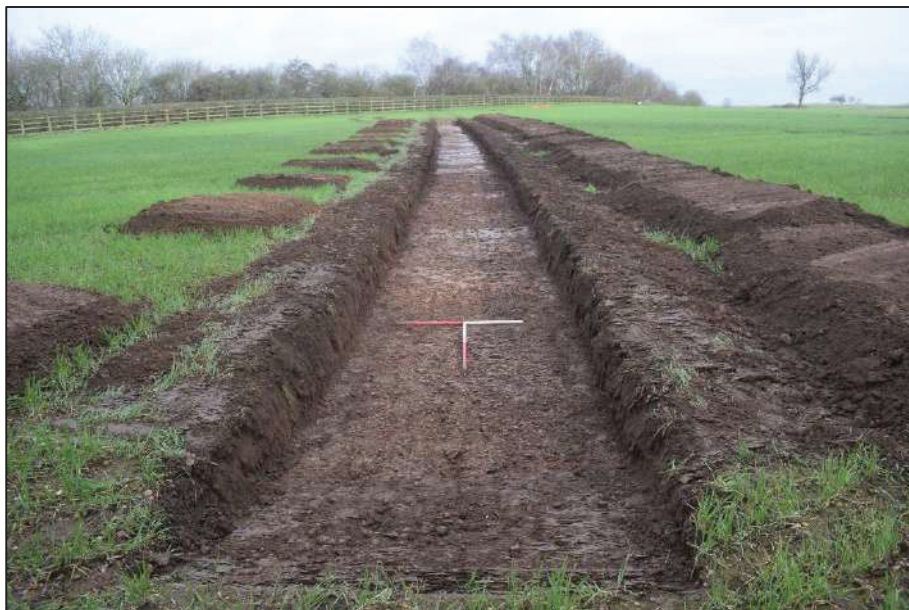
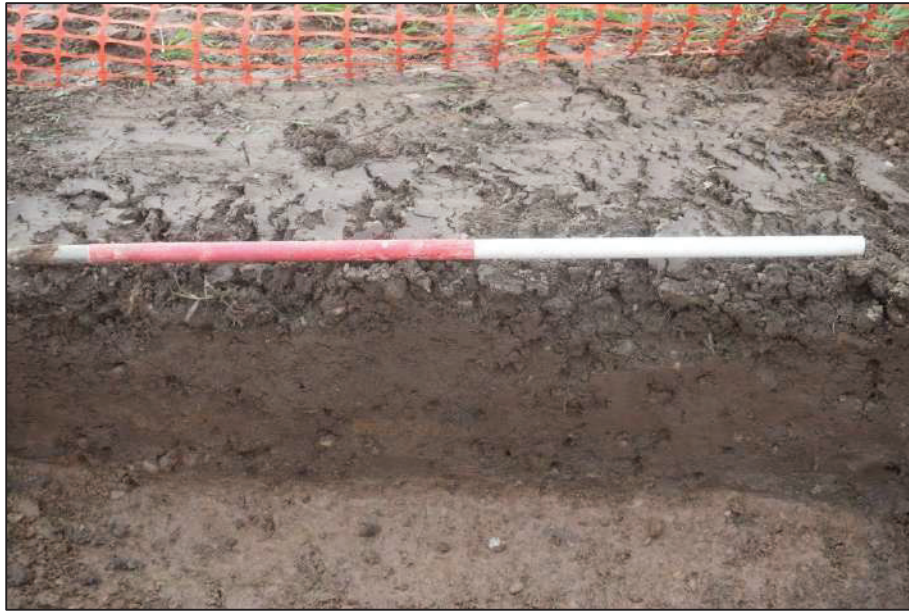
- 4.10.6. The earliest deposit encountered in Trench 43 was a natural sub-stratum formed of friable mid yellowish-brown silty sand (4302) (Figure 9, Section 2.12). The natural sub-stratum was encountered at heights ranging from 76.50m aOD to 77.49m aOD. This was overlain by a topsoil, 0.34m deep, of firm but friable mid brownish-grey sandy silty clay, with occasional, small, rounded stones (4301). The topsoil was encountered at heights ranging from 76.85m aOD to 77.93m aOD.

Plate 98: Trench 43 facing north

Plate 99: Trench 43 representative section facing east

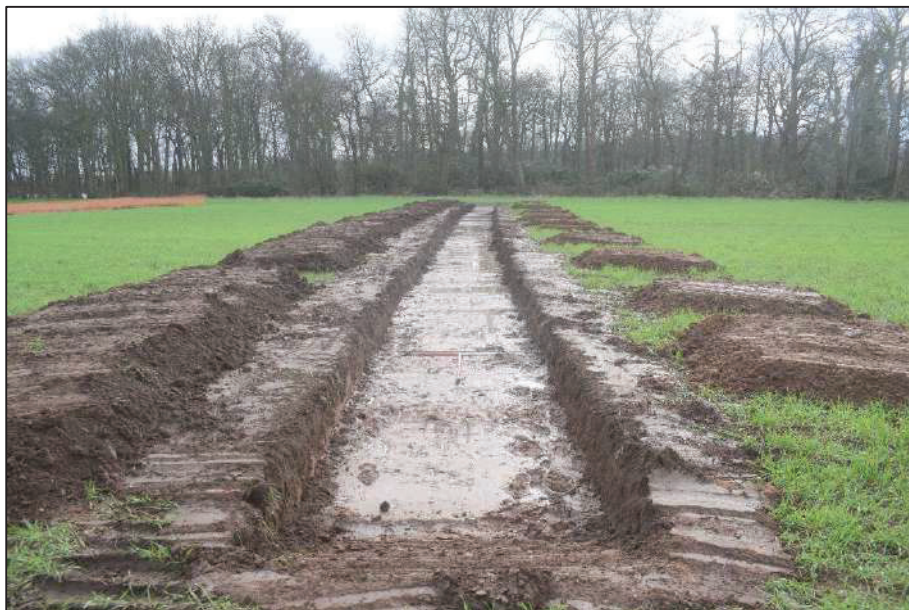
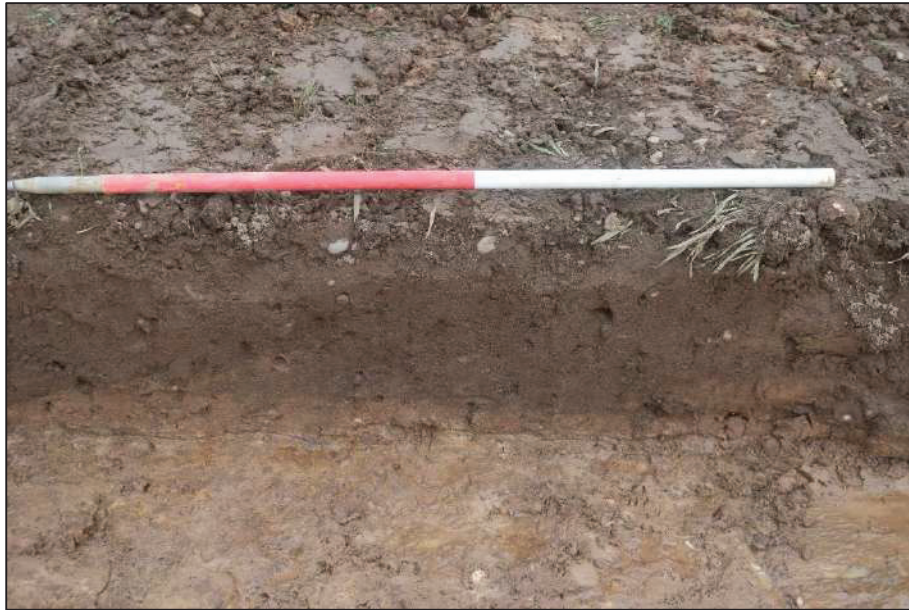
- 4.10.7. The earliest deposit encountered in Trench 44 was a natural sub-stratum formed of firm mid yellowish-brown, very silty, clayey sand, with occasional flecks of ironstone and small rounded stones (4402) (Figure 9, Section 2.13). The natural sub-stratum was encountered at heights ranging from 77.14m aOD to 77.73m aOD. This was overlain by a topsoil, 0.33m deep, of friable mid brownish-grey sandy, silty clay, with occasional, small, rounded stones (4401). The topsoil was encountered at heights ranging from 77.52m aOD to 78.16m aOD.

Plate 100: Trench 44 facing south-east

Plate 101: Trench 44 representative section facing east

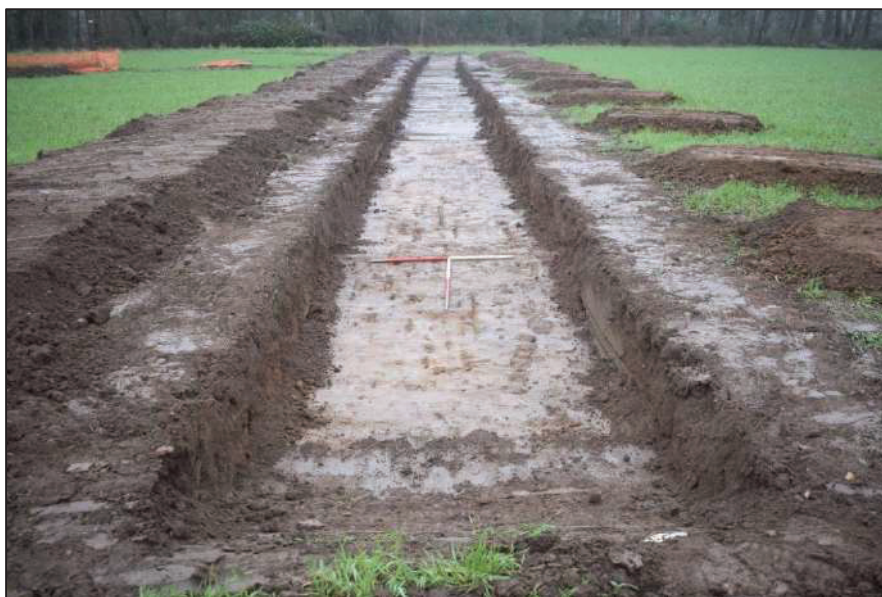
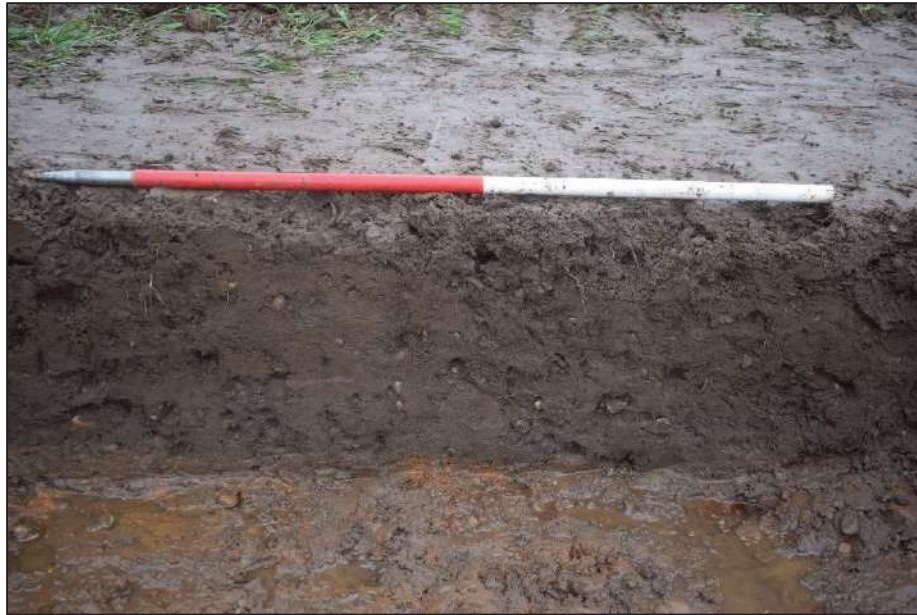
- 4.10.8. The earliest deposit encountered in Trench 45 was a natural sub-stratum formed of mottled reddish-brown silty clay with grey silty gavel patches throughout and medium sized, sub-rounded and rounded stones (4502) (Figure 8, Section 1.20). The natural sub-stratum was encountered at heights ranging from 77.24m aOD to 77.83m aOD. This was overlain by a topsoil, 0.36m deep, of very friable dark grey-brown sandy silt, with occasional, small to medium sized rounded stones (4501). The topsoil was encountered at heights ranging from 77.54m aOD to 78.14m aOD.

Plate 102: Trench 45 facing north

Plate 103: Trench 45 representative section facing east

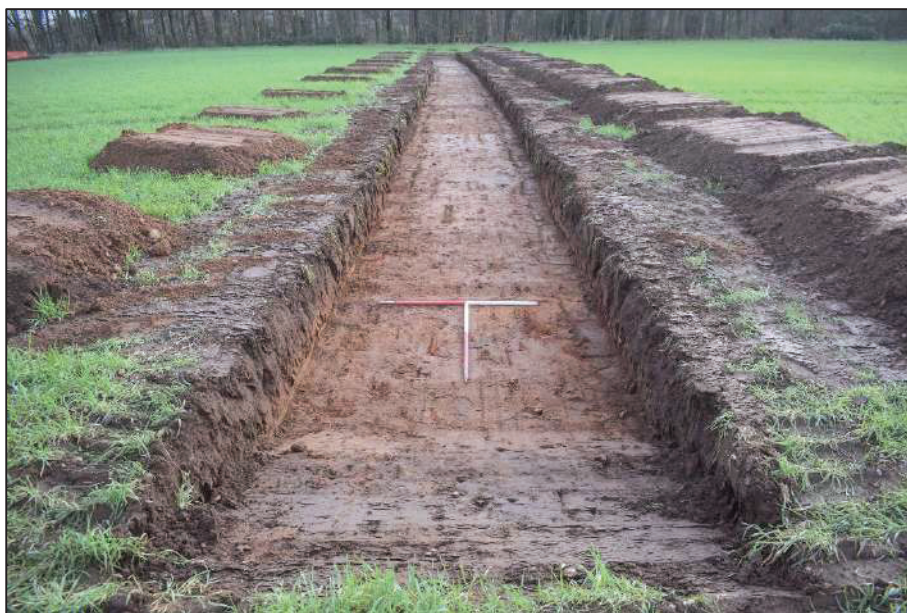
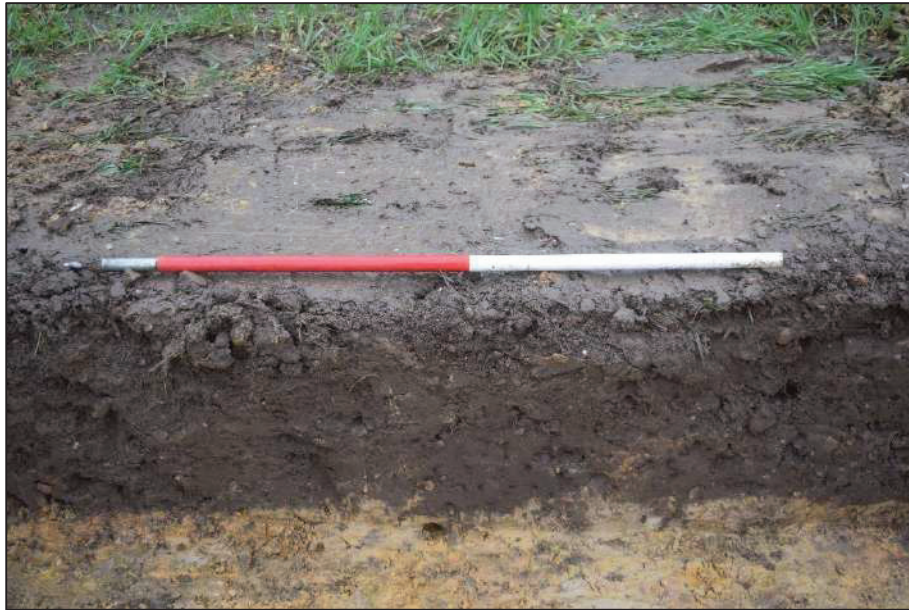
- 4.10.9. The earliest deposit encountered in Trench 46 was a natural sub-stratum formed of soft, friable mid brown, yellow clayey sand, with mottled brown, grey patches (4602) (Figure 8, Section 1.19). The natural sub-stratum was encountered at heights ranging from 77.35m aOD to 77.40m aOD. This was overlain by a topsoil, 0.32m deep, of firmly compacted dark grey-brown very sandy silt, with occasional, small to medium sized rounded stones (4601). The topsoil was encountered at heights ranging from 77.3m aOD to 77.87m aOD.

Plate 104: Trench 46 facing west

Plate 105: Trench 46 representative section facing north

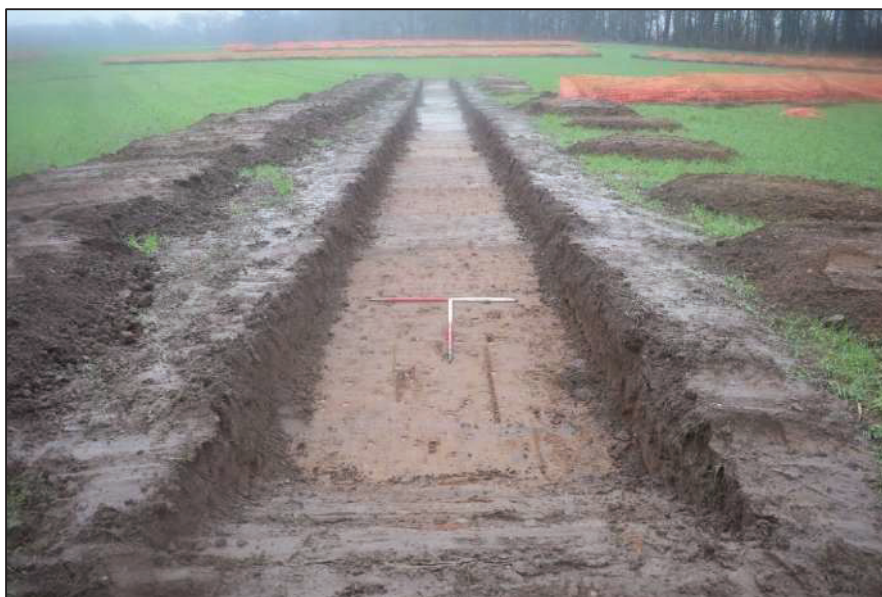
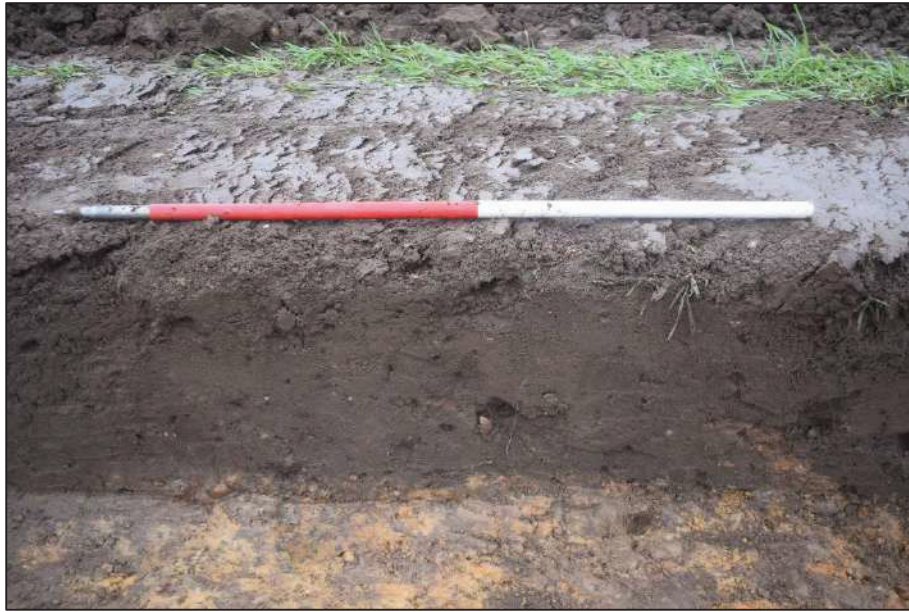
- 4.10.10. The earliest deposit encountered in Trench 47 was a natural sub-stratum formed of mottled mid-yellow/ reddish-brown sandy silt, with frequent rooting throughout, and frequent small to medium sized rounded stones (4702) (Figure 8, Section 2.2). The natural sub-stratum was encountered at heights ranging from 77.55m aOD to 78.19m aOD. This was overlain by a topsoil, 0.30m deep, of very friable dark grey, brown, very sandy silt, with occasional, small sized stones throughout (4701). The topsoil was encountered at heights ranging from 77.97m aOD to 78.59m aOD.

Plate 106: Trench 47 facing north

Plate 107: Trench 47 representative section facing east
