# **A46 Coventry Junctions (Walsgrave) Scheme number: TR010066**

### **Appendix 6.4 Archaeological Trial Trenching Survey Report**

# A46 COVENTRY JUNCTIONS UPGRADE (WALSgrave JUNCTION) STAGE 3

## Archaeological Trenching Report

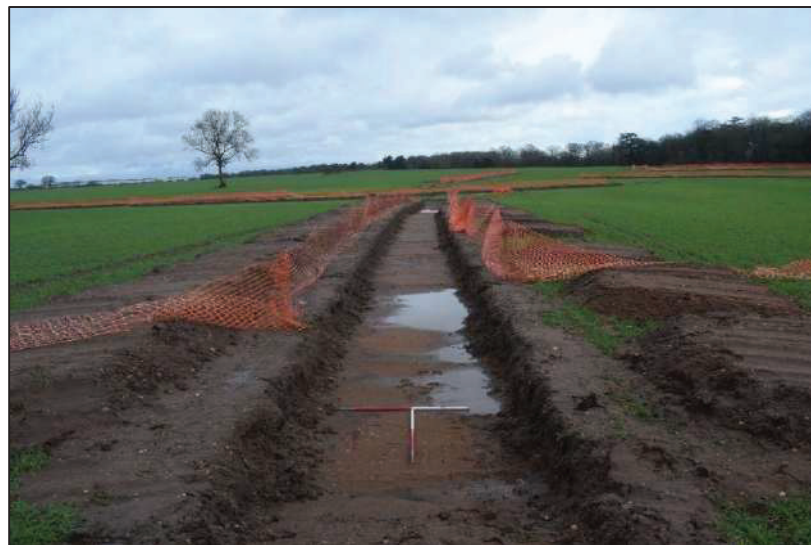
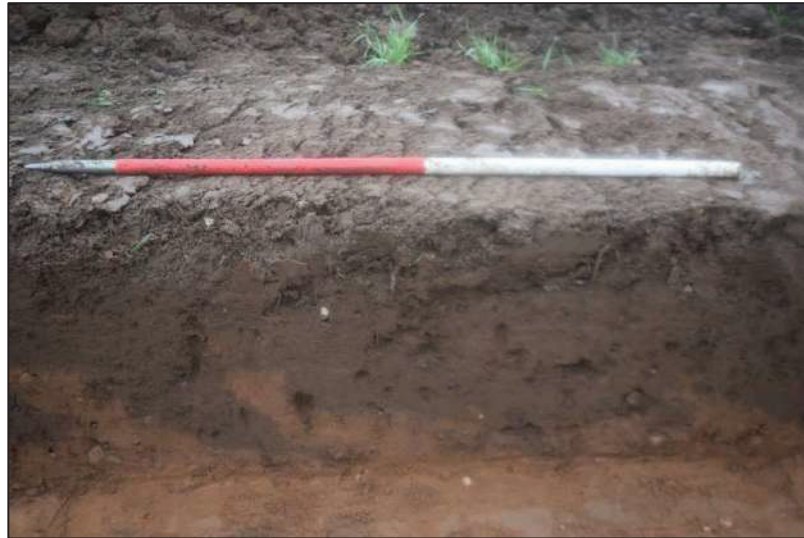
- 4.10.11. The earliest deposit encountered in Trench 48 was a natural sub-stratum formed of a soft but compacted mid-yellow mottled with grey-brown rooting patches, silty sand (4802) (Figure 8, Section 2.4). The natural sub-stratum was encountered at heights ranging from 77.73m aOD to 78.38m aOD. This was overlain by a topsoil, 0.34m deep, of firmly compacted mid brown silty clay, with occasional, small to medium sized stones and rounded pebbles (4801). The topsoil was encountered at heights ranging from 78.17m aOD to 78.76m aOD.

Plate 108: Trench 48 facing east

Plate 109: Trench 48 representative section facing south

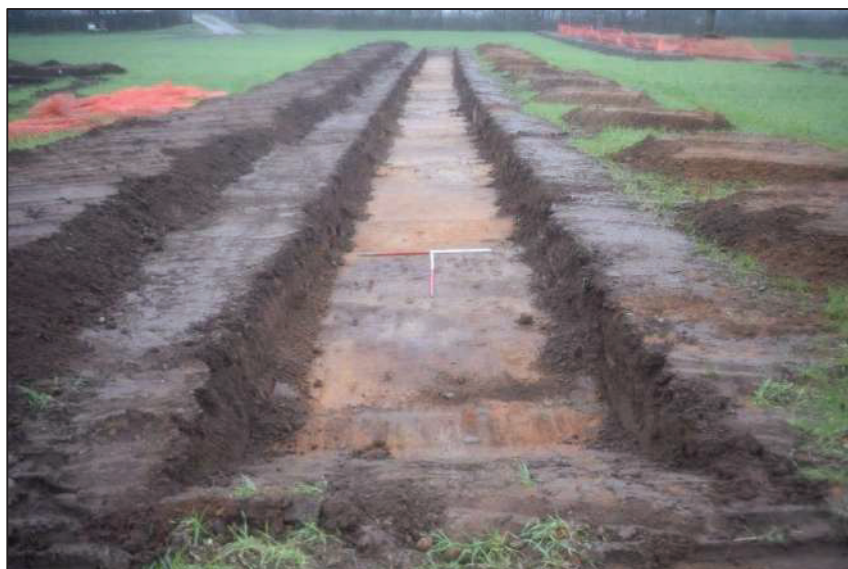
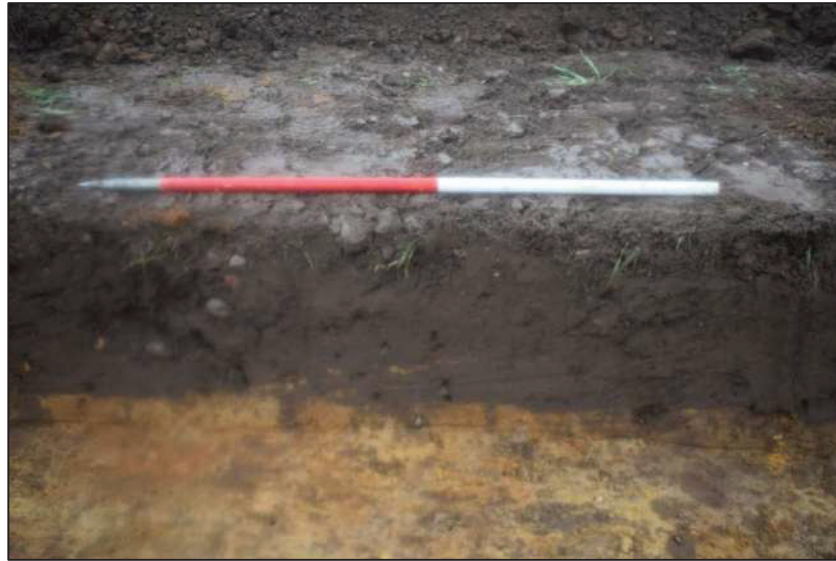
- 4.10.12. The earliest deposit encountered in Trench 49 was a natural sub-stratum formed of compact mid greyish-brown silty sand, with frequent small to medium sized, sub-rounded stones throughout (4902) (Figure 8, Section 2.3). The natural sub-stratum was encountered at heights ranging from 77.91m aOD to 78.05m aOD. This was overlain by a topsoil, 0.36m deep, of firmly compacted dark grey-brown sandy silt, with occasional, small, rounded stones (4901). The topsoil was encountered at heights ranging from 78.56m aOD to 78.43m aOD.

Plate 110: Trench 49 facing north-west

Plate 111: Trench 49 representative section facing south-west

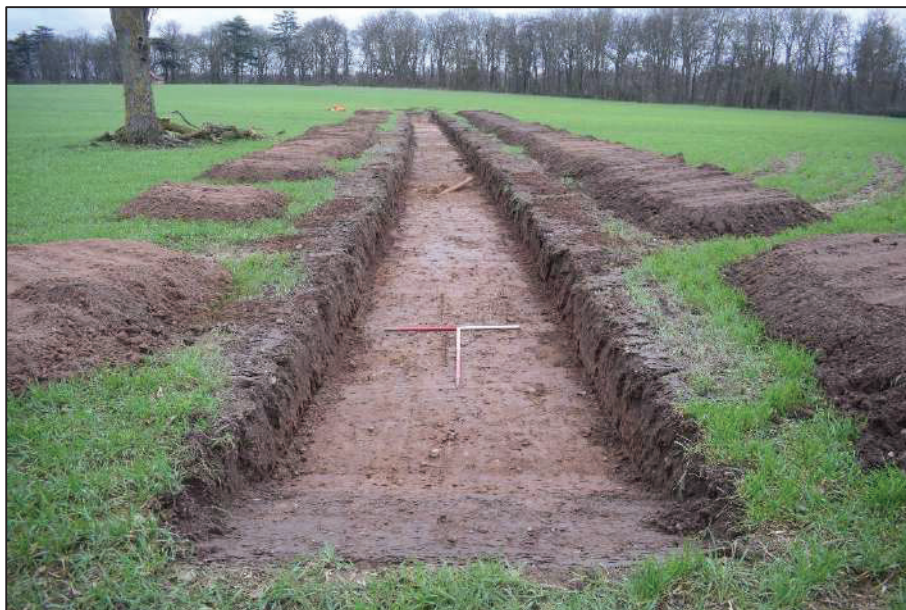
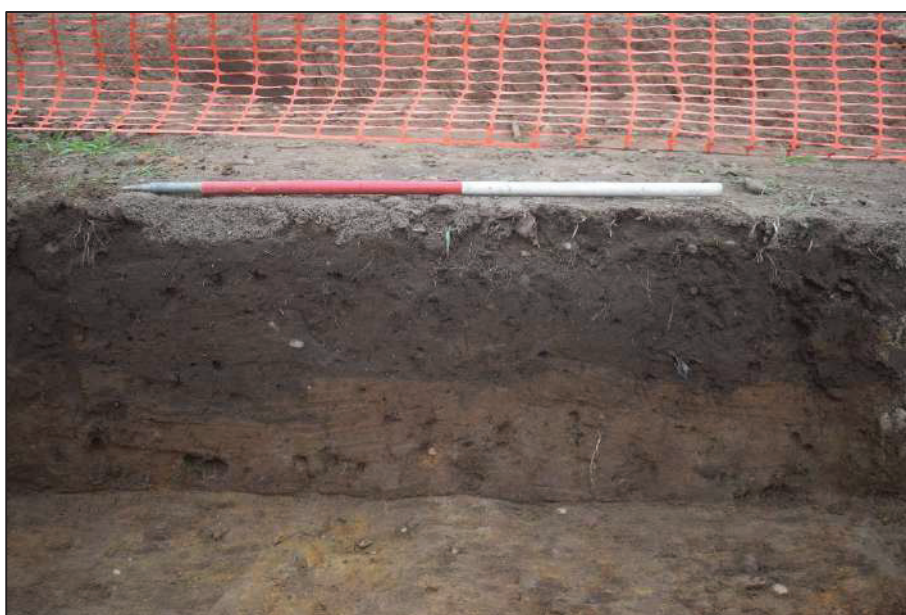
- 4.10.13. The earliest deposit encountered in Trench 50 was a natural sub-stratum formed of loose, silty fine sand, mottled mid grey and dark yellow, with occasional medium sized sub-rounded stones (5002) (Figure 8, Section 1.13). The natural sub-stratum was encountered at heights ranging from 77.72m aOD to 78.56m aOD. This was overlain by a topsoil, 0.33m deep, loose, mid greyish-brown, very sandy silt, heavily rooted, with occasional, small to medium sized rounded stones and modern plastic (5001). The topsoil was encountered at heights ranging from 78.32m aOD to 78.65m aOD. The topsoil and part of the natural sub-stratum had been disturbed with a deposit of modern debris, including bricks, a plastic pipe, and a broken beer bottle, therefore the natural was investigated to a deeper depth to ensure the correct level was reached.

Plate 112: Trench 50 facing south-east

Plate 113: Trench 50 representative section facing south-west

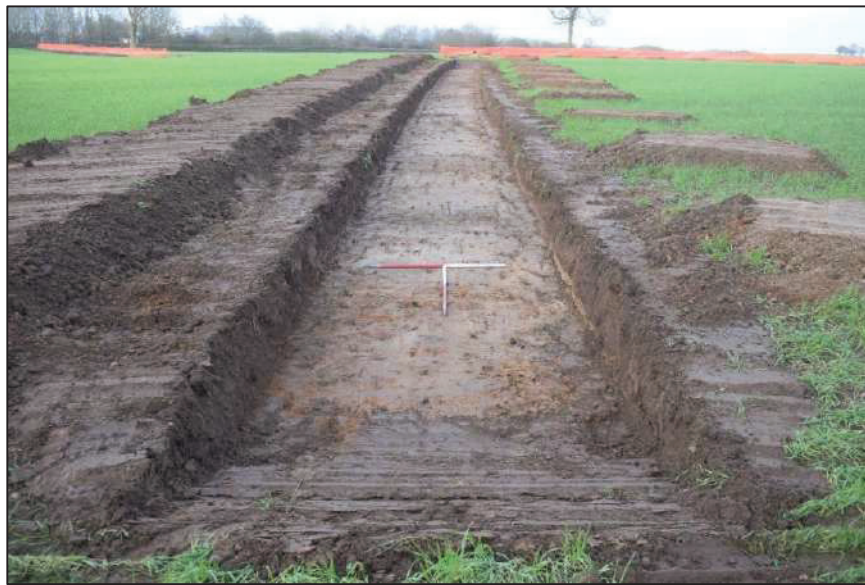
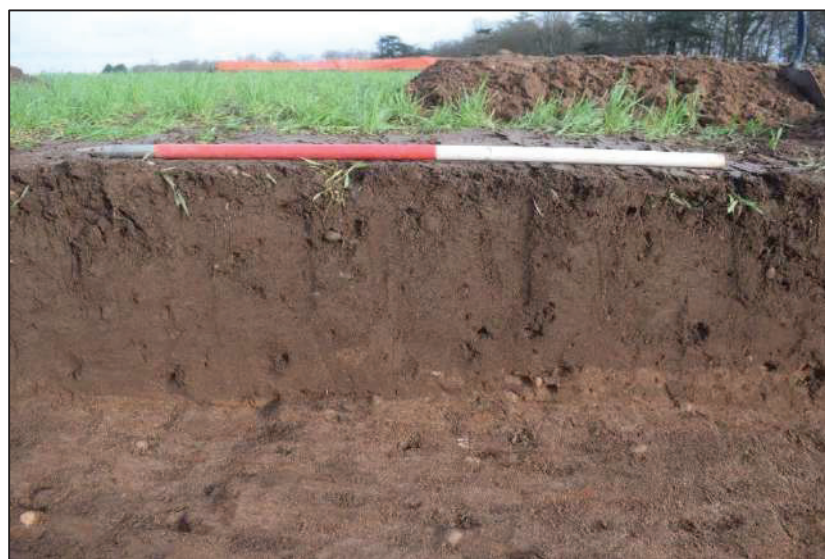
4.10.14. The earliest deposit encountered in Trench 51 was a natural sub-stratum formed of soft, mid brown-grey silty sand, with mottled reddish brown occurring at the northern end of the trench, with frequent sub-rounded small to medium sized stones throughout (5102) (Figure 8, Section 2.1). The natural sub-stratum was encountered at heights ranging from 78.42m aOD to 77.65m aOD. This was overlain by a topsoil, 0.32m deep, of friable dark grey-brown sandy silt, with occasional, small to medium sized rounded stones (5101). The topsoil was encountered at heights ranging from 78.92m aOD to 78.31m aOD.

Plate 114: Trench 51 facing north

Plate 115: Trench 51 representative section facing west

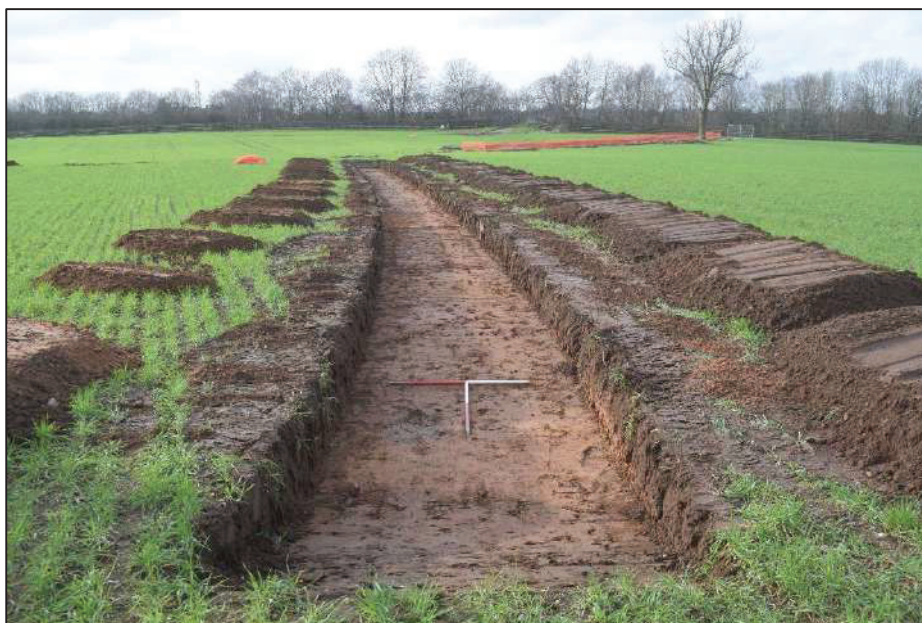
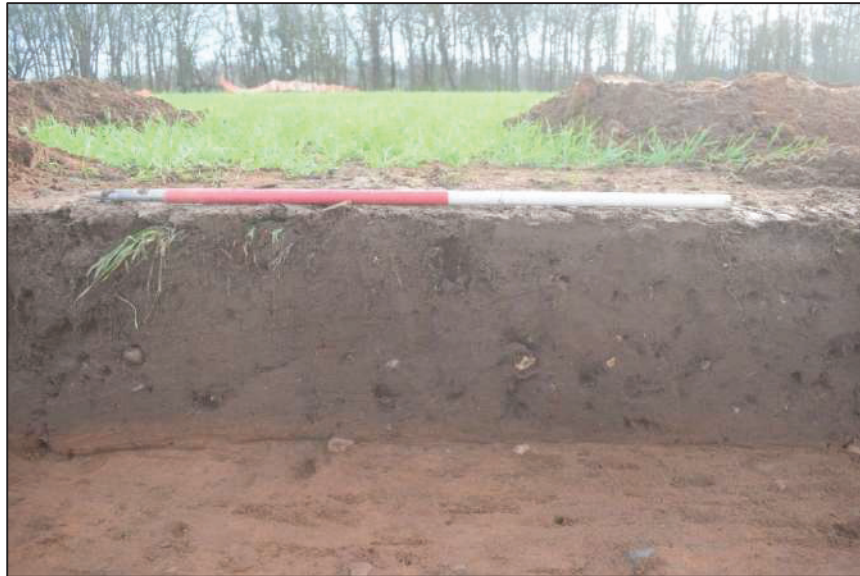
- 4.10.15. The earliest deposit encountered in Trench 52 was a natural sub-stratum formed of soft mid yellow-brown silty sand, with patches of small, rounded pebbles throughout (5202) (Figure 8, Section 1.18). The natural sub-stratum was encountered at heights ranging from 78.47m aOD to 79.23m aOD. This was overlain by a topsoil, 0.36m deep, of friable dark brown silty sand, with occasional, small sized rounded stones (5201). The topsoil was encountered at heights ranging from 78.69m aOD to 79.77m aOD.

Plate 116: Trench 52 representative section facing east

Plate 117: Trench 52 representative section facing south

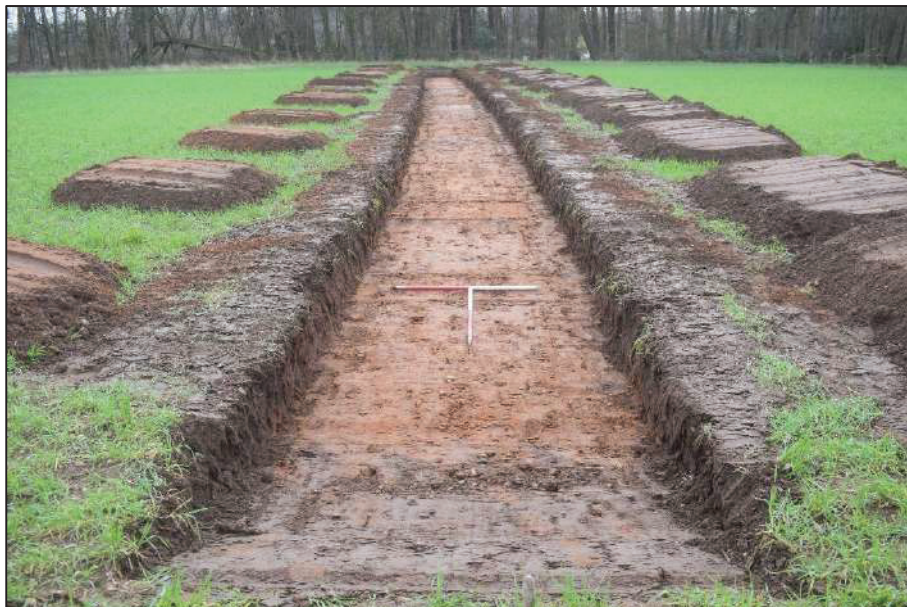
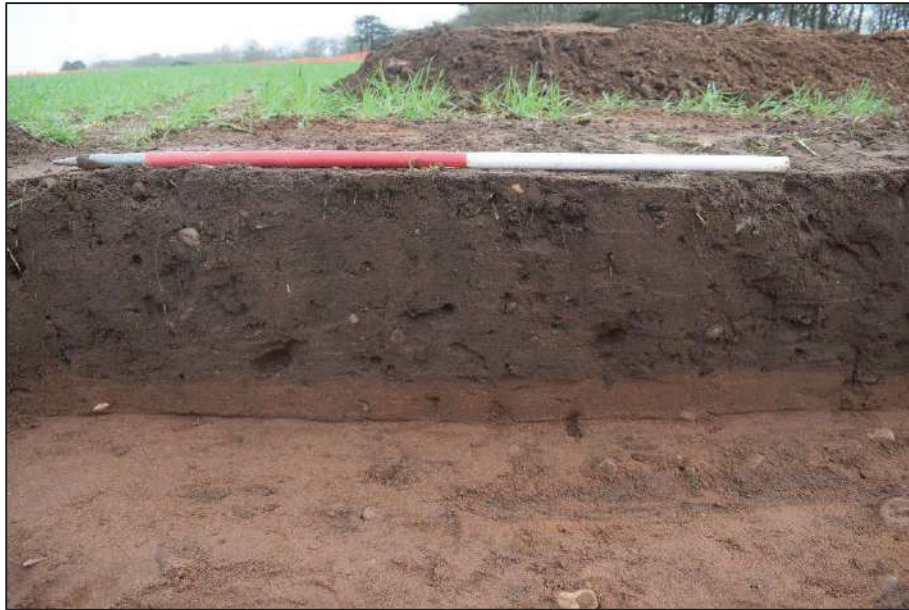
- 4.10.16. The earliest deposit encountered in Trench 53 was a natural sub-stratum formed of soft, mid yellow-brown silty sand, with occasional small to medium sized, rounded stones throughout (5302) (Figure 8, Section 1.17). The natural sub-stratum was encountered at heights ranging from 78.49m aOD to 79m aOD. This was overlain by a topsoil, 0.30m deep, of friable dark grey-brown sandy silt, with occasional, small to medium sized rounded stones (5301). The topsoil was encountered at heights ranging from 78.95m aOD to 79.45m aOD.

Plate 118: Trench 53 facing south

Plate 119: Trench 53 representative section facing east

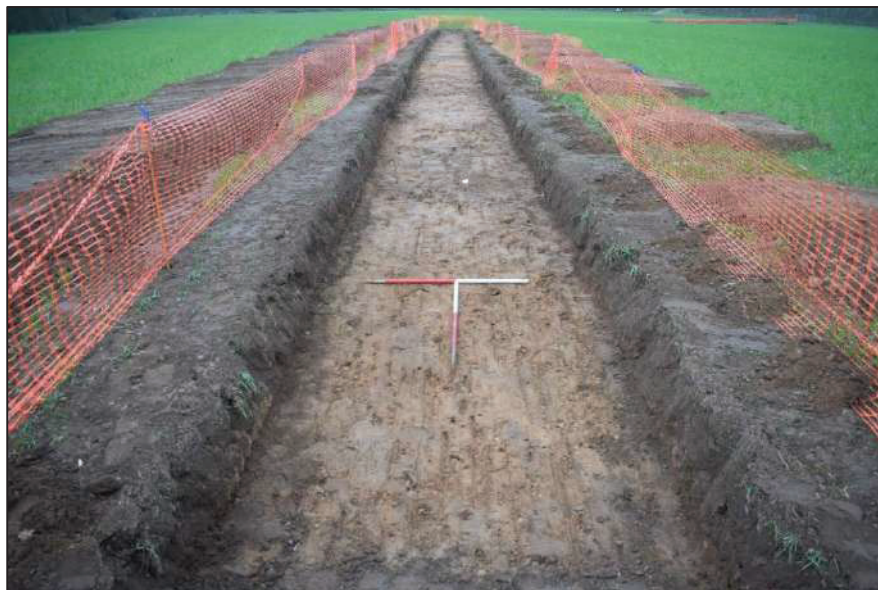
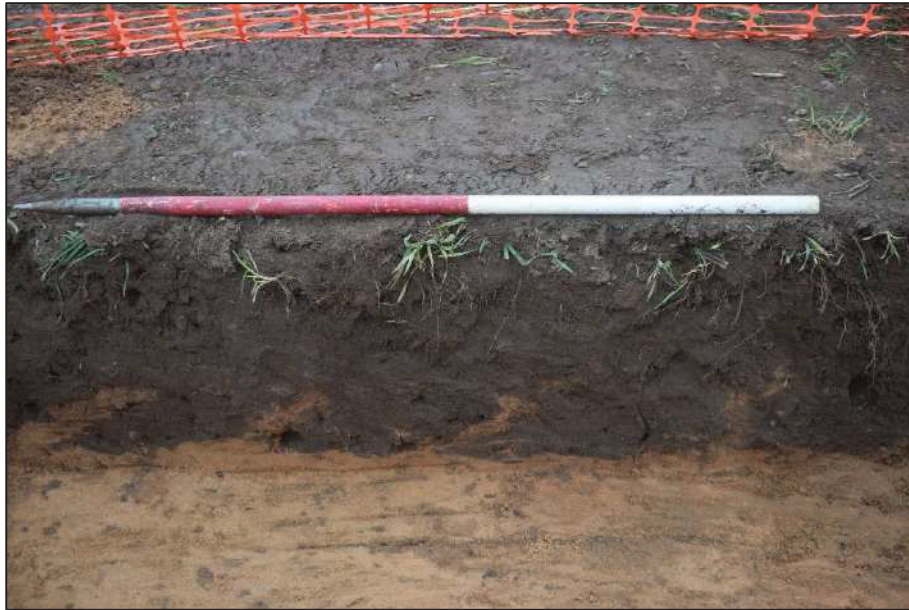
4.10.17. The earliest deposit encountered in Trench 54 was a natural sub-stratum formed of soft mid-yellow brown sandy silt, with very infrequent, sub-rounded, small to medium sized stones throughout (5402) (Figure 8, Section 1.14). The natural sub-stratum was encountered at heights ranging from 79.31m aOD to 79.54m aOD. This was overlain by a topsoil, 0.32m deep, of dark grey-brown sandy silt, with frequent, small to medium sized sub-rounded stones (5401). The topsoil was encountered at heights ranging from 79.73m aOD to 80.06m aOD.

Plate 120: Trench 54 facing east

Plate 121: Trench 54 representative section facing north

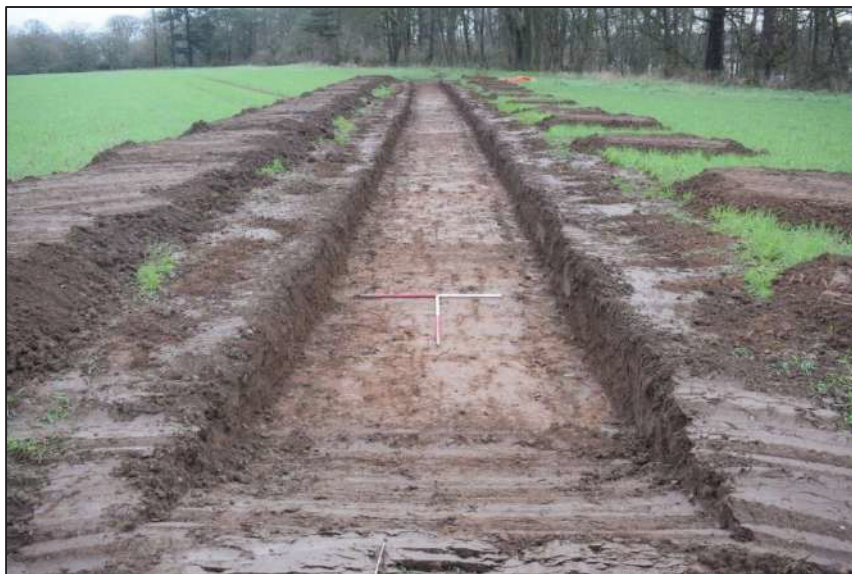
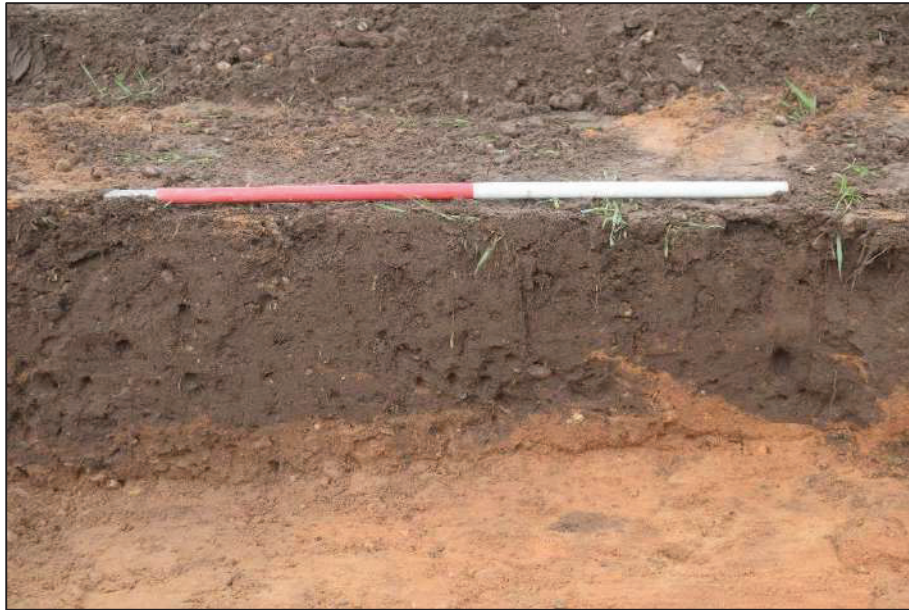
- 4.10.18. The earliest deposit encountered in Trench 55 was a natural sub-stratum formed of a soft mid yellow-brown silty sand, with frequent patches of small, sub-rounded stone gravels (5502) (Figure 8, Section 1.16). The natural sub-stratum was encountered at heights ranging from 79.06m aOD to 79.53m aOD. This was overlain by a topsoil, 0.30m deep, friable, dark grey-brown sandy silt, with occasional, small to medium sized rounded stones (5501). The topsoil was encountered at heights ranging from 79.48m aOD to 79.96m aOD.

Plate 122: Trench 55 facing east

Plate 123: Trench 55 representative section facing south-west

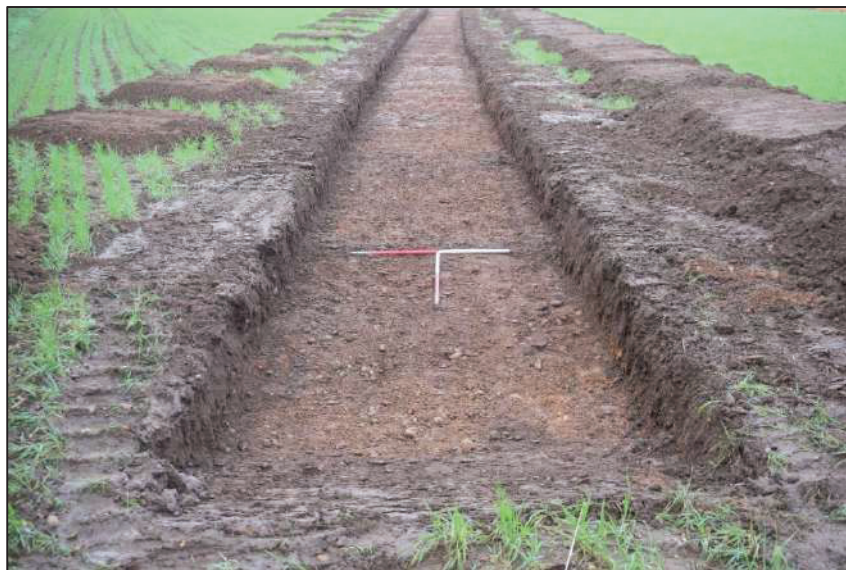
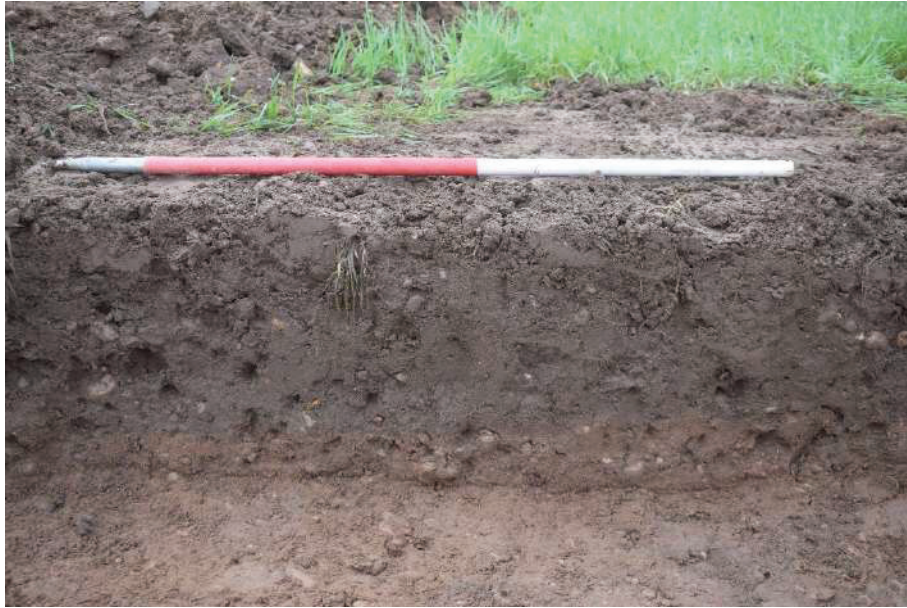
- 4.10.19. The earliest deposit encountered in Trench 56 was a natural sub-stratum formed of a friable, mid greyish-brown sandy silt, with frequent small to medium sized sub-rounded stones throughout (5602) (Figure 8, Section 1.15). The natural sub-stratum was encountered at heights ranging from 78.81m aOD to 79.12m aOD. This was overlain by a topsoil, 0.30m deep, of friable mid grey-brown sandy silt, with occasional, small sized sub-rounded stones throughout (5601). The topsoil was encountered at heights ranging from 79.16m aOD to 79.44m aOD.

Plate 124: Trench 56 facing west

Plate 125: Trench 56 representative section facing south

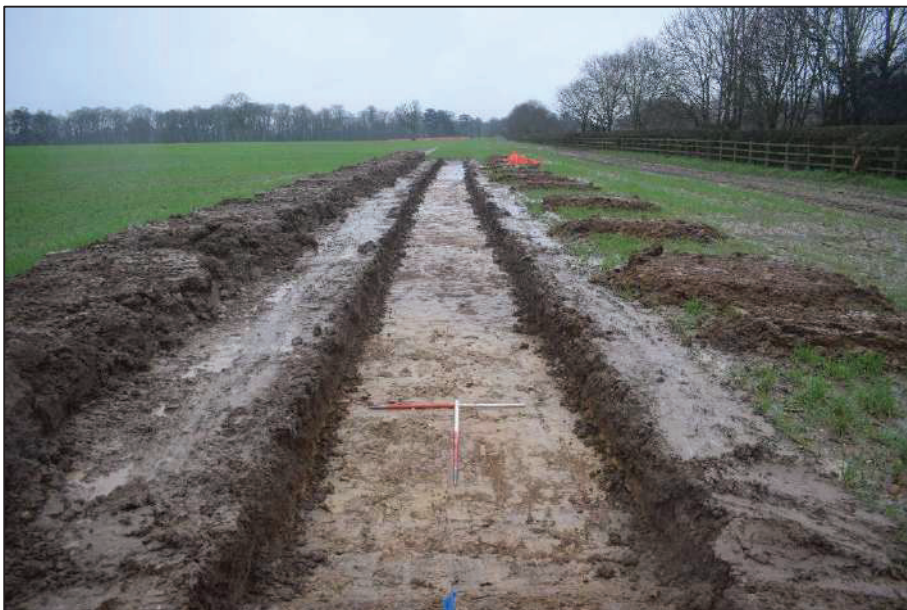
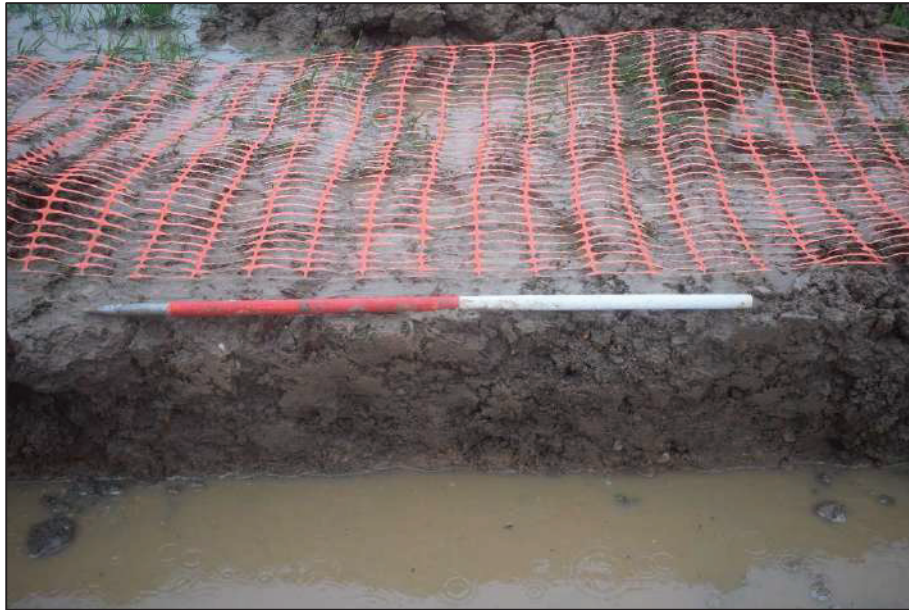
- 4.10.20. The earliest deposit encountered in Trench 57 was a natural sub-stratum formed of firm mid brownish-yellow, slightly silty clay, with occasional stone patches (5702) (Figure 9, Section 2.11). The natural sub-stratum was encountered at heights ranging from 76.60m aOD to 76.90m aOD. This was overlain by a topsoil, 0.30m deep, of firmly compacted, friable mid greyish-brown sandy, silty clay, with heavy rooting (5701). The topsoil was encountered at heights ranging from 77.09m aOD to 77.32m aOD.

Plate 126: Trench 57 facing south

Plate 127: Trench 57 representative section facing east

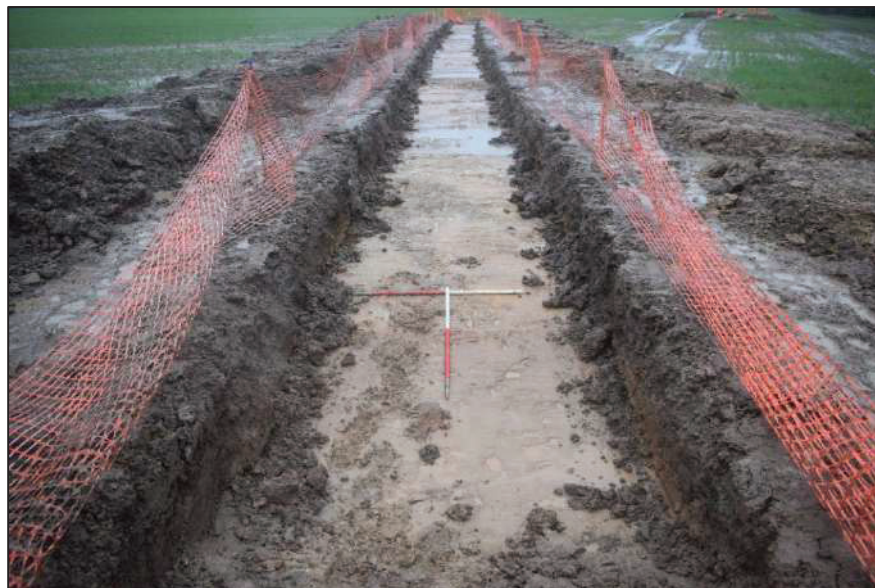
Plate 128: Trench 58 facing south

4.10.21. The earliest deposit encountered in Trench 58 was a natural sub-stratum formed of firm mid brownish-yellow slightly silty clay (5802) (Figure 9, Section 2.10). The natural sub-stratum was revealed to a depth of 0.10m and was encountered at heights ranging from 76m aOD to 76.83m aOD. This was overlain by a topsoil, 0.35m deep, a firm but friable mid greyish-brown silty clay, with heavy rooting and occasional, small sub-angular stones (5801). The topsoil was encountered at heights ranging from 76.31m aOD to 77.18m aOD.

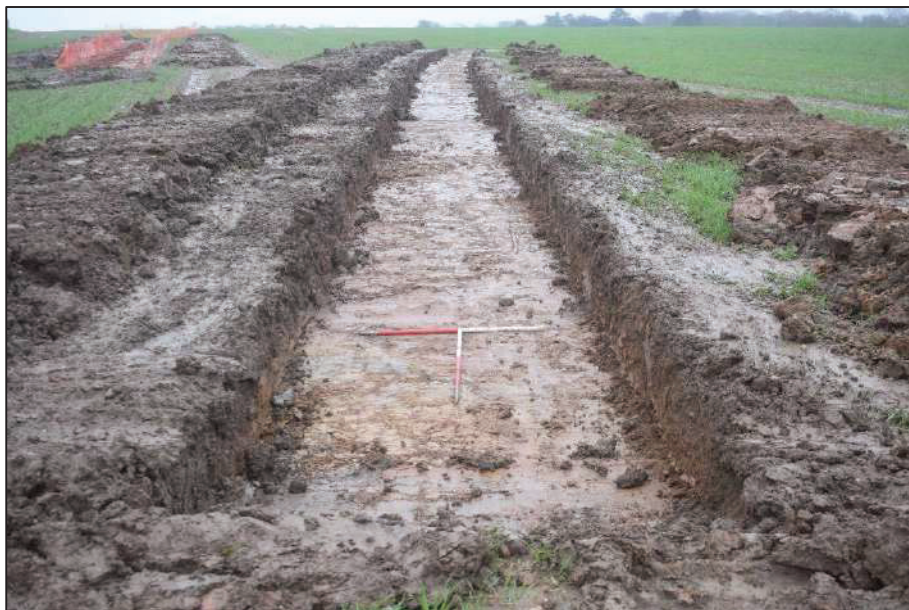
Plate 130: Trench 59 facing east

- 4.10.22. The earliest deposit encountered in Trench 59 was a natural sub-stratum formed of firm mid reddish-yellow brown silty clay, with stoney patches (5902). The natural sub-stratum was encountered at heights ranging from 76.34m aOD to 78.03m aOD (Figure 9, Section 2.9). This was overlain by a topsoil, 0.30m deep, a firm but friable mid greyish-brown, sandy silty clay, with frequent, small sub-angular stones (5901). The topsoil was encountered at heights ranging from 76.81m aOD to 78.44m aOD.

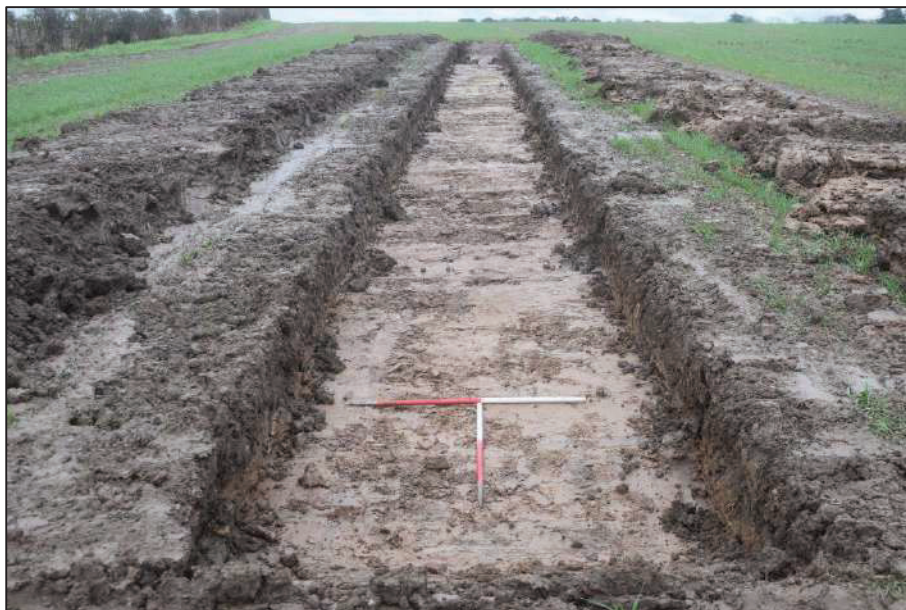
Plate 132: Trench 60 facing east

- 4.10.23. The earliest deposit encountered in Trench 60 was a natural sub-stratum formed of firm mid reddish-brown slightly silty clay (6004) (Figure 9, Section 2.8). The natural sub-stratum was encountered at heights ranging from 77.32m aOD to 78.37m aOD. A large cut [6003] containing modern debris truncated the natural sub-stratum. This measured 8m in length and exceeded the 1.80m of the trench width. It was machine excavated to a depth of 0.70m where it was halted due to safety concerns. The fill comprised loose, silty sand, containing a mixture of CBM, metal waste, crushed concrete, and burnt industrial material (6002). This was overlain by a topsoil (6001), 0.32m deep, of friable mid greyish-brown silty clay. The topsoil was encountered at heights ranging from 77.68m aOD to 79.59m aOD.

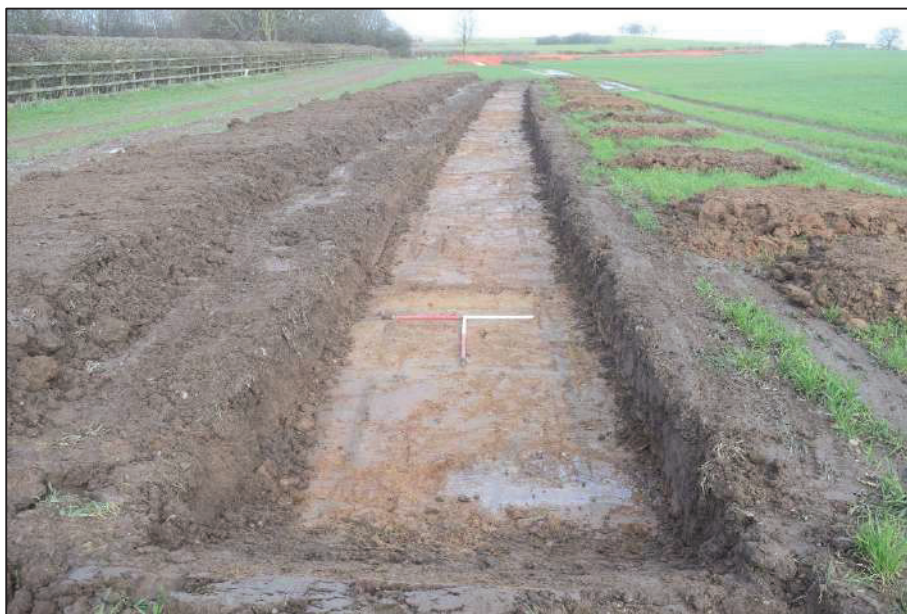
Plate 134: Trench 68 facing south-west

- 4.10.24. The earliest deposit encountered in Trench 68 was a natural sub-stratum formed of firm mid yellowish-brown, sandy, silty clay, with occasional patches of rounded stones (6803) (Figure 10, Section 4.6). The natural sub-stratum was encountered at heights ranging from 77.06m aOD to 77.31m aOD. This was overlain by a subsoil, 0.20m deep, of firm but friable mid brownish grey, sandy silty clay, with occasional, sub-angular stones (6802). This was sealed by a topsoil, 0.24m deep, of friable mid brownish-grey, silty clay with frequent medium sized rounded and sub-angular stones (6801). The topsoil was encountered at heights ranging from 77.42m aOD to 77.74m aOD.
