A46 Coventry Junctions (Walsgrave) Scheme Number: TR010066

Appendix 8.1 Biodiversity Net Gain Report

November 2024

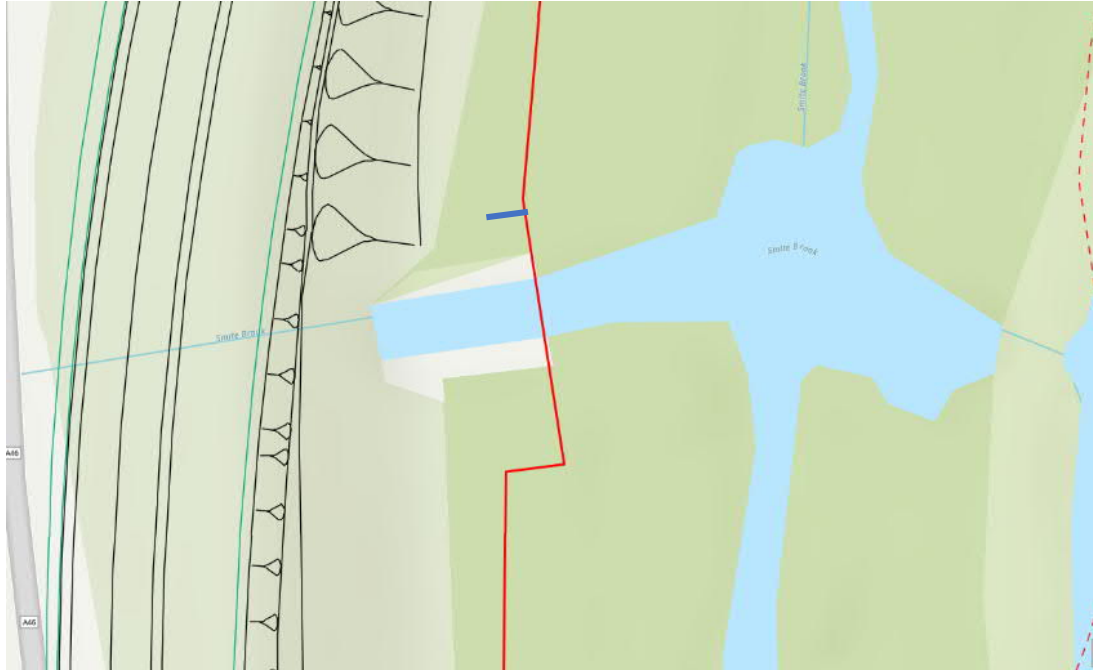
Plate 1: section east of the A46 culvert and approximate surveyed module (blue line)

- 3.4.4. Smite Brook to the east of the A46 culvert was assessed as being in moderate condition. Linear watercourse BNG units for the 15m scoped in section equal 0.09. Watercourse encroachment was assessed as major due to the presence of the culvert abutments and a reinforced brick/laid stone (cemented) wall extensive on the right bank face. No encroachment is present within the riparian zone which consists of semi-natural deciduous woodland.

- 3.4.6. Negative MoRPh indicators scoring a high negative (-3 of -4 of between 0 and -4) and limiting the condition of the subreach include the extent of the bank face reinforcement (extensive on the right bank) and the severity of the reinforcement material (brick/laid stone (cemented)) and channel bed siltation.

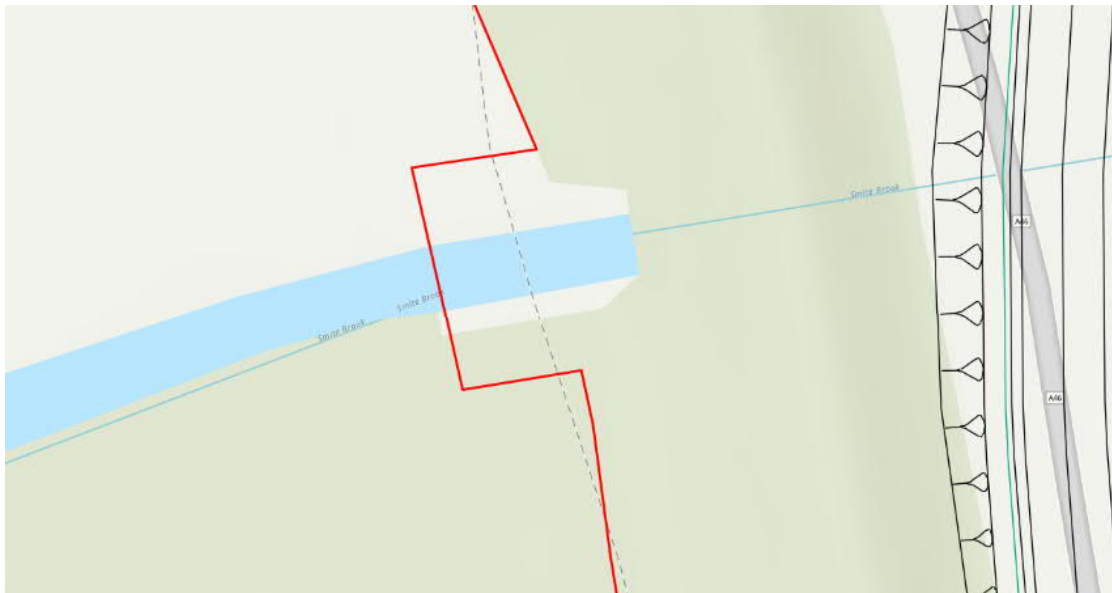
Plate 2: section west of the A46 culvert and approximate surveyed module (blue line)

- 3.4.7. Subreach A, to the west of the A46 culvert, was assessed as being in moderate condition. Linear watercourse BNG units for the 18m scoped in section equal 0.15. Watercourse encroachment was assessed as minor due to the presence of the culvert abutments. No riparian encroachment is present on the left bank which is semi-natural woodland habitat. Riparian encroachment on the right bank is assessed as major due to the extensive presence of permanently vegetated agriculture, including within 0m of the bank top.
- 3.4.8. Positive MoRPh indicators scoring highly (three or four out of four) include the extent of channel margin aquatic vegetation (emergent reeds/linear leaved species) extensive on the right bank and present on the left bank.

- 3.4.9. Negative MoRPh indicators scoring a high negative (-3 of -4 of between 0 and -4) and limiting the condition of the subreach include bank face non-native invasive species cover due to the present of Himalayan balsam (*Impatiens glandulifera*) seedlings and channel bed siltation.

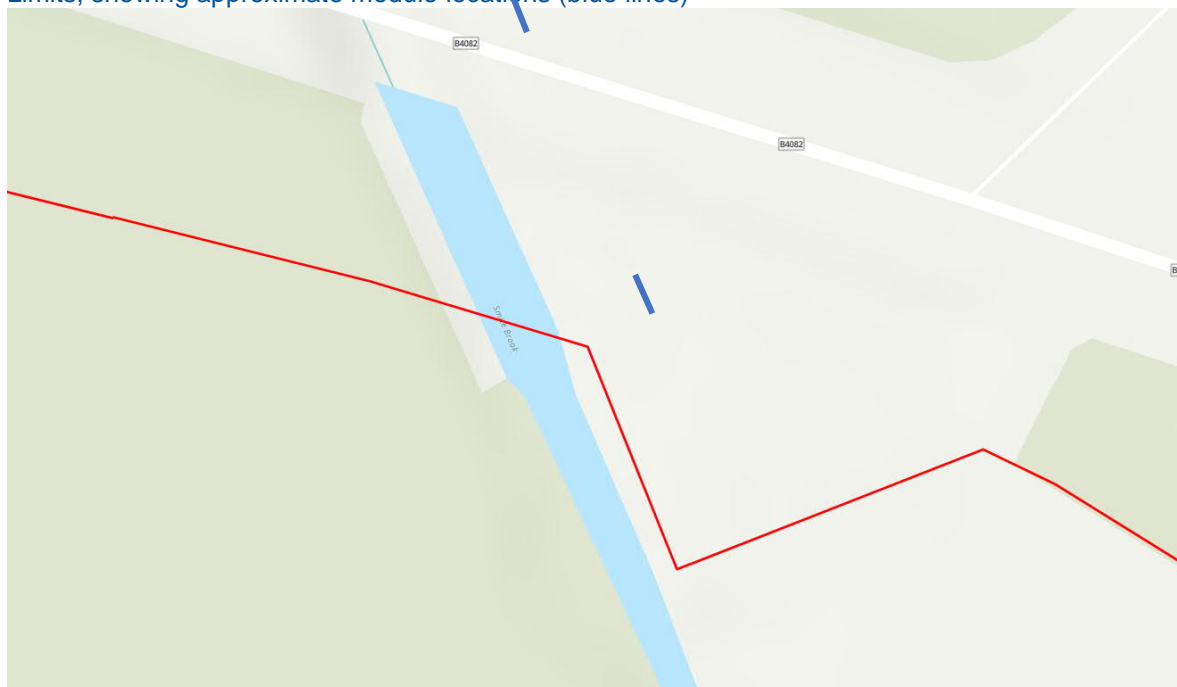
Plate 3: sections to the south of the B4082 within the Order Limits and outside of, but adjacent to, the Order Limits, showing approximate module locations (blue lines)

- 3.4.10. Subreach B to the south of the B4082 culvert was assessed as being in fairly poor condition. Linear watercourse BNG units for the 40m scoped in section equal 0.22. The subreach was categorised as being in moderate condition within Cartographer, however as the river shape was 2.32 it is considered likely that this section of the brook is over deep as it falls at the lower end of the identified shape band ≥ 2 to < 4 at which the majority of channels have been found to be over deep. As such, the final condition score was reduced from moderate to fairly poor.

- 3.4.13. Negative MoRPh indicators scoring a high negative (-3 of -4 of between 0 and -4) and limiting the condition of the subreach include bank face reinforcement extent (due to culvert abutments and brick/laid (cemented) reinforcement at the downstream end), channel bed siltation and the severity of channel bed artificial features (due to the presence of large trash).

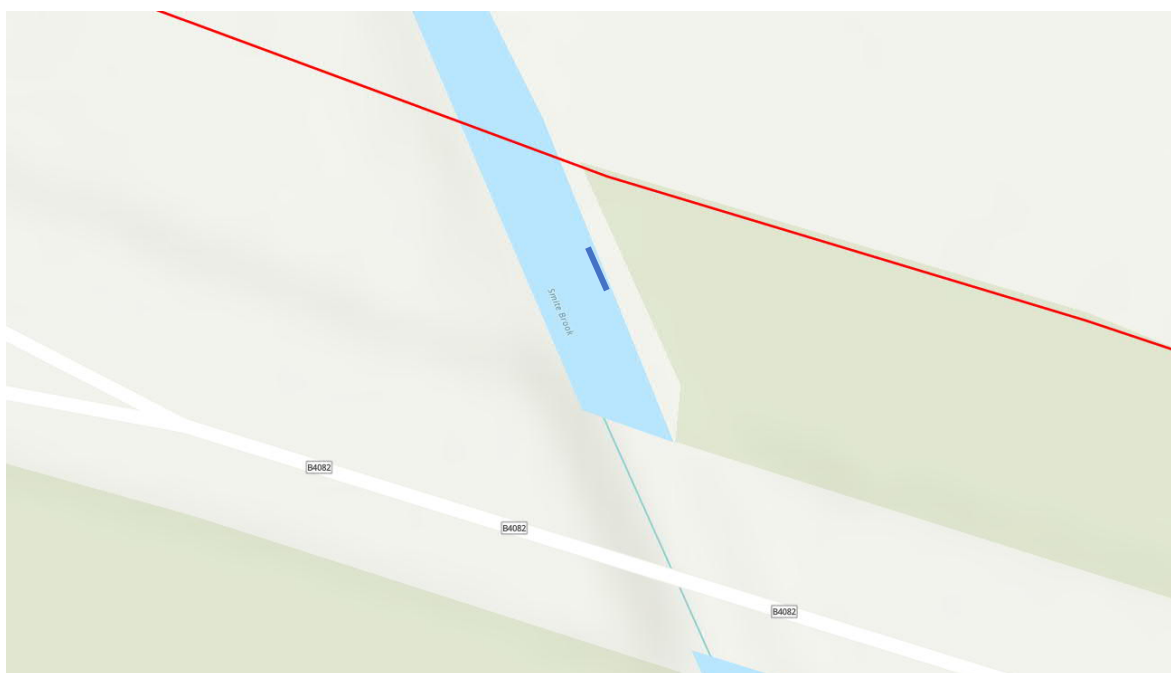
- 2.6.17. This section of the watercourse (see Plate 4 below) was inaccessible from the banks due to dense vegetation and the presence of a herd of cattle, including bulls, in the field on the right bank. The section was observed from the B4082 bridge however visibility was very poor.

Plate 4: section north of the B4082 and approximate surveyed module location (blue line)

- 3.4.14. Subreach A of the Smite Brook B4082 to the River Sowe reach has been assessed as being in poor condition. Linear watercourse BNG units for the 23m scoped in section equal 0.11. The subreach was categorised as being in fairly poor condition, however as the river shape was 2.0 this section of the brook has been considered likely over deep and the condition reduced to poor.
- 3.4.15. Watercourse encroachment was assessed as minor in consideration of the presence of the culvert abutments and assumed presence of reinforcement beyond this, as was recorded for the section of watercourse to the south of the B4082 culvert (Smite Brook A46 to B4082, Subreach B). No riparian

- 3.4.17. Negative MoRPh indicators scoring a high negative (-3 of -4 of between 0 and -4) and limiting the condition of the subreach include bank face non-native invasive species (assumed presence of Himalayan balsam on the bank face as the species is present to the south of the culvert), channel bed siltation and the severity of channel bed artificial features (due to the presence of large trash).

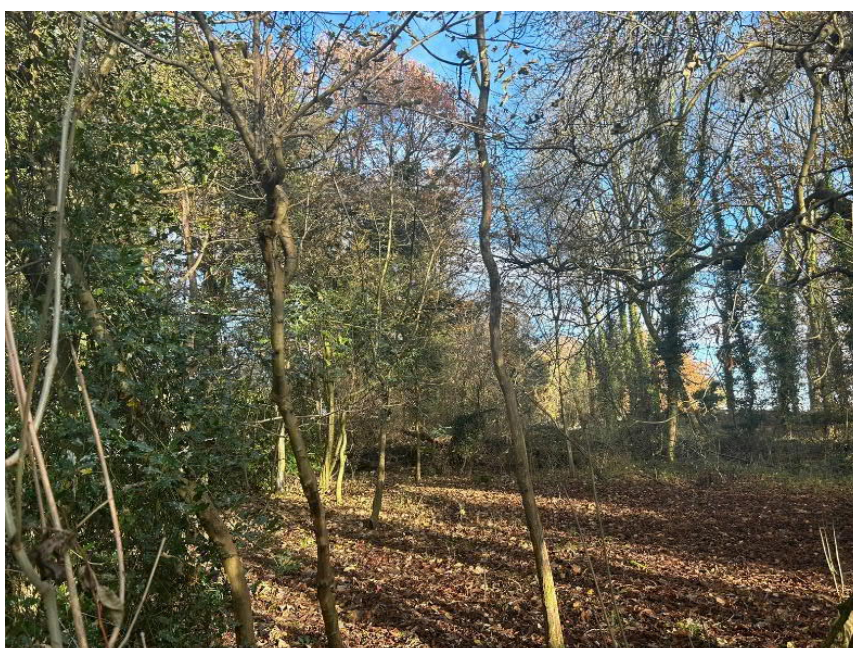
in the ground flora. The species is considered to be the native bluebell due to the drooping nature of the flowers. Bluebells are an ancient woodland indicator species, however due to a lack of other such indicator species the woodland is not considered ancient. The cover of native trees in the canopy and shrub layer exceeds 80% and there are considered to be three age classes and two storeys within the woodland. The common nettle in the field layer is considered to evidence extensive nutrient enrichment within the woodland. Deadwood was present in 50% of the woodland and veteran trees were recorded. Regeneration was recorded in the woodland with seedlings, saplings and trees 4-7cm diameter at breast height recorded.

Plate 5: Coombe Pool SSSI other broadleaved woodland W12 within the site baseline

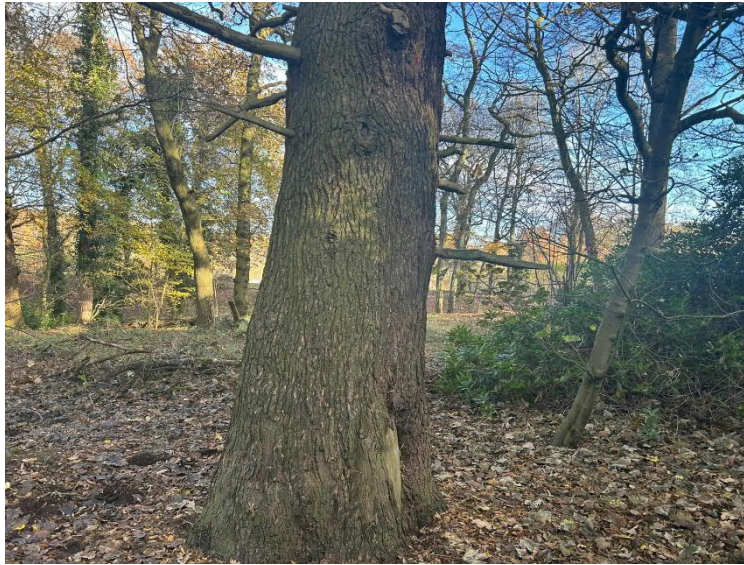
- 3.2.5. Species within W13 include pedunculate oak, London plane, elder, hazel, ash, sycamore and rhododendron. Species within the sparse field layer is limited to common nettle and ivy. The woodland differs from W12 in that the woodland is considered to have three storeys including a shrub layer, deadwood as only present in >25% of the woodland, evidence of nutrient enrichment was absent, veteran trees were occasional and there was no evidence of woodland regeneration.

Plate 6: Coombe Pool SSSI other broadleaved woodland W13 within the site baseline

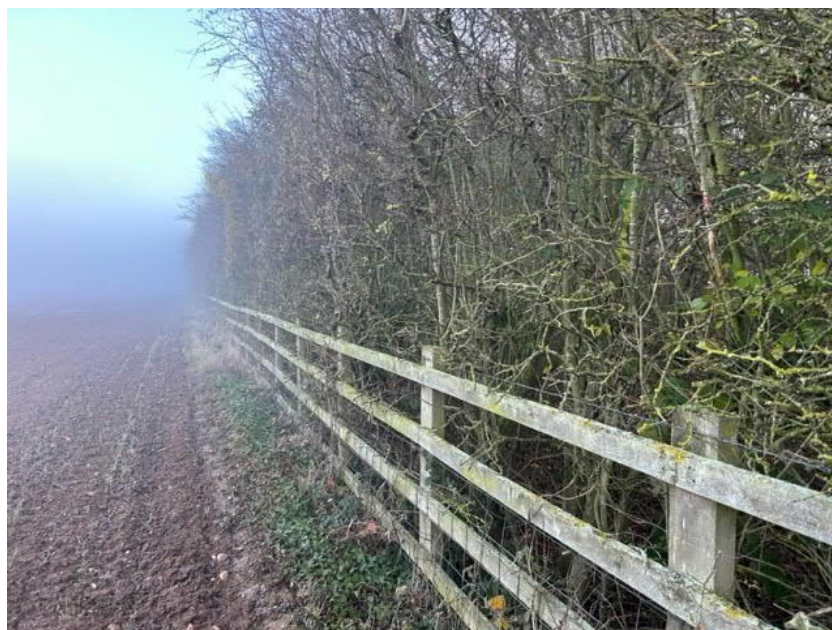
- 3.3.2. Thirteen native hedgerows are present on site within the largely arable landscape to the north of the existing junction. The hedgerows are all species-poor (<5 native species per 30m) and are largely hawthorn hedgerows. The hedgerows are all managed and subject to some degree of pruning, however the height and width of hedgerows is generally maintained at a minimum 1.5m.
- 3.3.3. Strips of undisturbed perennial vegetation a minimum of 1m wide are present adjacent to some hedgerows however not all. Hedgerows are intact with no gaps. No invasive non-native species were recorded within the hedgerows. The hedgerows are all assessed as being in either moderate or good condition.

Plate 7: An example of a native hedgerow on site (H8)

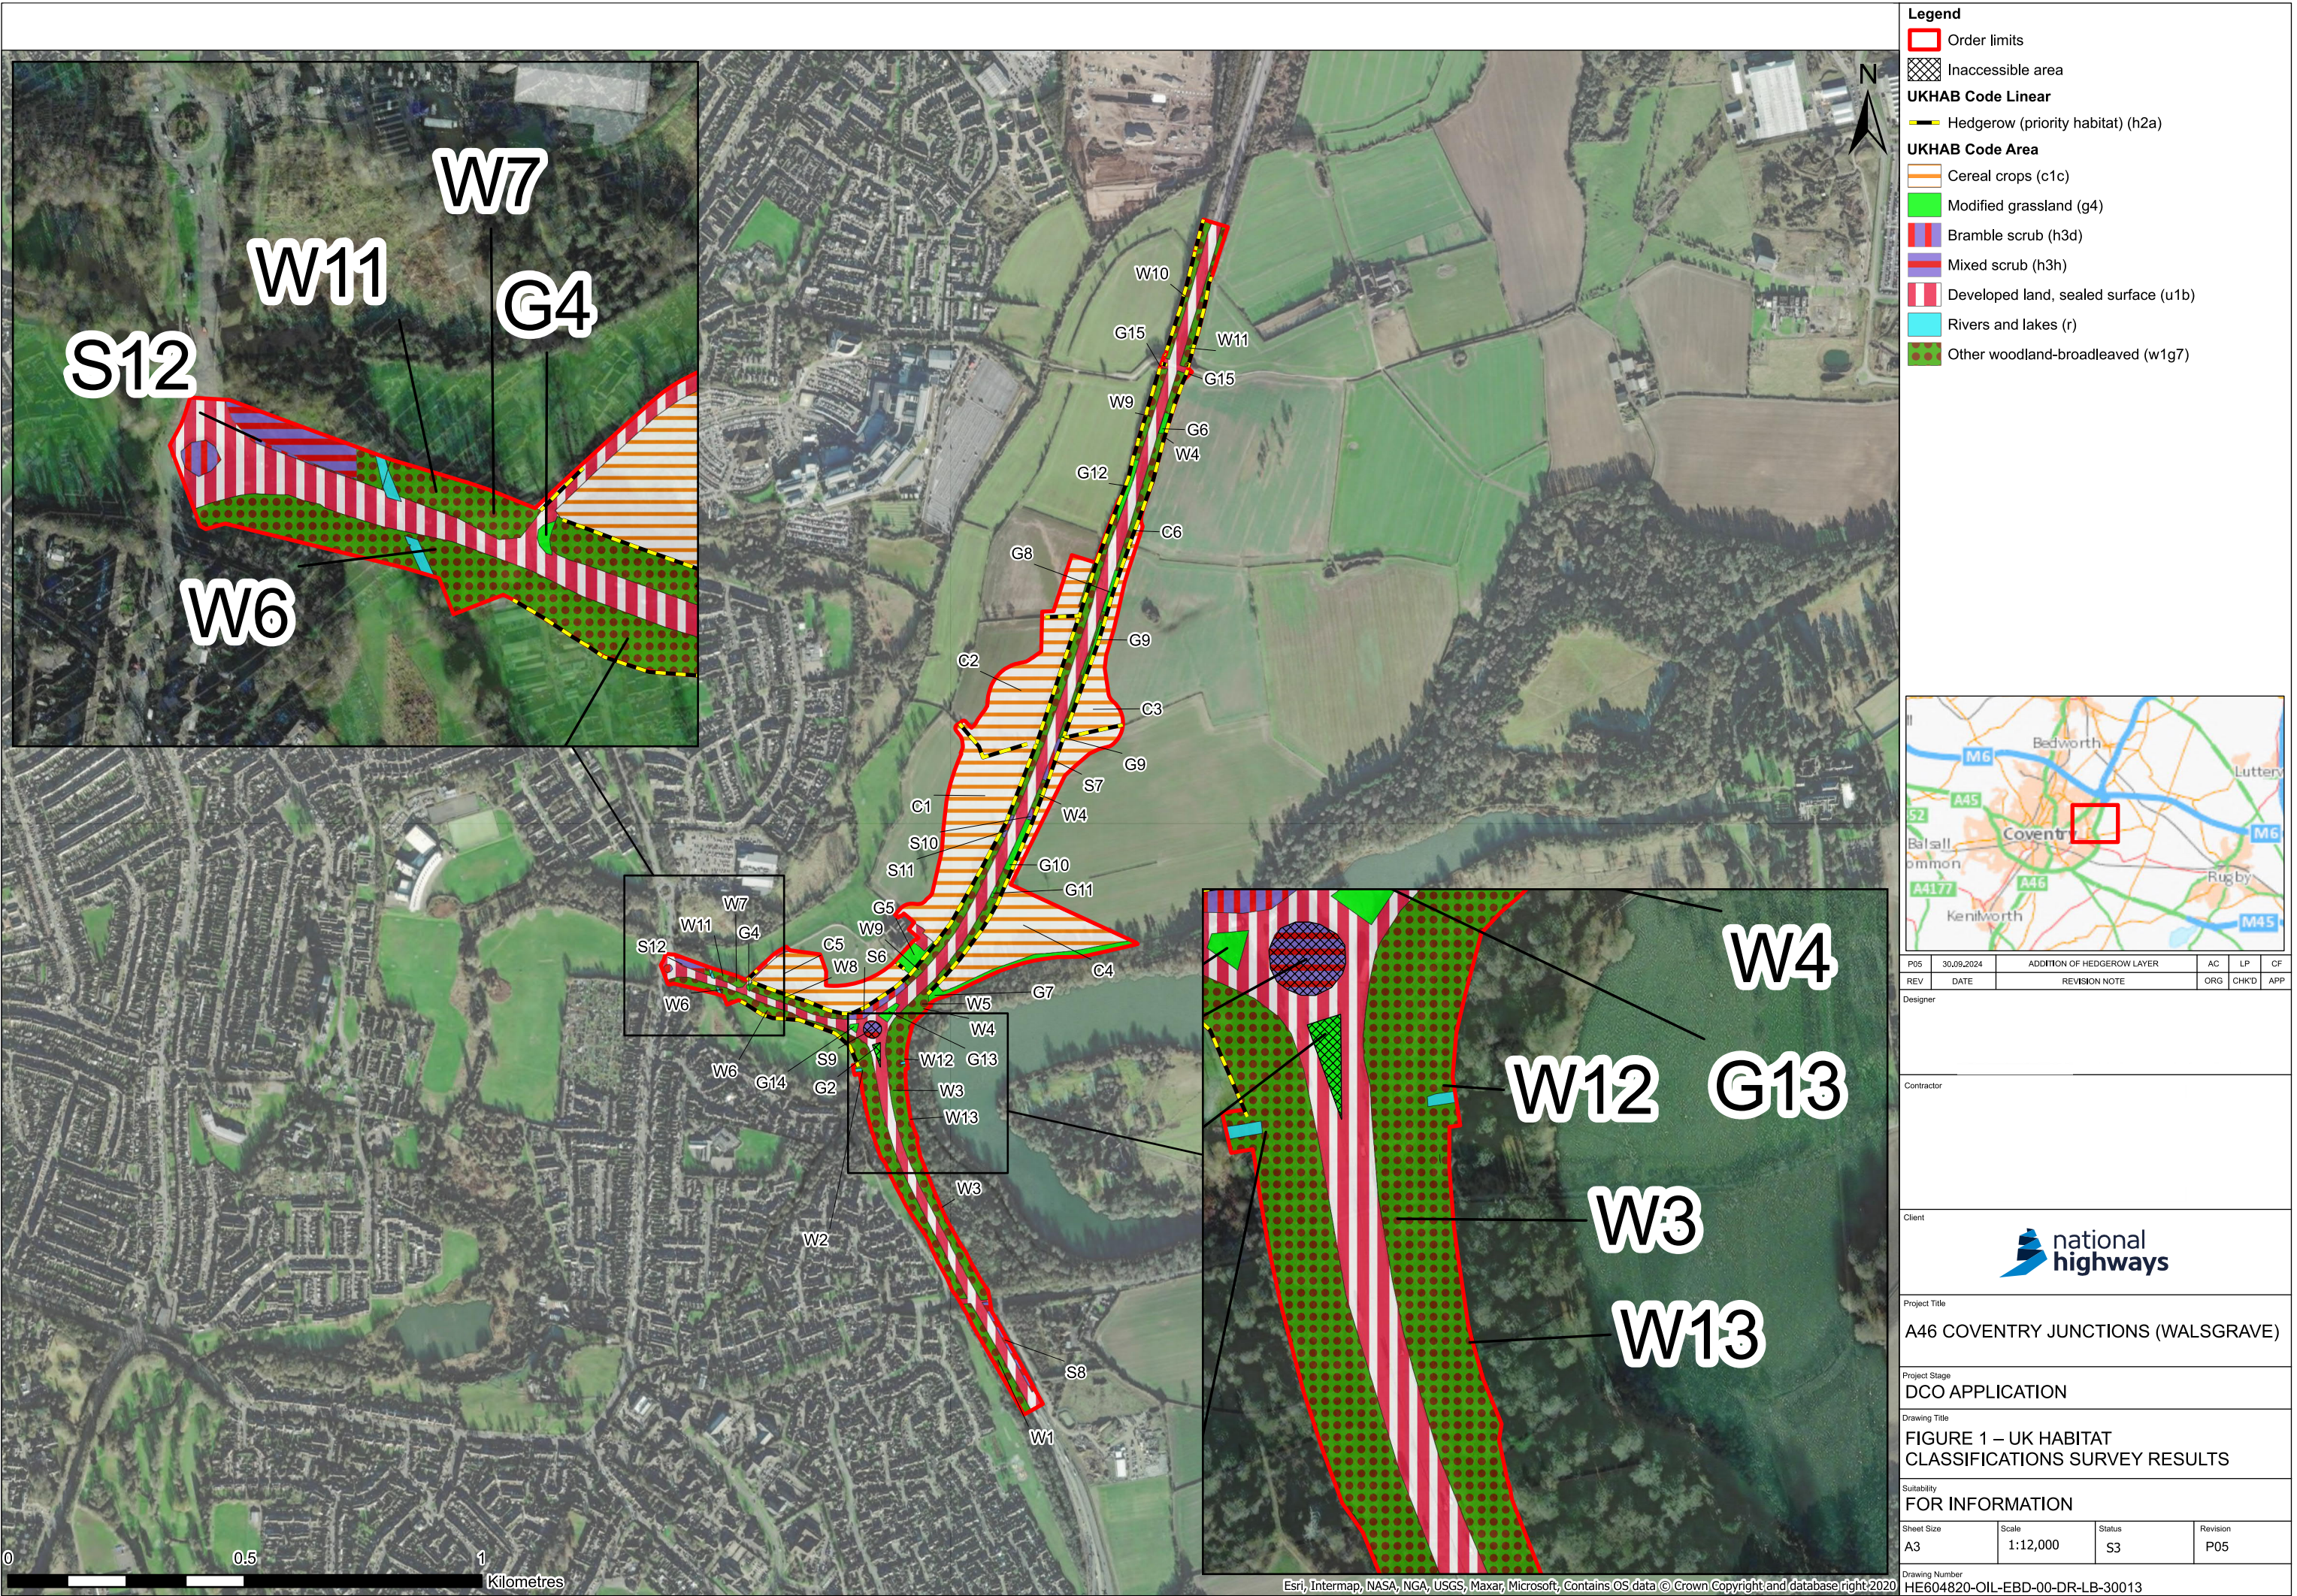
Appendix A. Figure 1 - UKHAB map

- 2.6.1. Due to the nature of some habitats, particularly those with dense vegetation growth, it was not possible to access certain areas of the site during the UKHab survey. The condition assessments of these habitat parcels were therefore undertaken from their perimeter. As such, the condition assessments for these areas may not be fully representative of each habitat parcel as a whole. All inaccessible areas are mapped on Figure 1 in Appendix A.

- 3.1.6. See Figure 1 in Appendix A for a UKHab map of the site baseline including individual area-based and linear hedgerow identifications as detailed in Tables 1 and 2 respectively, Appendix B for full condition assessments of the habitats and Appendix C for species lists.

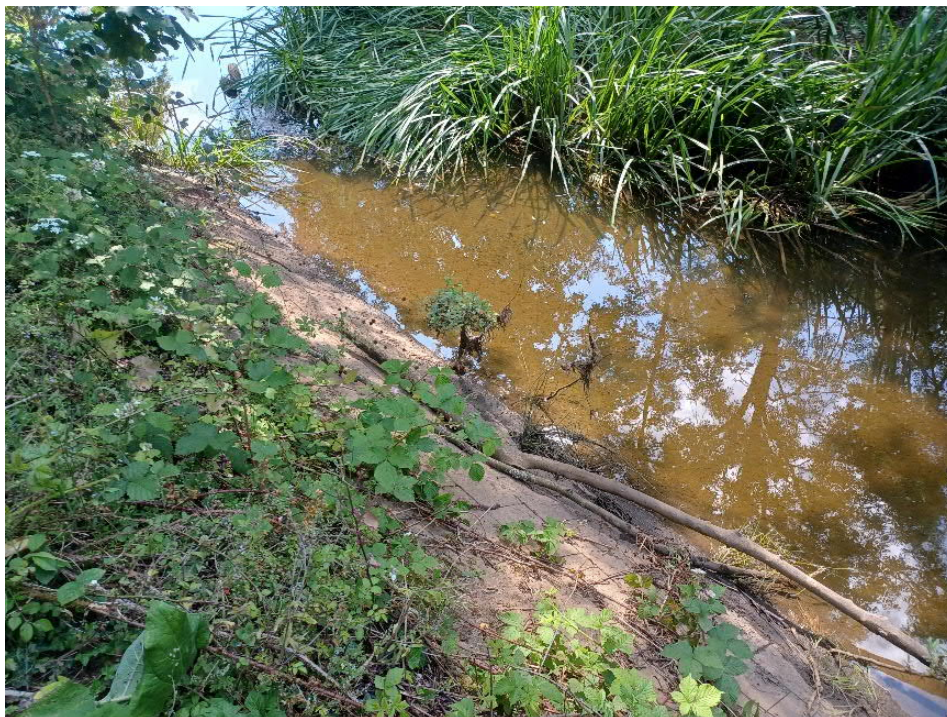
Appendix Plate 1: A46 East, subreach A, taken from the right bank looking slightly upstream

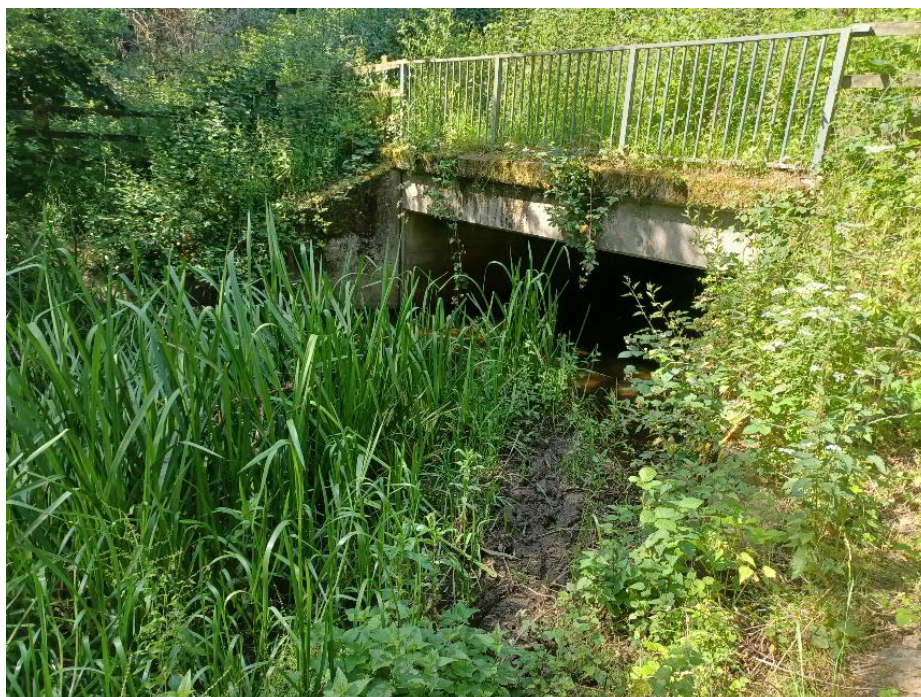
Appendix Plate 2: A46 East, subreach A, taken from the right bank looking downstream and showing the A46 culvert

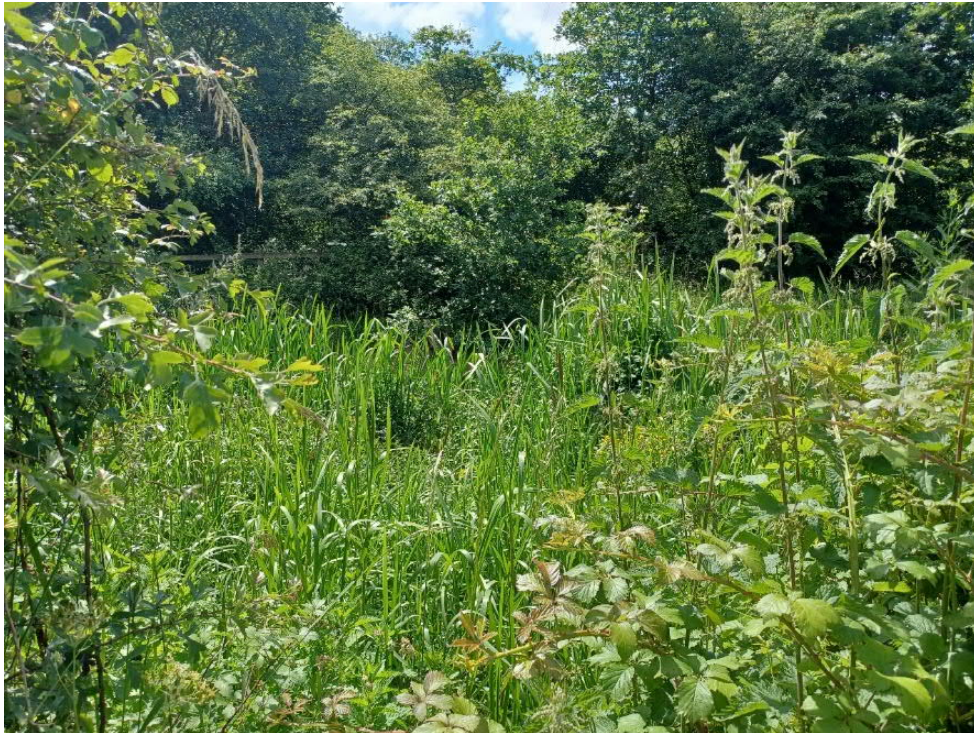
Appendix Plate 3: Smite Brook A46 to B4082 section within the Order Limits, taken from the right bank facing upstream.

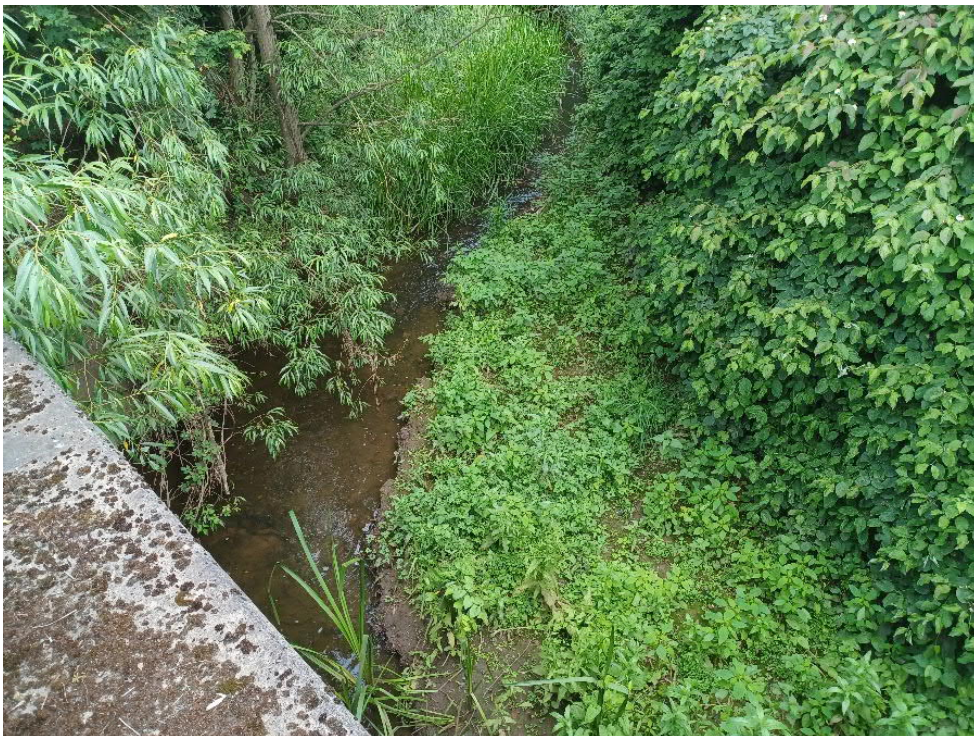
Appendix Plate 4: Smite Brook A46 to B4082 subreach B, module 5, taken from the B4082 bridge facing upstream.

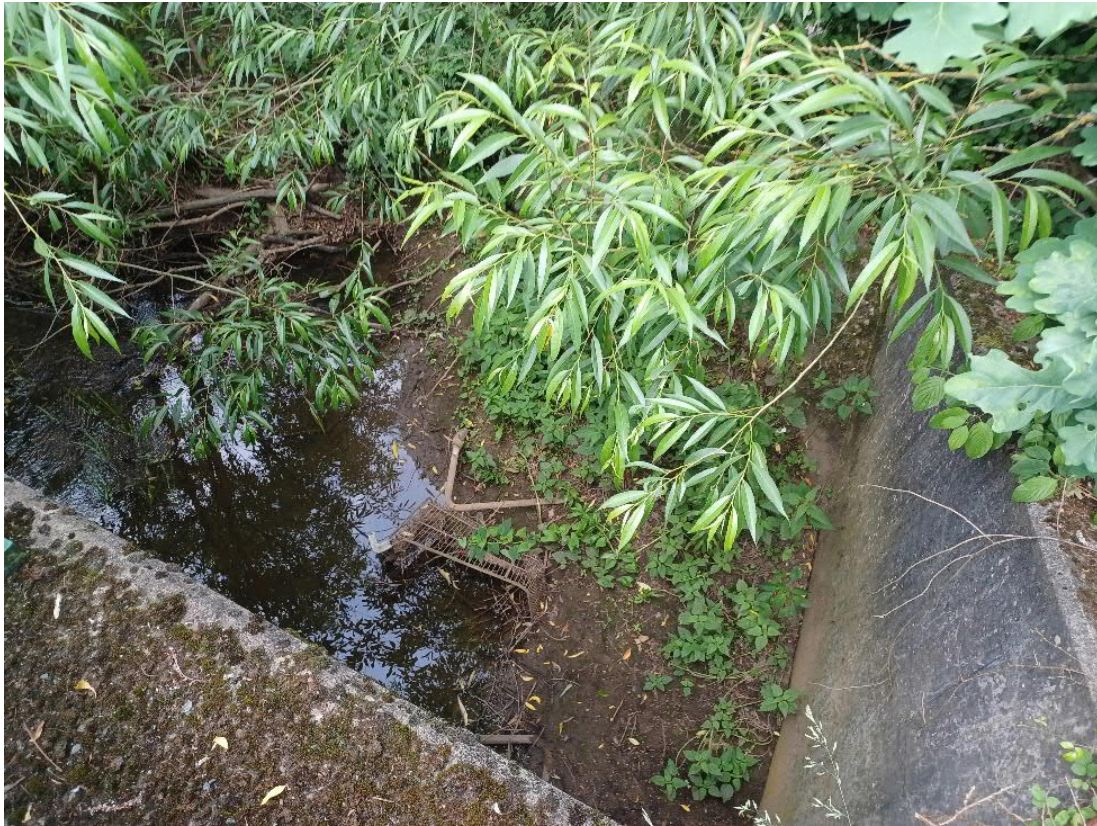
Appendix Plate 5: approximate 5m section of Smite Brook B4082 to the River Sowe subreach A visible from B4082 bridge
