# **A46 Coventry Junctions (Walsgrave) Scheme number: TR010066**

### **Appendix 8.4 Barn Owl Survey Report**

## **Barn Owl Survey Report**

### **A46, Walsgrave**

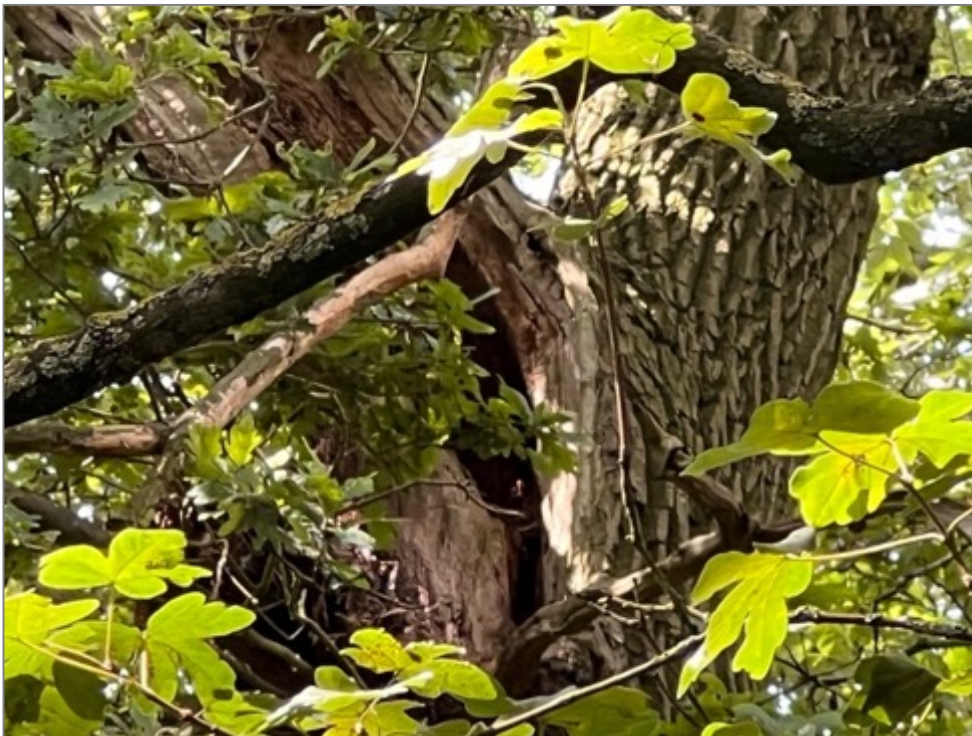
Picture 10: Land at Ansty Park: cavity in tree T10 with stick nesting material in base (likely jackdaw).  
Barn owl Potential Roost Site.

At the Ansty park land parcel, a single tree was found that had features suitable for a barn owl Potential Roost Site; however, the cavity was too small and open for nesting and no field signs of barn owl were found to indicate that it had been used.

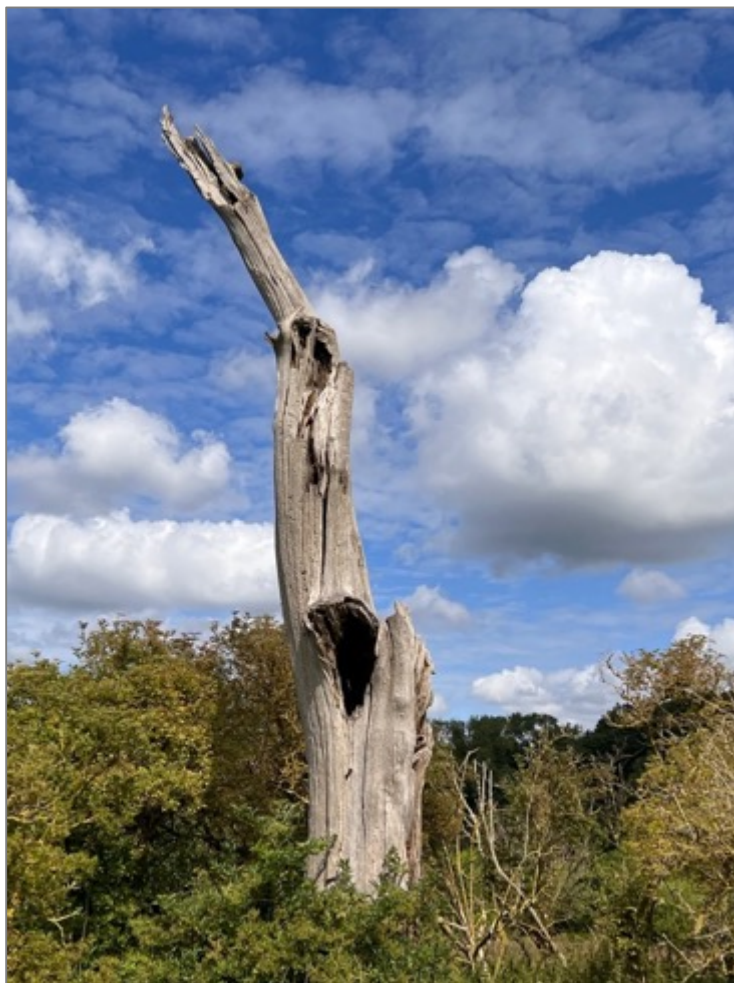
T5	SP 395 794	Dead tree on edge of meadow & rabbit grazed grassland. Completely open on one side from ground up. Two large cavity entrances at 3m south & 5m north. Lots of faecal splashing on vegetation below tree but buzzard was noted using branch in upper canopy as a perch on both days of survey so likely attributable to that species.	None (field signs likely from buzzard)	Suitable	Negligible

Picture 14: T5 – potential roost site but also frequently used as perch by buzzard

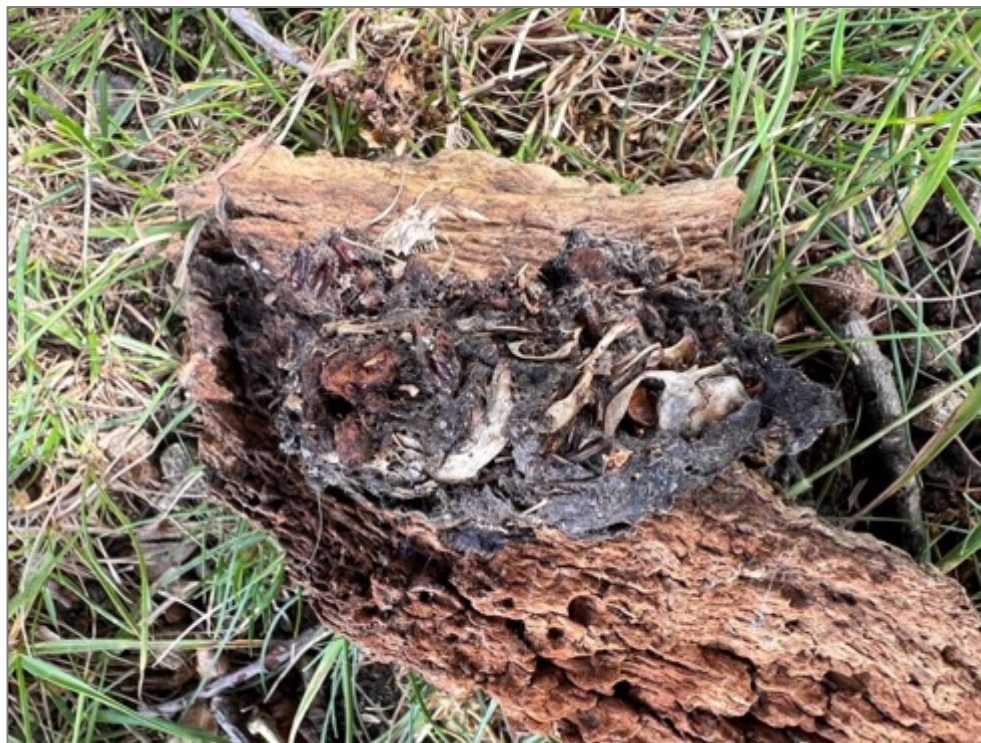
Picture 16: T6 – old barn owl pellet found at cavity entrance, partially disintegrating

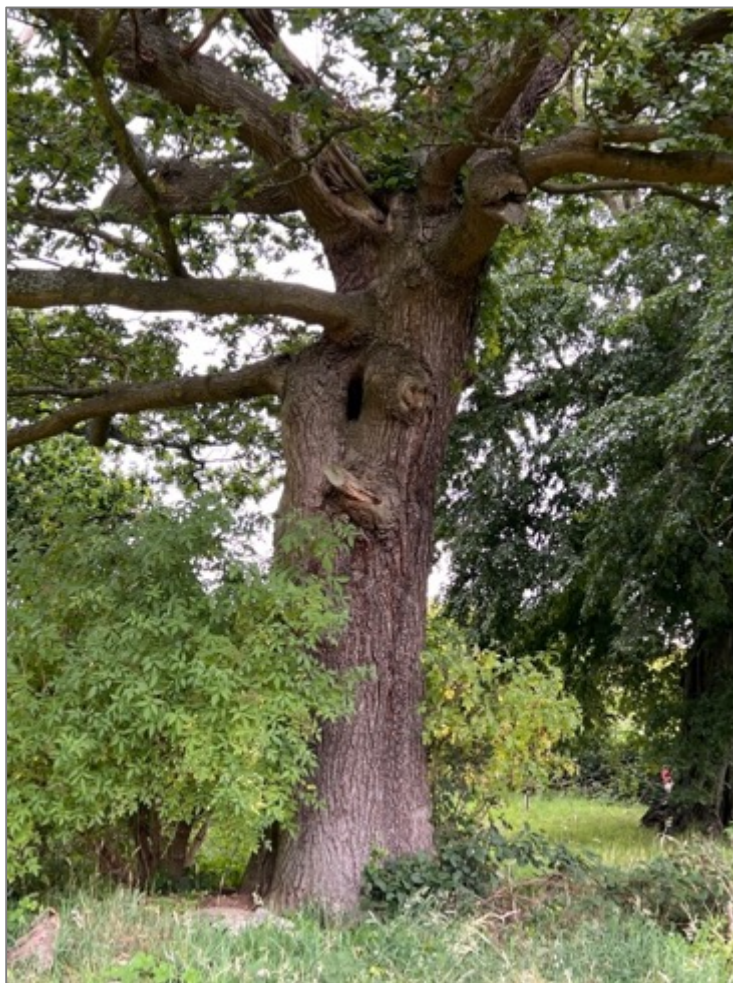
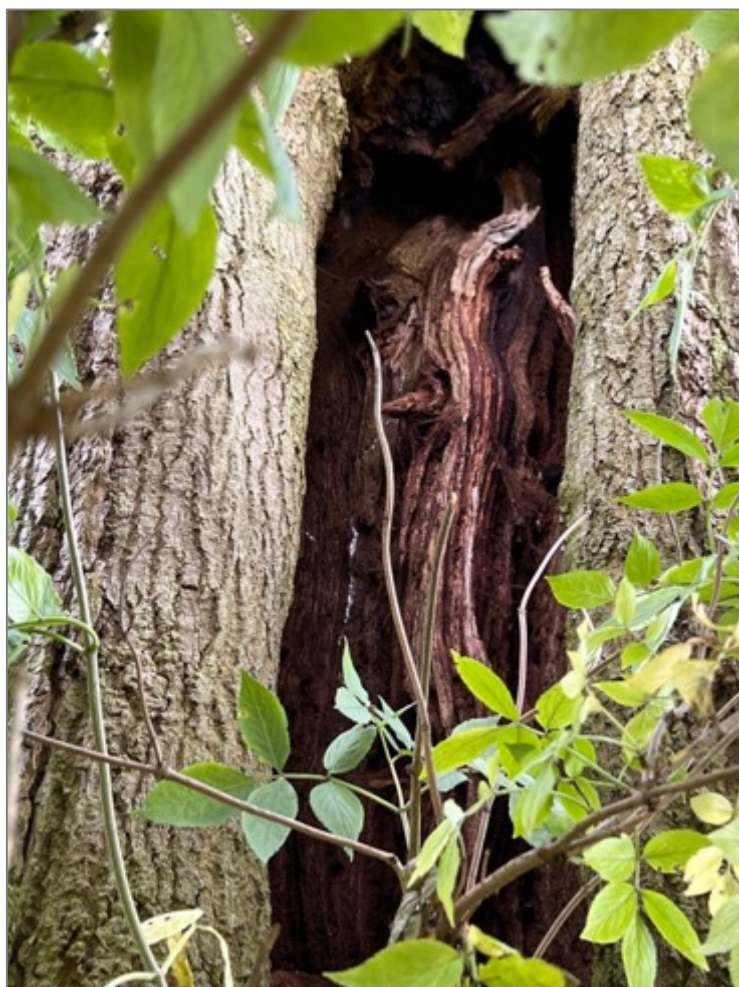
Picture 17: T7 – suitable size entrance but open to ground level down opposite side of stem, with no suitable ledges

Picture 18: T7 – Large open-sided cavity in stem with base at approximately 0.5m above ground level

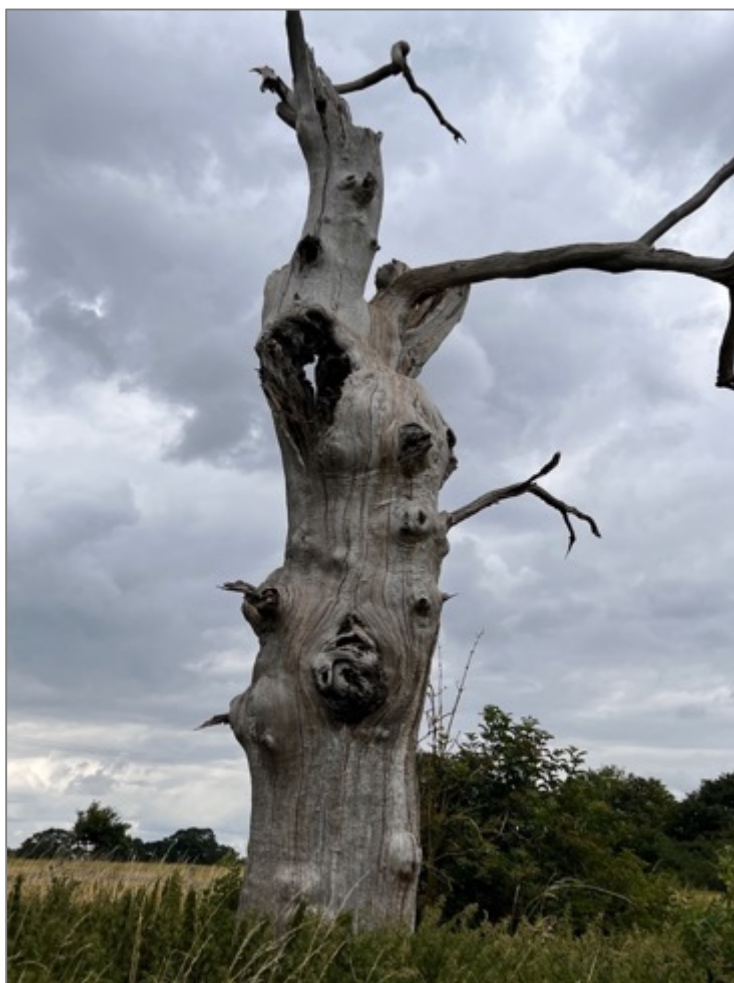
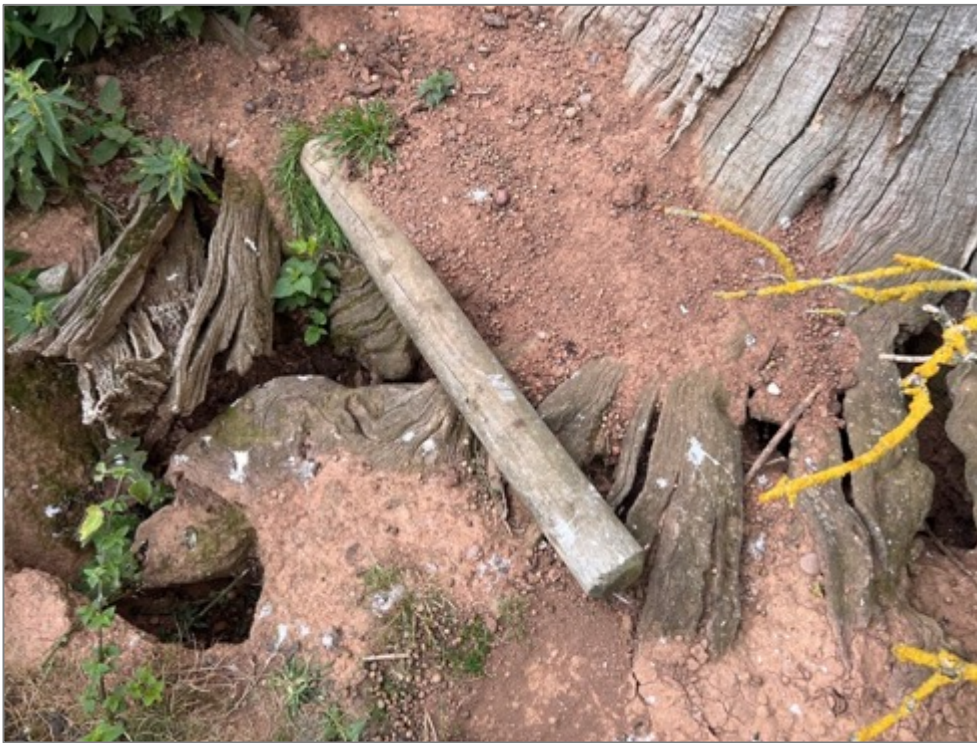
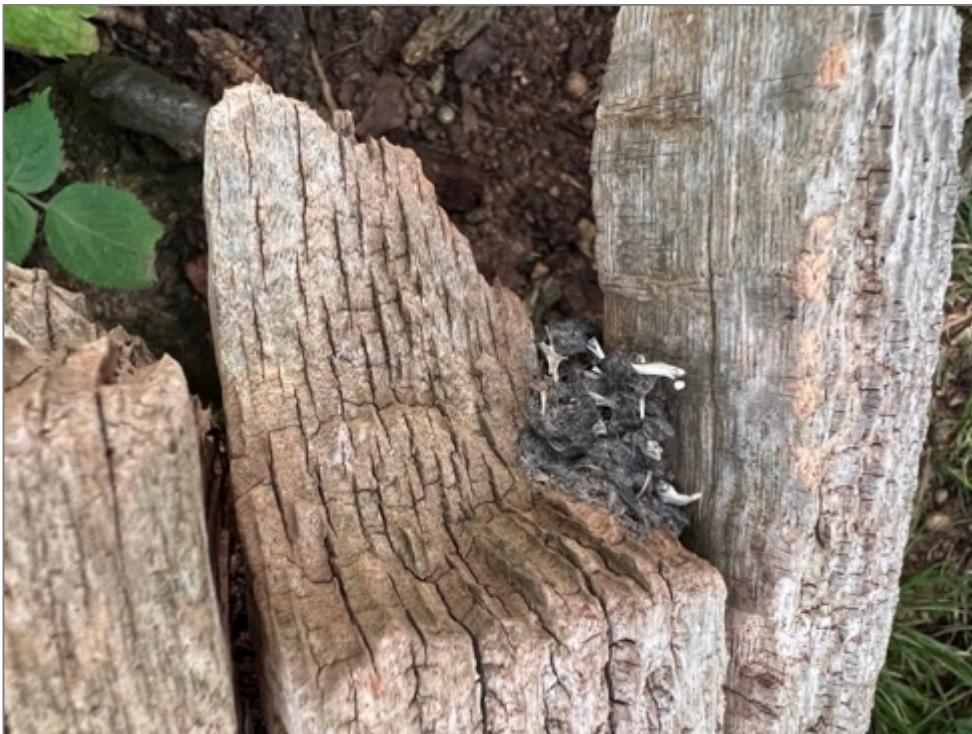
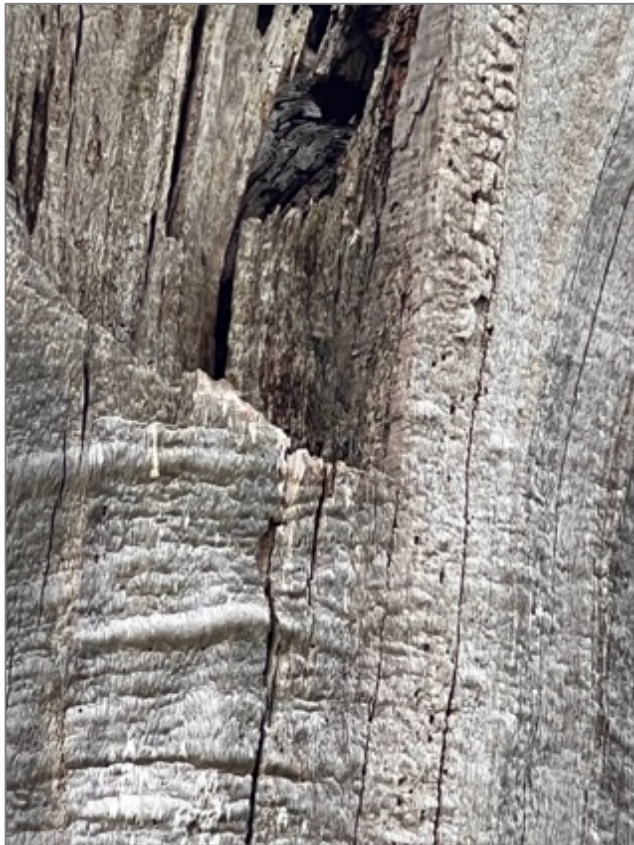
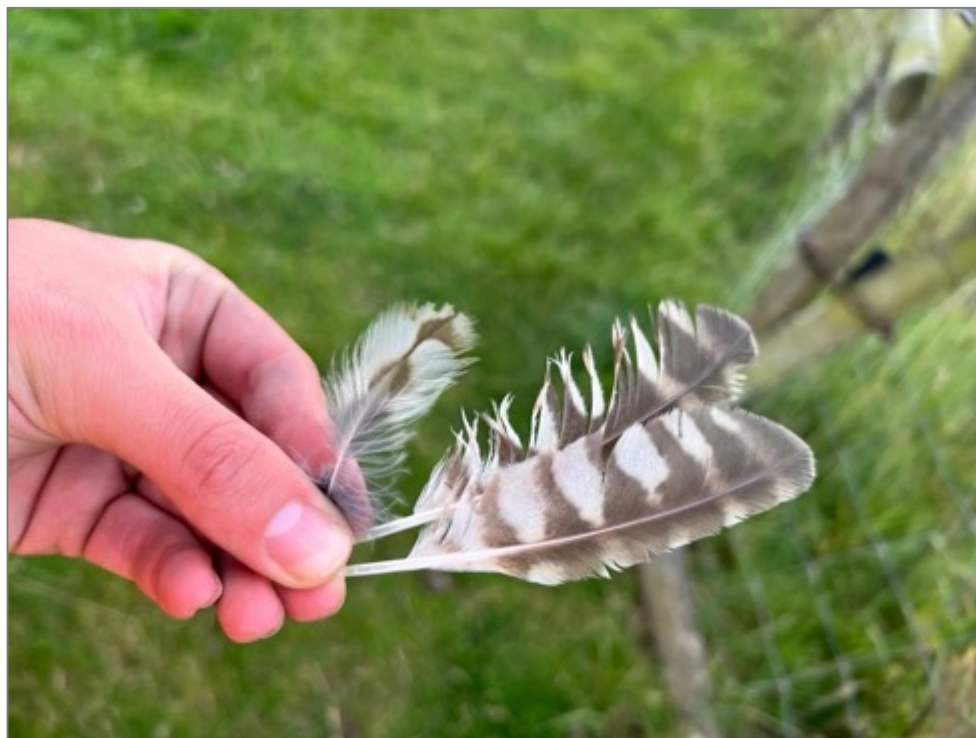
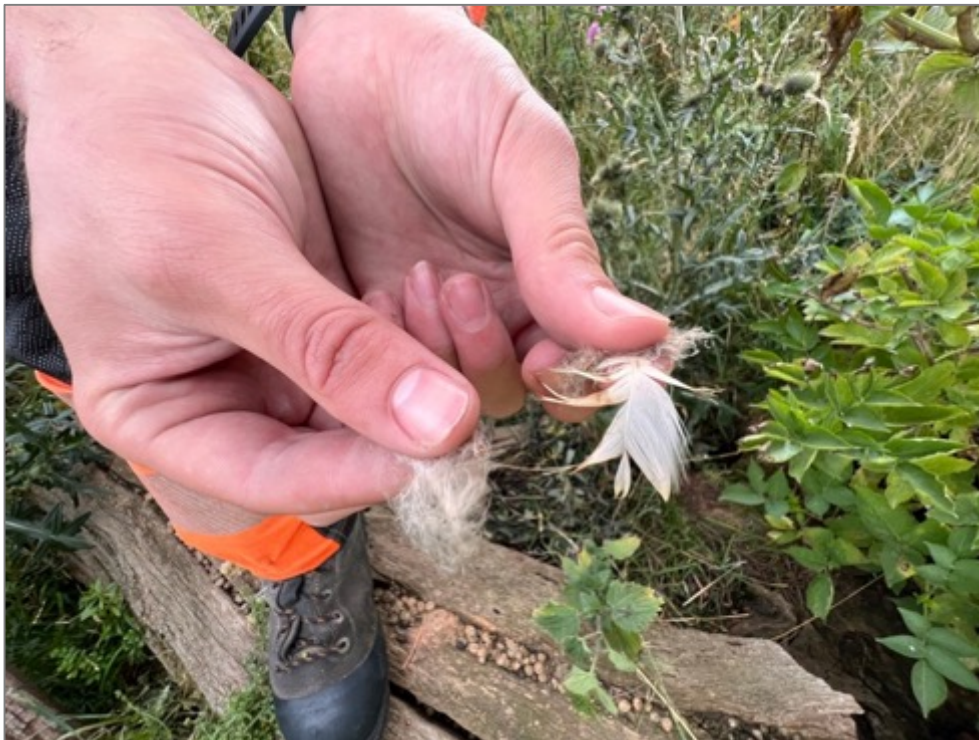
Of the surveyed trees in Coombe Country Park and farm F3, only T8 provided suitable nesting habitat for barn owl. Field signs indicated that it had been utilised by barn owls previously but pellets on the ground were old & crumbling and there was no obvious debris within the cavity itself, suggesting that it had not been an active nest site this season. All recent field signs indicated use by tawny owl; however,

Picture 19: T8 – potential nest site

Picture 20: T8 – white splashing on ground around base of tree

Picture 21: T8 – old barn owl pellet found wedged in fallen limbs at base of tree, dry and partially disintegrating

Picture 22: T8 – white splashing at cavity entrance

Picture 23: T8 – tawny owl feathers found on ground at base of tree

Picture 24: T8 – small amount of downy fluff found inside cavity but no other obvious nesting debris

The survey results indicated no barn owl nesting activity in the surveyed trees or buildings during the 2023 season; however, tree T8 at Coombe Country Park and the nest box at Farm F1 were confirmed to be Potential Nest Sites therefore one or both locations could be utilised by nesting barn owls in future years.

The results of this survey may be sufficient to inform impact assessment at the current stage of the A46 proposed scheme; however, these two locations should be monitored for nesting activity at appropriate timescales within the overall programme of development to avoid impacts that would result in offences under the legislation that protects barn owl and to ensure that suitable mitigation can be devised.

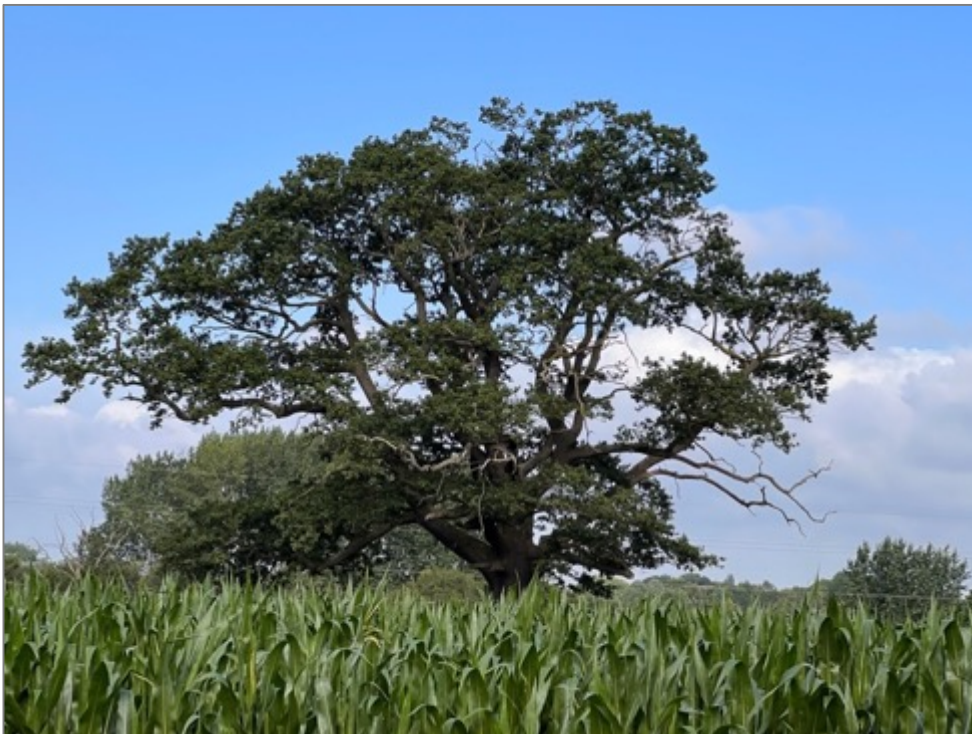
T9 at Farm F2 was found to have no nest boxes or cavities suitable for use by barn owl and the branches were considered too exposed to be used for open roosting. Depending on land use in any given season, this tree could at times provide a suitable hunting perch; however, at the date of survey the field in which it grows was planted with a maize crop, which would be Type 3 habitat for barn owls (poor habitat) and therefore was considered unlikely to be used for that purpose at this time.

Picture 25: T9 – no nest boxes or cavities suitable for nesting or roosting

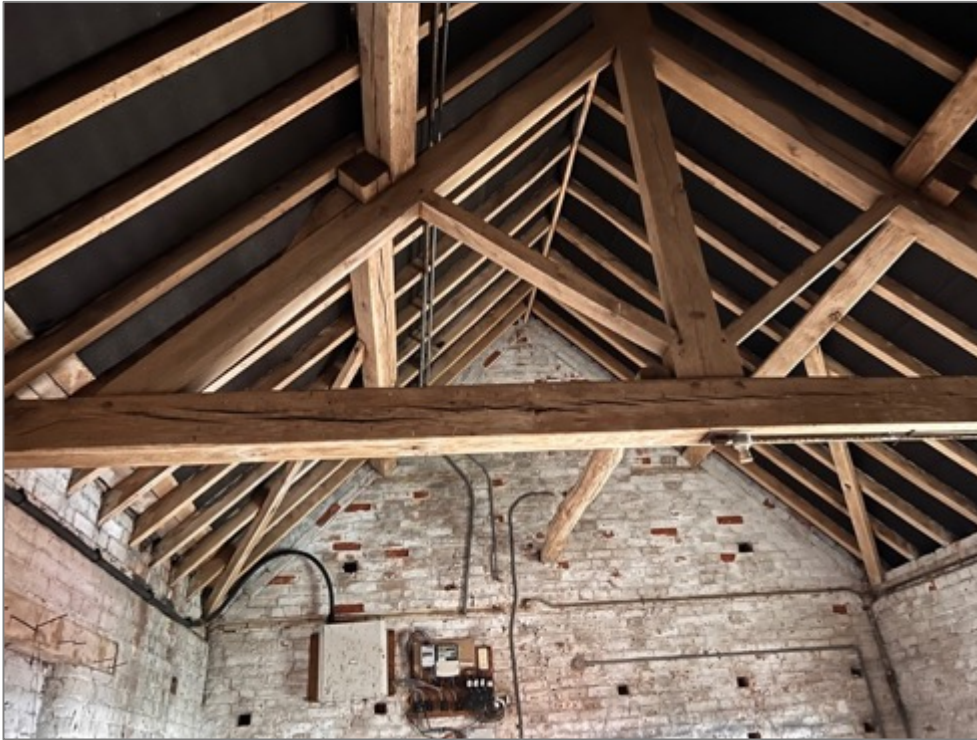
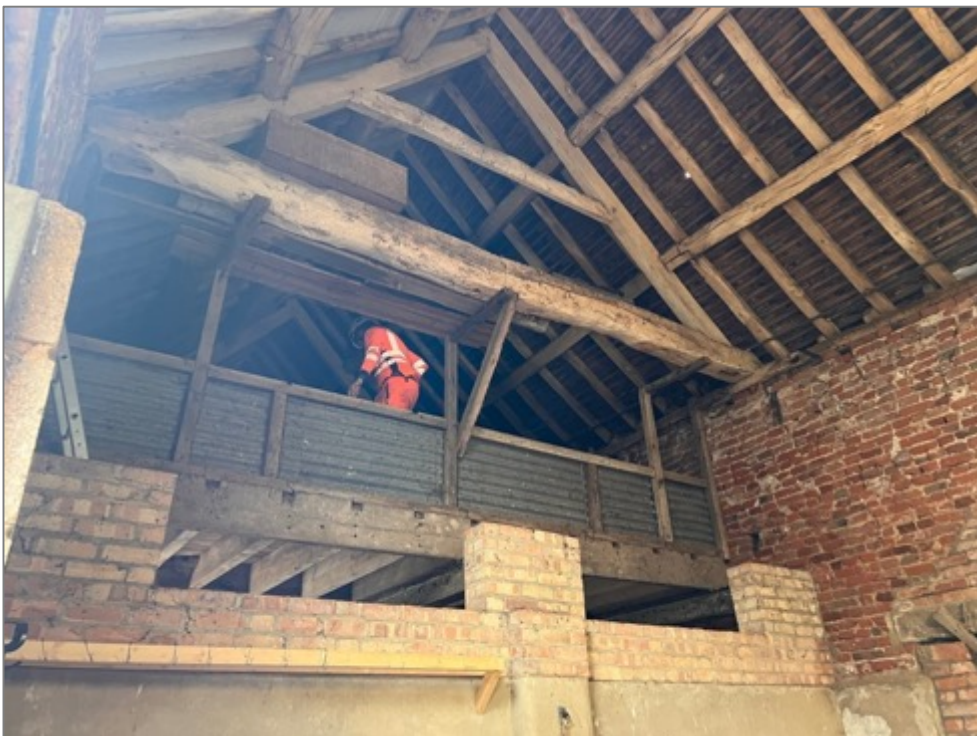
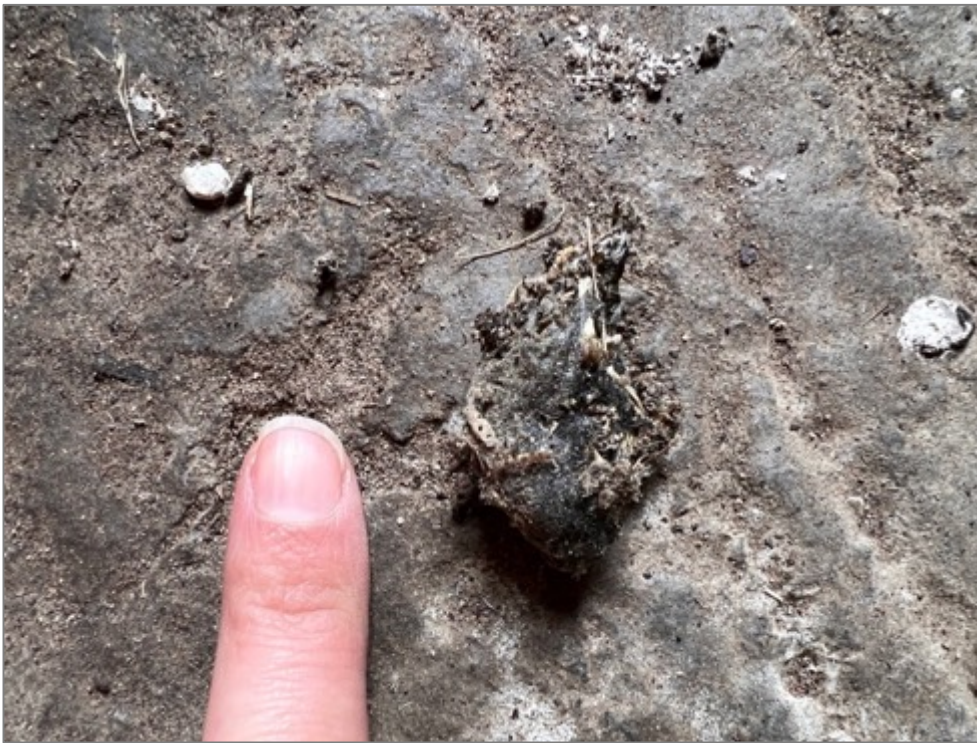
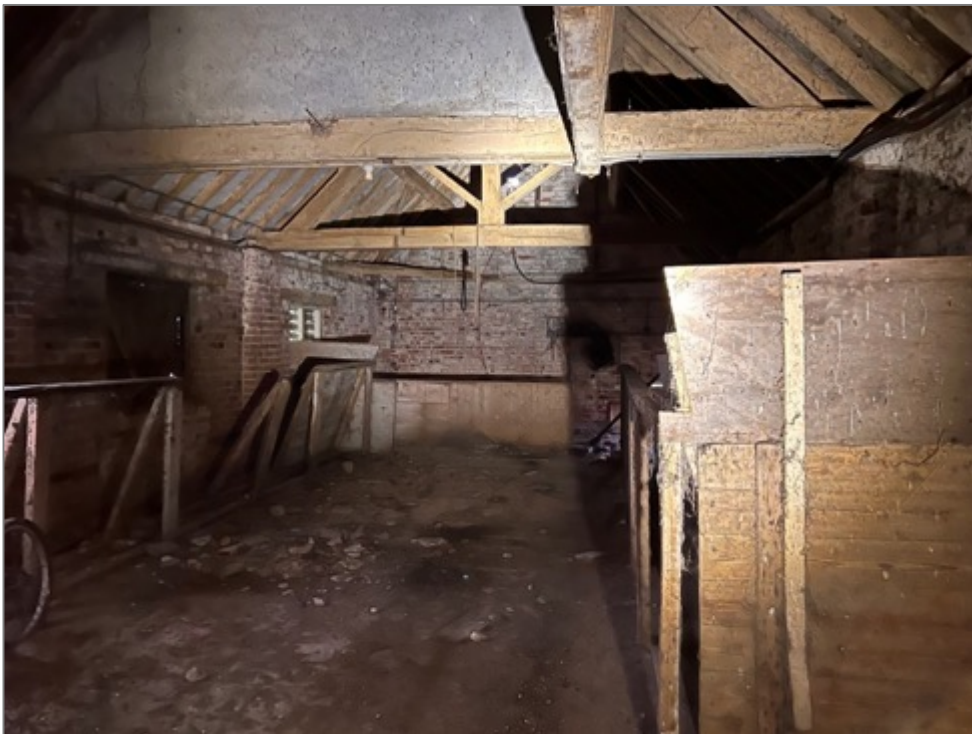
The nest box in the barn at farm F1 remains a potential nesting site but there was no evidence that it has been an active nest site.

Picture 26: F1 – barn containing nest box and with large timbers suitable for perching or roosting, no field signs of barn owl found. Several swallow nests and abundant bat droppings present.

Picture 27: F1 –nest box situated on beam inside barn, no field signs of barn owl found

Picture 28: F1 –old owl pellet found inside nest box, size consistent with tawny owl

Picture 29: F1 – rear room of barn with nest box, no field signs of barn owl found

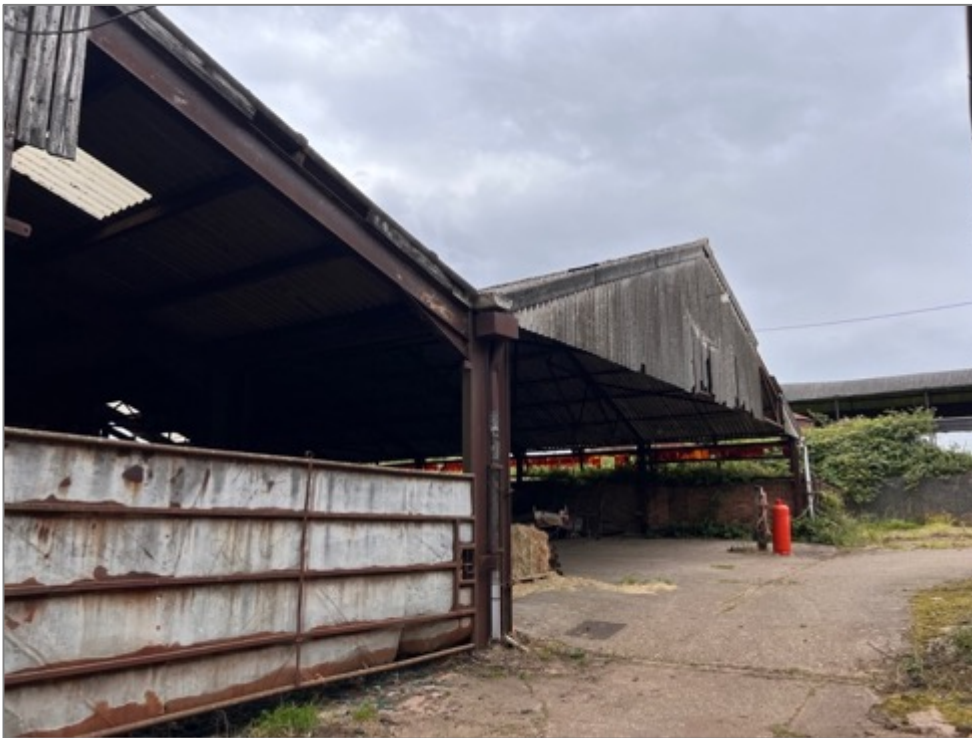
Picture 30: F1: modern agricultural barns with very limited potential for use by barn owl

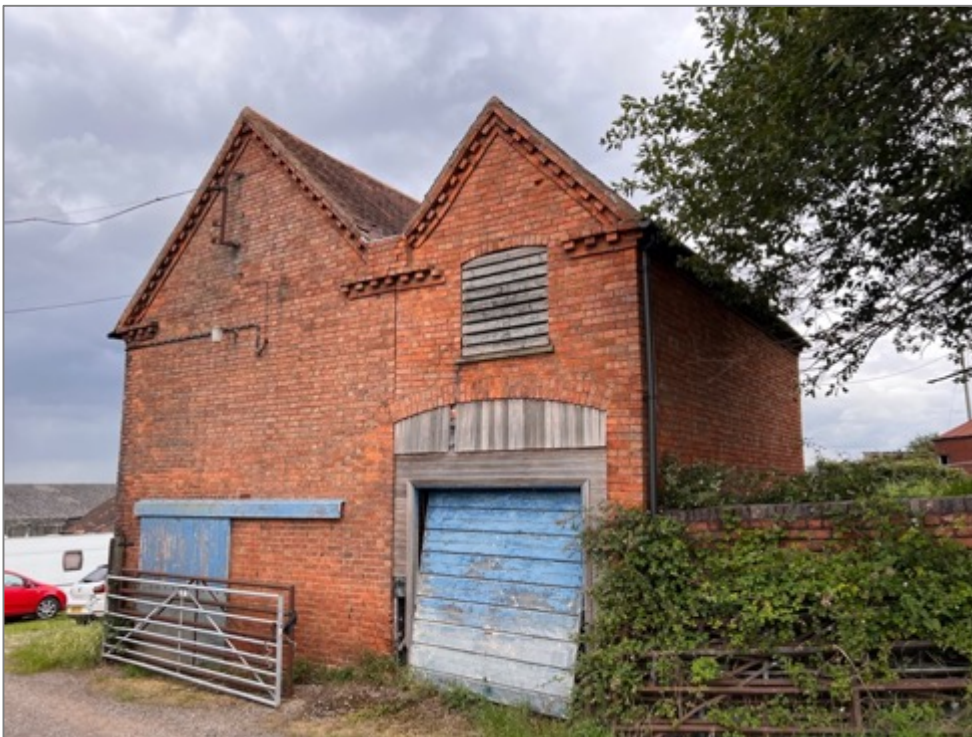
Picture 31: F1 – old milking parlour. Upper rooms appear suitable for barn owl but no field signs were found. Used extensively by nesting swallows and abundant bat droppings present.
