# **A46 Coventry Junctions (Walsgrave) Scheme number: TR010066**

### **Appendix 8.8 Bat Hibernation Report**

**ENVIRONMENTAL STATEMENT APPENDICES  
Appendix 8.8 Bat Hibernation Report**

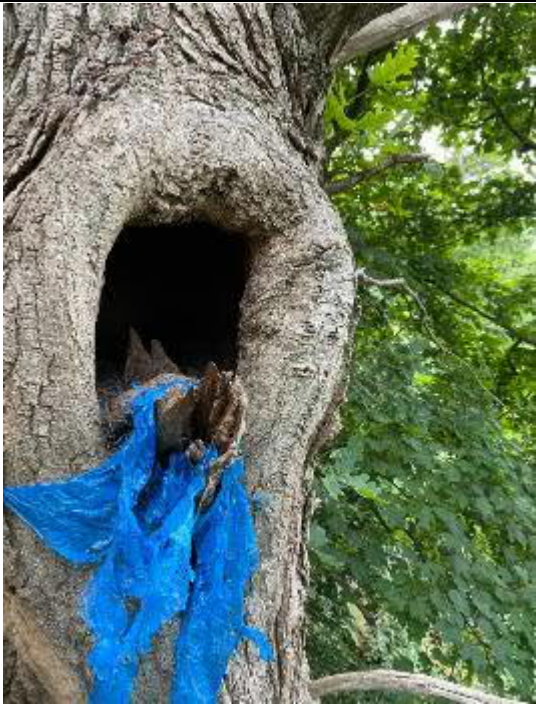
Tree ref.	PRF ref.	Photograph
	A

D	limb	LB	5	N	No	70	3	70	3	10	
								E	limb	W	6	E	No	10	2	30	2	2	Goes up 30cm and down 15cm
								F	limb	C	6	E	No	15	4	60	2	4	Goes up 60cm with multiple chambers, complex difficult to fully assess
■	152	Oak	110	17	Alive	SP38506 79032	High	A	stem	KH	10	W	No	20	15	26	20	0	Domed cavity, 25x25cm, tube extending up 60cm is 15cm wide, birds nest present with plenty of feathers

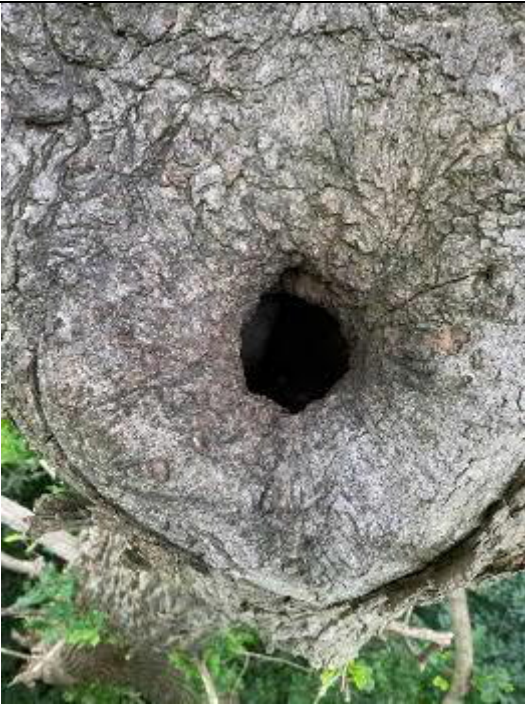
B	stem	KH	12	N	No	5	7	25	20	70	Extends down 40cm to flat base with bird's nest in base, also has a cavity extending up 25cm from right side of callus at opening of knothole
								C	stem	W P	13	S E	No	5	5	15	4	2	Chambers inside with multiple fissures that extend up and in
								D	stem	W P	14	N W	No	6	6	25	10	1	Domed top cavity in deadwood
								E	limb	W	11	N E	No	40	4	15	2	3	Several small internal chambers
								F	stem	KH	8	N W	No	20	20	20	25	0	Flat base with domed roof, bird feathers present but no obvious nest
								G	stem	LS	6	N W	No	35	5	25	10	20	
								H	stem	LS	2	W	Yes	5	5	1	1	2	Multiple crevices along lighting strike on main stem largest opening of 5x5cm, all with lots of debris
<u><b>KEY</b></u>																			
<b>Surveyors:</b> <div></div>																			
<b>PRF type:</b> TO = tear out; LS = lightning strike; KH = knothole; W = wound; LB = lifted bark; C = callus; WP = woodpecker hole
