A46 Coventry Junctions (Walsgrave) Scheme number: TR010066

Appendix 9.2 Soil Resource Plan and Agricultural Land Classification

Soil Resource Plan and Agricultural Land Classification

Title: A46 Coventry, Soil Resource Plan and ALC

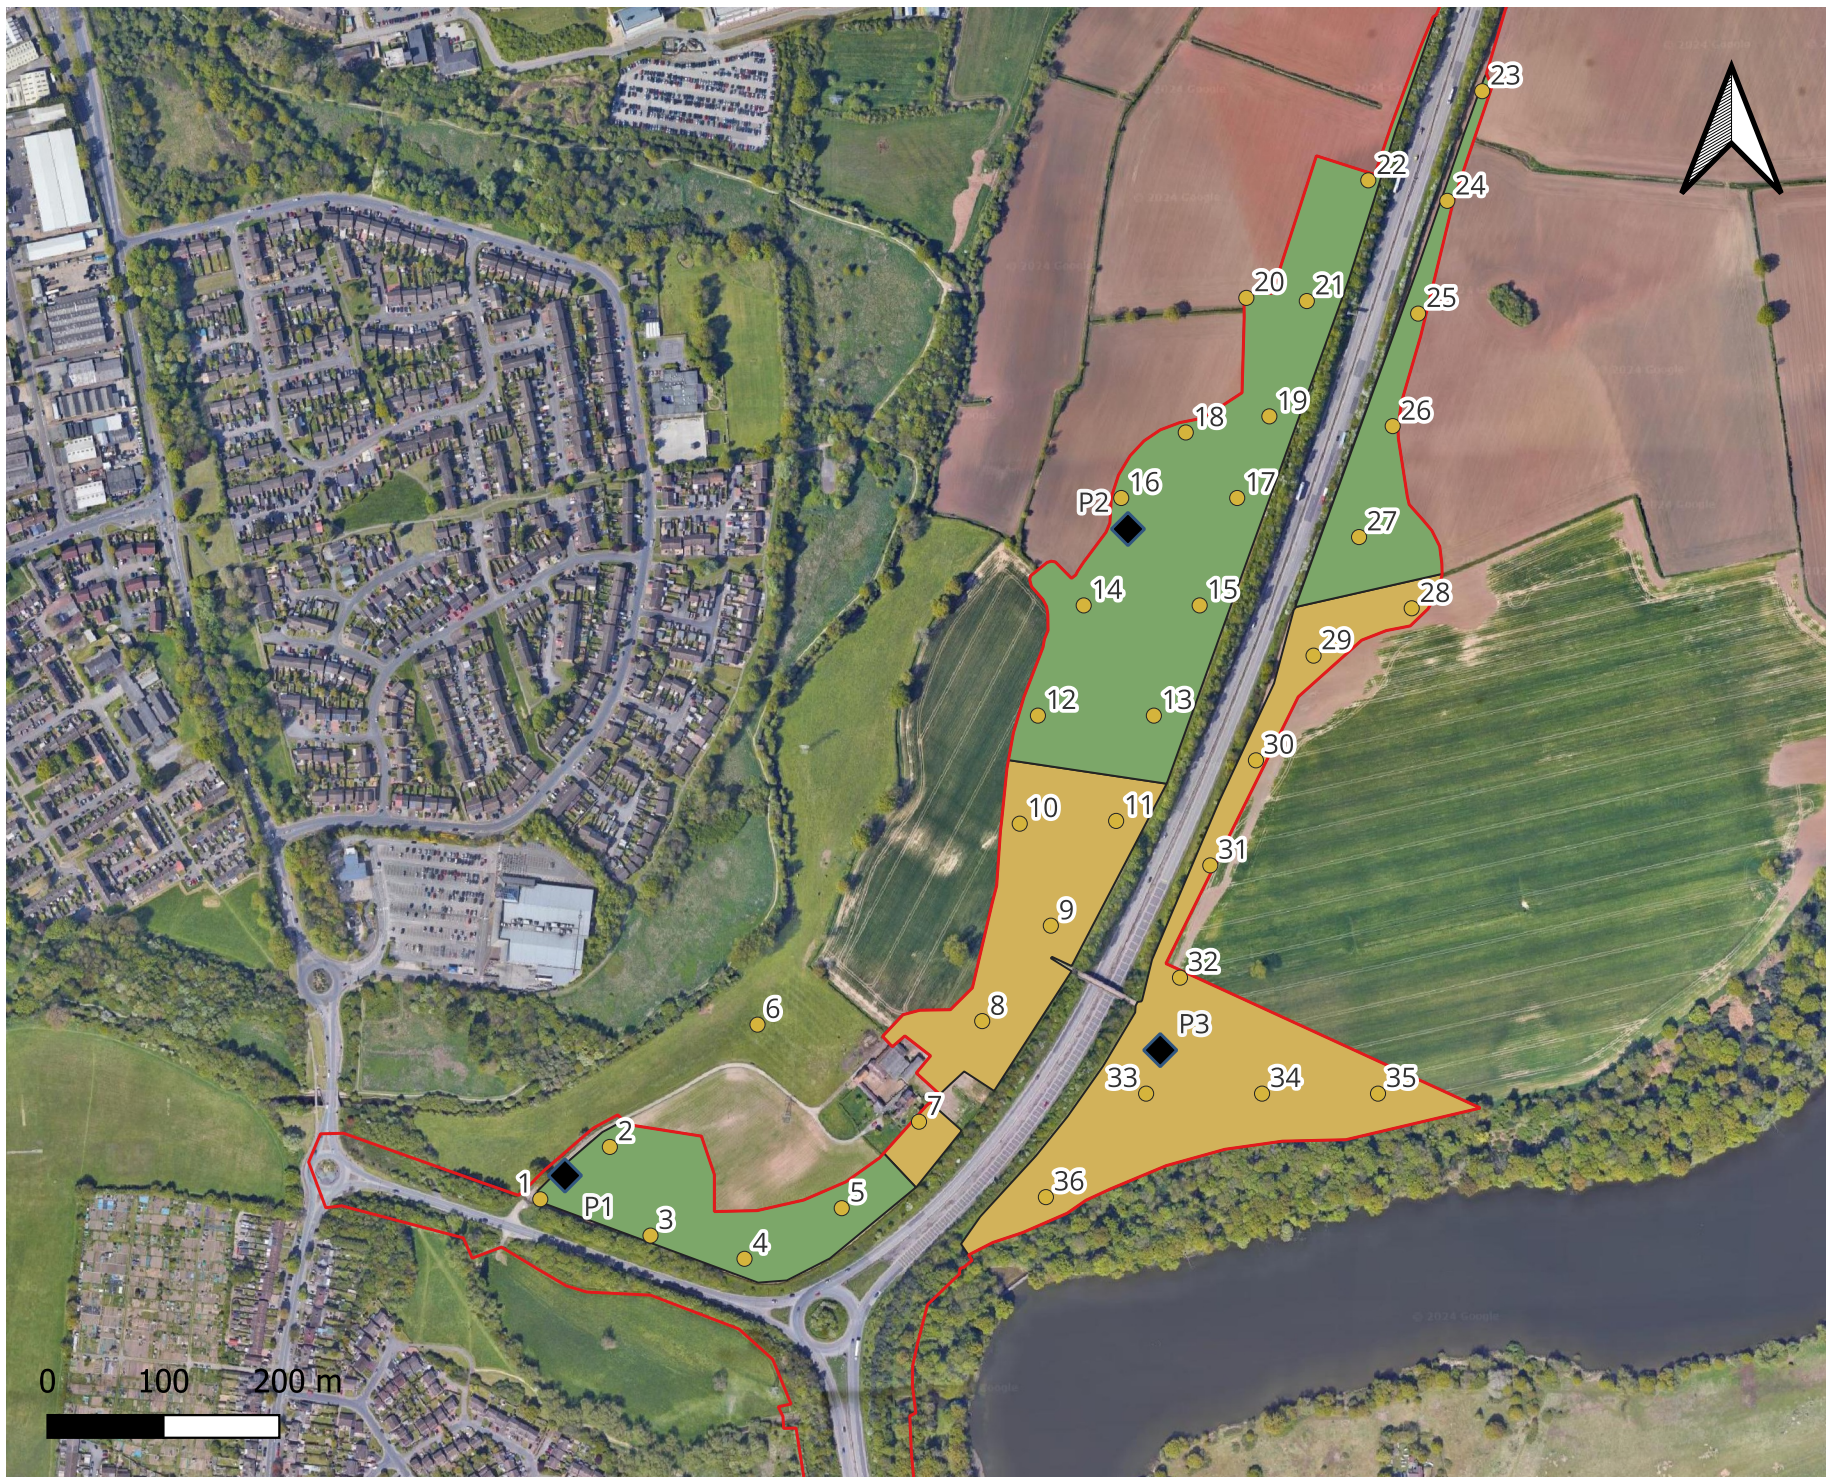
Appendix C. Soil Unit Map

- 5.1.1. The soils observed on site are representative of the two main soil associations mapped across the site.
- 5.1.2. For soil handling purposes the soils can be grouped into three soil types:
- Unit 1 – permeable, freely draining medium to light loamy soils
 - Unit 2 – permeable, moderately freely draining light loamy over clayey soils at depth
- 5.1.3. These soil types are described in detail below. A map showing areas covered by Soil Units 1 and 2 is included in this report in Appendix C.

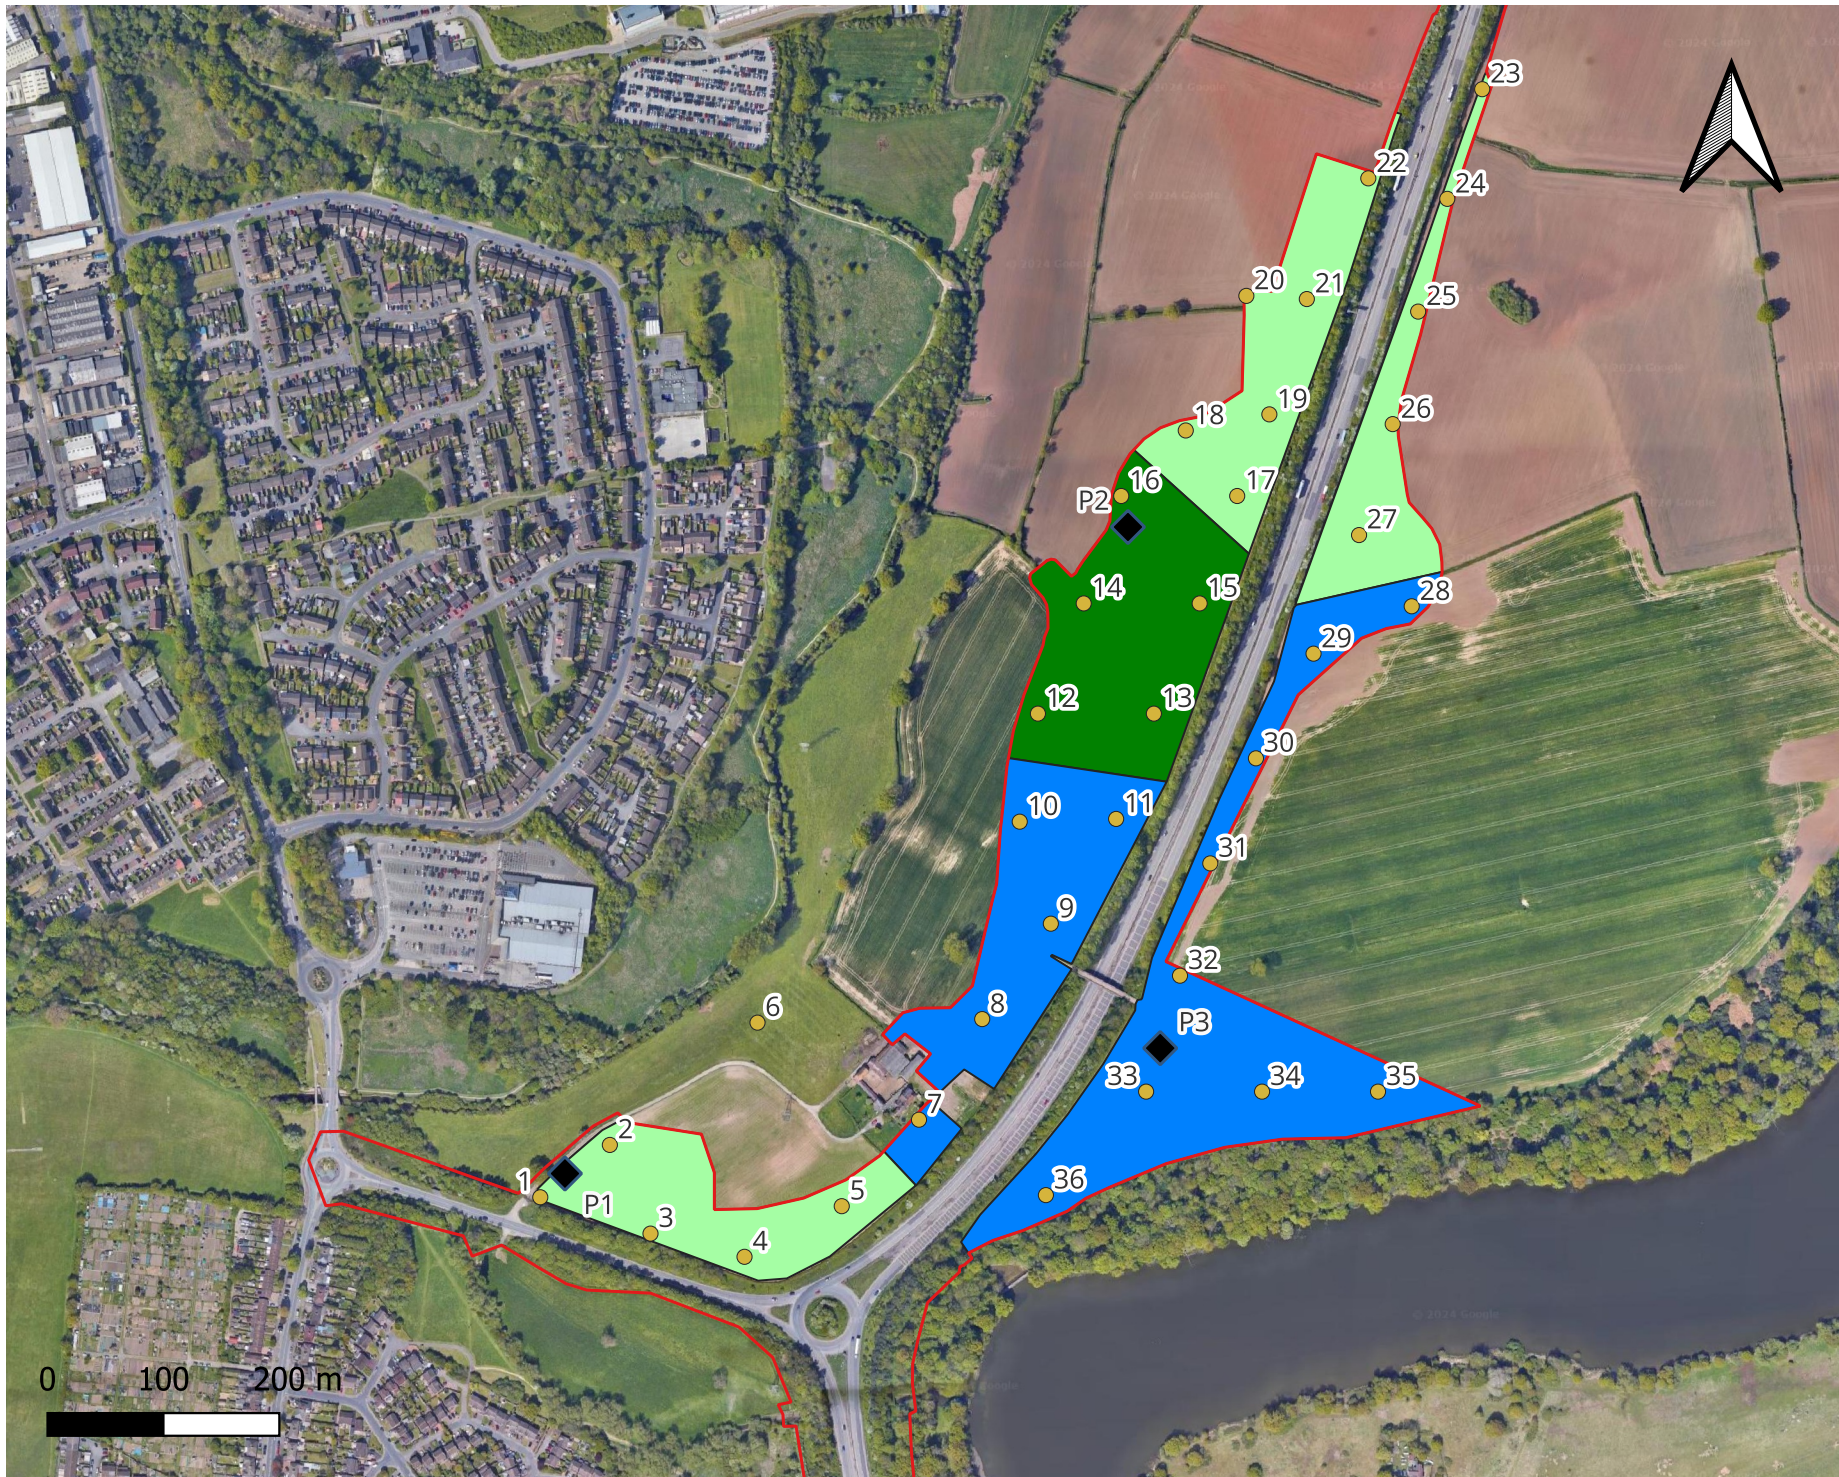
Appendix D. ALC Grade Map

- 10.1.4. In areas where the soils are medium/sandy and freely draining (Soil Unit 1), there is no limit to agriculture and the land is Grade 1 quality land. This land is found centrally in the survey area.
