A46 Coventry Junctions (Walsgrave)

Scheme Number: TR010066

Appendix 13.5 Hydromorphological Report

ENVIRONMENTAL STATEMENT APPENDICES **Appendix 13.5 Hydromorphological Report**

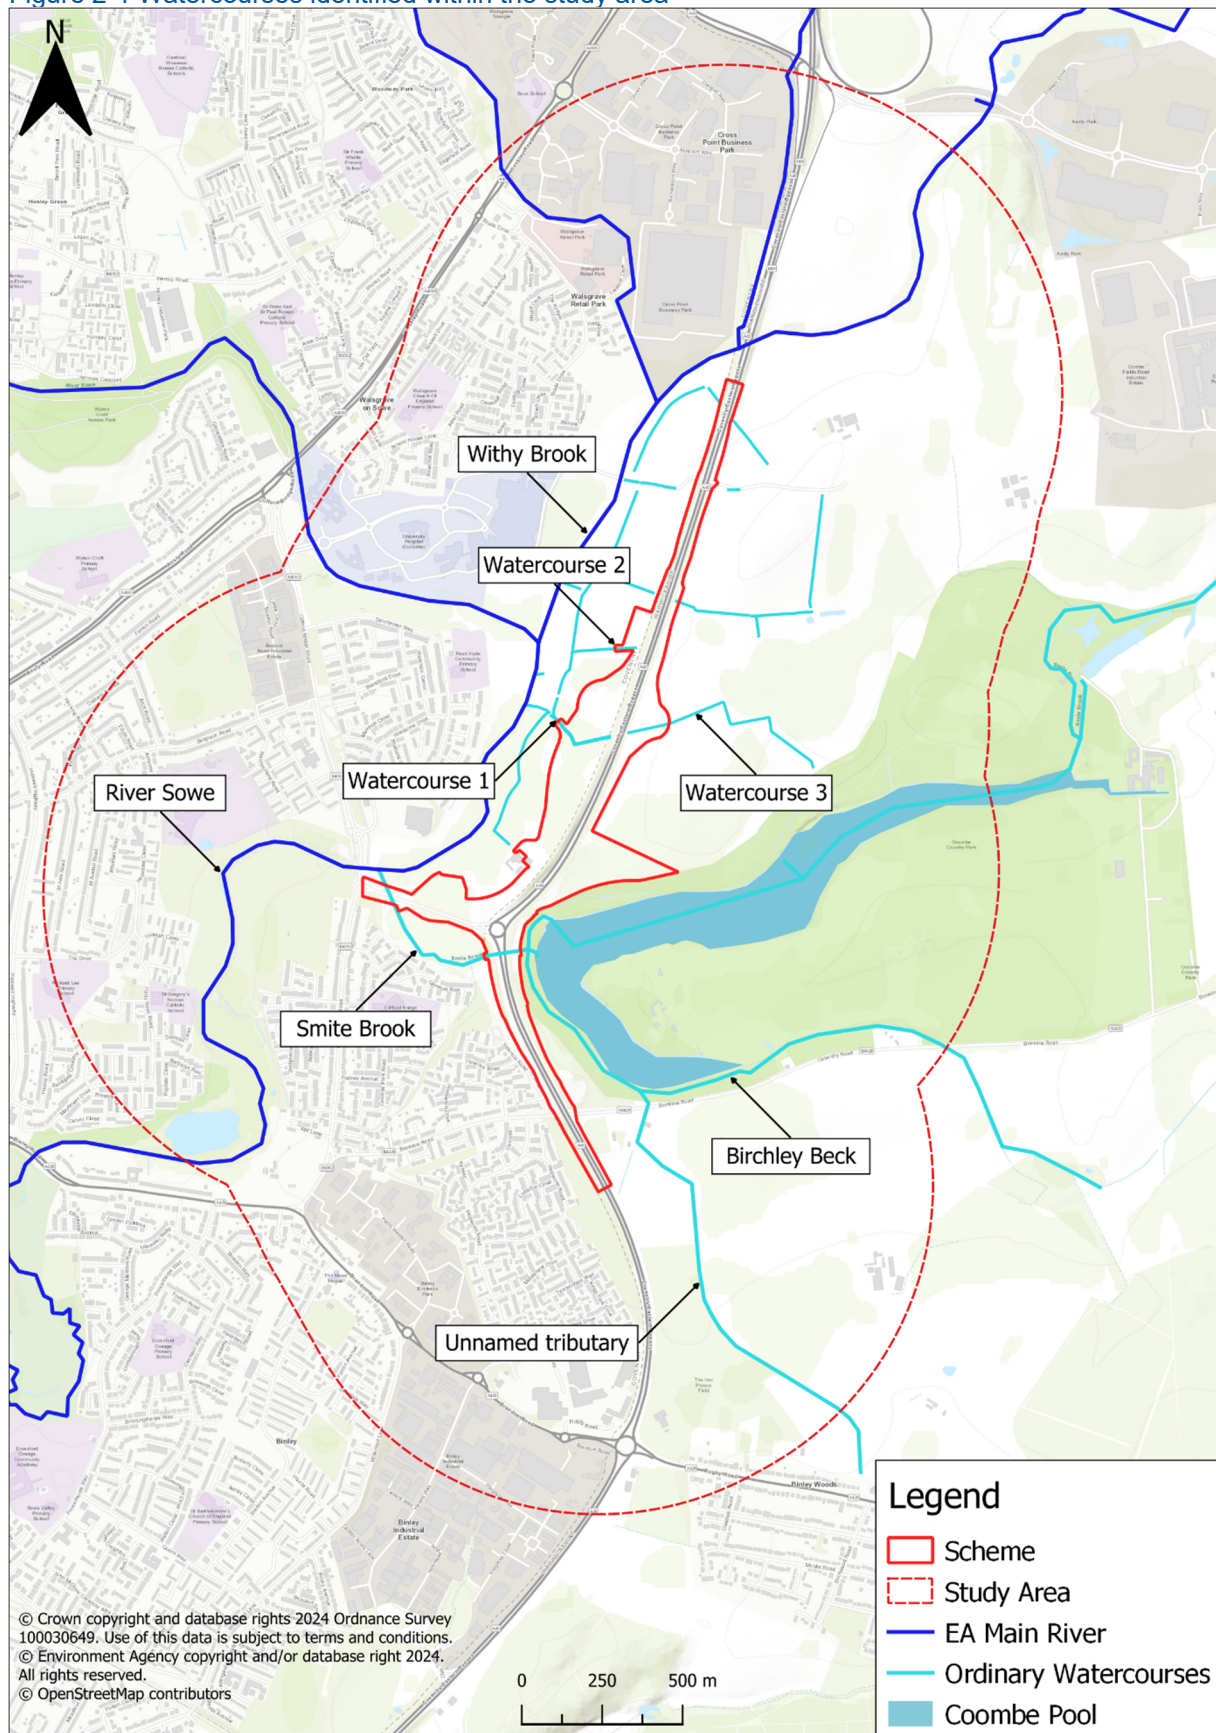
Figure 2-1 Watercourses identified within the study area

- 2.2.1. The study area contains several watercourses which include Coombe Pool, the River Sowe, Smite Brook, Withy Brook, Birchley Beck and unnamed watercourses (Figure 2-1). The River Sowe is a tributary of the River Avon which ultimately flows into the River Severn at Tewkesbury. The existing Walsgrave Junction is located 9km in a straight line upstream of the confluence with the River Avon. The catchment area of the River Sowe at the confluence of the River Avon is 265km² and is predominately characterised by a mixture of arable land use and the urban areas of East Coventry.

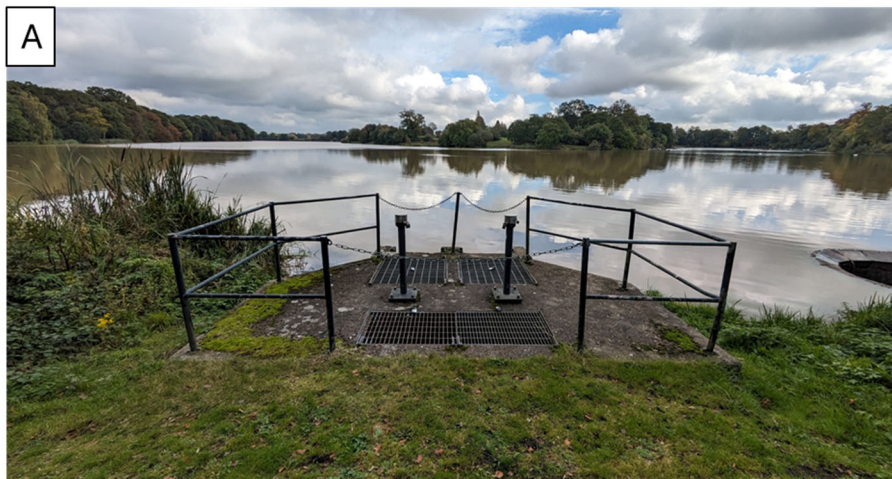
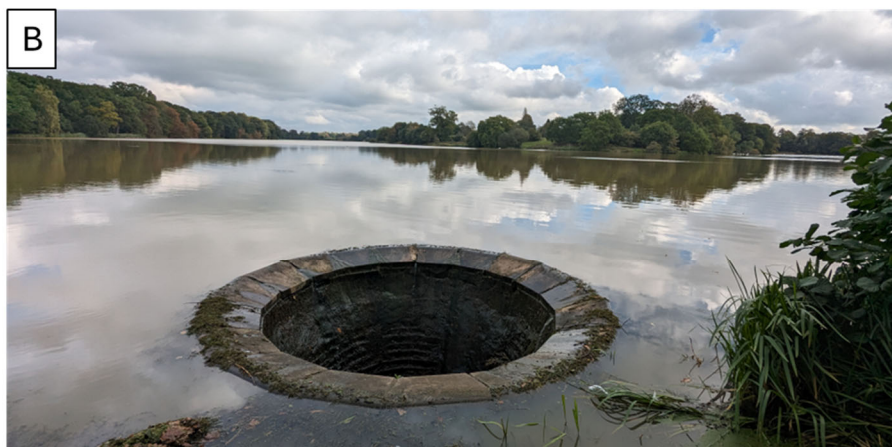
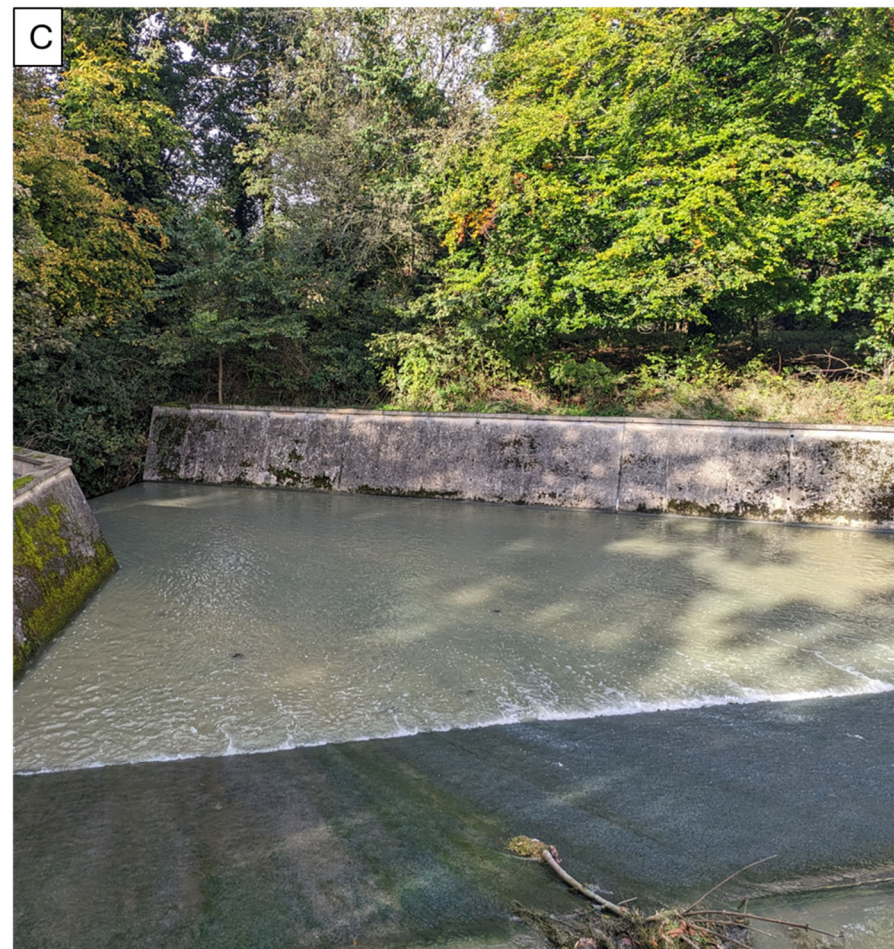
Figure 5-2 Photographs of the structures of Coombe Pool facing north for photos A-B and south for photo C

- 5.1.3. Smite Brook and Birchley Beck receive discharges from Coombe Pool via a sluice gate (Figure 5-2, photo A), a bell-mouth spillway (Figure 5-2, photo B) and an emergency drawdown spillway (Figure 5-2, photo C). Coombe Pool is a WFD water body (GB30937926). The reservoir is defined as heavily modified with a moderate ecological status, limited to moderate due to moderate physicochemical quality elements. Coombe Pool's chemical classification no longer requires assessment.

- 5.1.4. Coombe Pool and its connected watercourses are not directly modified by the Scheme but could receive overland runoff from construction works areas such as the reprofiling of the A46 southbound embankment. During the walkover there were no signs of erosion, instability or fallen trees in the reservoir.

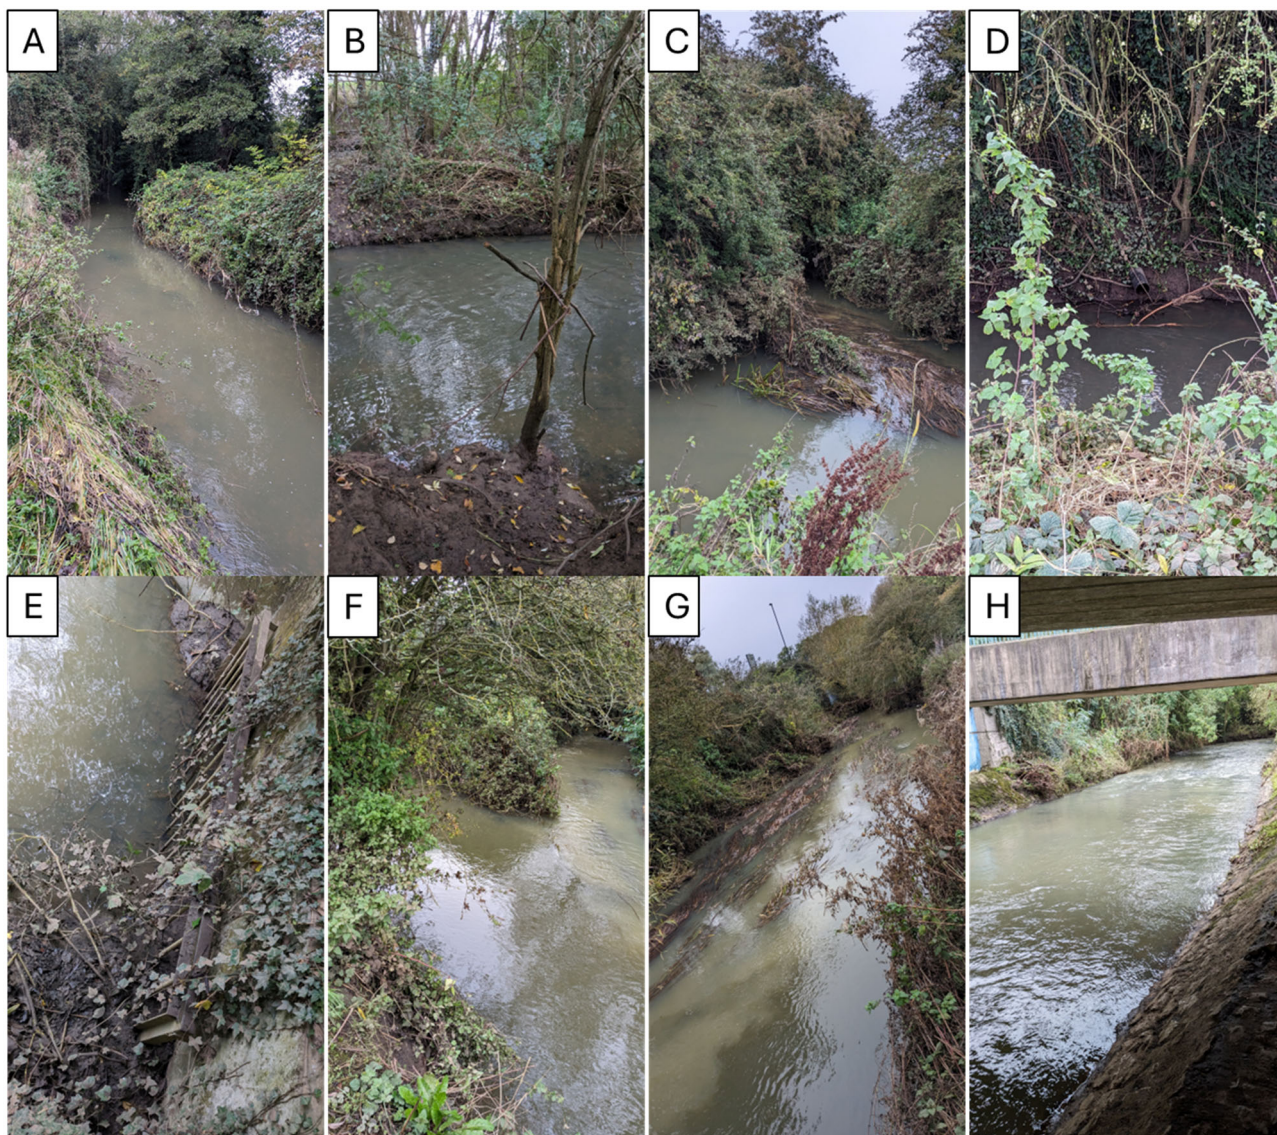
Figure 5-4 Photographs along the River Sowe

- 5.1.7. The River Sowe is approximately 5-6m wide and 1-1.5m deep within the study area and flows within an area of wooded/vegetated embankments and agricultural land (Figure 5-4). The riverbed is dominated by coarse pebbles and gravel in areas that the riverbed could be seen clearly. The watercourse is heavily vegetated with both in-channel and riparian vegetation at points (Figure 5-4, photos C and G) and is heavily modified by steep stone wall banks passing under the B4082. During the site walkover there were instances of minor bank erosion and instabilities as well as heavy vegetation and fallen trees in the watercourse. The turbid, silty water seen in Figure 5-4 is possibly due to recent storm events at the time of the walkover where there was evidence of the river breaking its banks as a result. This is evidence of floodplain connectivity between the River Sowe and surrounding fields.

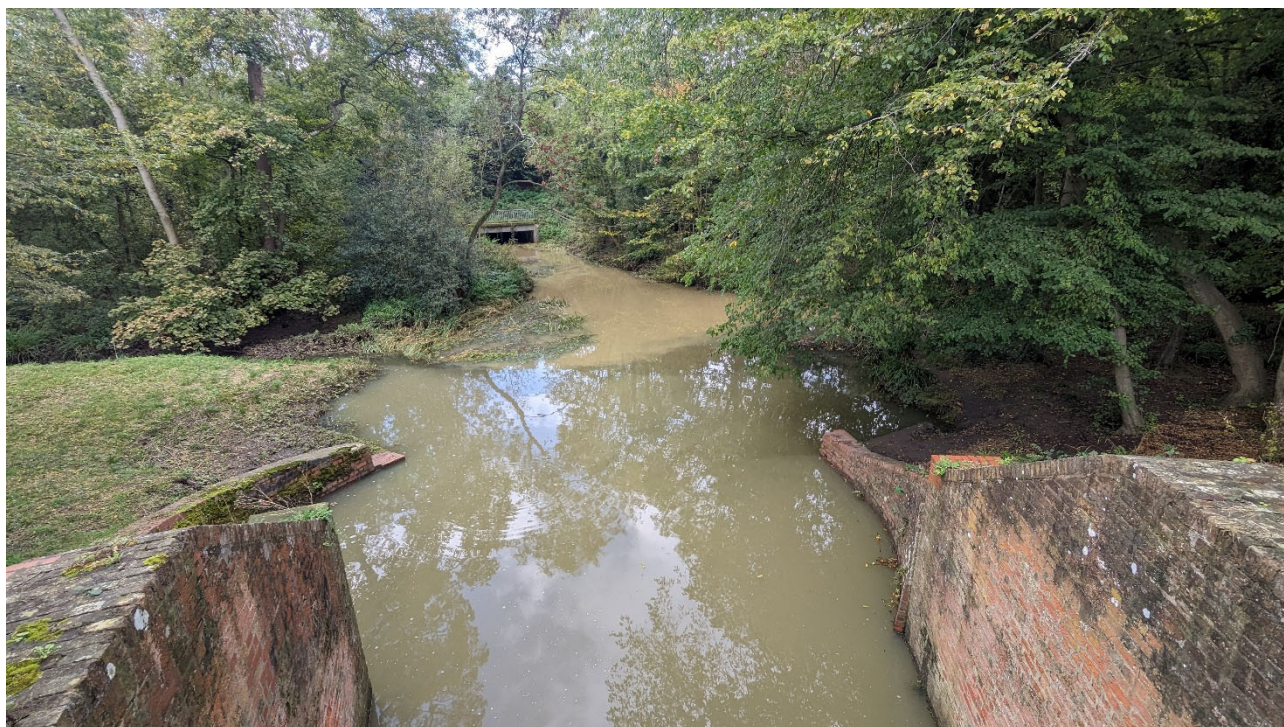
Figure 5-6 Upstream of A46 culvert

- 5.1.9. Figure 5-6 shows the Smite Brook and Birchley Beck confluence downstream of the Coombe Pool before passing beneath the A46 highway via the A46 culvert. Figure 5-6 highlights the turbidity of Smite Brook caused by the merging of discharges from Coombe Pool, flow from Smite Brook and flow from Birchley Beck.

- 5.1.12. During the site walkover there were instances of bank erosion and instabilities as well as heavy vegetation and fallen trees in the watercourse. Figure 5-6 shows the sediment input Smite Brook receives from Birchley Beck and Coombe Pool, this, coupled with the densely vegetated environment upstream of the A46 culvert creates a large amount of suspended sediment within the watercourse. Smite Brook then discharges into the River Sowe. The riverbed material along Smite Brook could not be determined due to the very silty watercourse likely caused by recent storm events identified in the desk study.

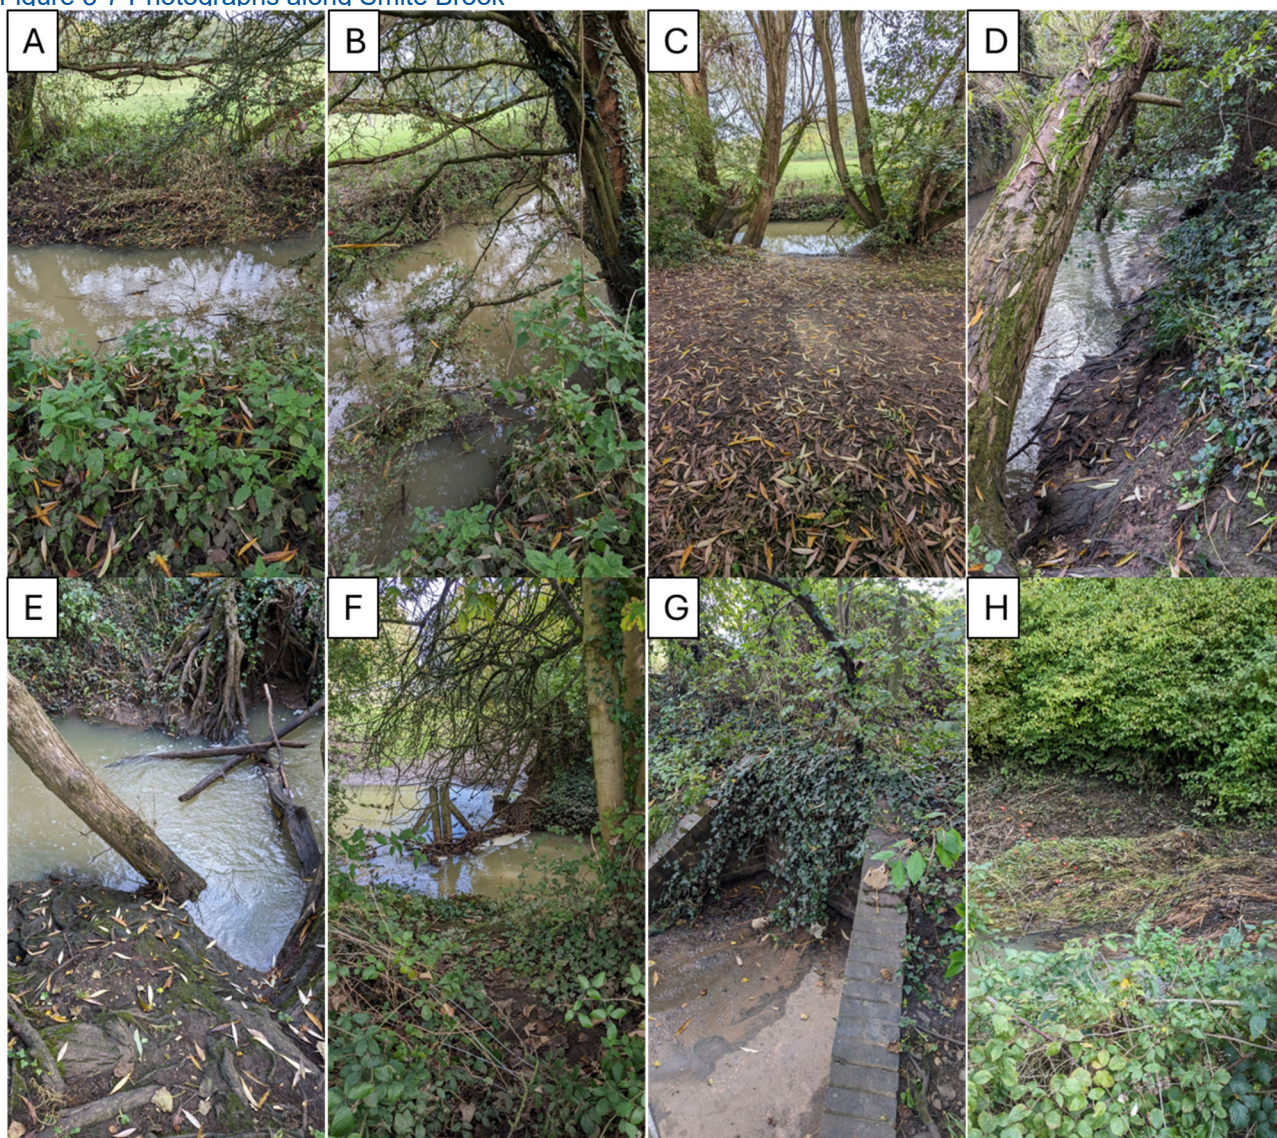
Figure 5-7 Photographs along Smite Brook

- 5.1.10. Smite Brook flows north-west through an area of pastureland (right bank) and an area with heavily terrestrial vegetated embankments about 0.5m high (left bank). The watercourse contains several areas of in-channel vegetation and fallen trees (Figure 5-7, photos D and E). Smite Brook is approximately 5m wide upstream of the A46 culvert with a higher bank and approximately 7m wide downstream of the A46 culvert with a lower bank.

- 5.1.11. The watercourse features several poaching areas for animals such as cattle as well as culverts, outfalls and an artificial wall which may have formed part of an old bridge (Figure 5-7, Photos D, F and G). Though this could not be confirmed through a comparison with historical mapping. The watercourse passes beneath the B4082 before its confluence with the River Sowe. Due to difficult terrain the hydromorphological condition of Smite Brook could not be assessed before the B4082 culvert and up to its confluence with the River Sowe.

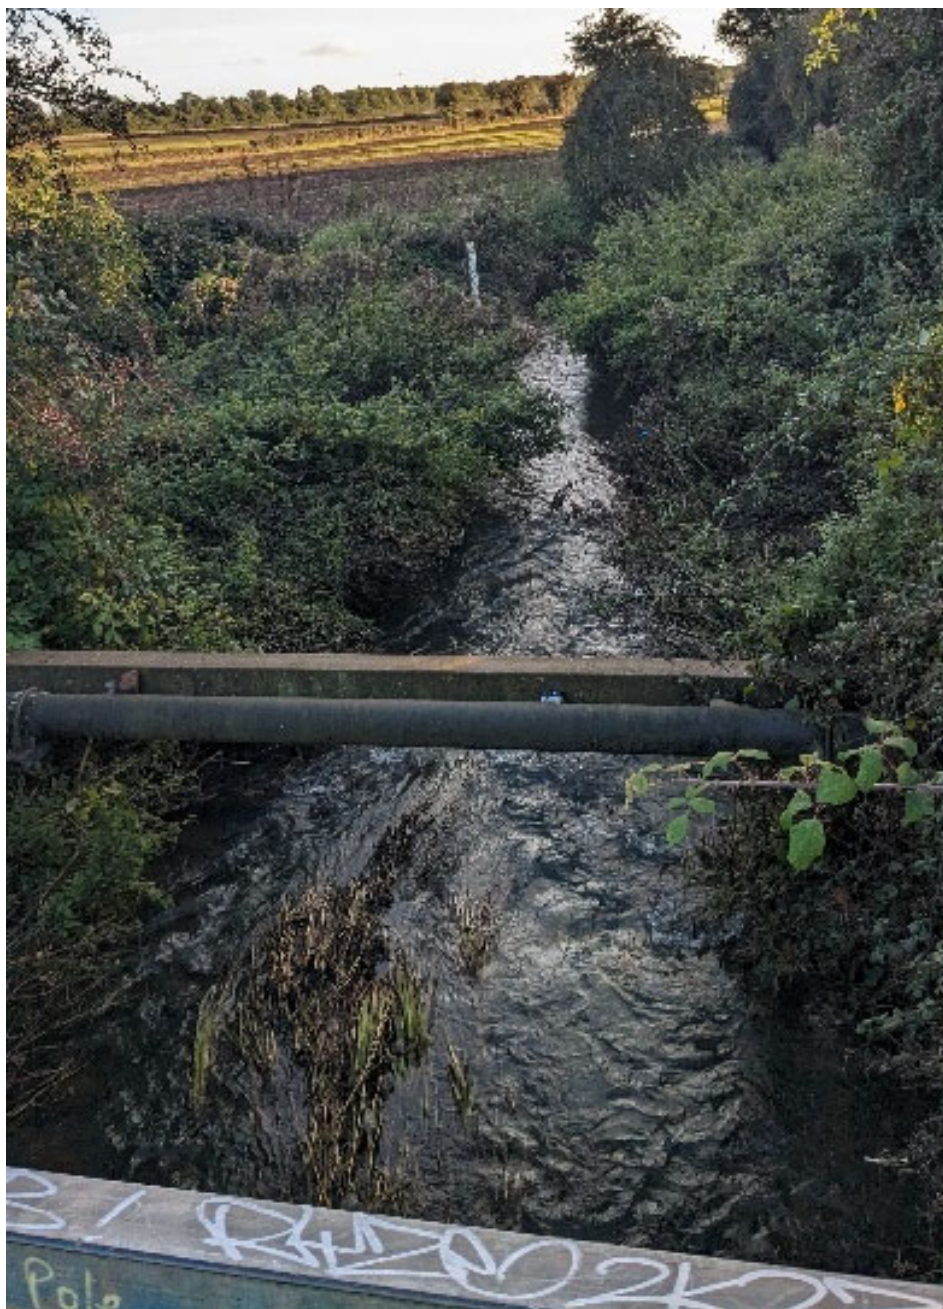
Figure 5-9 Looking downstream of High Bridge gauge on Withy Brook

- 5.1.14. Withy Brook is approximately 3m wide for its full length. Withy Brook flows through areas of pastureland where the watercourse is heavily vegetated with both in-channel and on the bank (Figure 5-9).

- 5.1.15. During the site walkover there were instances of heavy vegetation on the embankments overhanging the channel and fallen trees in the watercourse. The bank profile and bed substrate were unable to be determined due to the limited access to the watercourse and the heavy vegetation. Withy Brook receives discharge from a field drain 300m west of the Scheme.

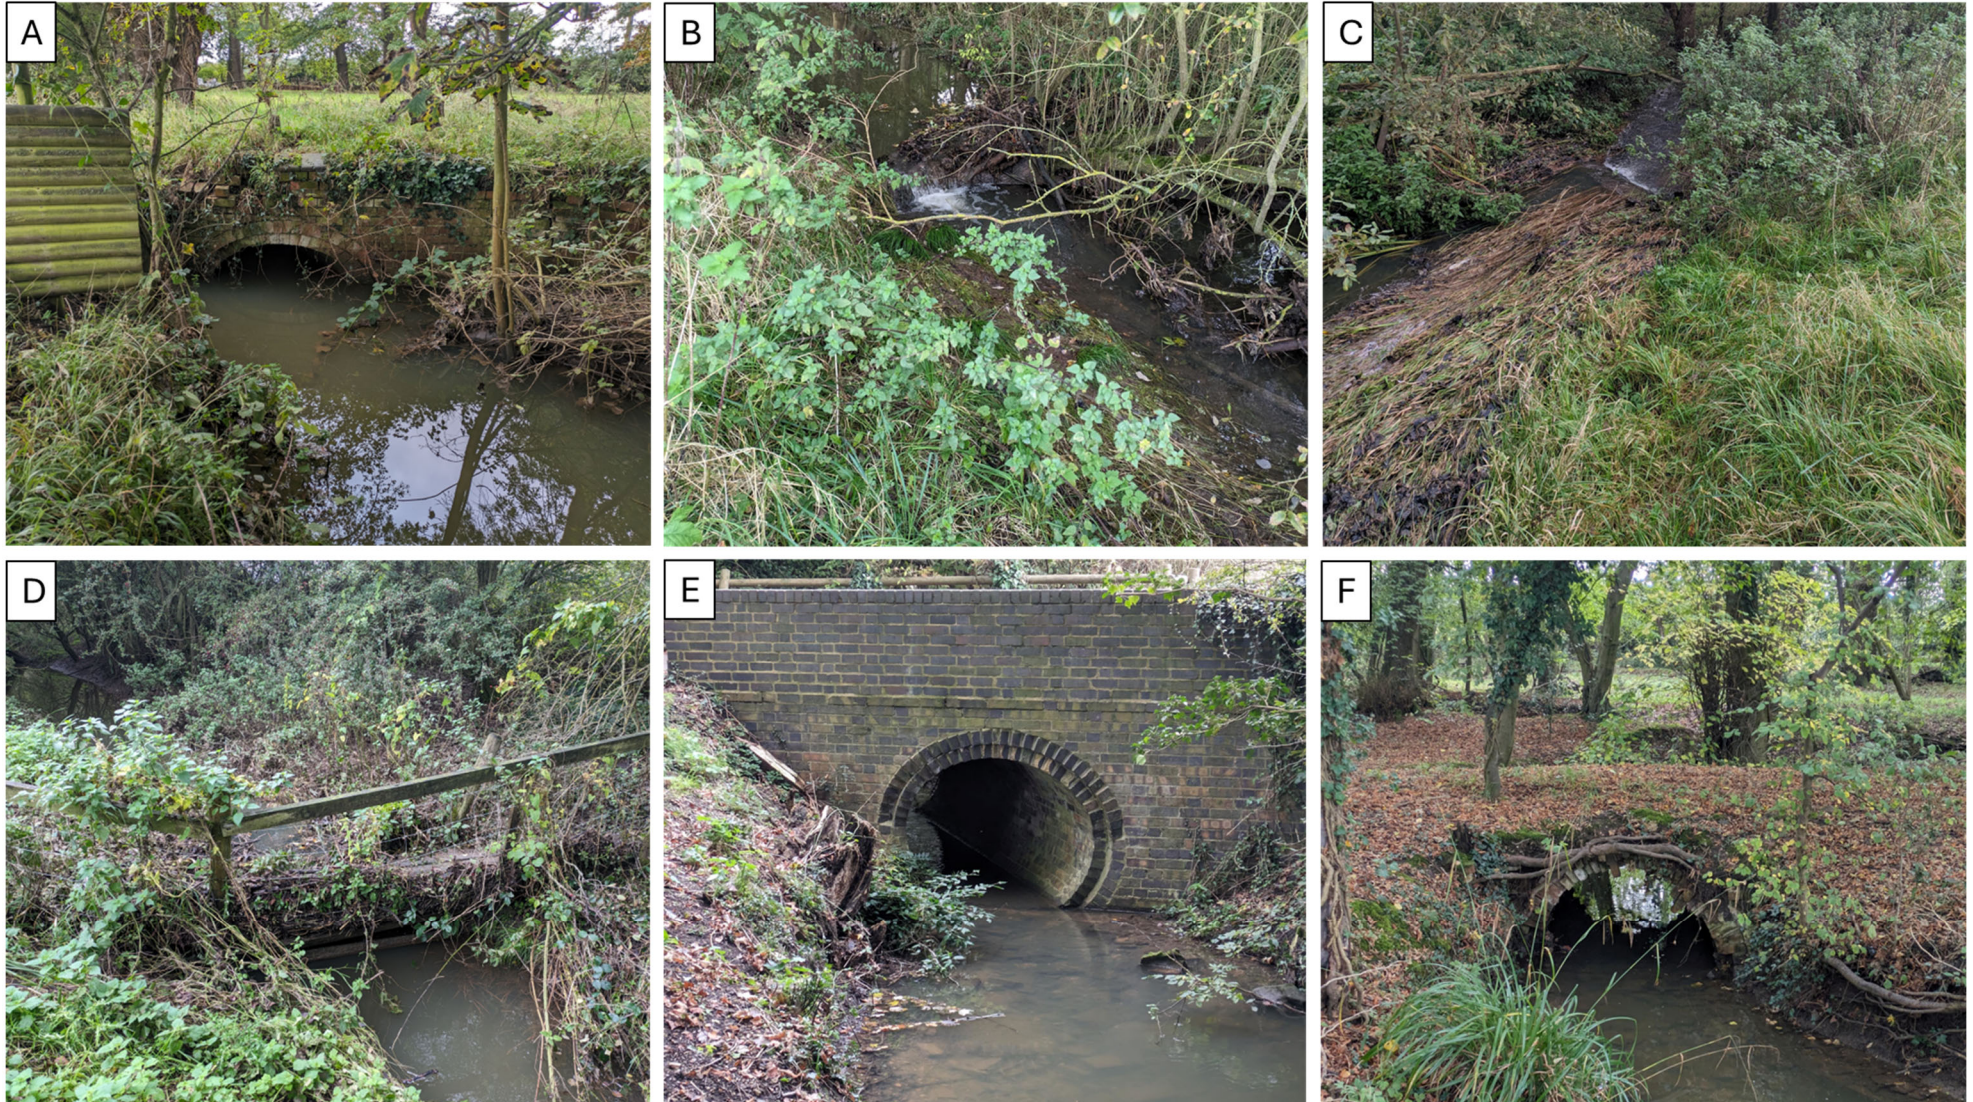
Figure 5-11 Photographs along Birchley Beck

- 5.1.17. Birchley Beck is culverted beneath the B4027 (Figure 5-11, photo A), and overtops steps in the bed. It is assumed these are made up of vegetation however the origin is unknown and could be further investigated during low flow conditions. (Figure 5-11, photos B and C). It is then culverted beneath a dilapidated footbridge (Figure 5-11, photo D).

- 5.1.18. Birchley Beck meets Smite Brook downstream of the Coombe Pool. Sluice gates (Figure 5-11) supply flows along Birchley Beck and Smite Brook and are managed by Warwickshire County Council. The watercourse at points is heavily vegetated with instances of falling trees and exposed roots, indicating channel incision. There were no J shaped trees, however leaning trees were observed. The riverbed is made up of a patchy silt layer.

- 5.1.19. Birchley Beck flows west through a series of culverts (Figure 5-11, photos E and F) before its confluence with the unnamed tributary, south of Coombe Pool. The unnamed tributary originates southeast of the Scheme and flows northwest. It is culverted beneath Brinklow Road before its confluence with Birchley Beck.
