Factual Report on  
Geoenvironmental Ground  
Investigation Cherry Cobb  
Sands

**FACTUAL REPORT ON GEO-  
ENVIRONMENTAL GROUND INVESTIGATION  
CHERRY COBB SANDS, HU12 9JX**

**FOR ABLE (UK)**

**DELTA-SIMONS PROJECT NO. 10-2041.01**

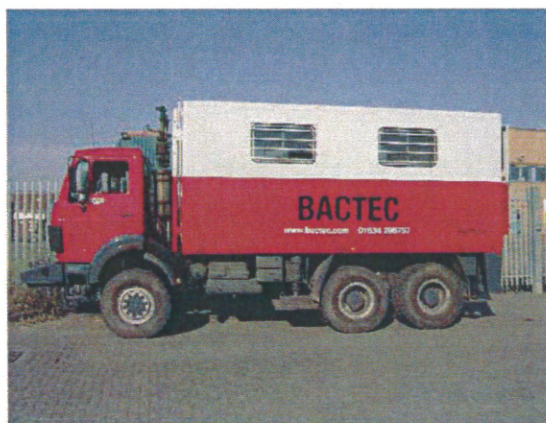
Annex B: CPT Rig Information

**Rig Description:** 6X6 Wheeled CPT/BXP Rig

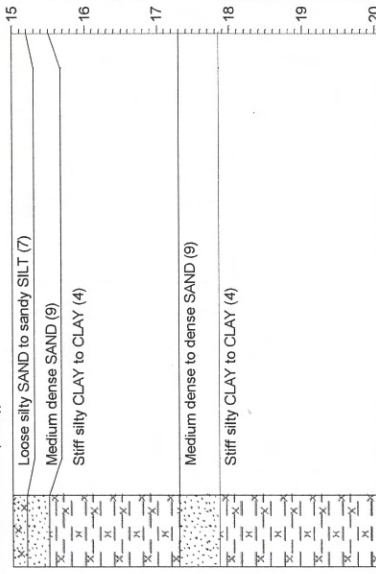
Estimated Soil Type  
(based on Robertson et al. (1986))

End of CPT at 20.08 m

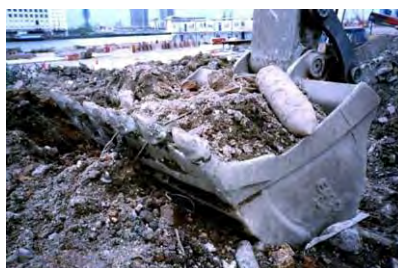
Bomb Dimensions: 1,090 x 280mm (42.9 x 11.0in)  
 Body Diameter: 200mm (7.87in)  
 Use: Against lightly damageable materials, hangars, railway rolling stock, ammunition depots, light bridges and buildings up to three stories.

Remarks: The smallest and most common conventional German bomb. Nearly 70% of bombs dropped on the UK were 50kg.

50kg bomb, London Docklands

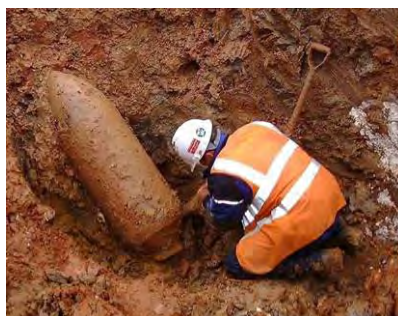
Bomb dimensions: 1640 x 512mm (64.57 x 20.16in)

Body diameter: 368mm (14.5in)  
 Use: Against railway installations, embankments, flyovers, underpasses, large buildings and below-ground installations.

250kg bomb, Hawkinge

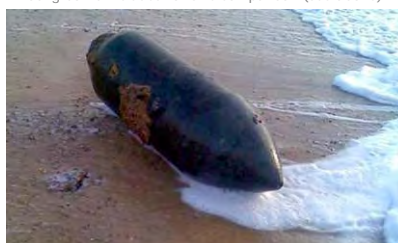
Bomb dimensions: 1957 x 640mm (77 x 25.2in)

Body Diameter: 470mm (18.5in)  
 Use: Against fixed airfield installations, hangars, assembly halls, flyovers, underpasses, high-rise buildings and below-ground installations.

500kg bomb, Felixstowe beach, April 2008

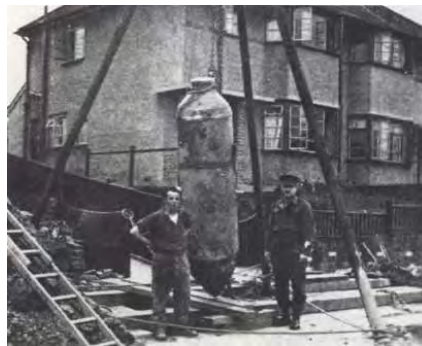
Bomb weight: 1,767-1,879kg (3,896-4,142lb)  
 Explosive weight: 1,000kg (2,205lb)  
 Fuze Type: Electrical impact fuze  
 Bomb Dimensions: 3500 x 670mm (137 x 26in)  
 Use: Against building complexes and large merchant vessels  
 Remarks: Known as the 'Satan'

1800kg bomb, Bristol, 1941

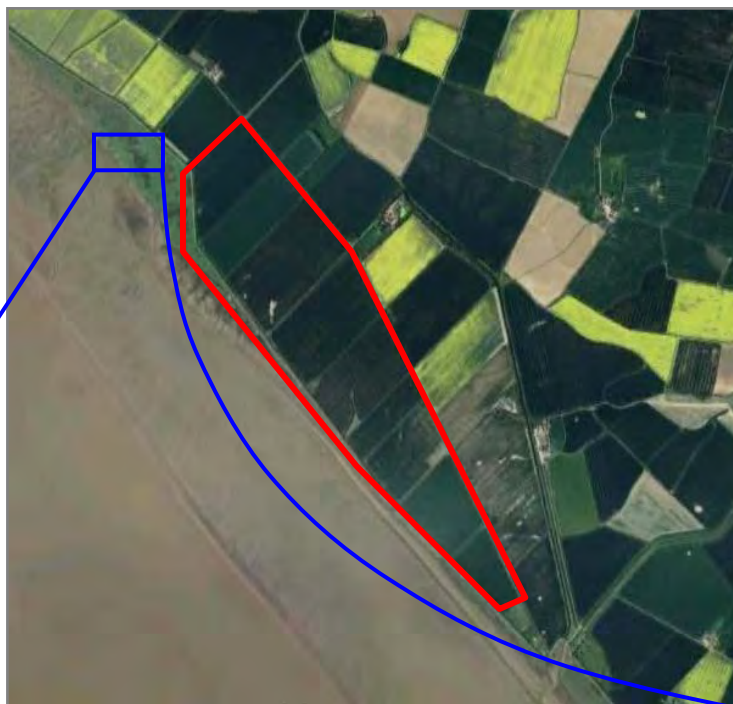
Annex I: Recent Aerial Photograph Showing WWII-era  
Naval Decoy in Proximity to Site

Enlarged Area

Artificial water pools

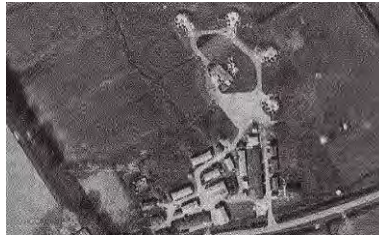
Slade Green's HAA battery, Dartford showing typical size and layout of the installation.

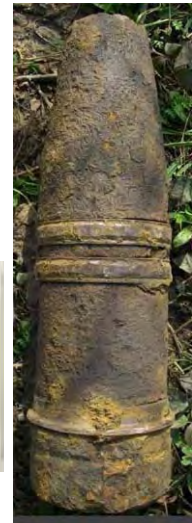
3.7 inch AA Projectile Minus Fuze

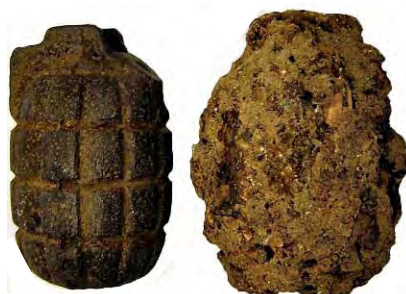
Weight: 0.7kg filled (1lb 6oz)  
 Type: Hand or discharger, fragmentation  
 Dimensions: 95 x 61mm (3.7 x 2.4in)  
 Filling: Alumatol, Amatol 2 or TNT  
 Remarks: 4 second hand-throwing fuse with approximate 30m range. First introduced May 1918.

Grenade, .303 inch rifle, No. 36M, Mark I.

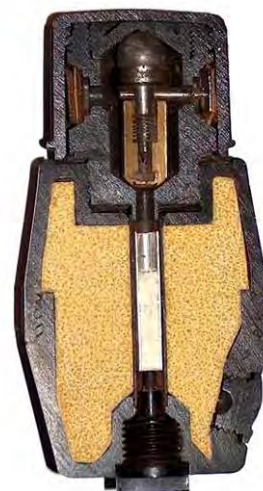
**Typical Smoke Grenade**

Dimensions: Approx. 65 x 115mm (2.5 x 4.5in)  
 Type: Smoke  
 Date Introduced: Current MoD issue  
 Remarks: Smoke grenades are used as ground-to-ground or ground-to-air signalling devices, target or landing zone marking devices, and screening devices for unit movement.

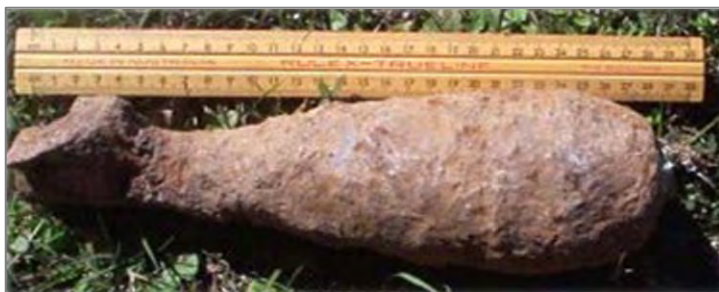
**Typical 2 inch Illuminating Mortar**

Type: Illum.  
 Dimensions: 51 x 290mm  
 Filling: Various  
 Remarks: The expulsion charge ignites and ejects the candle assembly. A spring ejects the parachute from the tail cone. The parachute opens, slowing the descent of the burning candle which illuminates the target.

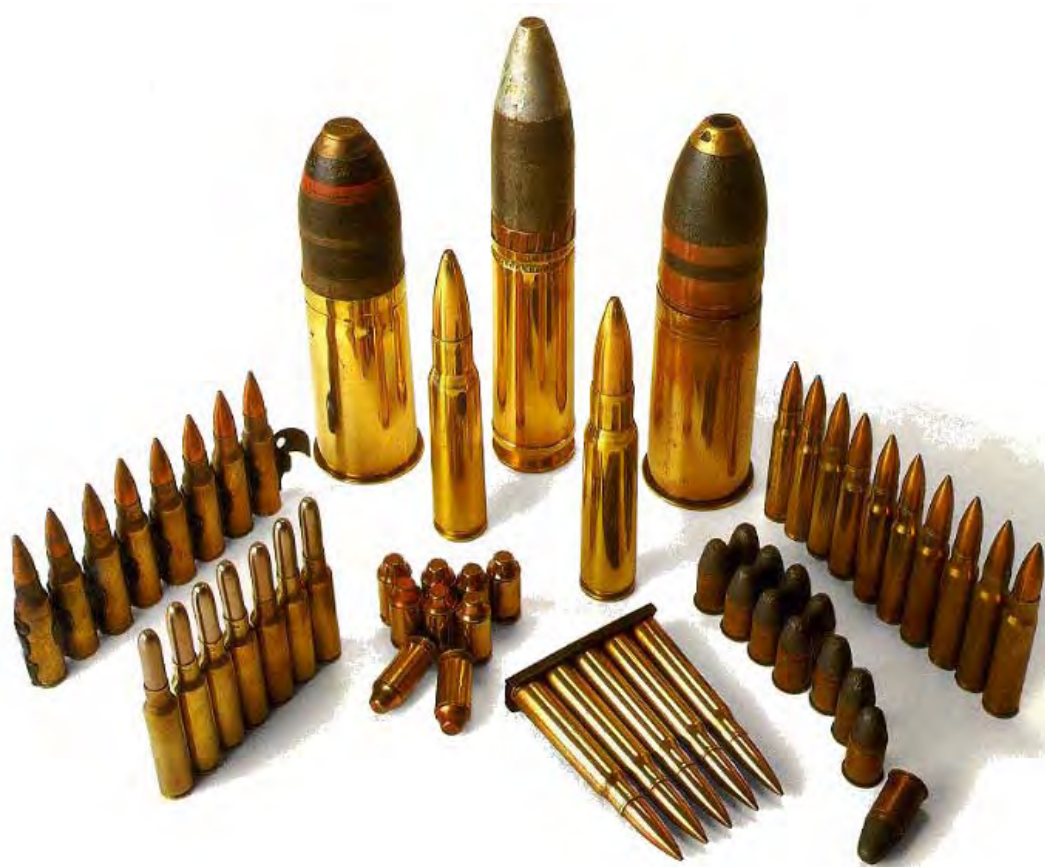
Small arms ammunition and cannon rounds up to 30mm

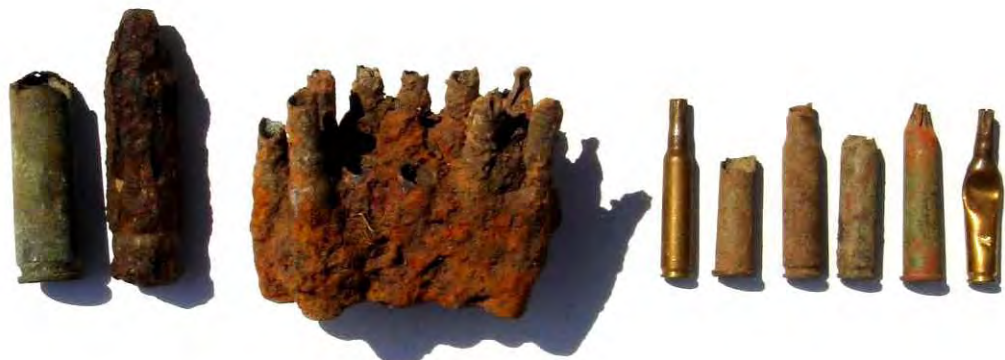
Recovered British WWII era SAA

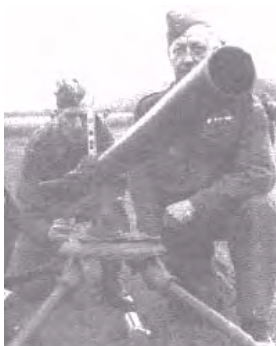
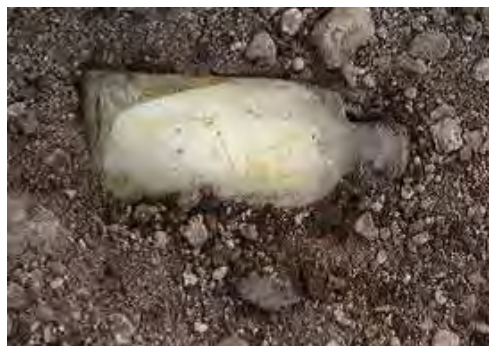
Filling: White Phosphorous and Benzene

Remarks: The grenade comprised a glass bottle with a total volume of approximately one pint. It was filled with White Phosphorus, benzene, a piece of rubber and water. Over time the rubber dissolved to create a sticky fluid which would self ignite when the bottle broke. Fired by hand or Northover Projector.

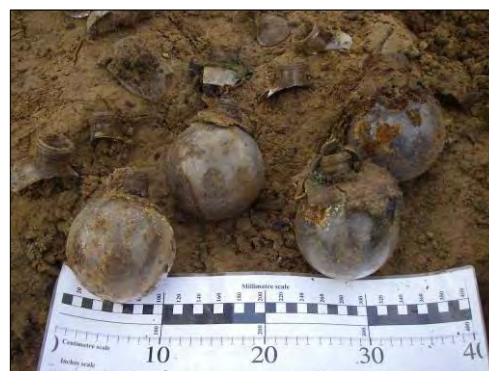
## No 74 Grenade (Sticky Bomb)

Remarks: Designed as an anti-tank grenade and used by the Home Guard. The grenade consisted of a glass ball on the end of a Bakelite (plastic) handle. Inside the glass ball was an explosive filling whilst on the outside was a very sticky adhesive covering. Until used, this adhesive covering was encased in a metal outer casing.

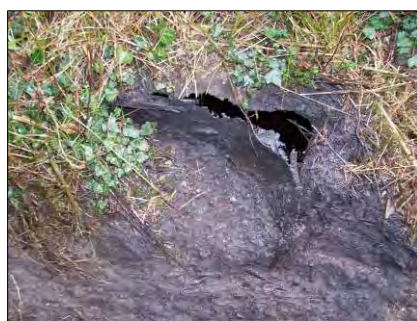
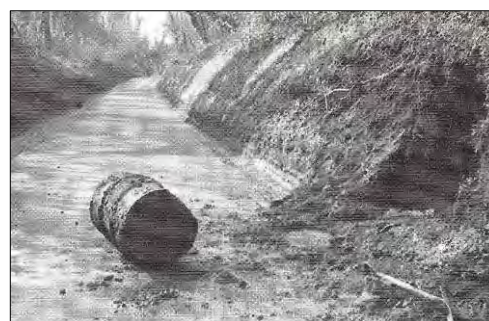
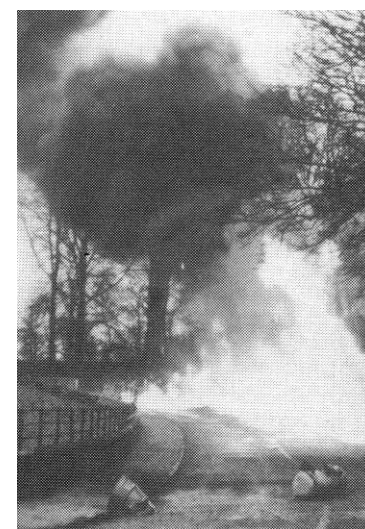
## Flame Fougasse Bomb

Remarks: A Flame Fougasse was a weapon in which the projectile was a flammable liquid, typically a mixture of petrol and oil. It was usually constructed from a 40-gallon drum dug into the roadside and camouflaged. Ammonal provided the propellant charge which, when triggered, caused the weapon to shoot a flame 3m (10ft) wide and 27m (30 yards) long. Initially a mixture of 40% petrol and 60% gas oil was used, this was later replaced by an adhesive gel of tar, lime and petrol known as 5B.
