**CHERRY COBB SANDS WET GRASSLAND  
KEYINGHAM DRAIN SALINITY STUDIES**

**OCT 2013**

Able UK Ltd  
Able House,  
Billingham Reach Industrial Estate,  
Teesside  
TS23 1PX  
Tel: 01642 806080 Fax: 01642 655655

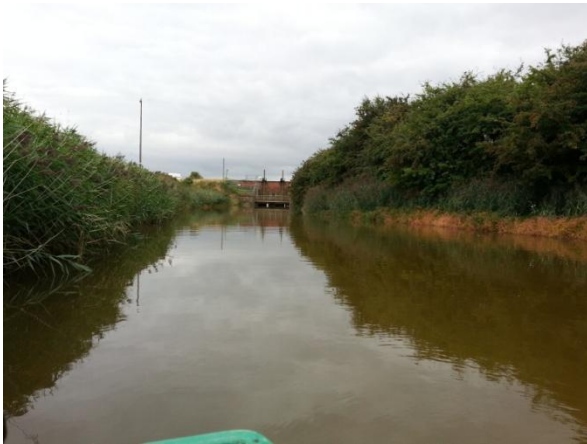
**Plate 1. Station 1 (direction south along drain)**

*Atriplex prostrata* fringing the water (Plates 1 - 4). Patches of *Scirpus maritimus* were also common along the drain with occasional *Aster tripolium* and *Aster tripolium var discoides*. All these species are tolerant of saline and brackish water, and are common on saltmarshes. The vegetation observed at station 7 (along the estuarine creek) was a typical mixture of salt marsh plants (Table 4).

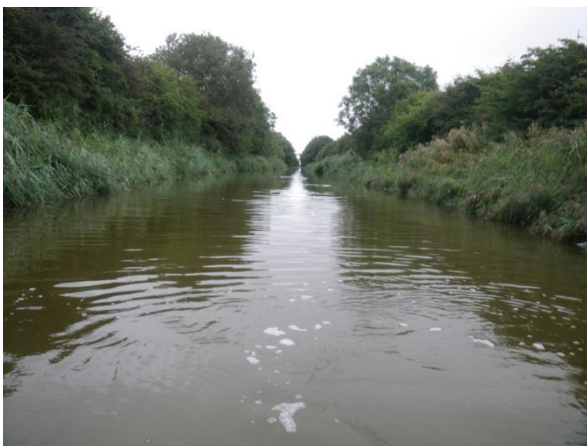
**Plate 3. Station 4 (direction north along drain)**

Along the length of the drain dense patches of *Crateagus monogyna* (Hawthorn) were present at the top of the banks, with mature *Fraxinus excelsior* (Ash trees) from stations 4 to 6 creating areas of dense shading and restricting the growth of ground vegetation.

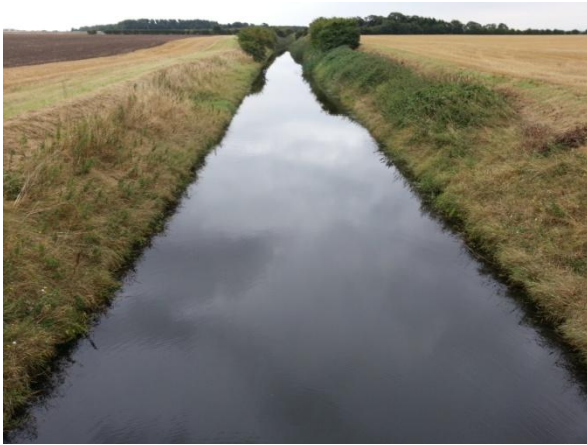
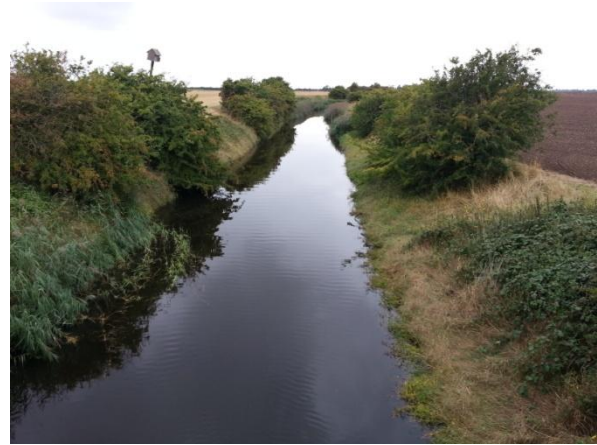
**Plate 5. Station 8 (direction south along drain)    Plate 6. Station 8 (direction north along drain)**

The only submerged aquatic vegetation observed along the drain was recorded at station 8, where small quantities of *Potamogeton pectinatus* and *Agrostis stolonifera* were present.

The presence of *Potamogeton* at station 8 could indicate freshwater conditions although it is also tolerant of brackish water. Vegetation along the banks was either often recorded in estuaries, or was common to both estuarine and freshwater conditions (e.g. *Phragmites*).

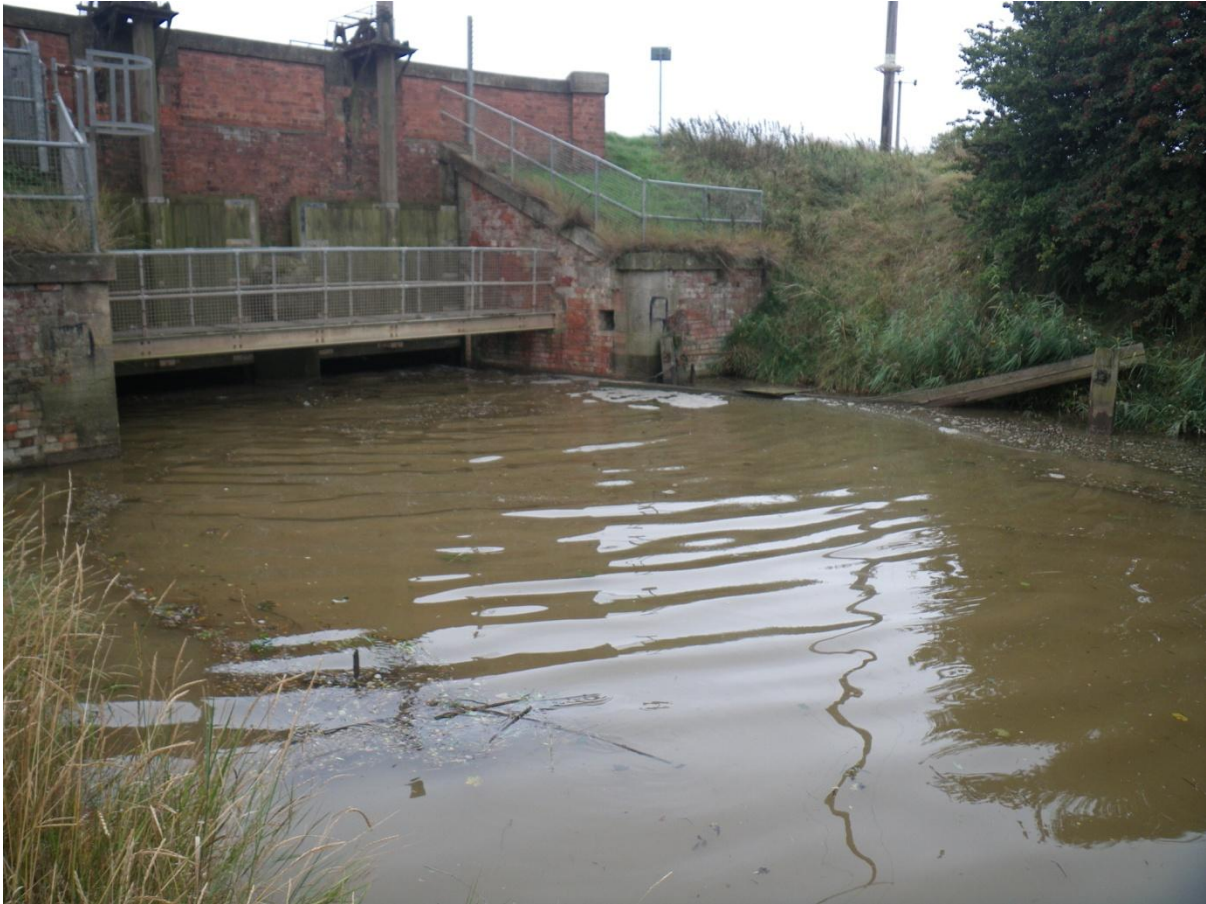
**Plate 7. Sluice at Keyingham drain with visible surface ripples from estuarine water entering the drain at high tide.**

- 4.1.3 A further conclusion of the IECS report is the positive identification that the clough is leaking significant volumes of water into the Drain even at comparatively high tides (the head of water on the Drain even at high tide is very small, and outflow is not powerful). Observational and photographic evidence is presented to demonstrate that water is passing inward through the clough. This further increases the likelihood that leakage through the clough is the principal source of saline contamination, as suggested by the other studies.

- 6.1.4      Discussions with the EA have identified that the clough is known to be in need of substantial refurbishment. Repair and refurbishment of this structure will lead to a dramatic increase in its efficiency, and although perfect efficiency may not be achieved, saline ingress will be reduced very significantly. Repair works to the clough will thus effectively resolve any uncertainty in the functioning of CCSWG which may arise from its water supply.

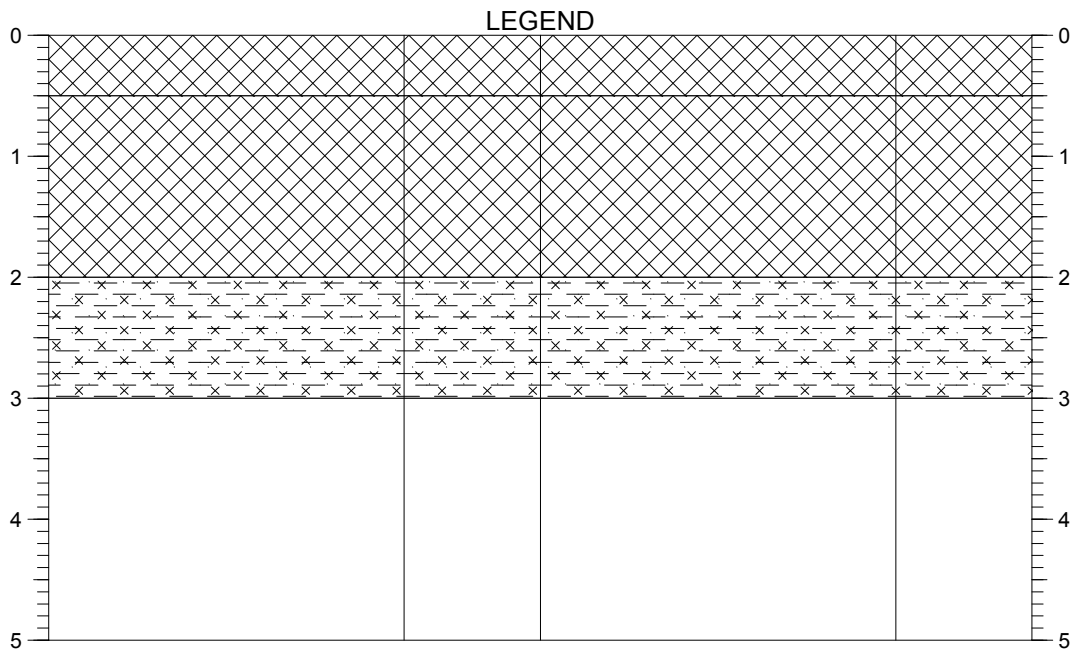
Project:	<b>Cherry Cobb Sands Wetland</b>	Project No:	<b>13-0054.01</b>	Hole ID:	<b>TP1</b>
<b>TRIAL PIT LOG</b>		Date:	11/04/2013	Client:	<b>Able UK</b>

STRATA			SAMPLES		TESTS	
Depth	No	DESCRIPTION	Depth	No	Depth	Results
(0.50)	0.50	MADE GROUND: Brown gravelly sandy clayey topsoil with grass. Gravel is fine to coarse. Sand is fine.	0.00	D		
			0.20	j		
(1.50)		MADE GROUND: Brown/yellow clayey sand.	0.50-2.00	B		
			1.00	j		
(1.00)		Black, clayey, silty SAND.	2.00-3.00	B		
			2.50	j		
		Borehole complete at 3.00m bgl.

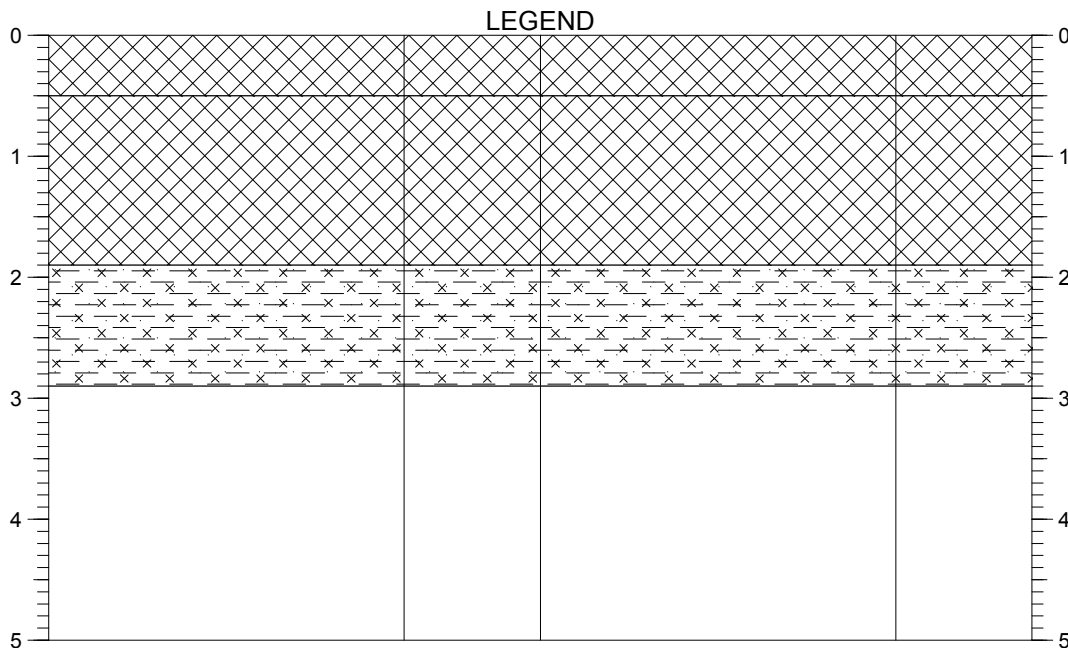
Project:	<b>Cherry Cobb Sands Wetland</b>	Project No:	<b>13-0054.01</b>	Hole ID:	<b>TP10</b>
<b>TRIAL PIT LOG</b>		Date:	11/04/2013	Client:	<b>Able UK</b>

STRATA			SAMPLES		TESTS	
Depth	No	DESCRIPTION	Depth	No	Depth	Results
(0.50)	0.50	MADE GROUND: Brown gravelly, sandy, clayey topsoil with grass. Gravel is fine to coarse. Sand is fine.	0.00	D		
(1.40)	1.90	MADE GROUND: Brown/yellow clayey sand.	0.50-1.90	B D		
(1.00)	2.90	Black clayey, silty SAND.	1.90-2.90	B D		
Borehole complete at 2.90m bgl.

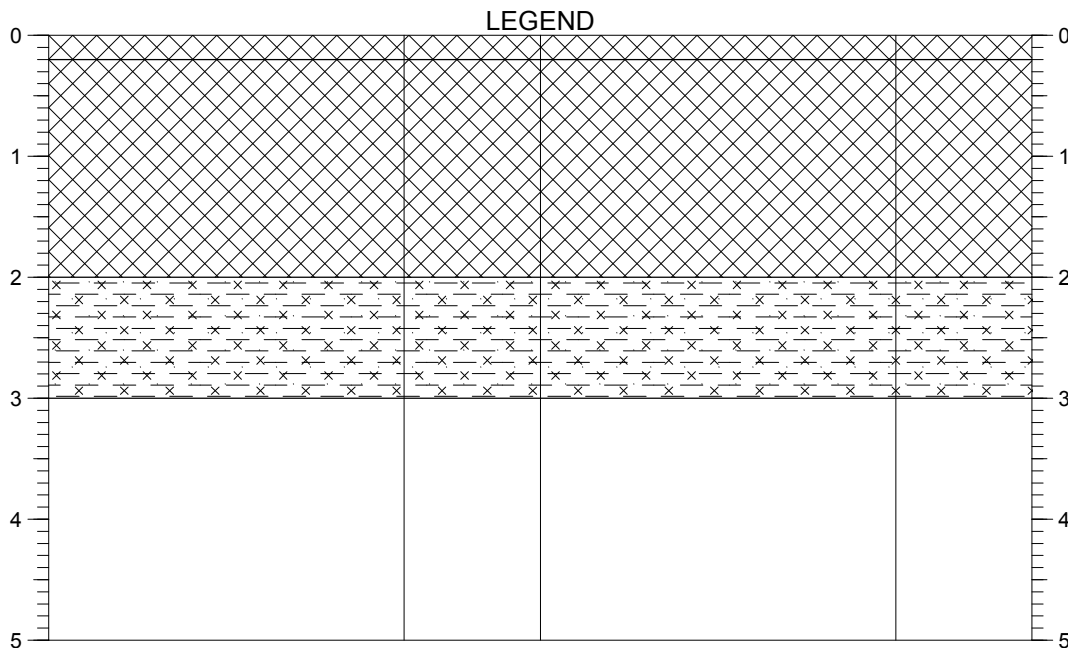
Project:	<b>Cherry Cobb Sands Wetland</b>	Project No:	<b>13-0054.01</b>	Hole ID:	<b>TP11</b>
<b>TRIAL PIT LOG</b>		Date:	11/04/2013	Client:	<b>Able UK</b>

STRATA			SAMPLES		TESTS	
Depth	No	DESCRIPTION	Depth	No	Depth	Results
0.20		MADE GROUND: Brown gravelly, sandy, clayey topsoil. Gravel is fine to coarse. Sand is fine.	0.00	D		
(1.80)		MADE GROUND: Brown clayey sand.	0.20-2.00	B		
2.00			0.20	D		
(1.00)		Black clayey, silty SAND.	2.00-3.00	B		
3.00		Borehole complete at 3.00m bgl.	2.00	D

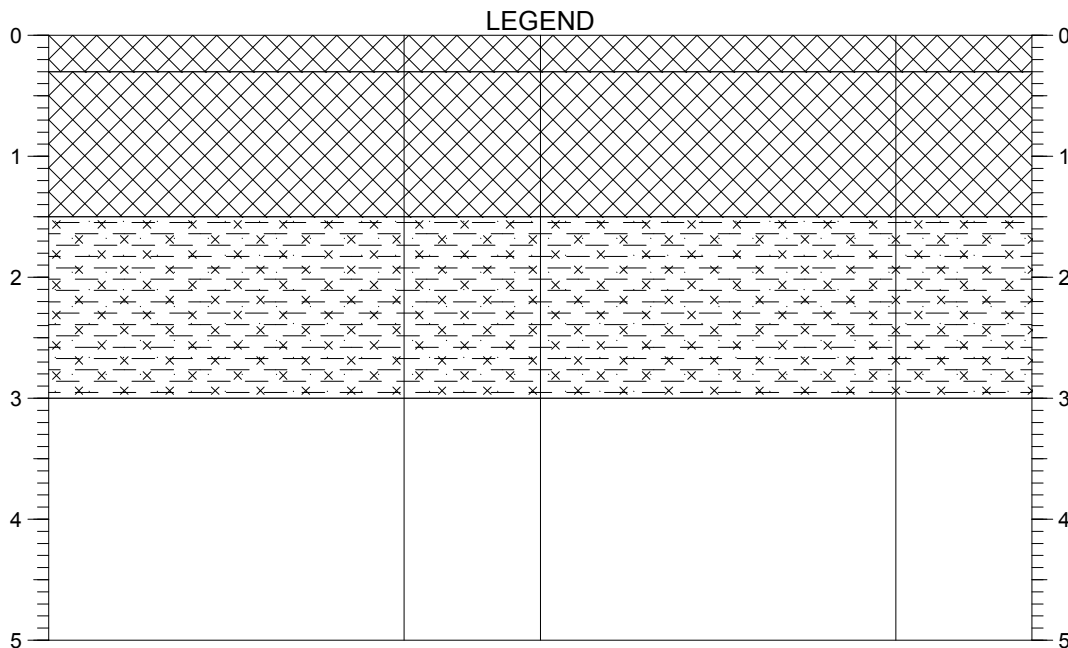
Project:	<b>Cherry Cobb Sands Wetland</b>	Project No:	<b>13-0054.01</b>	Hole ID:	<b>TP12</b>
<b>TRIAL PIT LOG</b>		Date:	11/04/2013	Client:	<b>Able UK</b>

STRATA			SAMPLES		TESTS	
Depth	No	DESCRIPTION	Depth	No	Depth	Results
0.30		MADE GROUND: Brown gravelly, sandy, clayey topsoil with grass. Gravel is fine to coarse. Sand is fine.	0.00	D		
(1.20)		MADE GROUND: Brown clayey sand.	0.30-1.50	B		
1.50			0.30	D		
(1.50)		Black clayey, silty SAND.	1.50-3.00	B		
3.00			1.50	D		
		Borehole complete at 3.00m bgl.

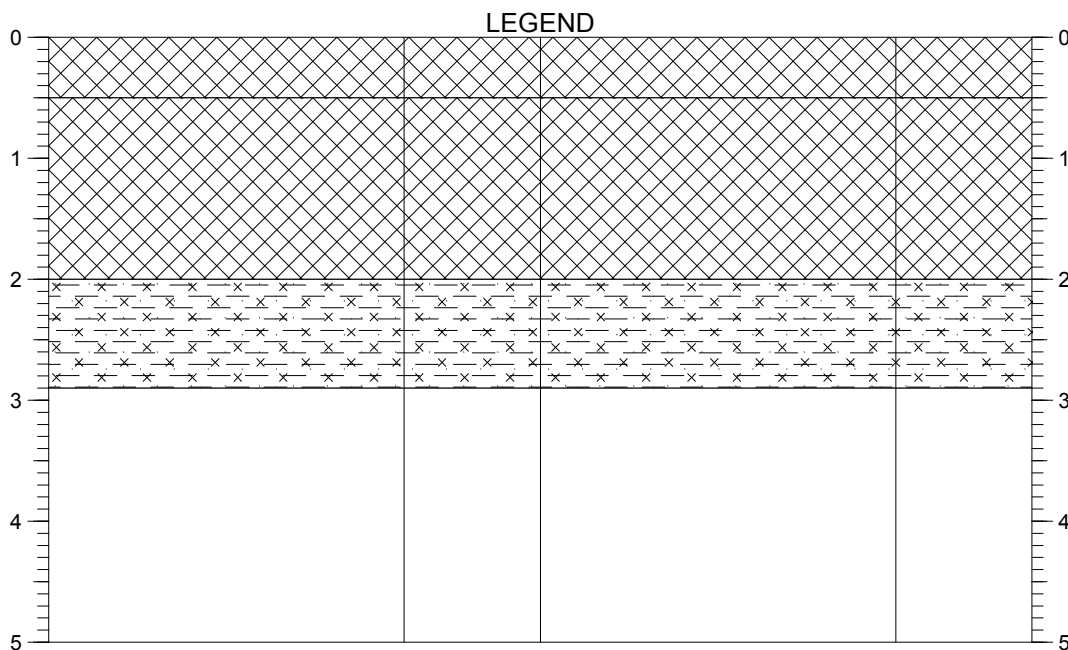
Project:	<b>Cherry Cobb Sands Wetland</b>	Project No:	<b>13-0054.01</b>	Hole ID:	<b>TP13</b>
<b>TRIAL PIT LOG</b>		Date:	11/04/2013	Client:	<b>Able UK</b>

STRATA			SAMPLES		TESTS	
Depth	No	DESCRIPTION	Depth	No	Depth	Results
(0.50)	0.50	MADE GROUND: Brown gravelly, sandy, clayey topsoil with grass. Gravel is fine to coarse. Sand is fine.	0.00	j		
(1.50)	2.00	MADE GROUND: Brown clayey sand.	0.50-2.00	B D		
(0.90)	2.90	Grey clayey, silty SAND.	2.00-2.90	B D		
Borehole complete at 2.90m bgl.

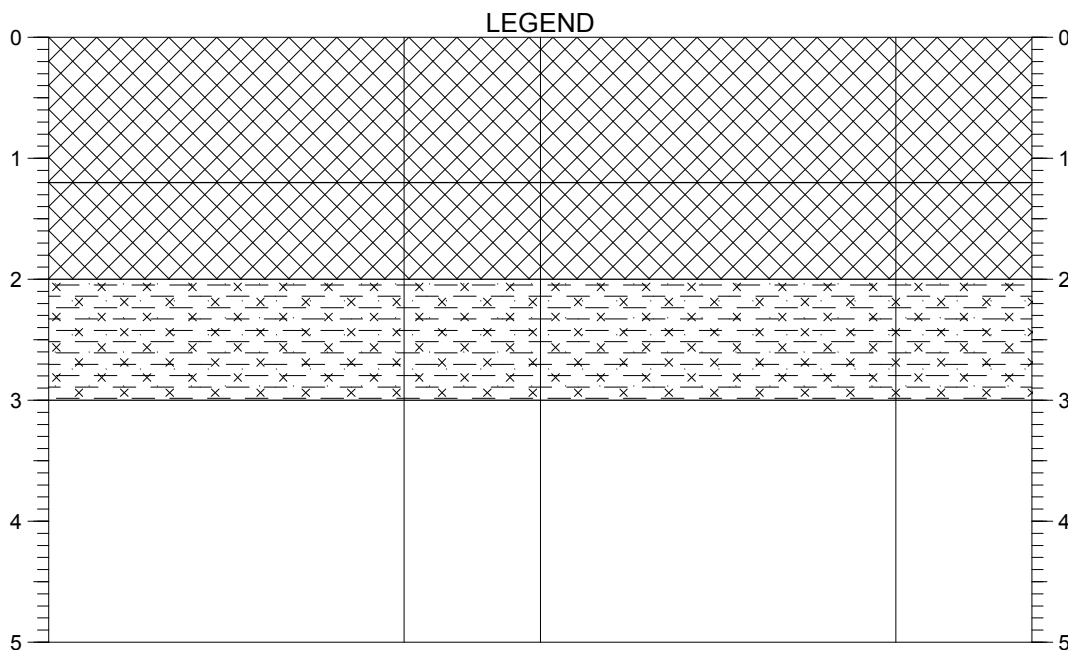
Project:	<b>Cherry Cobb Sands Wetland</b>	Project No:	<b>13-0054.01</b>	Hole ID:	<b>TP14</b>
<b>TRIAL PIT LOG</b>		Date:	11/04/2013	Client:	<b>Able UK</b>

STRATA			SAMPLES		TESTS	
Depth	No	DESCRIPTION	Depth	No	Depth	Results
(1.20)		MADE GROUND: Brown gravelly, sandy, clayey topsoil. Gravel is fine to coarse. Sand is fine.	0.00	j		
1.20						
(0.80)		MADE GROUND: Brown/orange clayey sand.	1.20-2.00	B		
2.00			1.20	D		
(1.00)		Black clayey, silty SAND.	2.00-3.00	B		
3.00			2.00	D		
		Borehole complete at 3.00m bgl.

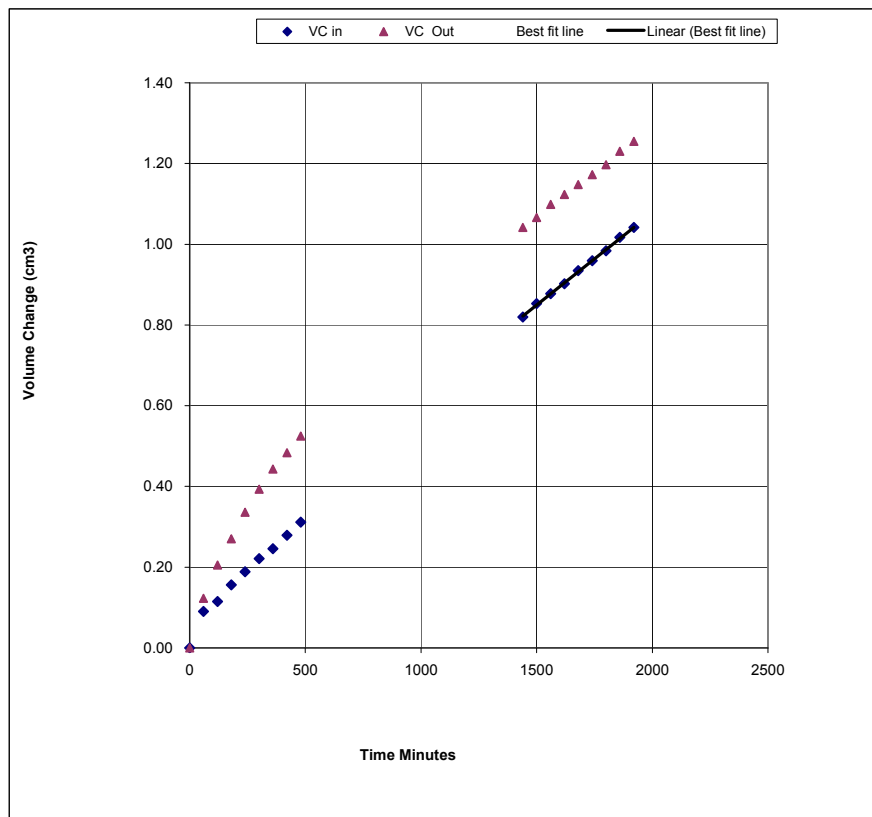
### Permeability Stage

Cell Pressure	kPa	400.00
Mean Effective Stress	kPa	100.00
Back Pressure Diff.	kPa	20.00
Mean Rate of Flow	ml/min	0.0005
Average Temperature	'C	20
Vertical Permeability Kv	m/s	$4.8 \times 10^{-11}$

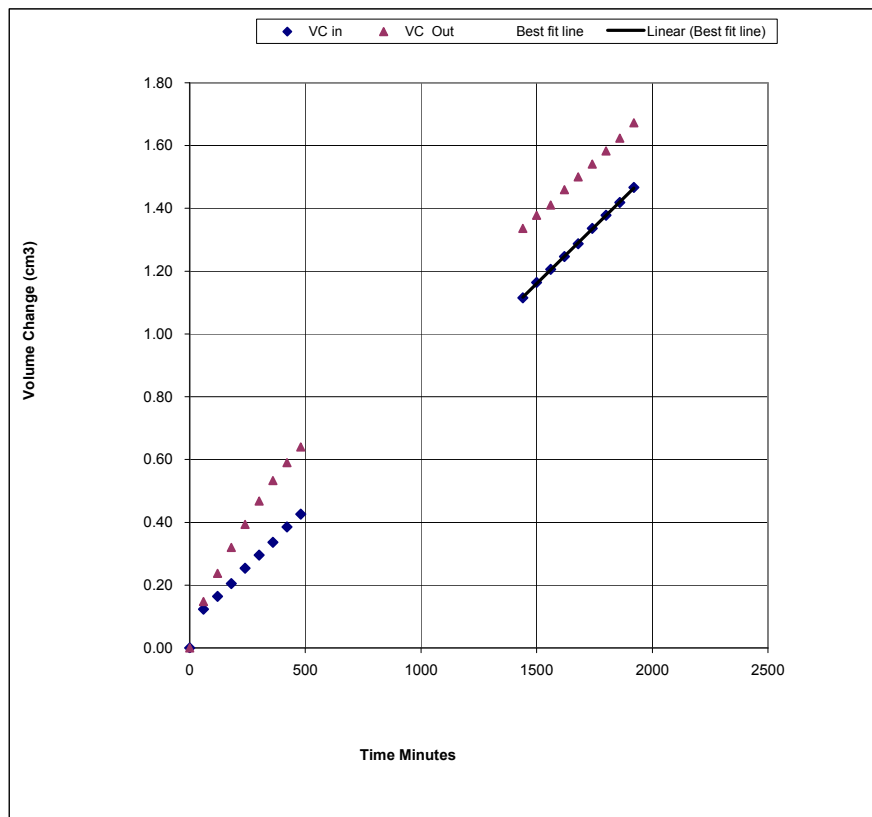
### Permeability Stage

Cell Pressure	kPa	400.00
Mean Effective Stress	kPa	100.00
Back Pressure Diff.	kPa	20.00
Mean Rate of Flow	ml/min	0.0007
Average Temperature	'C	20
Vertical Permeability Kv	m/s	$7.6 \times 10^{-11}$

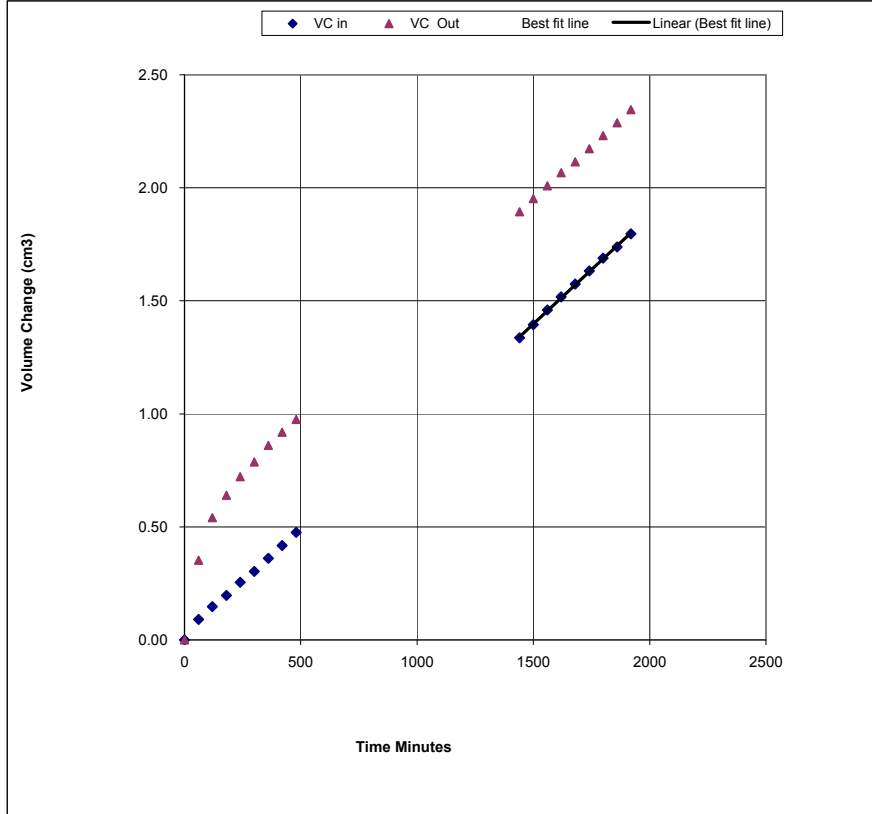
### Permeability Stage

Cell Pressure	kPa	400.00
Mean Effective Stress	kPa	100.00
Back Pressure Diff.	kPa	20.00
Mean Rate of Flow	ml/min	0.001
Average Temperature	'C	20
Vertical Permeability Kv	m/s	$9.9 \times 10^{-11}$

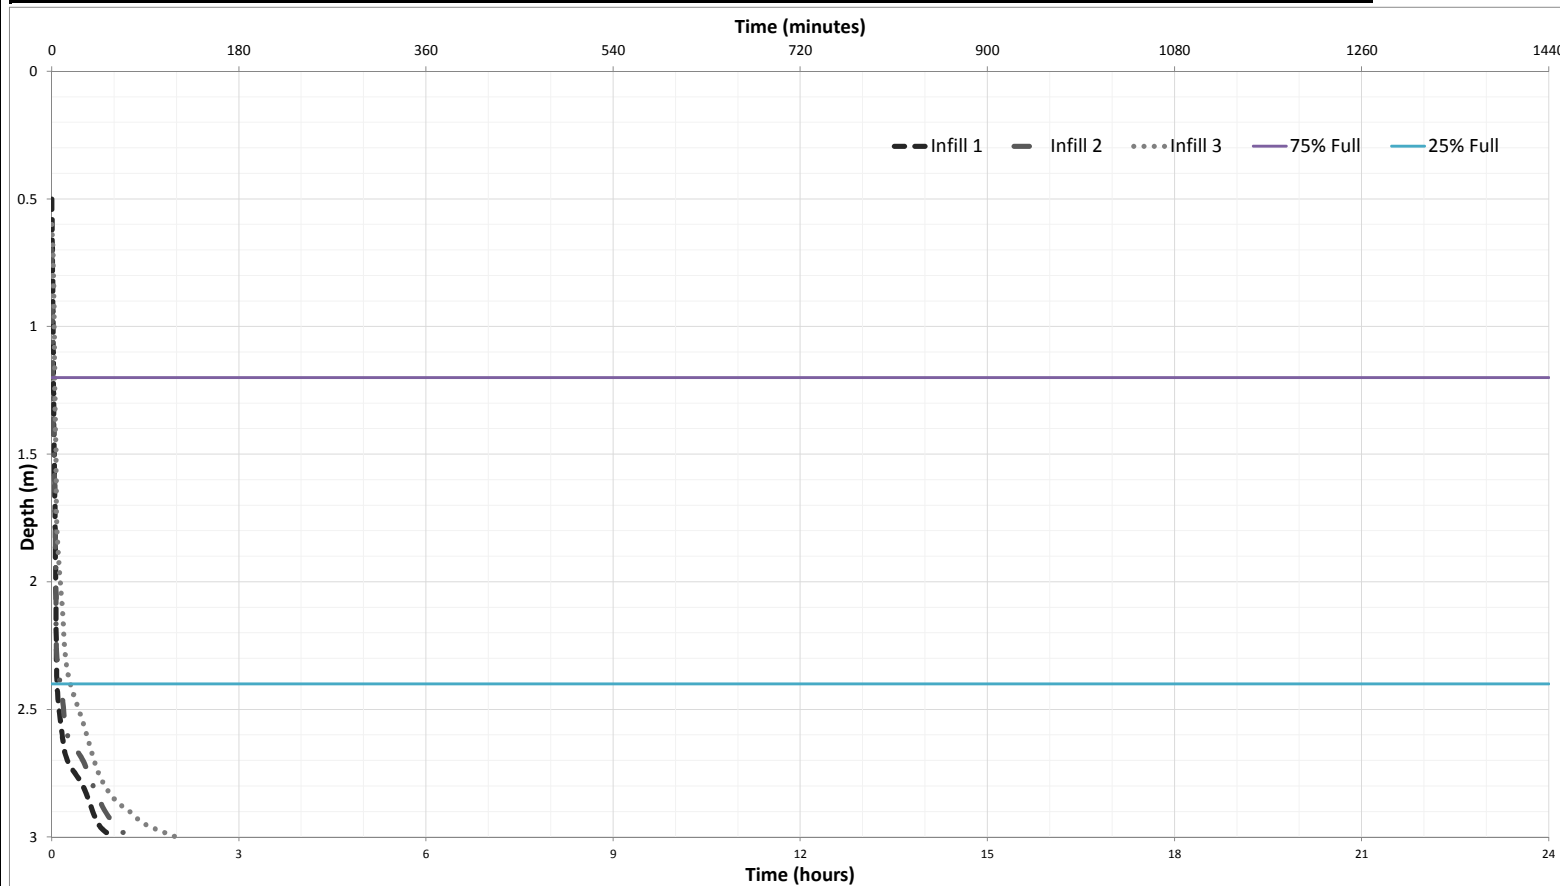
units	Fill 1	Fill 2	Fill 3
Depth (final reading)	m	3.10	3.10	3.10
Pit depth	m		3.10	
Pit length	m		4.00	
Pit width	m		0.60	
Depth to first reading	m	0.80	0.70	1.20
Maximum effective depth	m	2.30	2.40	1.90
Depth at 75% full	m	1.38	1.30	1.68
Depth at 25% full	m	2.53	2.50	2.63
Time at 75% full	mins	0.96	0.75	0.79
Time at 25% full	mins	10.63	8.00	8.75
Vp75 - 25 (volume outflowing between 75% and 25% effective depth)	m3	0.966	1.008	0.798
Mean surface area for outflow (50% effective depth)	m2	12.98	13.44	11.14
Time for outflow	mins	9.67	7.25	7.96
Soil infiltration rate, f =		<b>0.0001283141</b>	<b>0.0001724138</b>	<b>0.0001500183</b>
or		<b>1.28E-04</b>	<b>1.72E-04</b>	<b>1.50E-04</b>
