Portishead Branch Line (MetroWest Phase 1)

6.25, Environmental Statement, Volume 4, Appendix Series 8 Cultural Heritage

**6.25, Environmental Statement, Volume 4, Appendix 8.1 Cultural Heritage
Gazetteer**

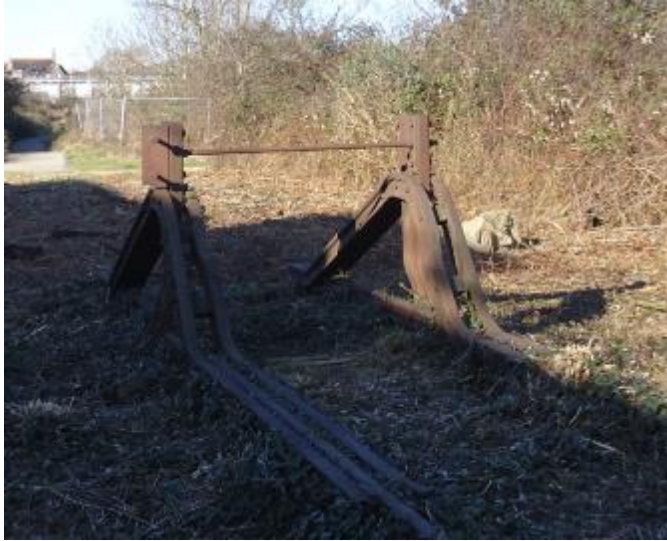
Asset Number	CH1
Asset Name	Buffer Stop
Description	Disused buffer stop located at the terminus of the Portishead to Pill section of the Railway. The metal framework of the asset remains, but is significantly rusted. The wooden bar typically found across the top of a buffer stop is missing, though the bolts which would have held such a bar are still present on the south side of the asset.
Location	ST 47271 76442
Value	Low
7/2/2018 Photograph Number 234

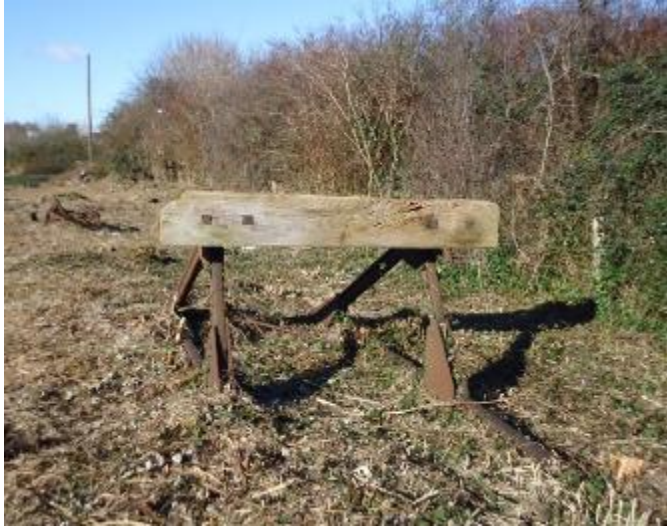
Asset Number	CH2
Asset Name	Buffer Stop
Description	Disused buffer stop adjacent to the <i>in-situ</i> track. The buffer stop is connected to a piece of railway track separate from the main line. The structure of the buffer stop is intact and retains its wooden bar. The metal parts of the structure are rusted and the wooden bar is in moderate condition with some signs of weathering.
Location	ST 47327 76429
Value	Low
7/2/2018 Photograph Number 232

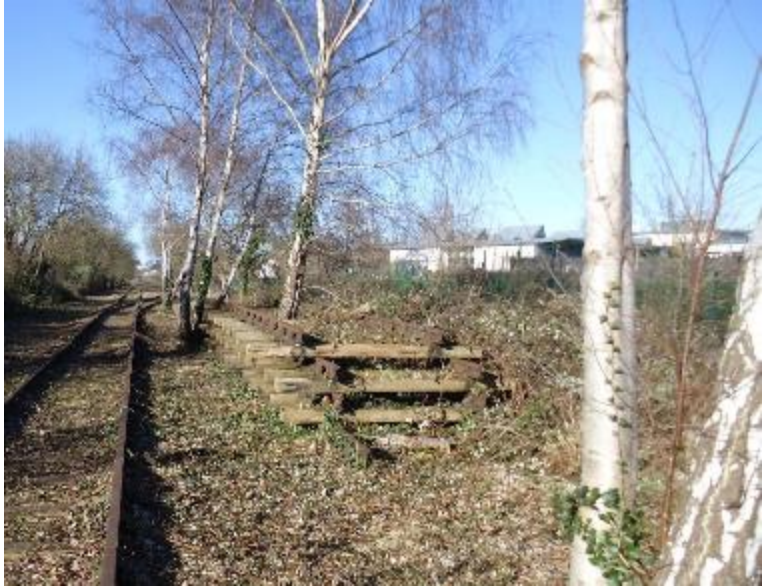
Asset Number	CH4
Asset Name	Track- <i>ex-situ</i>
Description	Three layers of track placed one on top of the other adjacent to the main line. The tracks are the same as the track on the disused line, and their wooden sleepers are also intact. The tracks are rusted. Trees have grown up in gaps in the tracks. Residual track is of negligible heritage interest.
Location	17+975m
Value	Negligible
7/2/2018 Photograph Number 222

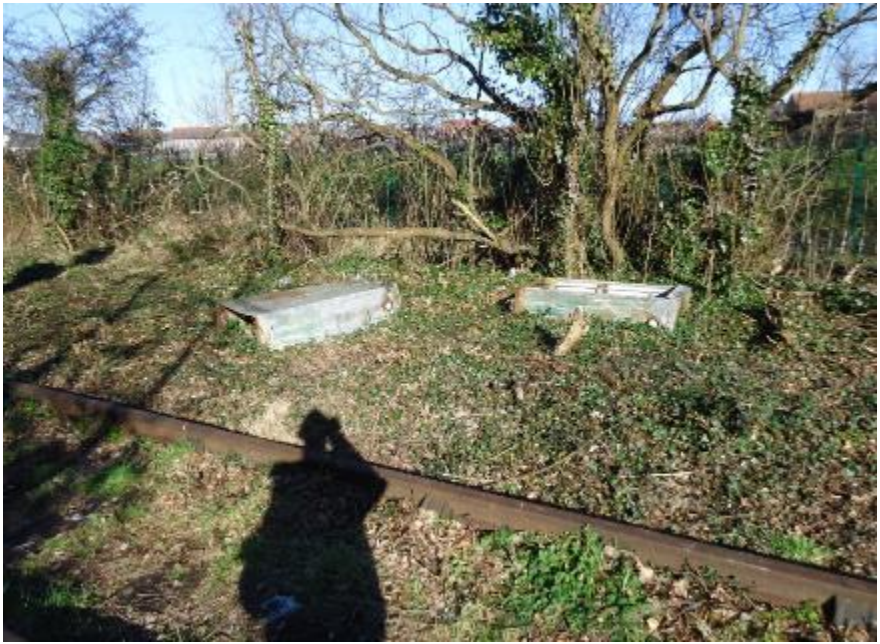
Asset Number	CH5
Asset Name	Electrical Boxes
Description	Two electrical boxes (consisting of only the casings, the electrical wiring seems to have been removed) that have been knocked off their pedestals and left adjacent to the disused railway line. Some areas of rusting are visible on both.
Location	17+800m
Value	Negligible
7/2/2018 Photograph Number 221

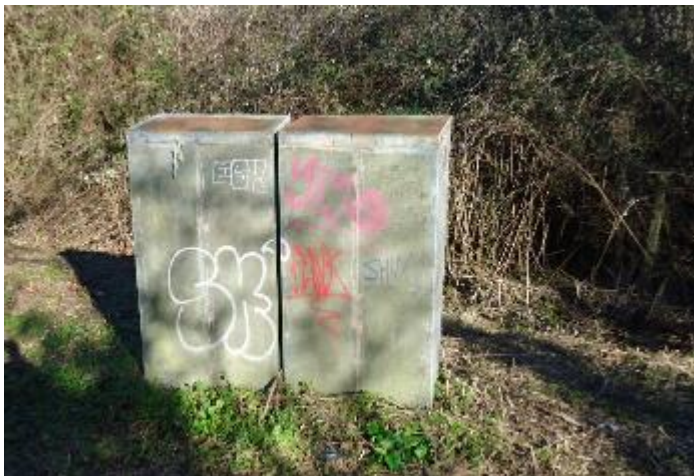
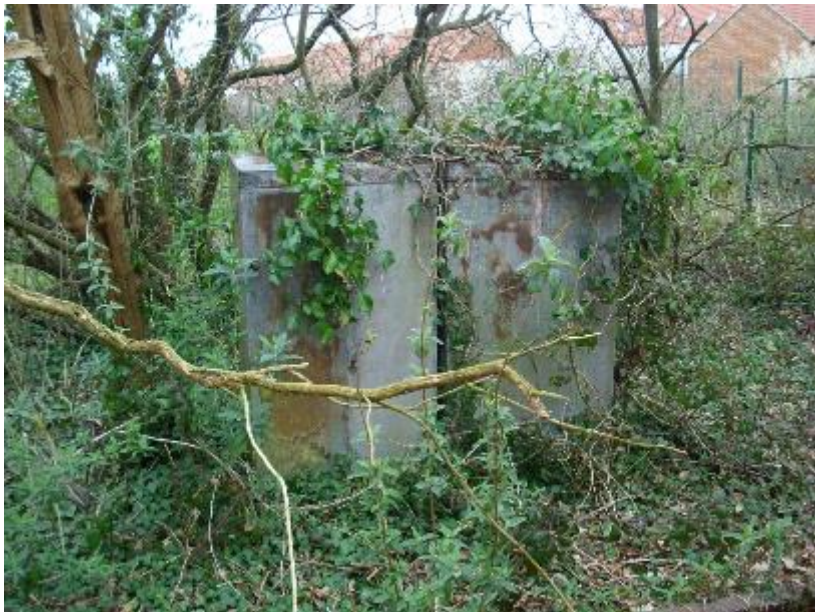
Asset Number	CH6
Asset Name	Electrical Boxes
Description	Two electrical boxes adjacent to the railway line. These assets are still <i>in-situ</i> and seem to be intact. The boxes are slightly rusted on their top side and have graffiti on their south facing side. Similar electrical boxes were found during the 2014 survey of the railway line in the same area, though were significantly overgrown with ivy and had more rusting. These may be the same boxes. These are of negligible heritage interest.
Location	17+725m
Value	Negligible
7/2/2018 Photograph Number 218

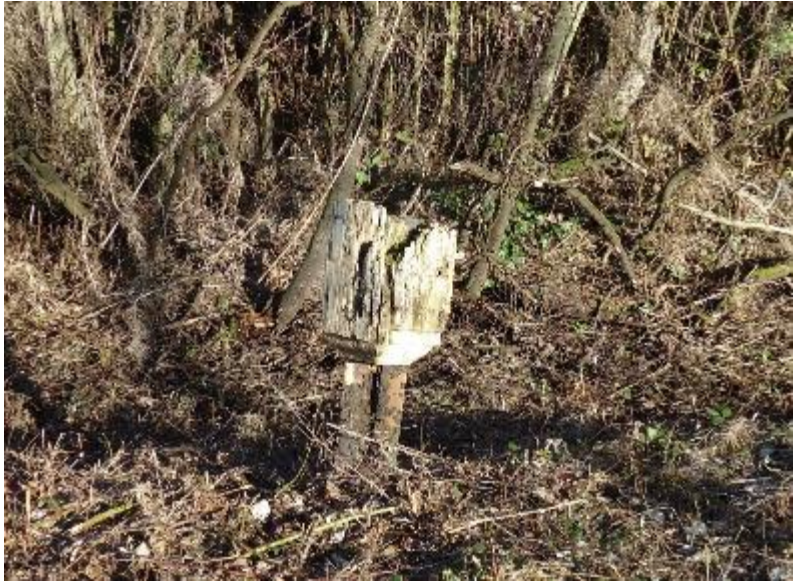
Asset Number	CH7
Asset Name	Milepost
Description	The remains of a milepost adjacent to the disused railway line. The stake and bottom part of the milepost is still extant, but nothing else remains. The remains are in poor condition with the metal stake significantly rusted and the wooden milepost bottom weathered.
Location	17+675m
Value	Negligible
7/2/2018 Photograph Number 217

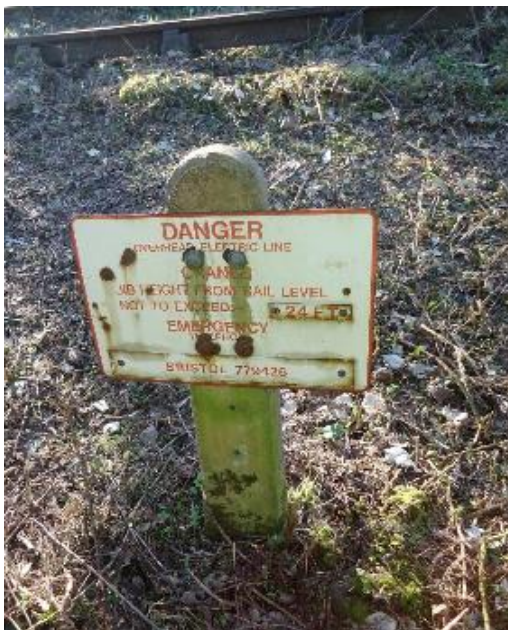
Asset Number	CH8
Asset Name	Danger Sign
Description	Concrete post with a sign warning of overhead electrical tables and providing an emergency contact number. Located adjacent to the disused railway line. The sign shows some weathering, but is still legible. Recorded during the 2014 survey of the disused railway line. This modern sign is of negligible heritage interest.
Location	17+625m
Value	Negligible
7/2/2018 Photograph Number 216

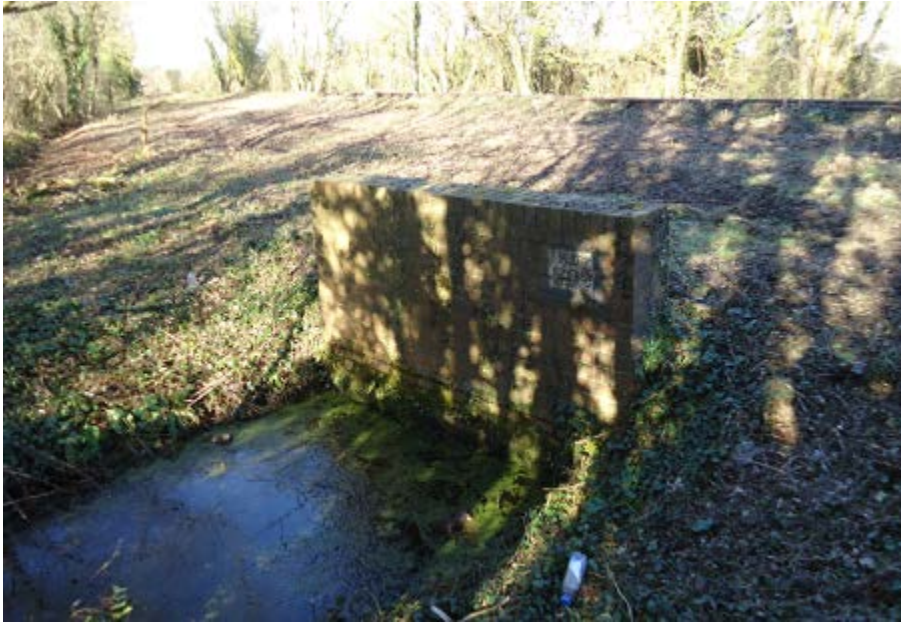
Asset Number	CH9
Asset Name	Culvert
Description	Culvert under the disused railway line. A brick wall forms the lintel of the culvert, though the sides seem to be cut from the railway bank. The brick wall seems to have two phases, with the bottom two courses being significantly more weathered than the upper courses.
Location	17+400m
Value	Low
7/2/2018 Photograph Number 215

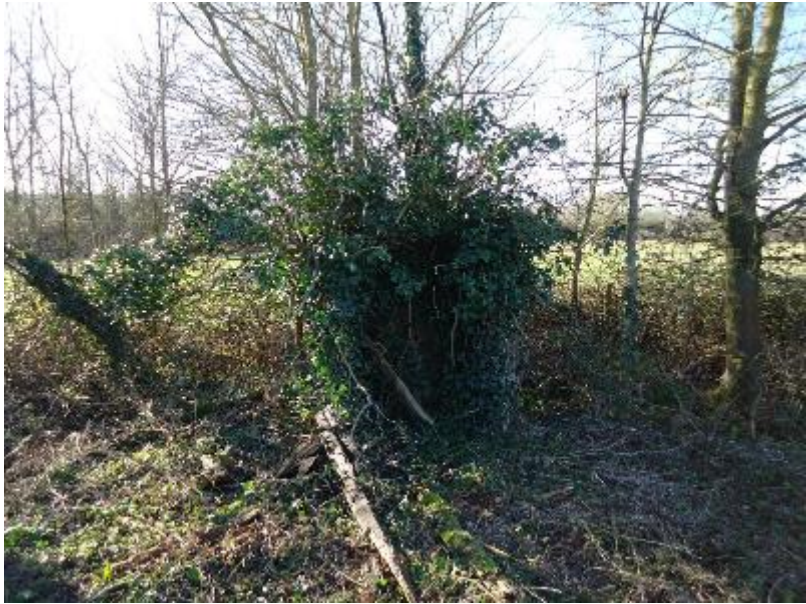
Asset Number	CH10
Asset Name	Brick Structure
Description	Brick Structure adjacent to the disused railway line. Little is visible of the structure as it is covered in ivy. Bits of broken timber are scattered around the structure, but do not seem to be related to it.
Location	17+280m
Value	Negligible
7/2/2018 Photograph Number 213

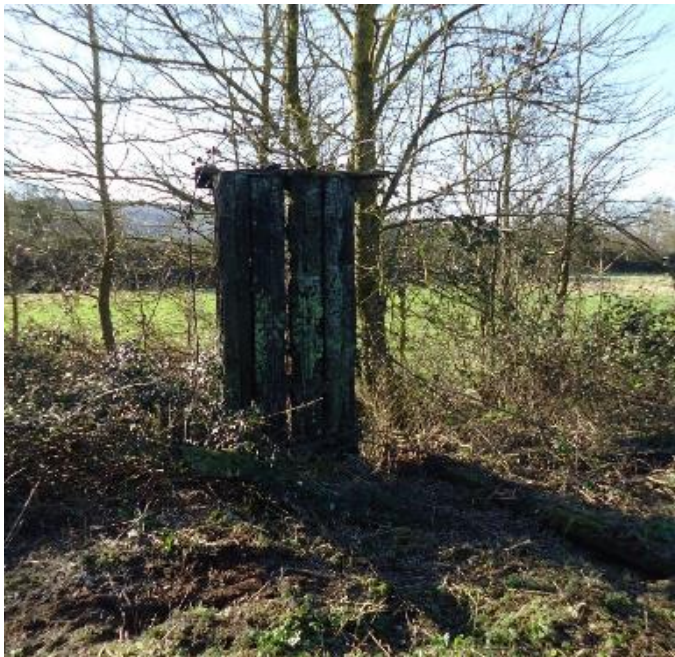
Asset Number	CH11
Asset Name	Timber Structure
Description	This timber structure appears to be constructed from sleepers erected on a concrete slab. The timber is rotting and the base of the structure is overgrown. The structure was photographed during the 2014 survey of the disused railway line, the timber appears to be the same to how it appeared in the 2014 walkover.
Location	17+270m
Value	Negligible
7/2/2018 Photograph Number 211

A photograph showing a weathered, dark brown timber structure, possibly a small shed or enclosure, situated in a grassy field. The structure is surrounded by bare trees and shrubs, suggesting a rural or semi-rural setting. The ground around the structure is overgrown with low-lying vegetation.
19/3/2014 Photograph Number WP_000286

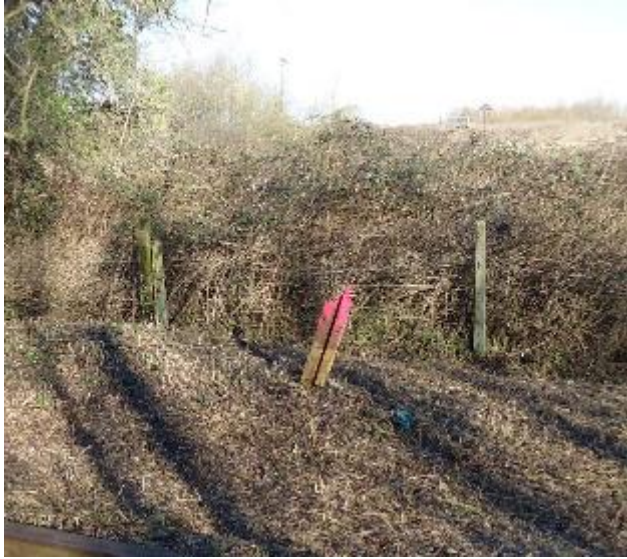
Asset Number	CH12
Asset Name	Milepost
Description	Milepost recorded in this location, a metal stake is located in this position and seems to be the remains of the milepost. It is rusted and has been spray painted pink on its top half.
Location	17+265m
Value	Negligible
7/2/2018 Photograph Number 210

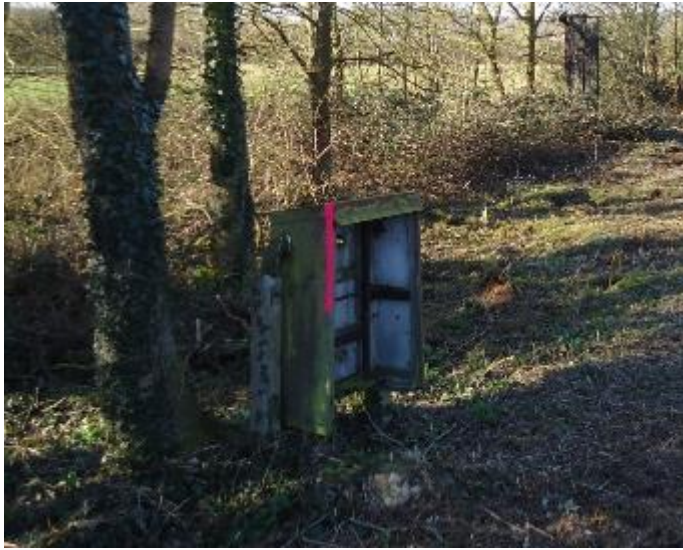
Asset Number	CH13
Asset Name	Electrical box
Description	The shell of an electrical box, still <i>in-situ</i> adjacent to the disused railway line. The door has been removed along with the interior elements. The box has been slightly graffitied and is badly weathered. Recorded during the 2014 survey, it still had its door attached at this time with thin metal bars across it to keep the door attached. This modern feature is of negligible heritage interest.
Location	17+265m
Value	Negligible
7/2/2018 Photograph Number 209

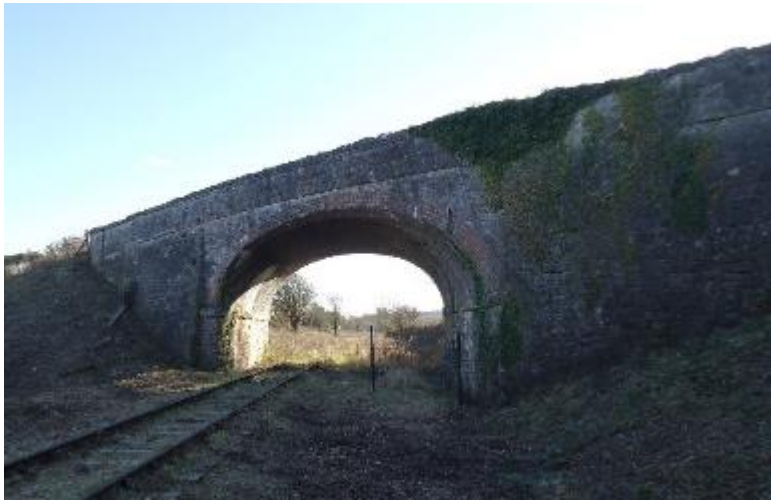
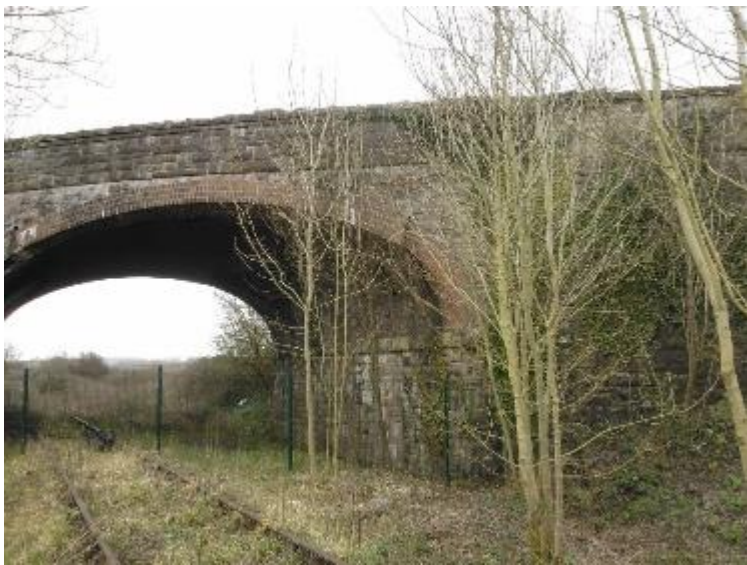
Asset Number	CH14
Asset Name	Sheepway Overbridge
Description	Single-span bridge which carries the Sheepway road over the disused railway line. The bridge is constructed from stone with an arch constructed from red brick. In good condition, with some weathering and vegetation on the parapet on the west side. There is a pipeline attached across the east parapet. Some of the red bricks in the arch seem to have been replaced since the original construction. Recorded on the 2014 survey and passage under the bridge is blocked by fencing at that time.
Location	17+175m
Value	Low
7/2/2018 Photograph Number 207

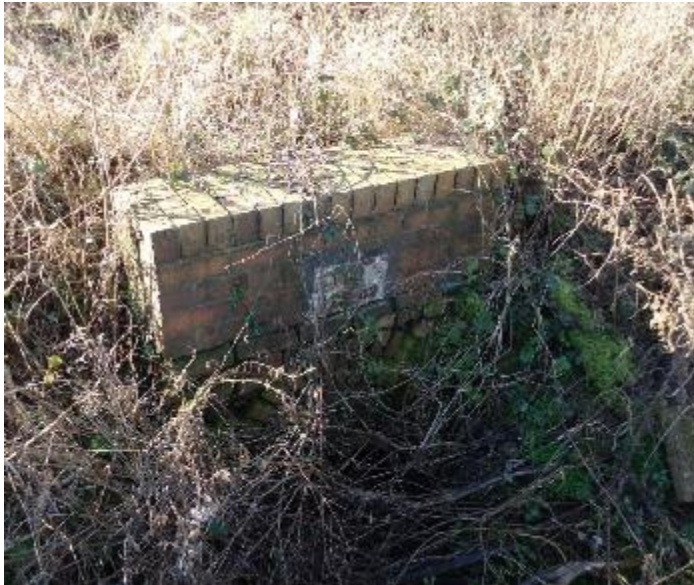
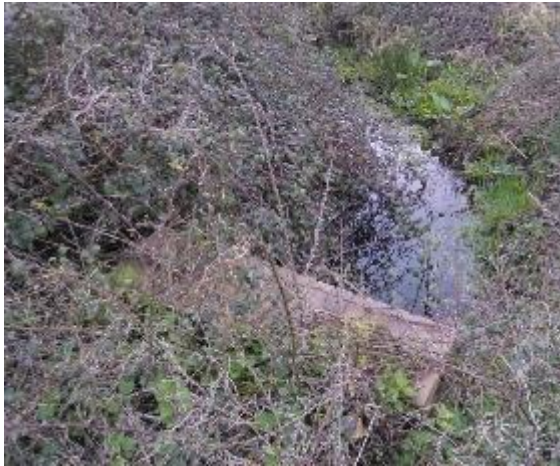
Asset Number	CH15
Asset Name	Culvert
Description	Culvert under the disused railway line. A brick wall forms the lintel and arch over the culvert, though the sides seem to be cut from the railway bank. The arch bricks seem to be of an earlier date to the bricks that form the upper lintel part of the culvert, and are in worse condition. Much of the culvert and the stream itself are hidden in overgrown vegetation. Recorded in the 2014 survey.
Location	16+900m
Value	Low
7/2/2018 Photograph Number 202

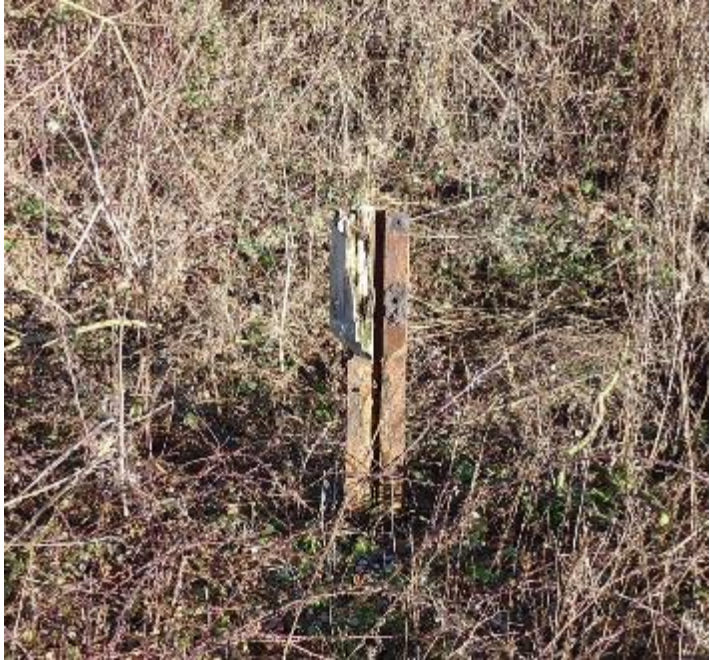
Asset Number	CH16
Asset Name	Milepost
Description	Milepost adjacent to the disused railway line. In very poor condition, with only a metal stake and part of the wooden signage left (the former is very rusted and the latter has been damaged).
Location	16+875m
Value	Negligible
7/2/2018 Photograph Number 200

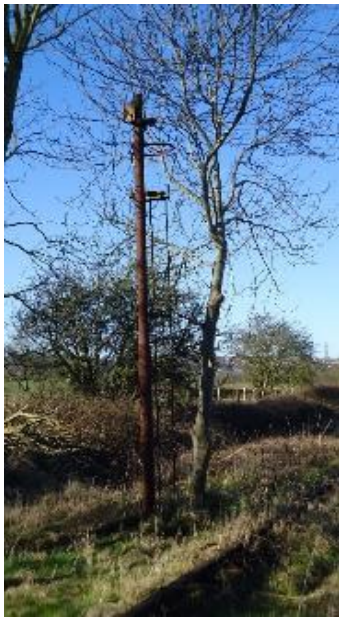
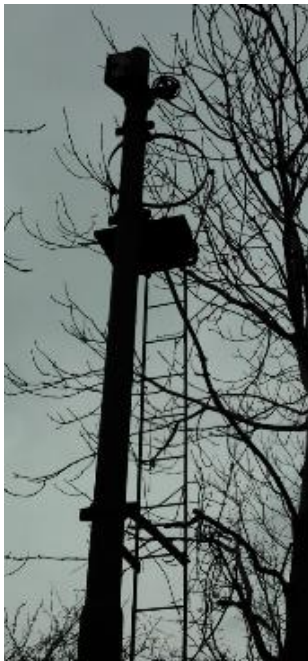
Asset Number	CH17
Asset Name	Signal Post
Description	Disused signal post. Metal post with ladder and holder for electrical equipment on top, all of which have become rusted due to disuse. Electrical elements have been removed. Photographed during the 2014 survey and there does not seem to have been any significant change to the asset since that time.
Location	16+750m
Value	Low
7/2/2018 Photograph Number 198

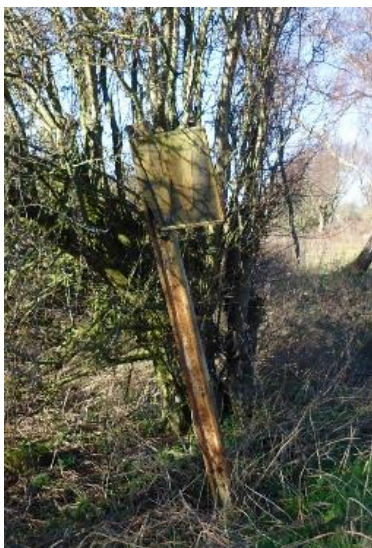
Asset Number	CH18
Asset Name	Whistle Post
Description	Metal post and sign with the letter “W” on it. Both badly rusted. In a similar condition to when it was recorded on the 2014 survey. This most likely represents a whistle post, which were installed to instruct drivers to sound the whistle as they approached crossings. These continue to be referred to as 'whistle boards', despite modern trains having two-tone horns instead of whistles [1].
Location	16+460m
Value	Low
7/2/2018 Photograph Number 195

- 1.1.16 However, there would be opportunities for the retention and reuse of some of these assets within the DCO Scheme. For example, the two buildings (CH20 and CH30) could be repaired and reused (note one of these is used by bats and its value is discussed in the Environmental Statement, Chapter 9 Ecology and Biodiversity, DCO Document Reference 6.12); and assets such as the two buffer stops (CH1 and CH2), the signal post (CH17) and whistle post (CH18) could be relocated and adapted to form heritage features.

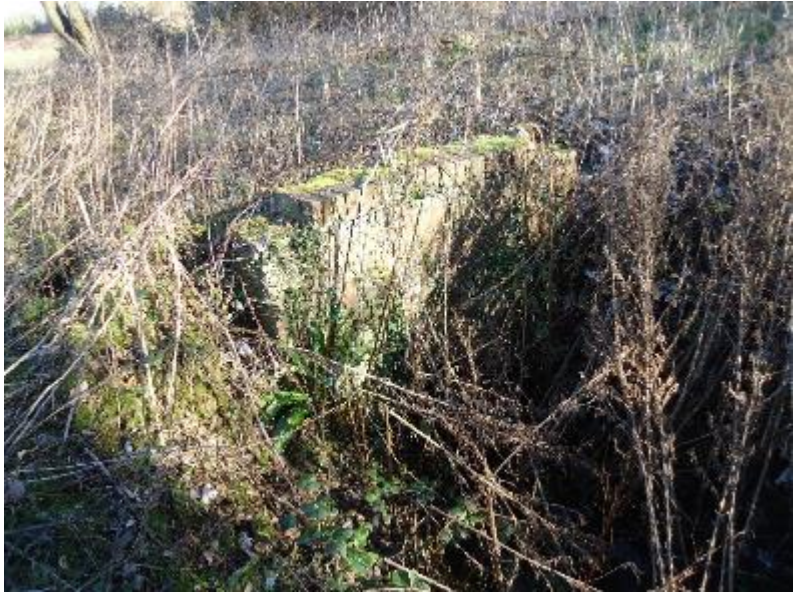
Asset Number	CH19
Asset Name	Culvert
Description	Culvert under the disused railway line. A brick wall forms the lintel of the culvert, though the sides seem to be cut from the railway bank. The culvert is very overgrown, and the stream and much of the brick structure are not visible due to the vegetation.
Location	16+340m
Value	Low
7/2/2018 Photograph Number 193

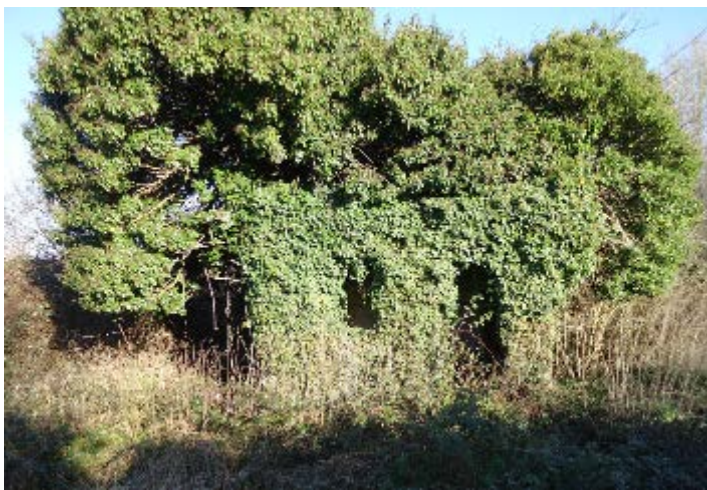
former Portbury Shipyard Station. Both assets are in a very advanced state of decay and are of **low** value.

Asset Number	CH20
Asset Name	Building
Description	Abandoned building in extremely poor condition. Single room with brick walls (with significant gaps) and a decaying wooden roof. There was a chimney in the interior but this has been opened up. The exterior of the building is completely covered in ivy. A structure in this location appears on the 1921-1945 revised edition of the OS map [1].
Location	16+150m
Value	Low
7/2/2018 Photograph Number 186

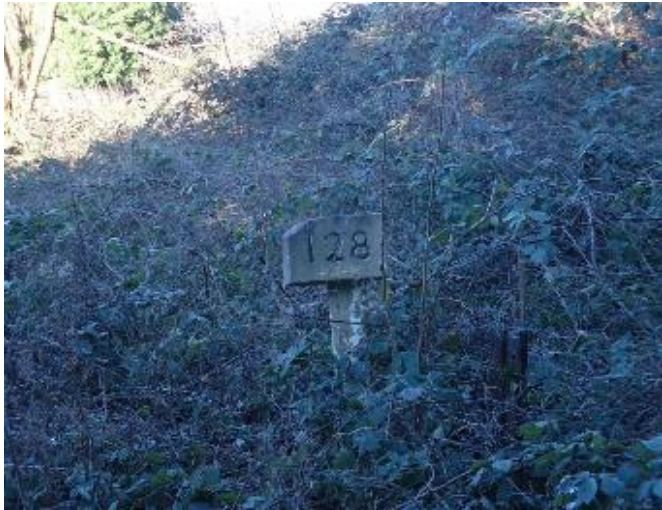
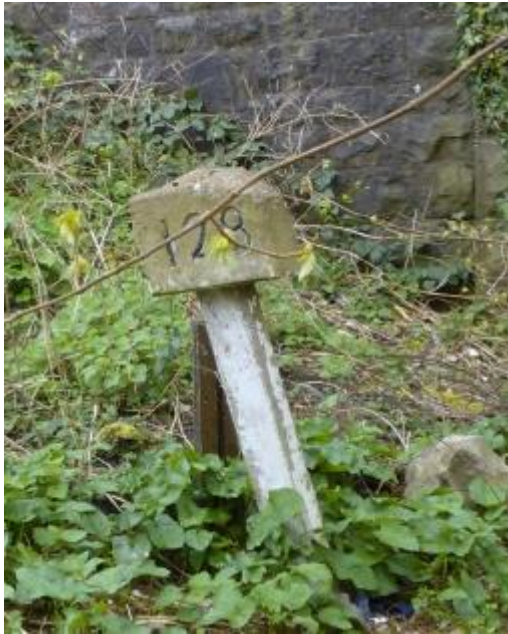
Asset Number	CH21
Asset Name	Milepost
Description	Intact milepost (mile 128) found by Station Road Overbridge. The milepost is of precast concrete and is in good condition, except for some damage on the top left corner of the front face. The milepost is of a type used by British Rail and would have been painted when in use [1], some black paint does remain in the grooves of the numbers on the front face and some white paint is visible on the stake. The milepost was photographed during the 2014 survey and more of the white paint was visible on the stake at that time.
Location	16+075m
Value	Low
7/2/2018 Photograph Number 184

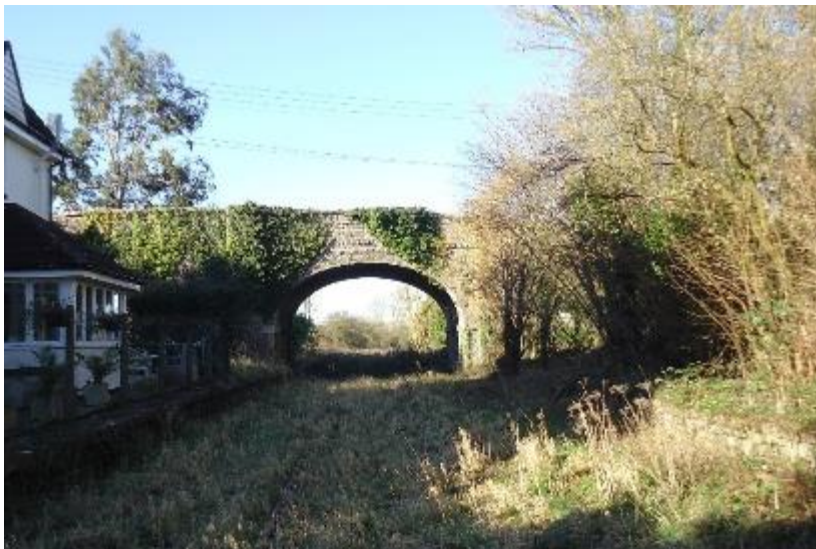
Asset Number	CH22
Asset Name	Station Road Overbridge
Description	Single-span bridge which carries the Station Road over the disused railway line next to the old Portbury station, which is now a private residence. The bridge is constructed from stone with an arch constructed from red brick (which has become discoloured with age). In good condition, with some weathering. The sides of the bridge are covered with ivy. Recorded on the 2014 survey with similar amounts of vegetation covering the bridge.
Location	16+050m
Value	Low
7/2/2018 Photograph Number 181

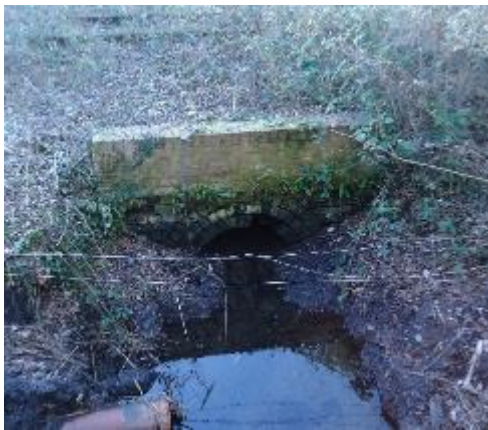
Asset Number	CH23
Asset Name	Culvert
Description	Culvert under the disused railway line. The lintel and arch over the culvert are made from brick, and the sides are cut from railway bank. The arch bricks seem to be of an earlier date to the bricks that form the upper lintel part of the culvert, being more discoloured and the mortar in these courses having eroded away. Photographed on the 2014 survey from the rear; more vegetation present around the culvert at that time.
Location	15+650m
Value	Low
7/2/2018 Photograph Number 176

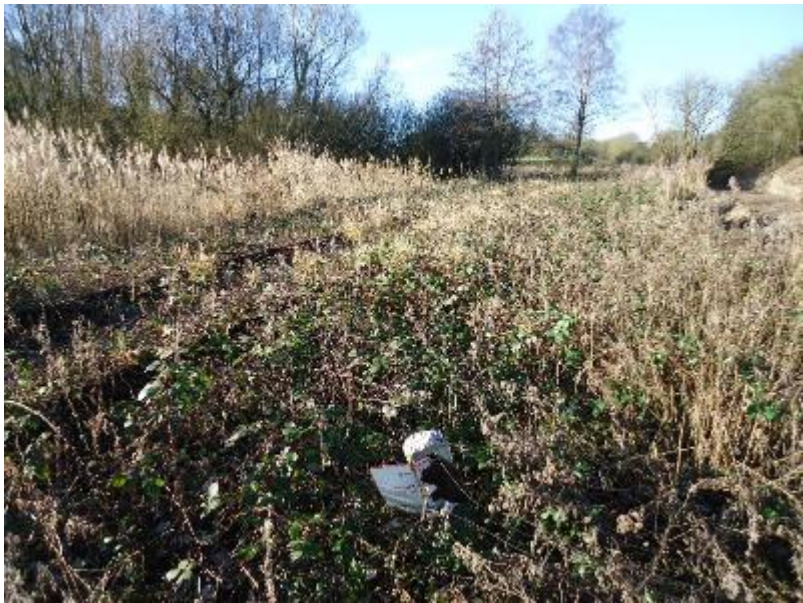
Asset Number	CH24
Asset Name	Danger Sign
Description	Concrete post with part of a sign, in poor condition. The sign has been folded onto its self, obscuring the writing on the sign. The top of the concrete post has been knocked off. It is located adjacent to the disused railway line and is surrounded by dense vegetation. This modern sign is of negligible heritage interest.
Location	15+625m
Value	Negligible
7/2/2018 Photograph Number 174

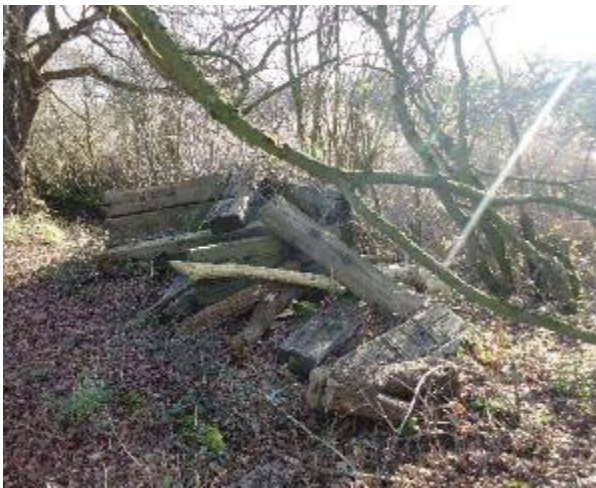
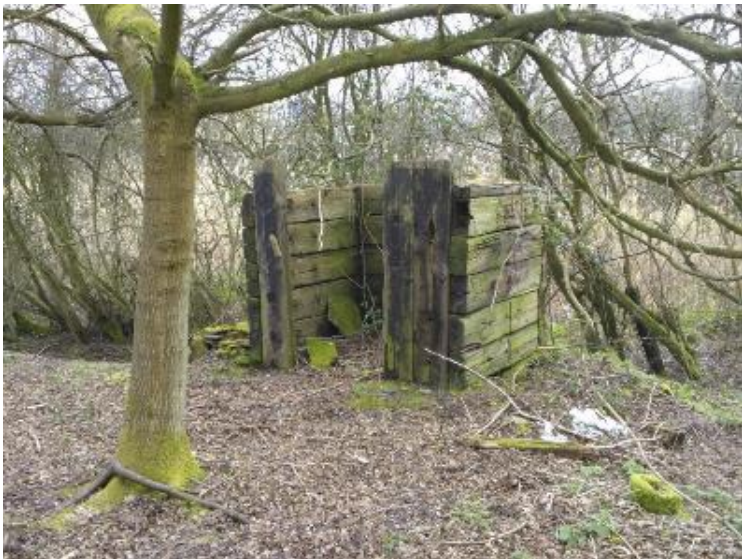
Asset Number	CH25
Asset Name	Structure- Sleepers on brick platform
Description	The remains of a structure built from sleepers on a brick platform. On the site of a structure recorded on the 1921-1943 OS 25" Revised Edition, no description is available and it may not relate to this feature [1]. Only the bottom two courses of the structure are still intact on the brick platform (which is covered by vegetation), the sleepers which have come loose are situated on and around the remains of the structure. All of the sleepers are in a state of decay. The 2014 survey also recorded the structure, which was more intact at the time. The structure, at that time, appeared to take the form of a small hut without a roof (one may have been in place at one time, as indicated by the damaged sleeper that makes up the top course on the west side).
Location	15+340m
Value	Negligible
7/2/2018 Photograph Number 171

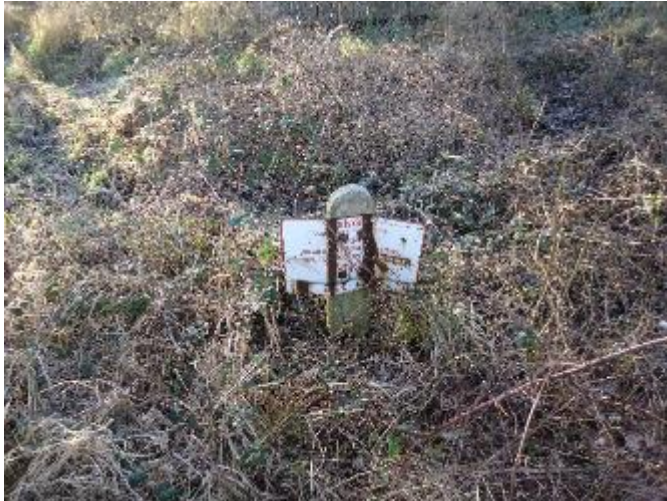
Asset Number	CH26
Asset Name	Danger Sign
Description	Concrete post with a sign warning of overhead electrical tables and providing a emergency contact number. Located adjacent to the disused railway line. The post is in good condition, but the sign has two thick bands of rusting down its face and has been slightly warped on each side; it is only partially legible. This modern sign is of negligible heritage interest.
Location	15+325m
Value	Negligible
7/2/2018 Photograph Number 168

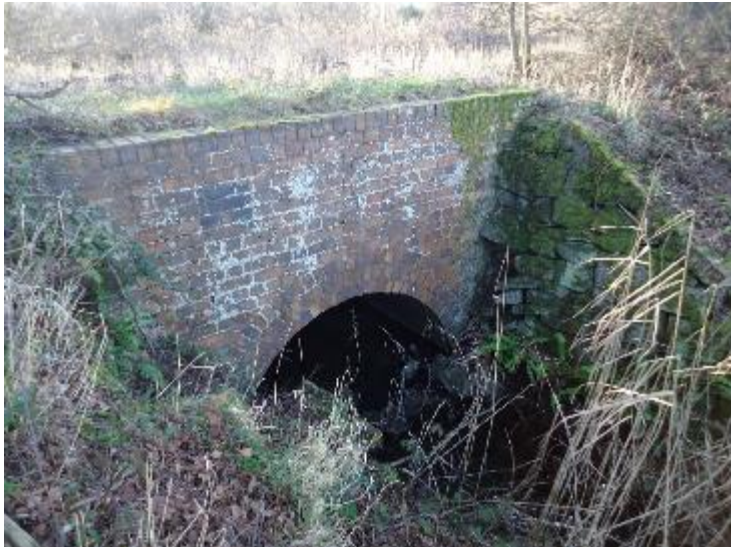
Asset Number	CH27
Asset Name	Culvert
Description	Culvert under the disused railway line. The lintel and arch over the culvert are made from brick, and the sides seem to be made from drystone walling; though they may have had mortar previously and it has simply been washed away. The sides may predate the brick culvert, as they seem to be more overgrown and a worse state of repair.
Location	15+280m
Value	Low
7/2/2018 Photograph Number 166

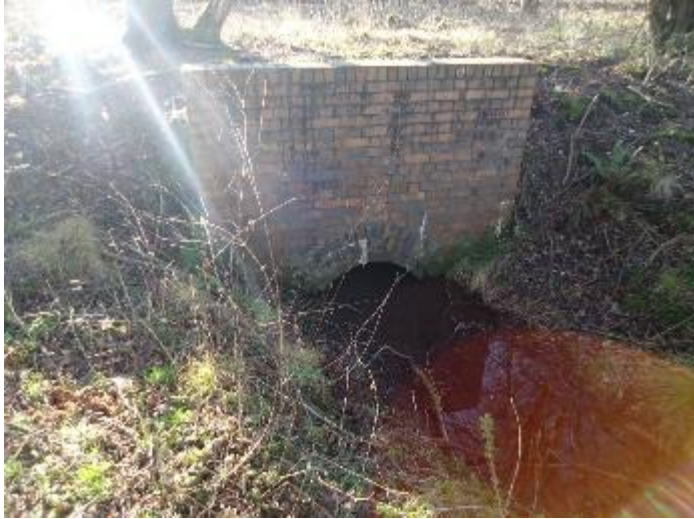
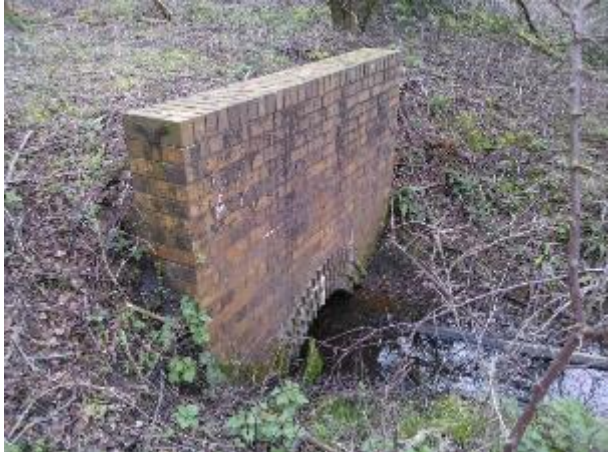
Asset Number	CH28
Asset Name	Culvert
Description	Culvert under the disused railway line. The lintel and arch over the culvert are made from brick, and the sides are cut from railway bank. The culvert is in good condition. Also recorded on the 2014 survey.
Location	15+150m
Value	Low
7/2/2018 Photograph Number 163

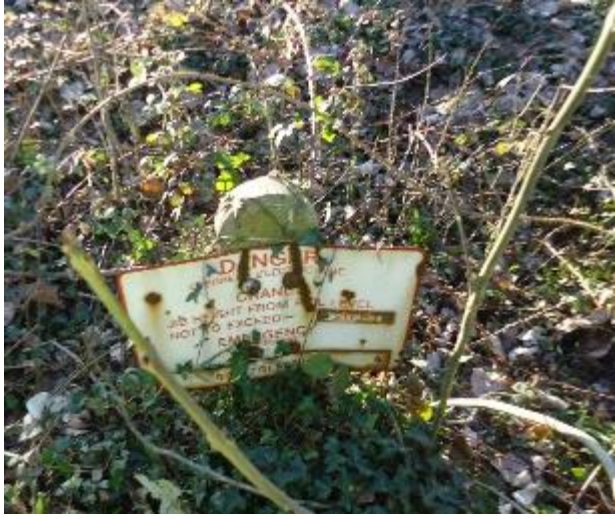
Asset Number	CH29
Asset Name	Danger Sign
Description	Concrete post with a sign warning of overhead electrical tables and providing a emergency contact number. Located adjacent to the disused railway line. The post is in good condition, the sign is has two limited areas of rusting and is mostly legible. Ivy is beginning to grow around the sign. This modern sign is of negligible heritage interest.
Location	14+780m
Value	Negligible
7/2/2018 Photograph Number 158

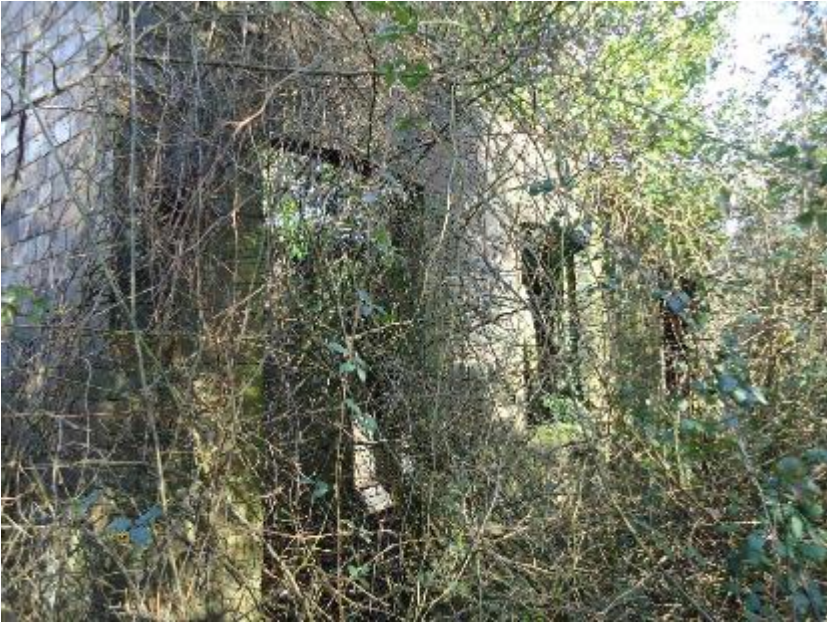
Asset Number	CH30
Asset Name	Building
Description	<p>Roofless brick building (in English bond). The building has a large chimney and is partitioned into two separate cells. Each cell has a doorway and adjacent window with a second window in the respective gable ends. Internally each cell was furnished with a fireplace, although one of these had been bricked-up. Sections of brickwork have been removed or decayed from the structure. Windows and doors have been removed and the structure has become overgrown with vegetation, including a tree inside of the building itself. No building is recorded in this location on available historic maps. However, the building is likely to relate to the Portbury Shipyard Station and date to the mid-20th century. The building includes a large chimney and there is no roof remaining.</p>
Location	14+800m
Value	Low
7/2/2018 Photograph Number 237

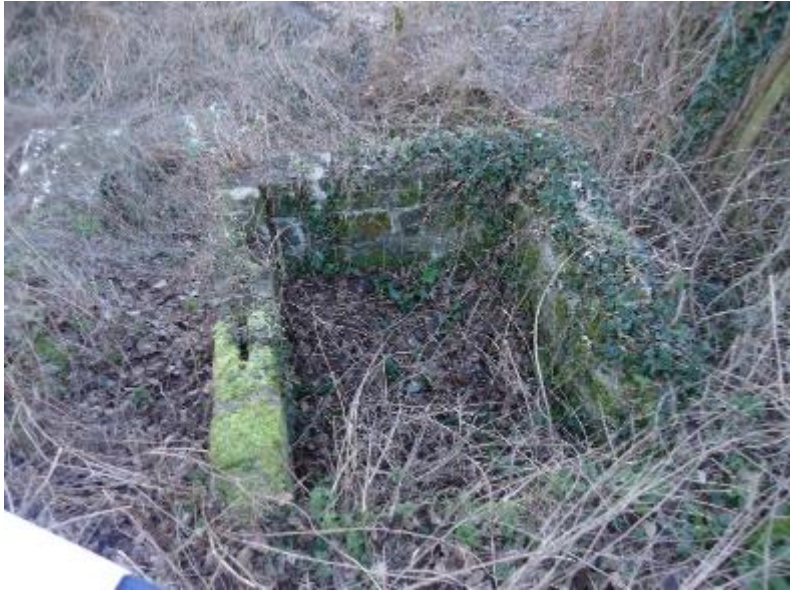
Asset Number	CH31
Asset Name	Structure – by Marsh Lane Bridge
Description	Structure constructed from breeze blocks, rectangular in shape with one of the short sides missing. Unknown function.
Location	14+520m
Value	Negligible
7/2/2018 Photograph Number 156

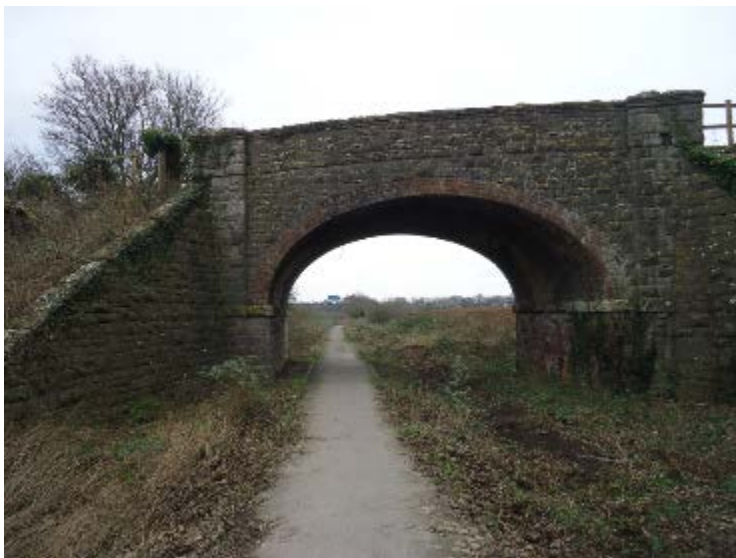
Asset Number	CH32
Asset Name	Marsh Lane Overbridge
Description	Single-span bridge which carries Marsh Lane over the disused railway line. The bridge is constructed from stone with an arch constructed from red brick. In good condition, with some weathering. Vegetation on the bridge has recently been cleared away. Recorded on the 2014 survey with more vegetation covering the bridge.
Location	14+500m
Value	Low
7/2/2018 Photograph Number 149

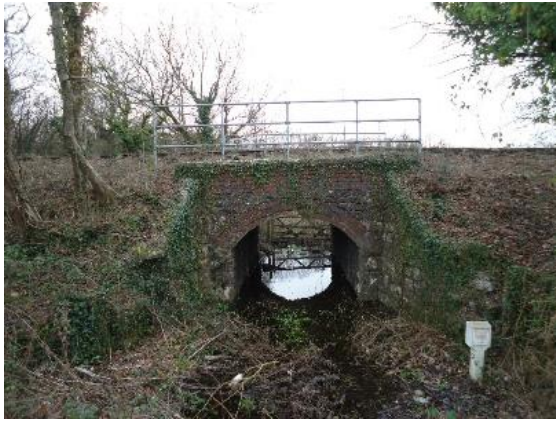
Asset Number	CH33
Asset Name	Cattle Creep Underbridge
Description	Single-span underbridge under the disused railway line, probably put in place to allow animals and people to move between fields on either side of the railway line. The top of the bridge and its arch is made from red brick while the courses lower than the arch and the sides are made out of building stone. Some of the red bricks seem to be more recent additions, being less weathered and discoloured, these newer bricks make up the top six courses and the arch; another new addition is a metal rail on top of the bridge parapets. A gate is present on one side of the bridge tunnel. The path under the bridge was flooded during the visit. The bridge is present on the 1844-1888 OS 25" 1st Edition and was most likely built at the same time as the railway. The underbridge was also recorded in the 2014 survey, at which point it had more vegetation covering it, but was otherwise the same.

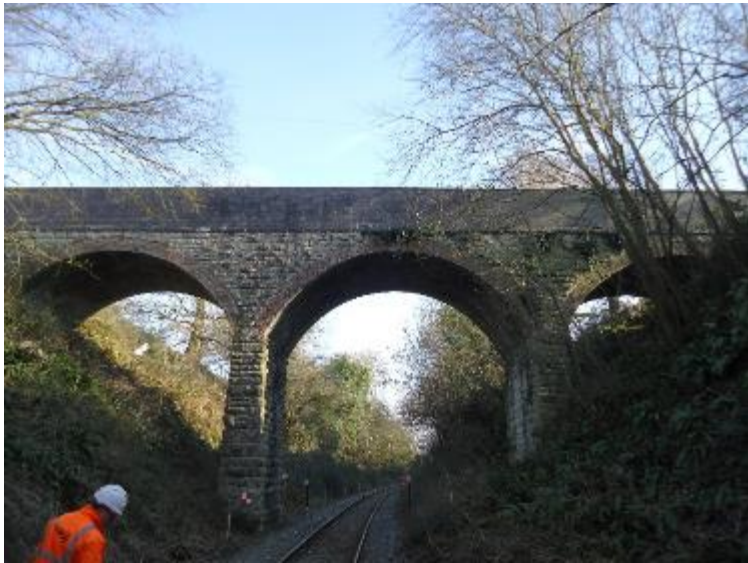
Asset Number	CH34
Asset Name	Cages Overbridge
Description	Single-span bridge carrying Chapel Pill Lane over the railway (active in this section). The bridge has three spans and is constructed from three types of materials: masonry blocks make up the main bulk of the structure, the piers and main body of the bridge, the arches are made from red brick and the parapets are made from Staffordshire Blue Brick. The bridge is in good condition, with some signs of weathering.
Location	11+175m
Value	Low
7/2/2018 Photograph Number 14

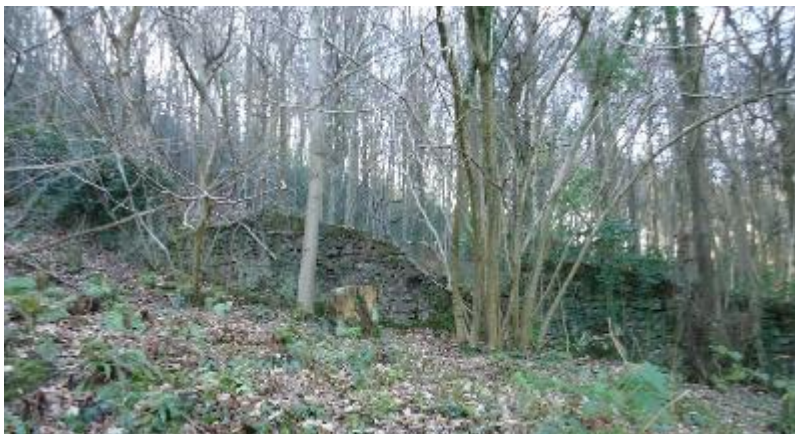
Asset Number	CH37
Asset Name	Boundary Wall
Description	Drystone wall along the boundary of Leigh Court Registered Park and Garden (NHLE: 1000407). In poor condition, with stones missing and overgrown sections.
Location	9+450m
Value	Negligible
7/2/2018 Photograph Number 22

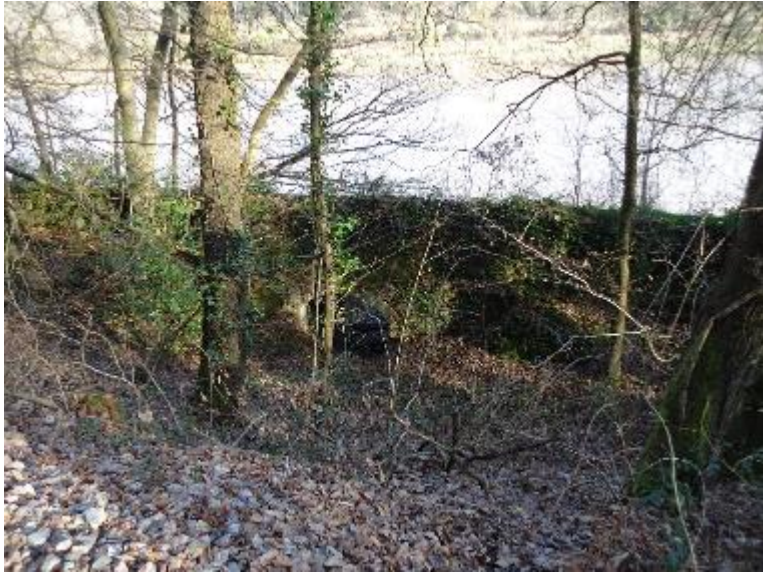
Asset Number	CH38
Asset Name	Culvert
Description	Culvert between Railway line and the River Avon. Constructed from brick and in adequate condition, bricks seem to be weathered and are covered in ivy.
Location	9+860m
Value	Low
7/2/2018 Photograph Number 25

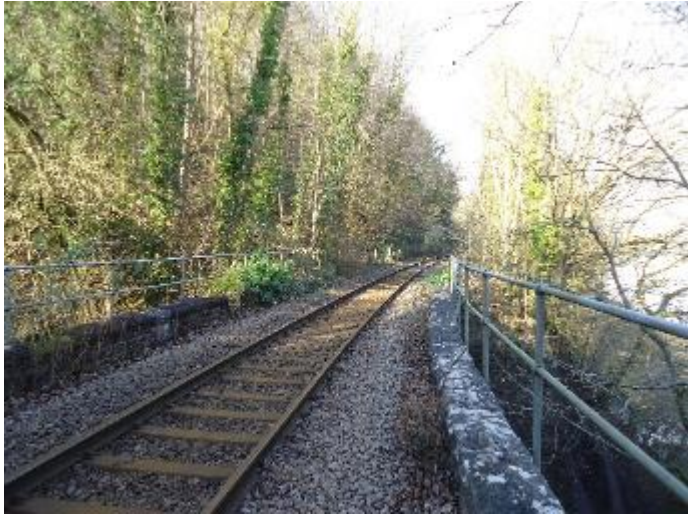
Asset Number	CH39
Asset Name	Quarry Underbridge 6
Description	Single-span underbridge constructed from stone with brick arch. The bridge is in good condition, though does show signs of weathering. There is a metal rail on each side of the parapet, which may have been added when the line was reinstated.
Location	9+300m
Value	Low
7/2/2018 Photograph Number 28

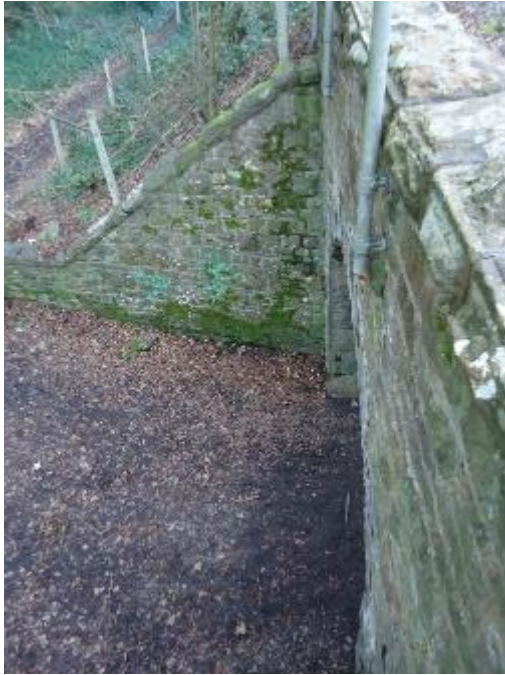
Asset Number	CH40
Asset Name	Quarry Underbridge 5
Description	Single-span underbridge constructed from stone with brick arch. The bridge is in good condition, though does show signs of weathering. There is a metal rail on each side of the parapet, which may have been added when the line was reinstated. Some graffiti is visible on the wing walls.
Location	8+700m
Value	Low
7/2/2018 Photograph Number 30

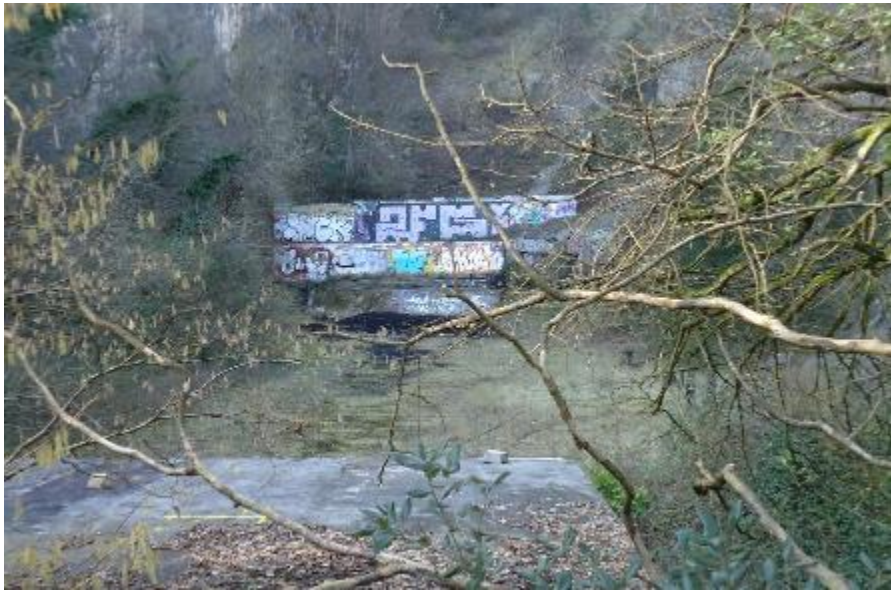
Asset Number	CH42
Asset Name	Rifle Range
Description	Disused police rifle range constructed from an old quarry to the west of the Portishead Railway. The site is described as a quarry up to the 1946 6" OS map [1], indicating it only became a rifle range in the mid-twentieth century. As a quarry it contained two buildings and had its own dedicated rail track to transport stone away. Police association is given in the local media, no exact dates given for use by them [2]. The range is covered extensively in graffiti and has become a hotspot for would be artists [3].
Location	Ch. 8250m
Value	Low
7/2/2018 Photograph Number 31
