Portishead Branch Line (MetroWest Phase 1)

6.25, Environmental Statement, Volume 4, Appendix Series 8 Cultural Heritage

**6.25, Environmental Statement, Volume 4, Appendix 8.1 Cultural Heritage
Gazetteer**

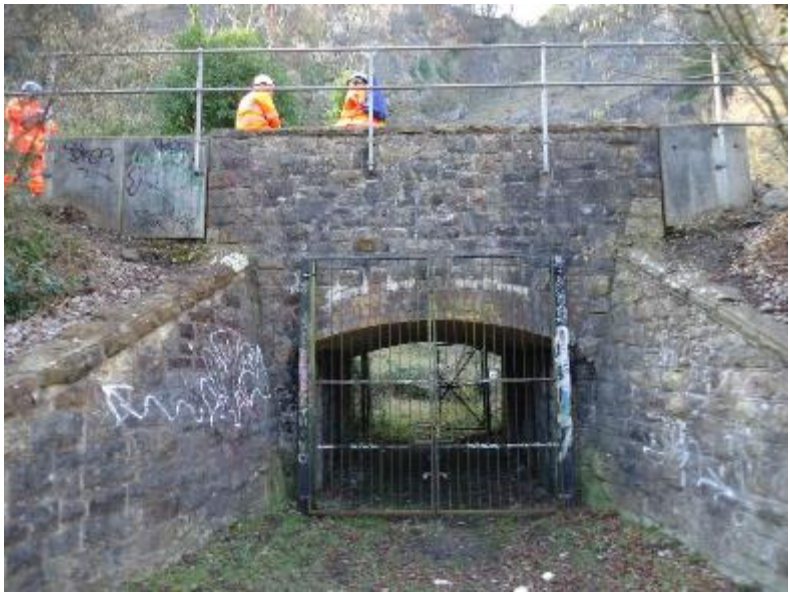
Asset Number	CH43
Asset Name	Quarry Underbridge 2
Description	Single-span underbridge constructed from stone with brick arch. The bridge is in good condition, though does show signs of weathering. There is a metal rail on each side of the parapet and metal sheets have been added to extend the length of the parapets, these may have been added when the line was reinstated in the 2000s. Fencing has been placed on each side of the bridge arches to prevent people accessing the former quarry. Some graffiti is visible on the wing walls and the gate. The National Trust uses this bridge to access the quarry to manage the woodland.
Location	7+900m
Value	Low
7/2/2018 Photograph Number 33

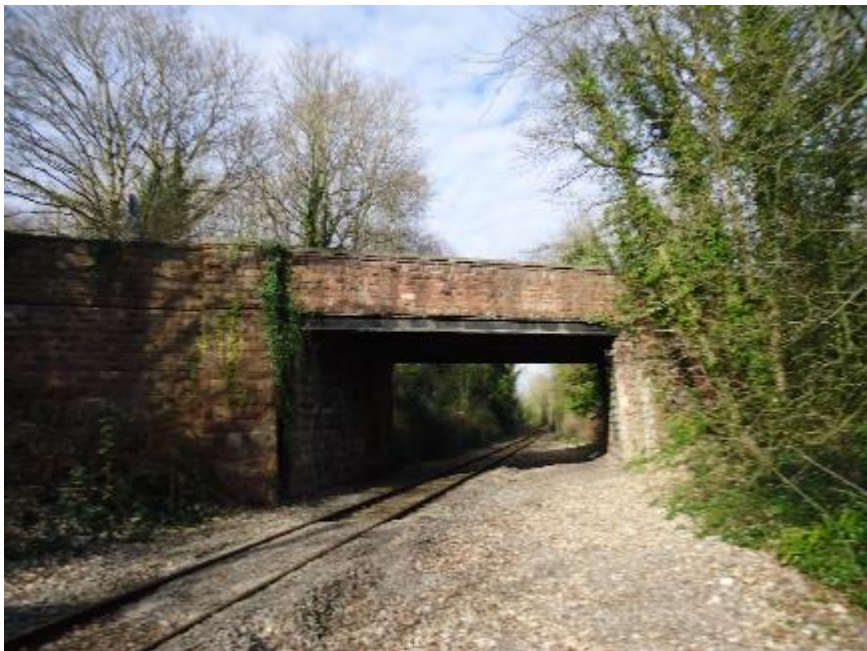
Asset Number	CH45
Asset Name	Clifton Overbridge
Description	Single-span sandstone masonry bridge. The road is supported by rigid steel joists, rather than the arch design found elsewhere on the Portishead Railway line.
Location	6+175m
Value	Low
7/2/2018 Photograph Number 44

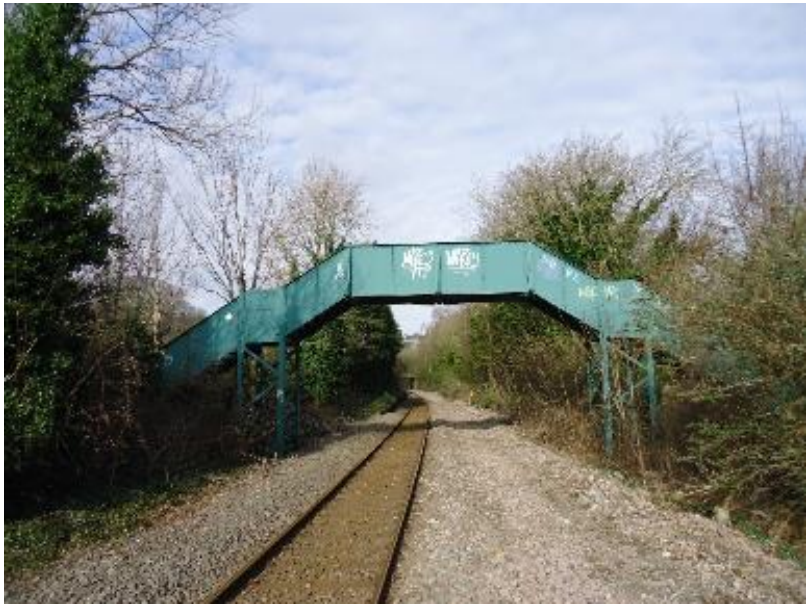
Asset Number	CH46
Asset Name	Footbridge
Description	Late 19th century Railway Footbridge at the south end of the former Clifton Bridge Station. Plain metal footbridge, painted green. In good condition, though some graffiti has been painted on its sides. Originally used for passengers to access both platforms, now in use for pedestrians to cross the railway line to and from Clainage Lane and the Avon Bridge. The footbridge was constructed in 1880 during the expansion of Clifton Bridge Station, coinciding with the track being upgraded to 4 ft. 8 1/2 in. (1,435 mm) standard gauge, and on a passing loop was brought into use through the station [1].
Location	5+975m
Value	Low
7/2/2018 Photograph Number 47

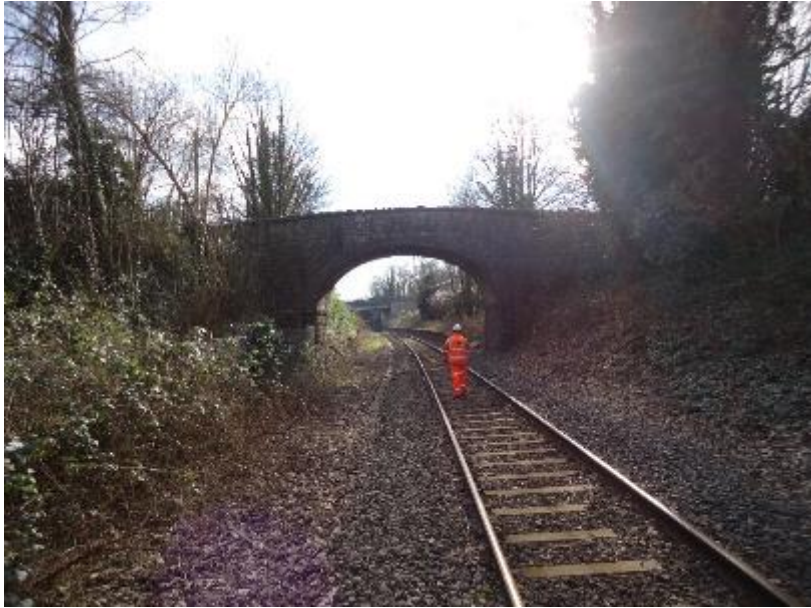
Asset Number	CH47
Asset Name	Purells Overbridge
Description	Single-span bridge over the Bristol-Portishead Line. Constructed from masonry with a red brick arch. In good condition.
Location	5+475m
Value	Low
7/2/2018 Photograph Number 50

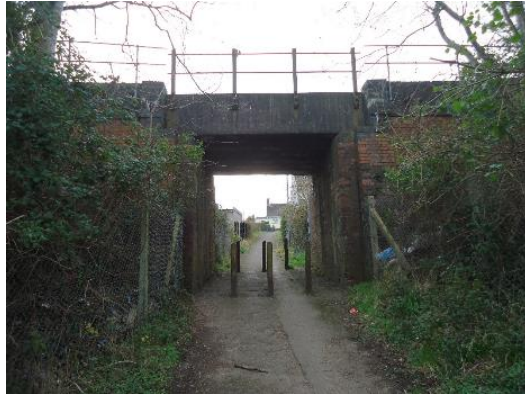
Asset Number	CH48
Asset Name	Avon Underbridge
Description	Underbridge located on the outskirts of Pill. Constructed primarily from red brick, but the top is made from concrete. The footpath has three wooden stakes on each side of the bridge. An underbridge is recorded in this location from the 1844-1888 OS 25" 1st Edition [1], but this may not be the same one, as it has a more modern design than would be expected for a late 19th century railway bridge (for example most bridges and underbridges contemporary with the railway use arches in their design, this bridge does not). Considering the expansion of Pill in the 20th century, a new bridge more appropriate for higher pedestrian foot traffic may have been built. Also recorded during the 2014 survey.
Location	13+425m
Value	Low
7/2/2018 Photograph Number 130

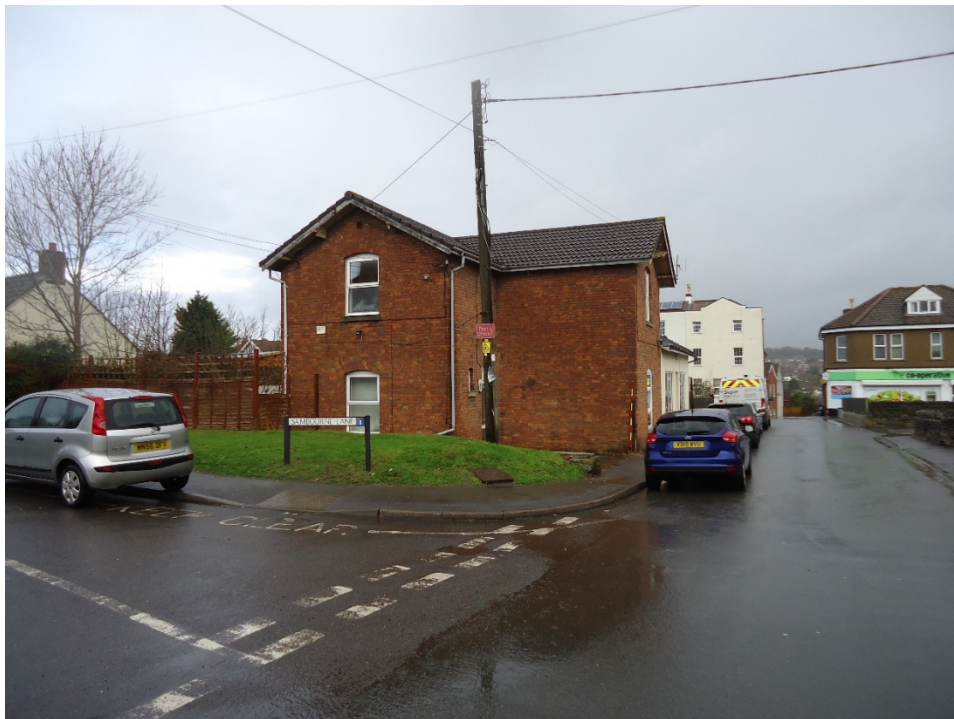
Plate 1: Looking north towards the asset from Station Road.

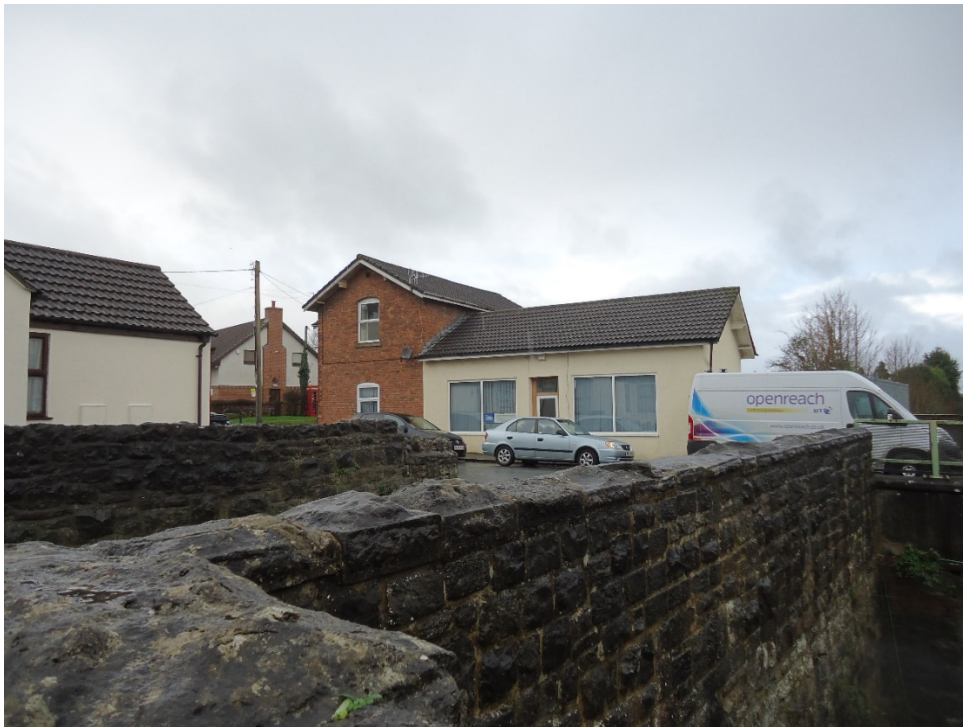
Plate 2: Looking west towards the asset from Pill footbridge.

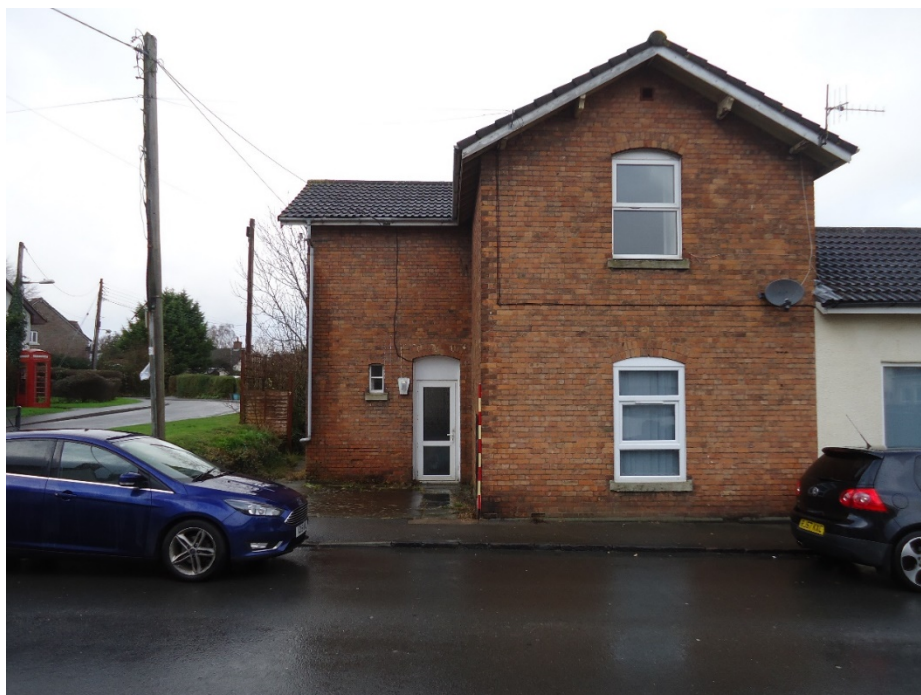
Plate 4: Original doorway within the Station Street frontage of the asset.

- 3.4.5 The Station Road frontage of the annexe has also had large modern windows installed and pebble-dash rendering as part of its commercial conversion. The most notable architectural feature within the Station Road frontage is an original doorway facing onto the road (Plate 4).

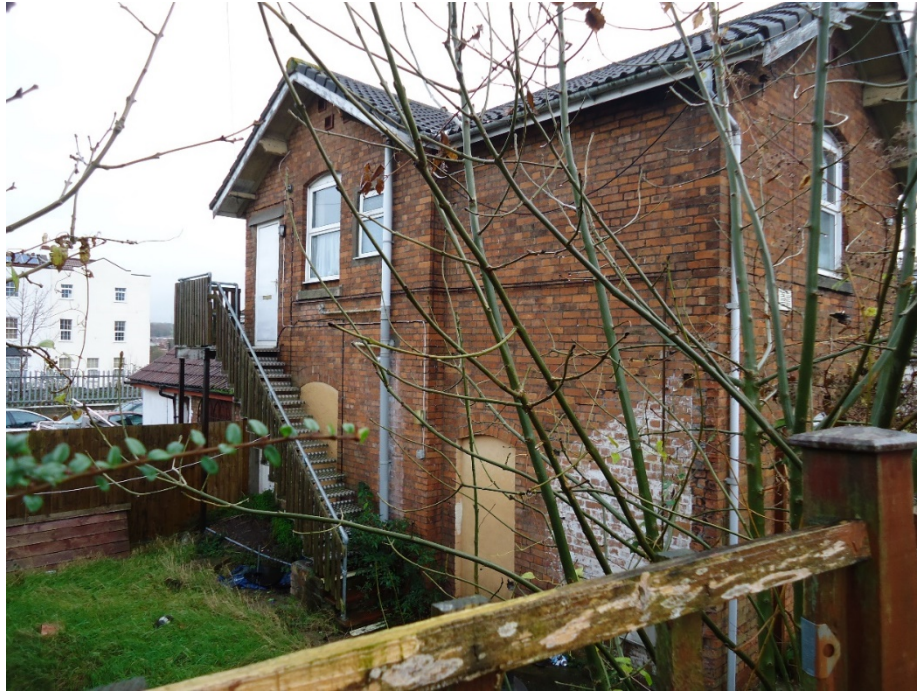
Plate 5: Looking north-east towards the rear of the asset from Sambourne Lane.

- 3.4.6 To the rear of the asset further modern modifications were noted. These included another blocked-up original doorway on the ground floor, a blocked-up original window on the ground floor, a modern steel staircase, and a modern door and window on the upper storey (Plate 5). These modifications are in accordance with the above noted planning applications.
- 3.4.7 Vestigial walls were noted to the rear of the asset, and at its north-eastern extent, that reflect the locations of former stores/outbuildings shown on historic mapping.
- 3.4.8 No other features of architectural interest were identified.
