Portishead Branch Line (MetroWest Phase 1)

6.25, Environmental Statement, Volume 4, Appendix 9.7 Dormice, 9.8 Otters and 9.9 Water Voles

Author: CH2M

Date: November 2019

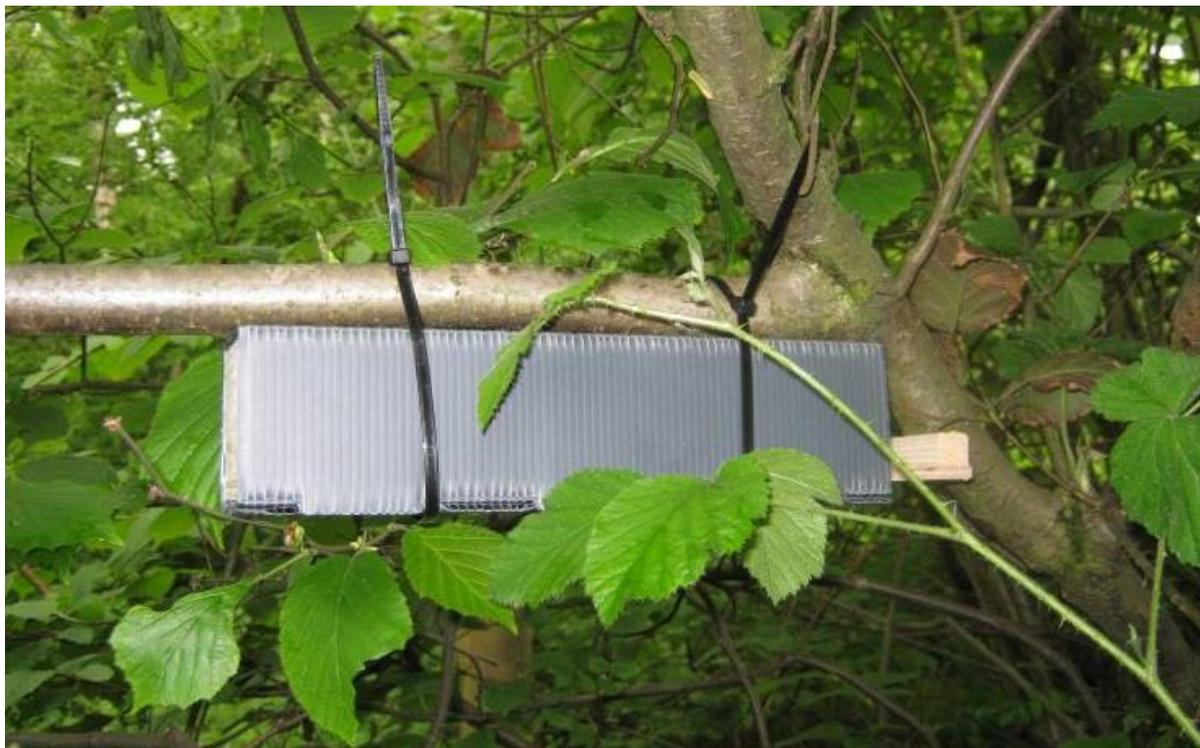
Figure 2.1: Dormouse nest tube.

- 2.2.3 Figure 2.1 illustrates how the tubes were attached to trees in the survey area. The tube number, grid reference and a description of where the tube was located, including species of tree the tube was attached to, was recorded and high visibility tape attached nearby to aid identification of the tubes.

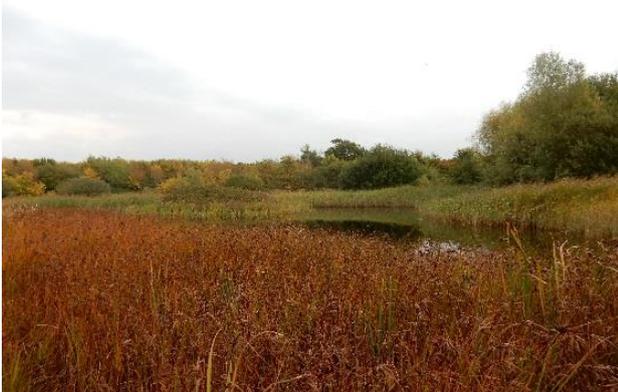
Target Note	Description	Plate
OT1	Habitat to the east of the M5 is good otter habitat with two large waterbodies, scrub, trees and rank grassland. The habitat is possibly connected to the land east of the freight line (Target Note OT2) via a culvert under the railway but this was not accessible. A mammal pathway and possible lying up site was identified close to the waterbody.

- 5.1.2 The area to the east of the M5 in the Pill area is particularly good otter habitat due to lack of disturbance, dense vegetation and links via the saltmarsh to the River Avon (OT1 and OT2). A mammal pathway and possible otter lying up site was found along one of the waterbodies (OT1).

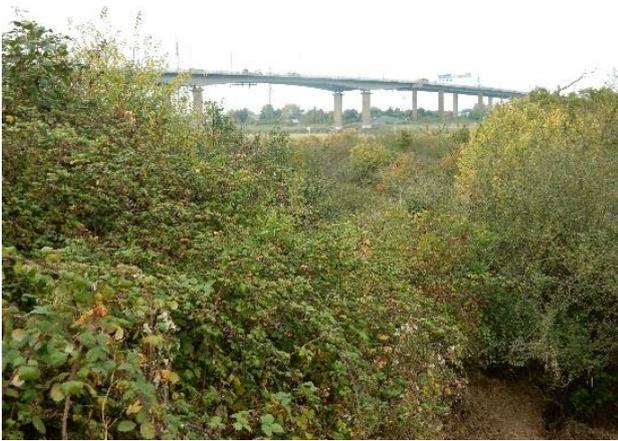
Photo taken 15/10/15		
OT2	Dense scrub, ponds and saltmarsh habitat between River Avon and Portbury Freight Line. Land to the west of a flood bank is inaccessible due to dense scrub. Suitable otter habitat.

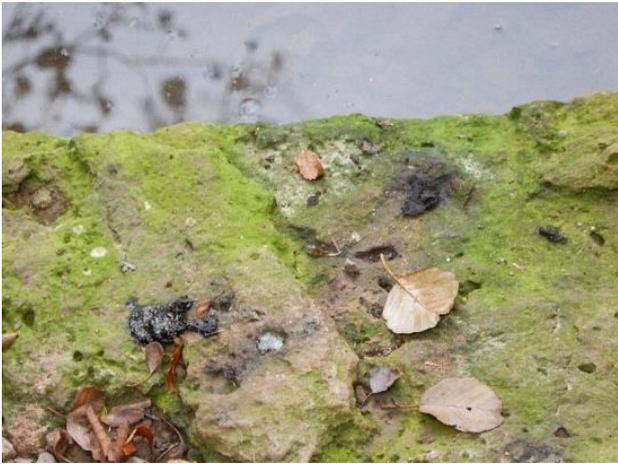
Target Note	Description	Plate
OT3	<p>Fresh otter spraint on a stone at the edge of Ham Lake. Ham Lake links to the River Avon and the fishing lake and adjacent woodland is good otter habitat.</p> <p>Photo taken 15/10/15</p>

- 5.1.3 An otter spraint was found at Ham Lake (OT3); the lake and adjacent woodland is particularly good otter habitat which is less disturbed than the River Avon Tow Path.

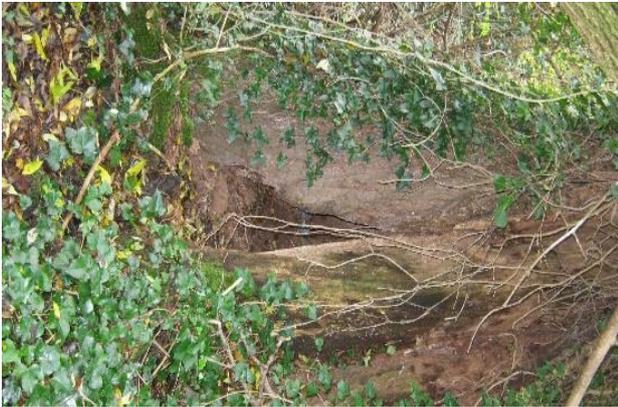
OT4	<p>Mammal pathways from River Avon Tow Path into woodland. Fallen tree may provide a good laying up site but it is close to the Avon Walkway so may be too much disturbance.</p> <p>Photo taken 14/10/15</p>

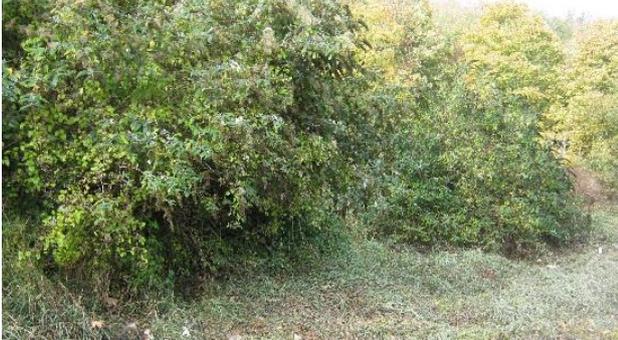
Target Note	Description	Plate
OT7	<p>Dense scrub between River Avon Tow Path and River Avon may provide suitable lying up habitat for otters. However, no signs were found.</p> <p>Photo taken 14/10/15</p>

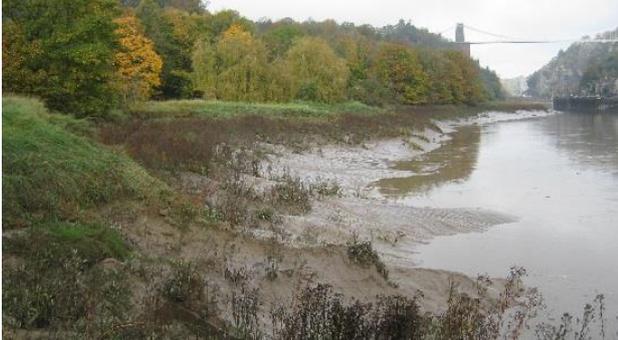
OT8	<p>Good otter habitat along the River Avon, associated saltmarsh and wooded area alongside the freight line. Evidence of regular tidal inundation which will remove evidence of use by otters. Human disturbance from regular use of the River Avon Tow Path.</p> <p>Photo taken 14/10/15</p>

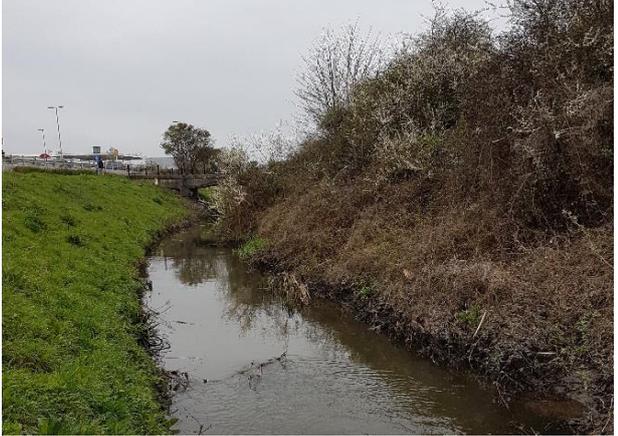
OT9	<p>Otter footprints found in Portbury Drain, Portishead during a water vole survey undertaken in April 2018</p> <p>Photo taken 13/04/18</p>

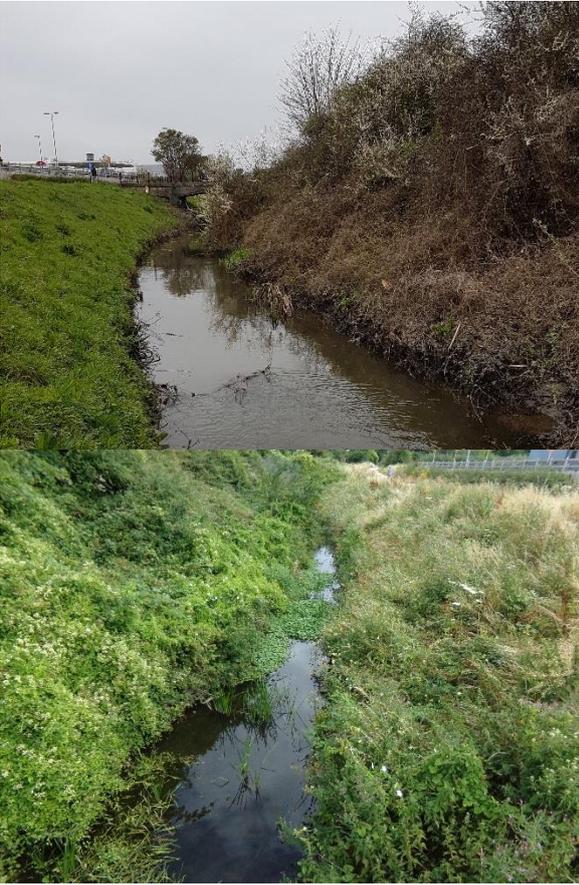
Target Note	Description	Plate
WV1	<p>Urban watercourse with approximately 50% sheet piled edge, with soft banks and berm in between. Dense vegetation on both banks. WVHS score of 8 - suitable for water voles.</p> <p>The red line boundary crosses this watercourse</p> <p>Photos taken 13/04/18 and 17/07/18</p>

- 5.1.1 No confirmed evidence of water vole presence was found during the survey in June 2015 or in 2018. However, potential burrows and footprints were recorded along waterbody WV1 during the April 2018 survey visit. The WVHS assessment identified five watercourses which provide habitat suitable for water voles (TN WV1, TN WV3, TN WV11, TN WV14, and TN WV16) and three which may be used as 'sink habitat' for water voles dispersing from other suitable habitats later in the breeding season (TN WV4, TN WV9 and TN WV15), which are of Local value.

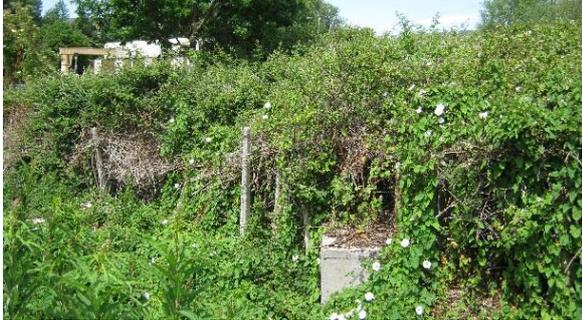
Target Note	Description	Plate
WV2	<p>A concrete lined watercourse next to a pumping station. No channel visible passing underneath the railway line, a concrete headwall is visible, therefore it is assumed that the channel is culverted and not suitable for water voles.</p> <p>Part of the watercourse is within the red line boundary</p> <p>Photo taken 25/6/15</p>

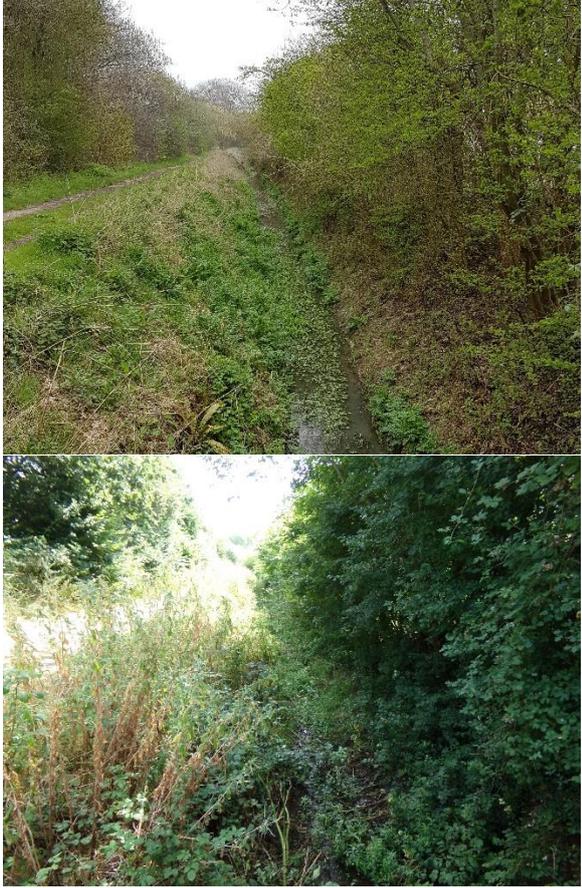
WV3	<p>A densely vegetated watercourse with steep soft banks but shallow water depth in summer (approx. 100mm deep) situated to the south of the railway line. WVHS score of 8 – therefore suitable for water voles but likely to be limited during summer months due to lack of water.</p> <p>Watercourse is within the red line boundary (temporary use)</p> <p>Photos taken 13/04/18 and 17/07/18</p>

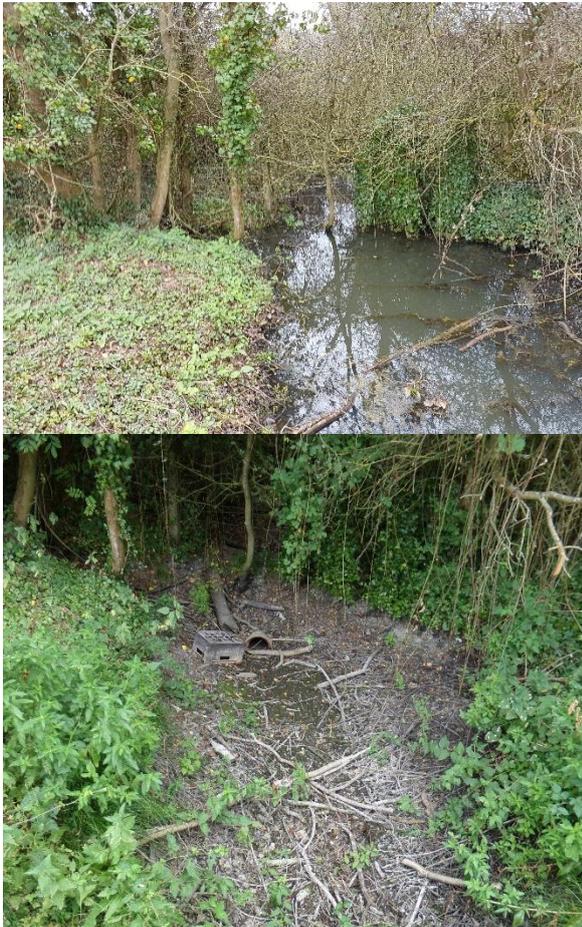
Target Note	Description	Plate
WV4	<p>Watercourse close to Portbury Wharf Nature Reserve and culverted under railway line. Wet during April 2018 survey but dry during July 2018 survey and no aquatic vegetation that would indicate that the watercourse is wet for the majority of the time. WVHS score of 3 – may provide a ‘sink’ habitat later in the breeding season.</p> <p>Watercourse is within the red line boundary.</p> <p>Photos taken 13/04/18 and 17/07/18</p>

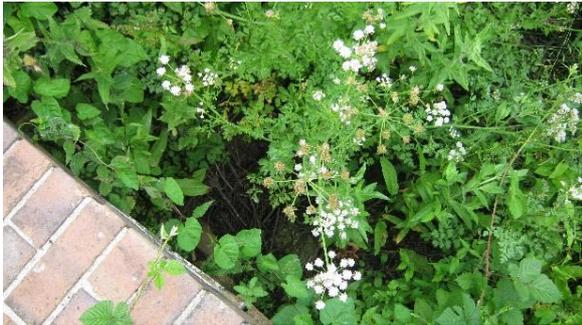
WV5	<p>Watercourse at Sheepway Gate Farm culverted under the railway line. Dry at the time of survey and evidence suggests that it is likely to be dry or contain very shallow water based on terrestrial plant species dominating rather than aquatic plants. WVHS score of 1 – unsuitable for water voles.</p> <p>Watercourse is within the red line boundary.</p> <p>Photo taken 25/6/15</p>

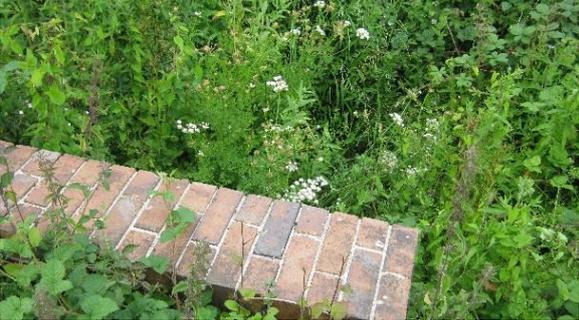
Target Note	Description	Plate
WV6	<p>A dry watercourse to the west of fishing lakes, culverted under the railway line and overgrown with bramble. WVHS score of 2 – unsuitable for water voles.</p> <p>Watercourse is within the red line boundary.</p> <p>Photo taken 25/6/15</p>

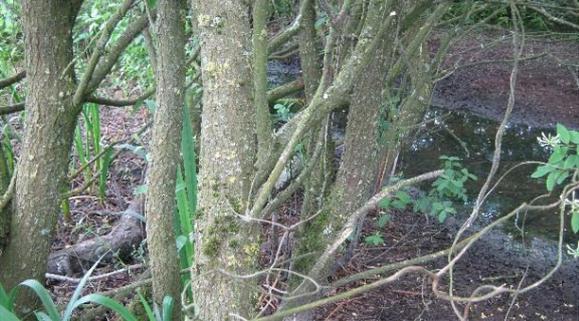
WV7	<p>A widened section of ditch to create a pond on the southern side of railway line. The ditch is culverted under the railway line. Shaded by trees, shallow banks and very little water. WVHS of 1 – unsuitable for water voles.</p> <p>Watercourse is within the red line boundary</p> <p>Photo taken 25/6/15</p>

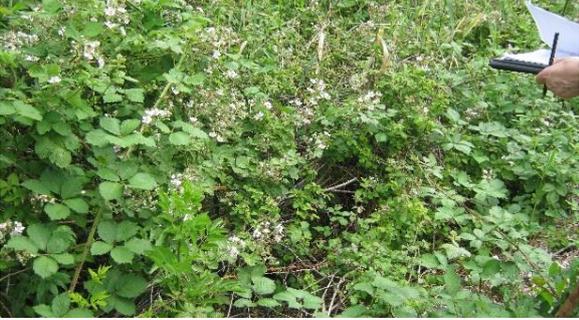
WV8	<p>Dry ditch to the north of the railway line, overgrown with bramble. WVHS score of 2 – unsuitable for water voles.</p> <p>Watercourse is within the red line boundary.</p> <p>Photo taken 25/6/15</p>

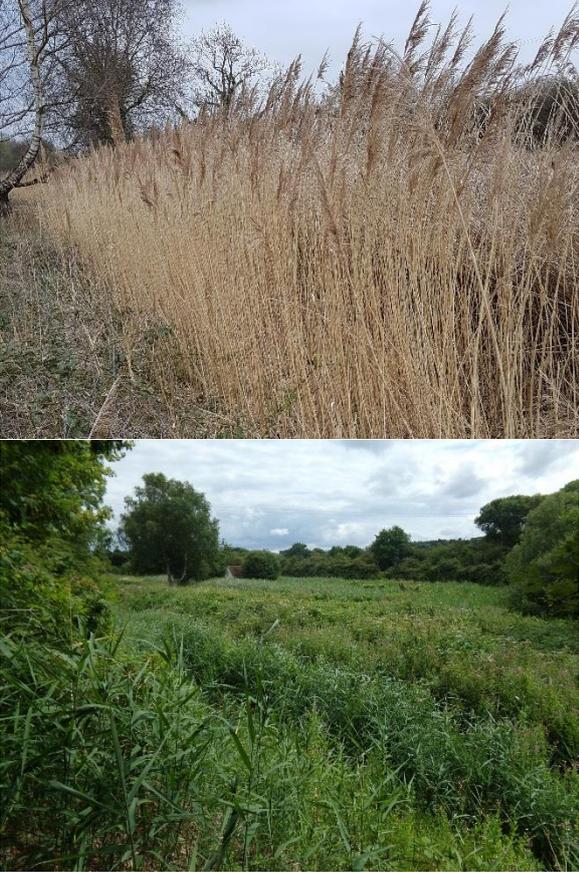
Target Note	Description	Plate
WV9	<p>A dense reed bed situated to the south of the railway line, dominated by common reed <i>Phragmites australis</i>. Almost dry during April 2018 survey and dry during July 2018 survey. WVHS score of 4 – may provide a ‘sink’ habitat later in the breeding season.</p> <p>The majority of this watercourse and reed bed is outside the red line boundary.</p> <p>Photos taken 13/04/18 and 17/07/18</p>

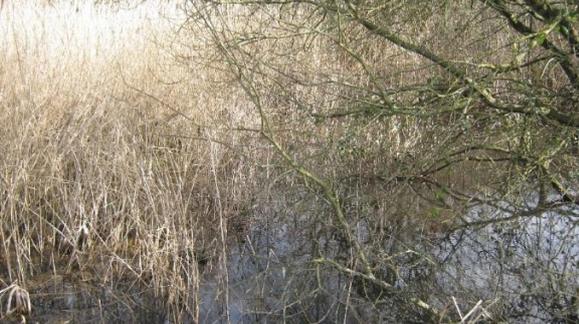
WV 10	<p>A pond located to the north of the railway line with dense common reed. Water voles were seen at this pond during great crested newt surveys in May 2016.</p> <p>Pond is outside the red line boundary.</p> <p>Photo taken 25/2/15</p>

- 4.3.2 An incidental survey was undertaken on 25th April 2016 during an eDNA survey for great crested newts of a waterbody located approximately 11.5 m north of Network Rail's land ownership boundary and two water voles were seen and one water vole burrow identified. This pond is referenced Target Note WV10 and is located at national grid reference ST 500 757. The pond is approximately 22 m long and 16 m wide surrounded by dense reed bed. It was noted that this pond had been partially cleared of dense reed in 2018.

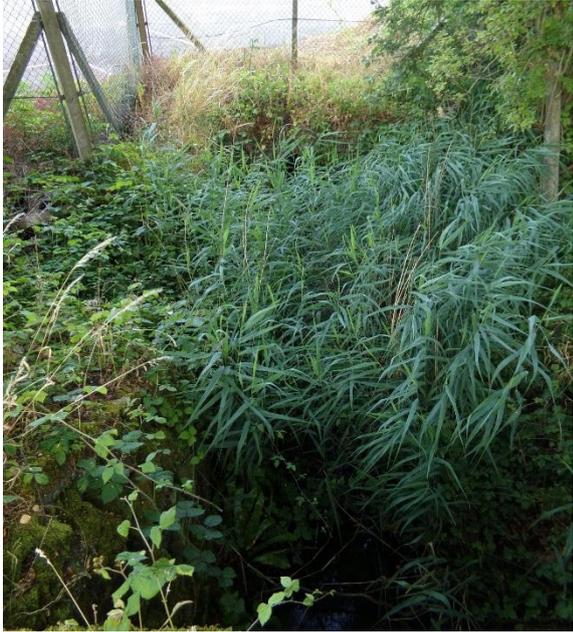
Target Note	Description	Plate
WV11	<p>Watercourse with running water culverted under the railway line but only 50mm deep. Possibly connected to Drove Rhyne to the north via a culvert under a car park. The culvert limits connectivity for water voles. WVHS score of 7 – therefore suitable for water voles but likely to be limited during summer months due to lack of water.</p> <p>Watercourse is within the red line boundary.</p> <p>Photo taken 17/07/18</p>

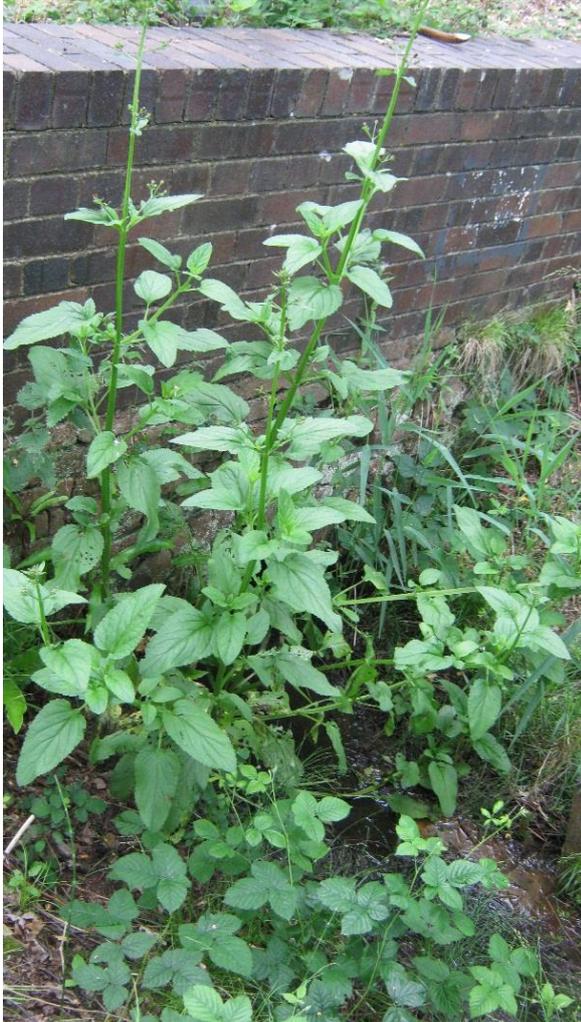
WV12	<p>A dry, shaded watercourse culverted under the railway line. WVHS score of 2 – unsuitable for water voles.</p> <p>Watercourse is within the red line boundary.</p> <p>Photo taken 25/6/15</p>

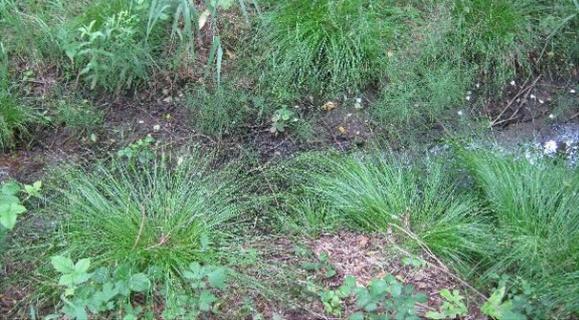
Target Note	Description	Plate
WV13	<p>A ditch with common reed to the north of the railway line. Dry at time of survey. WVHS score of 1 – unsuitable for water voles. Watercourse is within red line boundary. Photo taken 25/6/15</p>

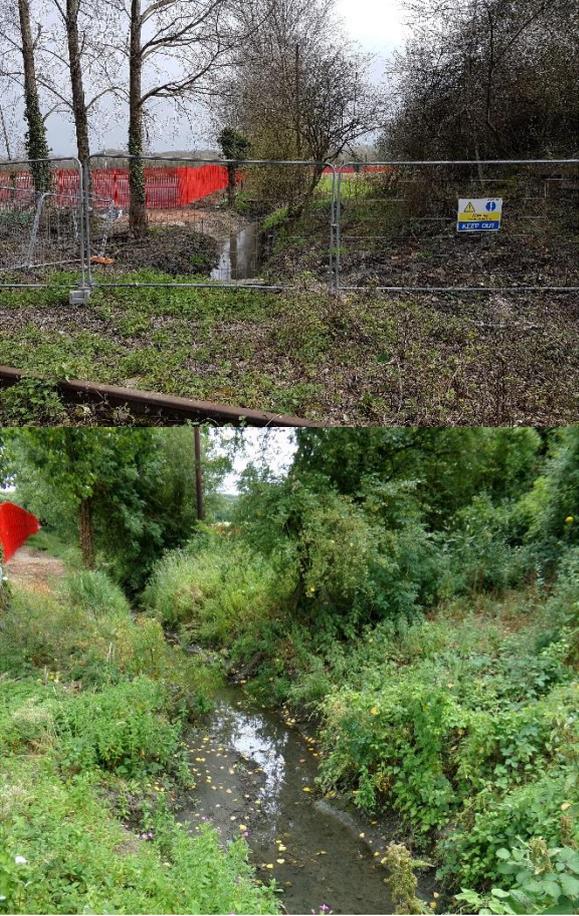
WV14	<p>A ditch with water – shallow depth (<100mm) during July 2018 survey. Relatively little bankside vegetation within 10m of railway line. Culverted under railway line and discharges into Drove Rhyne. Visibly polluted with sewage fungus. WVHS score of 6 – suitable for water voles and may be used as a ‘sink habitat’ for water voles dispersing from Drove Rhyne. Watercourse is within the red line boundary. Photos taken 13/04/18 and 17/07/18</p>

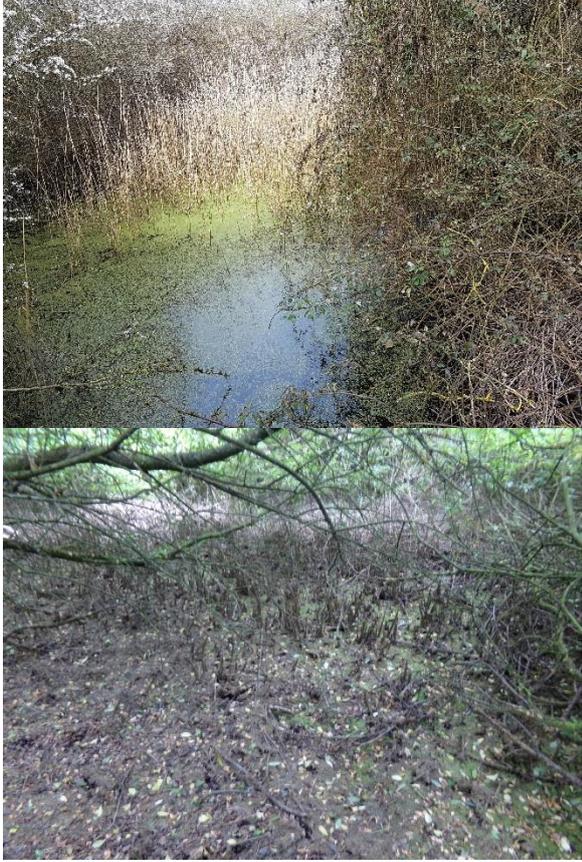
Target Note	Description	Plate
WV15	<p>A ditch dominated by common reed in the centre of the channel which widens at the western end into a pond, shaded by trees. Dry during July 2018 survey visit. Lack of optimal bankside vegetation such as emergent species/long grass. Steep bank on northern side. WVHS score of 3 – may provide ‘sink habitat’ especially due to proximity to Drove Rhyne. Watercourse is within the red line boundary (part to be acquired and part for temporary use). Photos taken 13/04/18 and 17/07/18</p>

<p>The 'Plate' column contains two photographs. The top photograph shows a wide view of a ditch or pond area. The water is dark and still, surrounded by dense, tall reeds and grasses. The banks are steep and covered in vegetation. The bottom photograph is a closer, ground-level view of the ditch, showing the water surface and the surrounding reeds and grasses in more detail.</p>

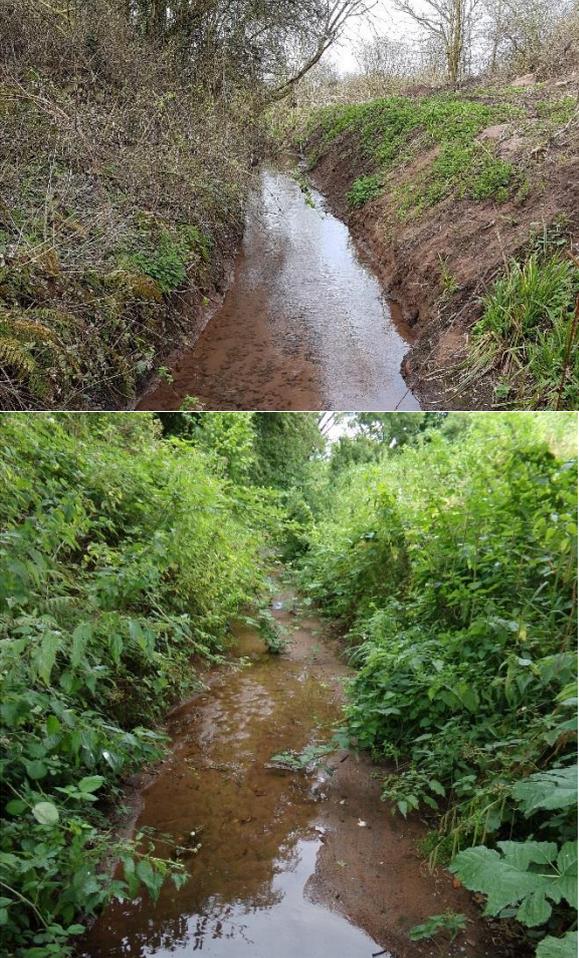
Target Note	Description	Plate
WV16	<p>Watercourse with steep banks that were relatively bare of vegetation during the April 2018 survey visit but well vegetated during the July 2018 survey visit. Water level was low during the July 2018 survey visit. May link to other ditches in the Portbury Dock area and may provide a 'sink habitat'. WVHS score of 6 – suitable for water voles.</p> <p>Watercourse is within the red line boundary (part to be acquired and part for temporary use).</p> <p>Photos taken 13/04/18 and 17/07/18</p>

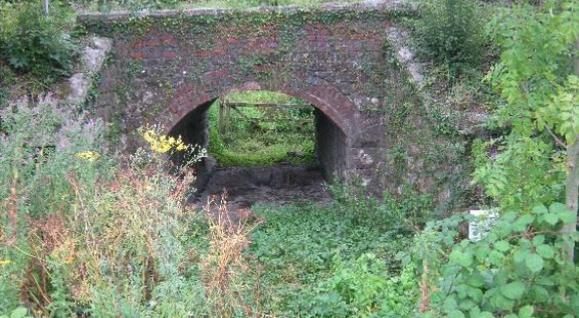
WV17	<p>Watercourse dry at time of survey. Evidence of trampling of the ground, possibly by cattle grazing grassland to the south. WVHS score of 2 – unsuitable for water voles.</p> <p>Watercourse is within the red line boundary.</p> <p>Photo taken 25/6/15</p>
