Portishead Branch Line (MetroWest Phase 1)

Applicant: North Somerset District Council

6.25, Environmental Statement, Volume 4, Appendix 9.11 Avon Gorge Vegetation Management Plan

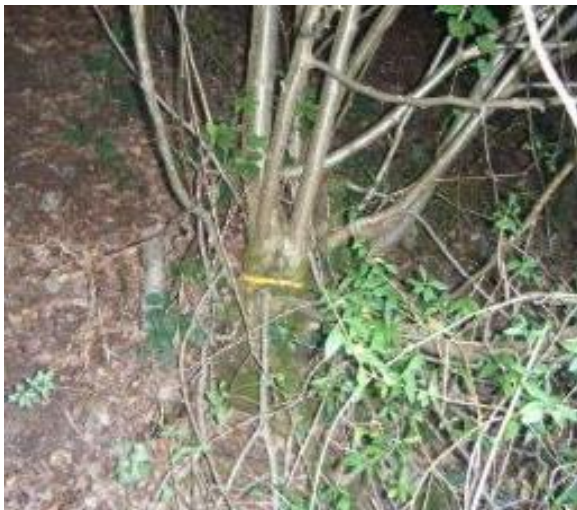
Plastic yellow collars installed to facilitate the identification of sensitive species during works along the freight line. A number of these collars are now constricting the plant which they demarcate and should be removed to prevent growth restriction and death of the tree.

- 2.1.27 A number of techniques including spray paint, coloured tape and plastic collars have been used to demarcate sensitive Whitebeam plants in the Avon Gorge, as shown in the photographs below. The number of methods employed have the potential to cause confusion to those undertaking works, alert the public to sensitive species and also distract from the natural setting of the woodland. As such the mechanism of demarcation needs to be consolidated, as discussed in Section 5.3.

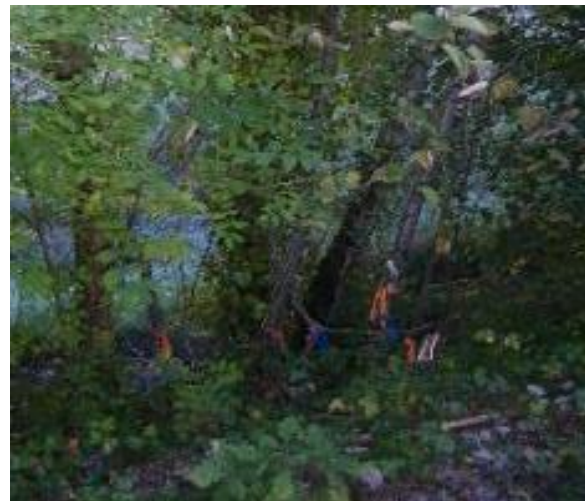
More recently blue and orange tape has been used to demarcate sensitive Whitebeam species. This method is temporary and vulnerable to removal from third parties. It also obtrusive to the natural setting of the gorge.

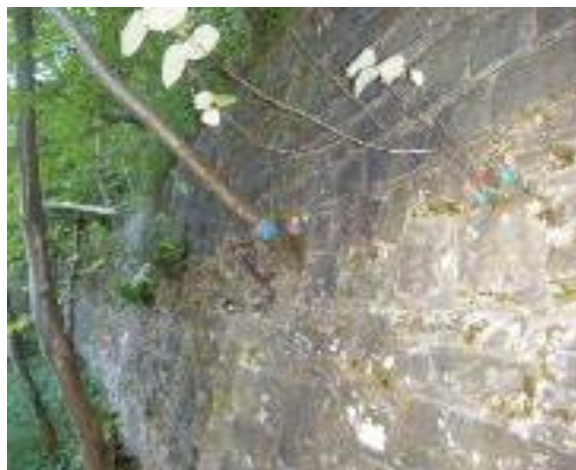
Trees on retaining walls marked with blue spray paint. There is evidence of trees having been removed along the wall by persons unknown and this could be attributed to the demarcation method employed.

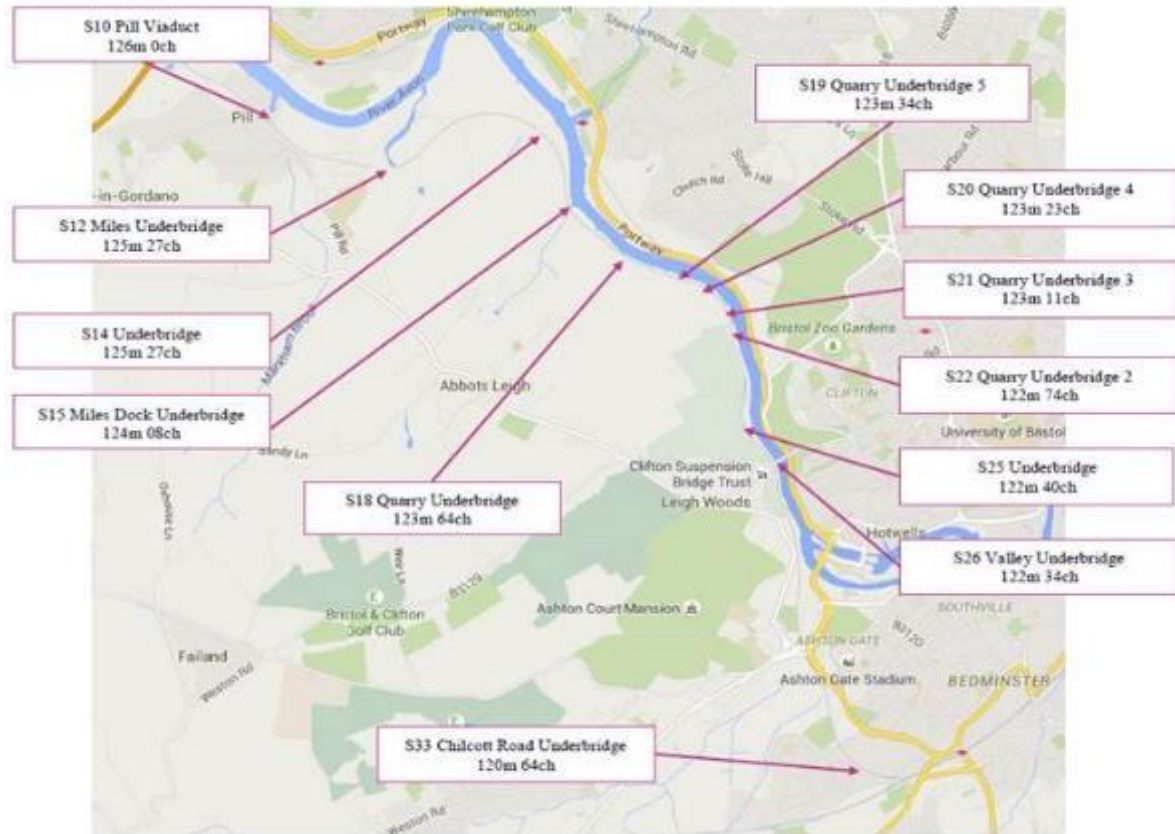
Figure 1: Location of bridges in the Avon Gorge

Structures within the Avon Gorge SAC/SSSI are S15, S18, S19, S20, S21, S22, S25 and S26

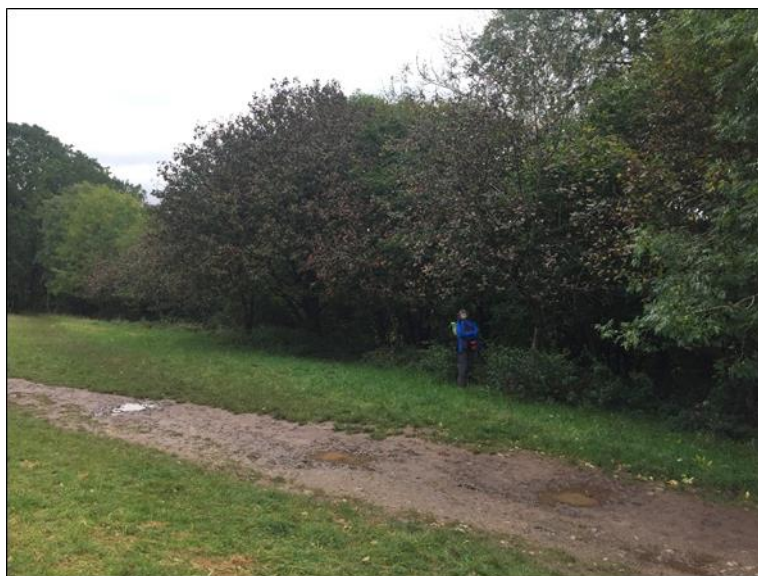
Photograph 2. Whitebeams planted in a row along the edge of The Plain over c. 50 m, photo taken 8/10/19

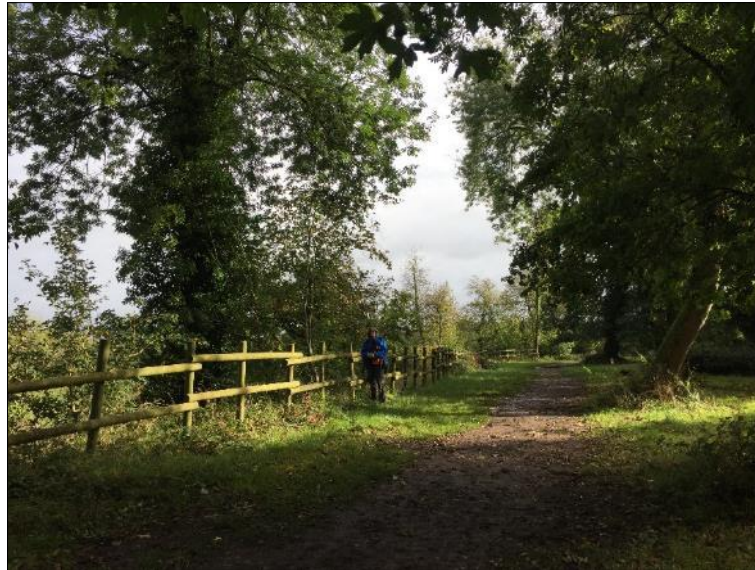
Photograph 3. Whitebeams planted behind the safety fence in the edge of Leigh Woods Camp, photo taken 8/10/19

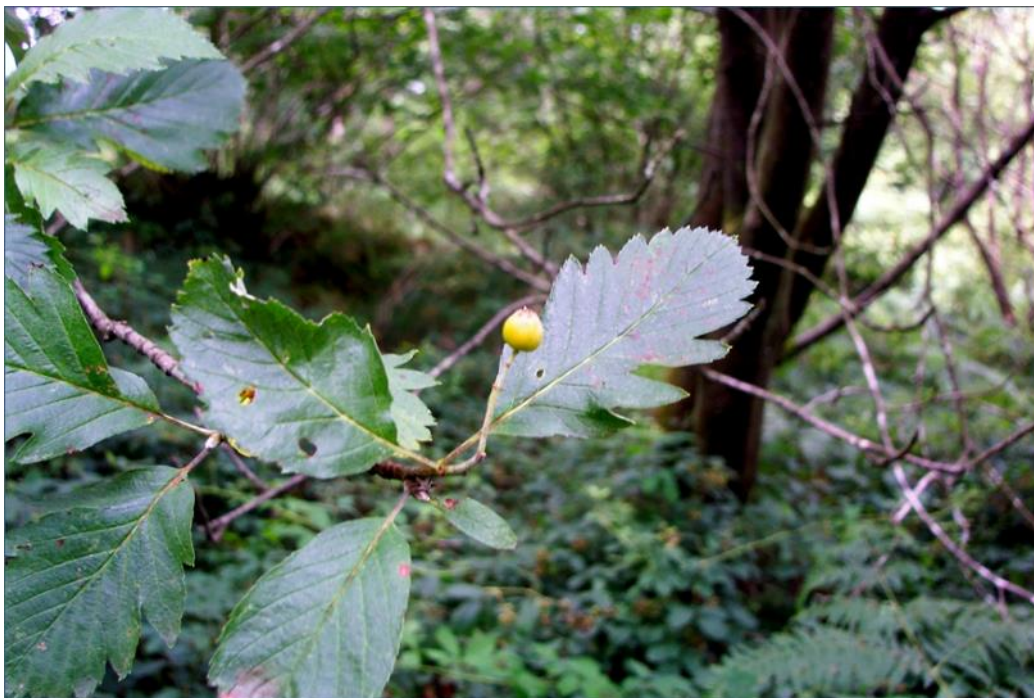
Photograph 5. One of the planted trees of Ley's whitebeam fruiting at Penmoelallt in August 2010 (planted in 1963).

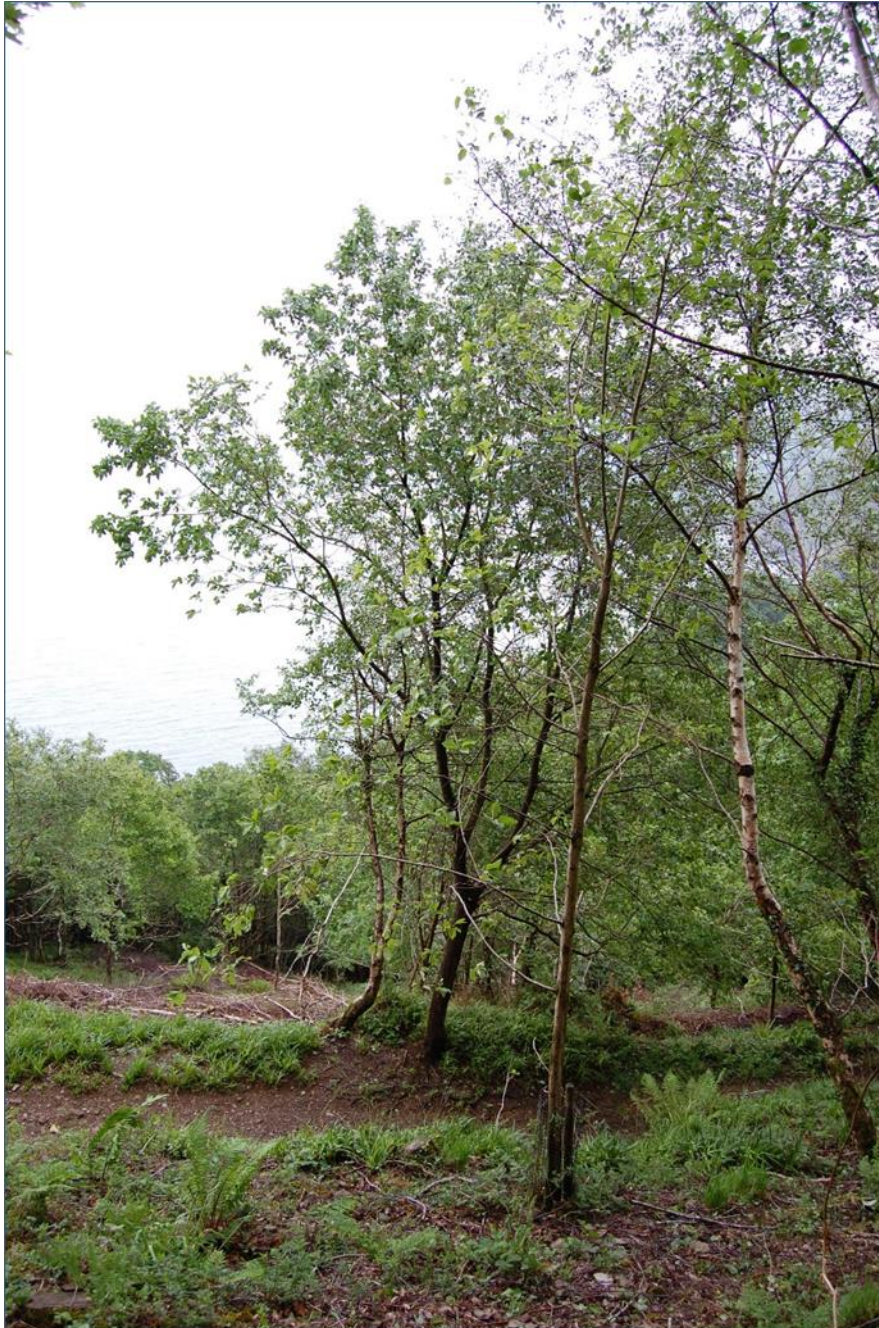
Photograph 6. Devon whitebeam planted out at Woody Bay, 2015, showing survival since planting in the early 1990s (note the stakes holding the original sapling)

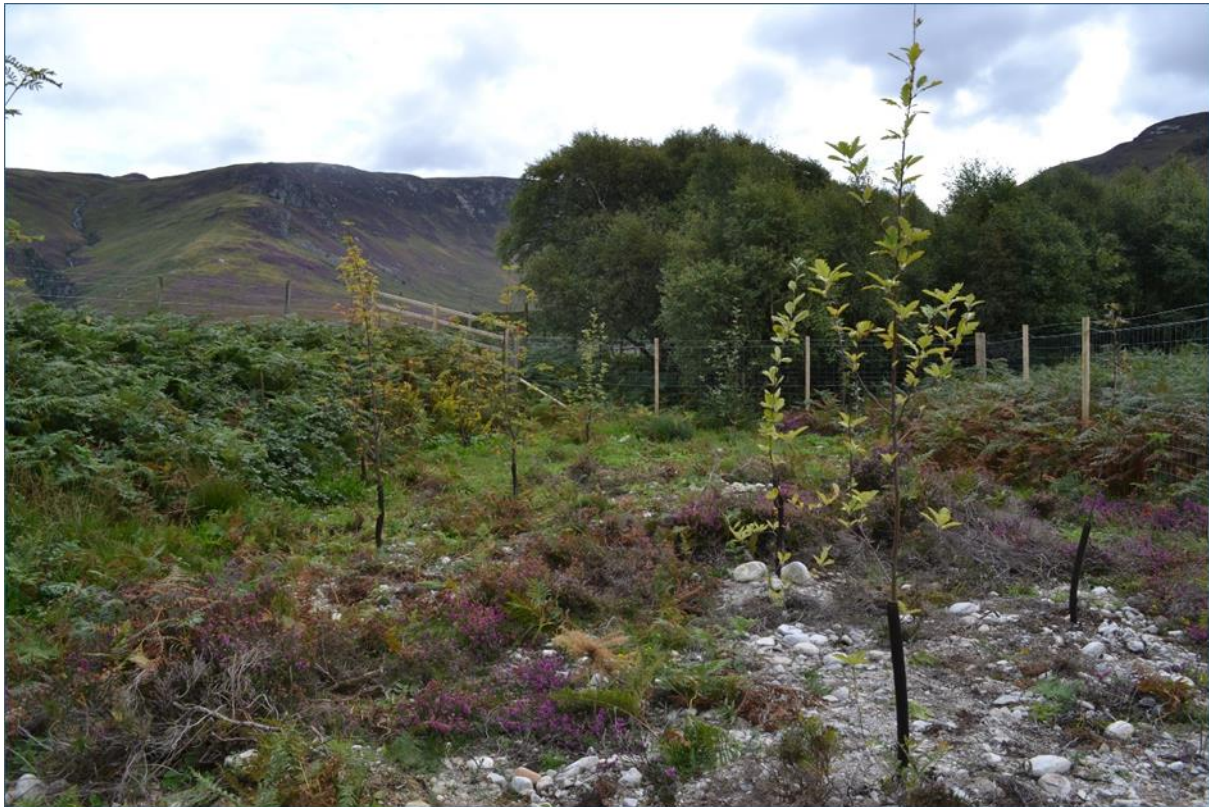
**Photograph 7. Arran Sorbus planting enclosure at mouth of Glen Catacol.
September 2014.**

seed from Arran origin have been planted out in an enclosure at the mouth of Glen Catacol and when visited in 2014 were growing well (Photograph 7). The saplings of Arran whitebeam *S. arranensis* and Arran service-tree *S. pseudofennica* were most likely grown from seed; the sapling of the false rowan *S. pseudomeinichii* may have been grown from cuttings (Dr Rich collected seed of it for the Royal Botanic Gardens Edinburgh to grow during his 2014 visit). The saplings were quite large when originally planted and have to be protected from the high red deer grazing pressure on Arran.
