## Portishead Branch Line (MetroWest Phase 1)

**6.25, Environmental Statement, Volume 4, Appendix 10.2, Annexes B to J  
The Infrastructure Planning (Applications: Prescribed Forms and  
Procedure) Regulations 2009, regulation 5(2)(a)  
Planning Act 2008**

**Ashton Vale Road Alternative Highway Access Preliminary Sources Study Report**

# Ashton Vale Road Alternative Highway Access, Preliminary Sources Study Report

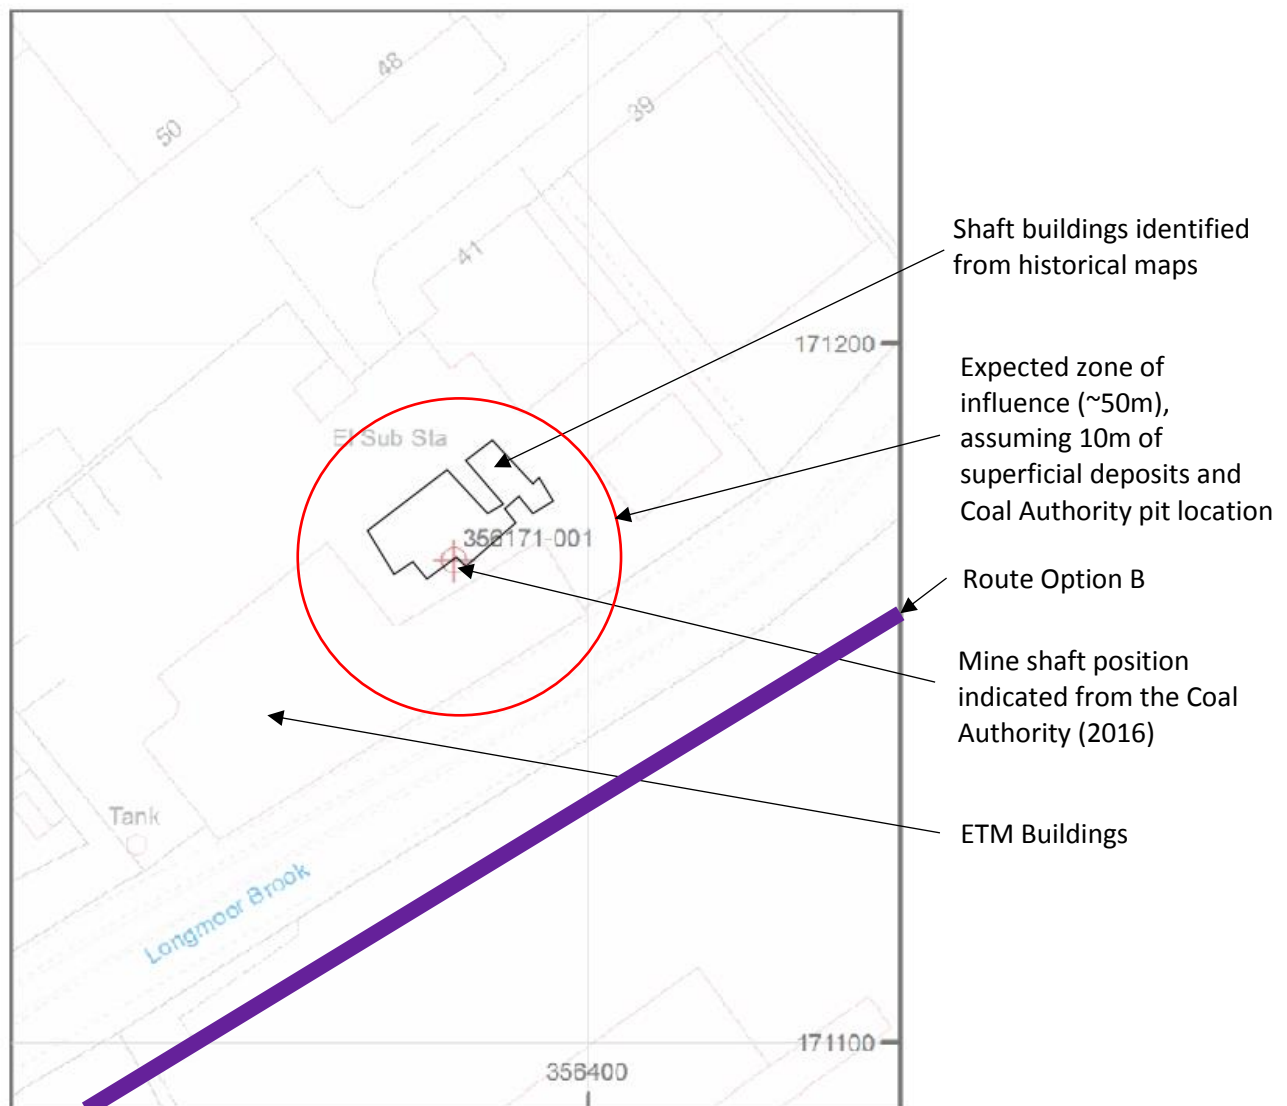
Figure 6-3: Map showing location of Ashton Vale Old Pit.

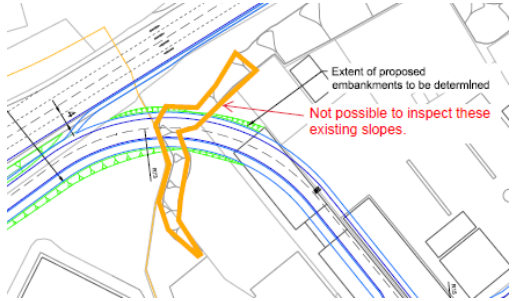
<b>Slope Stability</b>	Slope stability risk with respect to Route Option B is likely to be confined to the banks of local water courses and the slopes of the existing landfill. The stability of existing slopes should be reviewed during detailed design.	<p>There is risk with respect the stability of existing slopes which will need to be quantified by further inspection* and ground investigation.</p> <p>*Note that the area of site with the steepest slopes (and potentially the greatest risk) were out of bounds and could not be inspected as part of this study. It will be necessary to inspect these slopes (clay pit cut face) in order to evaluate their condition and in order to progress the design. Recommendation on further study is provided in Section 10.</p> <p>The area of site which could not be inspected is as follows:</p>

<p><i>Excerpt of drawing number 674946.BD.29.01-OPC-01 B (Appendix A)</i></p>

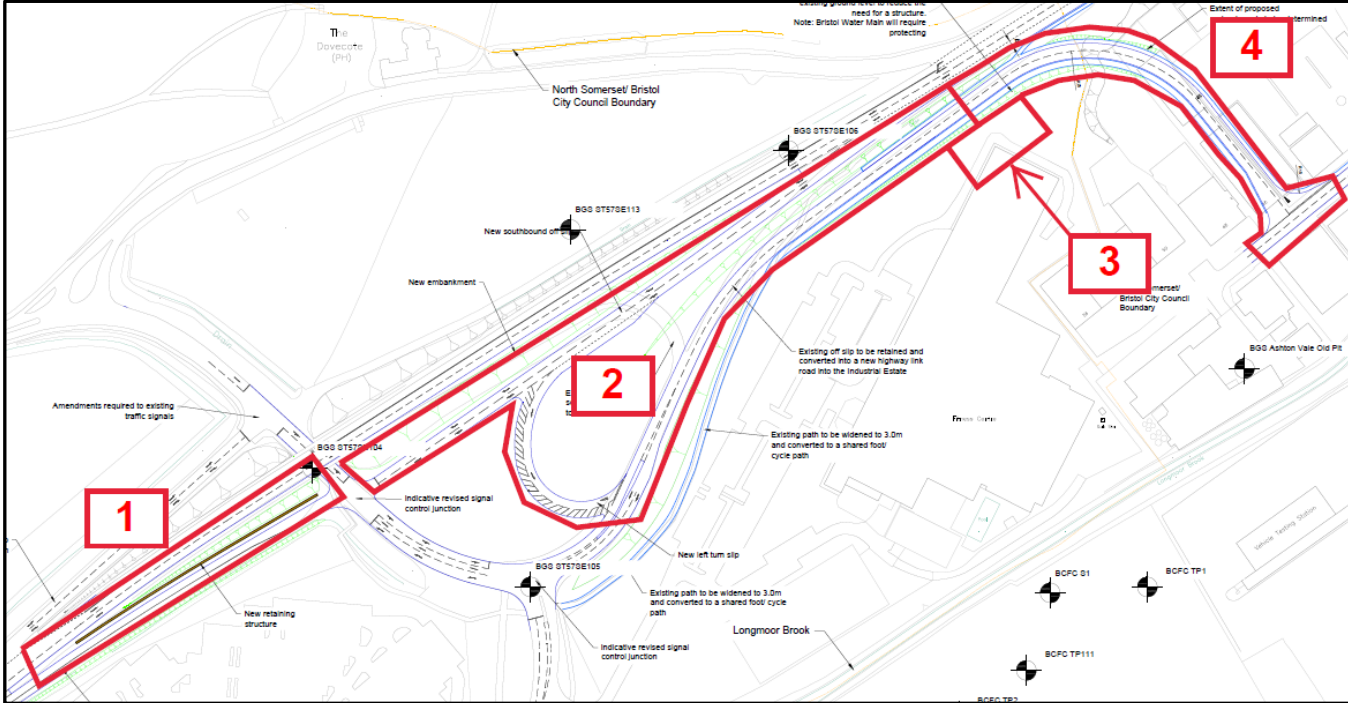
<p><b>Excerpt and annotated copy of drawing 674946.BD.29.01-OPC-01 A showing GI Areas for fieldwork and existing GI.</b></p>

Route Option C: Draft Ground Investigation Scope (Table 2 of 2)	
<p><b>Summary of GI Scope:</b></p> <p><b>Further Study</b> The following studies are recommended ahead of Fieldwork:</p> <ul style="list-style-type: none"> <li>Detailed UXO assessment;</li> </ul> <p>Coal Mining Risk Assessment (CMRA).</p> <p><b>Fieldwork:</b> Prior to exploratory (trial pit and borehole) investigation the following work is recommended:</p> <ul style="list-style-type: none"> <li><u>Geomorphological Walkover Survey</u>: access to and inspection of the existing slopes, landform and geological exposures of the area. The following scope is envisaged: <ul style="list-style-type: none"> <li>1 day’s attendance and inspection by 2No. geologists/geological engineers;</li> <li>Reporting and assessment of risk, recommendation with respect to existing condition and further studies/ground investigation;</li> </ul> </li> <li><u>Geophysics Survey</u>: There is a risk of undetected mine entries in the area which may result in subsidence or collapse. A CMRA will inform the nature of the fieldwork, however ahead of a CMRA, the following work is assumed as a minimum requirement: <ul style="list-style-type: none"> <li>Geophysical survey over the footprint of the project (allowance 3 days). Anticipated to be electrical resistivity magnetic methods and/or ground penetrating radar;</li> </ul> </li> </ul> <p>Subject to further study and a geophysical survey the GI is assumed:</p> <ul style="list-style-type: none"> <li>11No. Boreholes: <ul style="list-style-type: none"> <li>to 20m depth;</li> <li>Instrumentation to all boreholes;</li> <li>Weekly monitoring of gas and groundwater over 6 weeks;</li> <li>Associated field testing, sampling and laboratory testing for engineering and geoenvironmental sampling;</li> </ul> </li> <li>20-25No. trial pits: <ul style="list-style-type: none"> <li>Allowance 5 days;</li> <li>Assume to 3m depth;</li> <li>Associated field testing, sampling and laboratory testing for engineering and geoenvironmental sampling</li> </ul> </li> </ul>

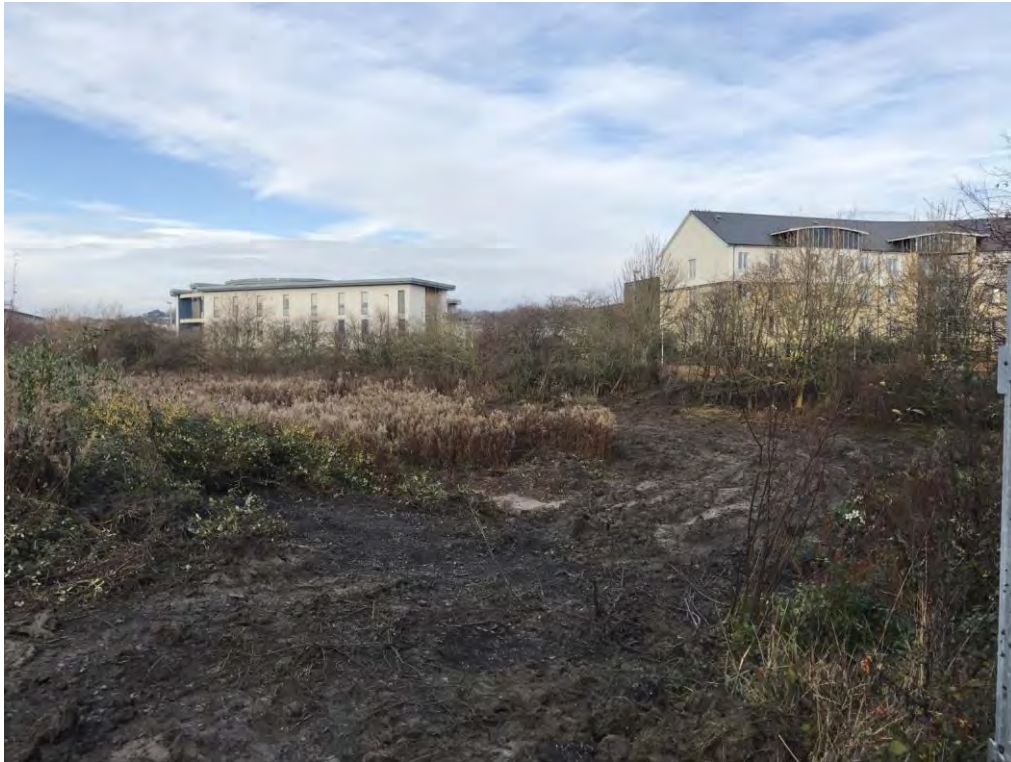
Plate 3. View north-west from the entrance gate on to site. Slight slope is noted downwards towards the north of the site.

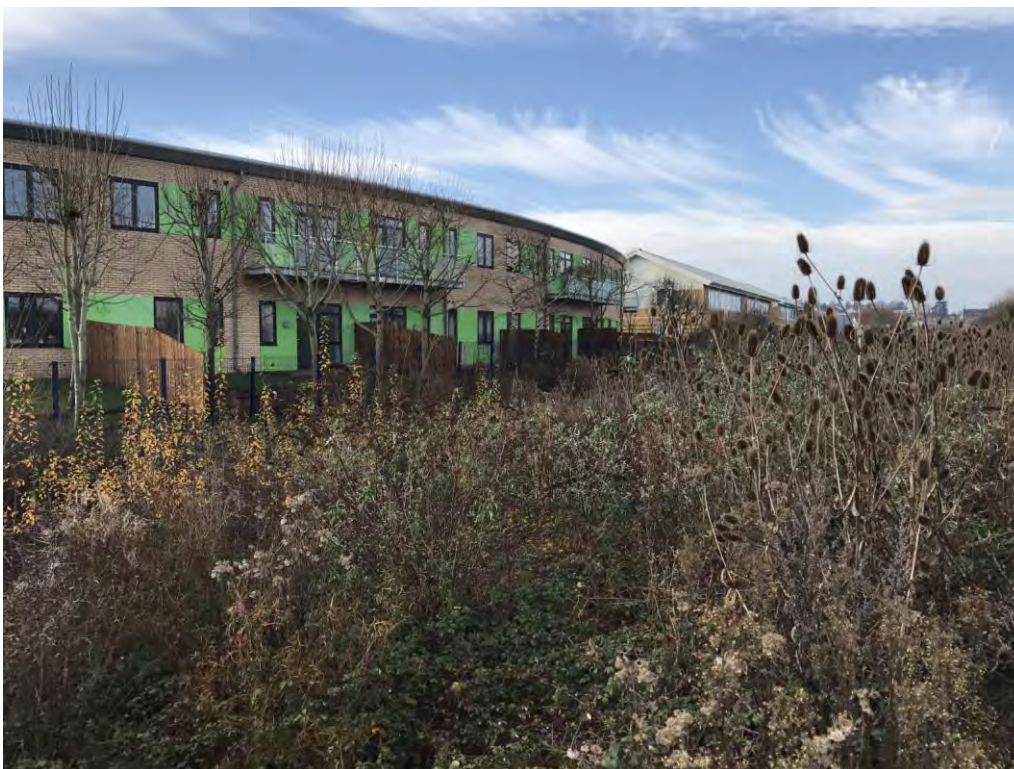
Plate 4. View south-west from the central area of the site. Note off site buildings that run adjacent to the southern boundary. A small ditch is present between the location where the photograph was taken and the site boundary. Note overgrowth which is present across the site.

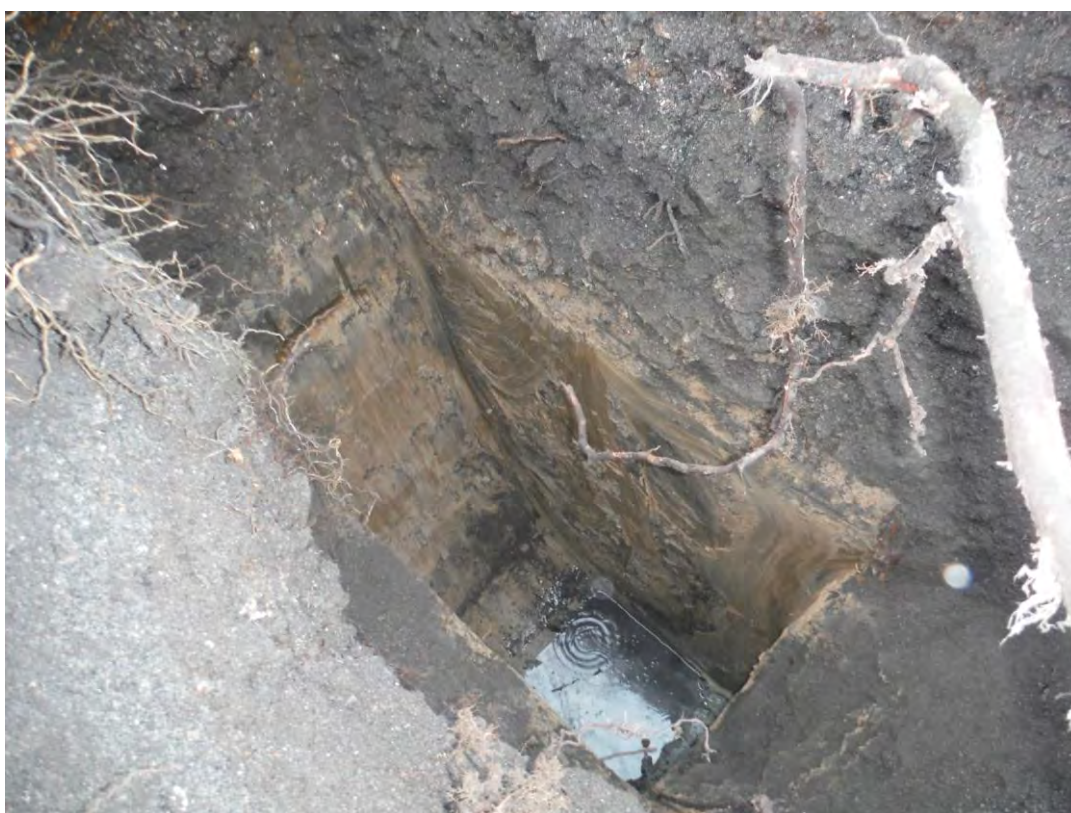
Plate 18. View within TPPH04, water in base is from gradual seepage from the base of the pit.
