## Portishead Branch Line (MetroWest Phase 1)

**Applicant: North Somerset District Council**  
**8.12, Avon Gorge Vegetation Management Plan**  
**The Infrastructure Planning (Applications: Prescribed Forms and Procedure)**  
**Regulations 2009, Regulation 5(2)(q)**  
**Planning Act 2008**

**Author: CH2M**

**Revision: Version 2**

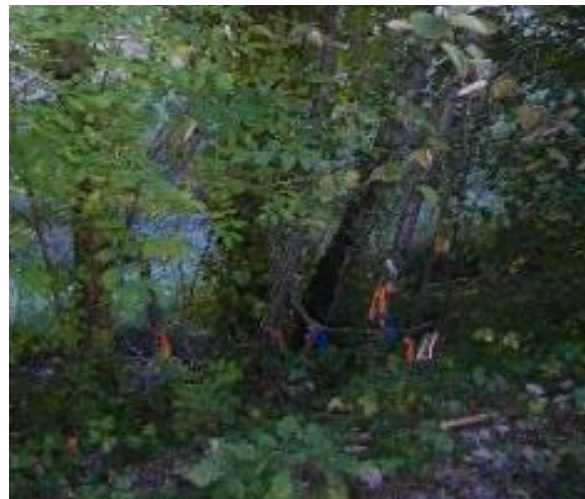
*Plastic yellow collars installed to facilitate the identification of sensitive species during works along the freight line. A number of these collars are now constricting the plant which they demarcate and should be removed to prevent growth restriction and death of the tree.*

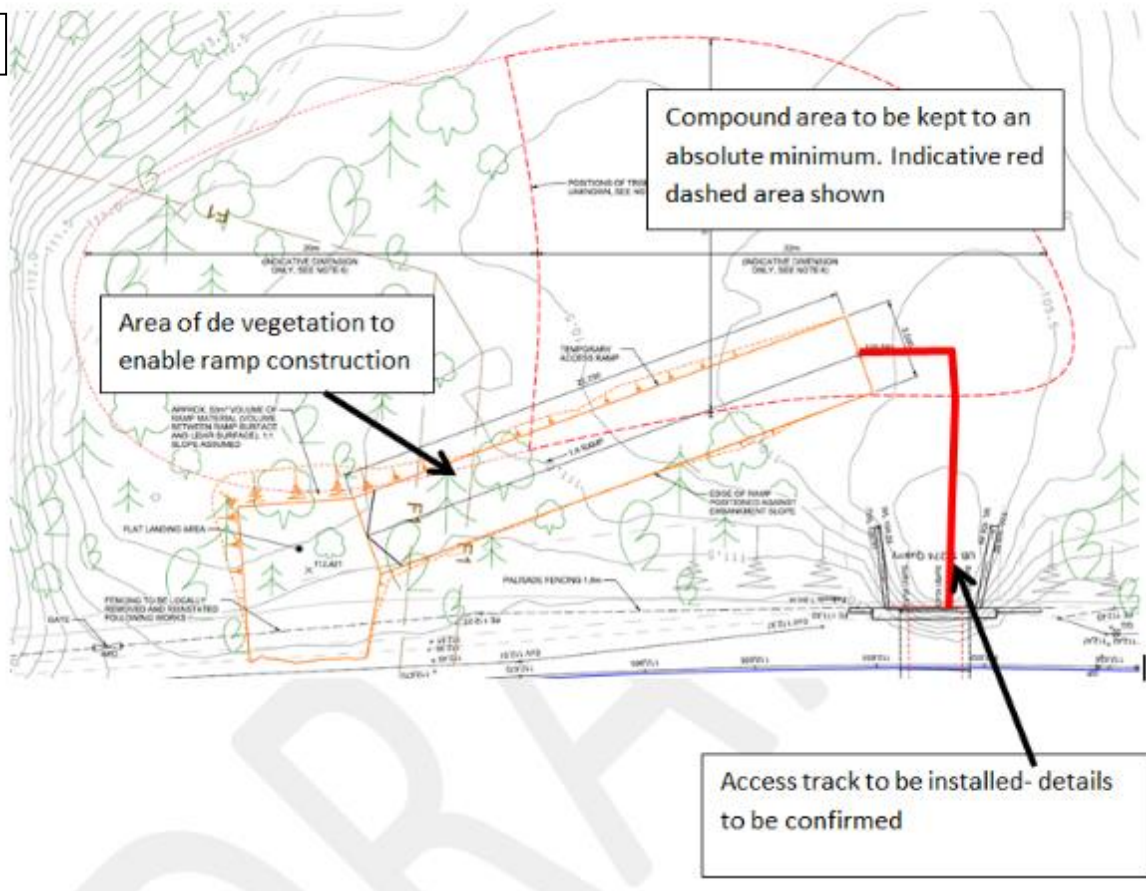
Recommended Location for Works Compound

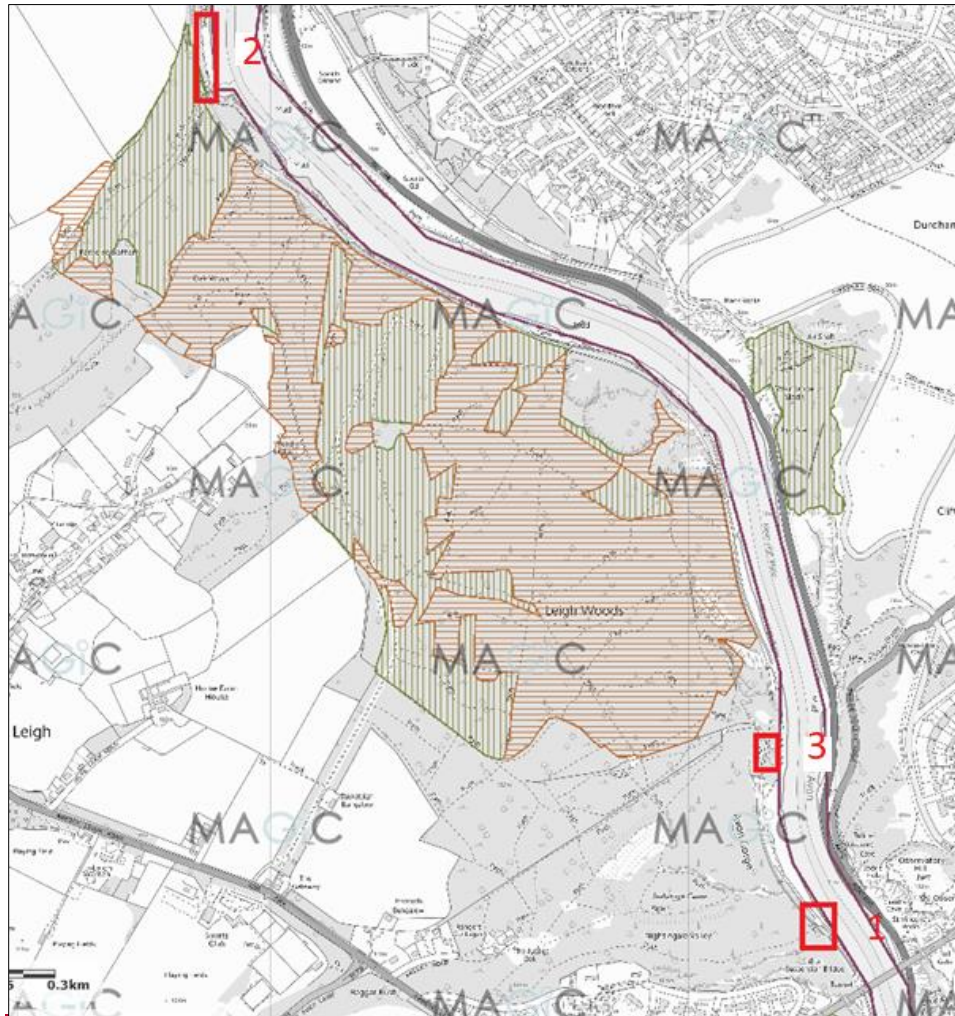
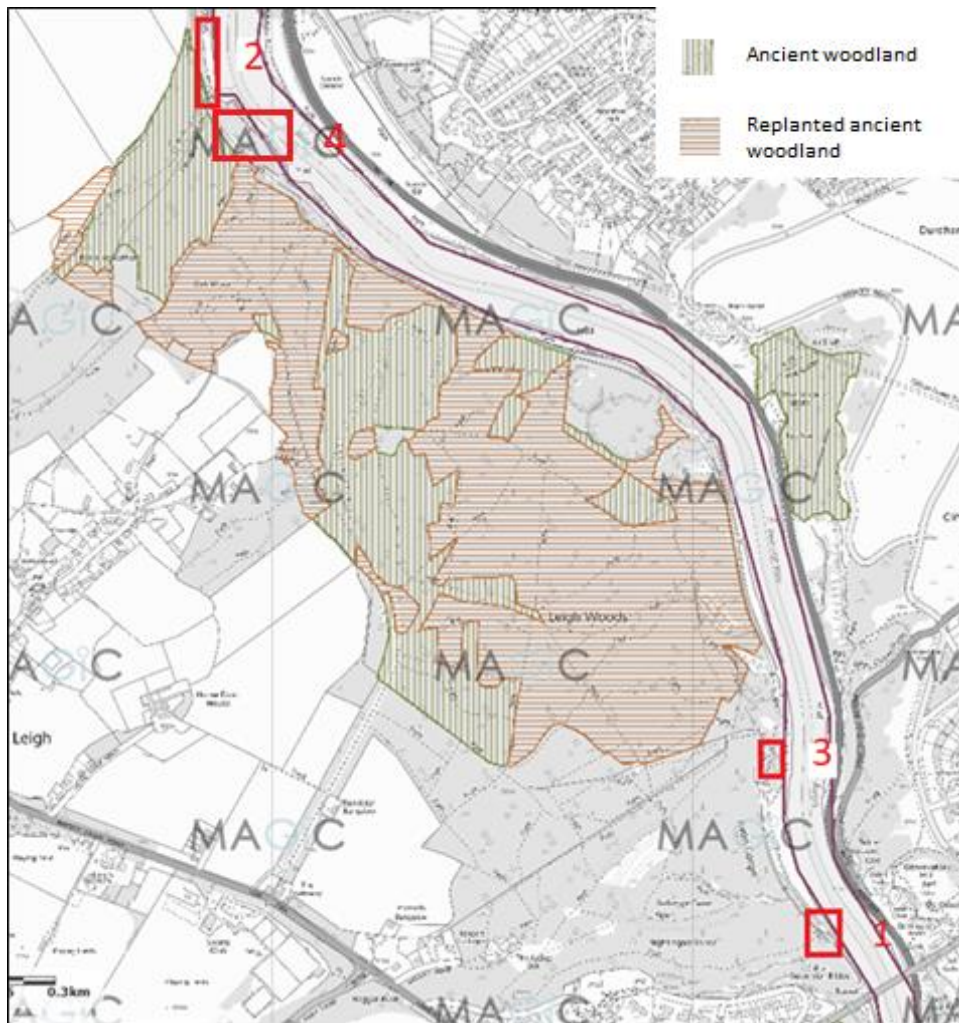
Figure 1. Map showing Ancient Woodland Inventory for Leigh Woods (accessed 18 June 2019) and the ~~three~~four planting sites.

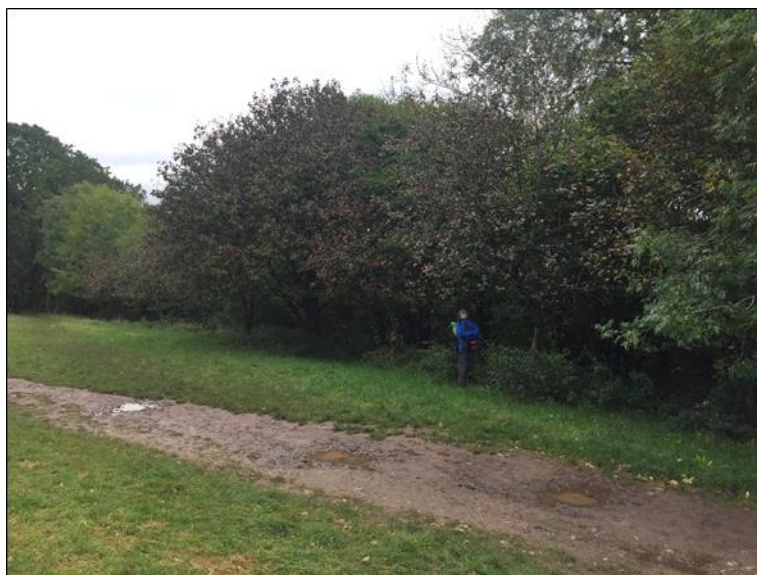
**Photograph 2. Whitebeams planted in a row along the edge of The Plain over c. 50 m, photo taken 8/10/19**

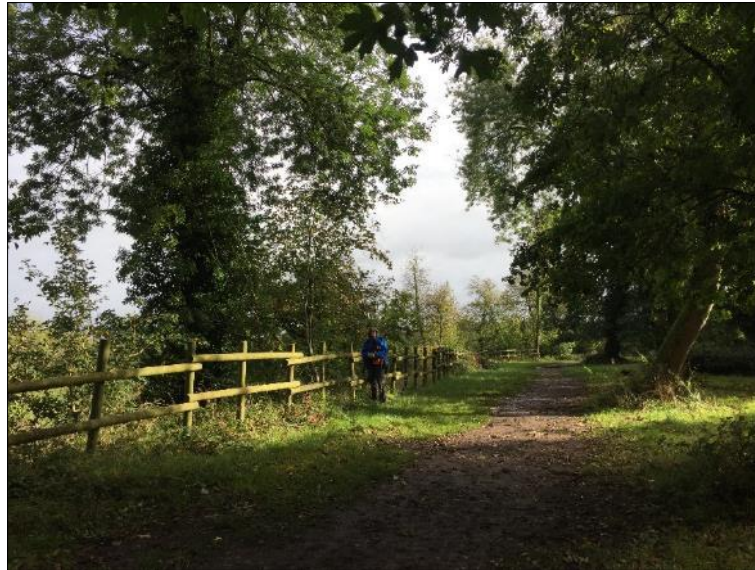
**Photograph 3. Whitebeams planted behind the safety fence in the edge of Leigh Woods Camp, photo taken 8/10/19**

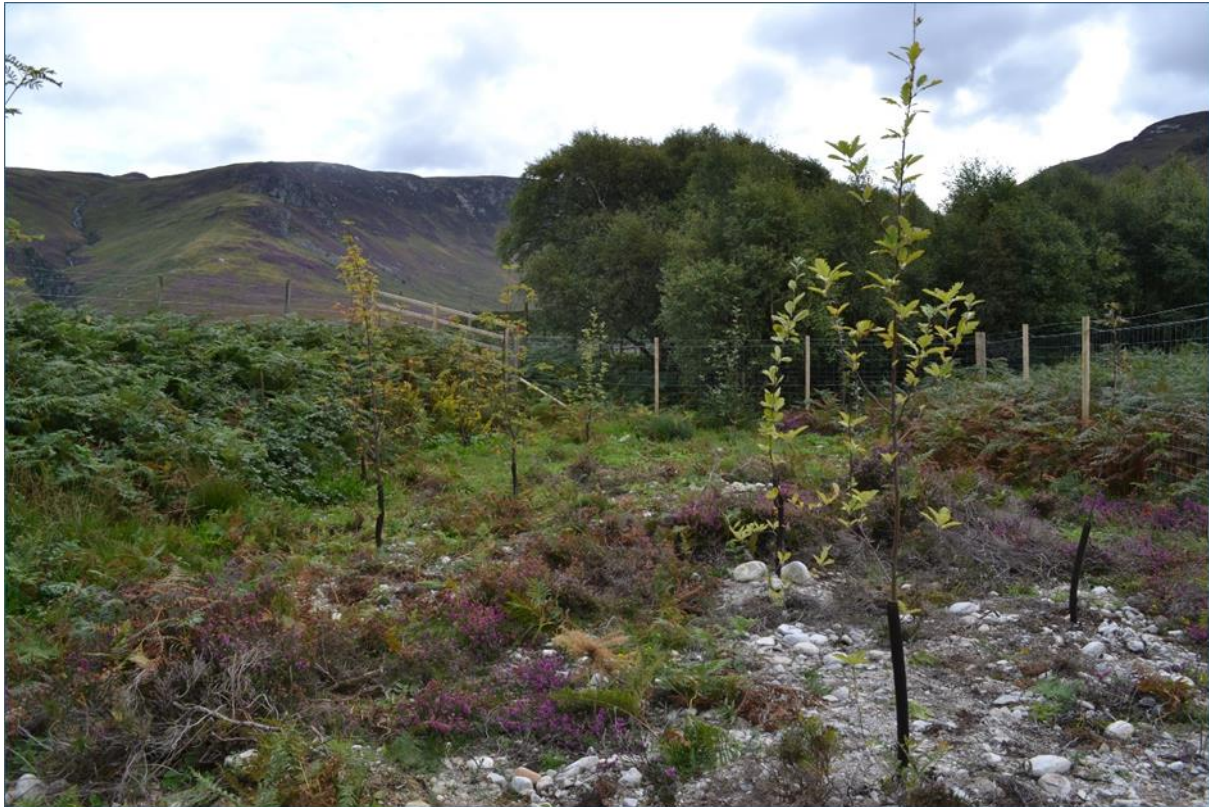
**Photograph 7. Arran Sorbus planting enclosure at mouth of Glen Catacol. September 2014.**

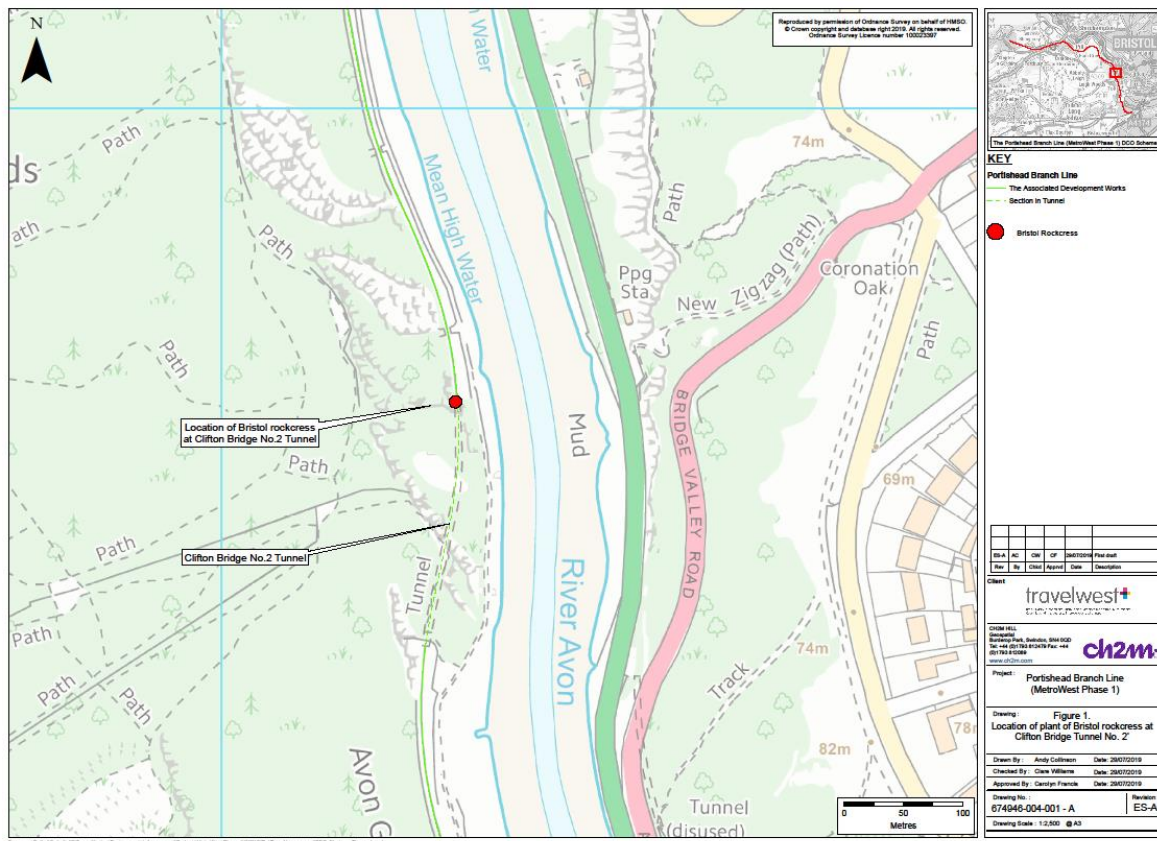
**Figure 1. Location of plant of Bristol rockcress at Clifton Bridge Tunnel No. 2**

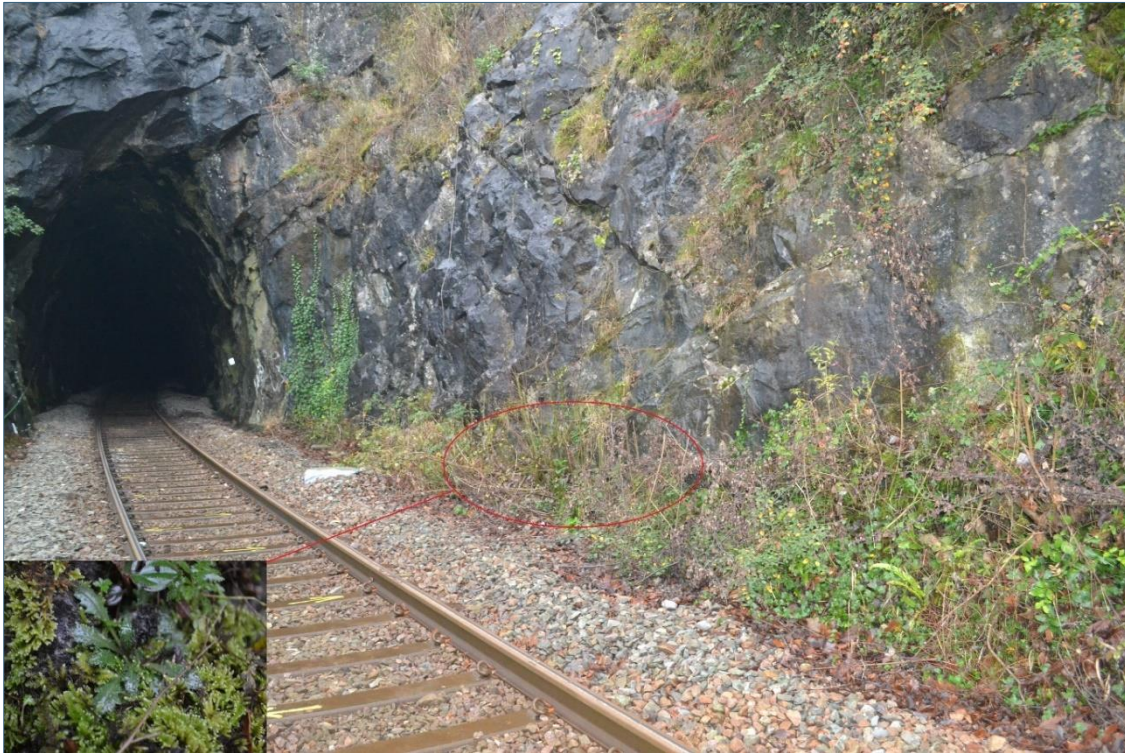
**Figure 2. Approximate location of Bristol rockcress on ledge just outside the Portishead portal of Clifton Bridge Tunnel 2. Inset bottom left: the Bristol rockcress plant in moss.**

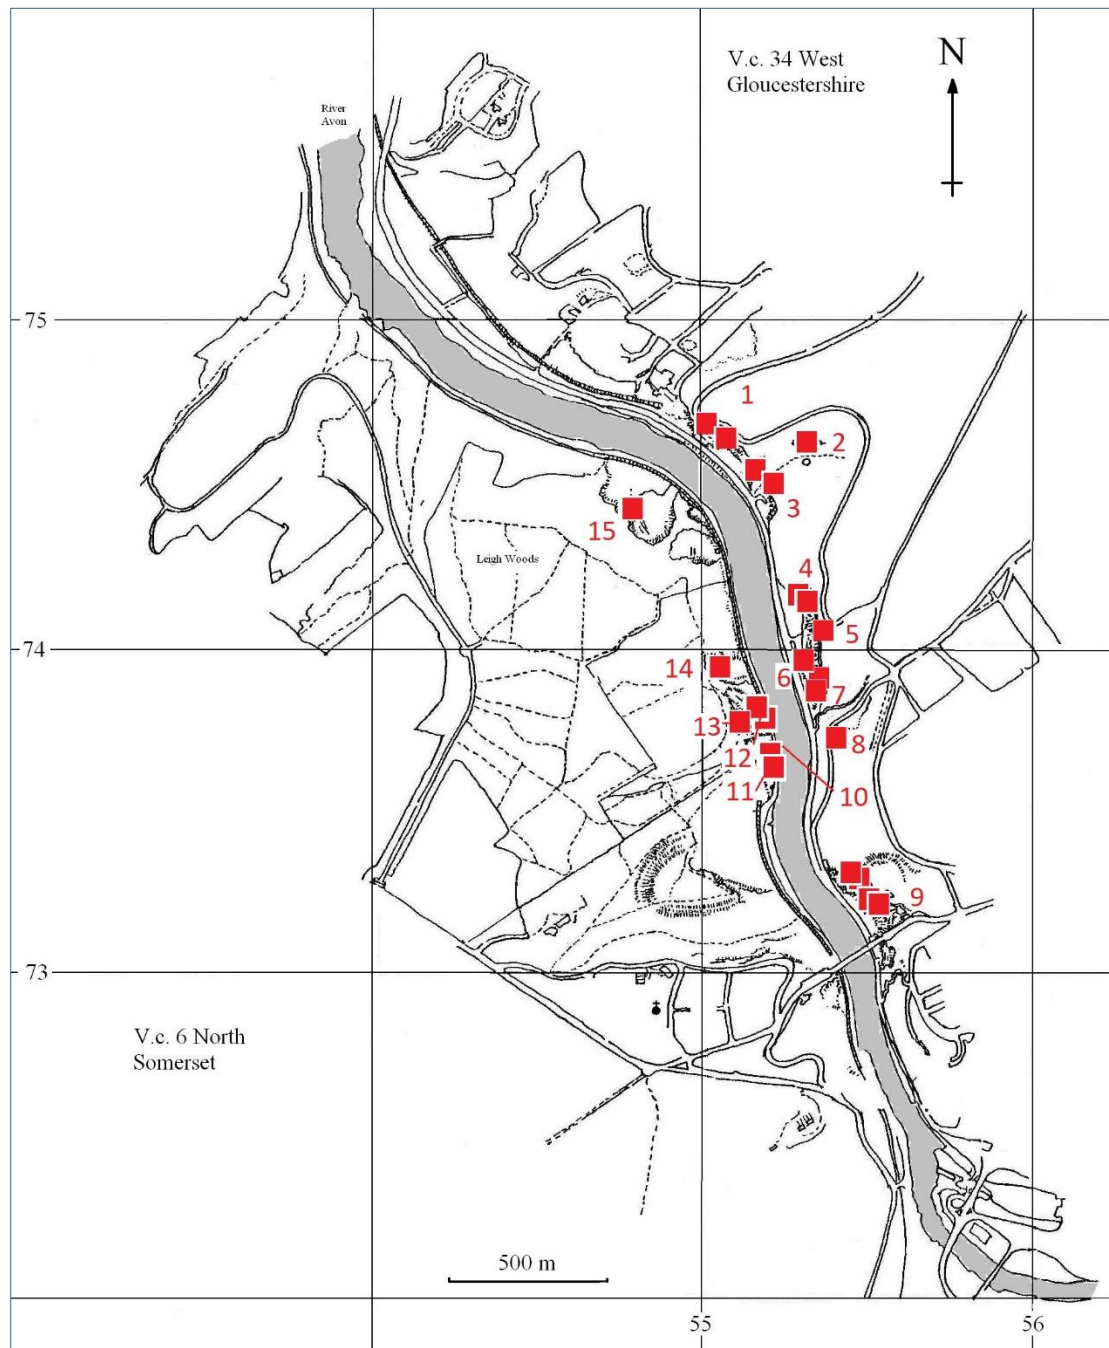
**Figure 3. Distribution of Bristol rockcress in the Avon Gorge.** Site numbering follows Table 1.
