## Portishead Branch Line (MetroWest Phase 1)

**Applicant: North Somerset District Council**

8.12, Avon Gorge Vegetation Management Plan

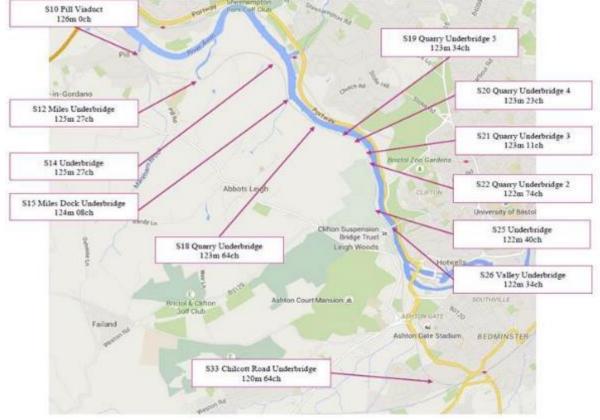
Figure 1: Location of bridges in the Avon Gorge

Structures within the Avon Gorge SAC/SSSI are S15, S18, S19, S20, S21, S22, S25 and S26

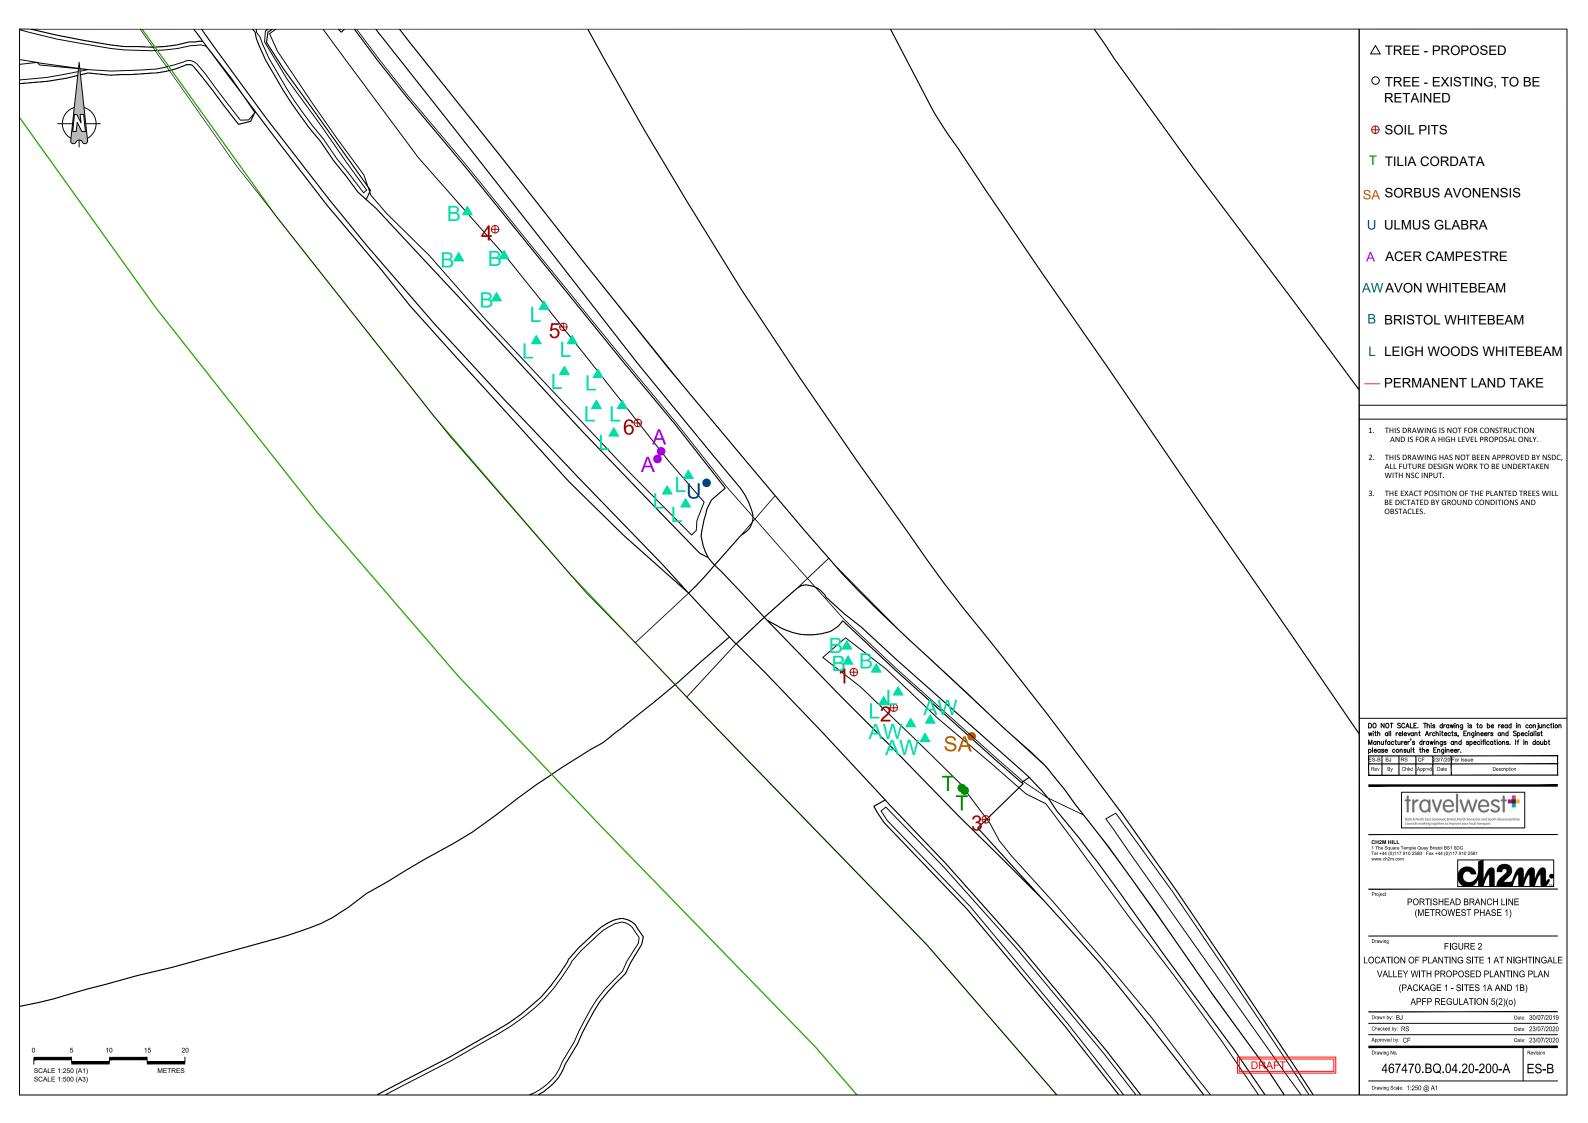
### Vegetation on SE side of Valley Bridge (site 1a)

- 3.2.2. Site 1a is on the east-facing embankment between the freight line and River Avon Tow Path at Nightingale Valley, south of Valley Bridge (Figure 2). The site covers 350 m² south-east of Valley Bridge (35 m long and 10 m wide). The lower side is bounded by a wall c. 1.5 m tall and the upper side is fenced from the railway. The site is on made ground.

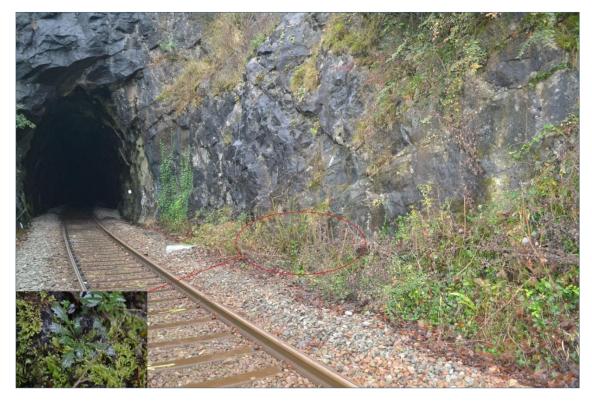
Figure 2. Approximate location of Bristol rockcress on ledge just outside the Portishead portal of Clifton Bridge Tunnel 2. Inset bottom left: the Bristol rockcress plant in moss.
